Stabilisation of open pit wall movements detected by InSAR using horizontal drains

The M15 west slope of Main Pit at First Quantum Minerals' Kansanshi copper–gold mine in Zambia is an actively mined eastward-facing wall. This study highlights the early warning provided by a monitoring service based on interferometric synthetic aperture radar (InSAR). Displacements were detected along the slope face, prompting an intervention using horizontal drains.

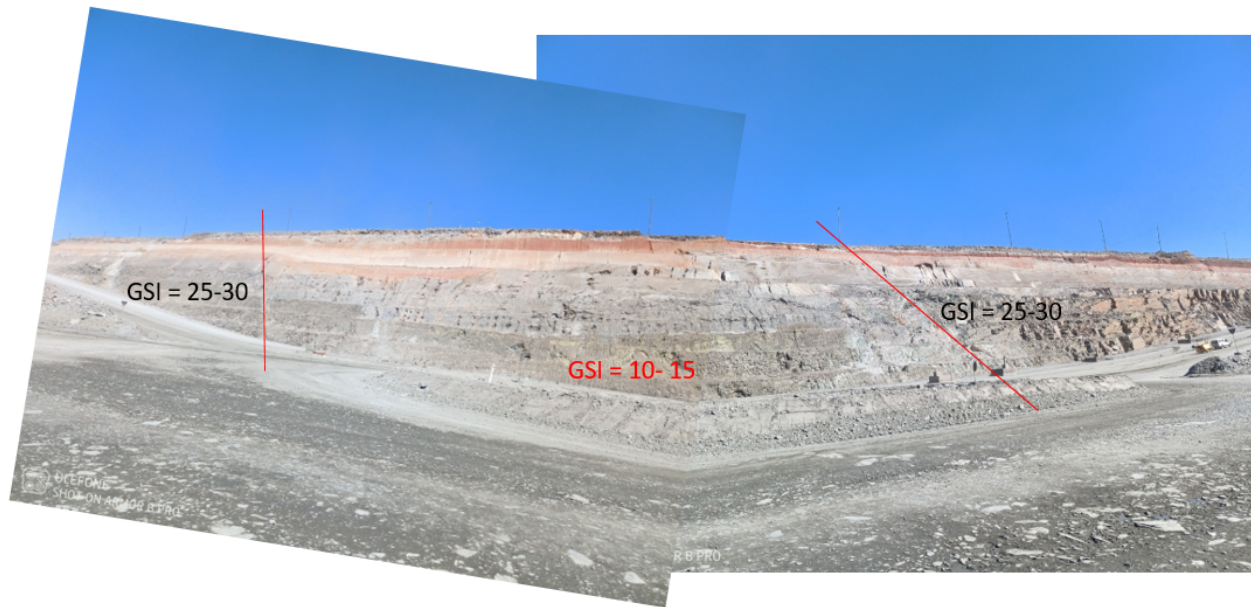
Window mapping was conducted on the Main 15 upper wall. Field observations indicate that the area of movement is confined by two fault planes to the north and south. In Figure 3, the slope and the materials on either side of the fault planes exhibit weathering (GSI = 25 to 30), while the material within the fault zone is highly weathered (GSI = 10 to 15). The rock mass rating (Bieniawski 1989) for the materials was determined to be 32 (weathered rock) and 14 (fault zone). The underlying mode of failure was identified as wedge failure; however, due to the high degree of weathering, it is believed that the failure mechanism may exhibit more complex behaviour, resembling a circular failure. The susceptibility of slopes to failure is influenced by a combination of internal and external factors, including slope geometry, rock type, geological discontinuities, groundwater conditions, surface drainage, rainfall, seismicity and human activities (First Quantum Minerals 2022).

Figure 3 Main 15 ramp intersection showing the difference in material quality

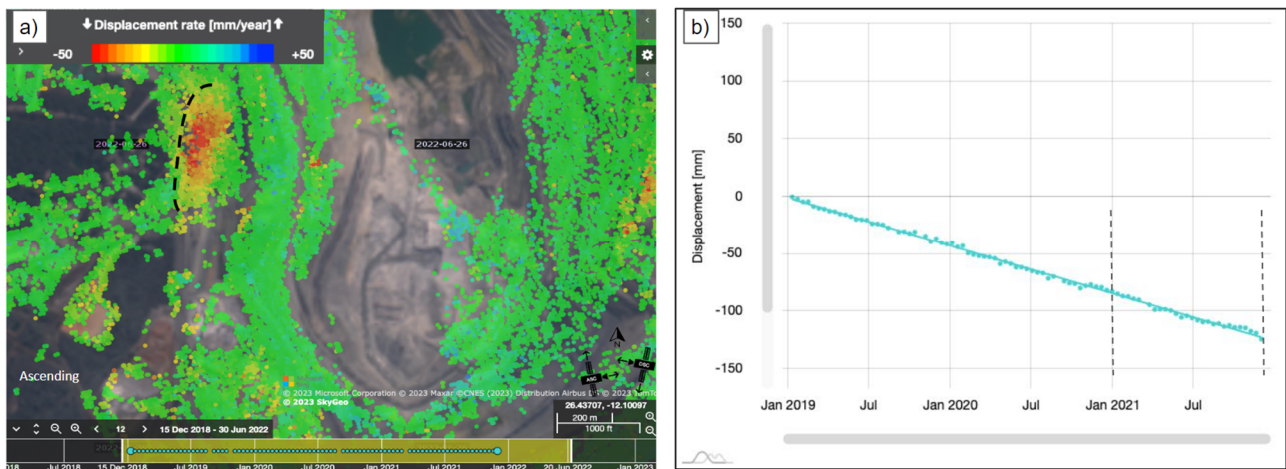
The Sentinel-1 data over the area of interest shows steady subsidence over time with no significant changes to the spatial extent of displacements (Figure 8). During the active mining of the waste-rock dump from May to August 2021, a slight reduction in the displacement rate was observed (from -41 mm/year to -39 mm/year).

Figure 8 Sentinel-1 ascending data over the area of interest, showing the time series of displacements from 2019 to 2022. (a) A heatmap of the rate of displacement over the same period; (b) The rate of displacement is an estimated average of 40 mm/year away from the line of sight of the satellite, which can be interpreted as subsidence

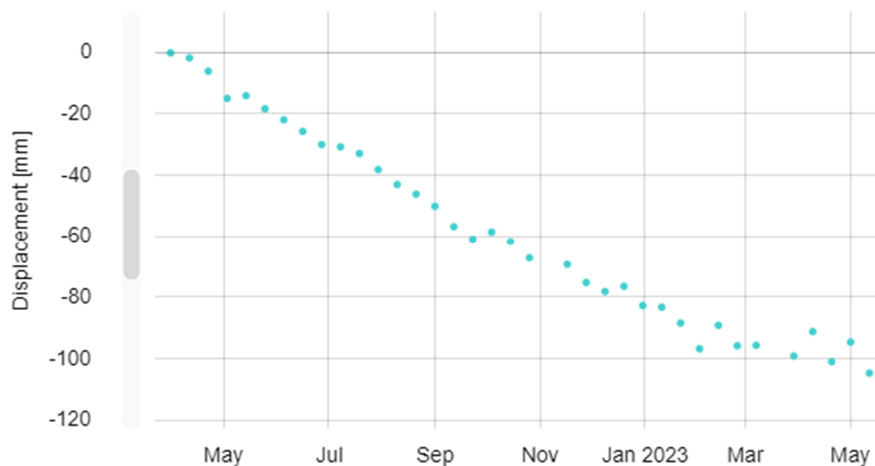
This section focuses on displacement estimations from the TerraSAR-X ascending satellite, which is particularly sensitive to slope displacements along the M15 wall due to its line of sight being parallel to the downward slope. The first early warning alert was issued by SkyGeo in June 2022 during the first quarterly review of pit displacements. Displacement rates between 30 March 2022 and 26 June 2022 were found to be around -85 mm/year, surpassing the historical baseline displacement rates of approximately -40 mm/year. In the subsequent quarterly report of September 2022, the M15 west pit was again flagged for accelerated displacements. Notably, the M15 west wall experienced a subsidence of over 3 cm between June and September 2022, marking the most significant subsidence observed on the wall face during the monitoring period, as indicated by Figure 9.

Figure 9 The time series and cumulative displacement from TerraSAR-X ascending indicated over 10 cm of displacement occurred during the entire time period between March 2022 and April 2023

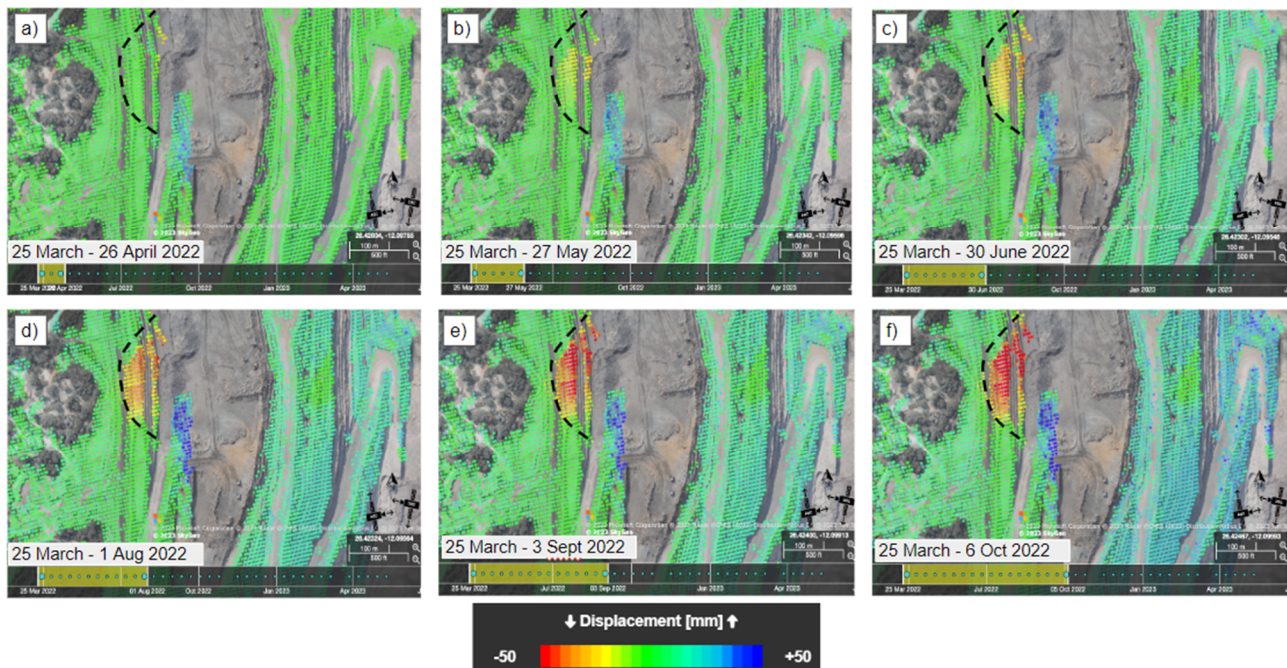
In addition to the increased magnitude of displacements, notable spatial patterns were detected, as depicted in Figure 10. Movement was observed on multiple benches, starting from the base of the wall and spreading radially and laterally, resulting in a circular subsidence pattern. This was considered a precursor to a planar failure along the slope face. Given that many types of failures are influenced by groundwater conditions and seismicity, the presence of groundwater daylighting structures and nearby blasting activity led to the hypothesis that these factors contributed to the failure mode. Consequently, the monitoring reports were updated to a monthly frequency and eventually a biweekly frequency to track the failure precursor in a more timely manner.

Figure 10 TerraSAR-X ascending data indicating the changing displacement rate and spatial extent of displacements on the M15 wall between March and October 2022 (a to e). Semi-circular subsidence pattern indicated by the black dashed line

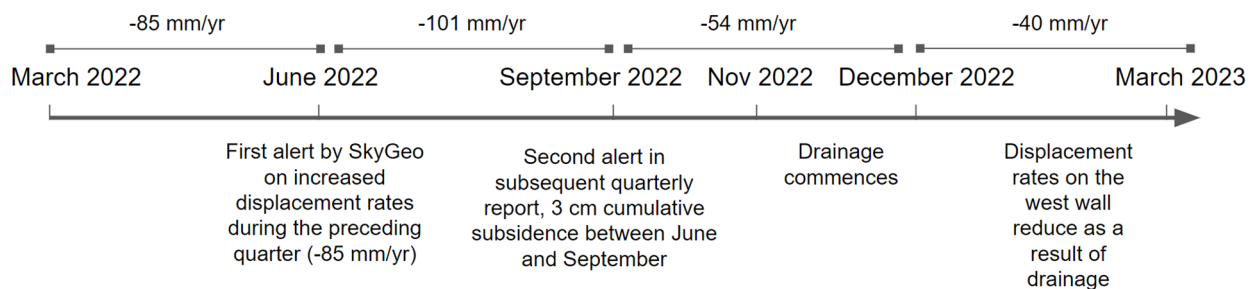
The depressurisation drilling began in November 2022 and lasted until December 2022. During this period, the rate of displacement estimated with InSAR on the wall showed major reduction going from -101 mm/year to -53.4 mm/year as depicted in Figure 12.

Figure 12 Timeline of events and displacement rates over the M15 west pit wall. Approximate location of displacement rates are shown in Figure 13

The drainage commenced in November 2022, with horizontal drains installed to a depth of 120 m and spaced 150 m apart at -5° inclination in specific locations. The drains were not cased. The response to groundwater elevations were monitored using the VWP network over the mine, as shown in Figure 11.

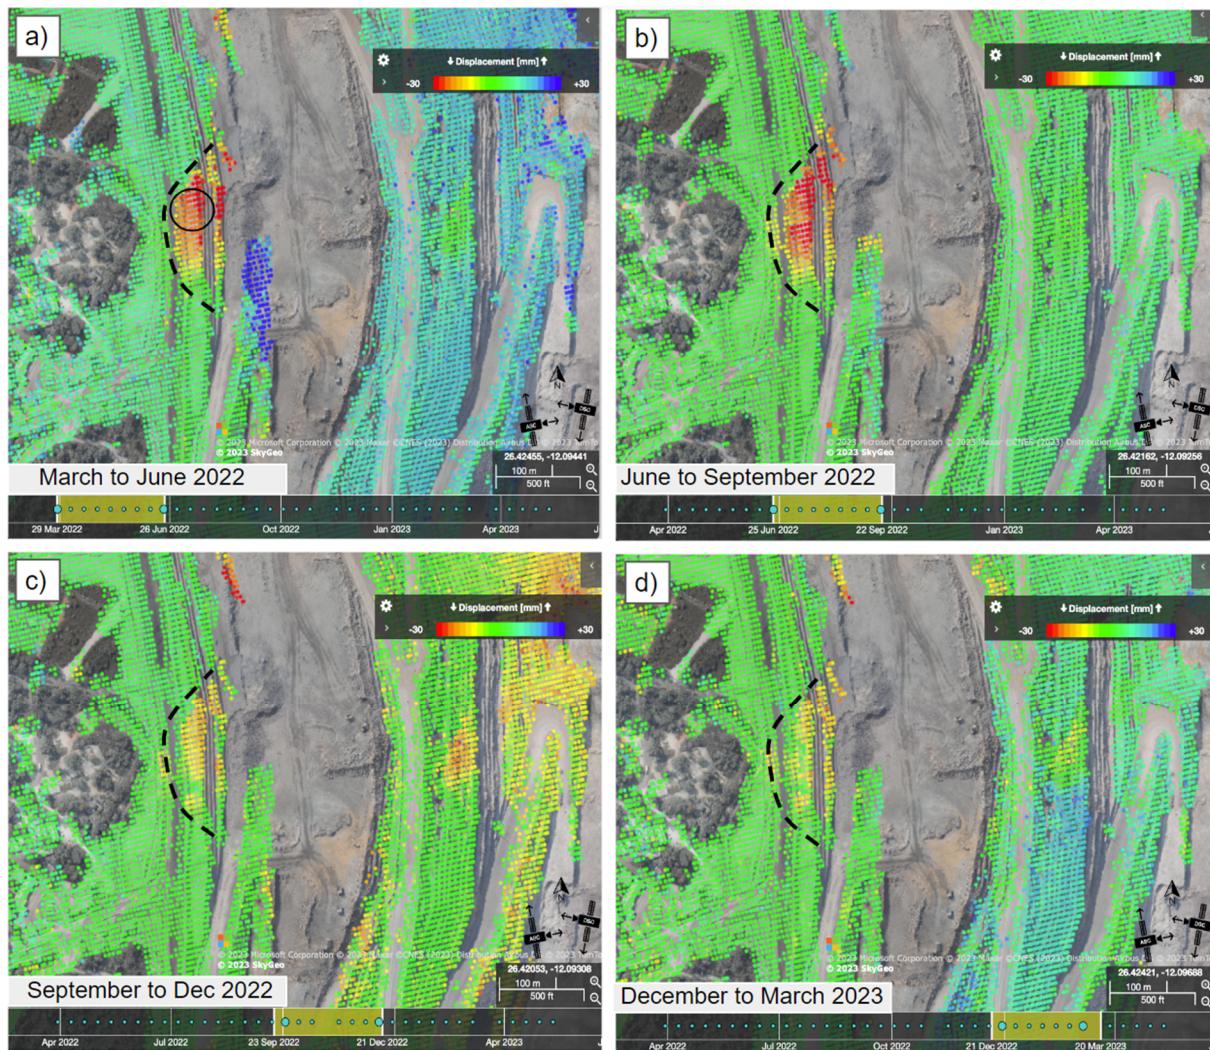
The circular spatial subsidence pattern was replaced by local spots of continued displacement. These regions were at the base of the pit wall, at the crest and on certain benches further south of the originally displacing area, where other mining activities were ongoing. This is depicted in Figure 13.

Figure 13 Evolution of the circular subsidence pattern on M15 West Pit wall. (a) March to June 2022; (b) June to September 2022; (c) September to December 2022; (d) December 2022 to March 2023. The black circle on (a) refers to the approximate location of the displacement rates quoted in Figure 12

It was well noted that despite the impact of the rainy season, displacement rates did not return to pre-intervention levels, indicating that the slope had been successfully stabilised. This is highlighted in Figure 13 where the displacement rates stabilise around -56.3 mm/year with a further reduction to -40.3 mm/year, which is in sync with the abatement of the rainy period.

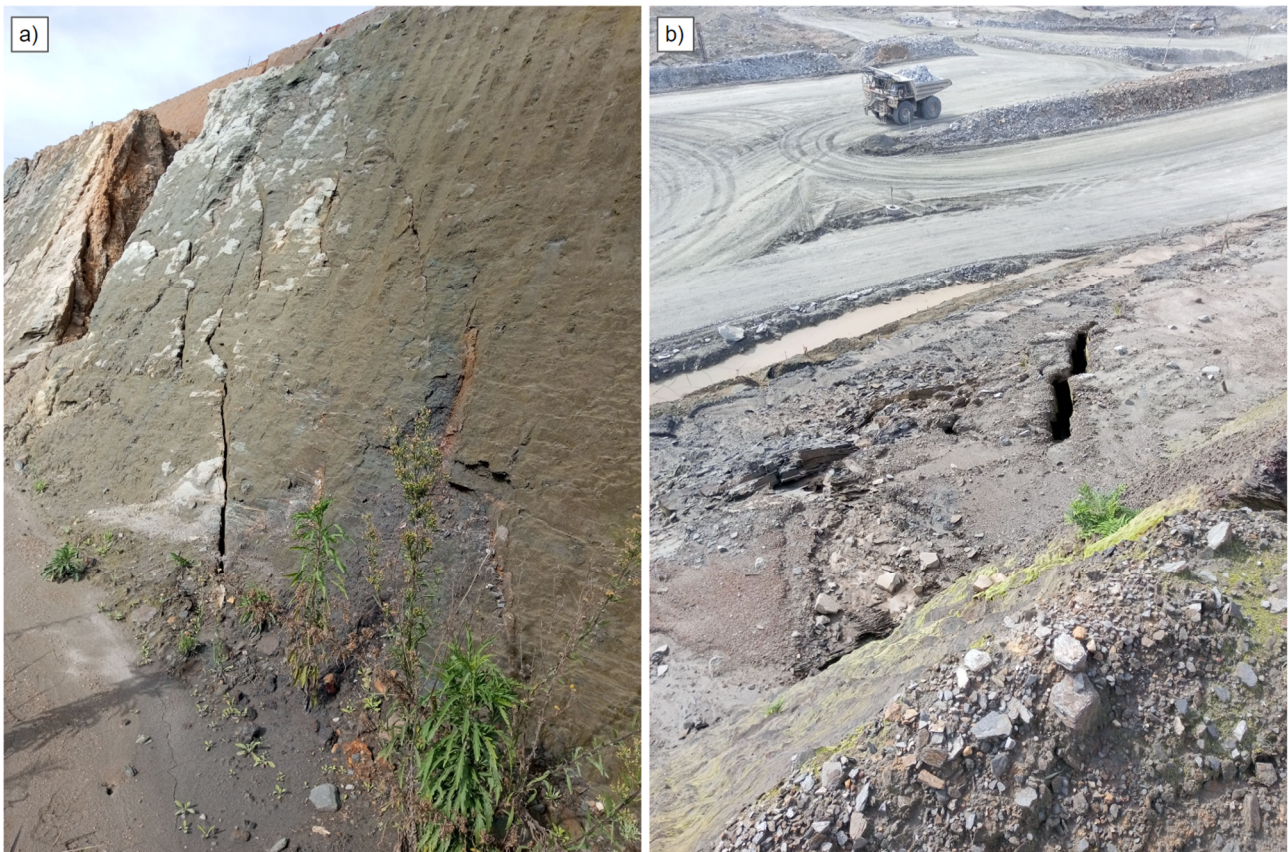
The deterioration of the Main 15 upper area, due to rainfall, is shown in Figures 15 and 16. Displacement recorded from the GBR shows an increase in displacement rate during both rainfall seasons 2021/2022 and 2022/2023, shown in Figure 17. The material does show delayed acceleration in the 2022/2023 season. The total movement recorded was 317 mm over 19 months, with a velocity of 0.56 mm/day. This displacement is not seen during daily operations, and if it were not for the InSAR monitoring, focus would not have been placed on this area until it was too late to remediate the area. The erosion and infiltration of rainwater reactivated the material and caused acceleration of the material mass during the 2022/2023 wet season.

Figure 15 Images (a) and (b) show open joints and erosional gullies

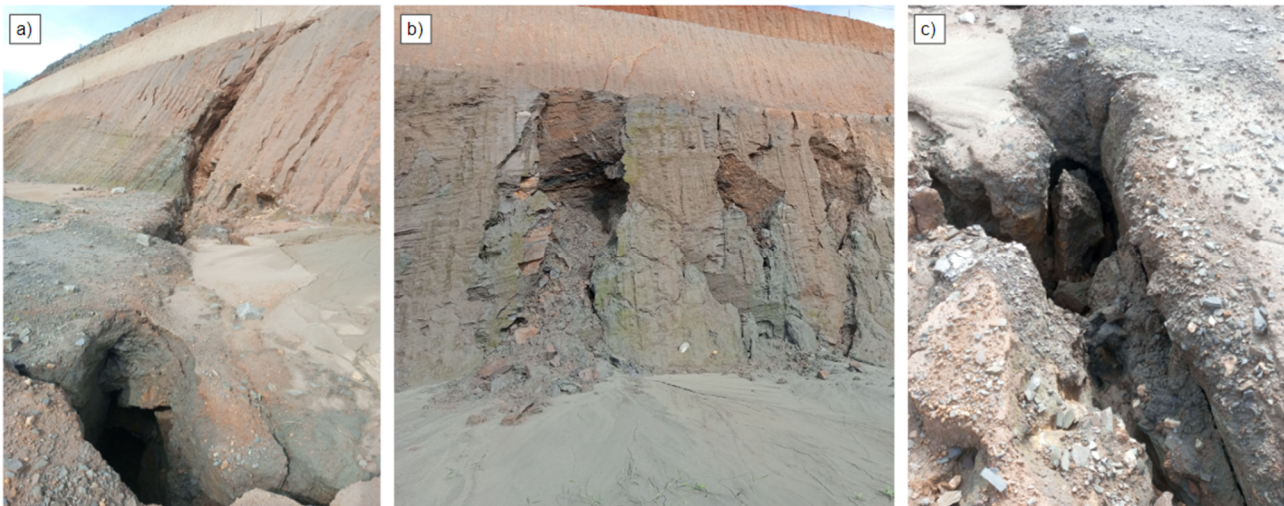
Figure 16 The effect of rainfall on the dispersive saprolites, showing piping in the slope. (a) Erosional channel through the joint; (b) Fall-out of saprolite material from the joints; (c) Erosion channel

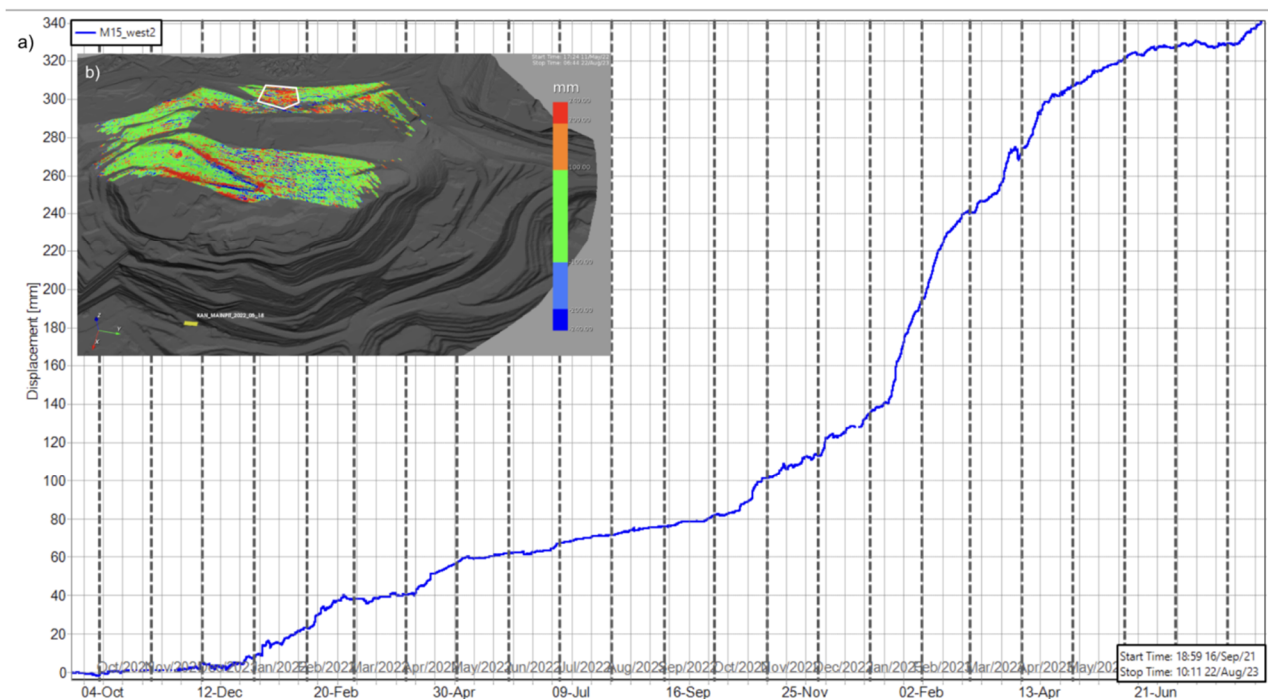
Figure 17 Main 15 ground-based radar data. (a) Average time series graph from 16 September 2021 to 22 August 2023; (b) Inset displays the slope face area, for which the time series graph was generated, overlain on a displacement heat map from 11 May 2022 to 22 August 2023 set to ± 240 mm colour scale (blue is -240 mm, red is $+240$ mm) in line of sight of the radar
