A case history of a major fault slip rockburst

David Landry ^{a,*}, Justin Roy ^a, Navita Ramdass ^a, Ana Leite ^a, Scott Shears ^a

^a Vale Base Metals, Canada

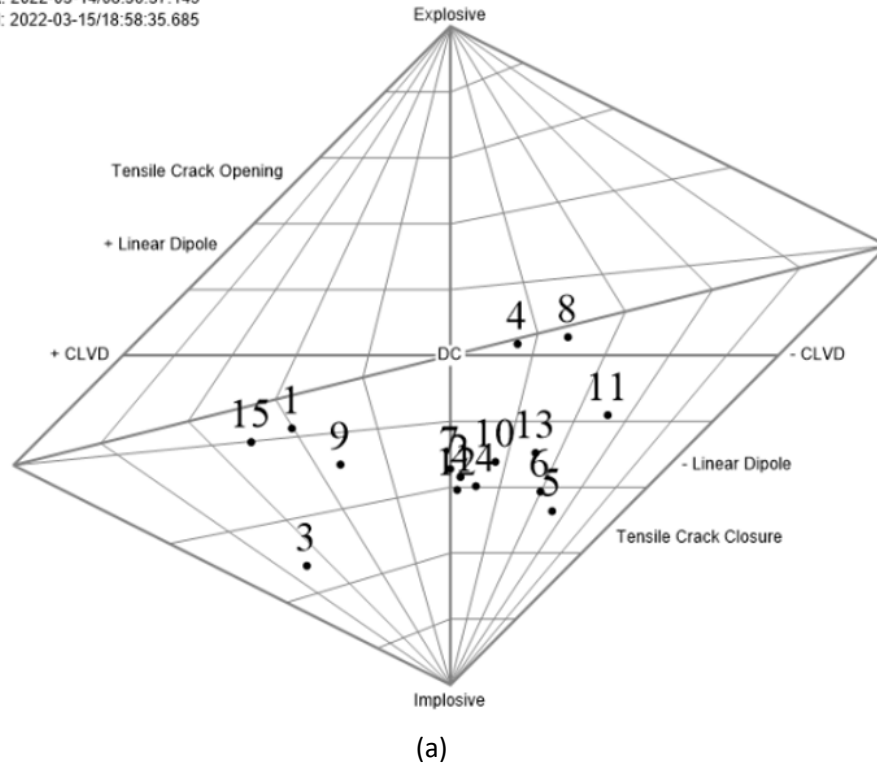
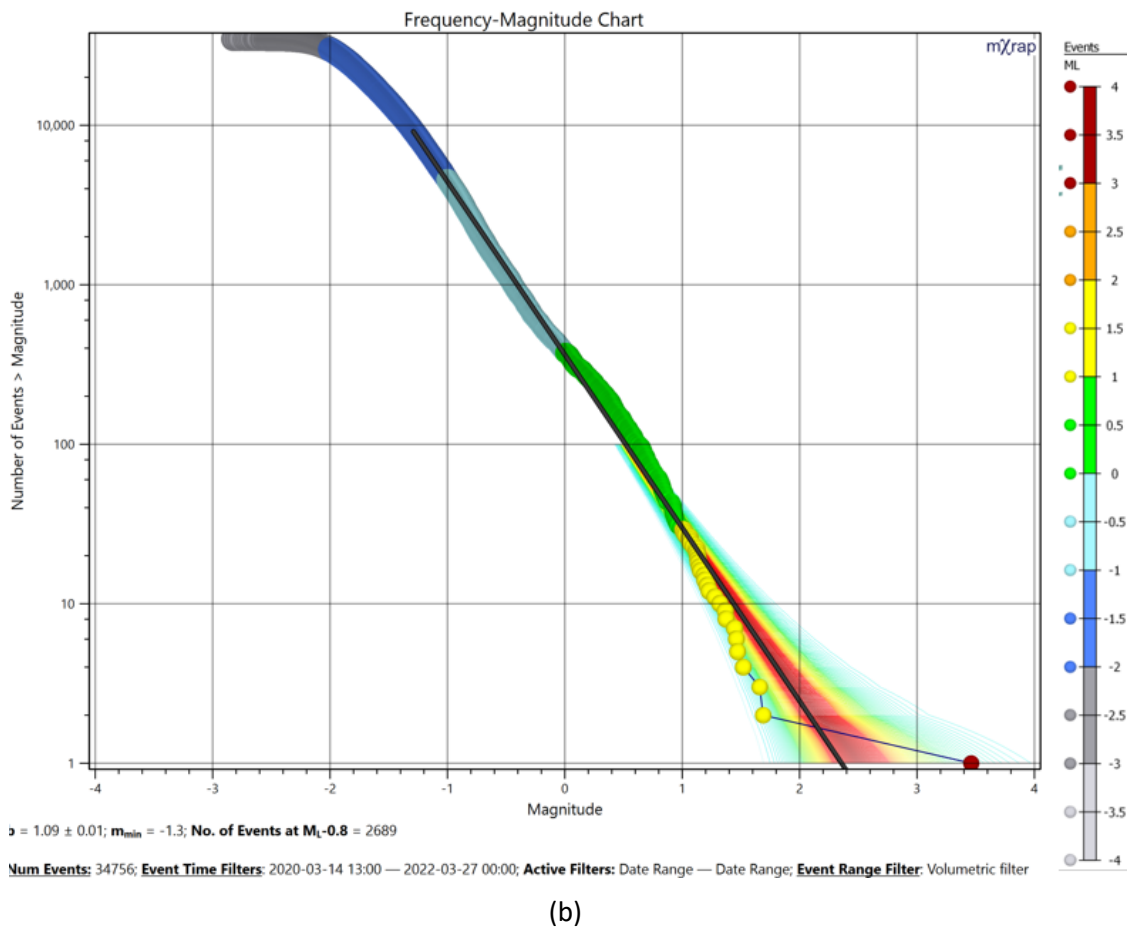
Figure 7 (a) Hudson plot for the ME-250 seismic event precursors and aftershocks. Most events are shear slip with closure and two are pure shear failure; (b) Frequency–magnitude relation for the 4945 Block 2 Sill Pillar for two years prior and two weeks following the ME-250 incident

Prior to the ME-250 event, the seismic data suggested a failure mechanism primarily driven by rock fracturing or sill pillar loading (strain events in the sill pillar). However, the MN3.5 event resulted in a series of seismic events along a distinct observable plane (now named the ME-250 fault) in the footwall of the orebody which was not previously observed. This indicated that the failure mechanism may have been a fault slip event. A seismic moment tensor inversion solution was not possible for the large event due to the complexities in the waveform, however 15 mechanism solutions for associated foreshocks and aftershocks were determined. Prior to the MN3.5 event, the ME-250 fault had not been apparent during routine seismic analysis or geologic reviews of drillcore carried out by engineering staff or during routine mapping of underground development drives. Figure 7 shows the Hudson plot produced for larger seismic event precursors and aftershocks, as well as a frequency–magnitude relation for the 4945 Block 2 Sill Pillar for two years prior to the ME-250 event.

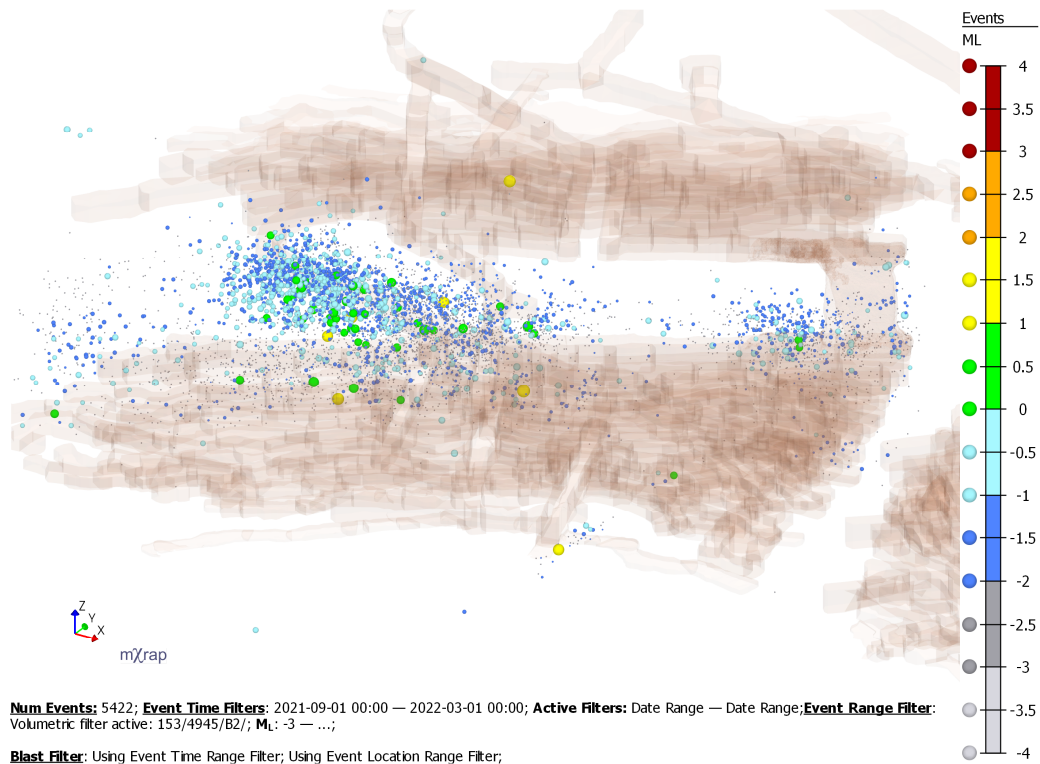
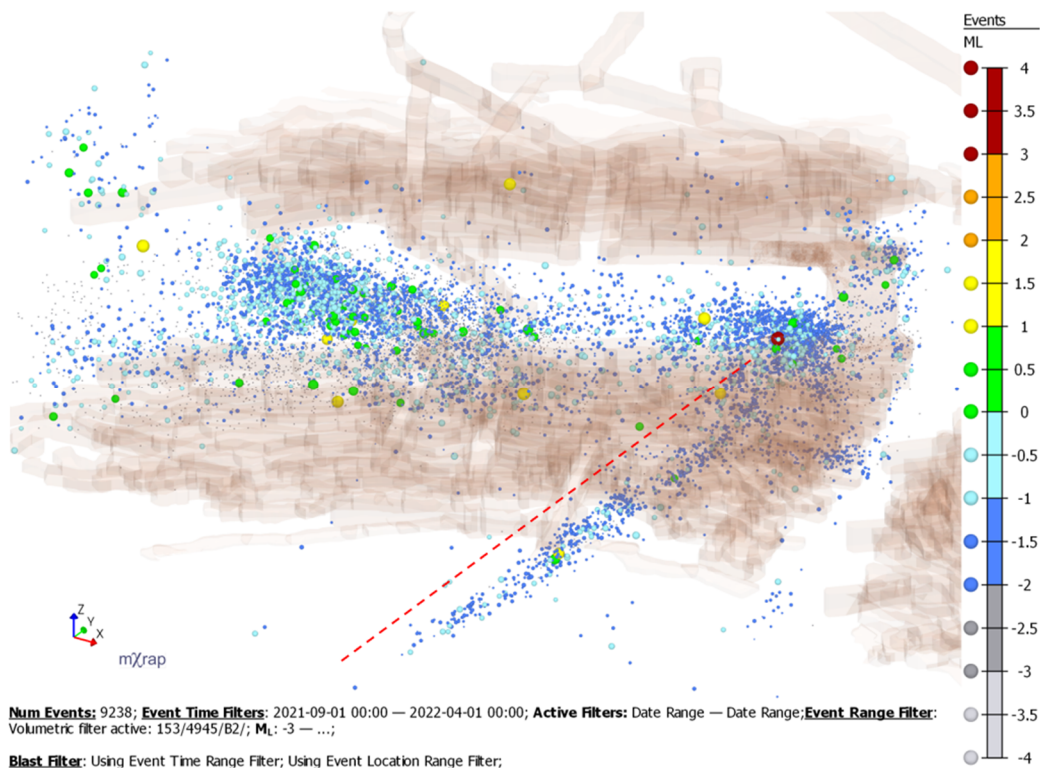
Figure 8 Isometric views looking north from the hanging wall of the orebody. (a) Seismic events coloured by magnitude (six months prior to ME-250); (b) Seismic events coloured by magnitude (six months prior to ME-250 and one month after) where the observable seismic trend (ME-250 fault) is evident

Figure 8 shows the seismic data before and after the ME-250 event.

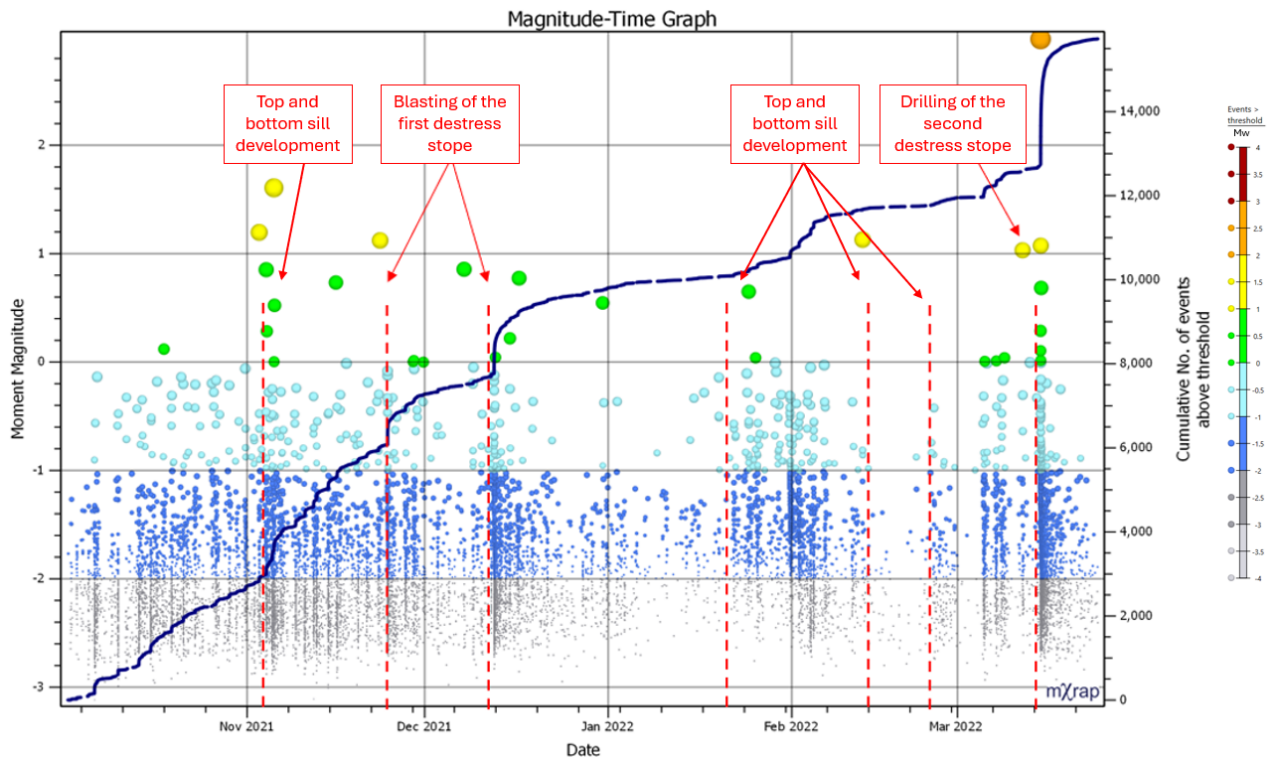
For the most part, mining-induced seismicity is triggered by blasting. However, the data suggested that there was no specific trigger for the MN3.5 event (i.e. blasting, drilling, filling, etc.). The event occurred while production holes were being measured and the stope had been drilled-off several days before. The neighbouring stope had been backfilled a month prior and stope blasting had not occurred for over three months. Prior to ME-250, the largest event in the block was a MN1.7 which occurred during production drilling several shifts prior to ME-250. Figure 9 shows the seismic trend (magnitude–time, in moment magnitude MW) for the sill pillar for roughly six months prior to the ME-250 event.

Figure 9 shows a seismic event trend where spikes in activity and large events are driven by key mining steps such as development, stope blasting or drilling. The challenge with the ME-250 event is that it was delayed, meaning there was no specific trigger and it occurred long after a blast. Additionally, the ME-250 fault structure was not known prior to the event. Delayed events are difficult to manage as a post blast re-entry protocol typically will not capture them. The primary tool to manage delayed events is ground support (once design measures are exhausted).

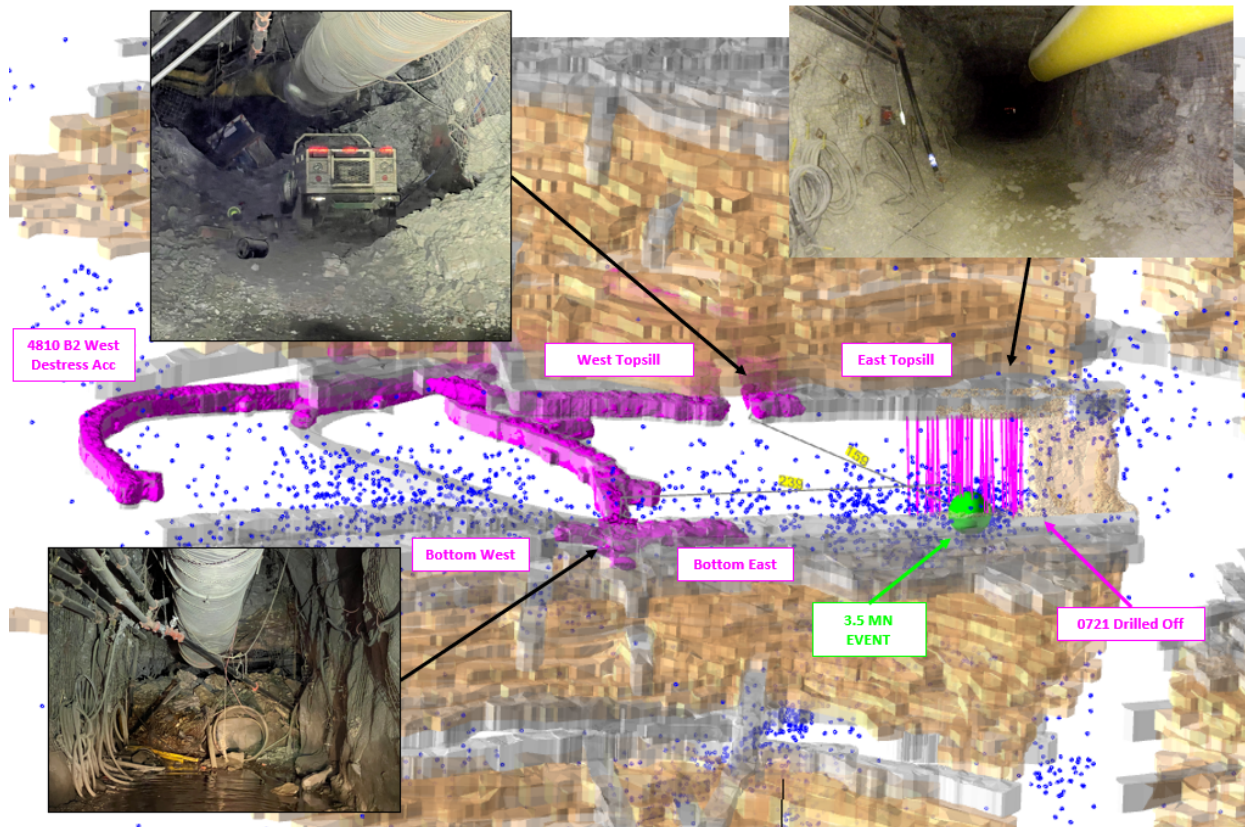
Figure 10 Long section looking North showing a simplified damage map of the 4945 Block 2 Sill Pillar post ME-250 rockburst

Observations from the site investigation indicate that most of the damage occurred at a distance between 80 m and 120 m from the seismic source, and ground support performed well closer to the seismic source. Much of the damage was driven by 'shakedown' (shake-out or shake-down of previously fractured material). Figure 10 shows an isometric view of the 4945 Block 2 Sill Pillar highlighting the MN3.5 event location, post event micro seismicity, and key damage locations (drone scan images).

On the top level, floor heaving, wall bulking and shakedown of backfill was observed throughout the main access. Several backfill fences previously installed had been cracked, ejected, or had bulked/heaved. A remote production drilling stand was also affected by the rockburst damage (see top left photo in Figure 10). The remote drilling stand was placed roughly 80 m from the stope but was inadvertently in the area which was damaged by the seismic event. Remote drilling was being utilised for production drilling in the sill pillar as seismicity is often triggered by drilling. Remote drilling is an important control measure to keep workers away from high stress ground conditions.

In the bottom level of the sill pillar, failure was isolated to a main intersection (roughly 450 t) which was used to access the stope for mucking. Failure extended beyond the intersection support (3.6 m inflatable bolts) up to the ore lens contact; depth of failure of roughly 3.6 m. Seven shotcrete pillars had been constructed in the main intersection area to reduce its effective span and limited the extent of the failure. Additionally, in some damaged areas, visible corrosion on the support elements was evident suggesting the capacity of these supporting elements had been compromised. An immediate lesson learned was actioned to inspect all high seismic hazard areas and upgrade the ground support where insufficient length or corrosion was identified.

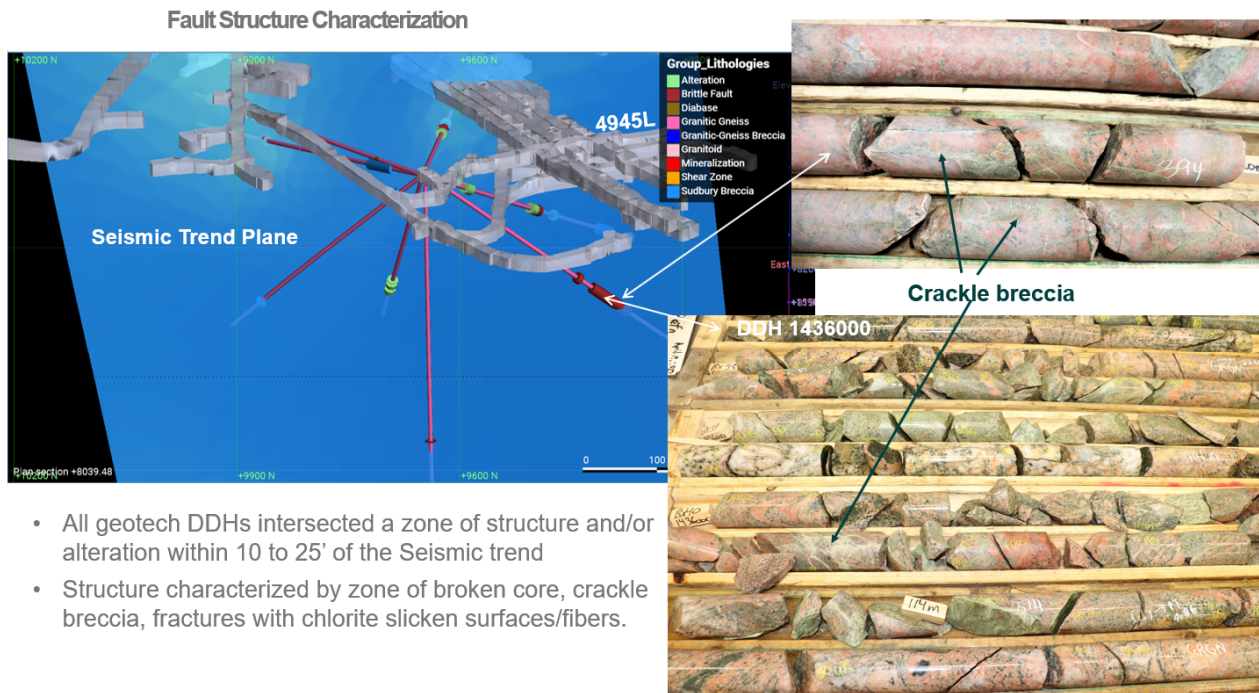
Figure 15 Isometric view of 4945 Block 2 footwall showing completed geotechnical drilling locations along with observations completed by the structural geology team

A targeted diamond drilling program was completed to better understand the ME-250 fault and test for other major structures in the sill pillar. The drilling confirmed and defined the ME-250 fault. The primary conclusion from the structural analysis is that the ME-250 fault was identified (post-MN3.5 event) by a small zone of broken ground (damaged from the seismic event). The zone is characterised by multiple slip surfaces (slip along fractures) containing chlorite alteration (pink potassic, epidote and chlorite alteration). Figure 15 summarises the results of the structural drilling program.

- All geotech DDHs intersected a zone of structure and/or alteration within 10 to 25’ of the Seismic trend
- Structure characterized by zone of broken core, crackle breccia, fractures with chlorite slicken surfaces/fibers.
