Lessons learnt from a pillarburst at a development heading in one of Vale's deep mines: a case study

Mike Yao ^{a,*}, Alex Hossack ^a, Chris Groccia ^a

^a Vale Base Metals, Canada

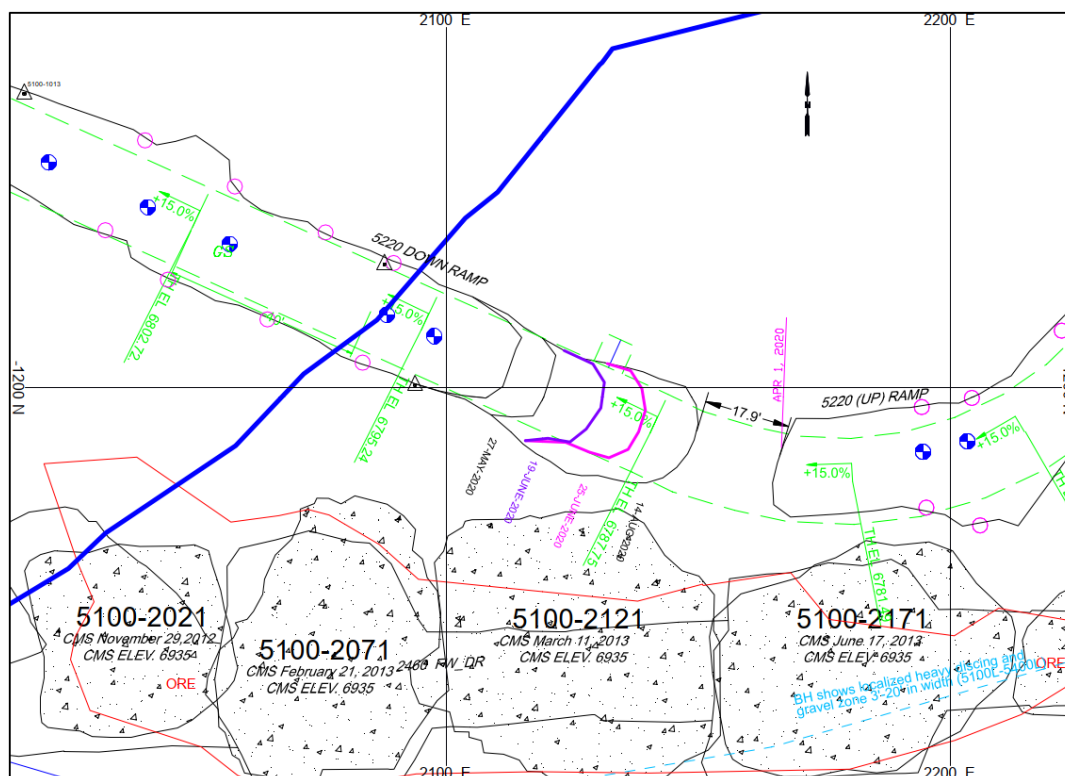
The 5220 Ramp is an access ramp that was advanced on the west side of the mining zone, between 5100 Level and 5200 Level. An access ramp on the east side of the mining zone between 5100 Level and 5200 Level enabled the 5220 Ramp to be developed from two access points concurrently; the 5220 down ramp was driven downwards toward 5200 Level, while the 5220 up ramp was driven from 5200 Level advancing upwards towards 5100 Level. The 5220 down ramp and the 5220 up ramp required a breakthrough to create a single continuous ramp (the 5220 Ramp). Therefore, by design, the 5220 Ramp excavation necessitated a development breakthrough pillar, as shown in Figure 3.

Figure 3 Plan view of the last survey of the 5220 Ramp before the breakthrough pillarburst

The last development round in the 5220 down ramp was blasted with 5.5 m left to breakthrough into the 5220 up ramp heading. After the blast, the round was mucked out and bolted, without incident. After one week, the Operations team initiated face bolting, as per ground support standards. During this task, a MN1.95 seismic event and pillarburst occurred resulting in the ejection of approximately 40 tonnes of material from the down ramp development face, and approximately 180 tonnes of material from the up ramp development face. At the time of the pillarburst, two employees were delivering additional materials to the down ramp to complete face bolting, and unfortunately both employees were injured by the ejected material.

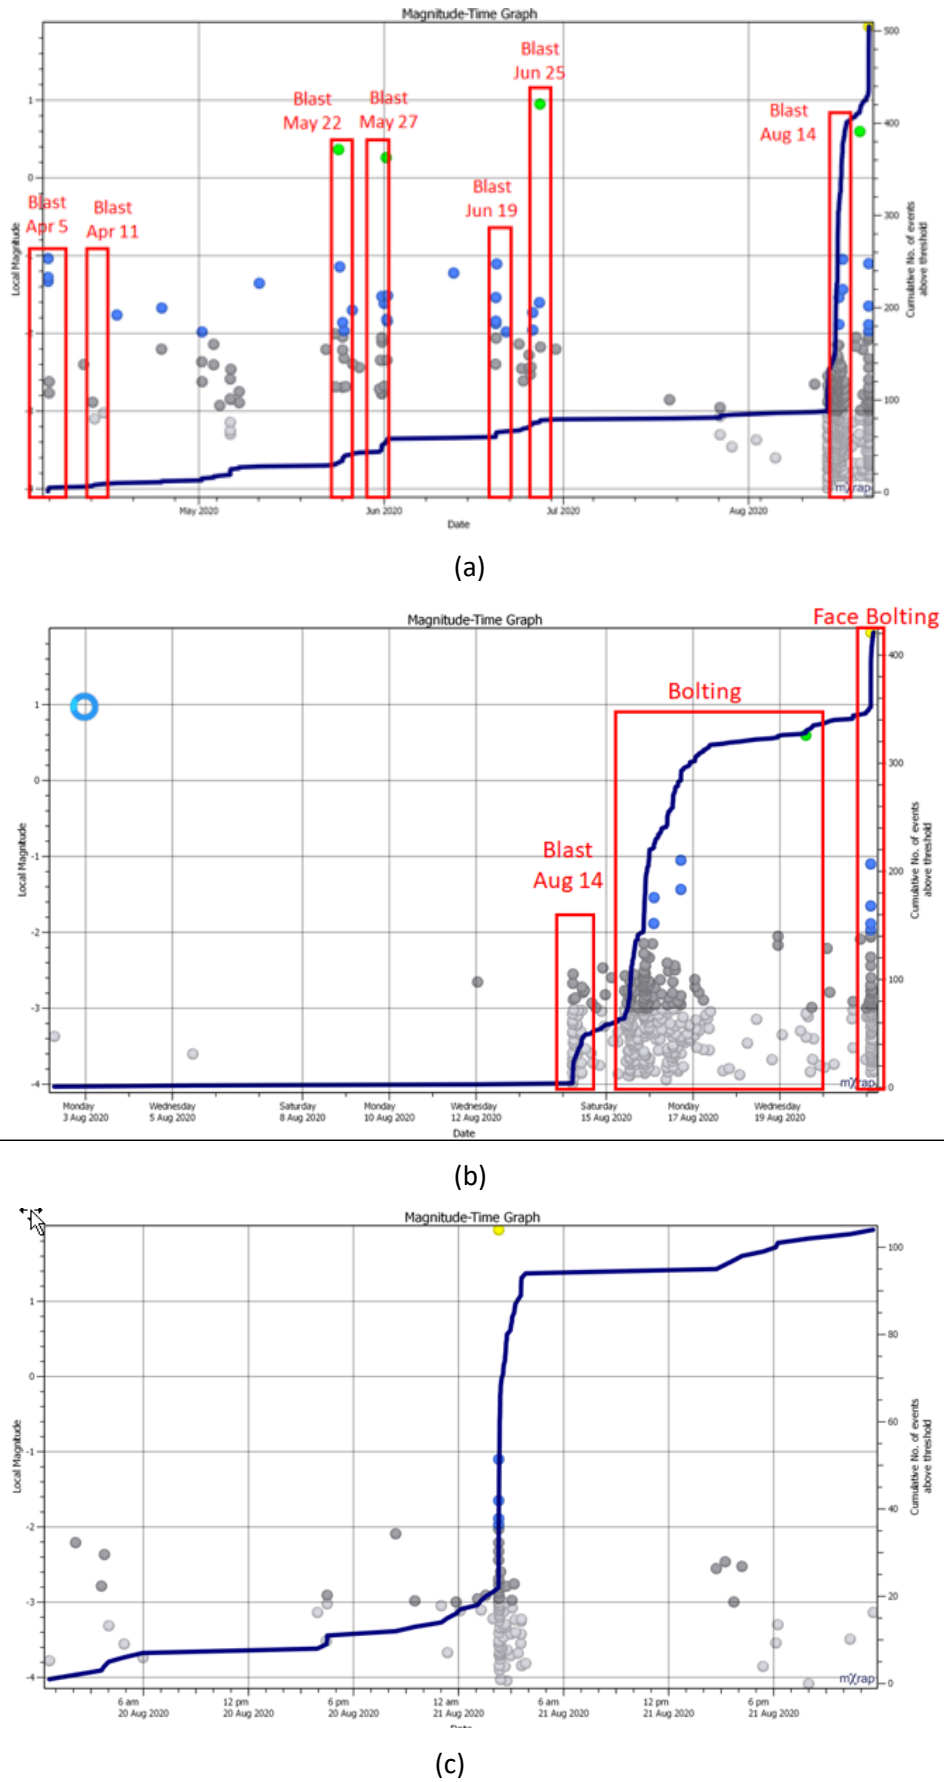
Figure 4 Local magnitude versus cumulative number of events for three time periods of (a), (b) and (c)

It is clear from these plots that very little seismicity occurred following the natural decay in the immediate period after the development rounds. Aside from random low magnitude seismic events occurring during these time periods, the only large cluster of events unrelated to development rounds occurred within the breakthrough pillar following the rockburst event. It is concluded that the microseismic response to the previous development rounds did not provide an indication that a large event was imminent (Ruest & Yao 2020).

It should be mentioned that additional seismic sensors were commissioned in the concerned area between 25 June and the final blast on 14 August 2020. As a result, the cumulative frequency plots indicate an elevation of microseismicity following the 14 August 2020 development blast (Figure 4b). However, this elevation in seismicity is attributed to an increase in seismic system sensitivity rather than serving as evidence of increased seismic response in the heading.

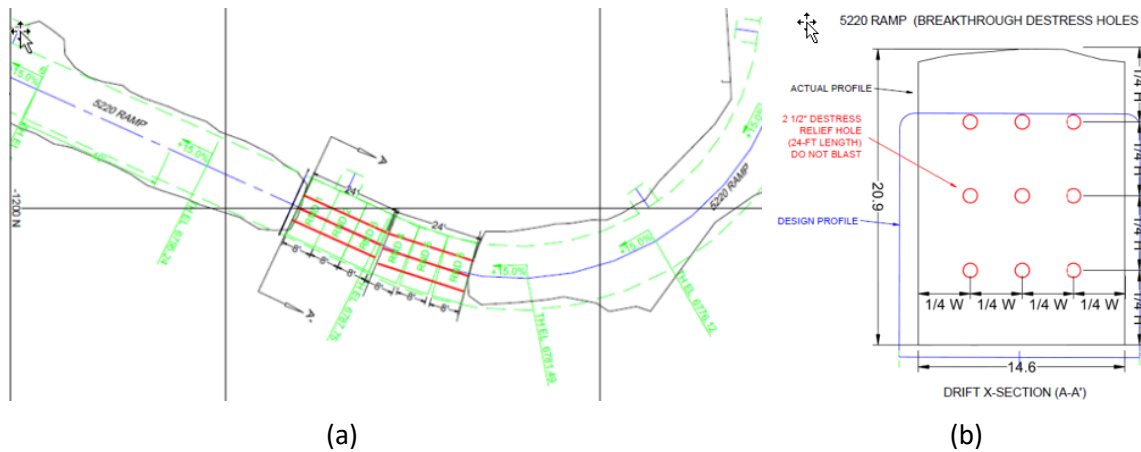
- de-stress development blasting – Garson Mine procedure (Figure 5) was followed for the 5220 Ramp (Yao & Moreau-Verlaan 2010)
- de-stress relief holes in the pillar – at 15 m to breakthrough, de-stress relief holes were drilled as follows (Figure 6):

- holes were 7.3 m long, and aligned with drift grade and azimuth
 - nine 63.5 mm diameter holes were collared into the 5220 down ramp face
 - nine 63.5 mm diameter holes were collared into 5220 up ramp face.

The purpose of the de-stress relief holes in the pillar was to precondition the rock mass by allowing the holes to squeeze and thus providing pressure relief points. Though the effectiveness of these ‘pressure-relief’ de-stress holes have not been categorically demonstrated, underground observations indicate they have provided some form of de-stressing in previous applications. However, this strategy proved inadequate in the 5220 Ramp breakthrough pillar.

Figure 6 De-stress relief holes in the pillar presented on (a) plan view and (b) section view

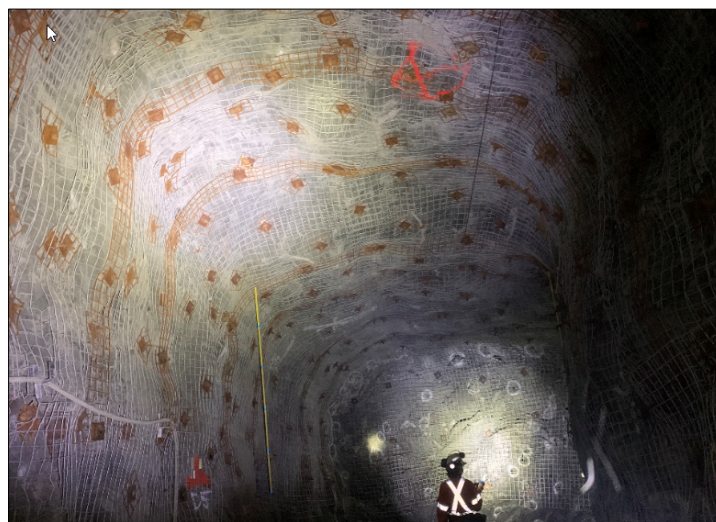
- enhanced dynamic support – primary support system consists of 2.4 m long PAR1 dynamic bolts (1.2 × 0.76 m pattern) with #4 gauge welded-wire mesh overlain with #0 gauge mesh straps secured with 2.4 m long PAR1 dynamic bolts (1.5 × 1.5 m pattern) at a 1.5 m spacing in the back and walls along the drift (Figure 7)

Figure 7 Dynamic support system

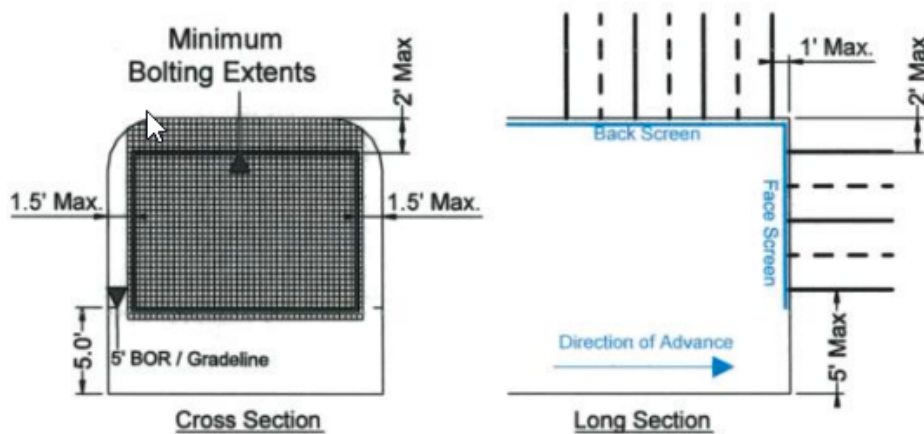
- face support – consists of 2.0 m long, 46 mm diameter friction sets (1.2 × 1.5 m pattern) with #4 gauge welded-wire mesh, and the face support extended to within 0.6 m (rather than 1.5 m) from the floor (Figure 8).

Figure 8 Face support system

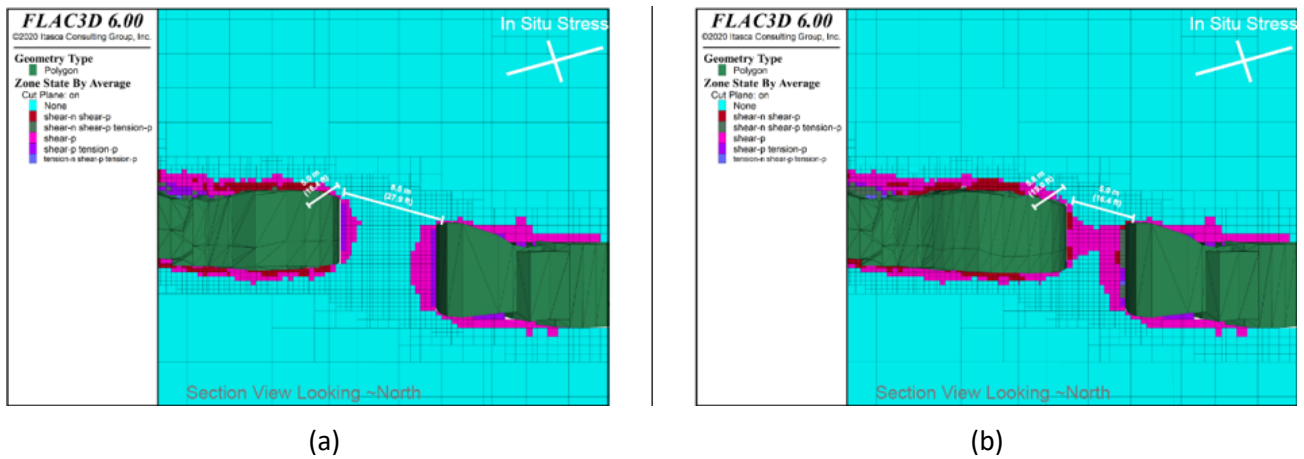
Yielded elements from the stress model output, shown in Figure 9, are contoured at a breakthrough pillar thickness of 8.5 m (consistent with the face position one round before the rockburst) and when the pillar has a thickness of 5.5 m, after the final round had been taken before the rockburst. These results show that at 8.5 m, the pillar core is intact while at 5.5 m, the core has yielded in a classic shear mechanism.

Figure 9 (a) Yielded elements in 8.5 m thick pillar; (b) Yielded elements in 5.5 m thick pillar

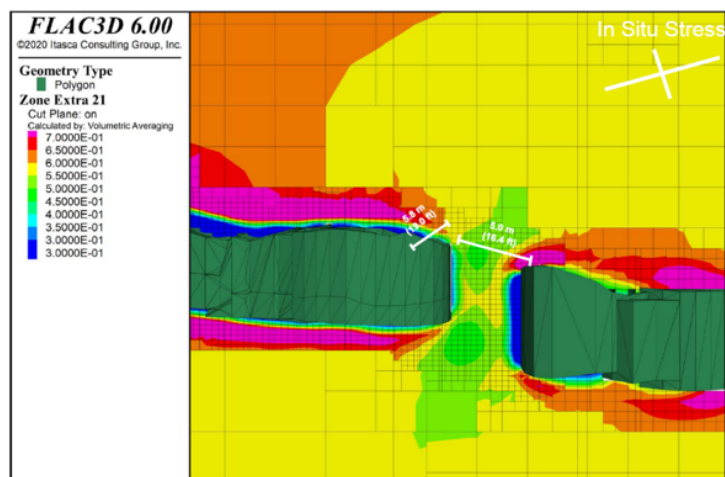
Pillar width:height (W:H) ratio has also been found to correlate well with seismic hazard in the mining industry. Pillars with a W:H ratio between 0.5 and 2.0 are relatively squat and have historically demonstrated greater seismic activity as compared to slender pillars. Figure 10 shows a plan view of secondary stopes (pillars) bounded by previously mined primary stopes and measured seismicity (Brad Simser, pers. comm., 2020). Because the main driving stress is horizontal and roughly perpendicular to the orebody, the relevant W:H ratio is the ratio of the stope strike length to the orebody thickness. As can be seen in Figure 11, there is significant seismicity in the squat pillars ($2.0 > W:H > 0.5$) and there is very little seismicity in the slender pillars. It is noted that the Garson breakthrough pillar had a W:H ratio of 5.5:5.8 m or 0.95.

Figure 10 Deviatoric stress ratio at 5.5 m wide pillar

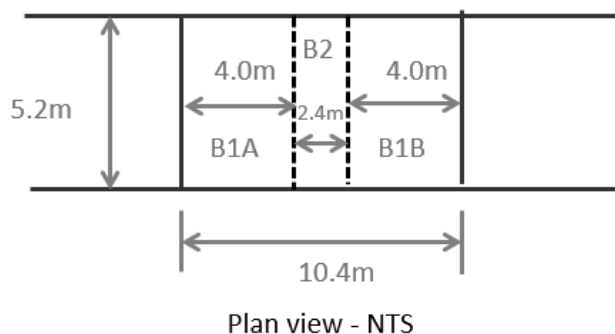
Figure 14 Blast design aimed at creating a yielded pillar state

One of the most effective control measures is to blast and mine the remaining pillar from stable to yielded in a single step, i.e. from $W:H > 2$ (likely stable) to $W:H \leq 0.5$ (likely yielded). An example is given in Figure 14 to demonstrate this design.

- *Stress conditions = High*
- *Drift height = 5.2m.*
- *Stable pillar = 10.4m (2 x drift height); and*
- *Yielded pillar $\leq 2.6m$ ($<0.5 \times$ drift height)*

- *Blast two 4.0m round at the same time with a delay (B1A and B1B); and*
- *Blast the last remaining 2.4m yielded round.*

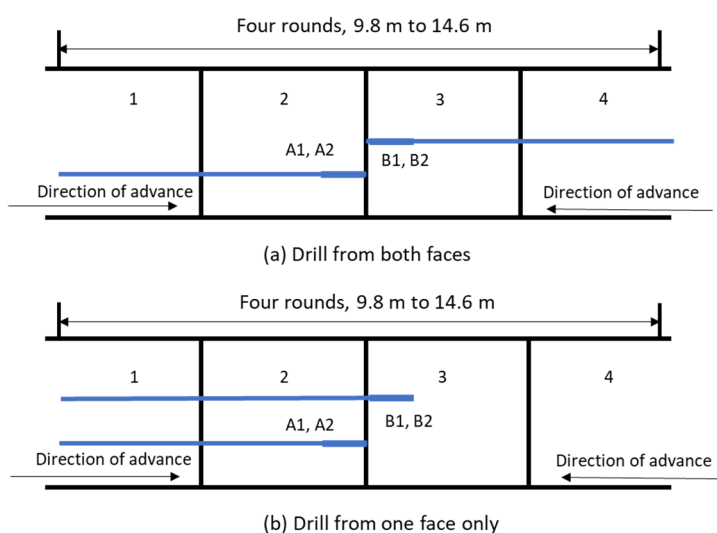
Figure 15 De-stress blasting of the core of breakthrough pillar (drift height of 4.9 m, not to scale)

Additionally, de-stress blasting may be implemented to alter the stiffness of the pillar, thus reducing high stress in the pillar, as shown in Figure 15. Similarly, preconditioning, including closely spaced drillholes, could be used to reduce the ability of the pillar to carry high stress.
