Change in mining sequence and design methods at the Frog's Leg underground mine due to high-stress seismic conditions

Ezilma Dias ^{a,*}, Werner Holtzhausen ^b

Abstract

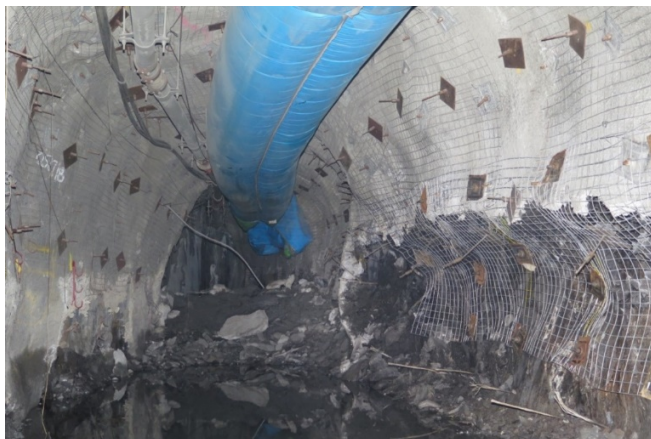
The rockburst damage experienced from a ML1.7 seismic event was estimated to be in the same location as previous seismic damage, with fibrecrete cracking and deformation extending further to the south down the ore drive (Figures 2 and 3).

Figure 2 Rehabilitated area following a seismic event occurred on 13 August 2018, at F7775NOD

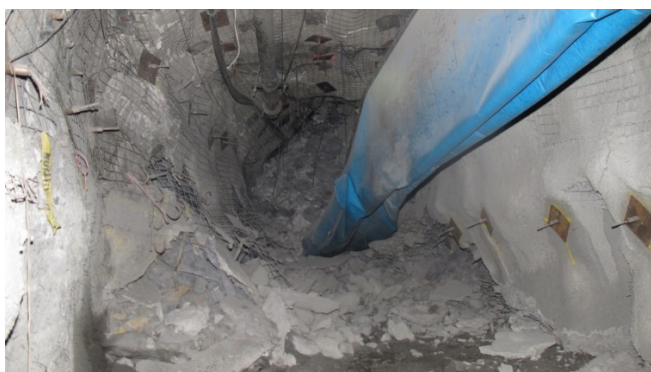
Further back from this area, there was significant drive closure in the order of 2 m. The dynamic cable bolts appeared to have yielded beyond their capacity (300 mm) and the fibrecrete (up to 150 mm in thickness) had cracked. In areas where it was possible to observe behind the fibrecrete the failure zone appeared to be ~ 1.5 m deep.

Figure 3 Seismic event occurred on 3 October 2018, at F7775NOD. Failure depth estimated at 1.5 m

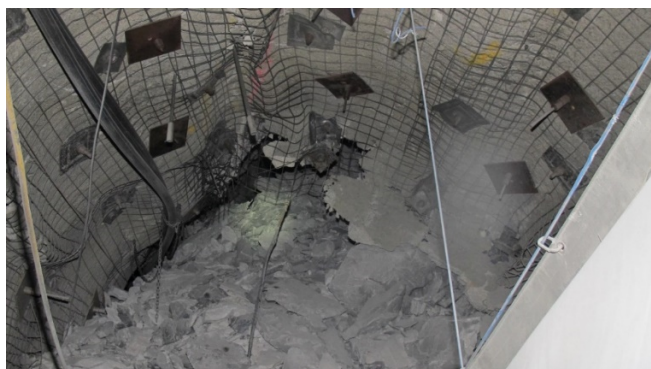
The small fragmentation size of the failed rock mass was consistent with a burst type event, resulting in fine fragmentation and explosive ejection of the fracture zone surrounding the drive (Figure 4). The initial rockburst damage was observed to have possibly come from the sidewalls, with approximately 1.4 m ejection depth on the eastern wall and ~0.5 m from the western wall (Figure 5 and 6).

Figure 4 Fall of material from the backs, south of the paste barricade. Note how fractured the material is

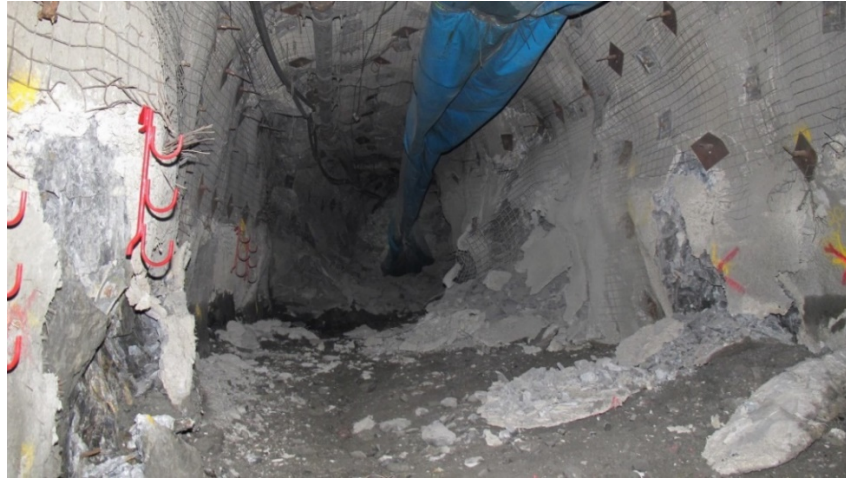
In other areas, there was localised spalling and blowouts of the fibrecrete and deformation of bolts. There was also floor heave in areas and overall, there seems to be more stress related deformation than was normally observed.

Figure 5 Seismic event occurred on 3 October 2018, at F7775NOD showing floor heave

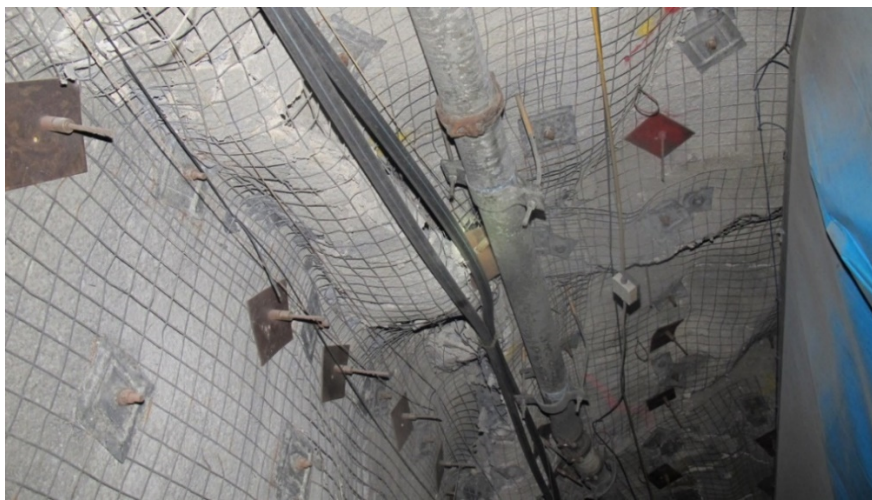
Figure 6 Seismic event occurred on 3 October 2018, at F7775NOD, showing loaded cable and Garford bolts

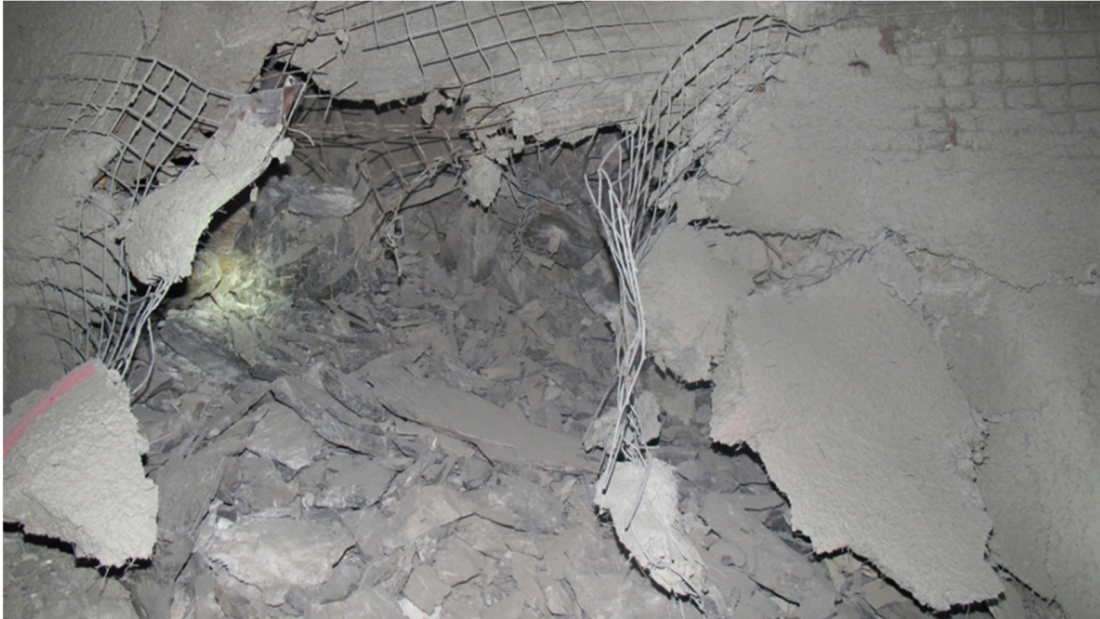
The dynamic ground support system in the sidewalls performed according to expectations in areas where the fibrecrete and mesh was displaced uniformly, with little differential displacement causing shear failure of the surface support (Figure 7).

Figure 7 Seismic event occurred on 3 October 2018, at F7775NOD, showing cable bolt with surface support failed around it

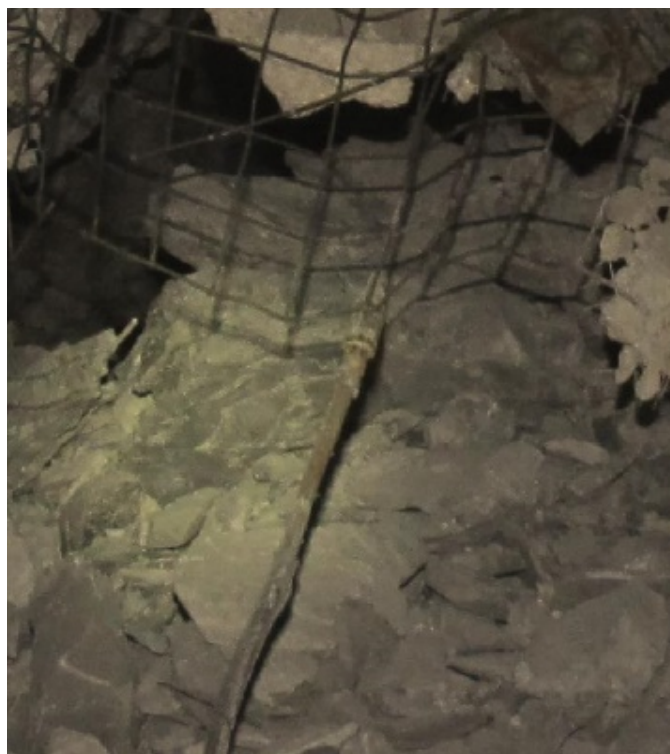
The failure observed from the back of the drive was unexpected and was a major concern with regards to ground support requirements going forward. The fragmentation size of the failed rock mass material indicated an extensive fracture zone in the backs of the drive. It was estimated, based on the volume of material observed originating from backs, that the depth of failure was approximately 3–6 m. A 6 m dynamic cable bolt was observed to have been stripped of its plate and was hanging from the backs, indicating yield capacity and/or failure of the barrel and wedge (Figure 8). This allowed the fibrecrete and mesh to fail, losing confinement of the highly fractured rock mass.

Figure 8 Seismic event occurred on 3 October 2018, at F7775NOD, showing Garford bolt yielded to the limit of its capacity
