# Experiences of seismic monitoring at the Kittilä mine

Antti Pyy <sup>a,\*</sup>, Stephen Meyer <sup>b</sup>, Véronique Falmagne <sup>c</sup>

<sup>a</sup> Kittilä mine, Agnico Eagle Mines, Finland

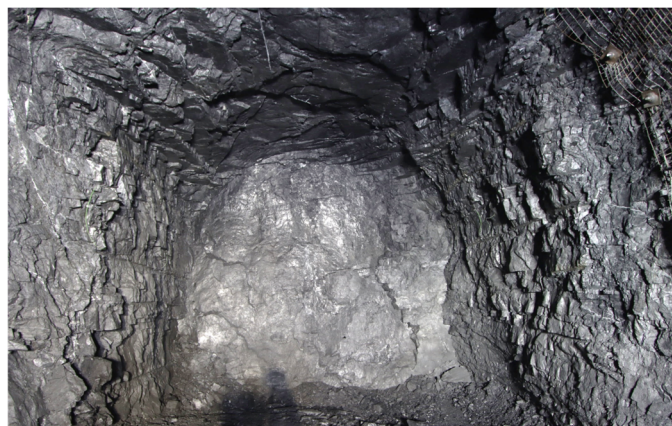
Development of the first crosscuts under the sill started in 2022. Figure 5 shows photo of the transverse access face at X925 level with sub-horizontal fracturing in the back. Horizontal jointing is not typically encountered and is believed to be related to stress-induced fracturing after mining of the upper stopes. Induced seismicity during the development was mostly  $MW < -1$  and did not release enough energy to induce fracturing, which endorses the earlier. Figure 6 shows section view of the seismic data from the same area. During mining of the stopes above X900 level the seismicity extended below the X925 level.

**Figure 5** Crosscut face at X925 level, 25 m below the sill and looking east towards the hanging wall. Visible horizontal stress-induced fracturing is in the back. Heading width is 5.8 m and height is 5.0 m. Sub-vertical graphite surfaces are visible on the face, typical to the mineralisation

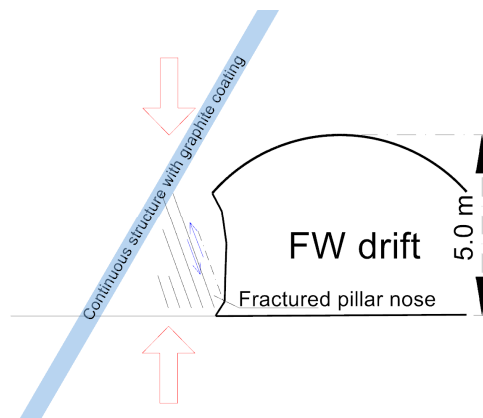
Damage to the ground support located were in the non-upgraded (FRS and rebar) parts of the pillar walls (Figures 13 and 14). Upgraded parts of the support (welded mesh, mesh straps and yielding bolts) sustained the displacement and loading caused by the event.

**Figure 13 Schematic section view of the damaged pillar looking north. Red arrows indicate vertical loading of the pillar**

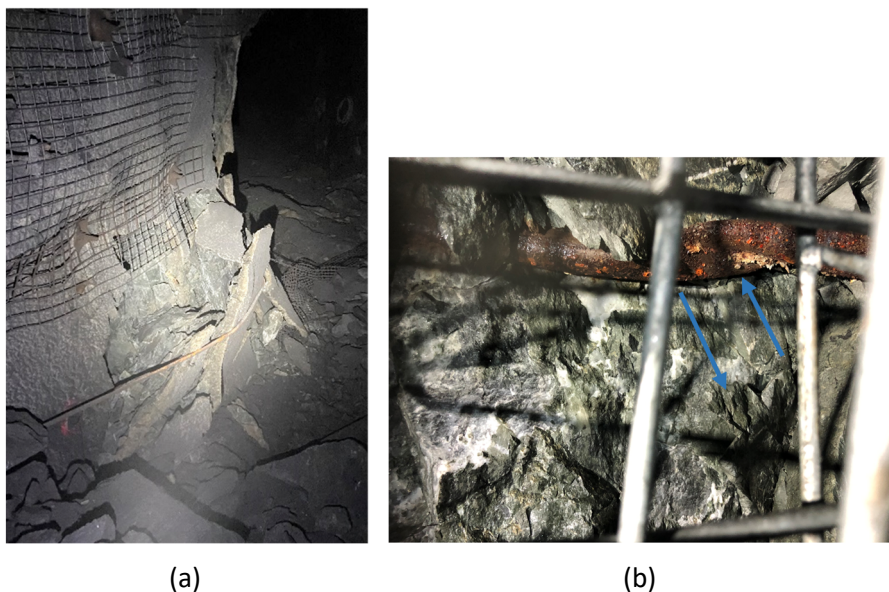
**Figure 14 (a) Damaged toe of the local pillar, with visible loading on the mesh strap (Ø7.8 mm wire) and yielding bolt faceplate (2.4 m/8 ft Ø22 mm D-bolt) due to the pillar dilation. (b) Sheared horizontal 120 kN Mn Swellex inside the pillar shows the movement**

The complete record of the seismicity confirms the earlier hypothesis of seismically active planes intersecting footwall development. Small slip events caused progressive weakening of the local pillar and wider damage was caused by the MW1.0 crush-type event. Monitoring of the relatively small events provides good information for the forensic analysis and insight into the rock mass behaviour. Proactive rehabilitation of the drives with yielding ground support was proven as an effective measure to control the dilatation of the pillar. Mesh and dynamic rockbolts are currently being installed during the development cycle in Rimpi's deeper levels.

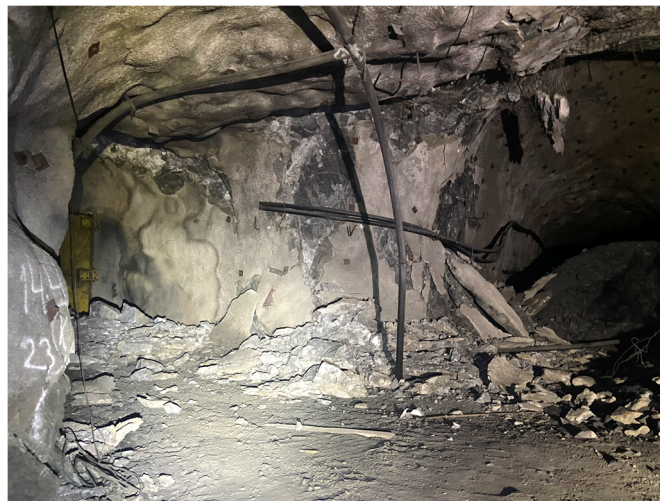
In March 2024, one hour after a nearby stope blast, a rockburst occurred on the X700 level (Figures 19 and 20). Three MW > 0 events were recorded in the area. MW1.5 waveform is complex, starting as a reverse faulting event. The MW1.0 event source mechanism is crush-type, indicating sub-vertical loading to the intersection area. Smaller slip-type events were located in the footwall area. Development design between the level access and the exhaust air raise left a very narrow pillar in between creating an area of high local extraction ratio. The area was supported with static ground support (FRS and resin grouted rebar) which proved inadequate for the dynamic loading. The intersection back (span  $\varnothing 10$  m) was also supported with 6 m-long cement grouted straight cables with plates in a  $2 \times 2$  m pattern as part of the standard ground support for intersections. The cabled back remained stable.

**Figure 20** Damages after the event in the intersection area of the footwall drive and exhaust air raise access, looking northwest

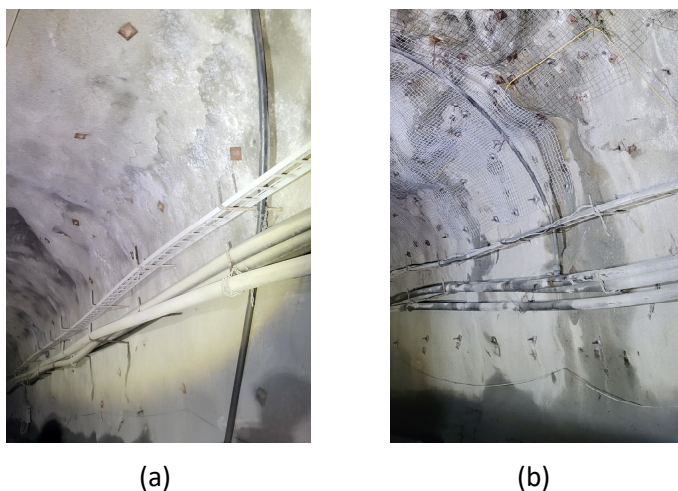
After the event, the ground support in the nearby decline was upgraded with mesh and yielding rockbolts. Two to three weeks after the event water seepage was observed through the damaged area intersected by the interpreted plane (Figure 23). Similar water seepage through increased porosity hydraulic conductivity of the structure was also noted after previous larger events in Rimpi.

**Figure 23 Development intersected by the interpreted fault: (a) Immediately after the event the shoulder fibre-reinforced shotcrete shows bulging; (b) After additional ground support installation, water seepage from the structure intersecting the wall became visible**

The analysis of the small events indicated previously unknown structures in the upper part of the Rimpi footwall intersecting the footwall drift and ramp. Back-analysis of area showed very small changes in seismicity prior to the damaging events. A high local extraction ratio next to the ventilation raise intersected by the fault was the key adverse element. Development of the parallel access to the ventilation raise from the footwall drive created a narrow span in between the ventilation and level access drives and the ventilation raise that was intersected by the indicated fault. The MW1.5 event was located in this gap. Static support was inadequate under dynamic conditions. The current Rimpi long-term development plan includes an updated ground support system to provide higher displacement and load capacity.
