Ground support design for rockburst damage rehabilitation at El Teniente mine, Codelco, Chile

Abstract

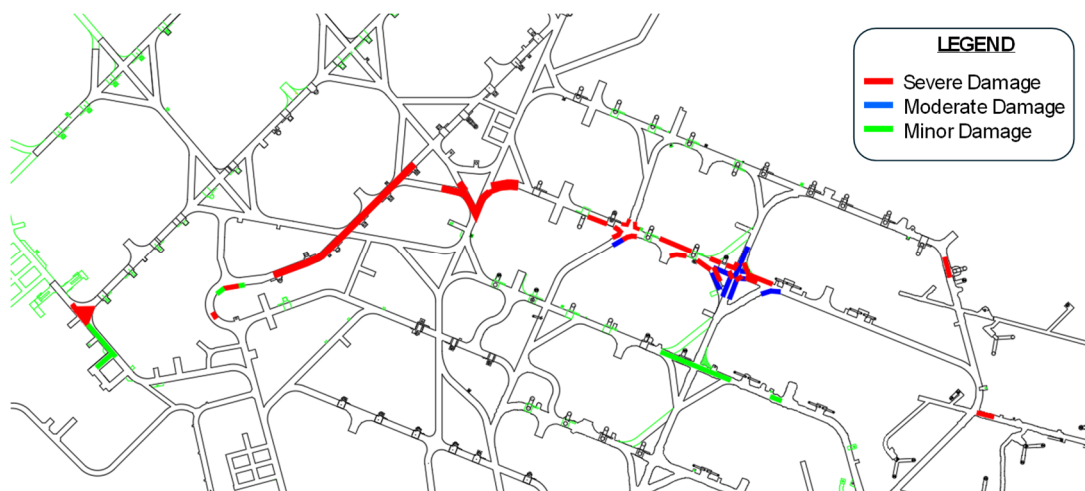
Figure 7 Damage assessment in the Recursos Norte mine haulage level after the 24 July 2023 rockburst

Ground damage is classified into severe, moderate and minor categories based on its severity. When surveys of post-rockburst damage are completed, a colour-coded nomenclature is used to identify these categories: green for minor damage, blue for moderate damage and red for severe damage.

For example, Figure 7 shows damage observations following the rockburst on 24 July 2023 at the haulage level of Recursos Norte mine. Rehabilitation of some sectors at this level will be discussed in more detail in Section 5.2 of this paper.

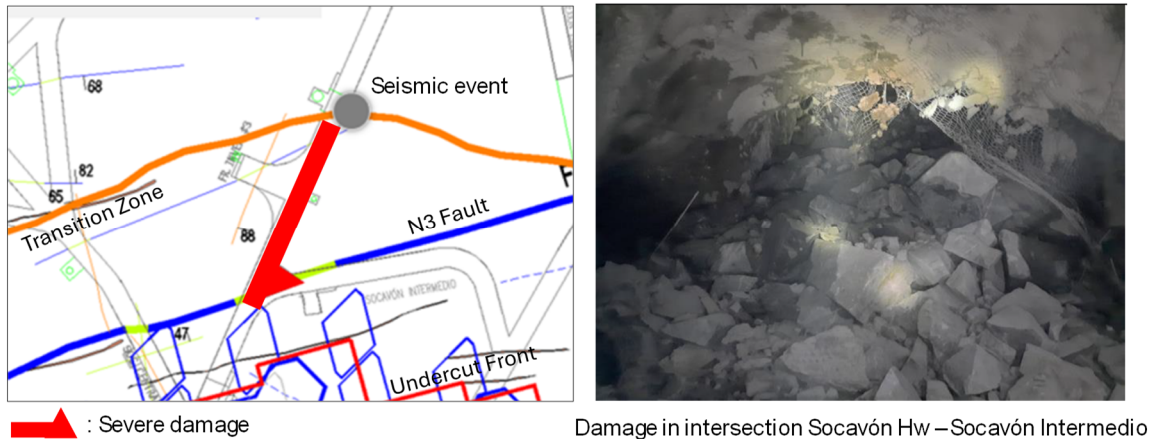
Figure 12 Location of damage

The damage, classified as severe (Figure 12), was located at the intersection of two drives (Socavón Hw with Socavón Intermedio) and extended 70 m along the Socavón Hw drift (Celis 2021).

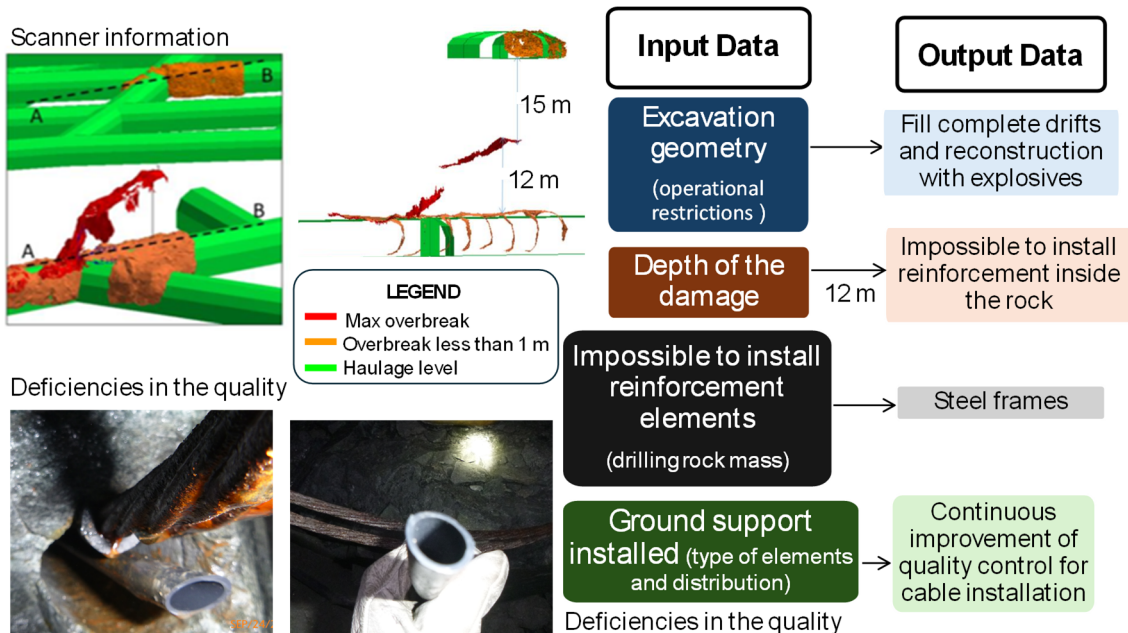
Figure 13 Field observations and input to the ground support rehabilitation diagram

As input data for the rehabilitation design, a maximum overbreak of 12 m was considered (lidar scan measurement). The presence of water suggested degradation of the rock mass and poor grouting was identified in some cables from the roof of the intersection, given that the grout injection hoses were found empty during the investigation (Figure 13).

With this information a decision was made to backfill the damaged area with concrete, re-excavate a new drift with explosives and install steel arches joined in sets of five arches each.

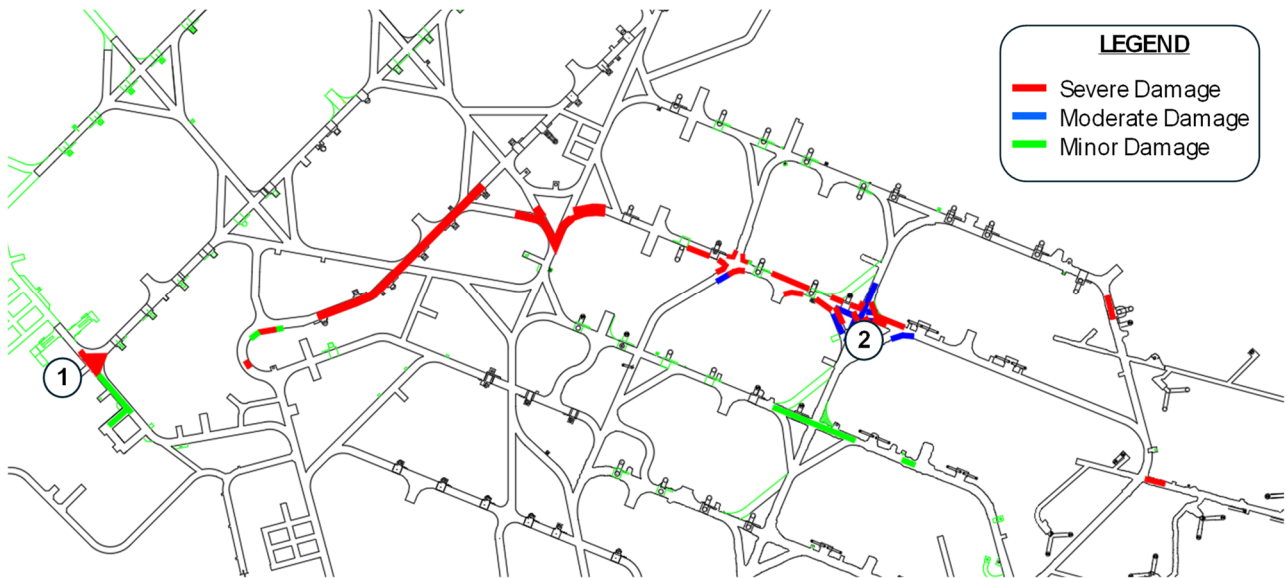
Figure 16 Sectors to review

On 24 July 2023 a seismic event of magnitude MW3.0 and energy of MJ1,900 was recorded, creating the damage represented in Figure 7 at the haulage level of Recursos Norte mine (Parraguez et al. 2023).

The rehabilitation process outlined in the diagram in Figure 11 was applied to two sectors with damage to the haulage level of Recursos Norte mine (Figure 16).

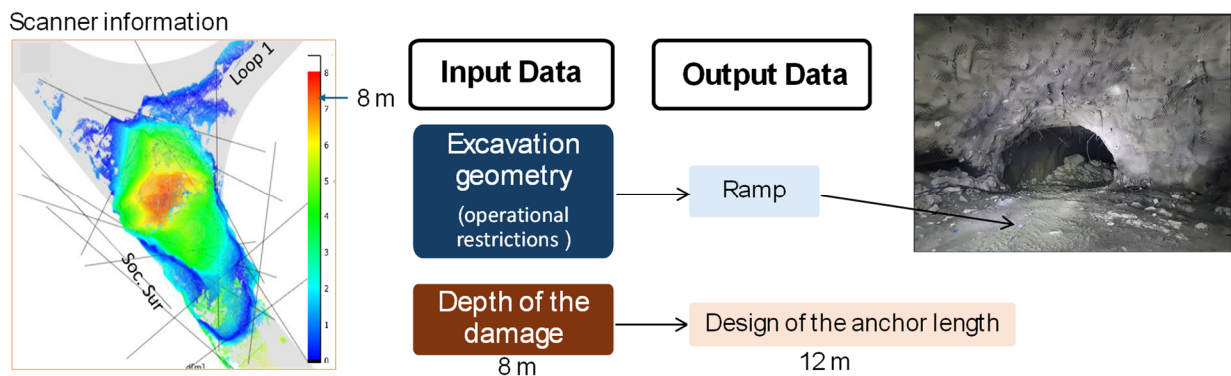
Figure 17 Field background information for sector 1

In sector 1 (Figure 17), the maximum overbreak in the roof was measured at 8 m with the lidar scan. There was no water infiltration and the rock mass was competent, making the installation of reinforcement elements such as bolts and cables on the roof of the excavation feasible. Due to the height, the support of an access ramp to the sector was required. No deviations were identified in the installed ground support and there were no quality issues.

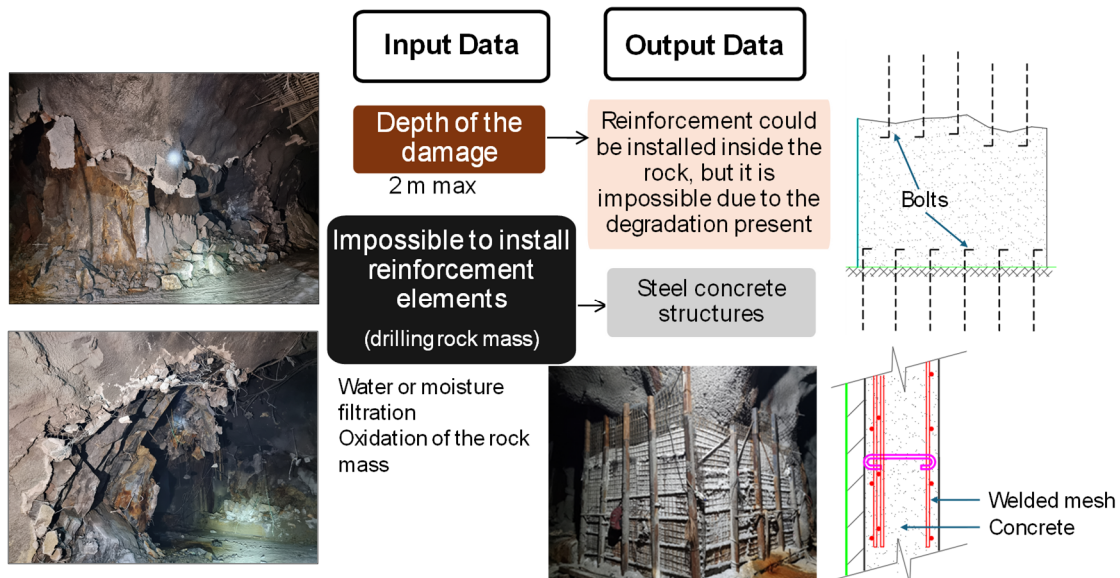
Figure 19 Rehabilitation in sector 2

In sector 2 (Figure 19), a damage depth of 1 to 2 m and rock mass blocks with abundant oxide coatings were identified in the field, which is consistent with the age of this drift compared to sector 1 of the same level. Additionally, the rock mass degradation prevented the anchoring of reinforcement elements so a reinforcing concrete wall anchored to the roof and floor was constructed. This wall was anchored to a more competent rock mass compared to the degraded rock mass of the pillar (wall rocks).
