Geotechnical strategies to resume mining at Westwood mine following a MN3.7 seismic event: part 1 – the investigation

Ali Jalbout ^{a,b,*}

Abstract

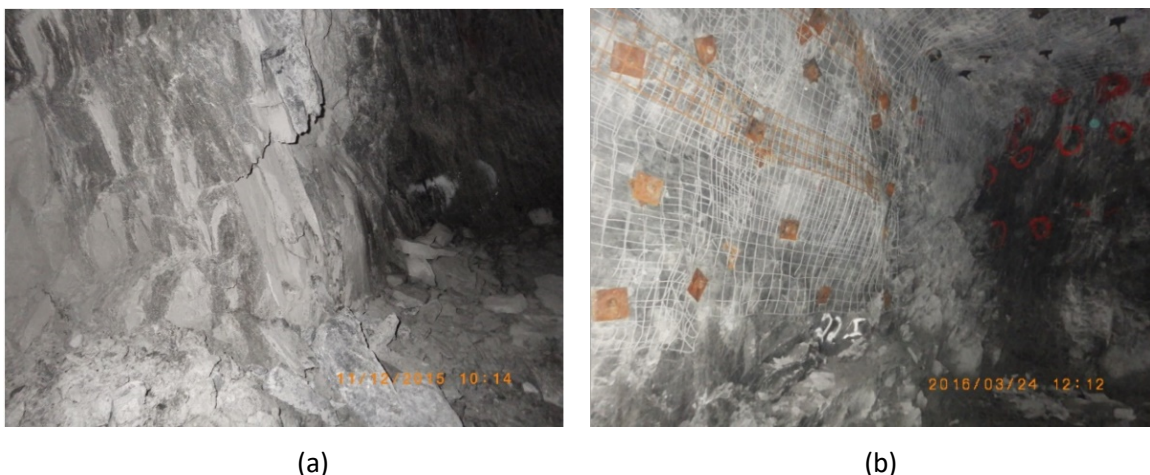
Movement of the east–west drive walls and the soft ground behaviour of the U5 rock mass were observed early in the development process. Evidence of this movement was noted as early as November 2015, as shown in Figure 5a. Development was stopped in order to proceed with the upgrade and only resumed in January 2016. Failure to rapidly install proper ground support after the development blast proved to be an important factor for the drive performance. It was noticed, non-compliance to ground support standards was a generalised problem in this section of the mine. In that specific area it amplified the convergence problem. As development progressed toward the west, conditions did not improve and ground movement could be seen rapidly once the round was blasted and mucked as it is shown on Figure 5b.

At the end of January 2016, a decision was made to change the orientation of the 132-02 drive to intersect the schistosity at an angle rather than running parallel to it. This was an effort to reduce or at least slow down the drive's convergence. A development angle of 45° was proposed to ensure significant results, but for technical reasons, a 20° angle was used. Furthermore, this angle proved insufficient, and the drive's performance did not improve. In April 2016, the orientation was changed again to the 45° angle at some places.

Figure 5 (a) Early sign of convergence on 132-02 east–west drive 2015-11-12; (b) Rapid convergence on 132-03 sublevel 2016-03-24 support not installed in time

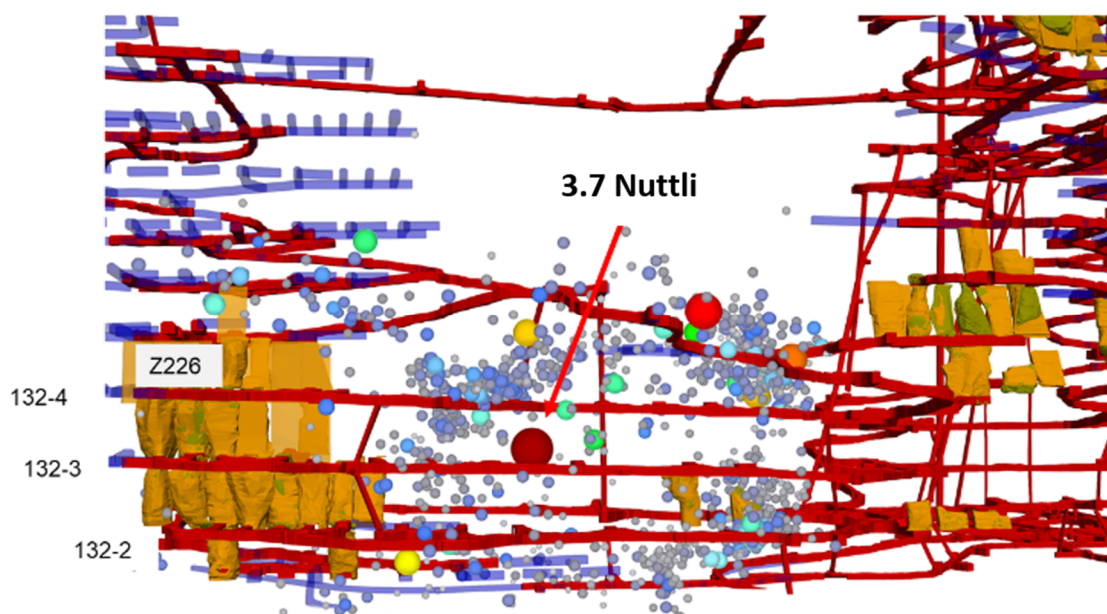
Figure 6 provides a view of the seismicity around Z226 captured by the seismic system on 30 October 2020. The circles represent different seismic events, with larger and warmer-coloured circles indicating events of greater magnitude.

Figure 6 View north of the seismicity on the access levels to z226 during 30 October 2020

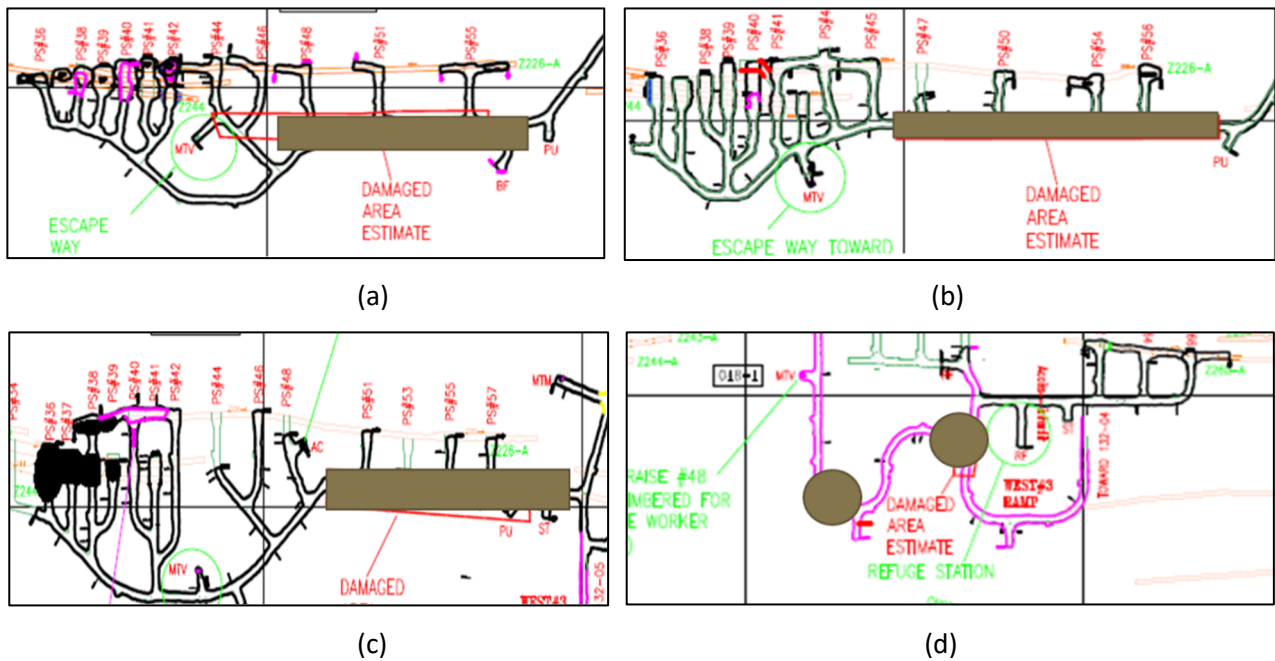
The known extents of the damages were those observed by the mine rescue teams and the underground workers who were near the area during the event. As of this date, no other employees have returned to levels 132-02, 132-03, 132-04, and 132-05. However, an inspection was conducted on level 132-01. Only minor damages were observed, including a few broken bolts, some small rock pieces fallen to the ground through the screen, cracks, and some loose rock accumulated in the screen. All mine infrastructure outside of the west #3 zone was inspected, and no other significant damage caused by the event was noted. The following four images (Figure 7a–d) summarise the extent of the known and estimated damages at the end of the mine rescue operation on October 31, 2020.

Figure 7 Known/estimated damage extents of October 31, 2020. (a) Level 132-02; (b) Level 132-03; (c) Level 132-03; (d) Level 132-04

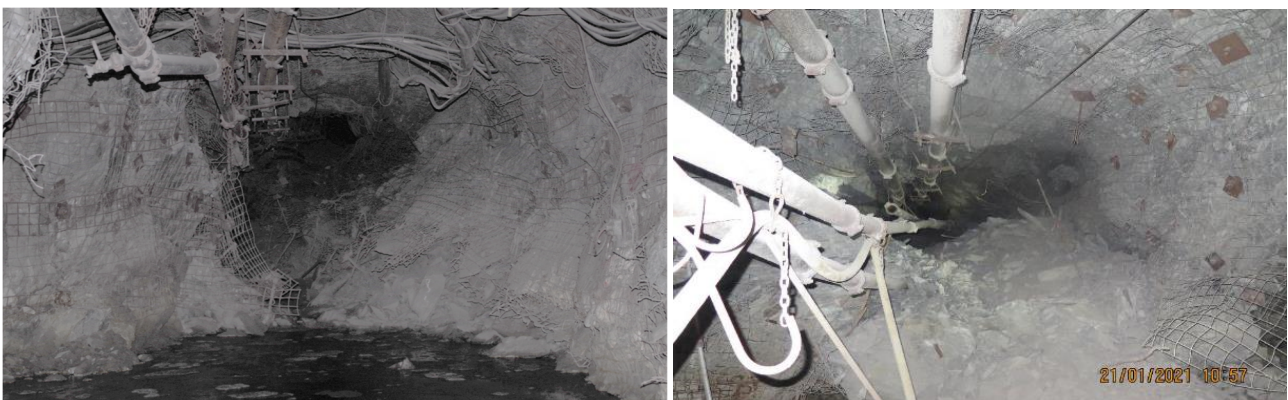
The core of the damage zone is primarily located in the 132-02, 132-03, and 132-04 TBW drifts. Figure 8 is a photo taken underground in 132-04 TBW (looking west), illustrating the extent and severity of the damages that occurred.

Figure 8 Example of the underground damage caused by the seismic event on 132-04 TBW (looking west) most of the visible damage came from the wall

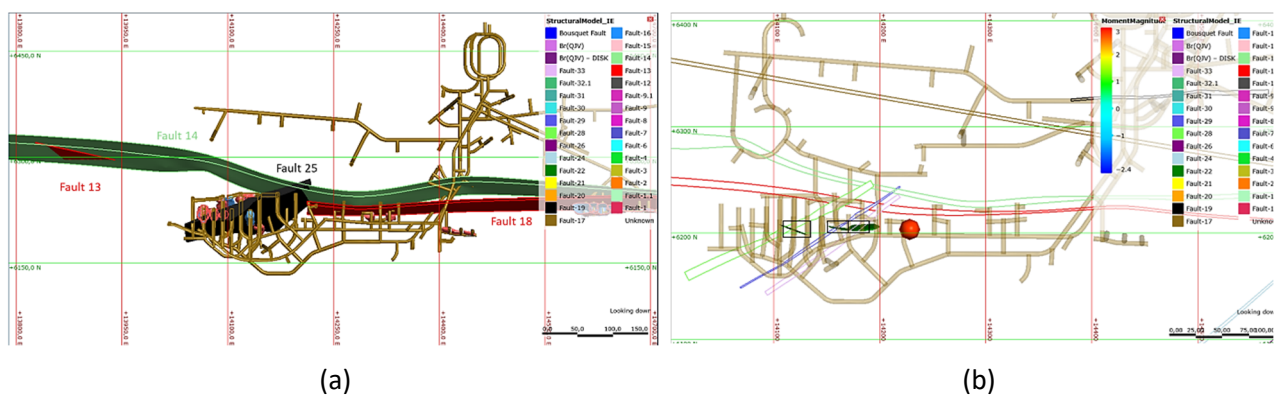
These efforts led to several updates in the structural model since the October 2020 event. The changes include modifications of different faults, and the addition of a north–south trend fault. Figure 10 shows the structural model interpretation on level 132-02 to 132-04 prior and post 30 October 2020 seismic event (taken from an internal report 2020).

Figure 10 General approach to risk management using multiple controls structural model interpretation on level 132-02 to 132-04. (a) Prior to 30 October 2020 seismic event; (b) After 30 October 2020 seismic event

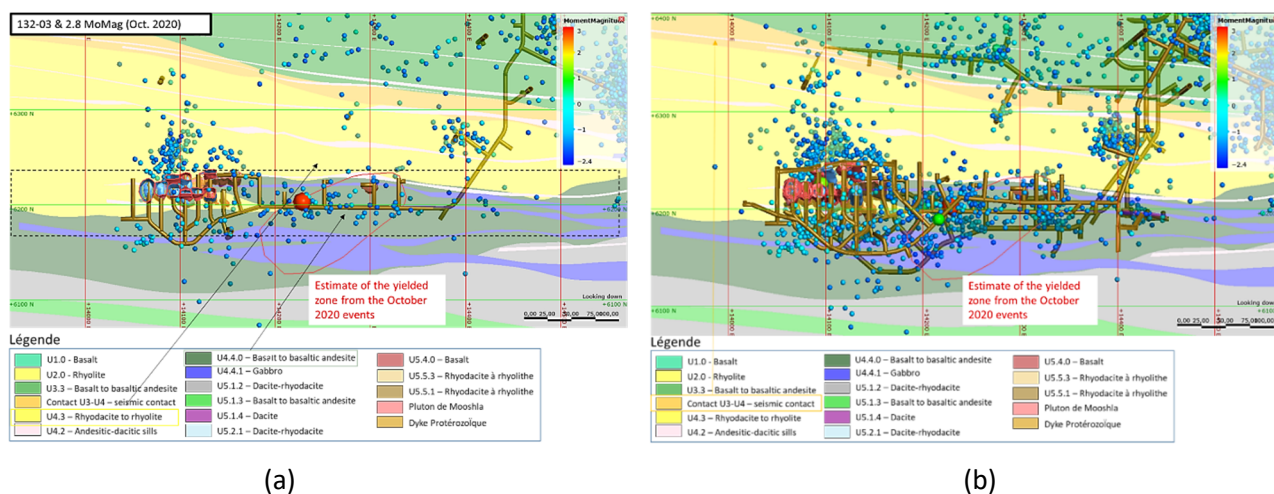
100 m north of the October 2020 event, it is not believed to have contributed to the mechanism of that particular event. Figure 11a illustrates the transition zone from 3.3.0 to 4.3.0 (highlighted in orange) in comparison to the seismic events of October 2020 and the affected development.

The east–west drifts severely affected by the October seismic event are situated within the 4.4.0 unit, albeit in close proximity to the contact zone (Figure 11b). When these drifts were constructed between 2015 and 2016, the seismic behaviour related to this contact was not yet fully understood; with comprehension beginning around mid-2018. Generally, based on the team's experience and the broader understanding of seismic activity, this contact is estimated to have seismic implications within a range of approximately 30 m on both sides.

Figure 11 (a) Seismic U3-U4 contact 100 m north of October 2020 seismic activity (Levels 132-02-0-04, clipping ± 30 m); (b) 4.3.0-4.4.0 seismic domain at 132-03 with location of 2.8 moment magnitude (MoMag) event (clipping ± 10 m)

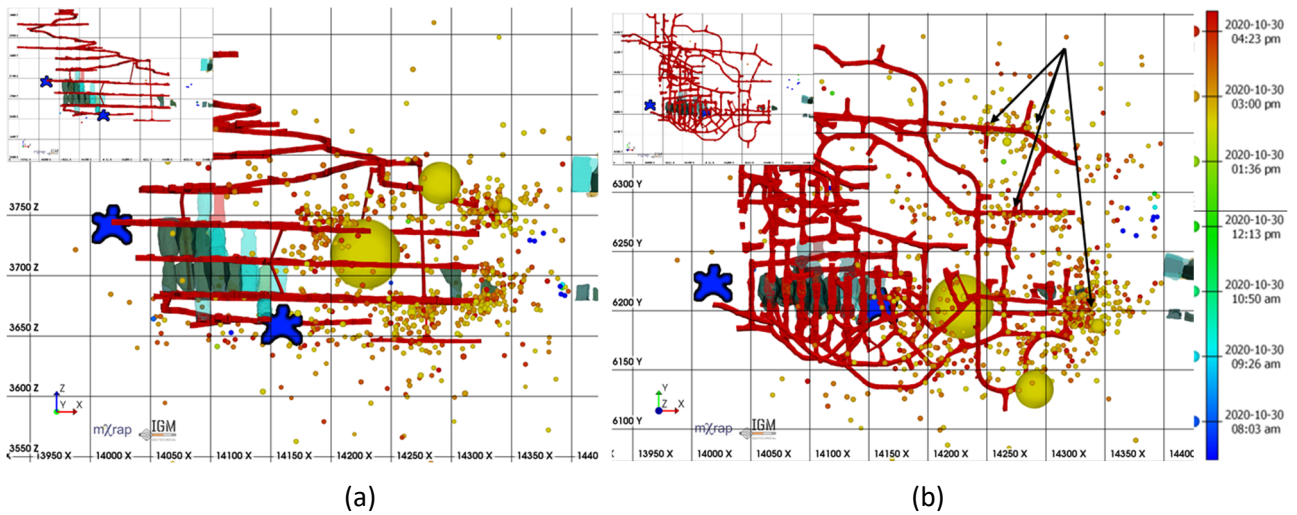
Based on the spatial distribution of events, two primary populations can be identified. The first population (indicated by the arrows in Figure 12) is closely associated with excavations such as stopes and development drives, exhibiting slight clustering in areas with larger spans like intersections and stopes. These events are likely attributed to secondary strain release resulting from the stress wave impact of the large event on these areas.

Figure 12 Plot of all events and blasts from 2020-10-30 05:00 to 2020-11-01 05:00. The events are indicated by the spheres and sized according to moment (to indicate relative event size). The blasts are indicated by the star symbols. Both blasts and events are coloured according to date. (a) section view and (b) plan view. The insert at the top left of each plot indicates the events from 05:00 to the time of the large event occurrence.

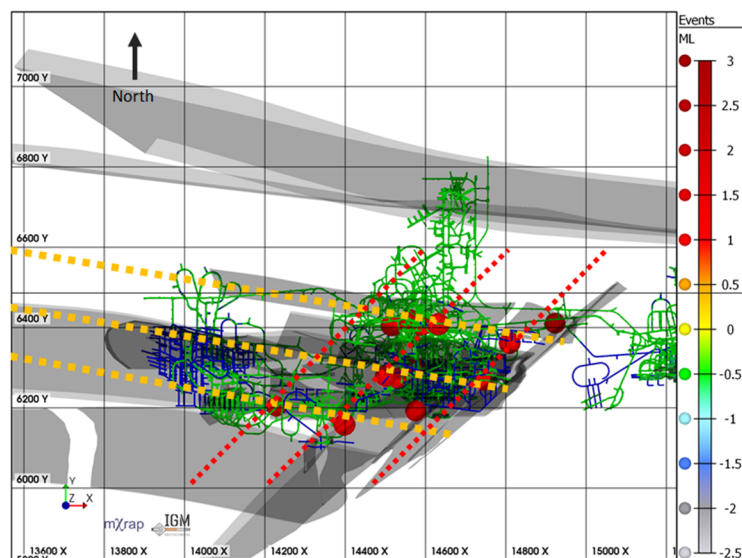
Figure 13 displays the known geological structures represented by the grey planes, with the prevailing orientations east-southeast and north-northeast. When plotting historical events (ML > 1.5), it becomes apparent that linear structures can be interpreted through the events, aligning with either the east-southeast (orange dashed lines) or north-northeast (red dashed lines) directions, corresponding to known geological structure orientations. Consequently, a spatial plot does not exhibit any predominant structural direction.

Figure 13 All seismic events ML > 1.5 during the life of mine within 3500-4100 elevation. The events are coloured by magnitude. Development are indicated by the coloured surveys, while the known structures are indicated by the grey surfaces. The orange and red dashed lines indicate linear trends correlating with the predominant structural directions as well as the locations of large seismic events

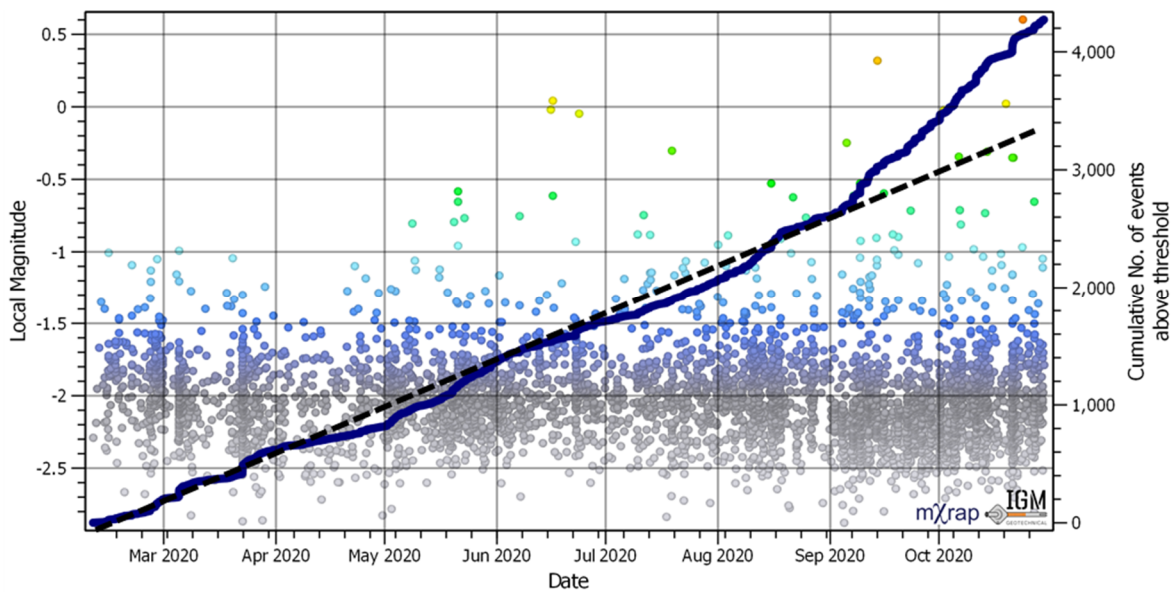
This section examines time trends leading up to the large seismic event to understand the rock mass response preceding the event. Figure 14 displays a magnitude-time chart with a cumulative event count curve (blue line). The black dashed line represents a visual straight line through the cumulative event count curve, highlighting a deviation from the main trend beginning in early September 2020. Due to the strong correlation between underground blasts and seismic activity, the number of blasts is also analysed in the area to determine their impact on the number of events (Figure 15).

Figure 14 Magnitude-time plot for the Z226 area, with the blue curve indicating the cumulative number of events. The black dotted line indicates the most common linear trend for the cumulative curve

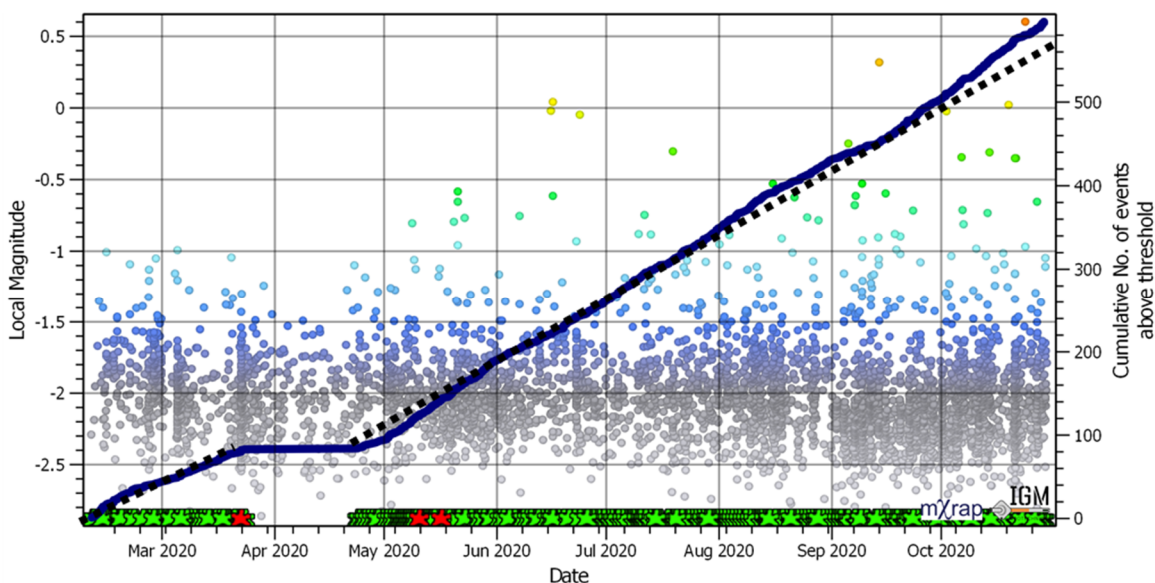
Figure 14 shows the cumulative number of blasts for the year preceding the large event, with the overall linear trend indicated by a black dotted line. A visual deviation from this trend appears in mid-September 2020, suggesting an increase in blasting activity in the Z226 area. This increased blasting likely contributed to the higher event rate identified in Figure 15.

Figure 15 Magnitude-time plot for the Z226 area, with the blue curve indicating the cumulative number of blasts. The black dotted line indicates the most common linear trend for the cumulative curve

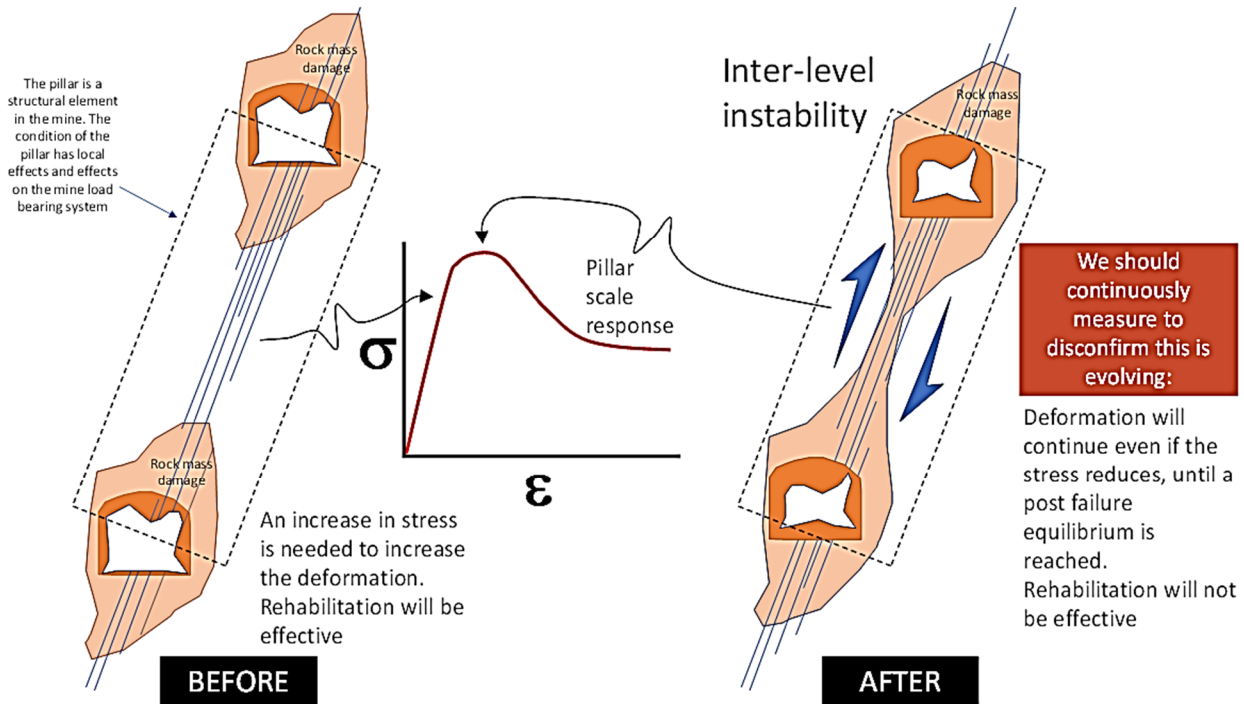
In the west zone, even small mining fronts interact with geological structures and the stress field on a large-scale. The model shows that in the west zone, the volume and magnitude of stress and strain changes induced by mining will increase substantially. Mechanisms of significant instability observed in the model are illustrated in Figure 16 (taken from an internal report 2020).

Figure 16 Inter-level instability at Westwood leads to significant stress change and deformation, and therefore high potential for large, damaging events

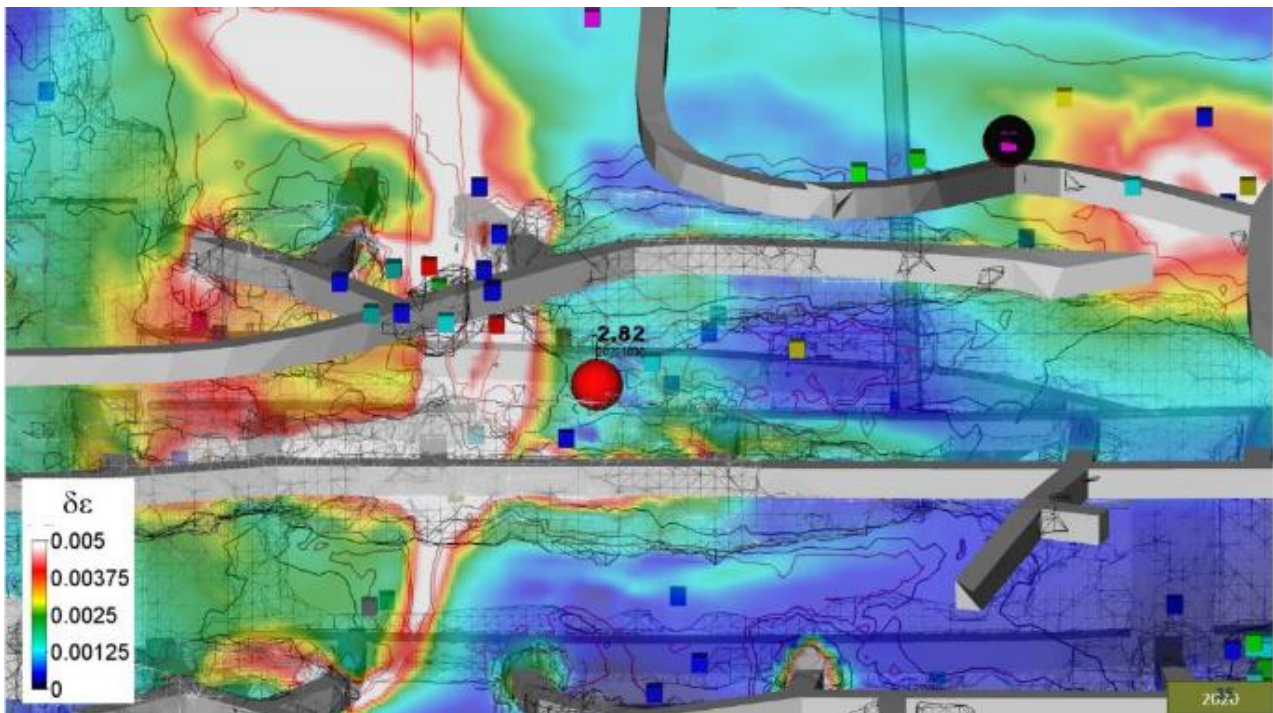
Figure 17 shows stress in the ramp in 2020 and the locations of large events.

Figure 17 West zone stress, 2020. Shows stress in the ramp in 2020 and the locations of the large events
