# Recent case histories for dam decommissioning in Alberta

Chris Gräpel <sup>a,\*</sup>

<sup>a</sup> Klohn Crippen Berger, Canada

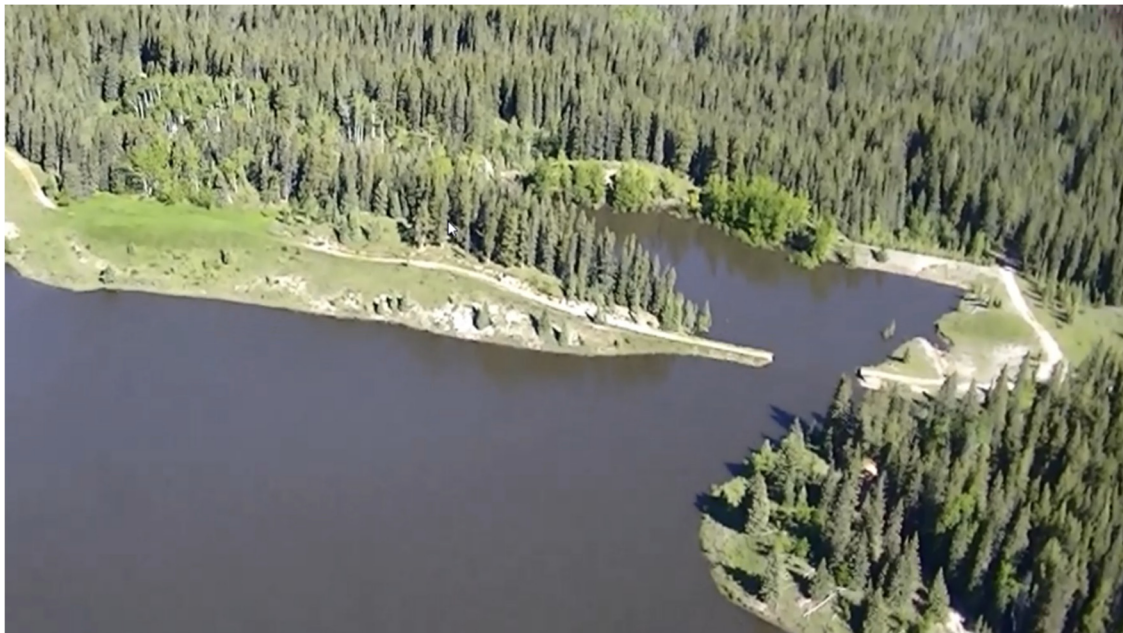
During the historic June 2013 severe rainfall event and flood, run-off flowed into Klein Lake and overtopped the Cofferdam. The Main Dam, however, retained the flood water, which was then gradually released through the open LLO, minimising flooding impact on the Panther Road and a private development located adjacent to the outlet creek, downstream of Panther Road. The breach of Cofferdam is shown in Figure 2 right after the flood, and in Figure 3 after flood water had passed. The lake upstream of Cofferdam soon after failure is shown in Figure 4.

**Figure 2 Klein Lake Dam failure in 2013 showing breach of Cofferdam and Main Dam impounding released water**

Following Cofferdam failure, the GOA conducted extensive studies to assess the feasibility of dam replacement versus dam removal. Ultimately, dam removal was selected as the most cost-effective and sustainable long-term solution. Additional details for the Klein Lake Dam removal project are presented in Gräpel et al. (2023).

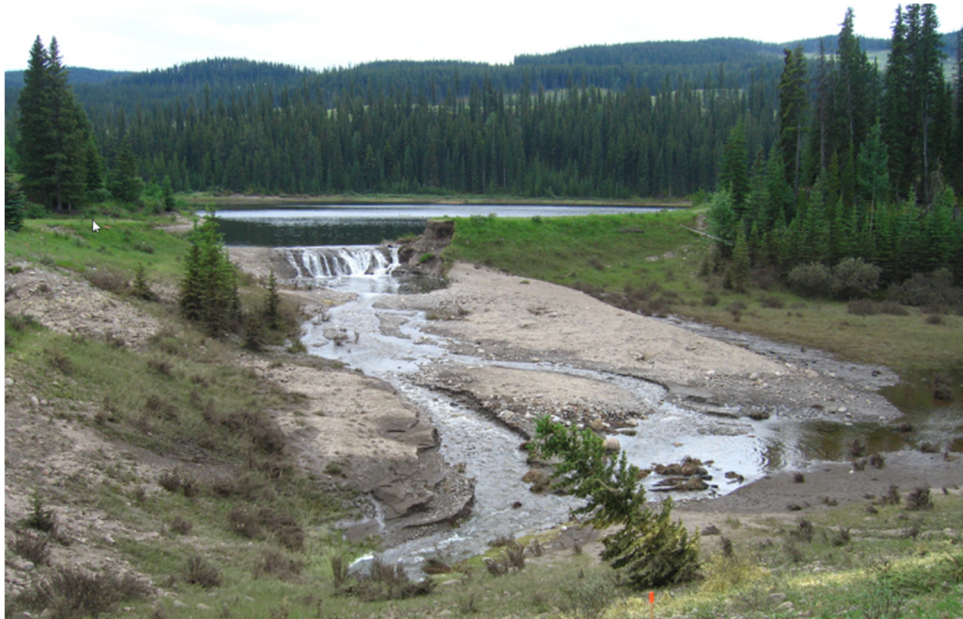
**Figure 3** Cofferdam breach viewed from Main Dam in July 2013

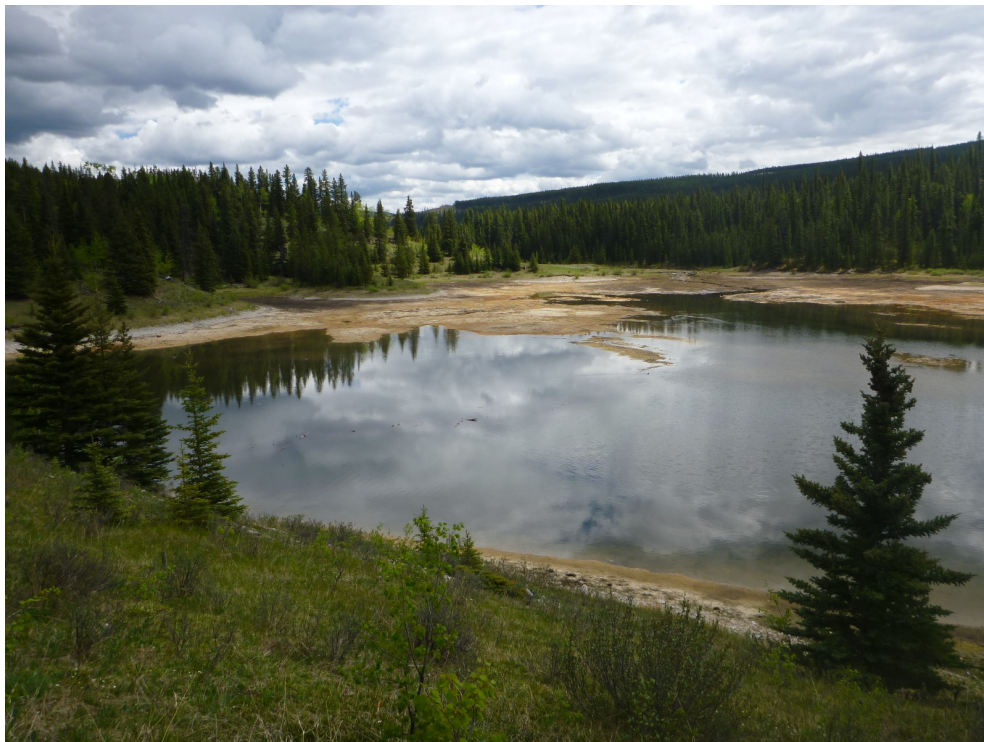
**Figure 4** Lakebed upstream of Cofferdam in July 2013

The level of Klein Lake gradually decreased between 2013 and 2020 due to ongoing erosion from lake outflows that naturally eroded Cofferdam fill to foundation level. The former lakebed naturally revegetated with native plant species as the lake level reduced in response to the erosion of the Cofferdam. By the time dam removal started, much of the former lakebed had started to naturally revegetate with native species, and inflow creeks had naturally removed lakebed sediments from pre-impoundment creek channels.

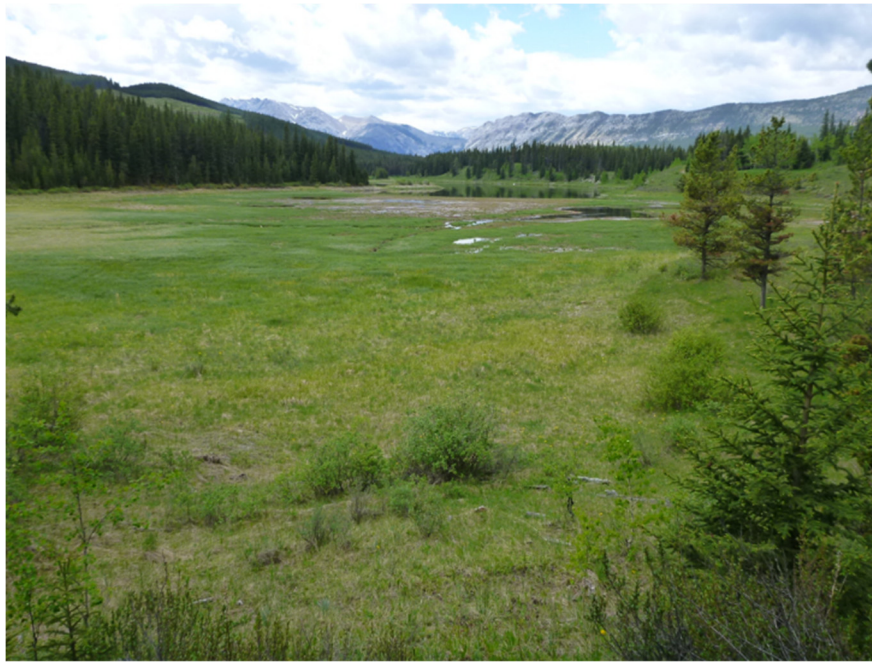
The revegetation design used native species and was based on a review of the species naturally repopulating the exposed lakebed. The design was informed by soil chemistry and nutrient profiles developed by KCB vegetation ecologists and soil scientists; supported by input from government rangeland ecologists. The revegetation design was prepared to augment and complement the natural revegetation that was occurring on the former lakebed. Recognising the potential for erosion of unvegetated surfaces to occur before native species had established ground cover, a sprayed-on erosion control blanket (bonded fibre matrix hydromulch) was used for all exposed soil surfaces and natural soil amendments were added to promote accelerated growth of vegetation. The lakebed a year after completion of construction is shown in Figure 5.

**Figure 5 Lakebed in August 2021**

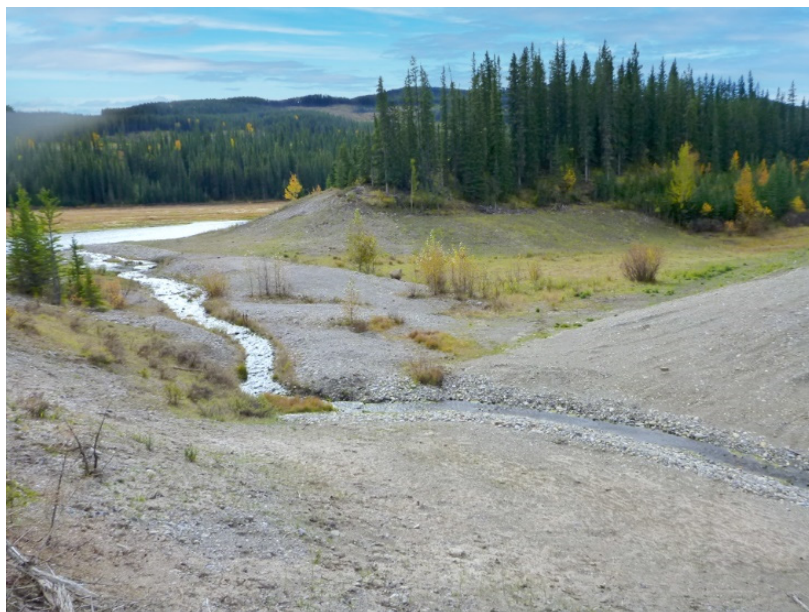
Review of the natural ground surface exposed during initial removal of Cofferdam indicated that Cofferdam had been constructed on a ridge of natural ground. The ridge of natural ground below Cofferdam was a remnant of a second esker on site that was partially covered with lakebed sediments from the former paleolake. Confirmatory ground investigations conducted after initial Cofferdam removal verified that all Cofferdam fill had been removed. As a result, a small pond remained upstream of the former Cofferdam location and the former outlet creek channel upstream of Cofferdam did not need to have sediments removed. The regulator was involved in discussions on this matter and visited the site before approving the design change. The final configuration of Cofferdam removal is shown in Figure 6.

**Figure 6 Cofferdam removed in September 2020, abutments of removed Main Dam in foreground**

by KCB and TEC, in discussion with regulators, not to reconstruct this portion of the channel. The channel had naturally stabilised and was providing a valuable fish habitat, which had developed between 2013 and 2020. The channel left unchanged between the former Cofferdam and Main Dam is shown in Figure 6.

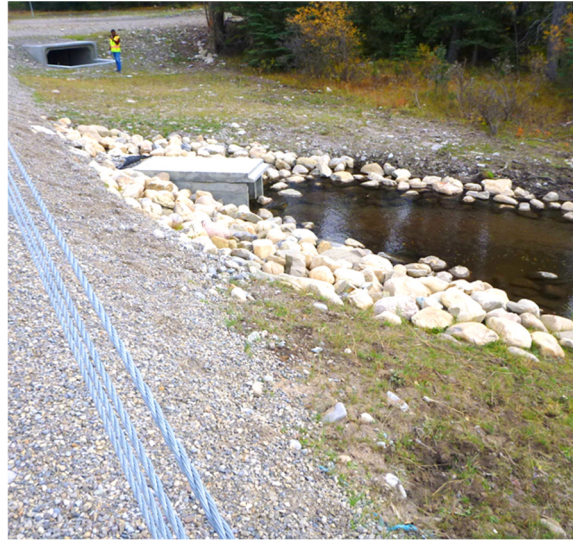
**Figure 7 Inlet to low-flow culvert below Panther Road that maintains primary channel and fish spawning habitat, with inlet of high-flow diversion culvert in background**

Normal flows in the outlet creek at Panther Road, after dam removal, were accommodated by a precast concrete box culvert ( $0.61 \times 0.61$  m), to maintain normal water flow to the valuable fish habitat in the existing outlet creek downstream of Panther Road. However, the increased flow rates from flood events could potentially flood the private development. To address flood management concerns after dam removal, a precast concrete box culvert was installed beneath Panther Road to convey high flows. During construction in the early days of the pandemic, the required high-flow diversion culvert size was not available so a larger, standard-size box culvert ( $2.4 \times 1.2$  m) was selected; which provided additional discharge capacity. The high-flow diversion culvert discharges into a high-flow diversion channel, which discharges into an outlet creek downstream of the sensitive fish habitat and the private development. A riprap-armoured diversion berm was constructed upstream of Panther Road to direct flood flows to the culverts below Panther Road. A 1:100-year flood event was used for the design of diversion works. The selection of the dual culvert system avoided the need for land expropriation to construct a diversion berm adjacent to the private development. The regulator provided valuable input throughout the conceptual design of the dual-channel system.

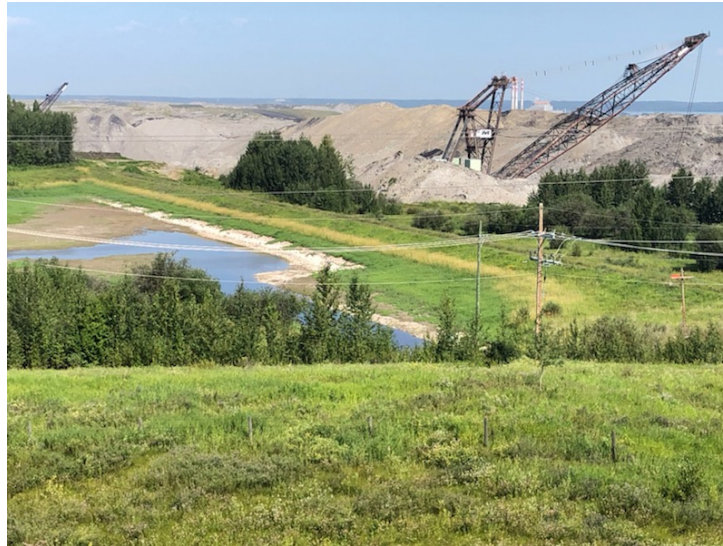
Billy Goat Dam is currently within 250 m of the limit of Pit 05 and within 100 m of a pre-cleared area at the crest of Pit 05. The area between the dam and the pit is land owned by the Highvale Mine and is unoccupied. Billy Goat Dam is shown in Figure 9.

**Figure 9 Billy Goat Dam with Pit 05 a short distance downstream**

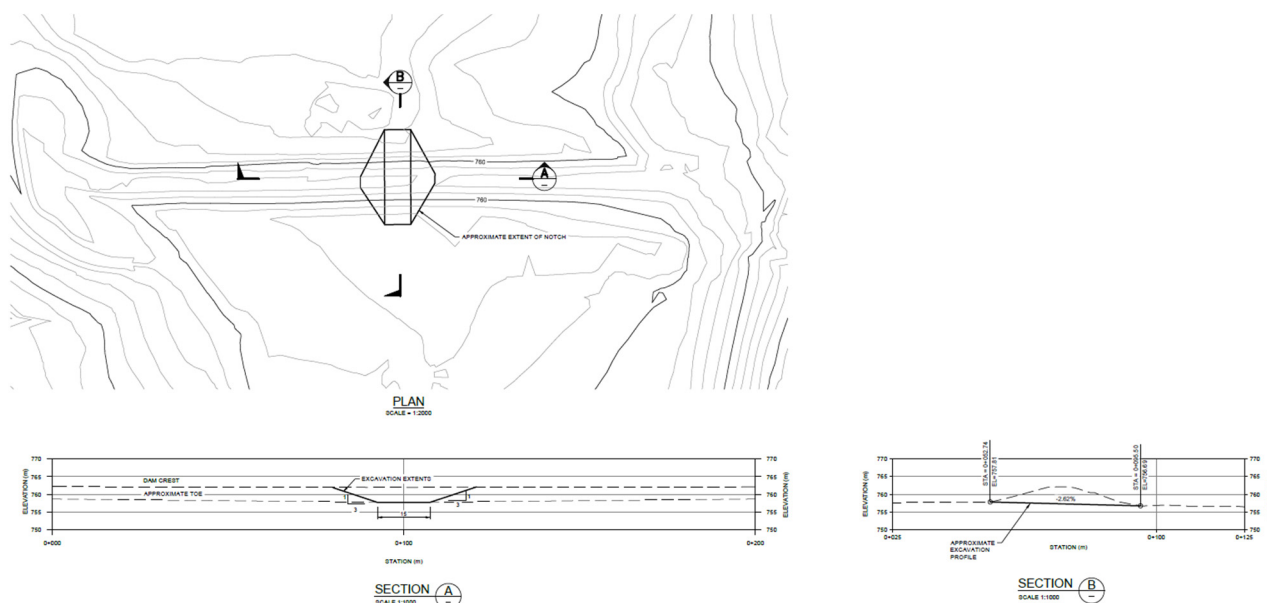
**Figure 10 Billy Goat Dam channel details**

Channel side slopes of 3H:1V were selected based on the dam being constructed with compacted fill and because the steepest slope on the existing dam is 3H:1V. Review of the available foundation soils and fill information, combined with engineering judgement and experience with fill slopes at Highvale Mine, indicated the channel slopes should be stable at 3H:1V.

Design work for the decommissioning and environmental assessment is presented in a design report submitted to TransAlta (KCB 2020). The decommissioning concept will be a channel excavated through the dam. The channel through Billy Goat Dam was designed to pass the 24-hour, 1:100-year runoff event. A channel base width of 15 m was selected to provide a wider-than-required notch to be conservative. Design details for the notch through Billy Goat Dam are shown in Figure 10.

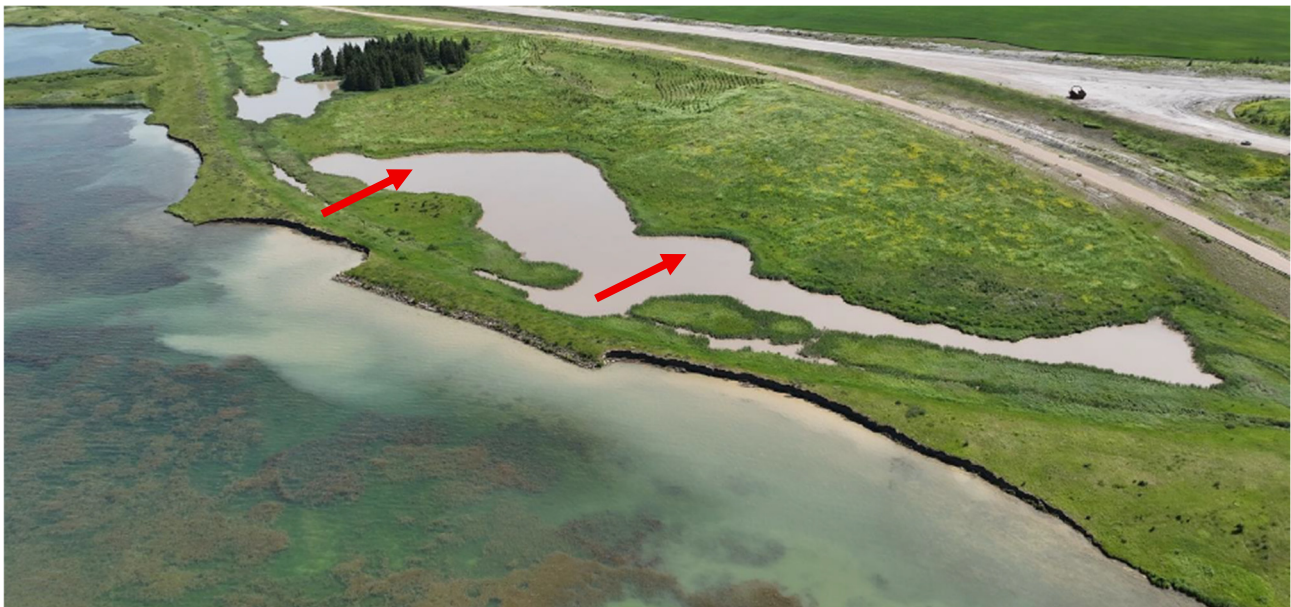
**Figure 11 East portion of Southeast Dyke. Red arrows indicate areas of erosion and ponded water downstream of the dyke (downstream direction is towards top of photo)**

downstream area. Water has ponded on the downstream toe area of the SE Dyke and in 2024 was approximately 1 m higher than the pond level in GCP.

Portions of SE Dyke are currently eroding because of wind-wave action, with erosion at two locations having removed the upstream slope and extended into the crest of the dyke. Failure of the SE Dyke would not result in an uncontrolled discharge of water from GCP. Conversely, due to the higher surface water elevation of the ponded water downstream of SE Dyke, ponded water on the downstream side of SE Dyke would discharge into GCP in response to failure of SE Dyke. The exact amount of water that would be released is unknown, but is not expected to cause water levels in the cooling pond to rise more than 1 cm. Given the limited difference in water levels between the downstream ponds and the cooling pond, a rapid rush of water is not predicted.

Dam decommissioning will be completed with a controlled breach. The controlled breach concept will consist of excavating two channels through the SE Dyke. The design concept currently includes a trapezoid shaped channel with a base width of 2 m, side slopes of 3H:1V, grade of at least 2% toward GCP to promote positive drainage, and seeding to promote vegetation growth. The channels will be excavated where the erosion is located. Due to the low height of SE Dyke at these locations, channel side slopes will be designed on the basis of engineering judgement and experience.
