# Rehabilitation of historical mine features: from mitigation towards true risk elimination

Erika Voyer <sup>a,\*</sup>, Jérémie Arsenault <sup>b</sup>

## Abstract

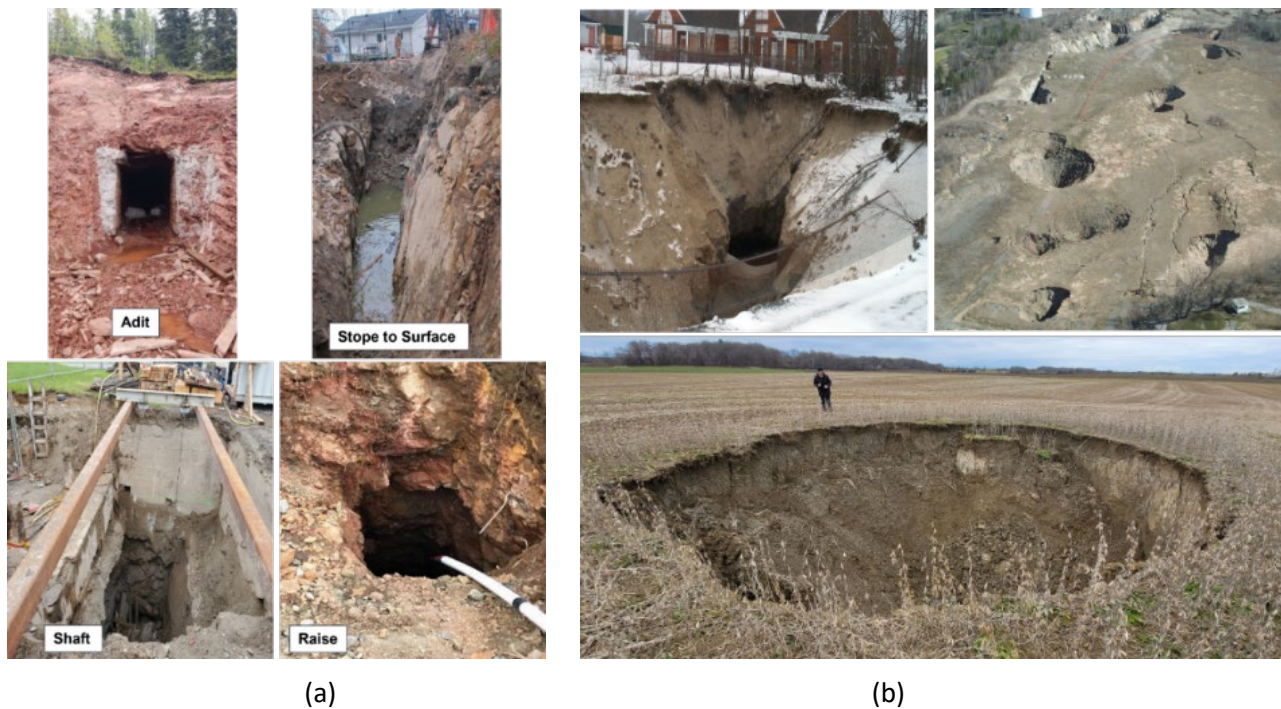
**Figure 2 (a) Examples of mine hazards (courtesy of WSP Canada Inc.); (b) Examples of mine hazard subsidence failures (courtesy of WSP Canada Inc.)**

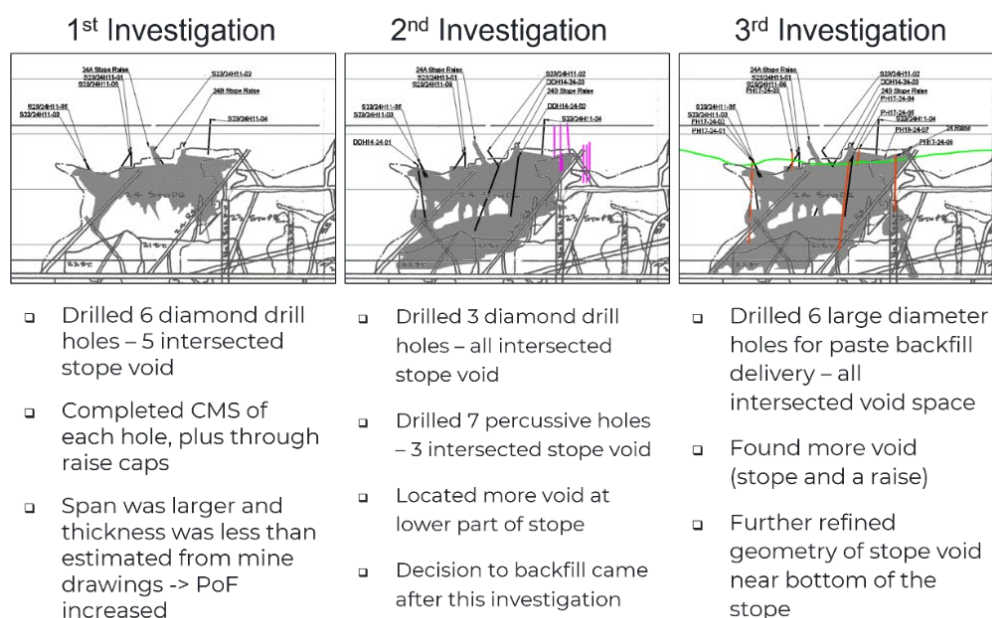
- First investigation: The mine's longitudinal section was investigated using 6 diamond drillholes, 5 of which successfully intersected the underground workings. Cavity monitoring surveys, deployed through selected boreholes, were used to generate the initial 3D void geometry. Due to line-of-sight limitations, some blind spots could not be fully surveyed. The dark grey areas shown in Figure 3 represent the voids derived from cavity monitoring surveys.

- Second investigation: Based on the results of the first investigation, additional stope delineation was undertaken. This phase included 3 diamond drillholes and, in one particularly difficult to locate area, 7 percussive drillholes, 3 of which intersected the stope. By the completion of this stage, the stope, along with connected raises and drifts, was sufficiently defined. Subsequent stability assessments determined that the crown pillar was not stable over the long term.

- Third investigation: Six large-diameter percussive holes were drilled into the stope to facilitate placement of cemented backfill (paste). During the backfilling process, additional void spaces and a previously unidentified raise were discovered, characterised and included in the ongoing remediation.

**Figure 3** Iterative stages of investigation and assessment for a legacy stope

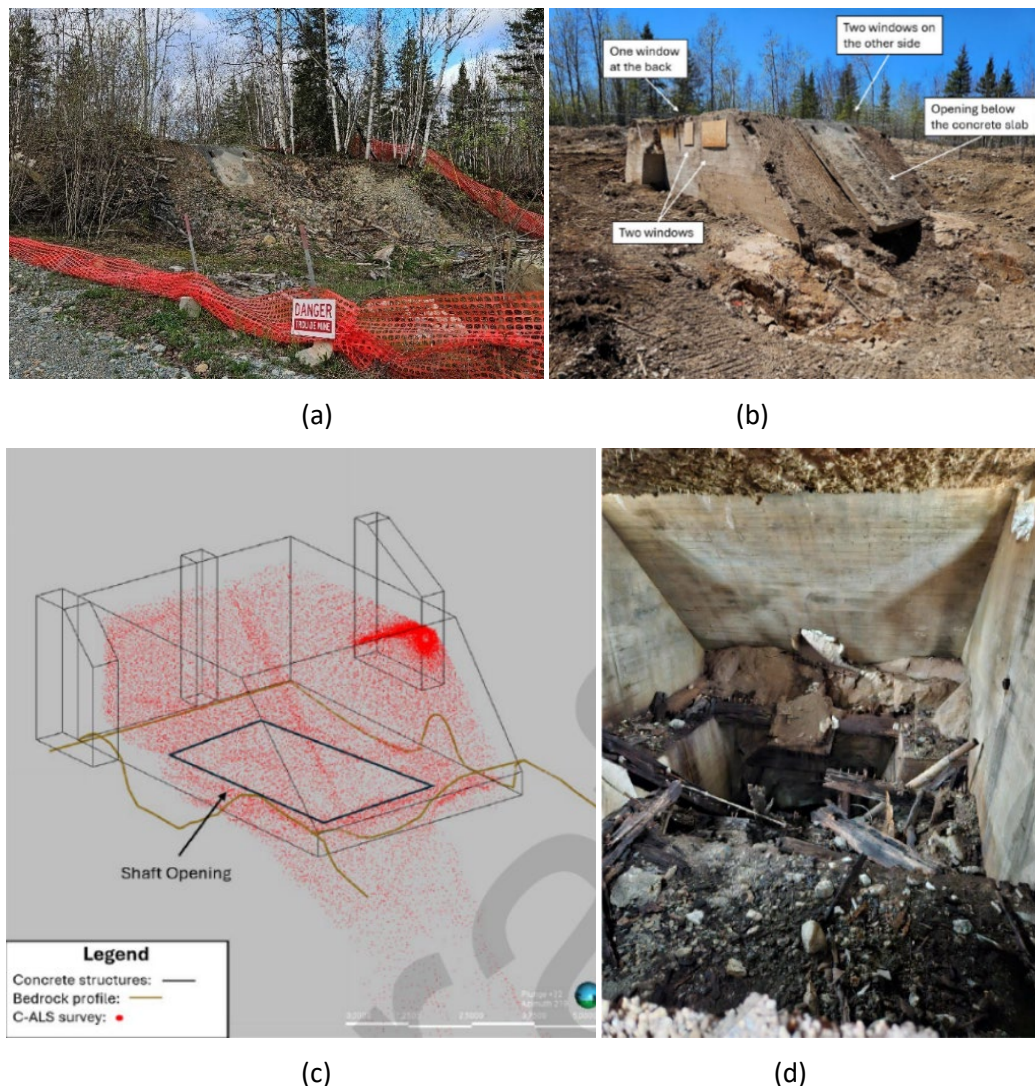
During 2024 a site visit, it was observed that shaft #3 was covered by 2 concrete slabs and surrounded by a temporary snow fence. An excavation program was then planned in 2025 to expose the structure down to bedrock where feasible. The excavation work exposed a concrete structure covering shaft #3 and revealing an unexpected large concrete structure with a sloped north face that acted as a collar structure for the inclined shaft, as presented on Figure 5.

The top part of the shaft was surveyed using a C-ALS (cavity auto-scanning laser system). The survey showed the shaft is inclined at an angle of approximately 45°, with span and width of approximately 2.5 m and 3.0 m, respectively. Pictures taken of the inside of the concrete structure revealed wooden debris around the shaft collar and visible old tracks along which hoisted carts circulated. Timber for roof support at the shaft brow was also observed during the investigation.

The concrete collar floor was found to be built in deeper than the observed bedrock elevation. Figure 5 also presents the C-ALS surveys of the shaft looking west and the inside of the concrete structure. Given the dip of the shaft, it was identified that the stability of the brow area needs to be assessed as part of the remediation design. The survey also suggested that the roof of the concrete structure was in poor condition, with the aggregate being exposed on nearly the whole surface. The concrete walls appeared in better shape, except around the openings where significant erosion and weathering occurred.

**Figure 5** (a) Shaft #3 before excavation; (b) Shaft #3 after excavation exposing the concrete structure; (c) C-ALS surveys of Shaft #3 looking west and bedrock profile; (d) Inside of the concrete structure of Shaft #3

The investigation confirmed that shaft #3 remains open to surface and is currently covered by a concrete structure. Although temporary measures have been implemented to restrict access, a permanent remediation strategy is required. Based on the information available, a conceptual remediation design will be developed, supported by a gap analysis to identify remaining risks and uncertainties.

The objective of the planned next phase is to evaluate remediation options that meet long-term stability requirements at the shaft brow and comply with regulatory standards for shaft closure. Given current observations, the existing concrete structure will likely need to be demolished, as retaining an elevated structure would require monitoring and could pose a long-term risk. Based on current design work for remediation, a concrete slab anchored to bedrock spanning both the opening and the potentially unstable brow area is considered an appropriate long-term solution.

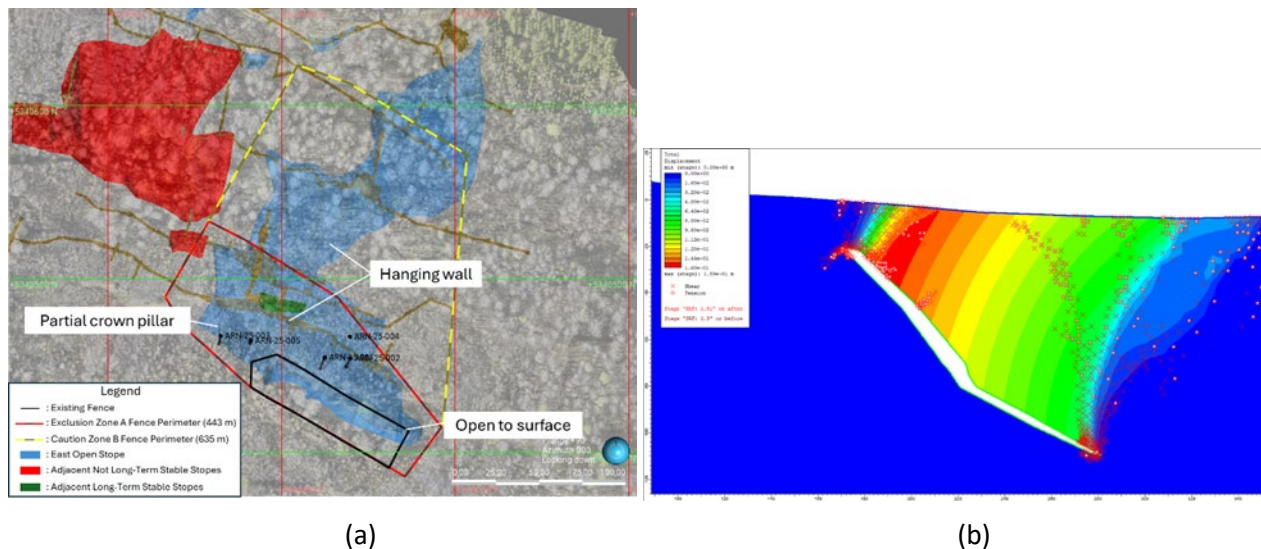
For the section of the stope underlain by the remnant crown pillar, numerical modelling indicates that the pillar is not stable in the long term. A crown pillar failure could also induce localised hanging wall instability, expressed as tension cracks and differential horizontal movement, but significant subsidence farther from the crown area is considered unlikely.

Two main zones were delineated (zones A and B), as presented on Figure 6. Zone A includes the surface-daylighting portion of the stope, the remnant crown pillar, and the upper section of the hanging wall. To protect public safety, a new fence – properly sized and complying with regulatory standards – will be installed around this zone in the short term.

A lower-risk Zone B is associated with the elevated potential for tension cracking and differential horizontal movement at surface above the stope footprint. Access restriction is not recommended at this time; however, future land use planning should restrict permanent infrastructure development due to the potential for ground deformation even before crown pillar failure.

**Figure 6 (a) East Open Stope and safety perimeters; (b) Modelling results supporting the perimeters**

To eliminate the risk rather than limiting access, backfilling remains a viable long-term, maintenance-free remediation solution capable of securing both zones without restricting land use. Given the mine configuration, with openings spanning multiple levels with a shallow dip, additional investigation and design work will be required to evaluate the feasibility of backfilling and other options.

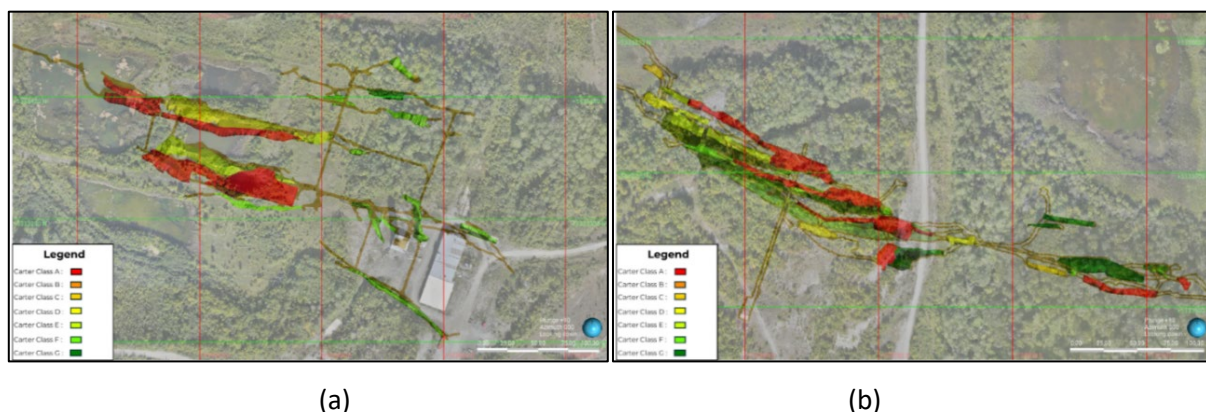
Crown pillar stability assessments for the 3 surveyed stopes were completed using the scaled span method (Carter 2014). From the surveyed geometries and rock mass classifications obtained during the preliminary drilling, based on acceptable guidelines for crown pillar stability (Carter et al. 2008 after Carter & Miller 1995), stope 1-F-50 is considered long-term stable, while stopes 1-D-47 and 1-5-21 are not, as summarised in Table 1. The acceptable guidelines for crown pillar stability in the context of mining use and public access are derived from a relationship between the scaled span ( $C_s$ ) and the Probability of Failure (PoF) based on logistic regression of the crown pillar failure database.

Based on the recently acquired preliminary investigation geotechnical data, crown pillar stability assessments were also completed for all other stopes located above the second level at both sites. Of these, 21 stopes are considered to not be long-term stable, while 20 are considered long-term stable, as presented in Table 2.

**Figure 8 Map of scaled span method results; (a) Site #1; (b) Site #2**

The 2026 investigation program will focus on assessing the level of risk associated with the crown pillars identified as not long-term stable and on evaluating potential remediation solutions. The primary objective will be to collect detailed geotechnical data (rock mass quality, presence and characteristics of fill material) and geometrical information (crown pillar and void dimensions). By validating the current risk level for each crown pillar or sector, appropriate risk mitigation and remediation scenarios will be developed based on the identified conditions and constraints.

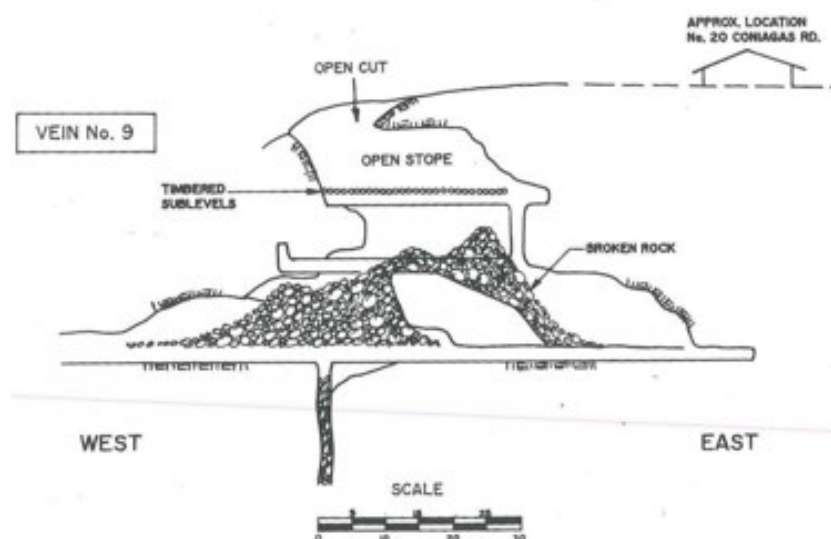
The first data reviews, geophysical surveys and drilling investigations completed on the Vein 9 stope (Figure 9), indicated an undulating vein mined to surface in the west end and underground portion towards the east end (Figure 10). Based on the historical drawings and investigations by Golder, the width of the Vein 9 stope is approximately 5 m and it is 60 m long (striking NE–SW). Data also indicated the Vein 9 stope was partially backfilled with waste rock and included a wooden timbered floor. The open cut in the west end was backfilled to surface and secured with a mine hazard fence. Towards the west end of the Vein 9 stope is a residential property which has been reported to have had a surface subsidence event beneath the residential driveway (Golder Associates 1992).

**Figure 9 Vein 9 stope simple longitudinal section (Golder Associates 1992)**

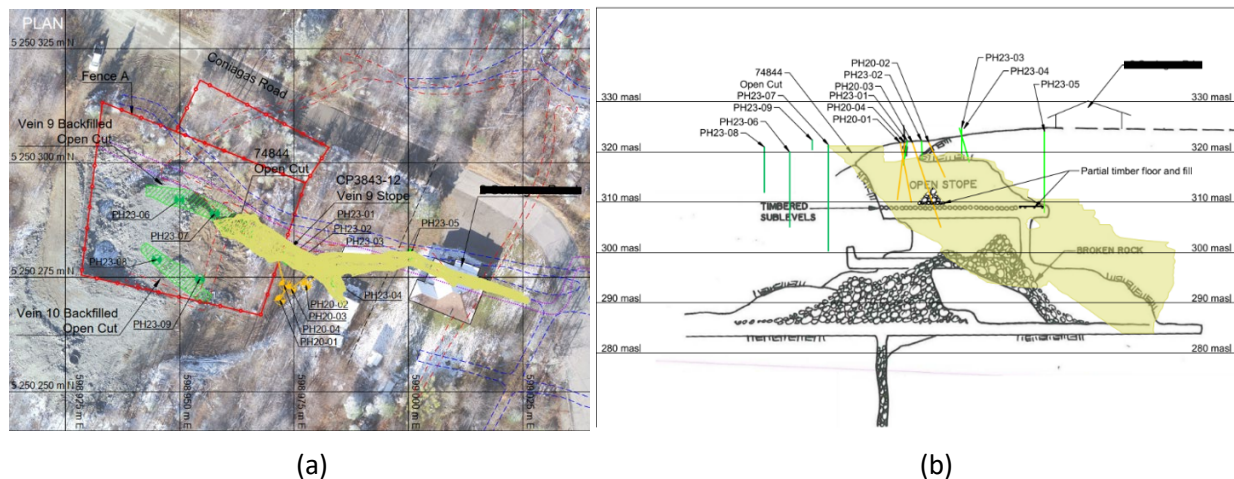
Subsequent drilling (4 diamond drillholes illustrated on Figure 11 coloured yellow) and void surveying in 2020 refined the understanding of the stope geometry and confirmed that a portion of the crown pillar extending beyond the fenced area required rehabilitation. A preliminary concept was developed based on the improved geometry, but residual uncertainty remained regarding the full extent and volume of the stope, as well as the condition of historically placed backfill.

- upper stope with a relatively thin crown pillar, assessed as not long-term stable
- lower stope with a substantially thicker crown pillar, assessed as long-term stable and not requiring rehabilitation.

**Figure 11 (a) 2020 and 2023 drilling investigations of Vein 9 stope (WSP 2026); (b) 2020 and 2023 longitudinal section of Vein 9 stope superposed to historical drawing (WSP 2026)**

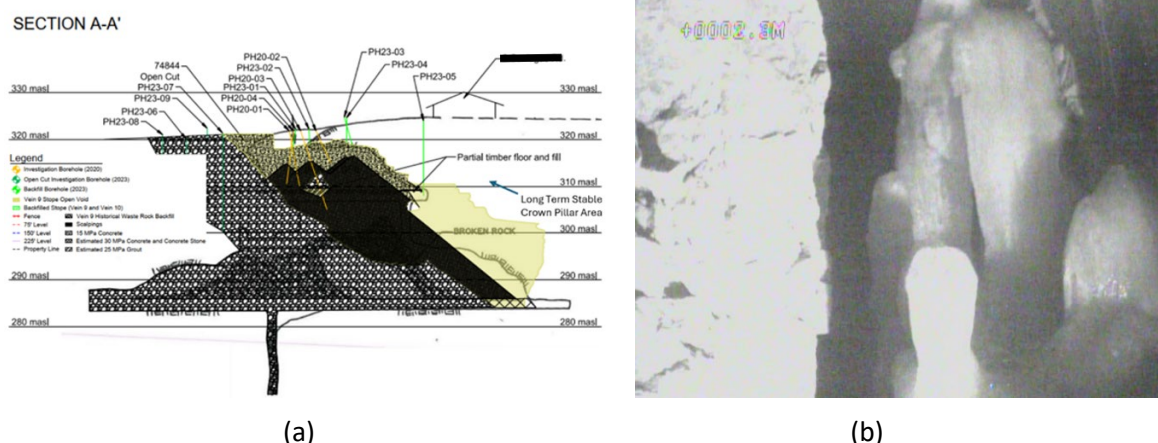
**Figure 12 (a) Longitudinal section of Vein 9 stope showing remediation filling (WSP 2026); (b) Initial ice conditions inside the stope**

The primary rehabilitation objective for the Vein 9 stope was to eliminate the hazard posed by void space beneath the unstable portion of the crown pillar, rather than relying on long-term access restriction.

A phased backfilling approach was selected, consisting of bulk filling with uncemented aggregate comprised of concrete stone and scalpings (scalpings hatch in Figure 12), followed by placement of an upper level of cemented backfill to achieve tight filling beneath the Upper Stope crown pillar region. Cemented backfill was used specifically where aggregate alone could not reliably achieve contact with the crown but was not intended to function as a self-supporting structural plug. All backfilled placement was via the 5 drillholes completed in 2023.
