# Low-disturbance decharacterisation of a legacy bauxite tailings facility in the Brazilian Amazon: integrated drainage, revegetation and monitoring

<sup>a</sup> Mineração Rio do Norte, Brazil

*The SP-2/3 bauxite tailings storage facility is part of a 1,405 ha tailings disposal system on a plateau in the Brazilian Amazon, planned for progressive, integrated closure of its structure to restore land function and reintegrate the plateau landform. Constructed in 1988 for deposition of thickened tailings, SP-2/3 operated until 2000 when it became inactive and then the natural recovery process began, during a period of limited Brazilian requirements for dam decharacterisation. After approximately 20 years of rehabilitation and ecological re-establishment, it was necessary to develop a closure strategy aligned with Brazilian dam decharacterisation requirements (including ANM Resolution No. 95) and with international best practices, such as the Global Industry Standard on Tailings Management (GISTM), while preserving established vegetation and minimising disturbance to the tailings surface.*

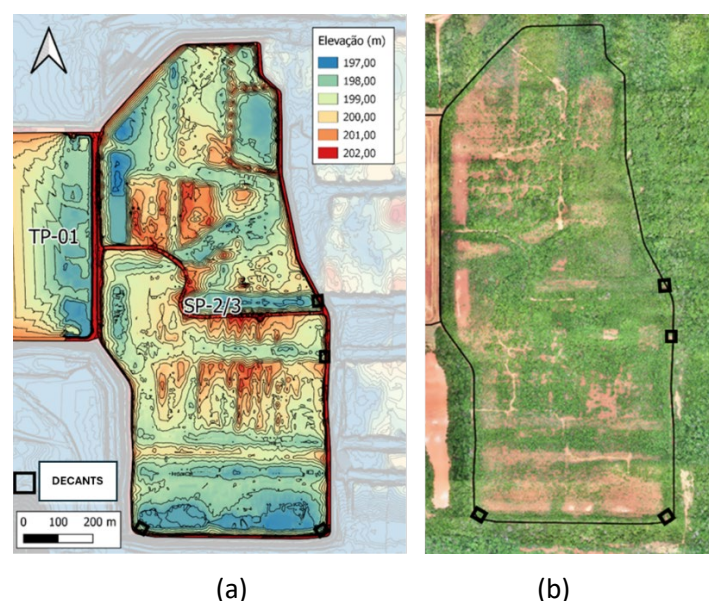
Spatial comparison between the elevation model and field observations indicated a consistent pattern: areas with well-developed vegetation were generally associated with higher elevations, whereas areas with limited vegetation performance coincided with lower-lying zones and depressions prone to persistent ponding (Figure 6). Although no specific eco-physiological assessment was conducted, field observations from revegetation programs implemented over several years in bauxite tailings areas indicate that prolonged waterlogging may limit vegetation establishment and development in such environments. Potential mechanisms include reduced oxygen availability within the root zone, decreased plant growth, partial mortality of fine roots, and increased susceptibility to phytopathogens under prolonged saturated conditions. In addition, revegetation efforts were focused on native Amazonian species consistent with the target ecosystem, limiting the selection of species naturally adapted to persistently flooded conditions. These observations supported the interpretation that persistent surface ponding was an important factor affecting revegetation performance and should be addressed as part of the closure strategy.

**Figure 6 (a) Surface elevation model; (b) Vegetation cover observed in the 2022 orthophoto**

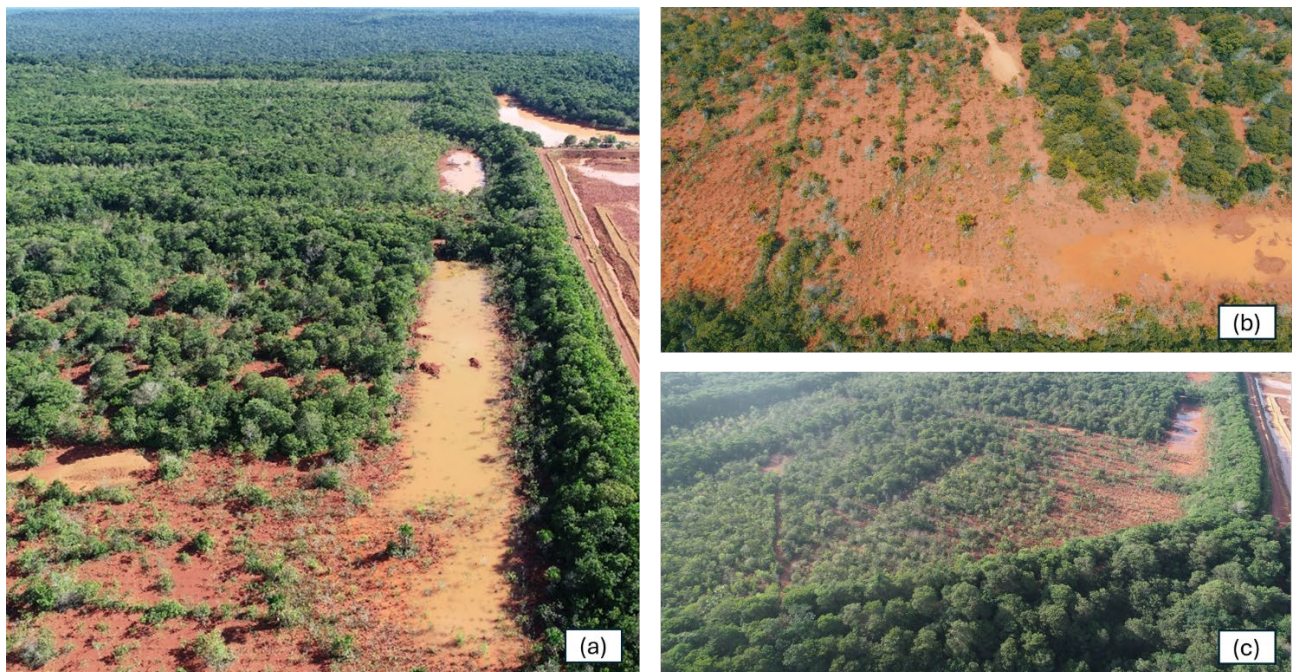
The diagnostic evaluation further indicated that the irregular surface and internal barriers constrained overland flow routing, reducing hydraulic connectivity between ponded areas and existing overflow routes. Consequently, surface run-off generated within the impoundment did not reliably contribute to overflow structures under rainfall events. This finding directly supported the closure concept by establishing the need for targeted, low-disturbance interventions to reinstate surface drainage connectivity – through localised openings and defined flow paths – so that stormwater could be conveyed from internally ponded zones towards the designed overflow discharge points.

Figure 7, obtained prior to the closure interventions, shows an irregular surface with internal topographic barriers that restricted surface run-off toward the overflow structures, which were also associated with areas of limited vegetation cover.

**Figure 7 (a) Areas with water accumulation and internal topographic barriers; (b) Zone with reduced vegetation cover; (c) General view of the northern sector in 2022**

To ensure hydrological and hydraulic safety, targeted low-disturbance interventions were implemented, including localised channels and internal connections to restore surface drainage continuity towards the new overflow discharge structures. Localised fills were applied within significant depressions to re-establish the required hydraulic connectivity.

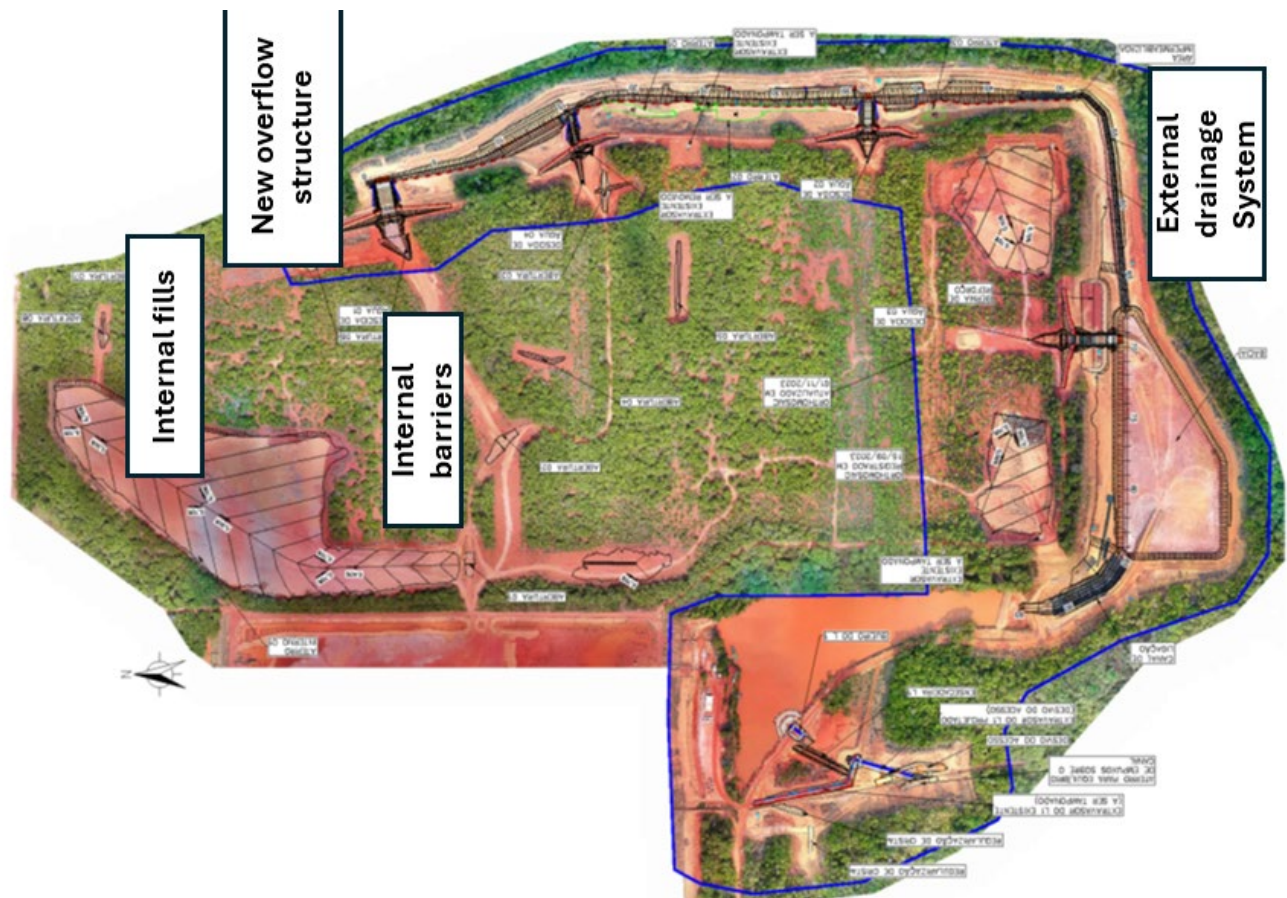
**Figure 8 Main interventions**

- Localised openings through major internal barriers
  - Localised openings were created across major internal topographic barriers to allow water transfer between previously disconnected internal compartments and to route run-off toward designated overflow discharge points.

- Localised internal fills to remove critical depressions and define drainage gradients
  - Internal fills were placed in areas characterised by significant depressions and recurrent water accumulation to re-establish hydraulic continuity and to support stable flow routing within the impoundment. Where implemented, fill geometries were developed to achieve gentle surface gradients (typically 0.5–0.7%) compatible with low-energy drainage conveyance and minimal disturbance objectives.

- New overflow structures to ensure hydrological and hydraulic safety
  - Four new overflow structures were implemented to connect the internal drainage system to external drainage pathways and to ensure hydrological and hydraulic safety against overtopping during extreme rainfall events. The system was designed to provide overflow capacity consistent with conservative event selection, including consideration of PMP and was framed to meet GISTM (GISTM 2020) expectations for robust performance irrespective of the facility's consequence classification.

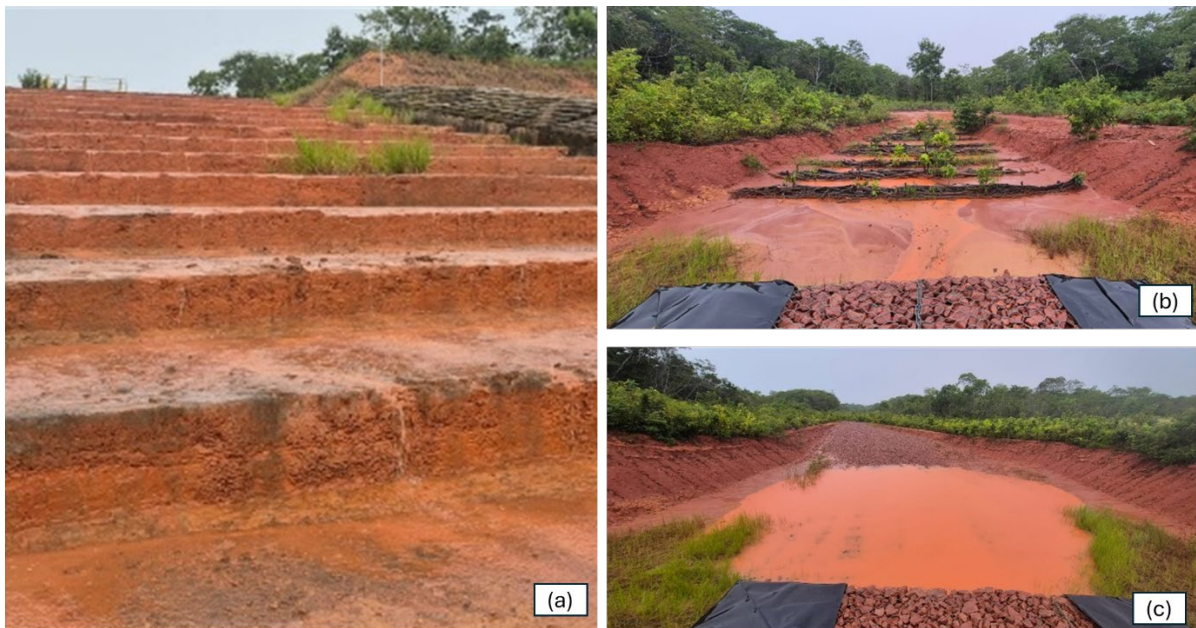
Routine field inspections of the drainage system and overflow structures confirmed satisfactory hydraulic performance throughout the monitoring period. The overflow structures operated as intended during rainfall events, providing controlled conveyance of surface run-off and preventing the formation of persistent ponding within the former impoundment.

As shown in Figure 11, the visual inspections also confirmed good structural condition and effective integration between internal drainage pathways, overflow structures and downstream drainage infrastructure. These observations demonstrate that the closure system is functioning reliably under current climatic conditions.

**Figure 11 (a) Performance of the stepped spillway; (b) and (c) Concentration of upstream drainage toward the overflow structure and sediment retention barriers**

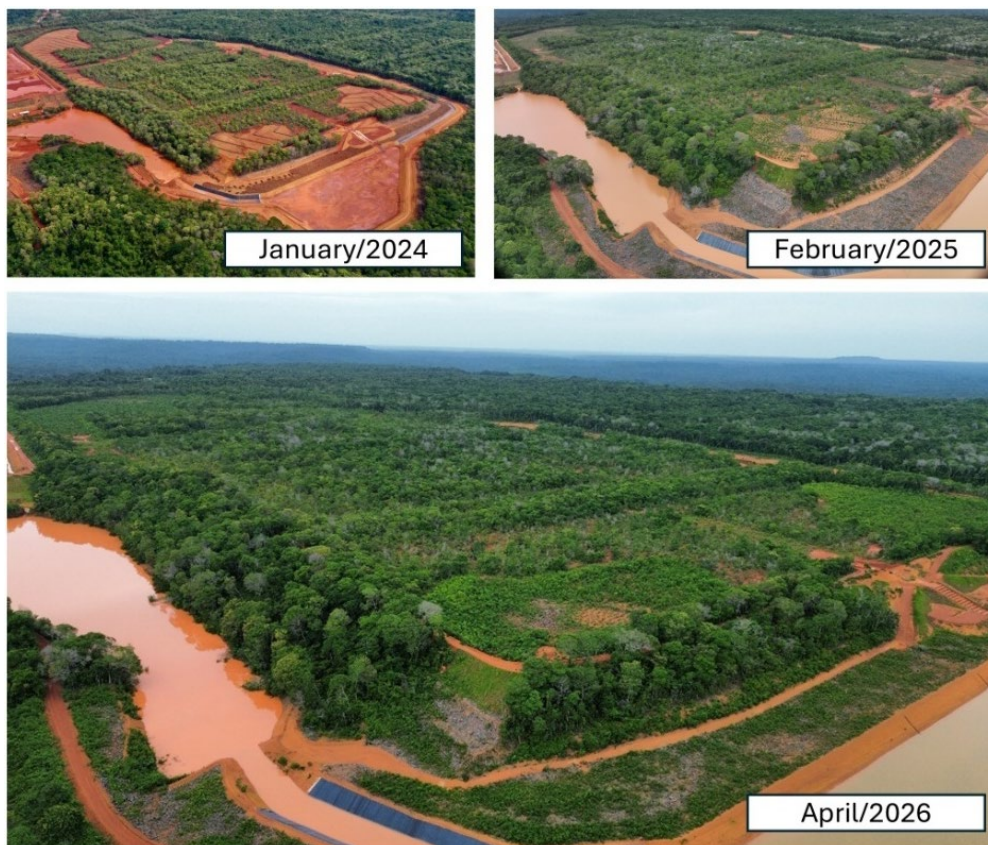
Figures 12–14 presented the visual assessments and comparative imagery demonstrate preservation of most pre-existing vegetation on the tailings surface, alongside gradual and sustained development of newly planted vegetation. A general overview of the facility indicates widespread vegetation cover, while treated areas previously affected by water accumulation show marked improvement in vegetation establishment and growth following topographic adjustments and drainage improvements.

**Figure 12** Aerial view of the area following intervention (2024) and during post-closure monitoring in 2025 and 2026

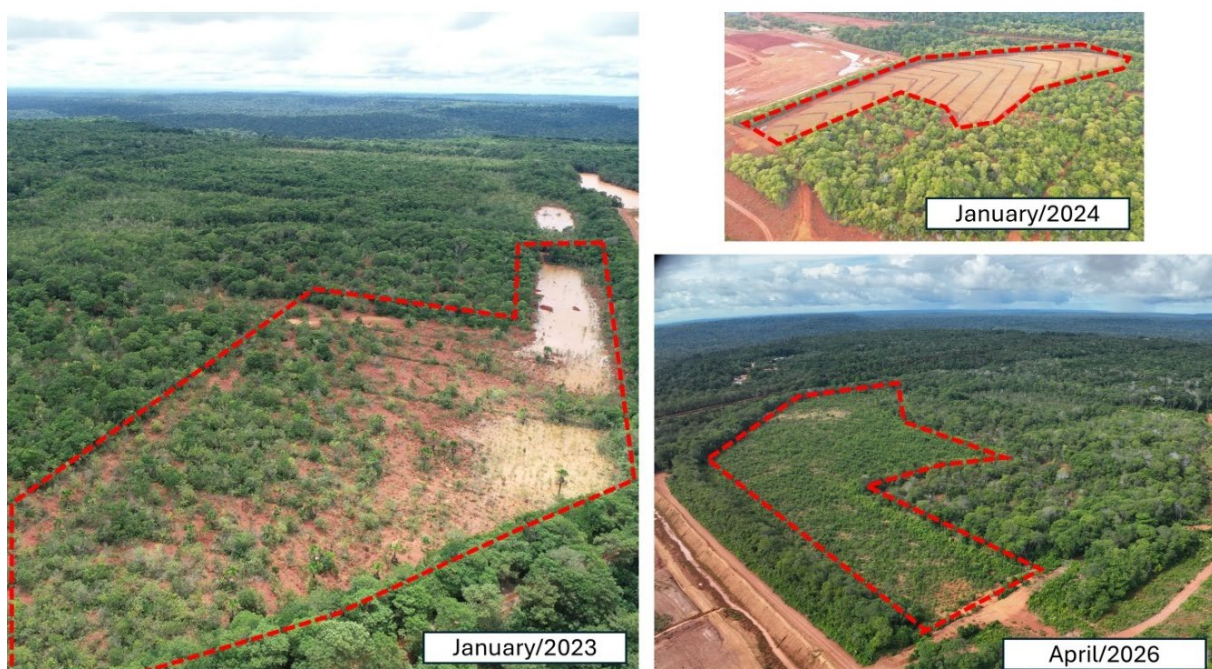
**Figure 13** Treatment of the northern sector

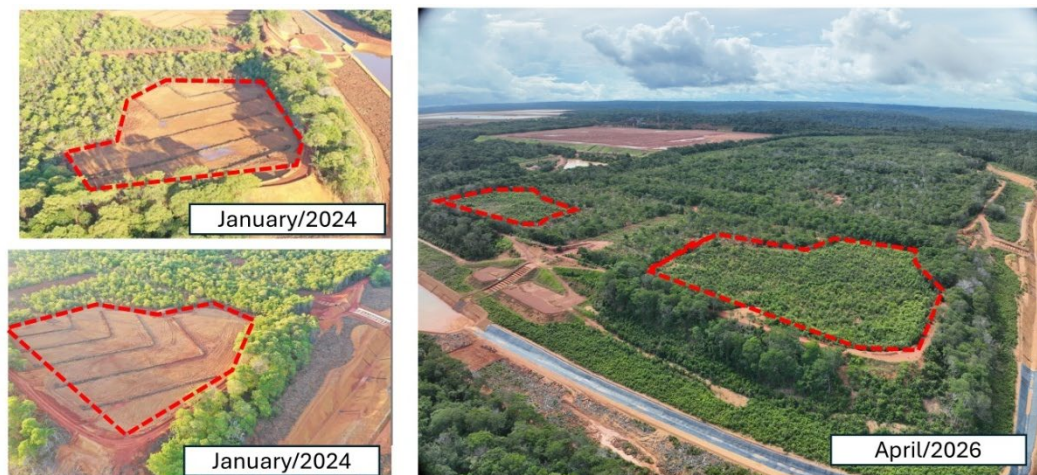
**Figure 14 Treatment of the southeast sector**
