# Innovative Mine Closure Design Based on Observations of Mine and Natural Analogues

**D.J. Williams** *The University of Queensland, Australia*

**J.T. Kline** *BHP Copper, San Manuel Mine, USA*

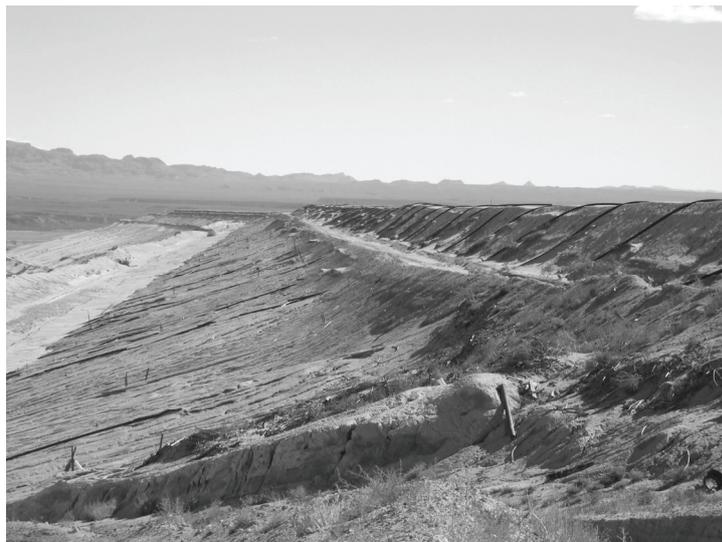
Figure 2 shows the unreclaimed, newer, upper bench of the outer slope of 3 and 4 Dam, showing only minor erosion. Figure 3 shows the unreclaimed outer slopes of the older 10 Dam, showing full-height rilling, tunnel erosion and gullying, and oxidation of the tailings.

**Figure 2** Unreclaimed, newer, upper bench of outer slope of 3 and 4 Dam, showing only minor erosion

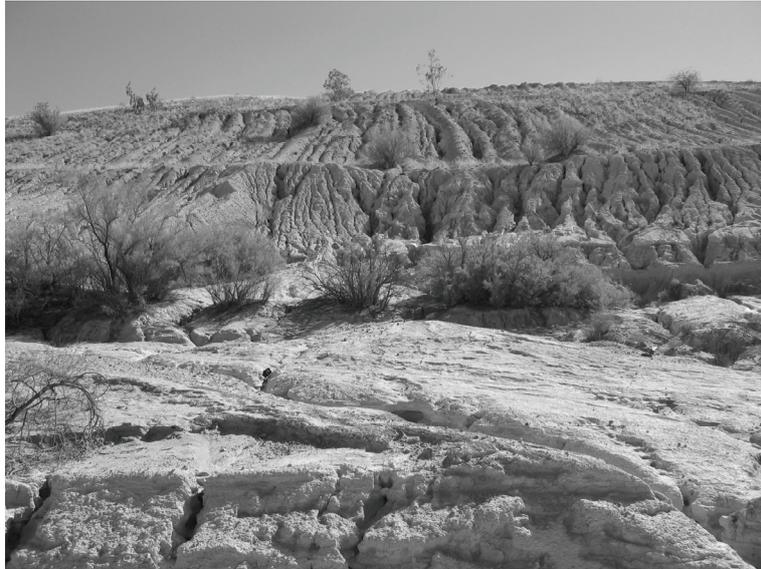
**Figure 3** Unreclaimed, older, outer slope of 10 Dam, showing full-height rilling, tunnel erosion and gullying

In relation to the outer slopes of the San Manuel tailings storages, it is likely that the majority of incident rainfall runs off, but benches (including drainage benches) that allow the ponding of water increase and concentrate infiltration into the erodable tailings, resulting in tunnel erosion and gulying. It appears that a fine-grained alluvium cover on the slope will initially revegetate, but rills will develop that promote tunnel erosion and gulying of the tailings, and the loss of the cover causes a loss of vegetation within about 10 years. A coarse-grained alluvium cover on the slope promotes only limited revegetation, and rills develop, leading to tunnel erosion and gulying of the tailings.

- Continuous 3(H):1(V) slope.
- A 0.3 m thick layer of fine-grained alluvium over the entire slope, with an average 230 mm of rip rap protection (nominally 150 mm maximum size quarry run, increasing in thickness down the slope from 150 mm at the crest to 300 mm at the toe), providing a dense, coarse-grained cover, since cementation is impractical. The coarse-grained alluvium cover originally proposed for the slopes between the drainage benches would promote only poor revegetation, and would be prone to rilling erosion, with the potential for concentrated infiltration into the underlying tailings leading to piping erosion.

- No drainage benches or downslope drains, and no reliance on revegetation of the rip rap. The drainage benches and downslope drains would concentrate runoff and would also be susceptible to undercutting. Also the drainage benches would be prone to silting up and differential settlement, which would lead to ponding of water, and/or overtopping.

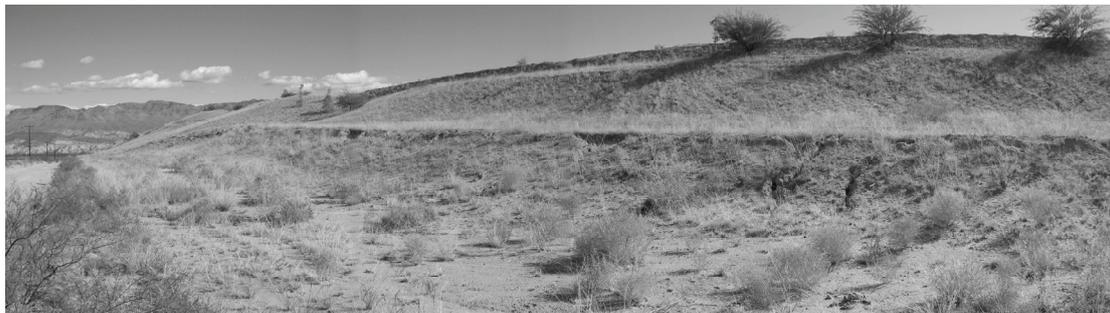
Figure 4 shows the revegetated fine-grained alluvium cover placed on the outer slope of 1 and 2 Dam in 2002, showing a reasonable vegetative cover and little erosion. Figure 5 shows the now poorly vegetated and badly eroded fine-grained alluvium cover placed on the outer slope of 1 and 2 Dam in 1991.

**Figure 4** Revegetated fine-grained alluvium cover placed on outer slope of Dam 1 and 2 in 2002

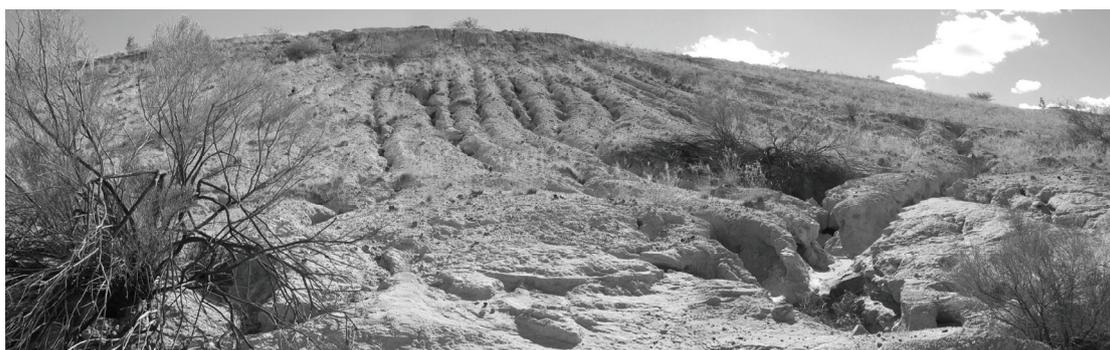
**Figure 5** Now poorly vegetated and badly eroded fine-grained alluvium cover placed on outer slope of 1 and 2 Dam in 1991

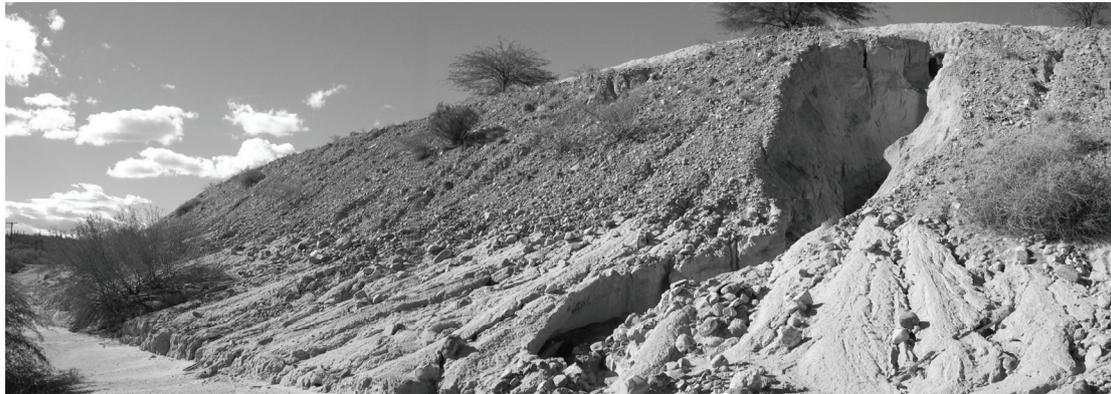
Figure 6 shows the poorly vegetated and gully-eroded coarse-grained alluvium cover placed on the outer slope of 6 Dam in 1991. The outer slopes of the San Manuel tailings storages show gulying developed from tunnel erosion of the tailings, which appears to follow the sequence:

- Ponding on benches, or surface rilling of uncovered tailings or of the cover, leading to increased and concentrated infiltration into the underlying erodable tailings.
- Initiation of tunnel erosion into the tailings at these infiltration points.
- Development of erosion tunnels.
- Emergence of erosion tunnels at the next bench downslope or at the toe of the slope.
- Collapse of the tunnels leading to gullies.
- Development of the gullies upslope and downslope, ultimately extending the full height of the slope, accompanied by a deepening and widening.

**Figure 6** Poorly vegetated and gully-eroded coarse-grained alluvium cover placed on outer slope of 6 Dam in 1991

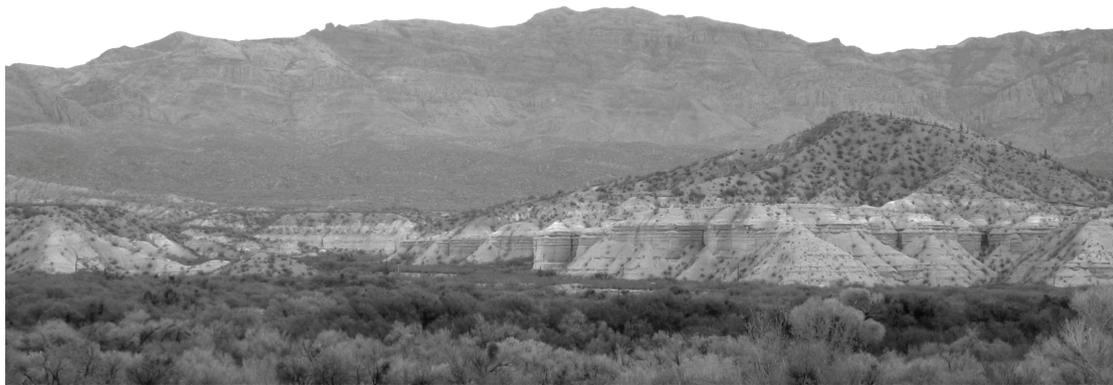
Figures 7 and 8 show natural, eroded, fine-grained and coarse-grained alluvial landforms in the vicinity of San Manuel. Figure 9 shows a natural cemented coarse-grained cap over erodable fines, exposed in a road cutting. The thickness of the cemented cap is typically about 0.6 m, and up to about 1 m, but diminishes to a very limited thickness beneath a sloping ground surface.

The natural analogues in the vicinity of San Manuel demonstrate the lack of vegetation on steep fine-grained alluvium, due to ongoing erosion at high rates, and reasonably stable and somewhat vegetated, steep coarse-grained alluvium slopes, possibly protected by a cemented coarse-grained cap or dense coarse-grained alluvium.

**Figure 7** Natural, eroded, fine-grained alluvium landform

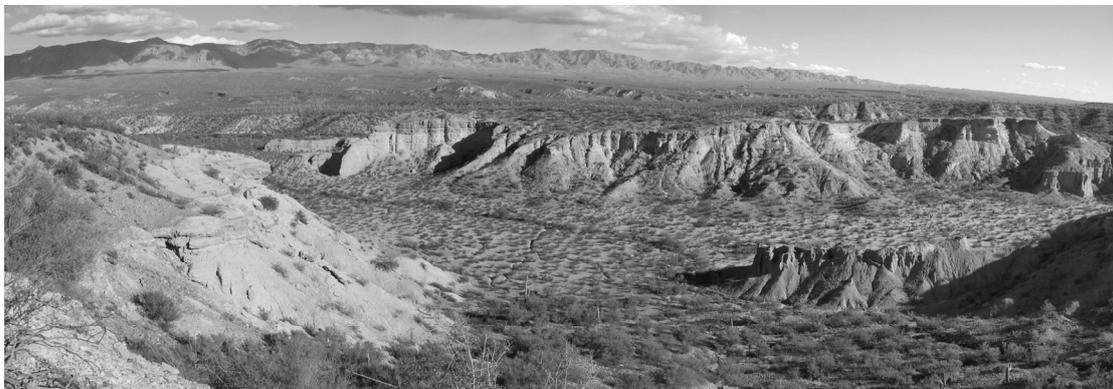
**Figure 8** Natural, eroded, coarse-grained alluvium landform

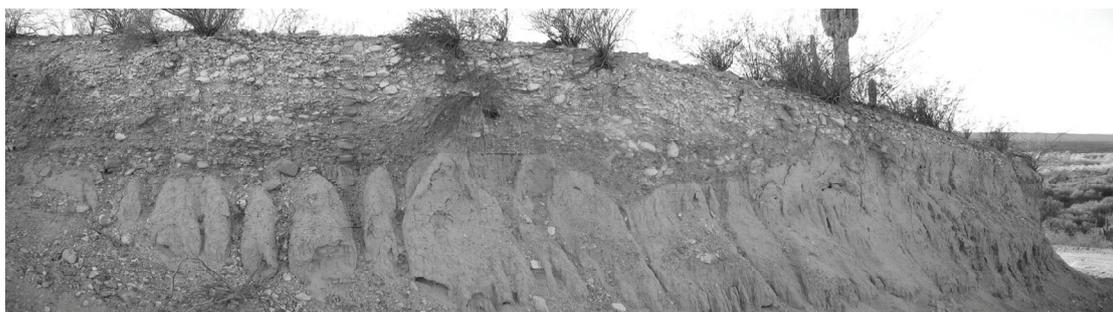
**Figure 9** Natural cemented coarse-grained cap over erodable fines

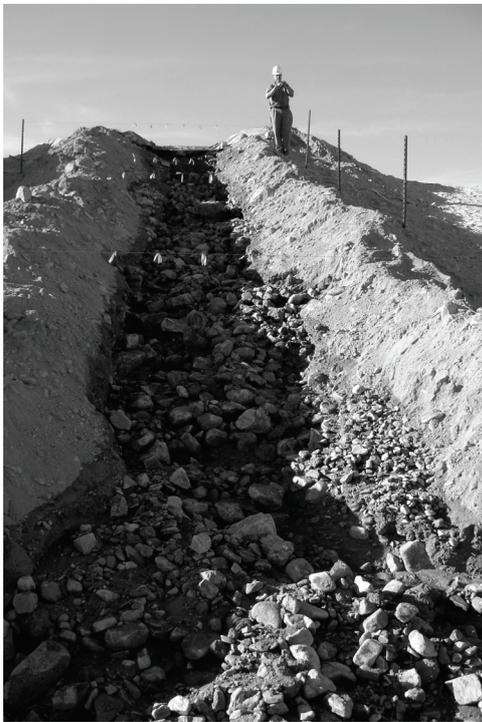
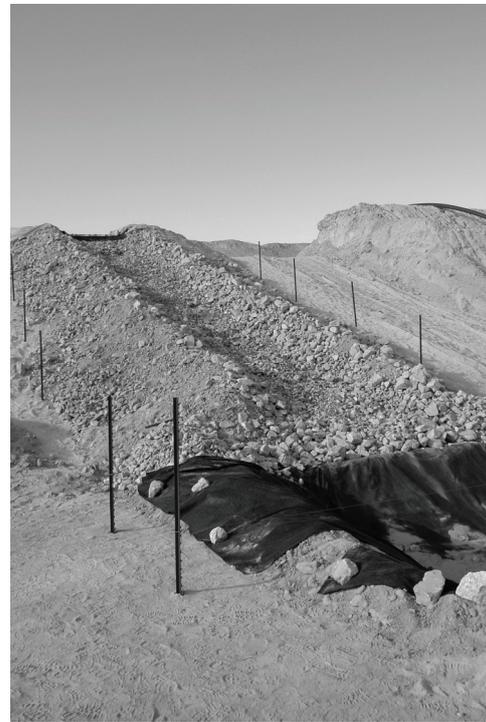
To confirm the relative merits of the refined outer tailings slope closure designs, erosion trials were carried out, testing coarse-grained alluvium directly over tailings, and rip rap over fine-grained alluvium overlying tailings. The results of the trials are shown pictorially in Figure 10 for the simulation of the 100-year, 24-hour storm at the base of a 275 m long 3:1 slope. For this extreme rainfall event, Figure 10 highlights the extensive washing out of fines and sand from the coarse-grained alluvium, while the rip rap has experienced negligible erosion.

**Figures 10** Erosion of (a) coarse-grained alluvium (showing extensive washing out of fines and sand) and (b) rip rap (showing negligible erosion)

From the results of the erosion simulations (highlighted on Figure 10), it was decided to use coarse-grained alluvium over fine-grained alluvium for the upper third of the outer slope of the tailings storages and rip rap over fine-grained alluvium for the lower two-thirds of the outer slope. The justification for the selection of a coarse-grained alluvium cover over the upper third of the slope was its acceptable performance over this length of slope from the erosion trial conducted for the corresponding simulated design rainfall runoff. This approach produced significant cost savings, making the cost of constructing the refined outer tailings slope closure design comparable to that of the original design at about \$US 80000 /ha, while retaining the substantial cost savings for ongoing maintenance. Figure 11 shows the early stages of the construction of the slope cover, with the tailings slope having been dozed to infill any erosion gullies, the fine-grained alluvium sub-layer and coarse-grained alluvium cover on the upper third of the slope having been placed, and the rip rap cover over the lower two-thirds of the slope in the process of being placed.

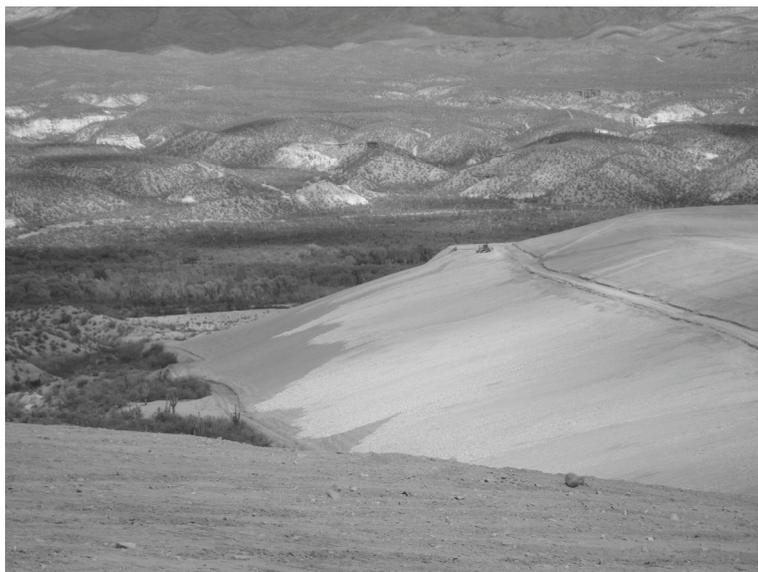
**Figure 11 Construction of cover on outer tailings slope**
