Monitoring of a Large Wall Failure at Tom Price Iron Ore Mine

A.P. Day *Rio Tinto Iron Ore, Australia*

Abstract

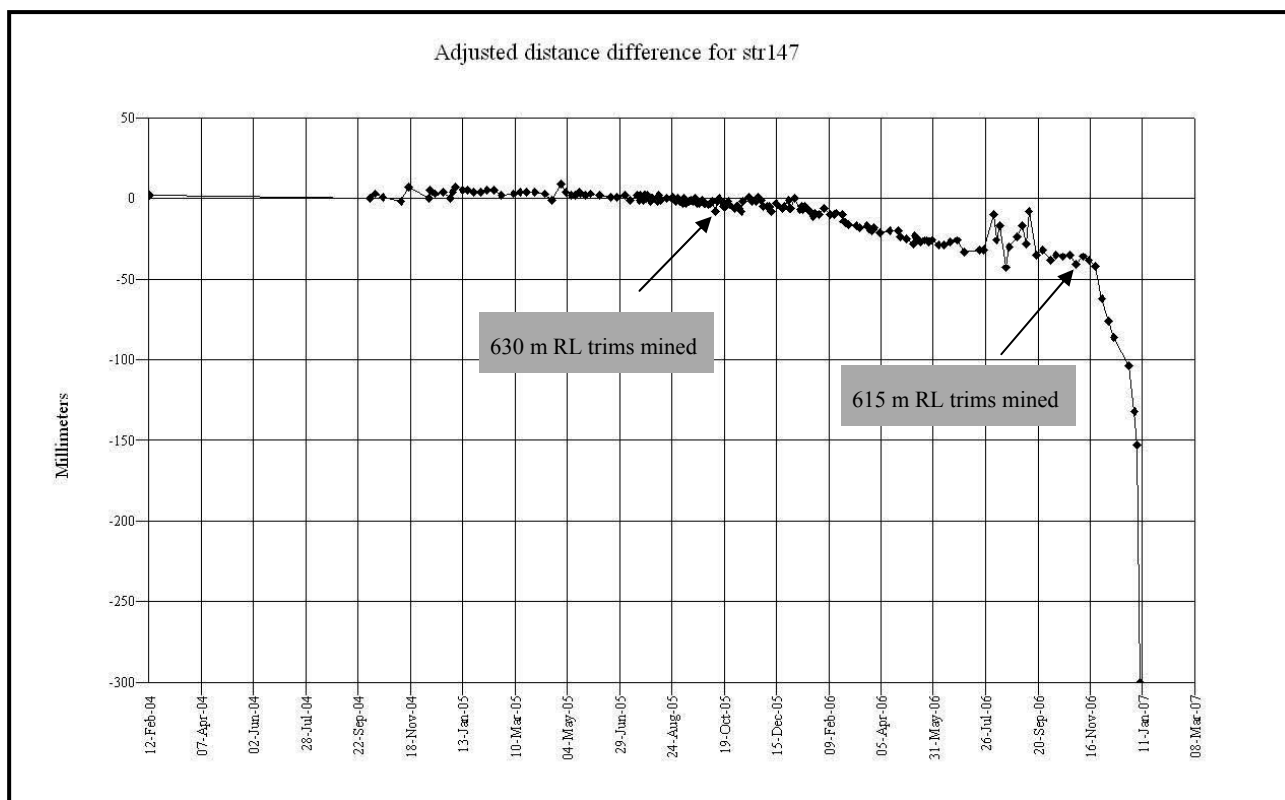
Figure 1 EDM prism monitoring data

Survey checks and further EDM readings over subsequent weeks confirmed that the prism continued to accelerate. In the first week of January 2007 movement rates increased to 5.5 mm/day. There was still no evidence of failure close to the prism but a horizontal tension cracks could be seen in a batter about 50 m above the prism. Some new berm failure was also evident about 35 m below the prism. At this point, the possibility of a large scale wall failure was considered, and the need for more data became apparent.

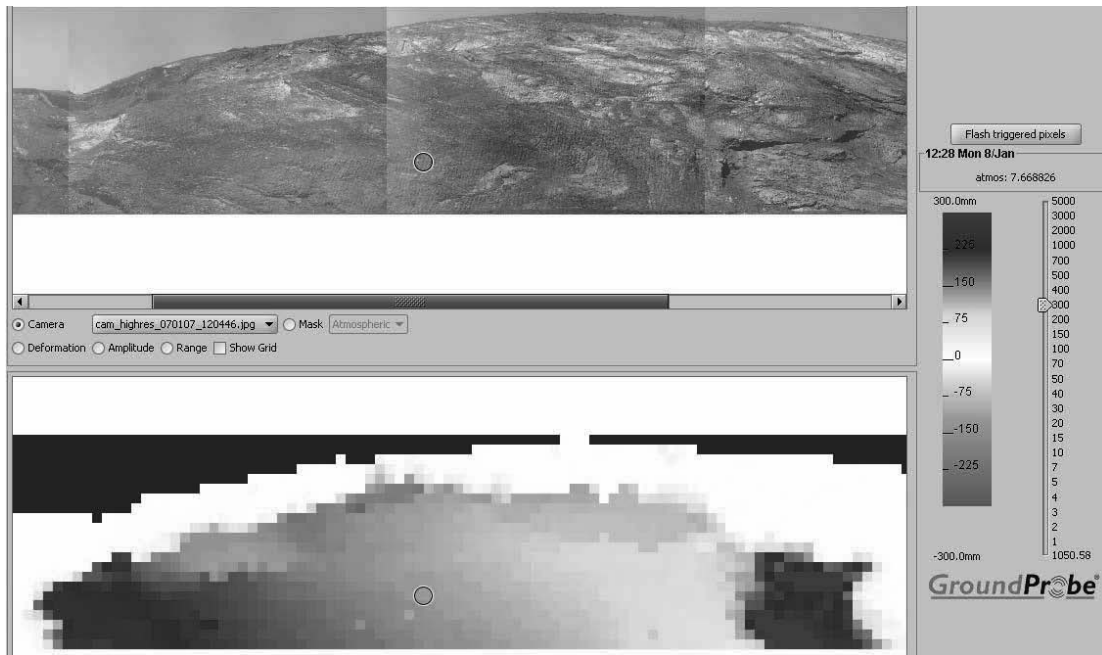
A Slope Stability Radar (SSR) was deployed to the SEP pit on 05 January 2007 in an attempt to confirm the movement indicated by the EDM prism monitoring and to help define the extent of the wall movement. Half a day of radar monitoring was enough to confirm that a large section of the wall was moving at rates of up to 200 mm/day (Figure 2). Two distinct “hotspots” were identified, one at the eastern end and one at the western end of the wall, with the central section having the lowest movement rate of around 60 mm/day. The pit was closed on 6 January 2007.

Figure 2 Radar scan showing pre-failure wall movements

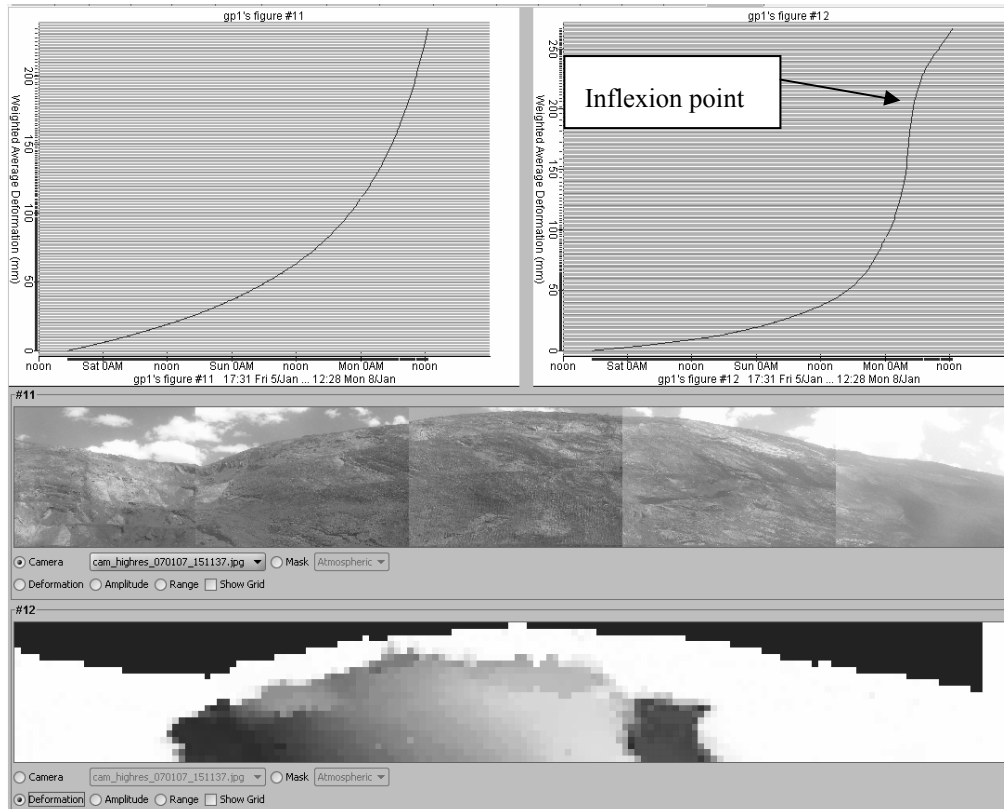
Over the next two days wall movements accelerated rapidly until the commencement of failure on 8 January 2007. Figure 3 below shows displacement with respect to time averaged over the areas highlighted in green on the images. Failure initiated at the displacement “hotspot” at the western end of the wall (right hand side of the photograph). The distinct inflexion of the curve in the early hours of Monday morning correlates well with the estimated time of failure. Failure of the eastern end “hotspot” commenced a few days later.

Figure 3 Acceleration in wall movement

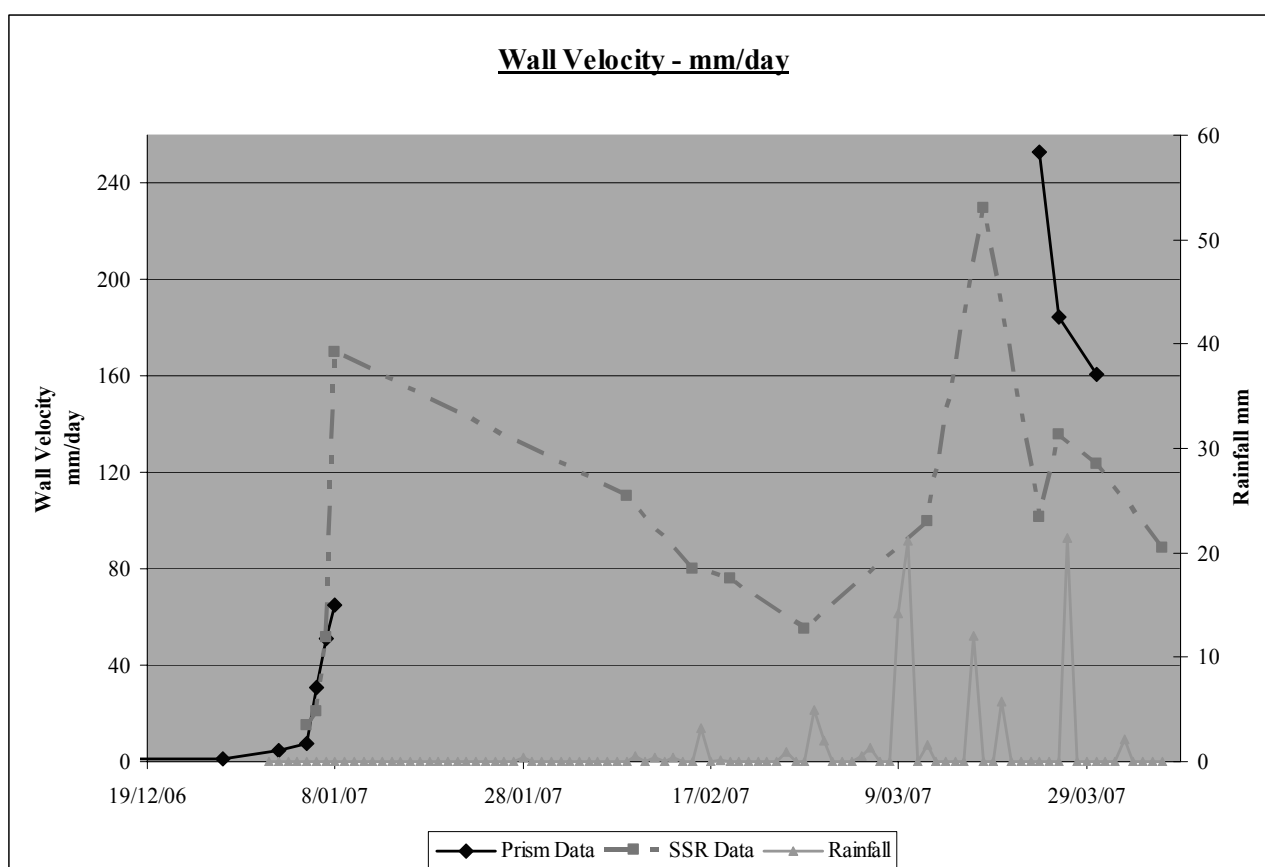
Unfortunately the radar had to be moved several times over this period and therefore the total amount of displacement cannot be compared for this period. However, displacement rates at various times when both systems were in operation are compared in Figure 4 below. The large gap in the solid line represents the period when the prism was not monitored.

Figure 4 Comparison of EDM prism movement with SSR scan data

Rainfall data from various sources in or close to the pit does not correlate with the initiation of the failure but does correlate with a sudden increase in post failure deformation rates towards the end of March shown in Figure 4. These rainfall peaks are related to tropical cyclone George during which the wall velocity increased

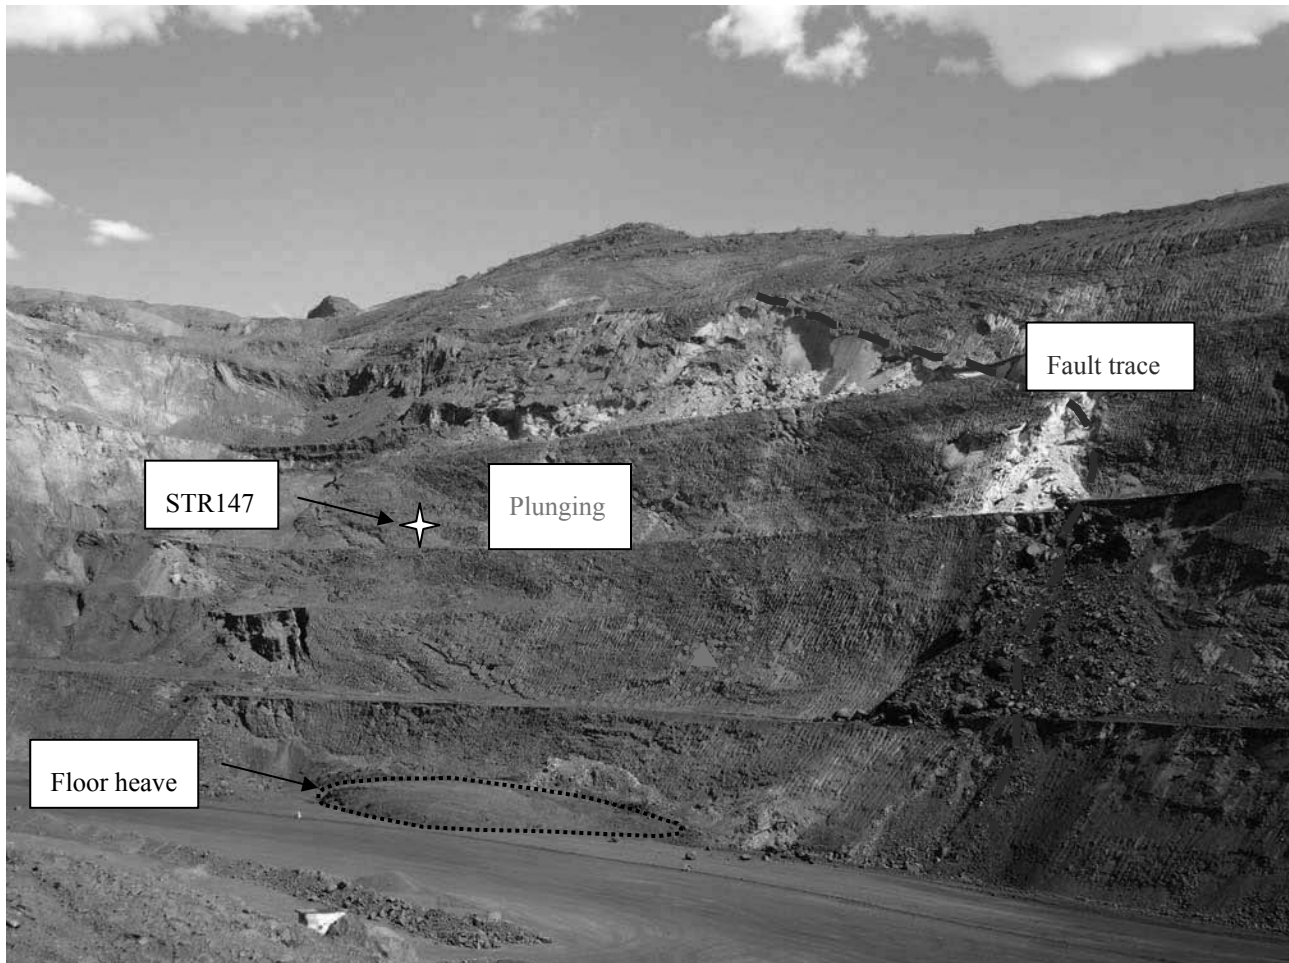
Whether bedding or fault initiated failure, there is some evidence that it was not purely controlled by structural discontinuities. Two days after the initial failure commenced, the pit floor began to heave, as shown in Figure 5 below. This section of the pit floor had been graded flat right up to the pit wall two days prior to the onset of failure. The most likely explanation for the floor heave is a change from structurally controlled failure to a circular type rock mass failure. The pit floor continued to heave over the next few months as the failure progressed (Figure 6) and was some 10 m above the original elevation at the time of writing.

Figure 5 Onset of failure – 9 January 2007

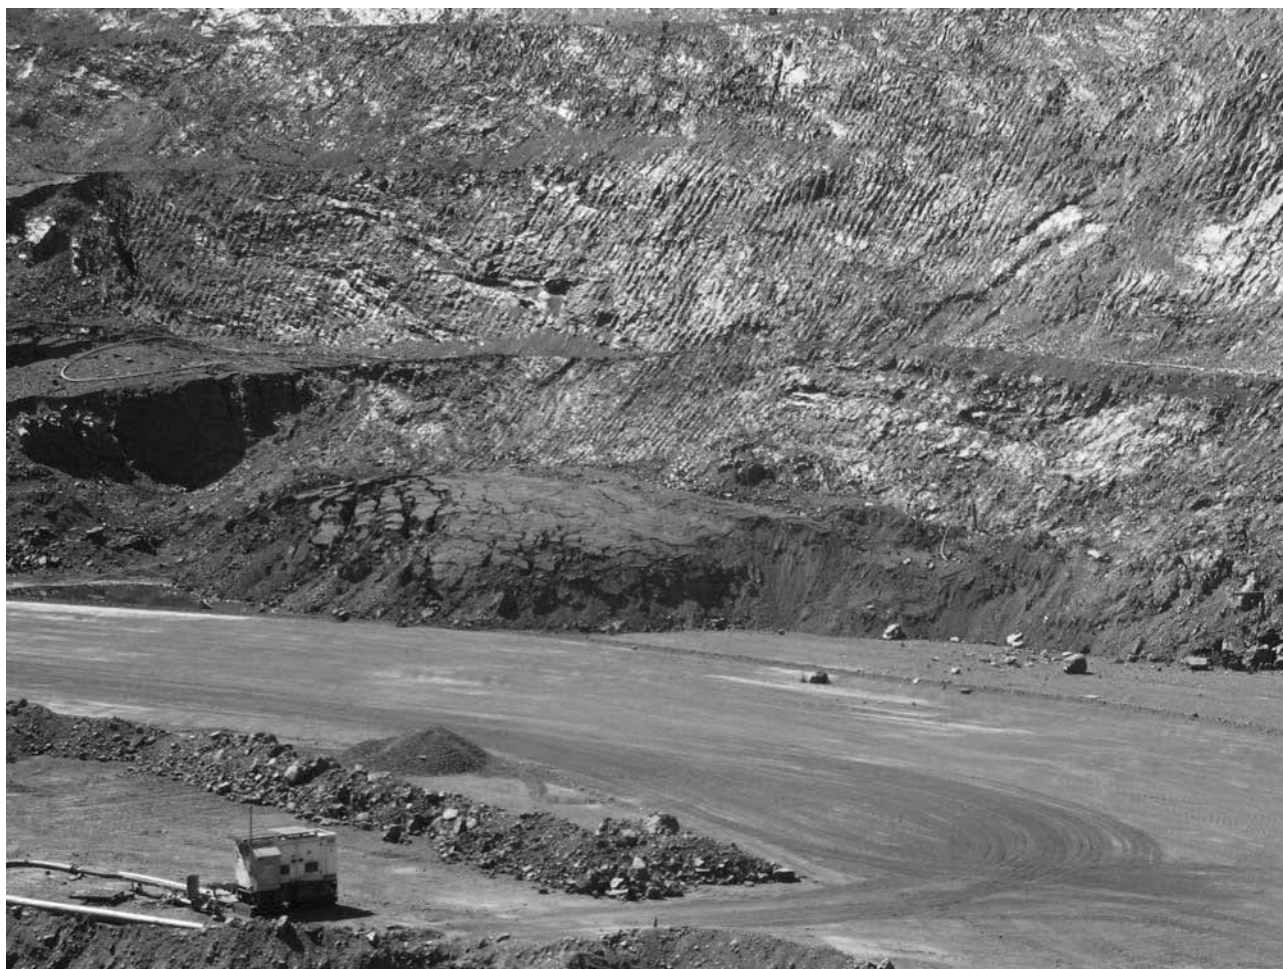
Figure 6 Floor heave – 6 February 2007

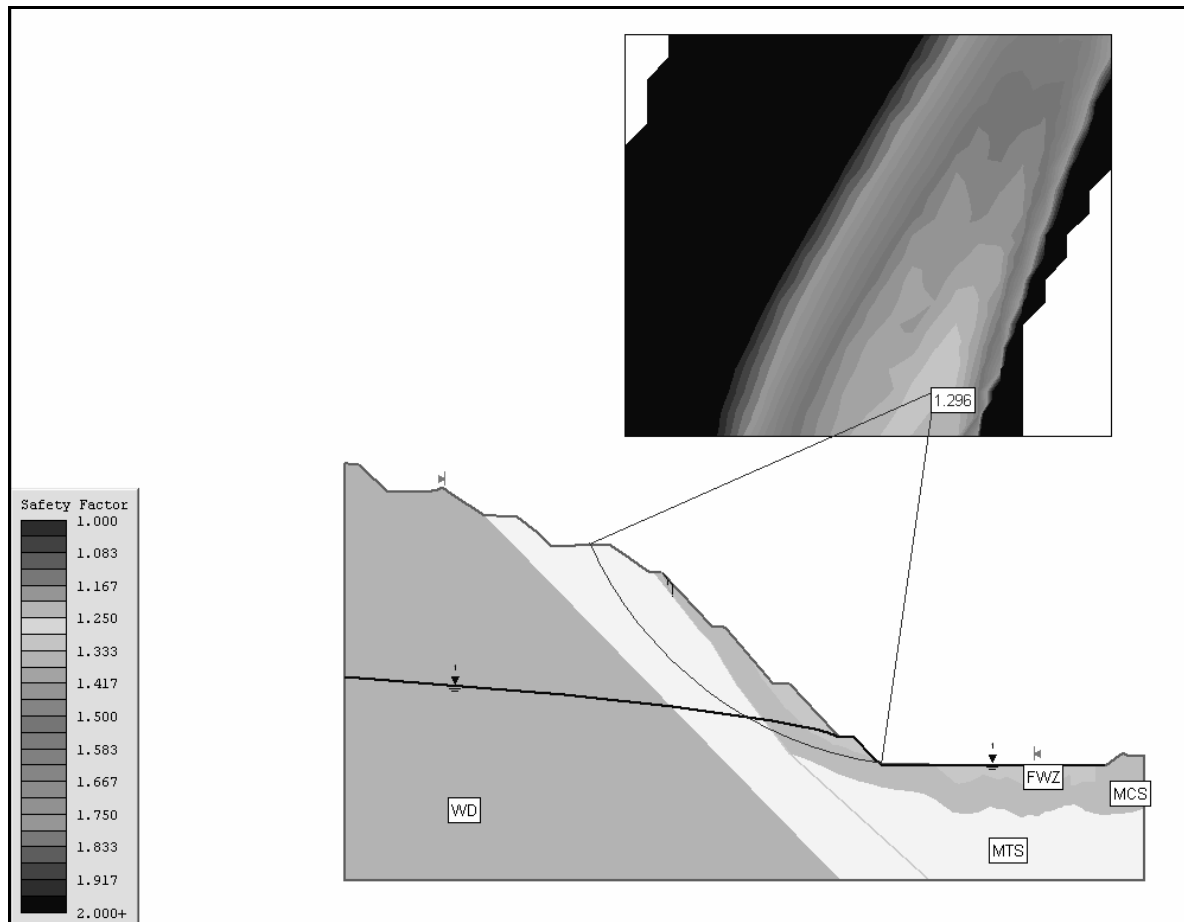
Using new structural geology data from post failure mapping, limit equilibrium analysis of the failure was undertaken with the Rocscience package, SLIDE™ (Rocscience, 2005). The water table was defined from piezometer readings. Using corrected Janbu type circular failure analysis, the factor of safety for a typical section through the area is 1.3 (Figure 7). This does not indicate failure by a purely circular mechanism.

Figure 7 Slide model – circular failure

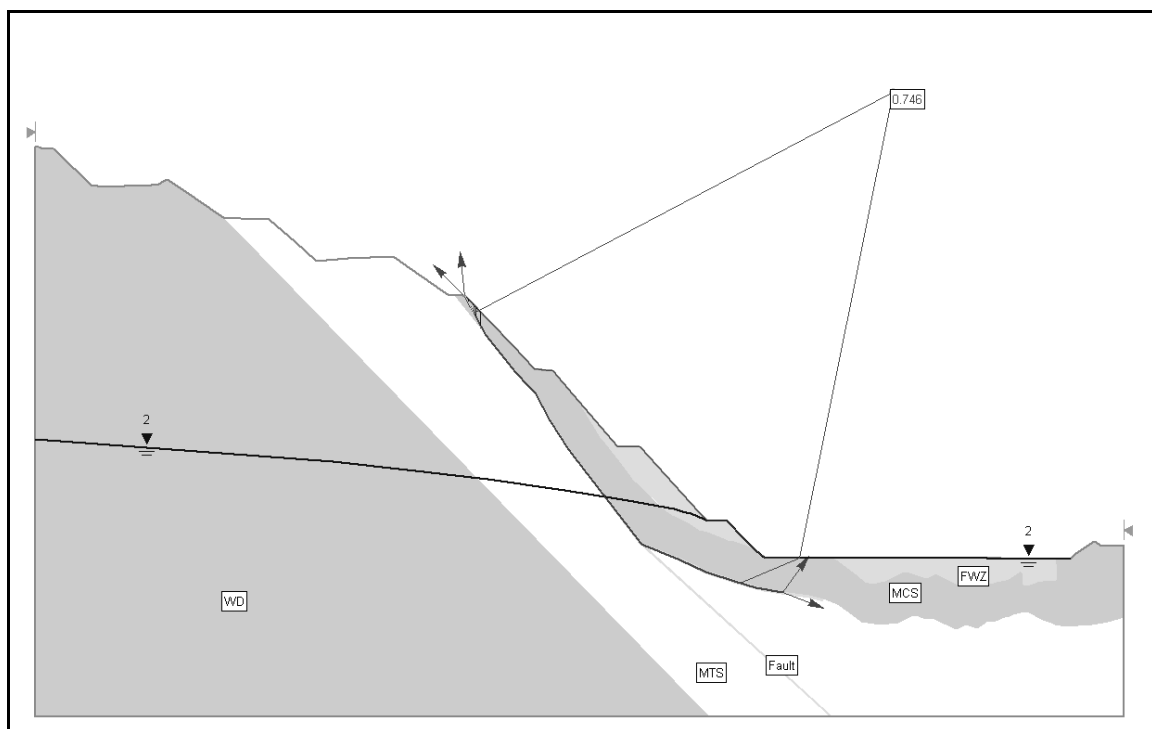
It is postulated that the failure path started along the fault plane, followed the bedding contact at the base of the Mcrae Shale before breaking through the rock mass into the pit floor. This hypothesis was tested by using a defined failure path, which follows a cohesionless fault. The lowest resultant factor of safety, shown in Figure 8, is 0.75 supporting the postulated failure path and highlighting the importance of major structural geological features in controlling slope failures.

Figure 8 Slide model – defined path failure
