Dynamic Rock Failures Due to ‘High’ Stress at Shallow Depth

Abstract

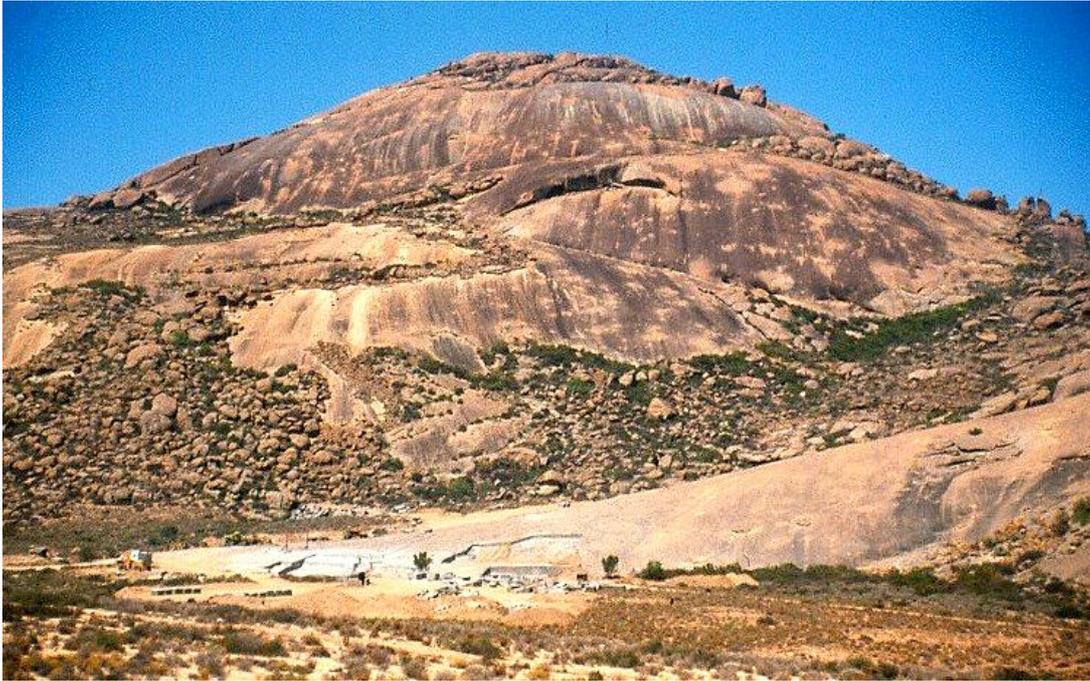
The environment of this case is shown in Figure 1, illustrating a small dimension stone quarry in high quality granite. At the stage of mining, only very limited extraction of rock had taken place, with quarry depths being only a few metres, as shown in Figure 2. Unfortunately, no detailed mapping, no laboratory testing and no in situ stress measurements were carried out. Therefore, this case is purely observational.

Figure 1 Setting of dimension stone granite quarry

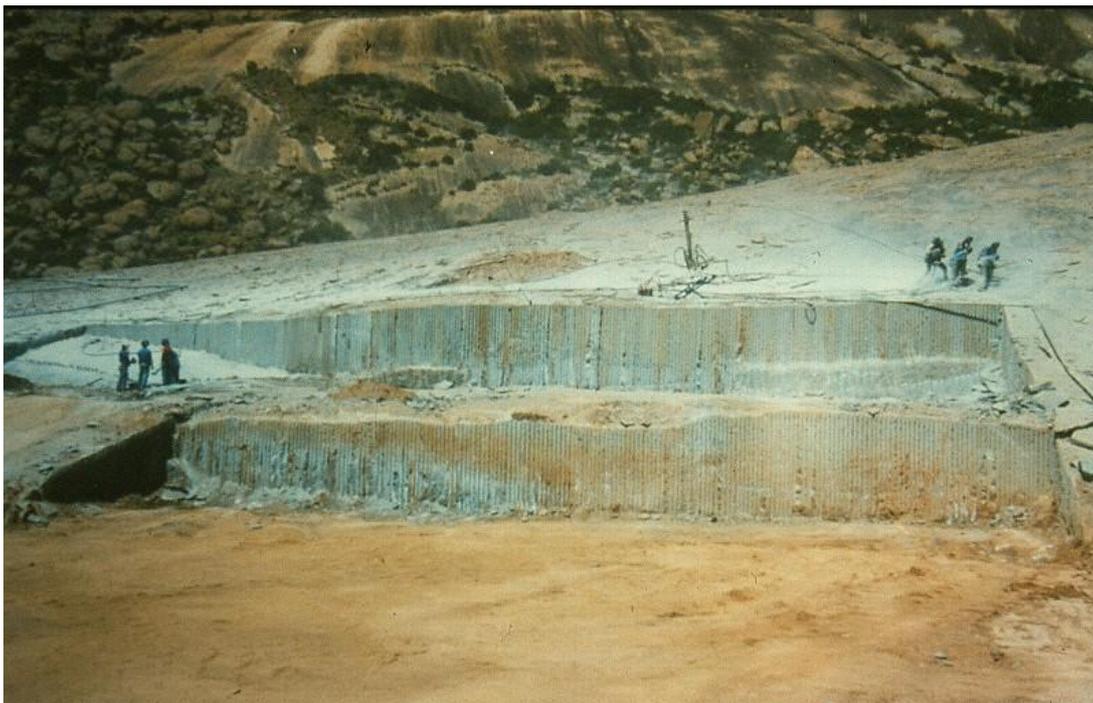
Figure 2 Extent of the quarry

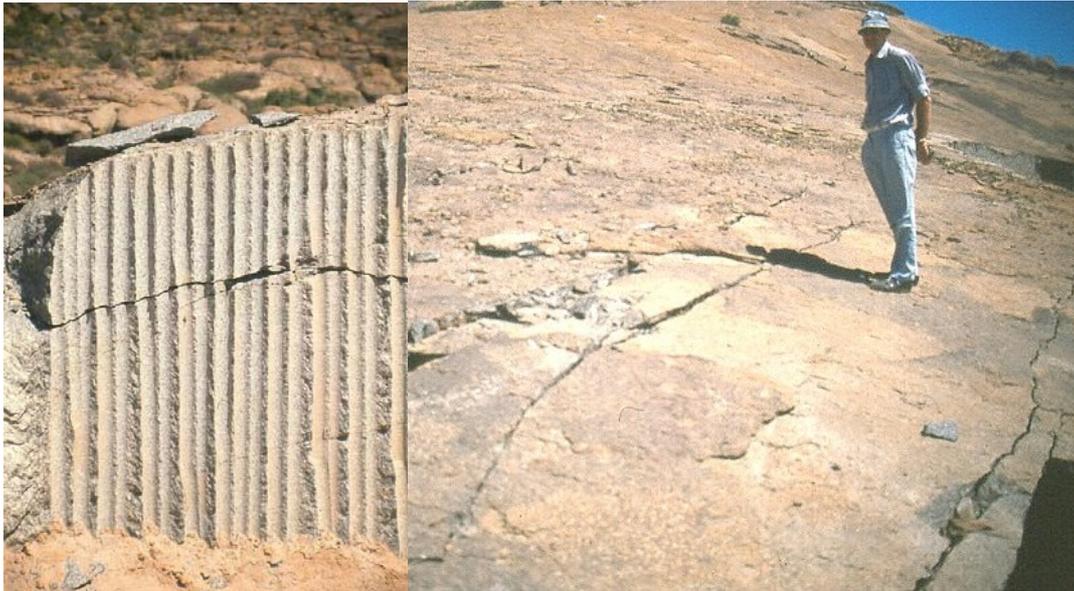
The granite is very high quality rock whose strength is unlikely to be less than 200 MPa. The stresses in the rock are unknown, but, taking into account the near surface location and the shallowness of the quarry, are unlikely to exceed say 10 to 20 MPa. Even if higher than these magnitudes, the stresses would be unlikely to be anywhere close to the strength of the rock. After excavation, fractures developed, often with considerable violence, sub-parallel to the surface, as shown in Figure 3. It was reported that the machine used to drill the closely-spaced vertical holes was “thrown” upwards on one occasion. Fracture development was heard as “rifle shots” in the evenings. Sub-vertical fractures developed subsequently, parallel to the cut face of the quarry, as shown in the right hand photograph in Figure 3, and it can be seen that they have extended beyond the boundary of the excavated quarry face. Minor offsets of the vertical drill holes can be seen in Figure 3, and this behaviour was more pronounced at other locations.

Figure 3 Stress-induced fractures sub-parallel to the surface and to the quarry face

A compressive stress in the near surface rock will induce extension strains in the rock, normal to the minimum principal stress. This is approximately sub-vertical prior to excavation, and then also sub-horizontal, normal to the quarry face, after excavation. With compressive stress magnitudes in the range of 10 to 20 MPa, the resulting extension strain magnitudes can be expected to be in the range of 100 to 200 microstrains. Stacey (1981) suggested an extension strain criterion to predict the initiation of rock fracture, and critical strain magnitudes identified for brittle rock were of this order. The fractures formed in the quarry appeared to be extension in nature and therefore this extension strain criterion satisfactorily predicts the initiation of such fractures. From reports of the time of occurrence of fracturing, temperature effects, due to heating during the day and cooling at night, also appear to have had an influence. The measurements of strains that develop in exposed rock surfaces due to temperature variations, carried out by Dunner et al. (2007), indicate that strain magnitudes can be significant. They measured compressive strains of about 200 microstrains sub-parallel to the surface and extension strains of about 100 microstrains perpendicular to the surface. Such temperature-induced strains would add to the strains resulting from the in situ stresses acting in the rock, and would clearly contribute to the development of extension fracturing.

The development of extension fracturing in the quarry is likely to have led to the formation of incipient slabs, and a buckling mechanism was probably involved in the ultimate violent failure observed, i.e. the mechanism violent failure of the roof at a depth of only about 25 m below surface.

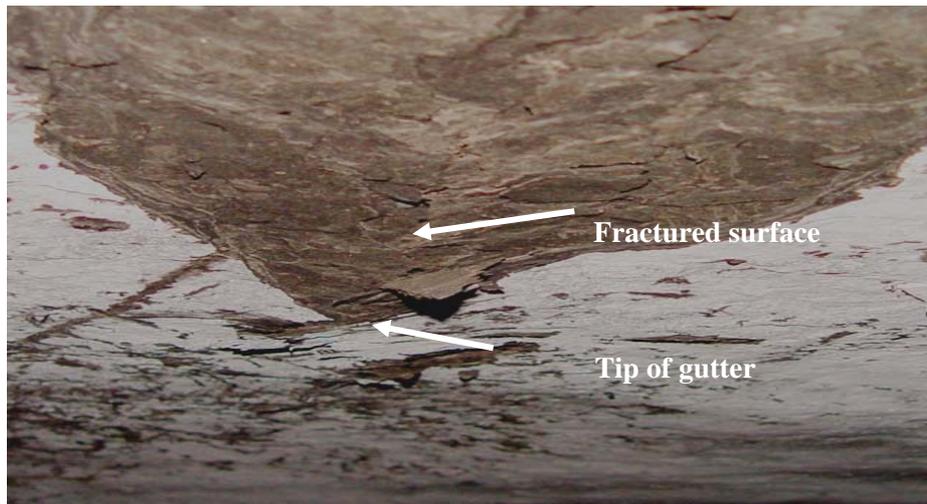
Mapping carried out in a shallow coal mine at a depth of about 50 m below surface showed that surface features observed along a guttering roof included the “upturned boat-shaped” geometry of a gutter, interlocking fracture surfaces towards the centre of a gutter, thin fractured slabs from centre of gutter going outwards and a heavily fractured surface ahead of a gutter (Ndlovu and Stacey, 2007; Ndlovu and Stacey, 2005). Figure 4 illustrates such geometry, the fractured surface and the tip of a gutter.

Figure 4 Upturned boat-shaped nature of guttering occurrence

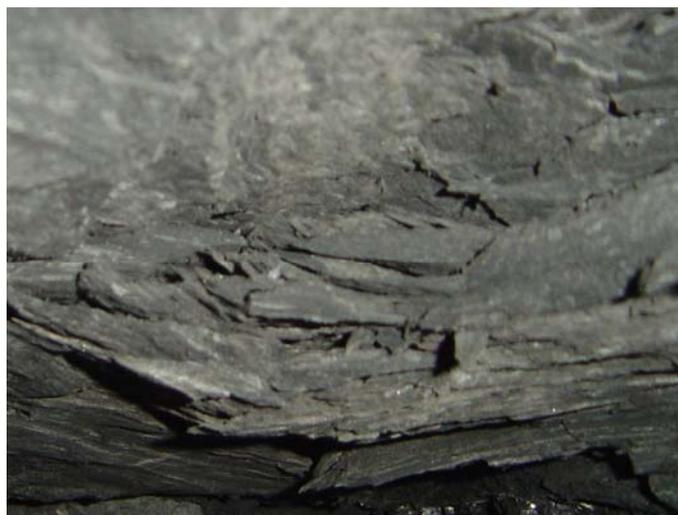
Figure 5 illustrates the fractured surface ahead of a gutter. On scaling down the fractured surface ahead of the gutter, roof falls occurred and led to the gutter developing further longitudinally, laterally, and in depth. After a few hours or days another fracture surface may develop ahead of the gutter. The process repeats itself until the gutter stabilises. The observed size of gutters ranged from about 2 m in length, 0.5 m in width, and 0.1 m in depth to about 70 m in length, 3.5 m in width and 0.5 m in depth. About 80% of gutters were observed to occur towards the centre of the roadways, the remaining 20% being located at the pillar-roof contact.

Figure 5 Stress induced fracturing ahead of a gutter. The roof gutter occurred towards the centre of a roadway

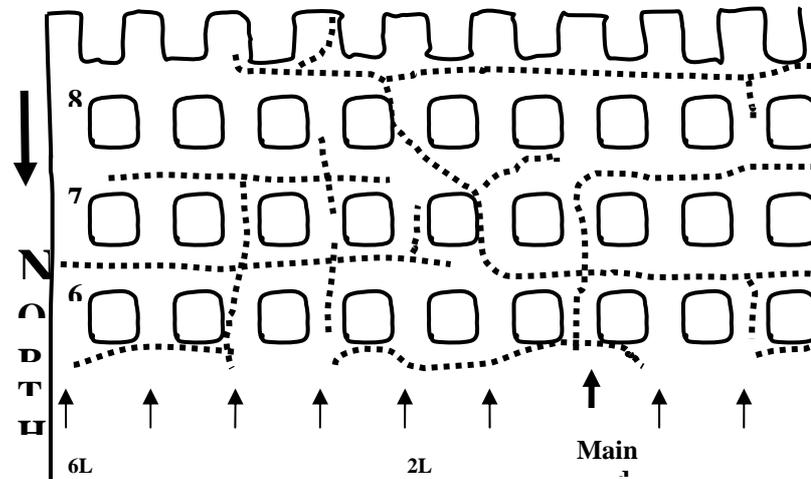
Figure 6 shows the extent of guttering as mapped in one of the sections of the mine. Guttering was observed to occur predominantly in two perpendicular directions. These corresponded approximately with the horizontal principal stress directions (note that the two principal stress magnitudes are similar) determined from in situ stress measurements carried out in the area (Munsamy, 2003; Walker and Altounyan, 2001).

Figure 6 Occurrence of guttering in part of a section. Dotted lines represent the gutters. 2 L, 6 L etc. denote roadways and the numbers 6, 7, and 8 denote splits (development from the roadways)

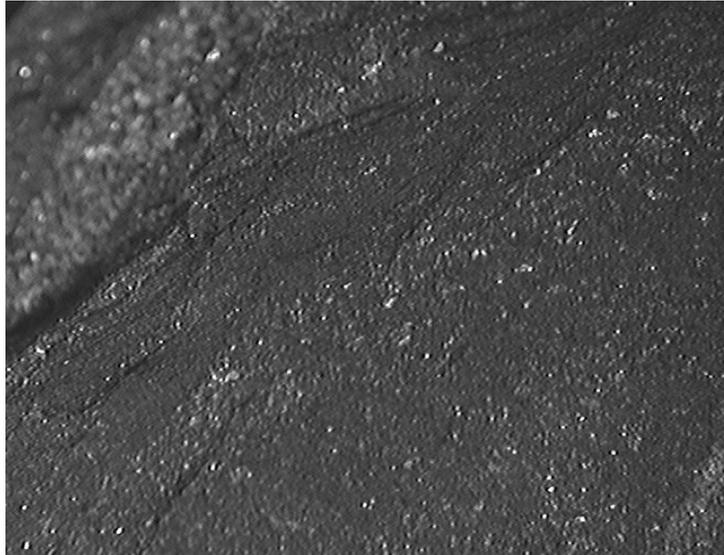
To study the possible mechanisms involved in the formation of roof gutters, fracture surfaces were observed with the aid of a microscope. Thin slabs obtained from different areas in the guttering roof were used. One hundred photo images were captured during this analysis. Two of these photographs are illustrated below. Figure 7 shows a fracture surface, which is believed to be of the extension type. There are no visible shear effects. Extensional type fractures were observed in about 90% of the images. Shear type fractures were observed in a few samples (about 10%), mainly at the edges of the slabs. It is possible that these apparent shear effects were due to secondary shear failure involved in the falling of rock fragments during the process of guttering. Figure 8 shows a fracture surface which is believed to be of the shear type. The visible white surfaces appear to be caused by relative movement during the shearing process.

Figure 7 Photograph of an extension fracture surface

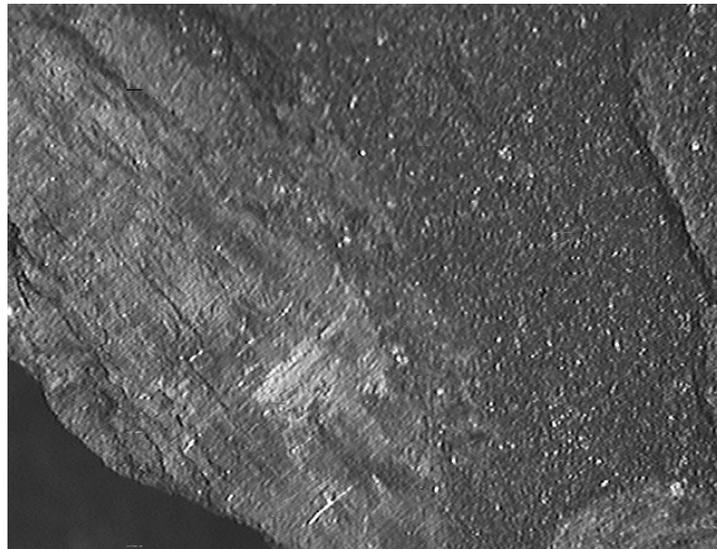
Figure 8 Photograph of a possible shear fracture surface

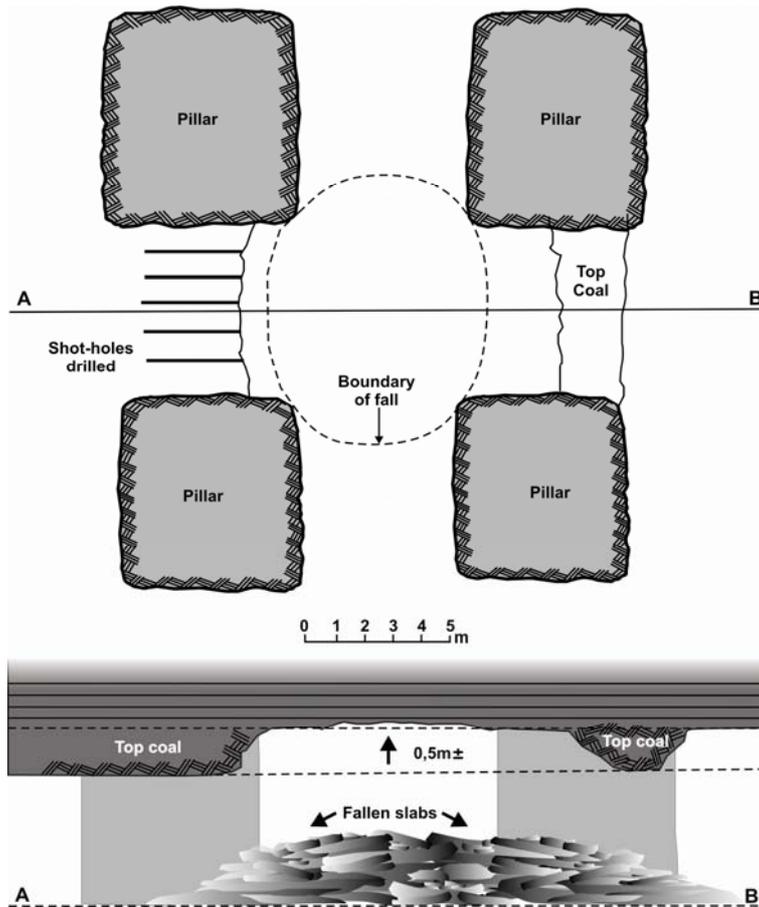
The geometry of the failure is shown in the plan and section in Figure 11. The failure took place during top-coaling (removal of the top slice of the seam as can be seen in Figure 11), the primary board and pillar extraction having been completed some months before. A roofbolt hole was being drilled at the time of the failure.

Figure 11 Plan and section of roof failure

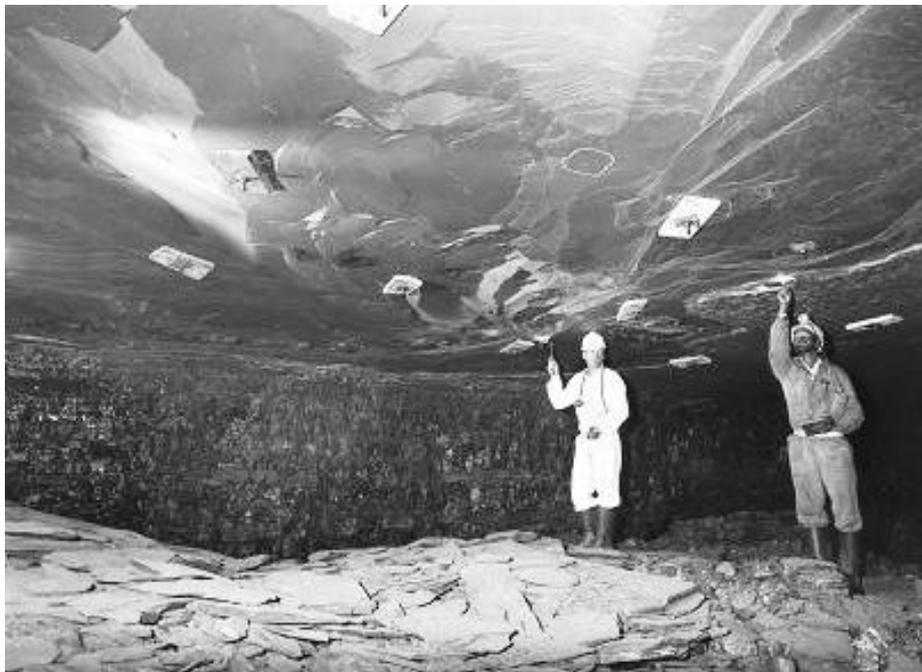
Figure 12 shows a photograph of the failure area after it had been resupported with rock bolts. Figure 13 shows the detail of a near-perfect arc which defines the transition from an extension fracture spreading smoothly at an increasing propagation velocity to fracturing of a hackly nature. The latter occurs to provide more surface area to accommodate the excess energy release – radial traces are formed along which two or more fractures develop out of the plane of the original fracture.

Figure 12 General view of the roof failure

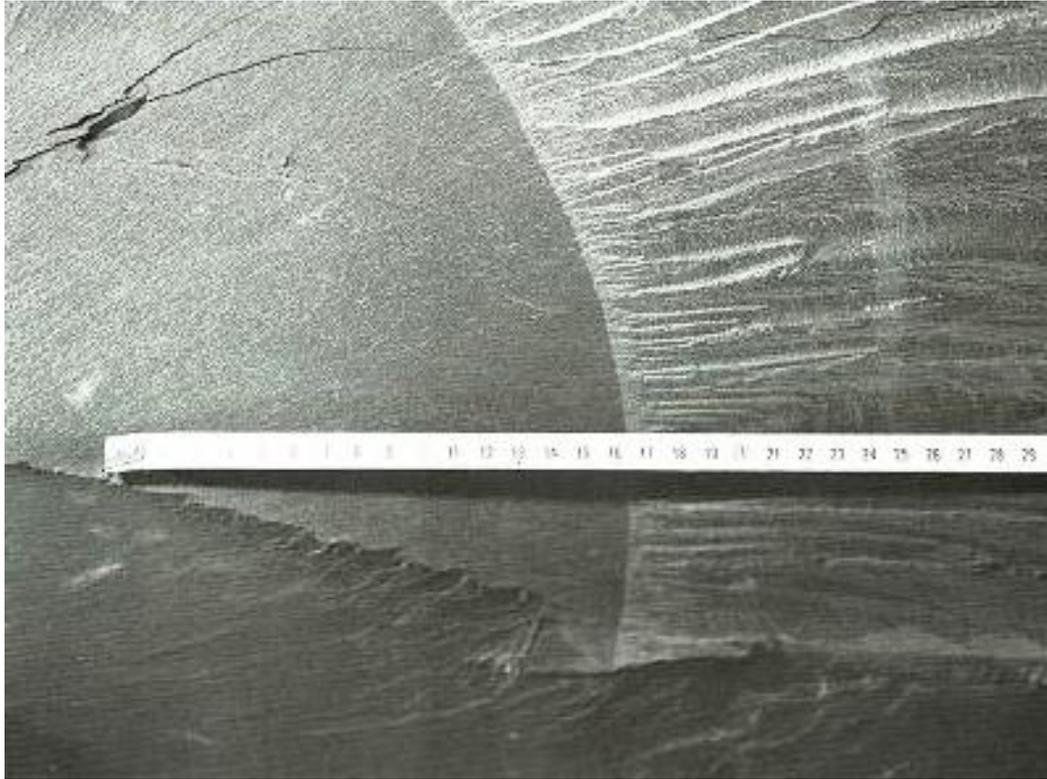
Ortlepp and Moore (1987) studied the mechanics of the failure process and estimated a value of 1.1 MPa for the tensile stress normal to the crack plane at the time the crack front reached the uniform-hackly boundary. This was reasonably close to the tensile strength normal to the stratification measured in the laboratory.

Figure 13 Detail of fracture propagation
