Working Together to Secure the Future — Cannington Ground Support Rehab Project

J.K. Todd *BHP Billiton, Cannington Mine, Australia*

Abstract

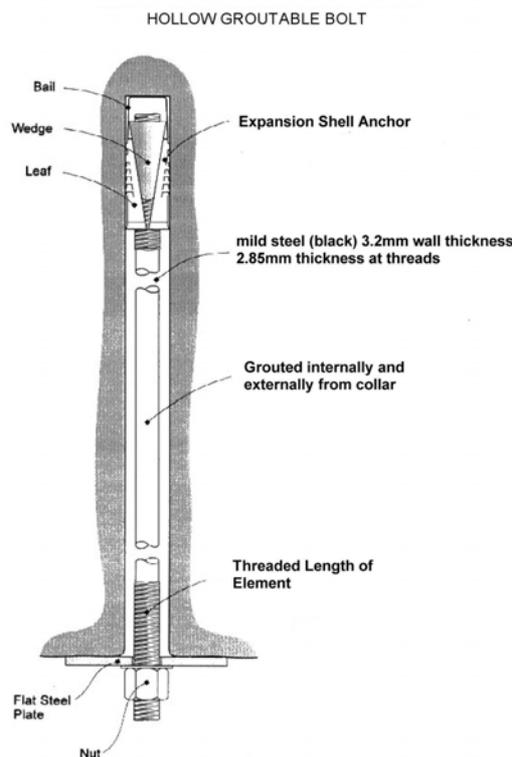
Cannington's early ground support practice consisted of installing 6–10, 3 metre HGB (Hollow Groutable Bolts) within the 6 x 6.2 m wide decline with only meshing (decline only 9% meshed) occurring in areas of poor to very poor ground as observed at the time of the development with minor amounts of metal reinforced fibrecrete in areas of very poor ground. The HGB was a thin walled (3.2 mm) hollow tubular pipe bolt (25 mm OD) made of mild steel that was not galvanised (Figure 2). It had 150 mm of the bolt threaded on the anchor end and 500 mm threaded on the collar. These became weak spots at the contact with the plate due to atmospheric corrosion and at the anchor end when they were not grouted properly (Todd et al., 2006). It relied on the cement grout to provide long term corrosion protection. Corrosion was measured during a WA School of Mines research project as low as 0.0022–0.04 mm/year atmospheric to high of 0.18–0.28 mm/year under high temperatures and humidity (Hassell, 2004). During the early development, in aerated flowing ground water conditions, the extremely corrosion rates were measured as high as 0.6–0.8 mm/year. Early testing of the HGB indicated that a 1 mm reduction in wall thickness would degrade the load capacity from 12 to 9 t (Pascoe, 1995).

Figure 2 Hollow Groutable Bolt (HGB) – modified after Windsor (2003)

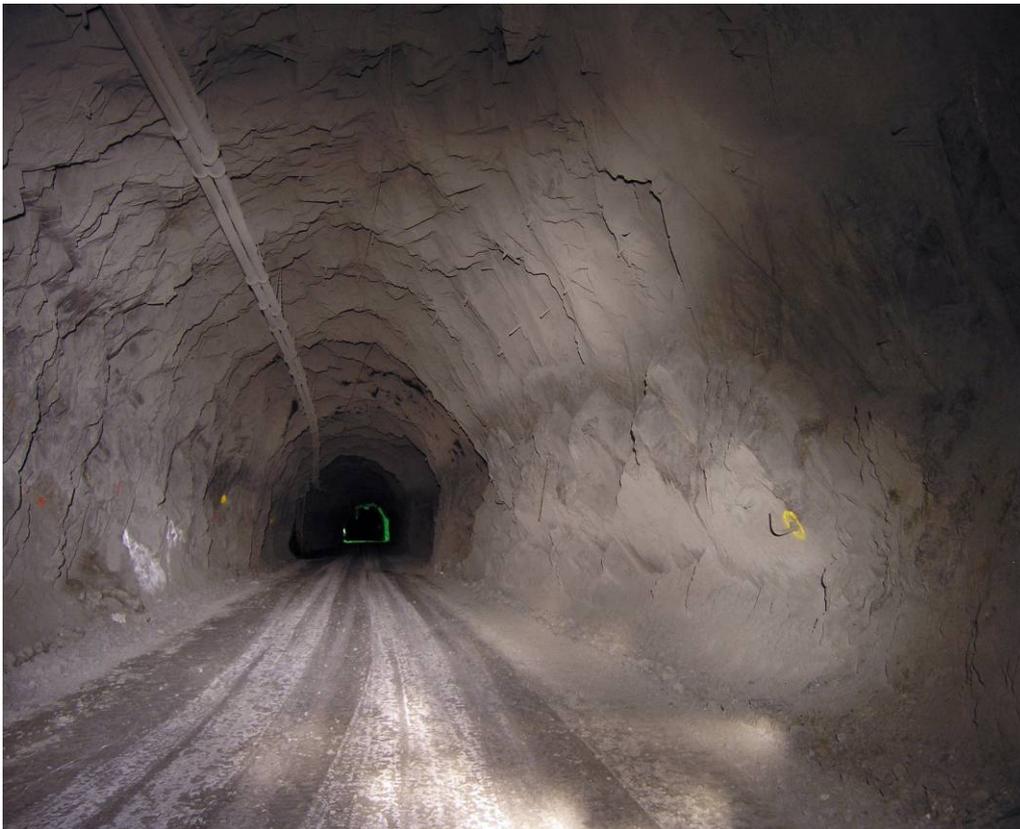
Figure 3 Typical decline photo of the blocky amphibolite with no surface support

The DRP was contracted to a mining contractor where 2–3 jumbos, additional service crews with Integrated Toolcarriers fitted with a man basket, and the on site fibrecreting fleet were used. The final scope of the DRP was to strip services (air, water, electrical, leader feeder), mechanically scale, and then prepare the surface by hydroscaling, spray 50–75 mm of fibrecrete and rebolt the 6.1 kilometres (5700 m of decline and 700 m of level access from the decline).

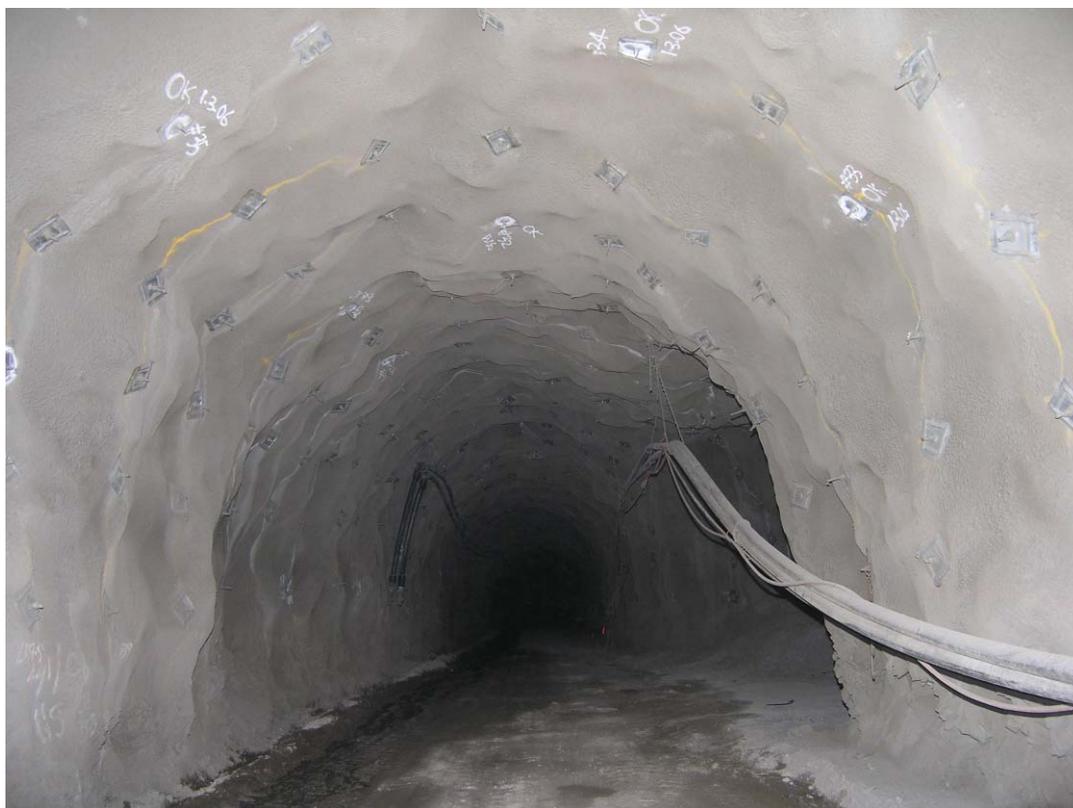
Figure 4 Decline photo after application of Fibrecrete surface support and Posi4bolting

The fibrecrete specifications at Cannington were a 50 MPa mix design to yield 40 MPa insitu 28 day strengths. Historically previous fibrecrete strengths showed a large variation in both mix and insitu strength and thickness assessment and control. To improve and reduce the variability, several projects were completed and trialled during the DRP. A new batching computer was installed to help control the batching and addition of chemical admixtures. Modifications to the contractor's spraymec allowed for better control of the accelerator through a dosage meter and a controller. Higher frequency of testing (every 50 m³ – once per day) during the project provided the data necessary to assess the quality of the fibrecrete (Figure 4). To improve the thickness assurance and control, plastic depth indicators were used in conjunction with the depth of the old HGB nuts as guides for the operator. Early in the project, a Riegl LMS-Z420i a 5 mm Terrestrial Laser Scanner was used to scan the before and after the fibrecreting to ensure the design thickness was obtained and to provide feedback to the operator and to ensure non-conformance areas were fixed (Figure 5). The majority of the decline was scanned which gave a very high confidence on the thickness of the fibrecrete sprayed on the decline. Probe drilling was also used but it was shortly discontinued after the laser was commissioned, since the probe holes can act as initiation points for early cracking of fibrecrete based on previous decline experience (Todd et al., 2006)

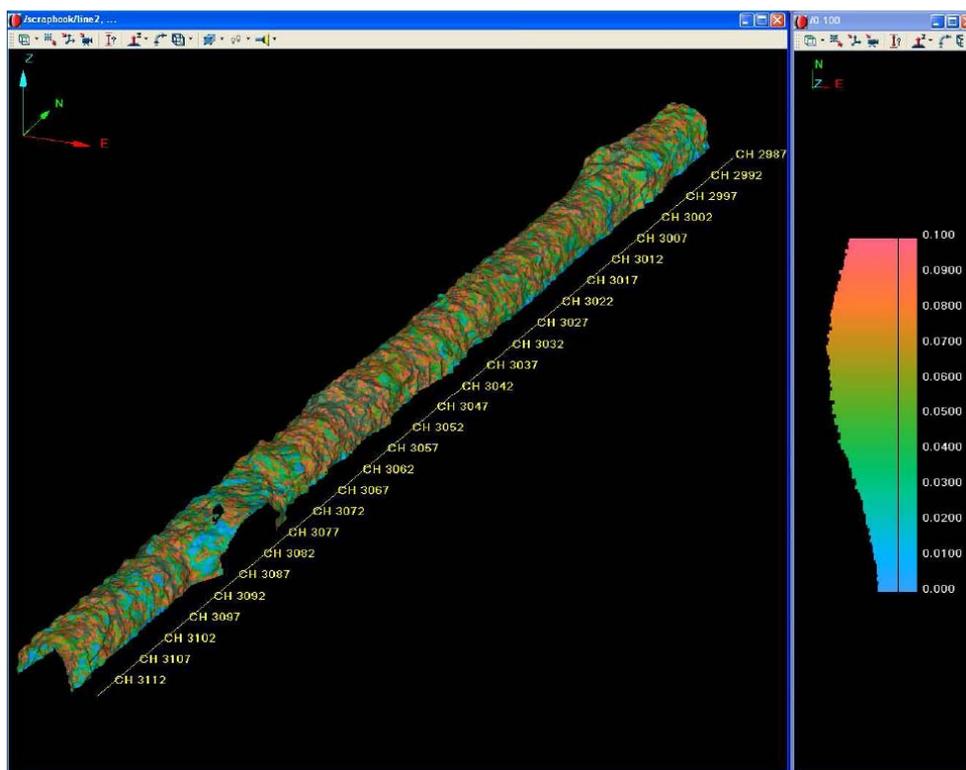
Figure 5 Laser scan showing thickness of fibrecrete by 0.010 m (10 mm) increments

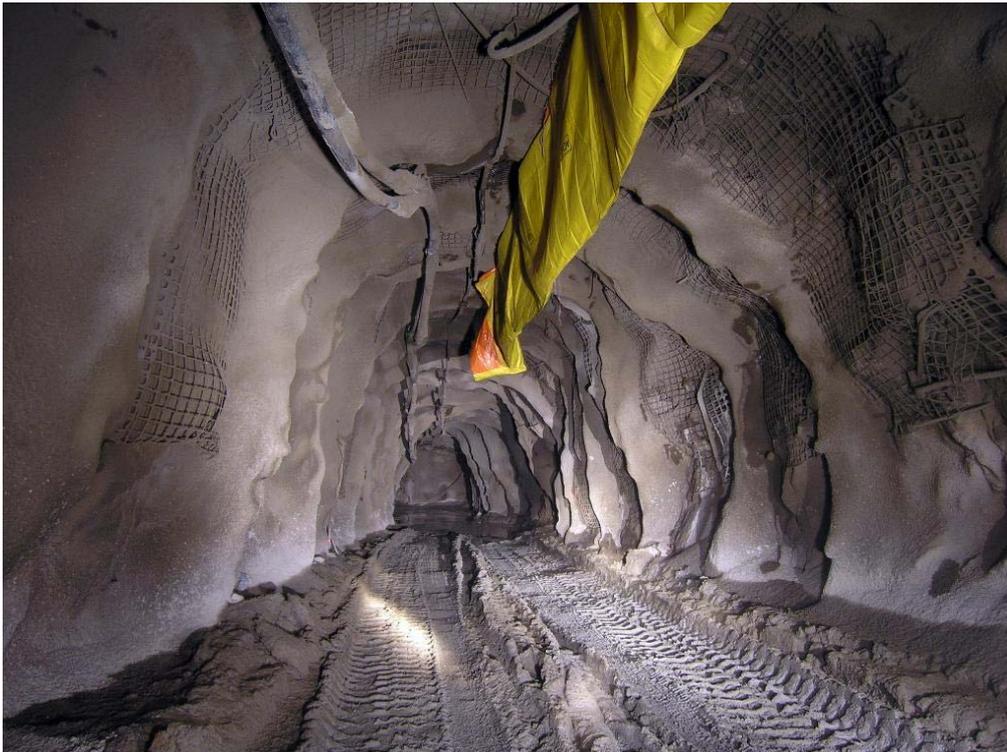
Figure 6 Fibrecrete arches on 475 m level

- In very poor ground areas with potential caving, fibrecrete filled 12 mm rebar form arches were installed to maintain the integrity of the fibrecrete shell (Figure 6).

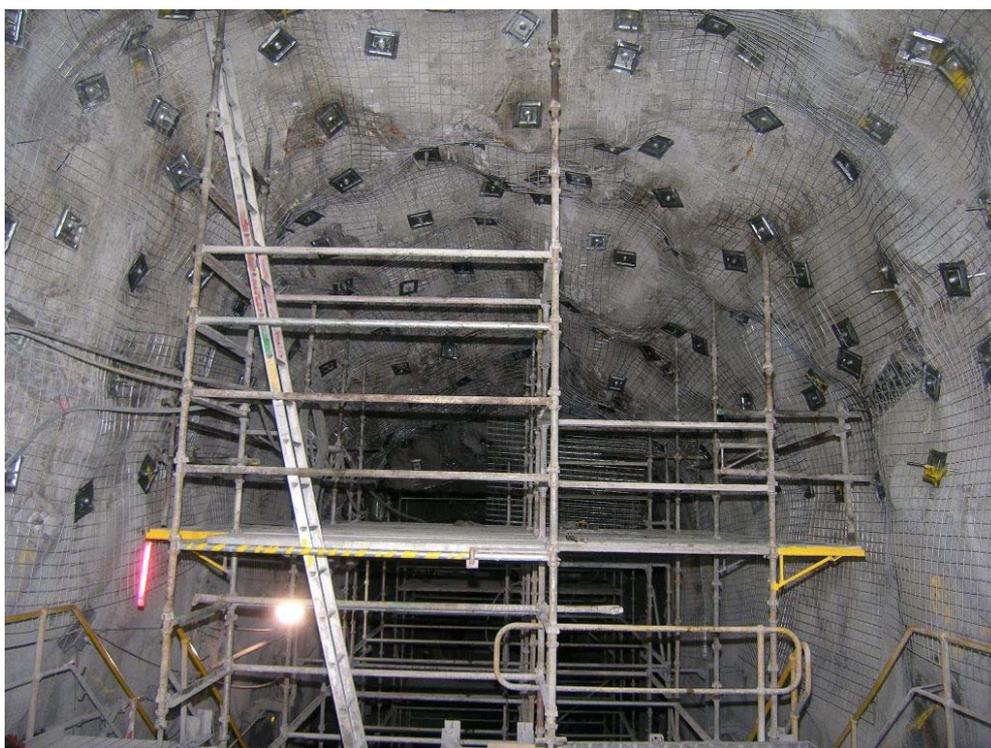
areas. In the Boutique area, 30 mm resin was used to maximise the resin available for CS and rebar bolting since the ground in these areas were poor and typically broke out during the drilling process (Figure 7).

Figure 7 Staging used at the loadout station for the boutique rehab project

Boutique rehab areas such as the transfer station and the load out station at the shaft had very little work space remaining since each chamber was custom excavated for the appropriate size of the mechanical infrastructure. This would make it impossible to rehab with jumbos or man-baskets. Staging specialist was used with a specialised air leg contractor to allow for meshing and bolting of the cracked fibrecrete in these

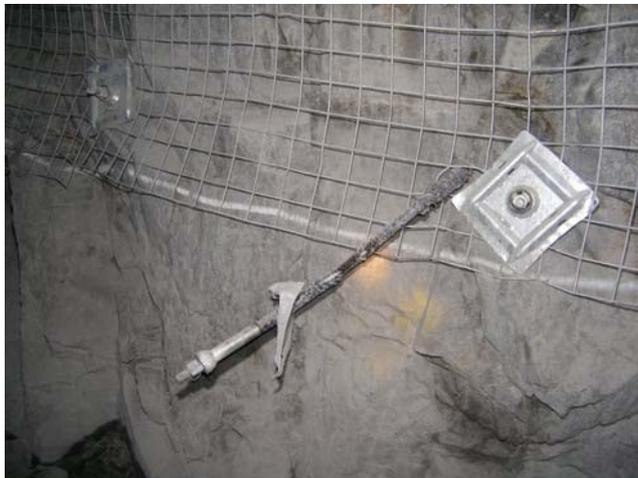
During the initial use of the Hybrid bolts, a high rate of installation failures (30–40%) occurred. This was not due to one, but several design, equipment, and training and environmental factors which needed to be addressed to meet quality and timeline milestones. With the Hybrid bolts, any damage or severe twisting to the sleeve can prevent full grouting of the bolt. Many contributing factors were identified such as: long rails

(3.6 m–12 feet) – this affected the angle which the bolts would go into the bolt hole which would damage the sleeve when it rubbed against the side of the drillhole (Figure 8). The BHP Billiton rigs were refitted with 3 m (10 ft) rails and the contractor jumbos were specified for 3 m rails. Plates, especially butterfly plates which typically had thin sharp edges that the poly sleeves would get caught and tear against on installation. This was drastically reduced by using combination plates with both the Butterfly and rockbolt plate welded together as one plate with the hole in the butterfly portion flanged inward to remove the sharp edges. The different Hybrid bolts came with two different types of anchor shells, a two leaf and a three leaf design with different wedge profiles. It was determined that in the Cannington conditions the three leaf design was preferred since it had a larger overall expansion (up to 52 mm), and it expanded quicker for the amount travelled. This was a factor for several reasons: greater travel required to engage the anchor, the more spin required would increase the chances to damage the sleeve. Due to the early bit size issue and some of the breakout during drilling in poor ground, the extra millimetres made a difference in engaging the anchor. From experience it was preferred by the operators since the consistency of the three leaf anchor gripping the drillhole improved. This preference was also influenced by the lack of worn drill bits available. Normally at Cannington a new Magnum bit had a diameter of 46.5 mm. These bits were used to bore the face during development drilling until the bit size was reduced to 45 mm. From 43.5 to 45 mm these drill bits are used for resin bolting for the jumbos and for split sets. When the Southern Zone was shut down for rehab there were only two jumbos concentrating on drilling in the North Zone which could not generate enough worn bits for the rehab fleet of ten jumbos. Until all of the two anchor shells were replaced by the new three anchors the Magnum bits were ground down to 45 mm to allow for better engaging by the two leaf anchors.

Figure 8 Damage poly grouting sleeve on a hybrid bolt

The sleeve length was also modified to ensure that if the nut at the collar broke-out early and travelled prematurely (instead of tension up the plate), the extra travel at the anchor end to tension the plate, would not block the end of the poly sleeve and prevent grout from passing into the borehole. The breakout device did not reliably break when required and appeared to be potentially affected by the galvanisation of the bolt (extra thickness on the threads). Galvanisation of these bolts was unique in mining. The mining application of these bolts before had used only 'black' hybrid bolts. Applying galvanisation to these bolts did create problems in the early period mostly with the fine M24 threads on the anchor end. Some of the early batches did not account for the extra galvanisation thickness and the anchors would not turn. This was fixed with later batches by cutting deeper threads into the bar. Later batches were also affected by fine 'contaminants' of zinc galvanisation on the threads. This was resolved by the manufacturer wire brushing the threads during assembly and spinning the anchor partially down the rebar. Training had a large impact on the failure rates, especially for operators from Western Australia who were used to installing simple split sets that could be installed at an angle to the hole without damaging the rockbolt. Many training sessions with the manufacturers and daily checks by the geotechnical engineers and the BHPB operational staff made the difference. Ensuring that the holes were well clear of rock fragments, and the operator had optimum water, air and feed pressure for the ground conditions was important. Preventative maintenance on the jumbo especially the boom hydraulic cylinders were essential to maintain the correct dip and angle to the hole while spinning was required reducing the damage to the sleeve. Finally, the geotechnical engineers also placed a minimum rock mass quality limit on what ground that the Hybrid would be installed in. Near the end of the program the Hybrid bolts were being installed daily at between <4% failure rate.
