Rock Mechanics Practices and Experiences at Xstrata Mount Isa Copper Operations

H.C.J. Esterhuizen *Xstrata Copper, Australia*

Abstract

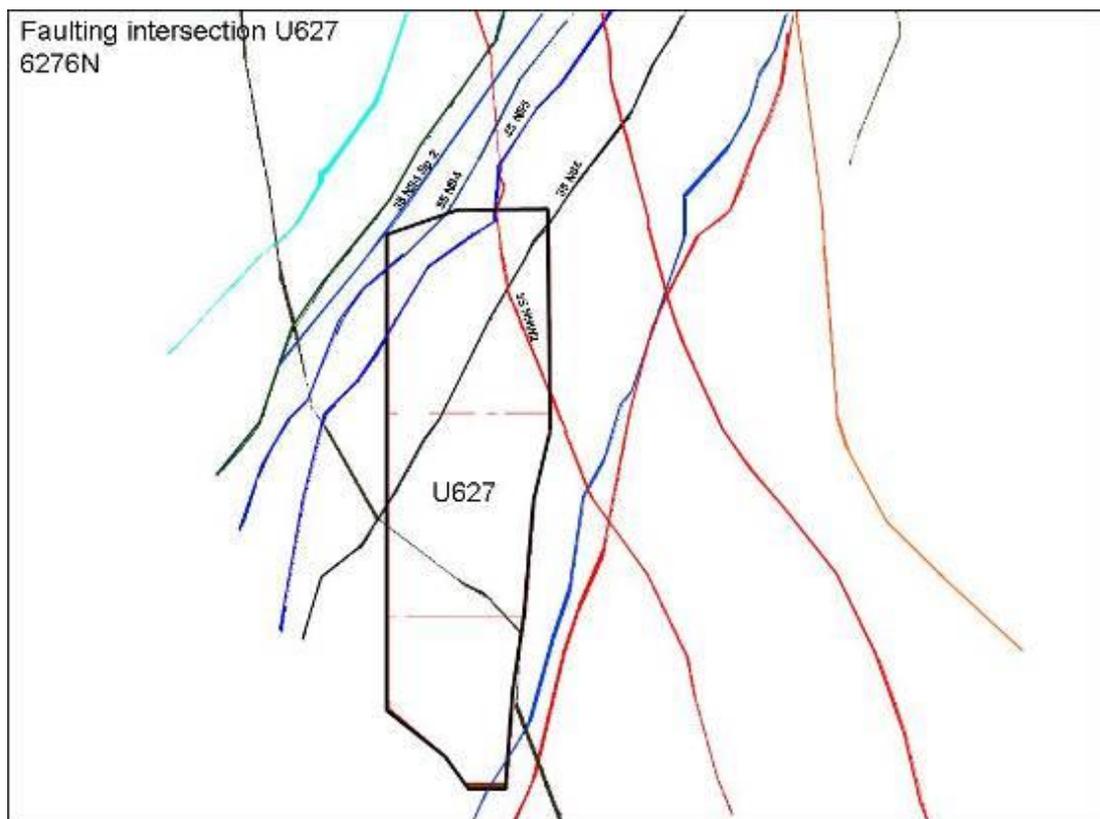
Figure 4 U627 fault intersections

Figure 4 show the faults that intersected the planned stope. 35 NS4, NS5 and NS6 were some of the weaker faults that intersected the crown of the stope. These three faults are known to be graphitic (have graphitic infill), and have sheared and fractured zones associated with them. Some of the fault intersections created potential wedges above the crown.

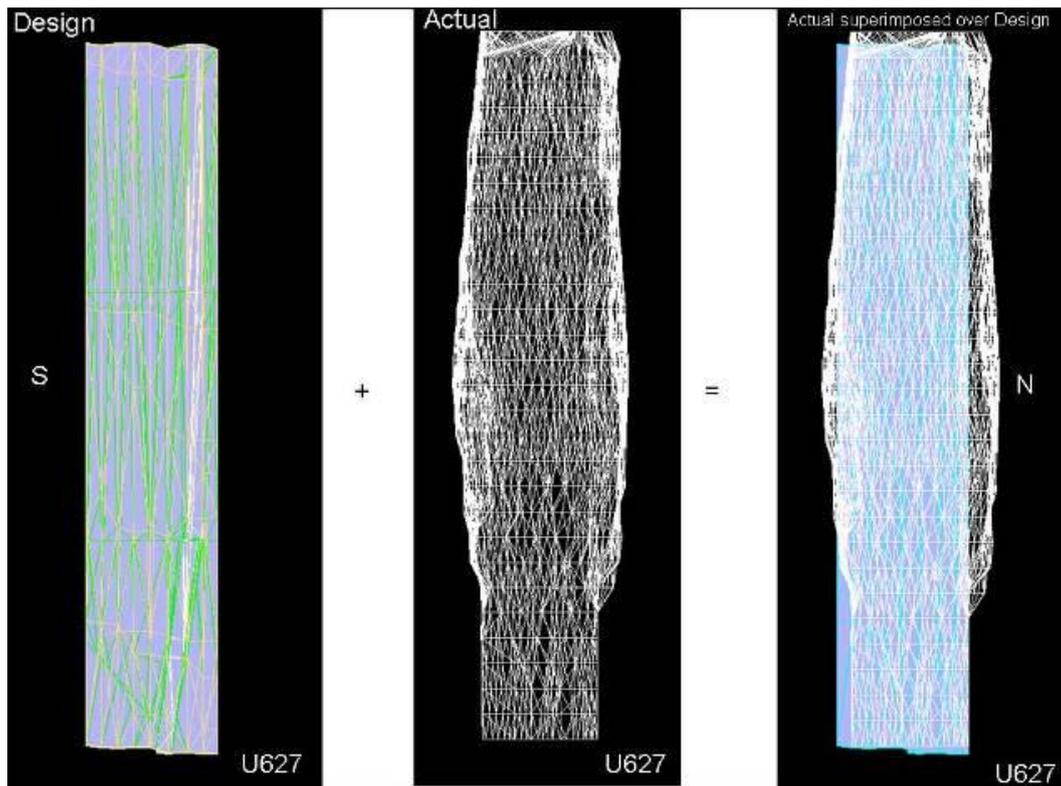
Figure 5 U627 overbreak

Extraction of U627 was undertaken according to plan and schedule and was a success. No major overbreak or other issues occurred. This performance is typical for the stopes extracted in the southern domain. Figure 5 illustrates the planned mining shape with the actual measured superimposed over the planned.

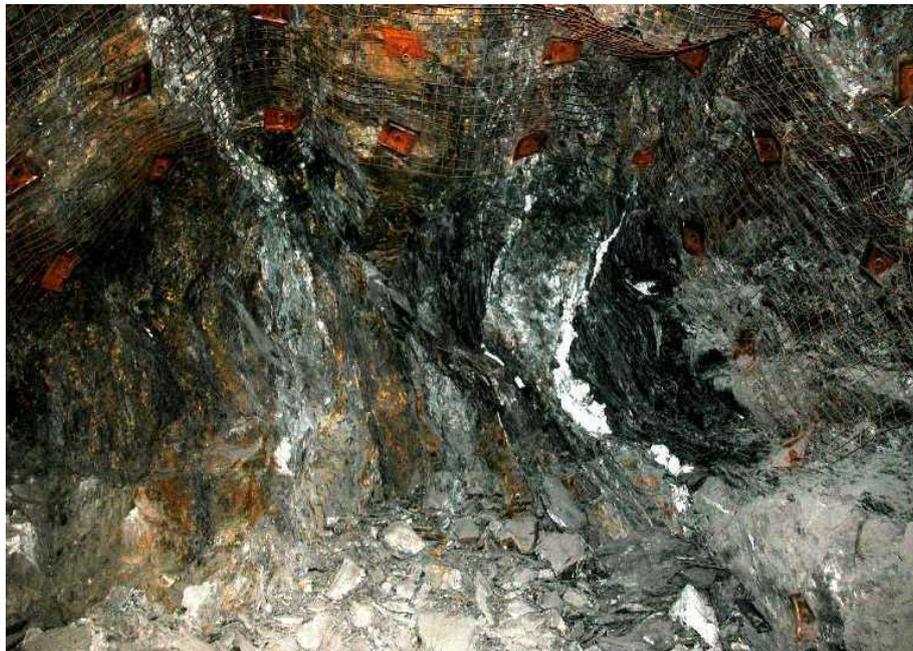
Figure 7 U654 DDR on 27C sub-level (2004)

Increased drive deformation and high loading of support units were common during all phases of the U654 extraction. This increased deformation was attributed to the higher talc content, increased fracturing, fault presence, and increased in situ stress conditions (horizontal). Figure 7 illustrates the high talc content, faulting, shearing and buckling of bedded layers.

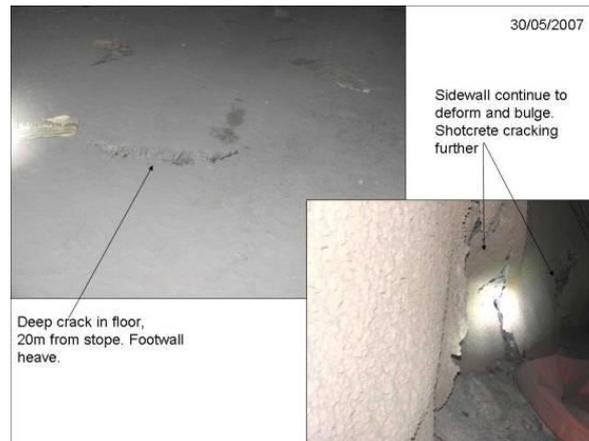
Figure 9 Drive floor and sidewall cracks

Figure 9 illustrates the cracks that formed up to 30 m away from the stope. Figures 10 and 11 illustrate the drive deformation that occurred. During the development phase prior to stoping it was observed that the drives were deforming at higher than normal rates. Up to 1.5 m of drive sidewall deformation was measured. Support installed included 20 mm resin bolts and weld mesh, 6 m cable bolts into the sidewalls and 100 mm steel fibre reinforced shotcrete.

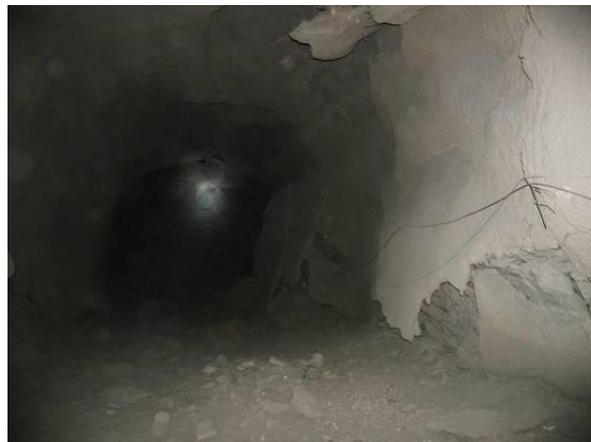
Figure 10 28D Level access drive

The drive deformation on the mid-levels near U654 stope (28D and 29E) exceeded the capacity of some elements of the ground support. Although access was still safely managed through these drives, they were severely damaged. Figure 10 illustrates the damage on 28D level, and Figure 11 illustrates the conditions on 29E. The support on 28D Level did however stand up long enough in order to complete the stope firings.

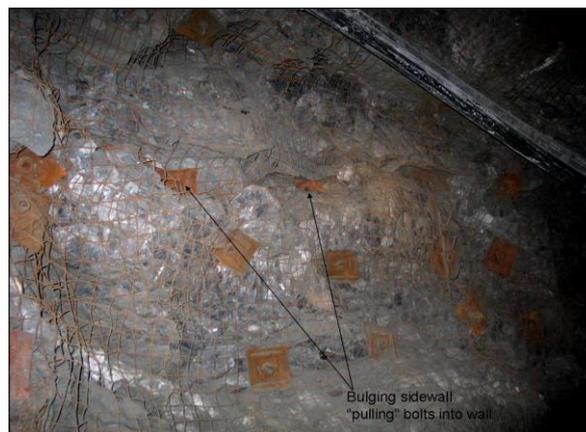
Figure 11 29E Level drive deformation. Note cable bolt plates 'pulled in' as the rock mass deforms around the solid anchored steel

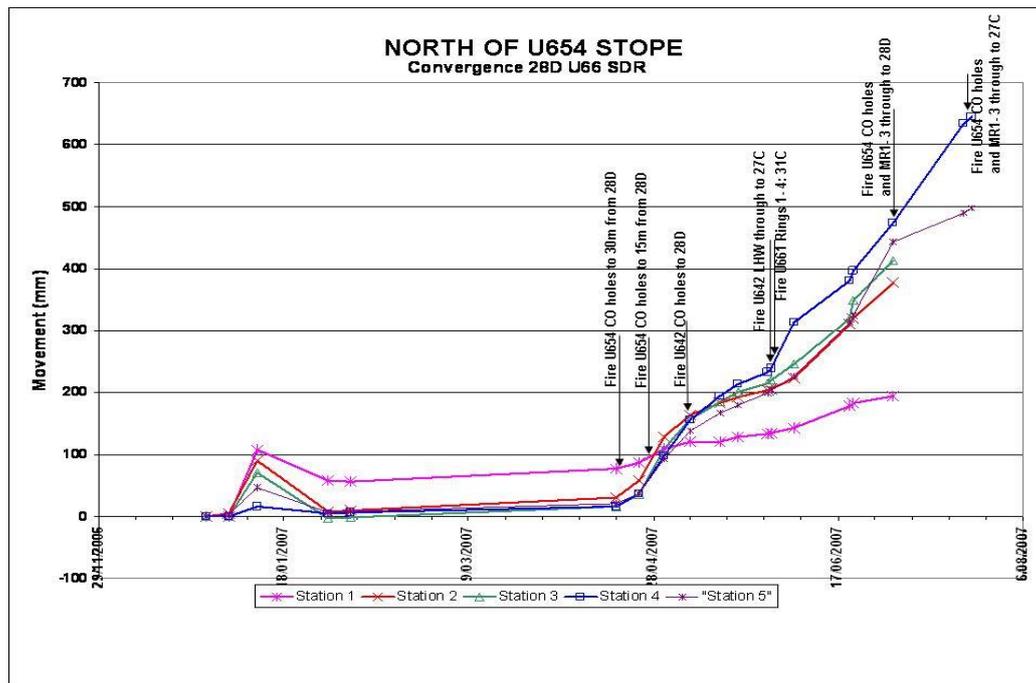
Figure 12 U654 drive deformation on 28D level

Figure 12 shows the progressive deformation of the sidewalls on 28D level. This drive was N–S orientated with several faults striking parallel to the drive. The major in situ principle stress was interpreted to be N–S orientated (horizontal).

There was a two month period in which U654 was mucked but not blasted. Other stopes within 100 m from U654 continued to be blasted. During this time the rocknoise and the deformation (Figure 12) continued.

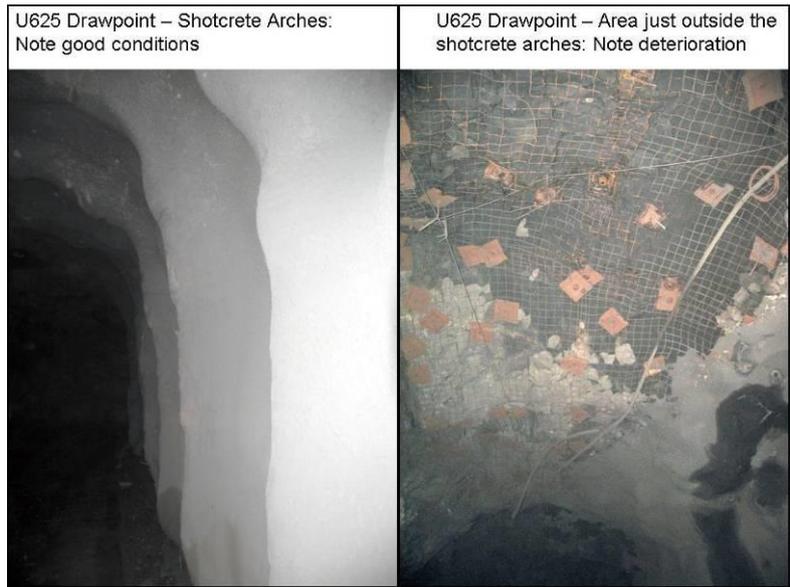
Figure 13 Photos comparing shotcrete arches versus conventional support

- Drawpoint support designs have to be able to resist large stress changes and deformation. MICO has implemented more rigorous support measures in drawpoints including a mixture of concrete shuttering, shotcrete arches, cables, mesh and split-sets for a period of years. The specific mix depends on anticipated conditions for the stope designed. The support is designed to limit drawpoint production associated delays due to poor rock mass or support conditions. Figure 13 shows an example of a drawpoint with the increased support installed. This drawpoint recently completed production without any delays due to poor drawpoint conditions.

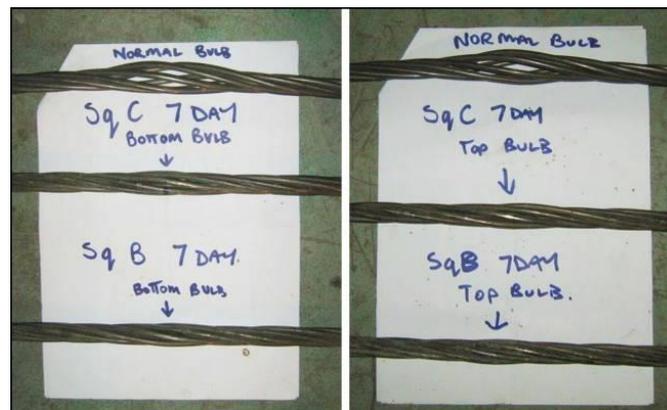
Figure 15 Squashed versus normal bulbed cables

The potential squashing of cable bolt bulbs by mechanised installation needs to be checked and where needed, fixed. Squashed cable bolts will reduce the early strength required in some underground applications. Cables should suit the rock mass conditions and purpose. Use smooth or specialist yielding cables where required.

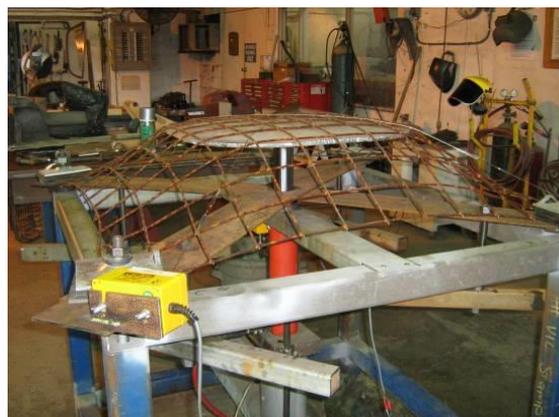
Figure 25 Black steel mesh test

The base tests involved testing steel mesh until failure occurs. Failure was noted to occur on the welded intersection of strands. Failure occurred between 1.8 and 2.1 t. Figures 23 and 24 show the results of black steel mesh compared to a polymer type mesh (called HAS). Note that some of the steel mesh samples also achieved 2 t. This was the only polymer or geogrid type mesh that could relatively closely match black steel in the results. All other geogrids tested were found to have inadequate strength or baggage capacity. The advantage of the polymer mesh is that it does not corrode and therefore has a longer life than steel. It is also not as expensive as stainless steel alternative products. MICO will now start to investigate the opportunities and challenges with underground development mining trials of this polymer mesh where operational practical application will be of importance.

Figure 25 graphically illustrates the amount of stretch the steel mesh can accommodate before failure. Figure 26 illustrates the HAS mesh being loaded to failure. The steel mesh failed on the welding, whilst the HAS polymer mesh failed through tearing individual strands apart around the tendons.
