Extraction of Two Sill Pillars Under Paste Backfill at Louvicourt Mine, Canada

C. Doucet, *Natural Resources Canada, CANMET Mining and Mineral Sciences Laboratories*

S. Lampron, B. Bisson, R. Harrisson, *Aur Resources, Louvicourt Mine, Canada*

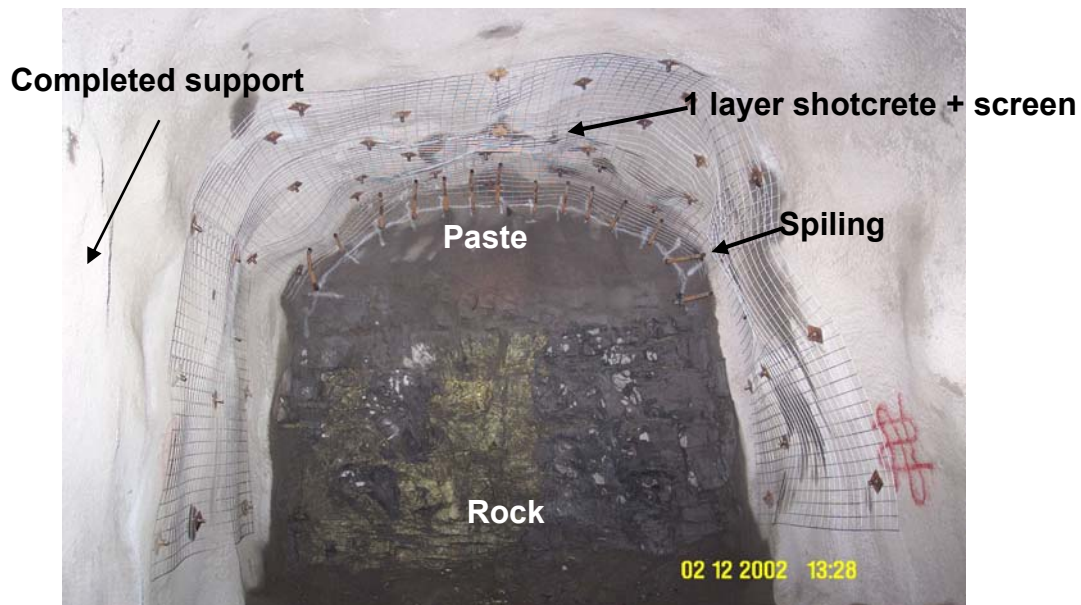
With drifting under paste, development is almost exclusively in ore, while being far enough away from high seismic risk zones. The rockmass in these areas was extremely fractured. These drill drifts start at the main drift level and ramp down to a minimum of 3.5 m below the paste of the overlying stopes. Reserves need to be far enough from the main drift in order to ramp down safely. Figure 1 shows a typical development face.

Figure 1 Typical development face under very poor quality paste in the 680 sill pillar

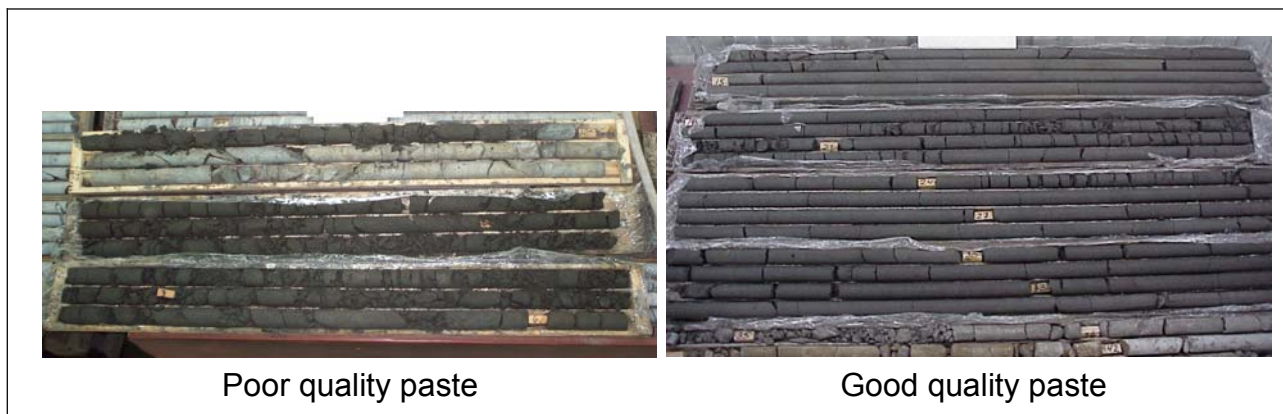
Figure 2 Pictures of poor and good quality pastes

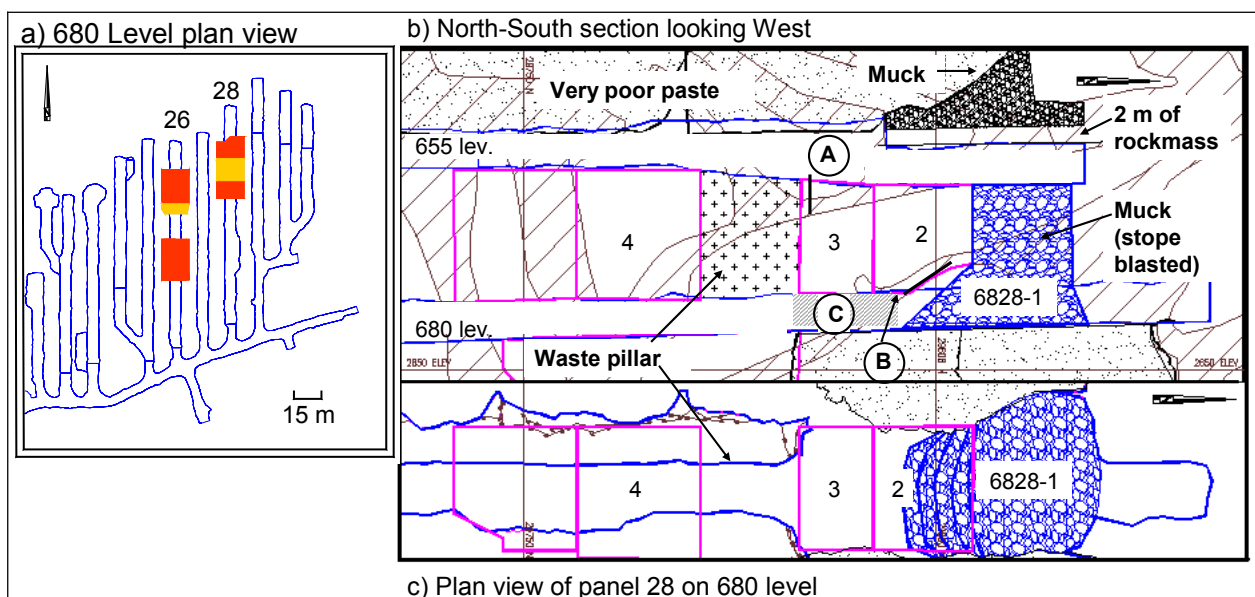
No skin pillar was planned for the first secondary stope (stope 6828-1) as it was partially located under a 2-m thick slab of rock that was judged sufficient to establish a stable back. Stope 6828-1 was blasted in one shot with electronic caps. Figure 7 shows the location of panels 26 and 28 on the 680 level (a), a North-South section through Panel 28 (b) and a larger plan view of Panel 28 (c). Since the rockmass was extremely fractured in this area, the blast resulted in the appearance of many open fractures (Point A – in Figure 7) in

the shotcrete of the drill drift on the 655 level as well a major fracture in the floor of the drill drift. A portion of the adjacent stope in the panel (block 2) caved during the blast (Point B – in Figure 7). The footing pillars on the 680 level of block 2 and part of block 3 were missing (Point C – in Figure 7) i.e. the drill drift pillars of the underlying stopes (7128-1 & 2) had caved when the stopes were blasted. The presence of major fractures and the missing footings combined to create an unstable block. An action plan was developed to remedy the situation:

Figure 7 Results of the blast of stope 6828-1

The problems encountered had major consequences. The rehabilitation caused important delays in the mining sequence and a more profitable stope could not be mined. As a result, stope 6828-1 was not mucked out, 6828-2 left in place as a transversal pillar and 6828-3 mined. Stope 6828-3 was 9 m long with an arched 4 m thick skin pillar at its centre. The skin pillar remained stable and the muck piled under block 2 provided the support needed for the duration of the extraction of the stope.

- Apply a new layer of shotcrete on the back and walls of the shotcrete shell in the access on the 655 level.
- Pile up muck along the walls in the mucking drift (680 level) under block 2 to compensate for the missing footing pillars. The muck provided support, although not as rigid as rockmass, to the unstable block. It was recognized that the muck would let the block move to a certain extent, but it was felt that it would prevent its failure.
- Install an extensometer in the top of 6828-3 to monitor its movement.

- Review of all subsequent secondary stopes in order to verify the condition of the footing pillars along the access drift and plan alternative support if needed.
- Verify the condition of adjacent stopes drift pillars (i.e. stopes along strike) and plan backfilling of primary stope accesses on the 655 level in order to reinforce the drift pillars.
- Inspect drill drifts to determine possible rehabilitation needs.
- Plan installation of extensometers in subsequent transverse stopes (i.e. stopes located south of the planned stope in the same access) in order to monitor potential movements in these blocks during mucking.

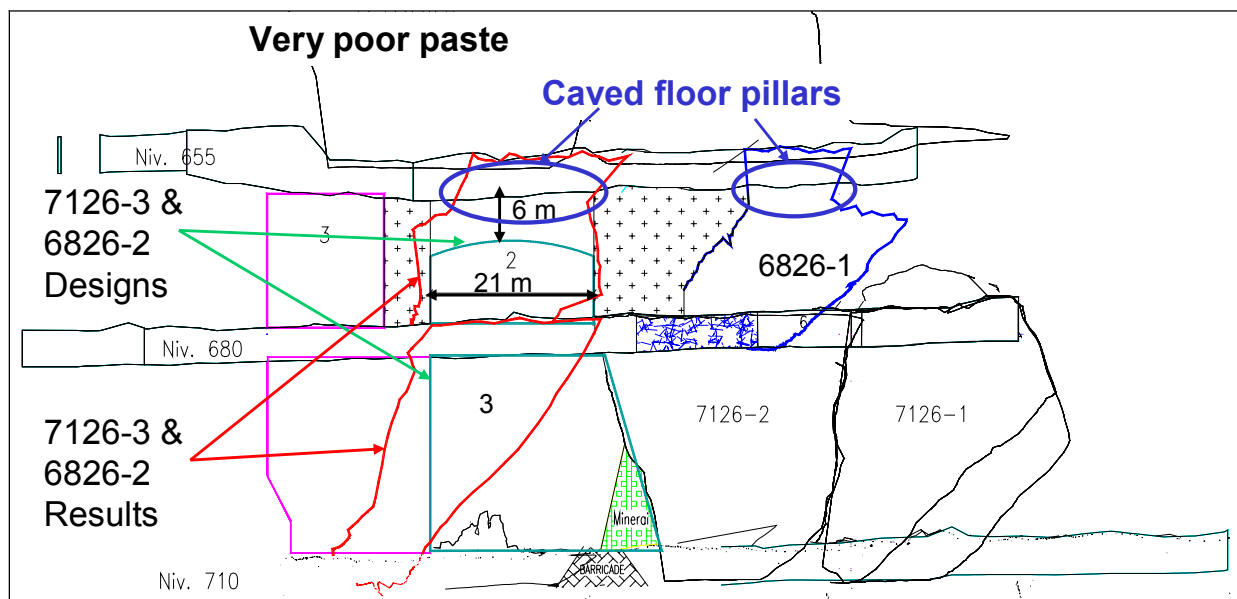
Important delays in the mining sequence of the 680 sill pillar forced the engineering department to revise the mining plan for many secondary stopes. To compensate for this, mining experience was used in order to increase the length of the stopes. In some panels, it was possible to combine stopes when the rockmass was relatively massive. In others, the stopes were blasted into the underlying open stope and backfilled altogether. An example of this is the stope 6826-2 (Figure 8) which was blasted into stope 7126-3 and mucked out from the 710 level.

Figure 8 Initial and final designs of the extraction of Panel 26 (North-South section looking West).

The only major failures of the shotcrete shells occurred in Panel 26. The skin pillar of stope 6826-1 caved over a length of 11.5 m and subsequently caused the failure of the shotcrete shell east wall over a 6-m length three days later. The very poor quality paste exposed and the rest of the shotcrete shell remained relatively stable. The skin pillar of stope 6826-2 caved over an 18-m length between two major fracture zones. Approximately eight days later, the east wall of the shotcrete shell ruptured and exposed the very poor quality paste located in the back over an 8 m long by 10 m wide section, which started caving. Figure 6

showed that a surface of 15 m by 6 m of exposed paste with cohesion of 100 kPa (poor quality) would remain stable. The dimensions exposed by the 6826-2 failure were less than those specified in the model but paste quality was poorer. The rest of the shotcrete shell remained stable.
