# Lessons from the geotechnical reconciliation of the B3 cave

Komal Mann <sup>a</sup>, Yoko Yanagimura <sup>b</sup>, John Hadjigeorgiou <sup>a,\*</sup>

**Keywords:** block caving, reconciliation, extraction level

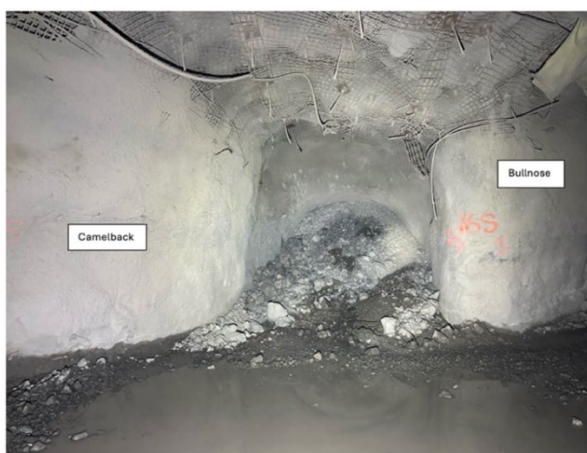
**Figure 7 J16S drawpoint conditions at the end of B3 cave life**

Throughout the duration of the cave life, the field inspections identified minimal signs of damage on the drawpoint pillars. Figure 7 presents the ground conditions at the J16S and K16N drawpoints as of October 2025. The J16S drawpoint minor damage was observed on the pillars, which did not indicate signs of deformation and was likely due to equipment contact. However, the fibre-reinforced shotcrete layer may hide visible signs of pillar deformation.

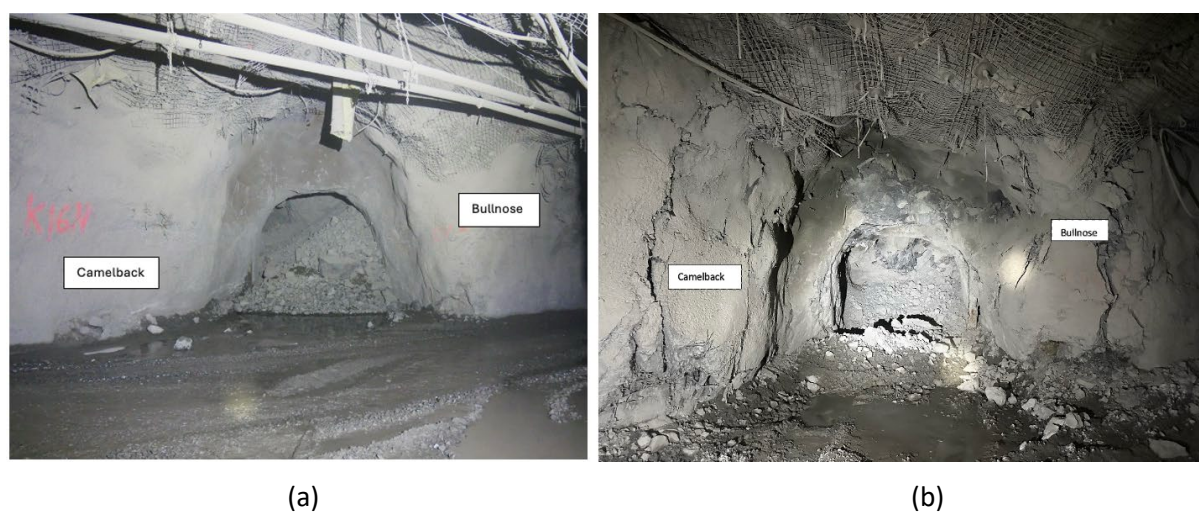
**Figure 10 K16N drawpoint conditions in (a) January 2025 to (b) October 2025**

The K16N bullnose and camelback pillar wrapping, similar to J16S, did not exhibit an increase in displacement until January 2025. Field inspections conducted in February 2025 revealed no significant signs of damage at K16N (Figure 10). Overall, the ground conditions at the drawpoint were good. The fibre-reinforced shotcrete layer showed minimal or no fracturing, and the drawpoint brow remained intact with no visible damage to the steel sets. No ground support damage was observed. The back of the drawpoint appeared relatively flat, with no visible ‘hummocks’ or other indicators of stress-related deformation. However, between February and October 2025, ground conditions at the K16N drawpoint deteriorated, with the first signs of damage observed in June 2025, indicating elevated stress conditions. The drawpoint transitioned from no visible damage to widespread shotcrete cracking, with slabs peeling from the brow and exposing the steel set.
