# Management of orepasses in poor ground: learnings from Carrapateena sublevel cave

<sup>a</sup> BHP, Australia

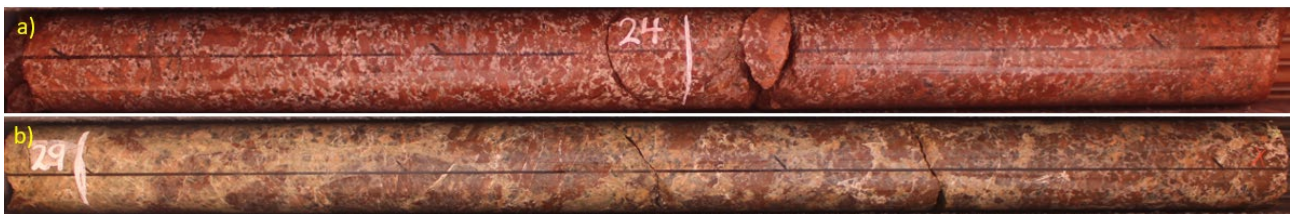
**Figure 1** Typical core runs of (a) Donington Suite granite and (b) Reinette shear zone granite. The Reinette shear zone core can be seen to have significantly increased alteration, veining and fracturing, reducing the intact and rock mass strength within the unit

coatings of persistent defects within the shear zone reduce the rock mass quality and contributes to consistent overbreak from the backs of development drives. Measured geological strength index (Marinos & Hoek 2000) from development faces within the zone range between 45–65. These characteristics are compared to typical values in Table 1. Typical core trays of Reinette and 'normal' granite are shown in Figure 1.

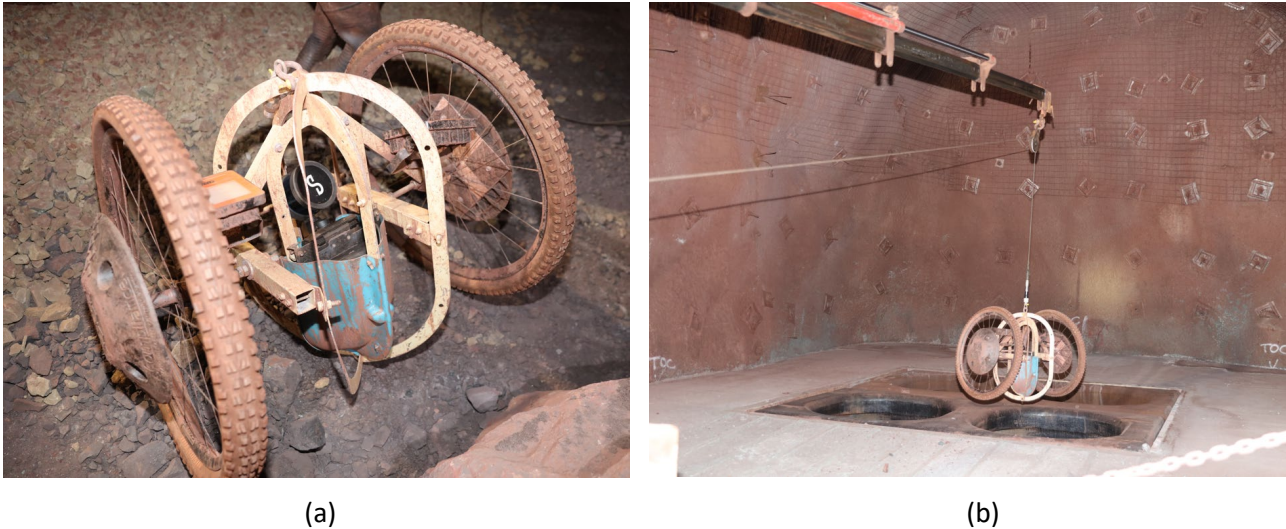
**Figure 10 Cage-mounted LiDAR scanner (a) set-up and (b) being lowered through grizzly aperture**

LiDAR scanning is conducted primarily using an Emesent Hovermap ST scanner mounted in a protective cage (Figure 10). This is either lowered down the main orepass itself using a winch and swing-arm system mounted at the top of the pass, or through apertures of the grizzly and run down the angled finger passes into the main shaft. Carrapateena's survey department rigged the cage on a larger frame of bike wheels, which both protected the LiDAR unit from impact and also allows it to run (relatively) smoothly down pass walls.
