# Lessons from 2 reticulation-induced shotcrete barricade failures in drift and fill mining

## Abstract

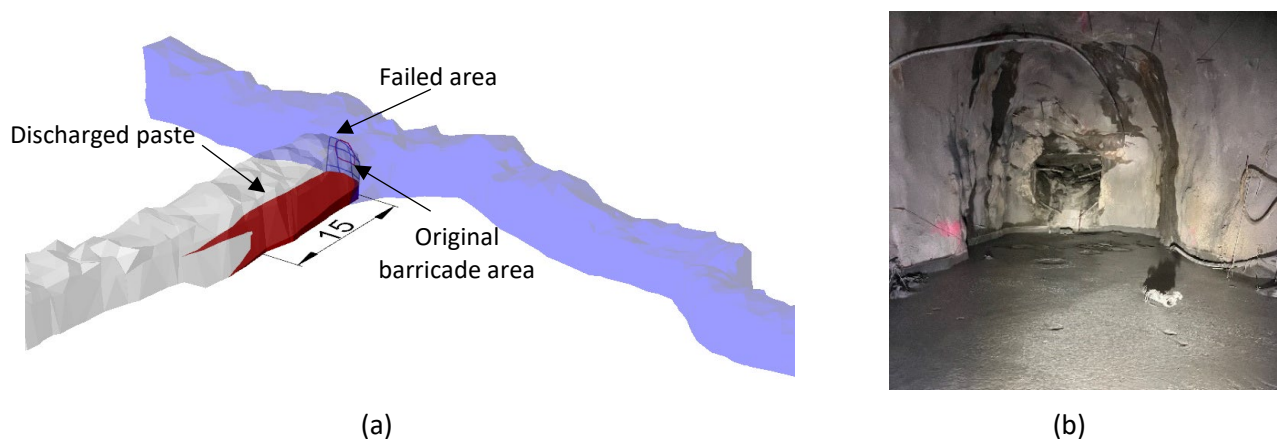
During the shift of the barricade failure, all breather pipes except Fill Point 5 had discharged paste. Near the end of the shift, the service crew requested line flushing. Since Breather Point 5 had not discharged and 45 m<sup>3</sup> remained to reach the planned volume, the crew left the flushing valve closed, allowing the remaining paste in the reticulation to be pumped into the drift. Surveyed volumes indicated the drift was 99% full. Line flushing began at 03:55, by which time a total of 117 m<sup>3</sup> of paste had been pumped during the shift. After 25 minutes, the underground service crew observed water leaking through the rock mass joints and the shotcrete above the barricade, followed by minor cracking. Within a minute, partial failure occurred in the upper central part of the barricade, affecting 4.6 m<sup>2</sup>, or 23% of the total barricade area. An estimated 60 m<sup>3</sup> of paste and water escaped, spreading 15 m from the breach. The service crew was safely away from the incident. Nonetheless, the event caused operational disruption and delays, resulting in financial impact, as the drift remained inactive until the investigation concluded and the escaped paste cured sufficiently to be removed. Figure 7a illustrates the original barricade perimeter, failure area, and discharged paste, while Figure 7b depicts the barricade failure and Breather Pipe 5, which never discharged.

**Figure 7** (a) Original barricade perimeter, failure area and paste discharged; (b) OLW\_-330\_-330\_1\_3 and -330\_1\_6 barricade failure and blocked Breather Pipe 5

After conducting in situ measurements of shotcrete thickness on the barricade perimeter within the failure zone, it was found to range between 200–300 mm. Despite the large volume of shotcrete applied, the spraying was uneven, leaving sections thinner than the required standard. When an estimated pressure of 804 kPa was exerted on the barricade during tight filling, the weaker area failed. Additionally, inadequate communication between the underground service crew and the paste plant control room contributed to the event. Although cracking of fill wall was observed, paste pumping was not halted quickly enough to prevent the failure.

The failure mechanism indicates overloading of the barricade, causing tensile failure of the shotcrete, induced by paste line pressure surge.

The response and mitigation measures implemented following the failure included a redesign of the breather pipe layout to ensure adequate separation from the fill pipe, preventing paste backflow and blockages by standardising a minimum distance in the design drawings. The updated design also incorporated additional redundant breather pipes to provide backup pressure relief in case one becomes blocked.

For the fill wall, the barricade design was revised to accommodate more shotcrete thickness guides, helping operators apply shotcrete evenly and maintain the required thickness. Additionally, the barricades were considered for redesign to account for transient pressure allowances.

In terms of operational procedures and communication, a remotely operated flushing valve was introduced to minimise the need for service crew presence at the barricade. A refresher training campaign was also conducted for both underground and paste plant crews to reinforce their ability to identify potential barricade over-pressurisation and ensure barricade integrity.

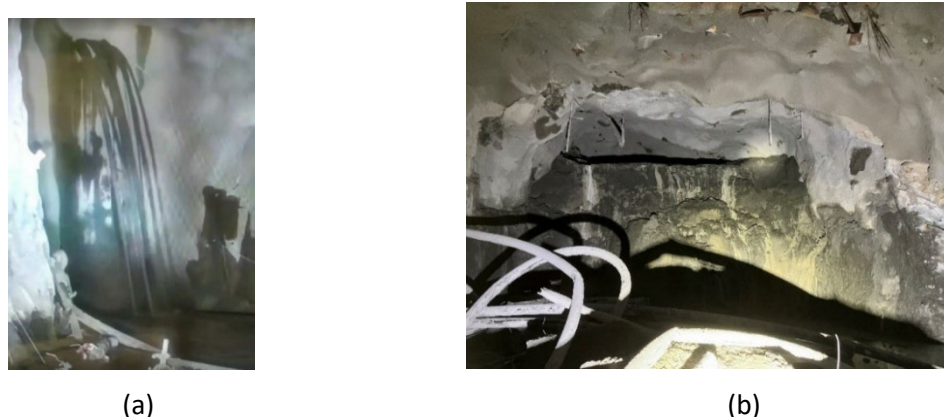
Meanwhile, Breather Pipe 1 began discharging paste. To relieve pressure, the crew opened the valve on Breather Pipe 3 and proceeded to the flush valve, which they attempted to open multiple times. The valve, however, was stuck due to paste buildup, and the crew retreated to a safe distance. At that stage, based on surveyed and expected fill volumes, the drift was estimated to be 86.6% full, although it had been tight-filled. During the water flushing, because the flush valve was malfunctioning, the remaining paste/diluted paste in the pipeline was pumped into the already tight-filled drift. Leakage of watery material was observed on the upper part of the barricade and recorded by the monitoring camera (Figure 11a).

Upon completion of the water flush and confirmation from the paste plant that the pipeline pressure had dropped to zero, indicating the line was clear, the crew requested an air/water line flush. Despite concerns expressed by the paste plant operator, the underground crew insisted that compressed air was necessary to fully flush the line. The operator complied. When the compressed air reached the barricade, the entire surface of the barricade failed, resulting in the release of an estimated 100 m<sup>3</sup> of paste, which spread over approximately 12 m.

**Figure 11** (a) Barricade leakage recorded by the camera at OLF\_-340\_-345\_1\_7 drift before the failure and (b) OLF\_-340\_-345\_1\_7 drift after the failure

The response and mitigation measures focused on procedural improvements, including the development and enforcement of clear flushing procedures that outlined approved methods, limitations, and prohibitions on the use of compressed air for clearing paste lines. Targeted training was delivered to service crews, operators, and supervisors to improve understanding of air-induced pressure surges. The incident analysis was shared with both surface and underground teams to promote collective learning. Communication protocols were strengthened to require supervisory approval before any non-standard flushing methods could be initiated. In addition, inspection protocols were enhanced to cover reticulation, flushing, and barricade integrity.
