Design and implementation of a damage assessment system at Argyle Diamond's block cave project

F. Fernandez *Argyle Diamonds Pty Ltd, Australia*

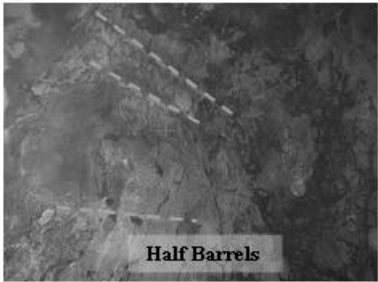
Condition	Description	
Most of half barrels are observed Depth of overbreak $Dob < 0.5 \text{ m}$	Observation of half barrels around the excavation indicates very low blast disturbance during development and subsequently very good stability condition of backs and walls. The required length of rock reinforcement (bolts and/or cable bolts) corresponds to the proposed design.

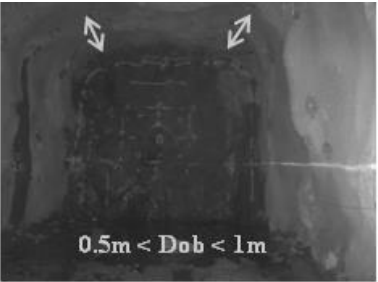
Half Barrels
Depth of overbreak $0.5 < Dob < 1 \text{ m}$	Half barrels not observed. Rock mass around the excavation has been slightly affected by mining. The length of rock anchors (rockbolts and/or cable bolts) is at least 30 cm lower with respect to the original design.

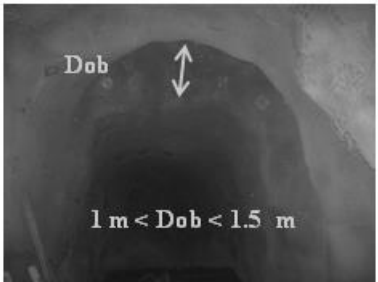
1 m < Dob < 1.5 m

0.5m < Dob < 1m
Depth of overbreak $1 \text{ m} < Dob < 1.5 \text{ m}$	Rock mass around the excavation has been moderately affected by mining. The observed length of rock anchors (rockbolts and/or cable bolts) is at least 50 cm lower with respect to the original design.

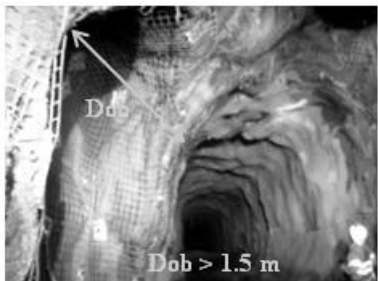
Dob > 1.5 m

Depth of overbreak $Dob > 1.5 \text{ m}$	Rock mass around the excavation has been highly affected by mining. The observed length of rock anchors (rockbolts and/or cable bolts) is at least 70 cm compared to the original design.

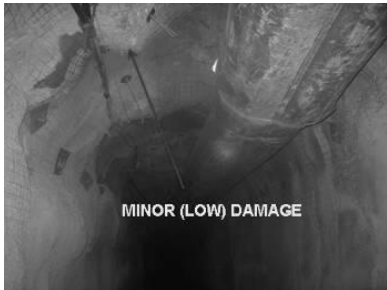
Minor and spot cracking (< 10 mm wide), commencement of fibrecrete slabbing and/or minor mesh deformation. Evidence of spot loading in rockbolts plates, primarily in friction stabilisers. Up to 0.5 m overbreak and wet condition may be observed.	87–71
Moderate

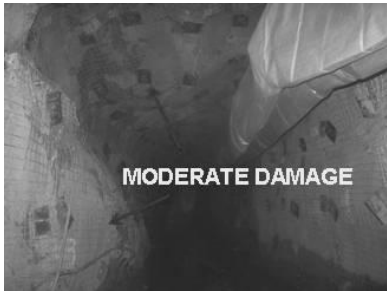
Multiple cracking (10–20 mm wide), fibrecrete slabbing, exposed embedded mesh with isolated broken welds are evidenced. Increased load in rockbolts and cable bolts plates. Failure of friction stabilisers and isolated failure of resin bolts plates. Up to 1 m overbreak and dripping condition of water influx could be observed.	70–50
High

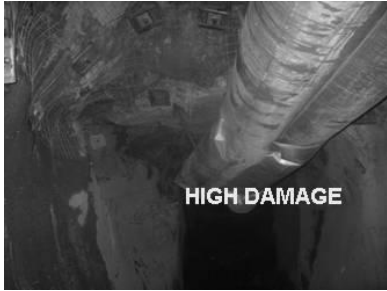
Multiple cracks (> 20 mm wide), multiple fibrecrete slabbing, failure behind mesh and failure of mesh (broken welds and strands) are evidenced. Significant and multiple failures of friction and resin bolts and isolated failure of cable bolts are observed. Up to 1.5 m of overbreak and dripping to rain water influx could be observed.	49–33

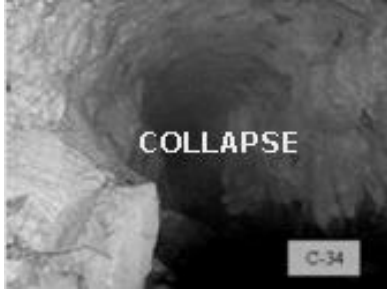
Collapse

Massive failure of fibrecrete and mesh strands occurs. High significant cracks and open rock blocks are observed. Significant and multiple failures of rockbolts and cable bolts are observed. Overbreak is usually higher than 1.5 m and high flowing/raining water could be observed.	< 33

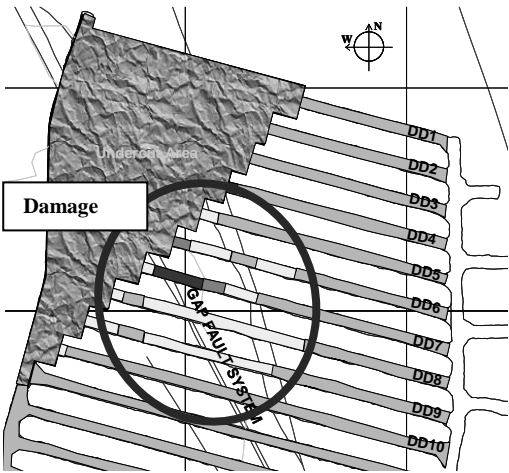
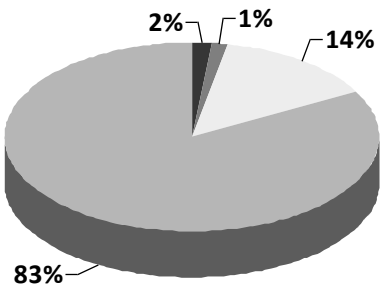
Damage: September 2009	Statistics: September 2009

<p>Damage assessment performed during September 2009 indicates that 17% of the evaluated area of the undercut level (UCL) evidences damage. No damage was recorded in the rest of the area (83%). The damage distribution corresponds to: 2% high damage, 1% moderate and 14% minor damage.</p>
Damage: October 2009	Statistics: October 2009

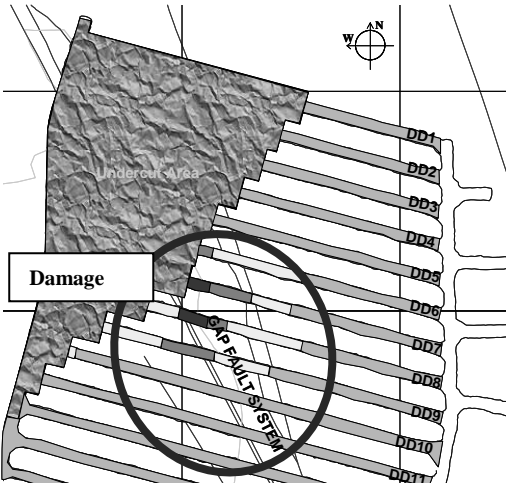
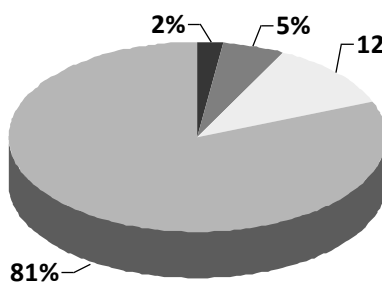
<p>Damage assessment performed during October 2009 indicates that 19% of the evaluated area of the UCL evidences damage. No damage was recorded in the rest of the area (81%). The damage distribution corresponds to: 2% high damage, 4% moderate and 13% minor damage.</p>
Damage: November 2009	Statistics: November 2009

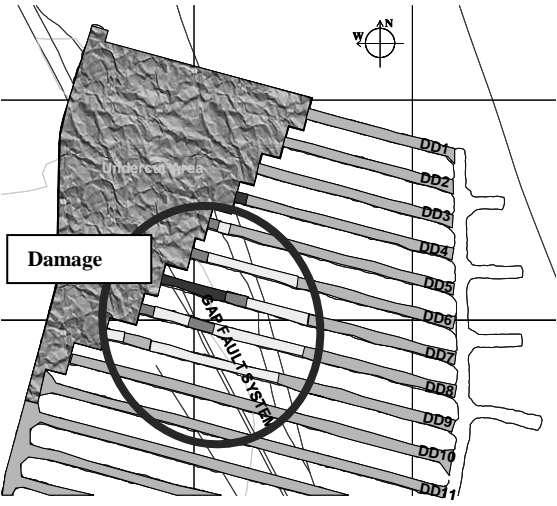
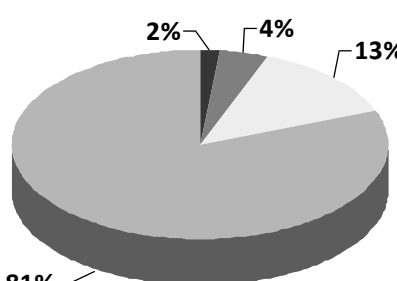
<p>Damage assessment performed during November 2009 indicates that 19% of the evaluated area of the UCL evidences damage. No damage was recorded in the rest of the area (81%). The damage distribution corresponds to: 2% high damage, 5% moderate and 12% minor damage. Note that moderate damage during November was smaller than in October due to change in ground conditions.</p>

The previous information demonstrates that an 80 to 20% no-damage to damage ratio has been maintained during the evaluated period.
