# Dynamic testing of High Energy Absorption (HEA) Mesh

## Abstract

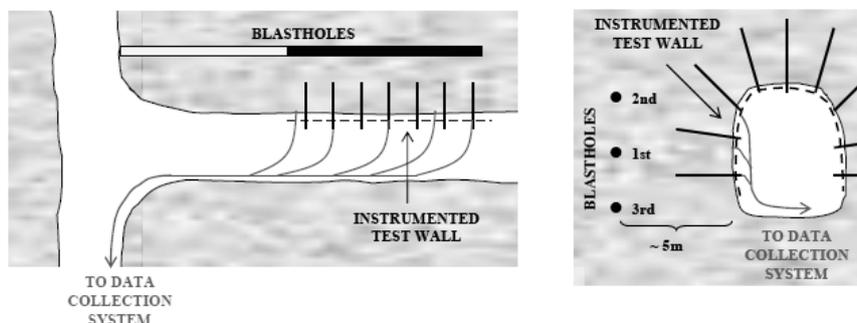
**Figure 1** Conceptual plan and cross-sectional views of a simulated rockburst test site layout

Simulated rockburst experiments are conducted by blasting adjacent to the walls of disused excavations. Three blastholes are drilled parallel to the test wall at each site, as shown in Figure 1.

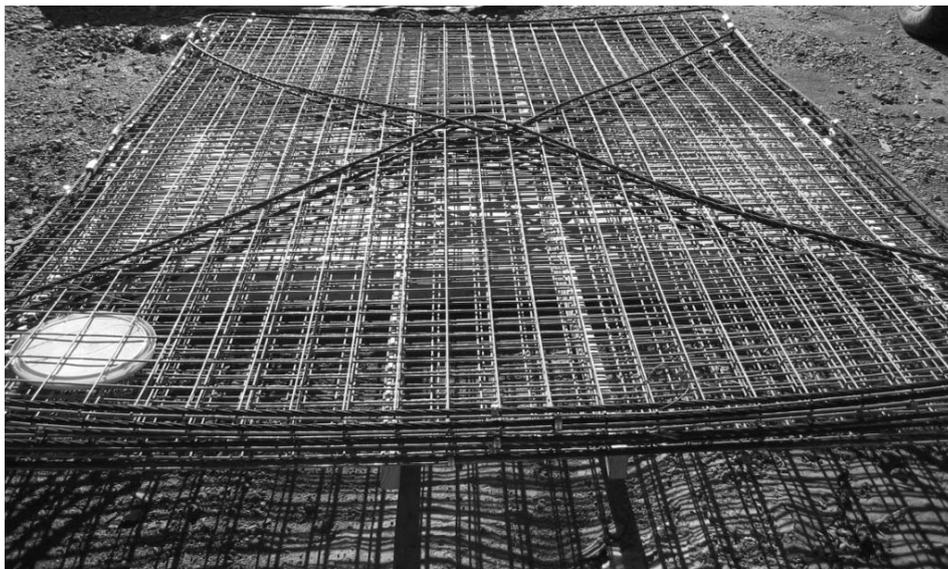
**Figure 2** Prototype of the HEA Mesh

The 18 ton tensile strength cable bolt significantly increases the load bearing capacity of the mesh. Based on static laboratory tests, the HEA Mesh can sustain loads of well over 15 tons compared to the 2–4 tons of regular weld mesh. These tests involve central loading (pulling) of a full sheet of mesh, and the deflection is measured perpendicular to the plane of the sheet. More details on these tests are given in Potvin and Giles (2008). Also, with the cable being free to stretch over its entire length, the HEA Mesh has a good capacity to deform, which is not the case for FRS. The combined high load bearing and large deformation capacity produces a high energy absorption system.

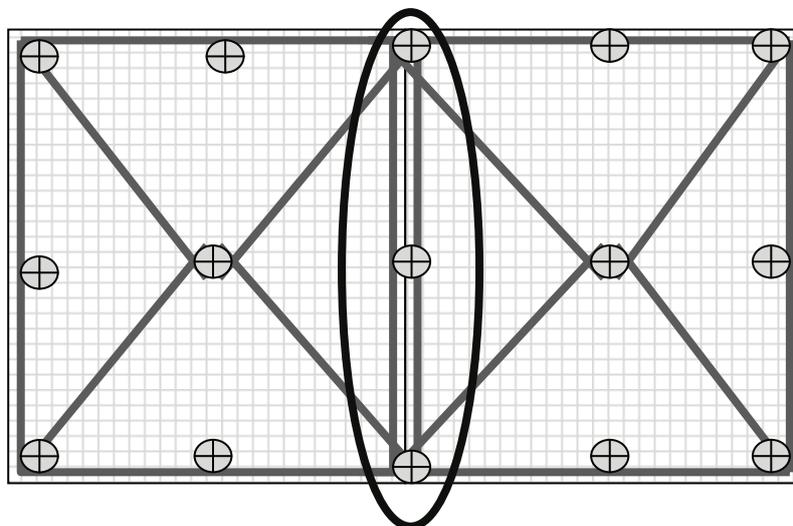
**Figure 3** Two sheets of HEA Mesh overlapping. The overlap has two lengths of cable criss-crossing. The cable wraps around the rockbolt underneath the plate producing a good load transfer between the surface support and the reinforcement

HEA Mesh results in having two criss-crossing cables parallel to the mesh overlaps (Figure 3), transforming this weak area in regular meshing into a particularly strong area for the HEA Mesh.

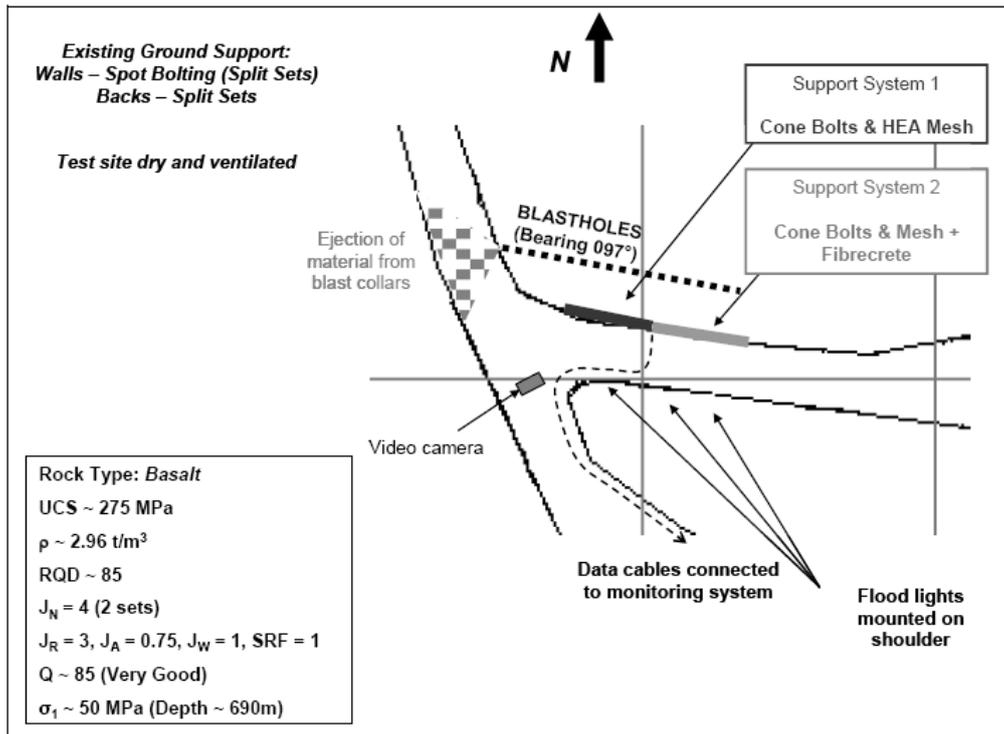
Figure 4 Long Shaft 14L Eimrock Access 1 test site layout

The test site layout is shown in Figure 4, with a photograph of the test wall after set-up shown in Figure 5. The ground support layout instruction is shown in Figure 6 and the test wall drilling layout is shown in Figure 7. Sixteen 46 mm observation holes were drilled at 1 and 3 m height across the test wall. The main function of these holes is to determine the thickness of the damaged zone around the excavation, using observations from a borehole camera, before and after each simulated rockburst blast. These observation holes may also assist in venting the gases from the blasts.

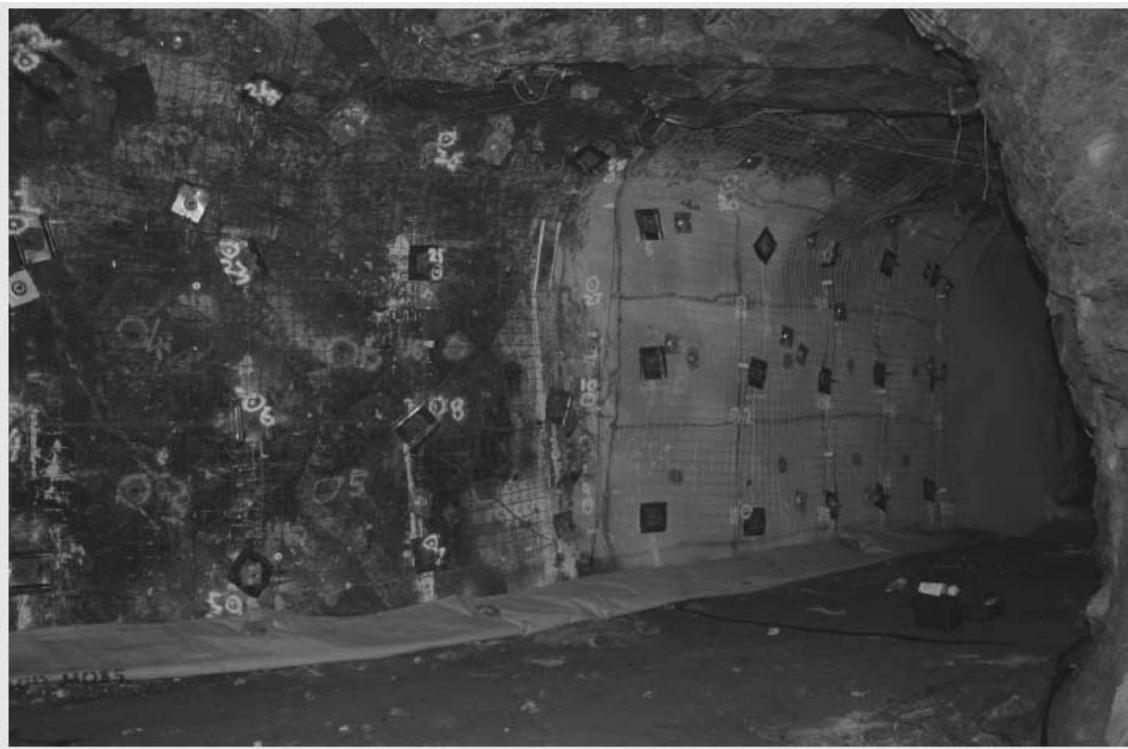
Figure 5 Photograph of the test wall

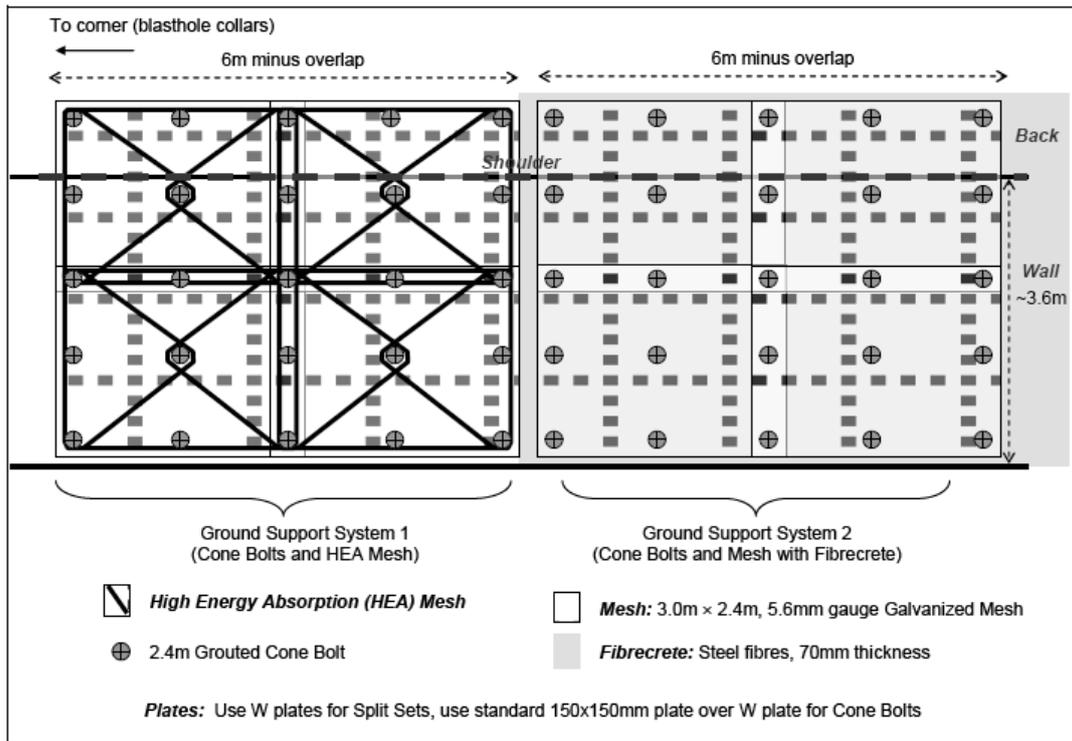
Figure 6 Ground support layout instruction

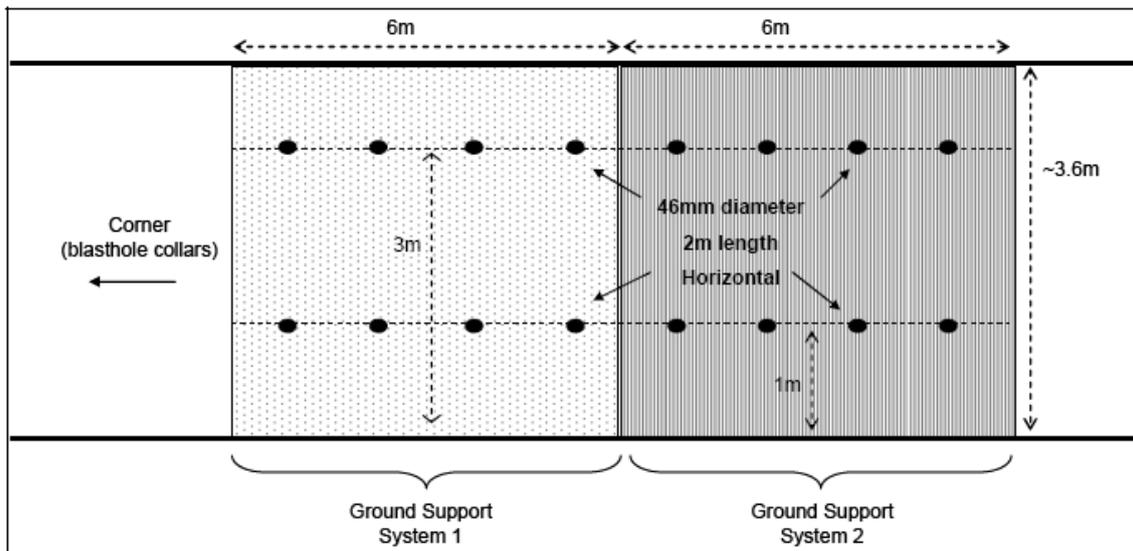
Figure 7 Test wall drilling

The 46 mm observation holes (Figure 7) were used to assess the depth and nature of rock mass fracturing before and after each blast and, specifically, the thickness of failed rock acting upon the ground support for use in energy demand calculations.

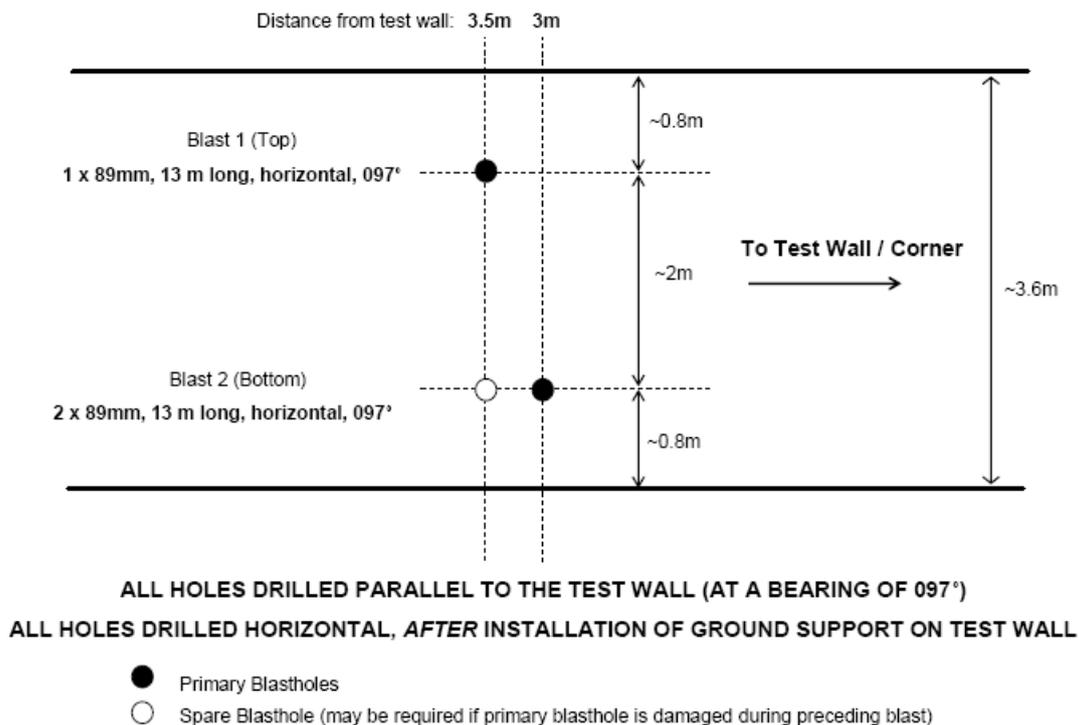
**Figure 8 Blasthole drilling instruction**

For this particular simulated rockburst test at Long Shaft, the blast design parameters are shown in Table 1. The blasthole drilling instructions issued prior to testing are shown in Figure 8.

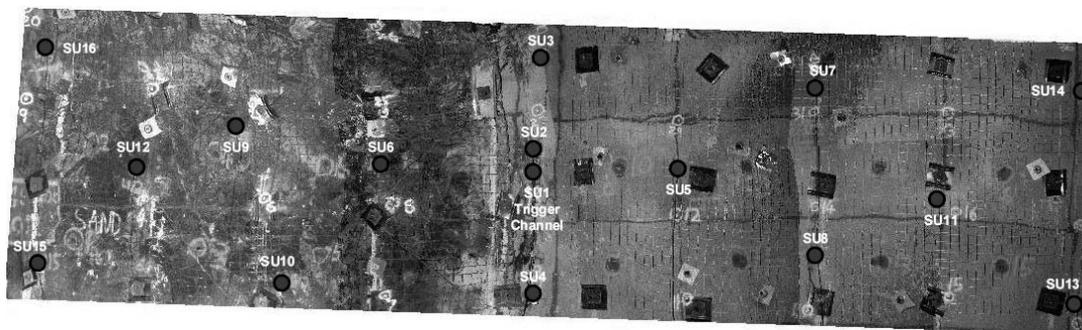
**Figure 9 Test wall geophone locations**

Ground motion monitoring at each test site was conducted using heavily over-damped 14Hz SM6 geophones connected to a 16 channel Impulse seismic monitoring system. Inclusion of a damping resistor in each geophone circuit allowed a much higher velocity to be recorded (up to around 5 m/s). The impulse system allows a maximum sampling rate of 10 kHz per channel, which is adequate to prevent aliasing of waveforms, considering the maximum frequency of ground motion expected to be generated by blasting is not more than 1 kHz. Surface mounted geophones are used to measure the ground velocity generated by blasting. Geophone locations are shown in Figure 9.

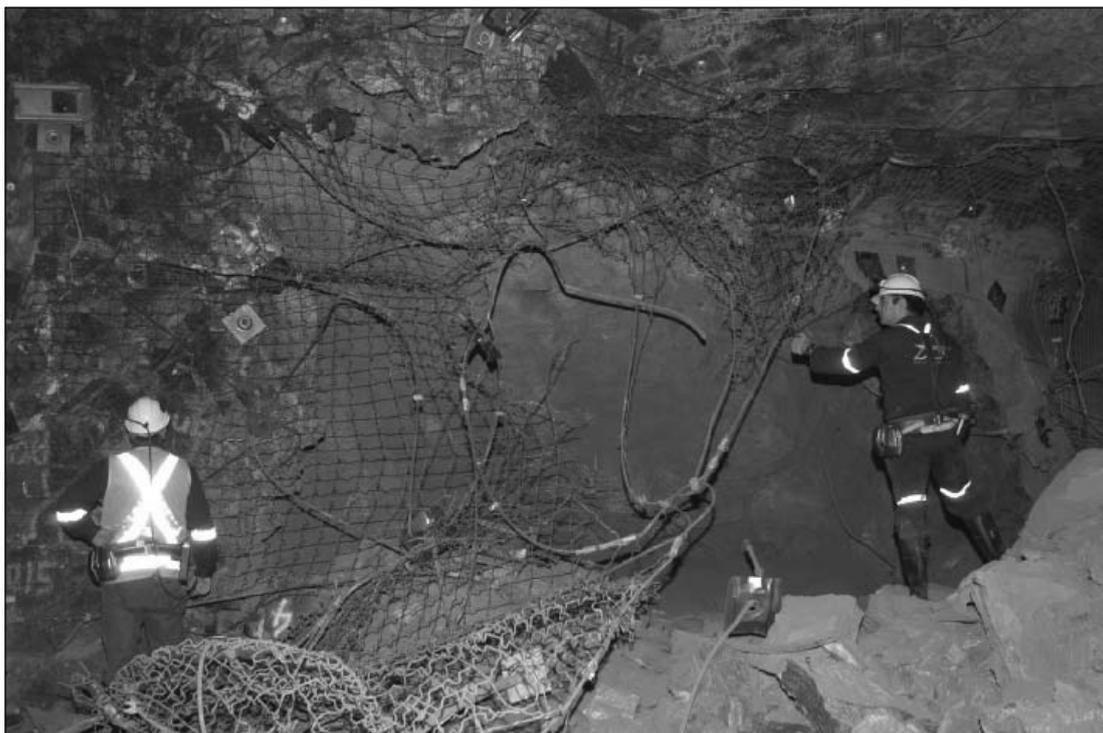
**Figure 12** Test wall after the second blast

The severe damage generated by the second simulated rockburst is shown in Figure 12. The level of damage was likely influenced by the geometry of the charge relative to the test wall, with the blasthole closer to the test wall than designed, particularly in the HEA Mesh and cone bolts section. Selected photographs of the damage to the test wall due to the second blast are shown in Appendix A. These photos show that many of the cone bolts appear to have been pulled out, with evidence of cone bolt plough such as striations length-wise along the bolts. It is conceivable that the grout may have been too weak in this case and once the HEA Mesh was loaded, the lacing pulled many of the cone bolts out as the entire system deformed.

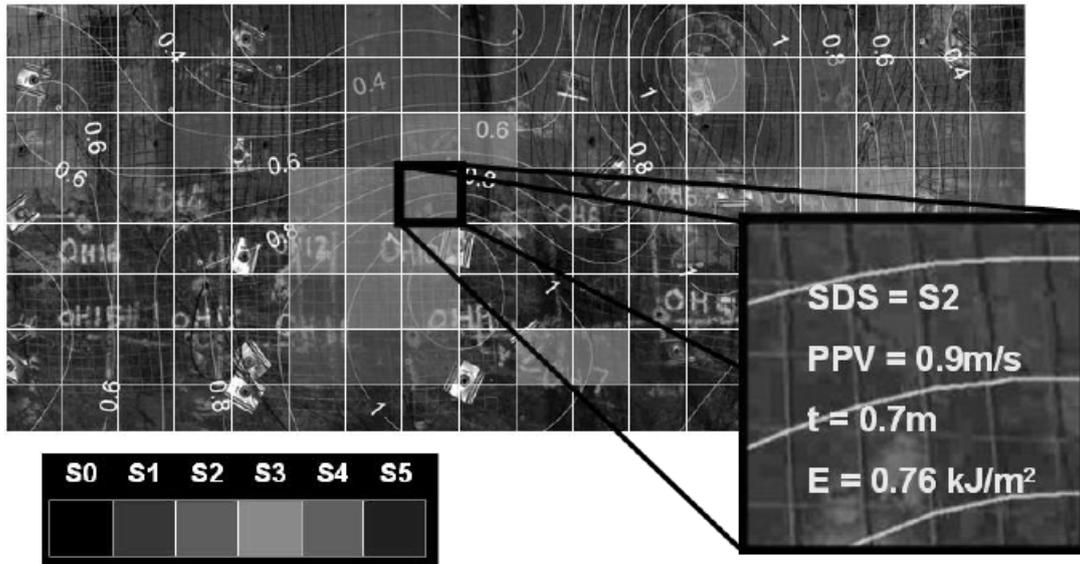
**Figure 13** An example of the damage assessment procedure — each grid square is assigned a SDS rating, a PPV and a failure thickness to give a value for energy demand per square metre

The damage assessment procedure is shown graphically in Figure 13. There are many site specific factors which probably influence the damage generated by the simulated rockburst, such as local stress conditions, rock type, rock mass discontinuities and blast related damage. It is considered that all of these factors contribute to the two variables used to analyse the data — failure thickness and PPV. The analysis technique is simplified by considering only the result of these influences, rather than attempting to quantify each influence individually.

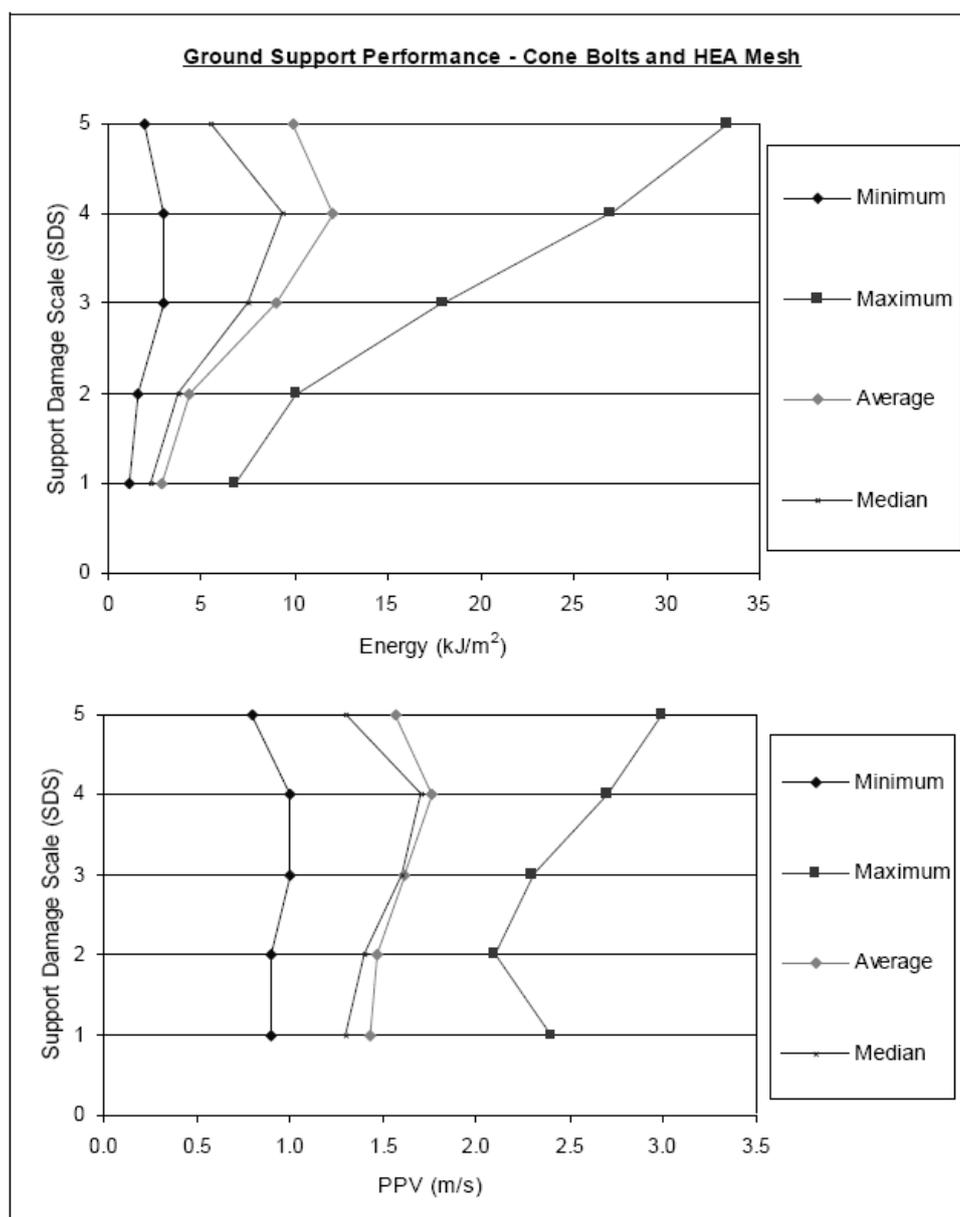
**Figure 14 Cone bolts and HEA Mesh support performance**

The results of the damage assessment are shown in Tables 5 and 6 and Figures 14 and 16. As shown in Figure 14, support damage scale level S3 occurred at an average of around 9 kJ/m<sup>2</sup> energy demand for the cone bolts and HEA Mesh support system.

In general, there is a slightly increasing PPV for the damage levels encountered, but there is a much stronger relationship between energy demand and ground support system performance. Energy demands at lower damage levels (S1, S2) appear comparable to other ground support systems tested, however, once higher energy demands are achieved, the HEA Mesh and cone bolts system rapidly gains capacity. This is likely due to the fact that the cable lacing built into the HEA Mesh is not engaged until significant support system deformation is achieved.

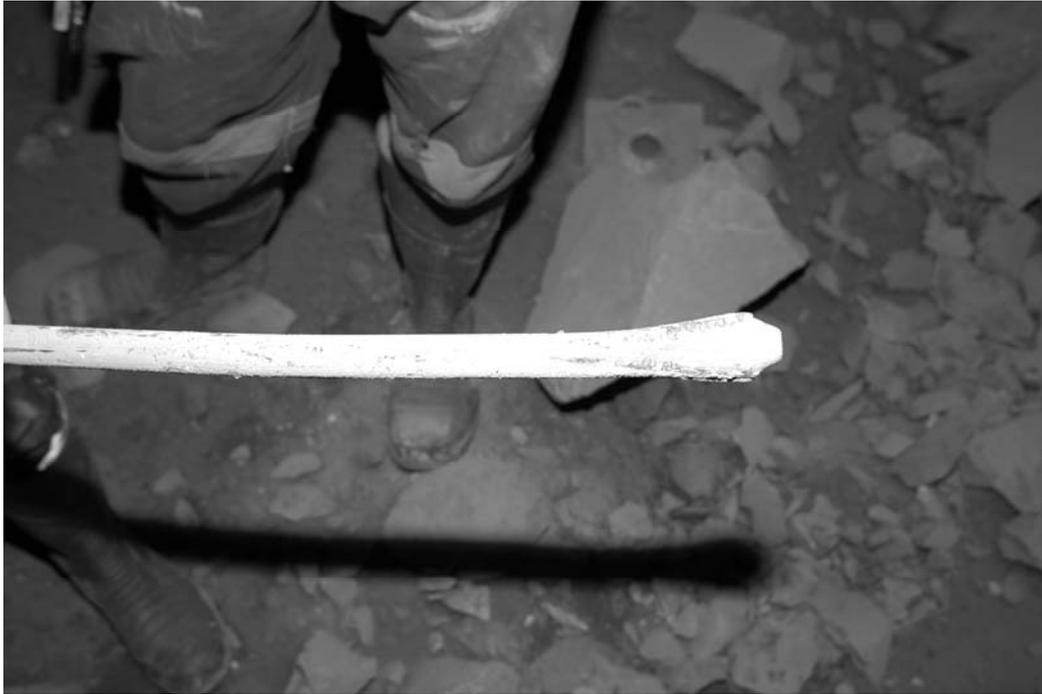
**Figure 15 Cone bolts pulled out of the grout during the second blast**

Despite the extremely high energy demands which were achieved in this test (up to around 35 kJ/m<sup>2</sup>), the lacing component of the HEA Mesh remained intact. No breaks in the lacing were observed, despite it being heavily bent and deformed. This indicates that the HEA Mesh shows good potential for providing high energy capacity in a rockburst prone environment when a suitably strong and yielding reinforcing element is used. Many of the cone bolts were pulled out of the grout demonstrating a very efficient transfer of force between the surface support and the reinforcement.

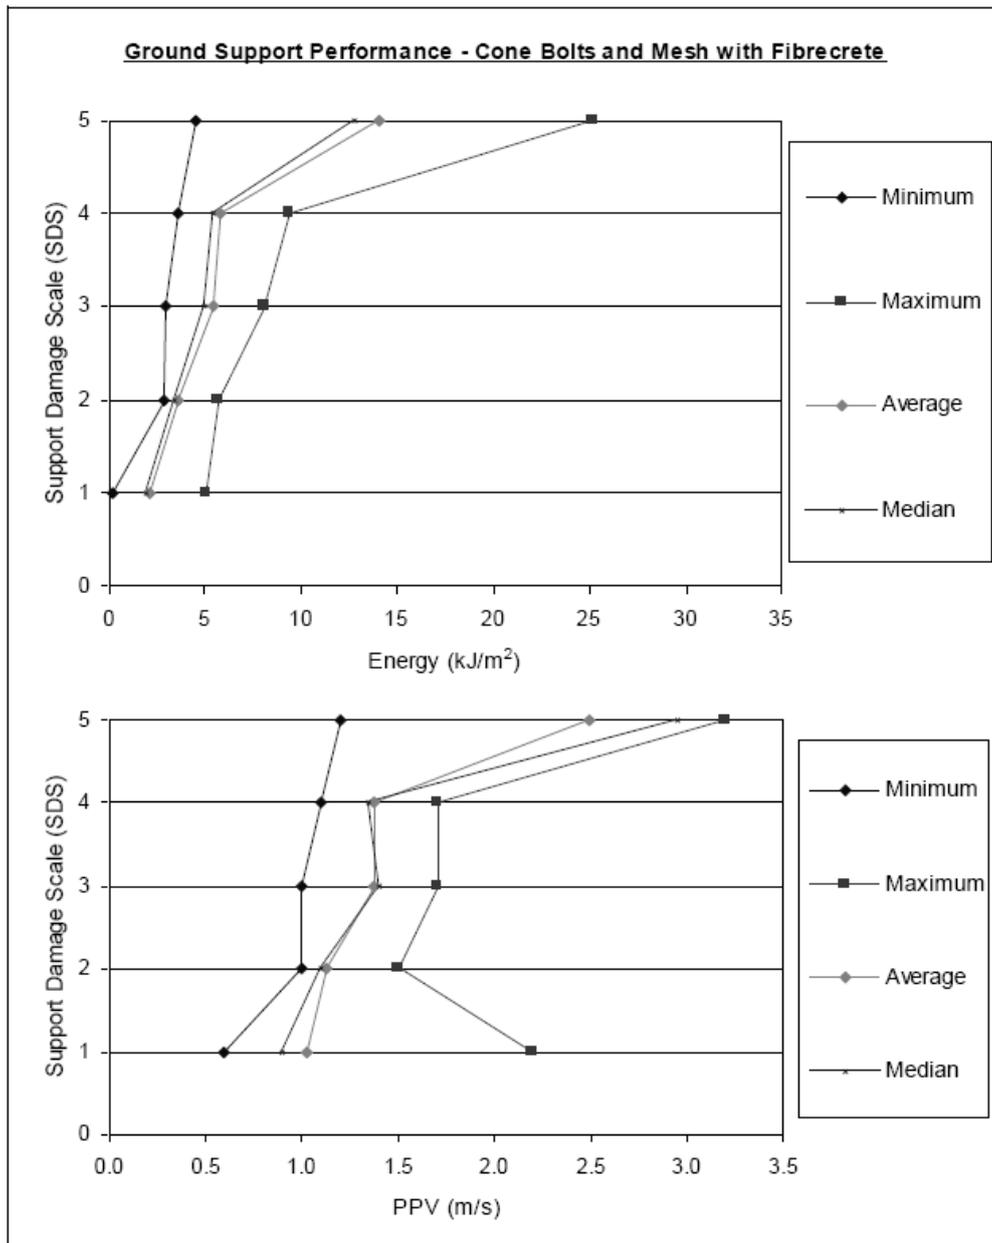
**Figure 16 Cone bolts and mesh with fibrecrete support performance**

The performance of cone bolts and mesh with fibrecrete, in terms of energy absorption, was approximately 45% lower than the HEA Mesh support system. In this case, S3 damage occurred at an average of approximately 5 kJ/m<sup>2</sup> (Table 6 and Figure 16). This is an almost identical result to other support systems tested using the simulated rockburst method with mesh (with or without fibrecrete) and rockbolts at a spacing of around 1.2–1.5 m (Figure 17). The stiff fibrecrete and mesh surface support generally provides adequate load transfer to individual rockbolts only at energy demands of around 5 kJ/m<sup>2</sup> or less. The damage to this section of the test wall showed a very sharp transition from severe damage to minor damage. This is more a function of the rapid attenuation of PPVs further from the worst affected section of the test wall (as shown in Figure 11) rather than a property of the support system.

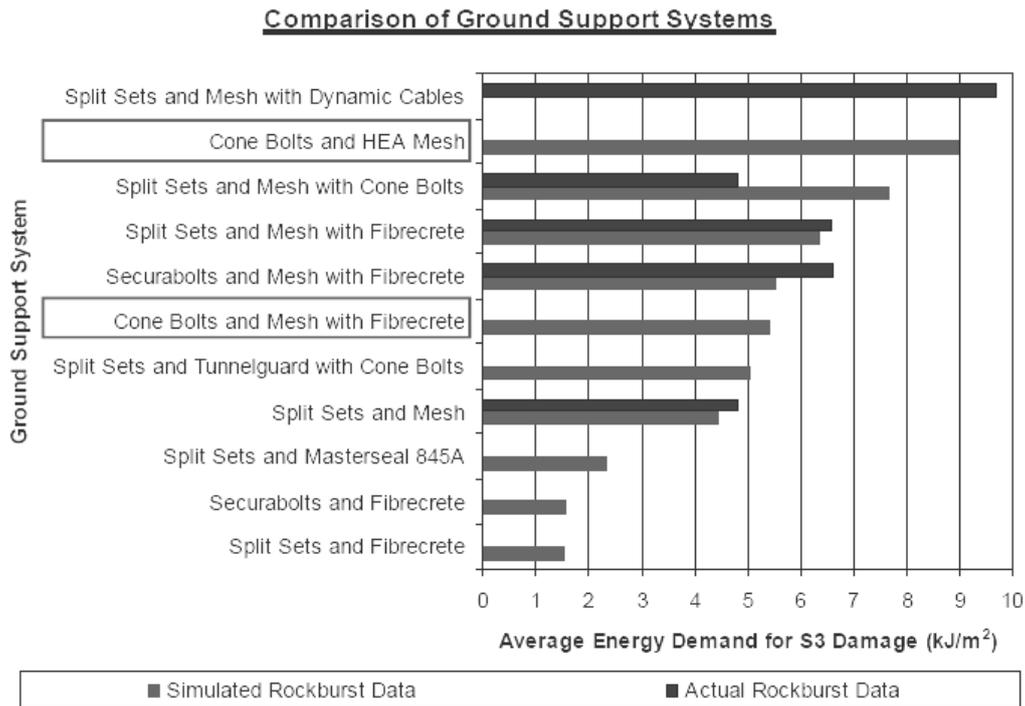
**Figure 17 Comparison of ground support performance (after Heal, 2010)**

Figure 17 shows a comparison of ground support systems tested using simulated rockbursts from a number of mine sites, as well as some data from actual rockburst case histories from the ACG rockburst catalogue (Heal et al., 2006; Heal, 2010). The chart shows the average energy demand for S3 damage. The PPV for the actual rockburst data (blue line in Figure 17) was estimated using a far-field scaling law. All ground support systems using only one type of bolt (e.g. split sets and mesh, securabолts and fibrecrete, etc.) had a bolt spacing of  $1.2 \times 1.5$  m. The systems using two types of bolt systems tested generally had a bolt spacing of around half that.

Figure 17 demonstrates the consistently better performance of support systems incorporating strong and ductile surface support over those which do not. In the test described in this paper, the same rock bolt was tested on both sides of the test wall, however, the surface support varied. The HEA Mesh was shown to almost double the overall capacity of the ground support system. A finding of previous simulated rockburst testing was that the overall performance of a ground support system in dynamic loading is strongly controlled by:

The chart shows that ground support systems without mesh can be expected to fail at energy demands of around 1.5–2 kJ/m<sup>2</sup> while those with mesh can be expected to fail at energy demands of around 5–8 kJ/m<sup>2</sup>, depending on overall bolt spacing. The exception is the split sets and tunnelguard with cone bolts system. In that case, it was thought that the tighter bolt spacing meant there was better load transfer to the individual rockbolt units, which prevented some of the damage that would have otherwise occurred to the tunnelguard.
