Former Clinton Creek asbestos mine

T.R. Wingrove AECOM Canada Ltd., Canada

Abstract

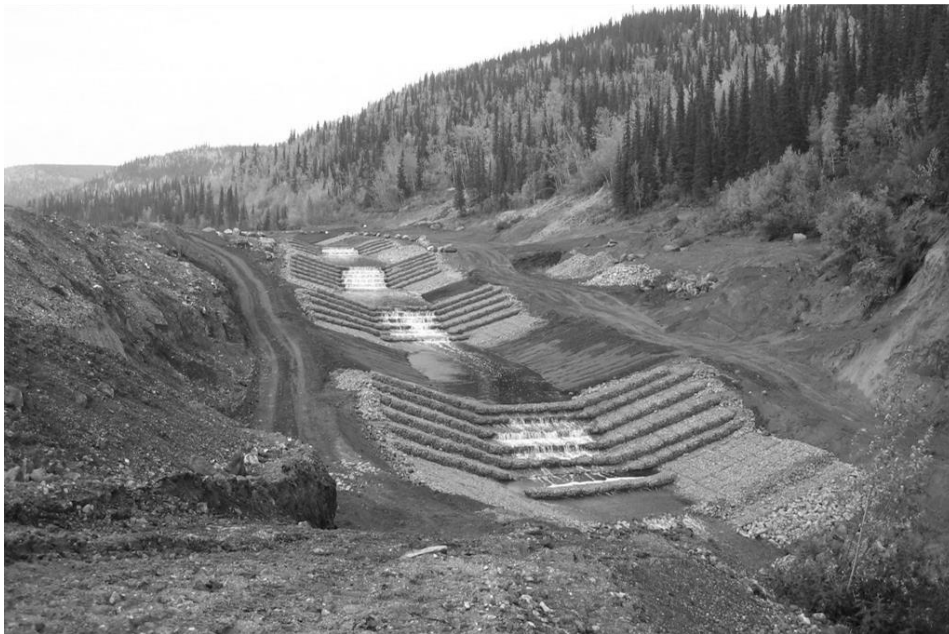
Figure 5 Completed channel stabilisation works (2004)

Gabion drop structures (i.e. grade control structures) were selected over rigid structures (e.g. concrete) because they are flexible enough to allow some deformation while remaining structurally sound and fully functional, an important consideration given the observed creep movements of the waste rock (Figure 5).

Based on evidence of ongoing deterioration of the Clinton Creek Channel downstream of the Hudgeon Lake outlet, the implementation of remedial measures, i.e. creek stabilisation, was considered necessary. Because the waste rock is still undergoing creep movements, and may do so for many more years, the channel stabilisation measures had to be able to accommodate some movements of the waste rock pile and remain functional. This design requirement was met through the use of gabion drop structures that serve as grade control points connecting nearly flat channel sections (UMA, 2003). The waste rock movements are being monitored along with the measurements of the gabion drop structures to determine if the channel stabilisation works are being impacted.

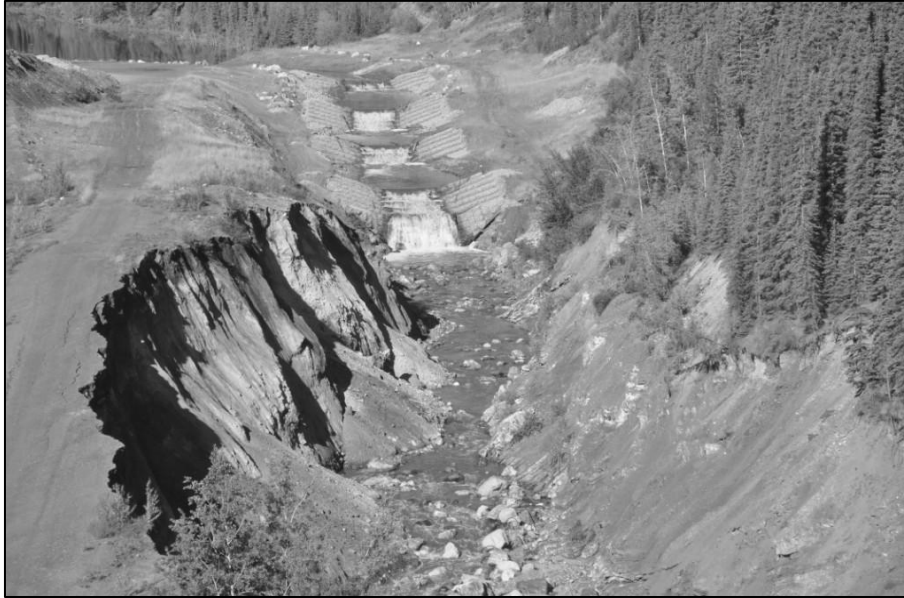
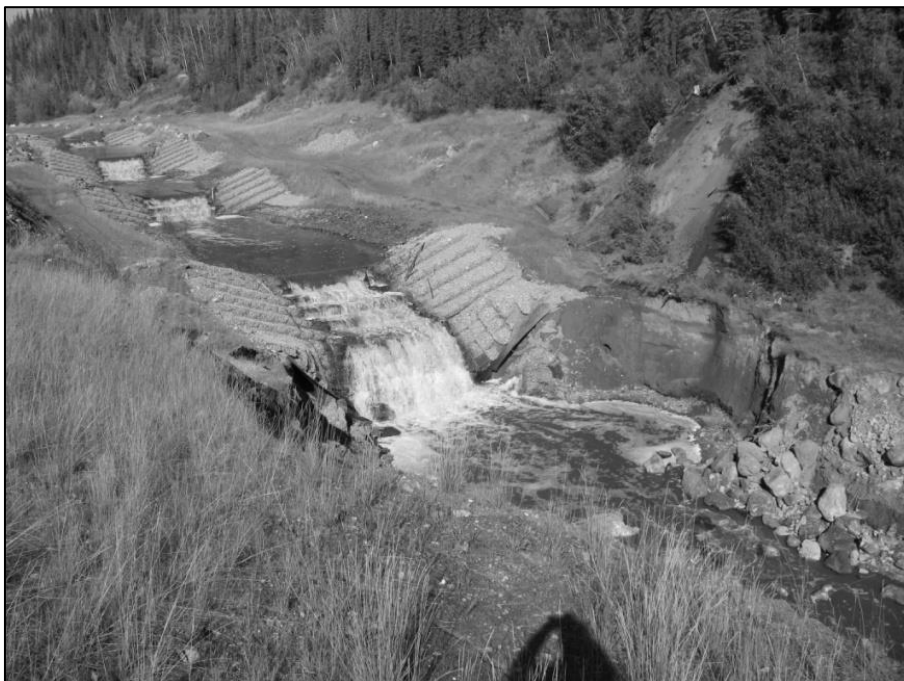
In August of 2010 there was a period of intense rainfall that produced extraordinary flows in Clinton Creek. Extensive erosion and channel downcutting occurred. Drop Structure 4 (DS#4) was partially damaged (Figures 6 and 7) and will be repaired. This event reinforced the effectiveness of the four drop structures in protecting against a breach of the Hudgeon Lake Outlet (AECOM, 2011b).

Figure 6 Clinton Creek Channel d/s of DS#4 on August 23, 2010

Figure 7 Clinton Creek Channel – DS#4 on August 23, 2010

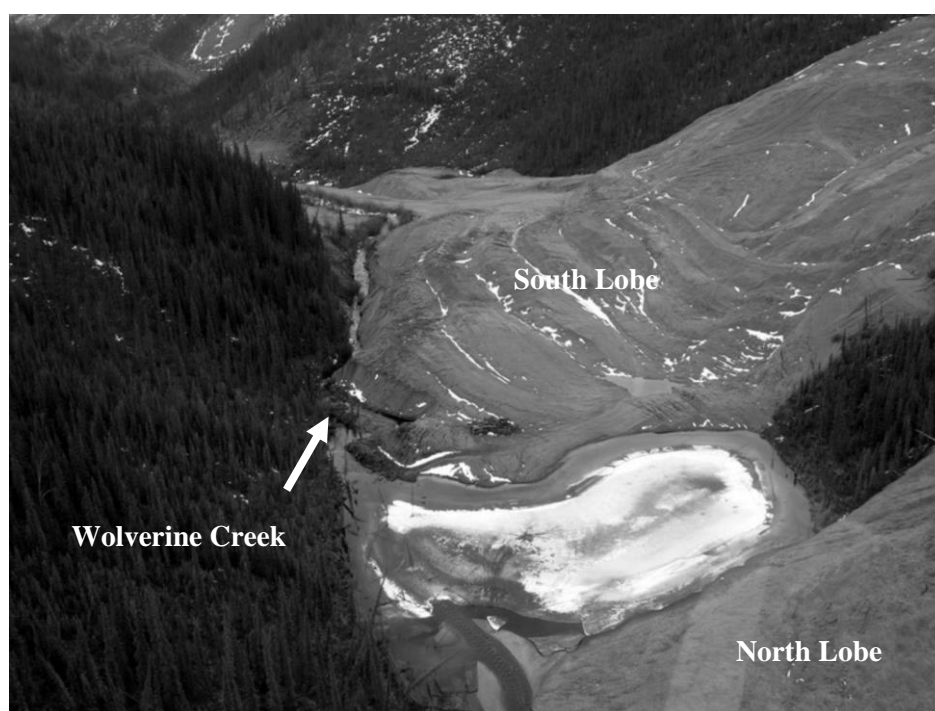
Figure 9 View of Wolverine Creek and lower portion of tailings lobes

The small movement rates on the upper slope area of the South Lobe are not unexpected because the original landslide did not encompass much of this area, which may be due to a decrease in the inclination of the underlying valley slope above elevation 530 m. The flatter valley slope feature is visible on aerial photographs taken before mine site development (UMA, 2003). The mid and lower slopes are most active since these areas are coincident with the main area of the original landslide which occurred in 1974 (UMA, 2003). As the tailings mound up in the valley bottom (i.e. lower slope area), the movement rates in the mid-slope area may continue to decrease as toe support due to mounding increases (Figure 9).

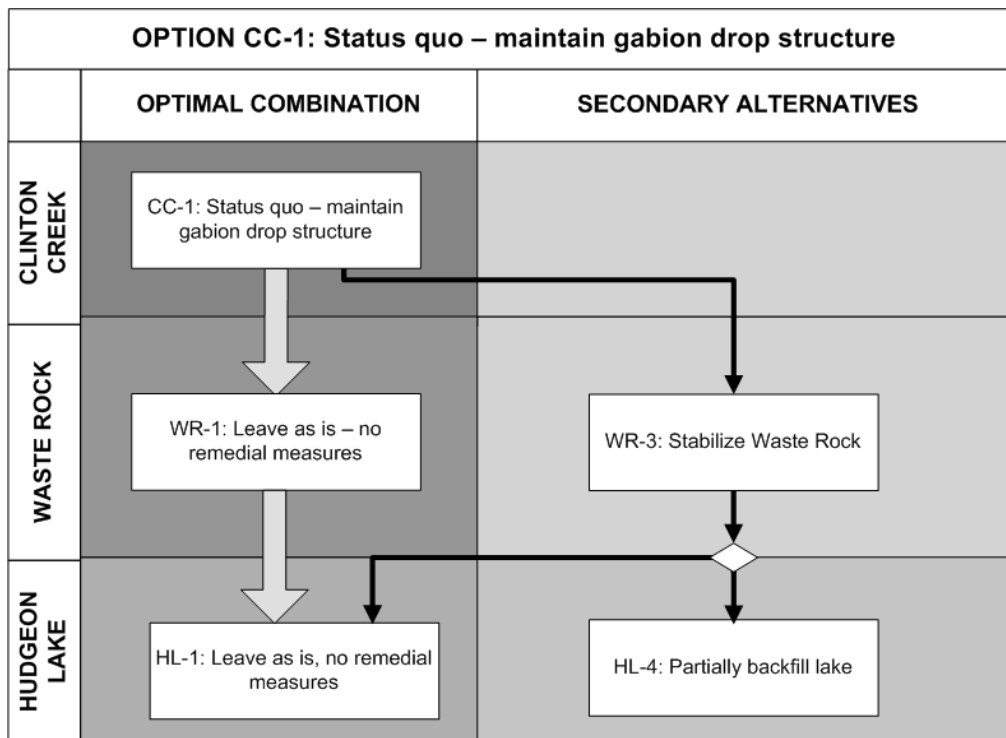
Figure 10 Alternatives for waste rock and Hudgeon Lake that are compatible with Option CC-1

Figure 10 illustrates how the interaction between adjacent features was presented for maintaining the status quo of the gabion drop structures in Clinton Creek.

Hudgeon Lake would be maintained at its current elevation if no other changes are made because the lake level is controlled by Drop Structure #1. The lake level could be lowered by removing individual steps or entire drop structures proceeding downstream from the Hudgeon Lake outlet.
