Leading practice waste dump rehabilitation at the Ginkgo mineral sands mine

Abstract

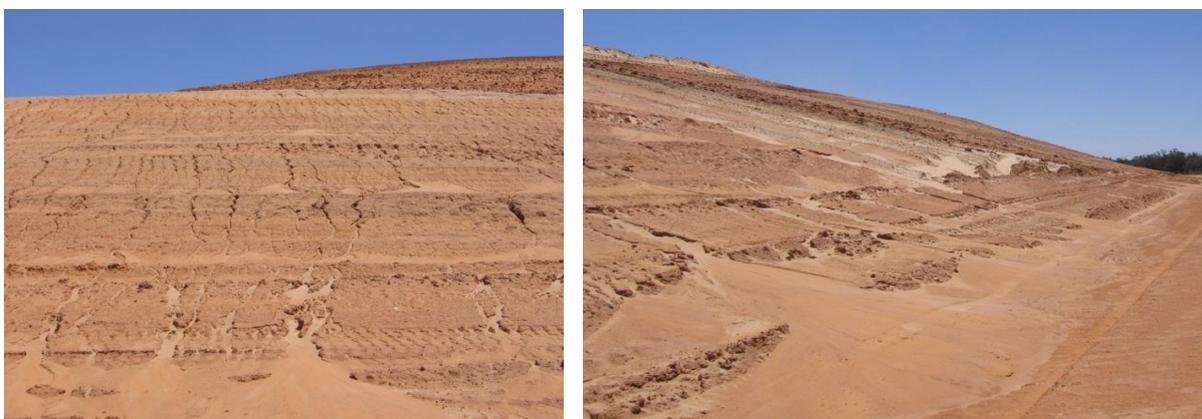
Figure 1 Rilled batter slope on waste dump

Previous landforms at Ginkgo Mine appeared to have had little limitation on height, and were constructed with 20% gradient outer batter slopes. The batters were compacted (which increases runoff) and showed rilling in some areas (Figure 1). A massive gully, on a landform that had no design or batter shaping considered with respect to stability, can be seen in Figure 2. Some batter slopes also showed evidence of tunnel erosion (Figure 3) indicating that care needed to be taken with management of surface water, and with ponding and deep drainage in the profiles that were created.

- In the absence of hard-setting or consolidation, the loamy topsoil (when bare) has low resistance to rill development.
- Once established, eroding batter slope systems (rills, gullies) have little potential to stabilise through time, as the materials have virtually no rock content and no potential to armour. Hence, incision could eventually reach considerable depths in the landforms.

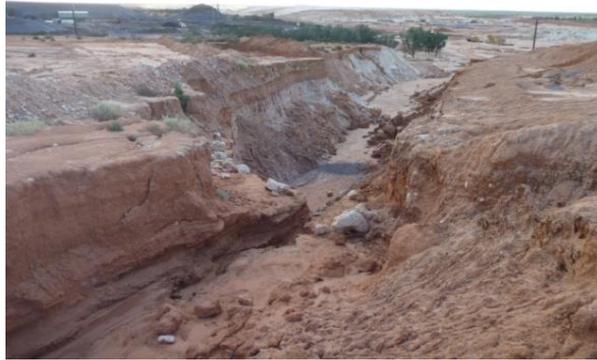
Figure 2 Massive gully erosion in an existing waste dump where no design and batter shaping has taken place

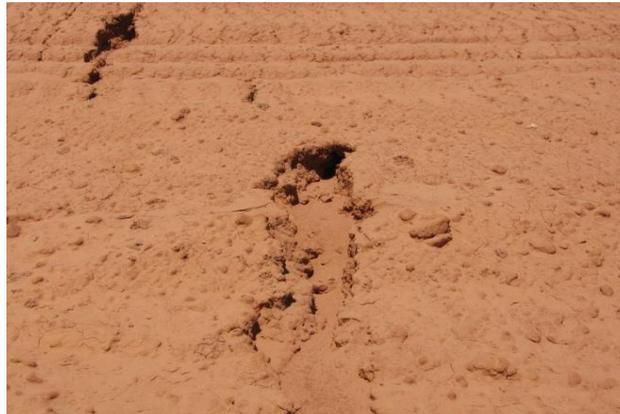
Figure 3 Tunnel erosion on waste dump batter

The sodicity (ESP >6%) of the topsoil suggests that surface sealing under rain and crusting on drying could be expected, and that there may be potential for tunnel erosion if the material is placed in a manner such that site conditions (significant depth and duration of ponding at specific points) favour the development of tunnelling. This is consistent with the observations made on site of tunnel erosion.

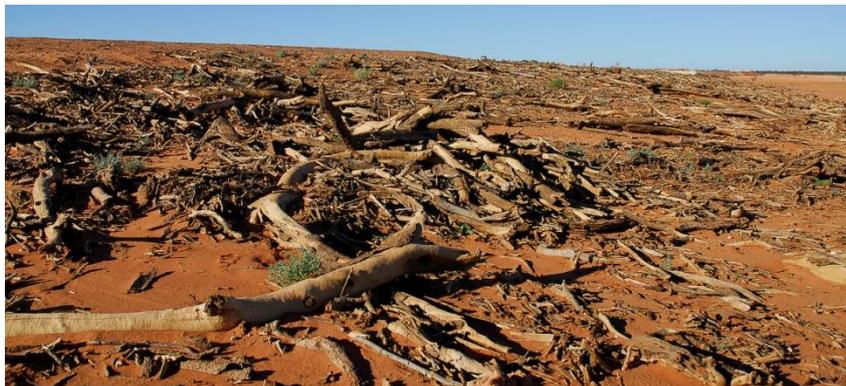
After the base shaping of the overburden dump is completed, subsoil and topsoil are spread in 200 mm deep layers respectively. Timber that was stockpiled from the clearing operations is placed on the batters after topsoiling has been completed (Figure 5). This timber is transported to the site with six wheel dump trucks and spread using a D7 with a stick rake attached to the blade for better spreading of the timber.

Figure 5 Tree debris spread to reduce surface flow, improve vegetation establishment and provide habitat for small vertebrates

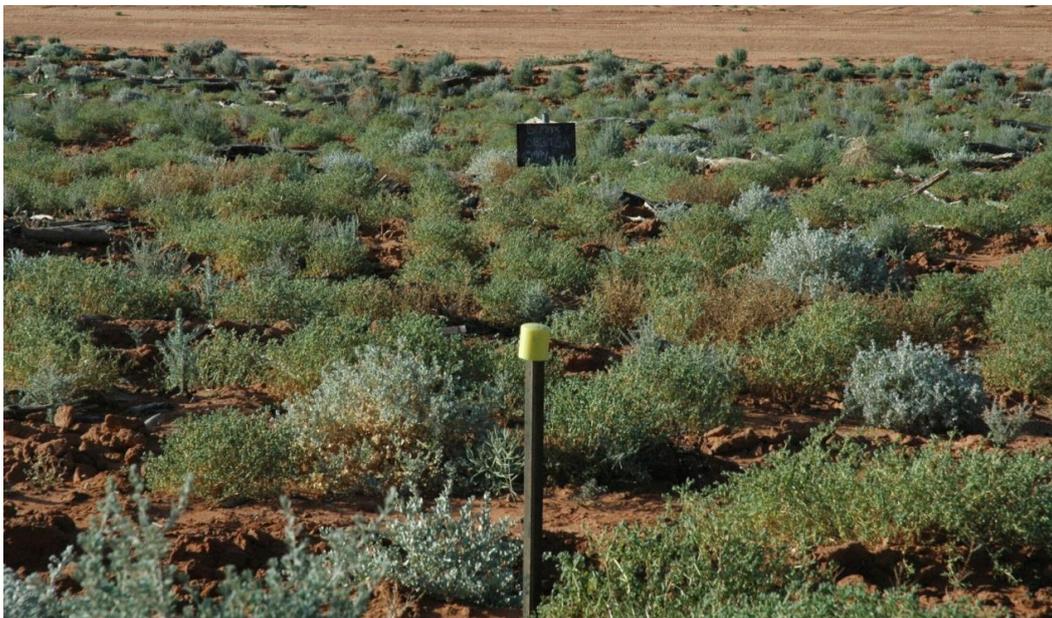
Vegetation monitoring of the batter transects showed they are dominated by one major plant taxon – *Zygophyllum aurantiacum* (Figure 7).

Figure 7 OB3 batter transect May 2010 showing an overwhelming dominance of *Zygophyllum aurantiacum*

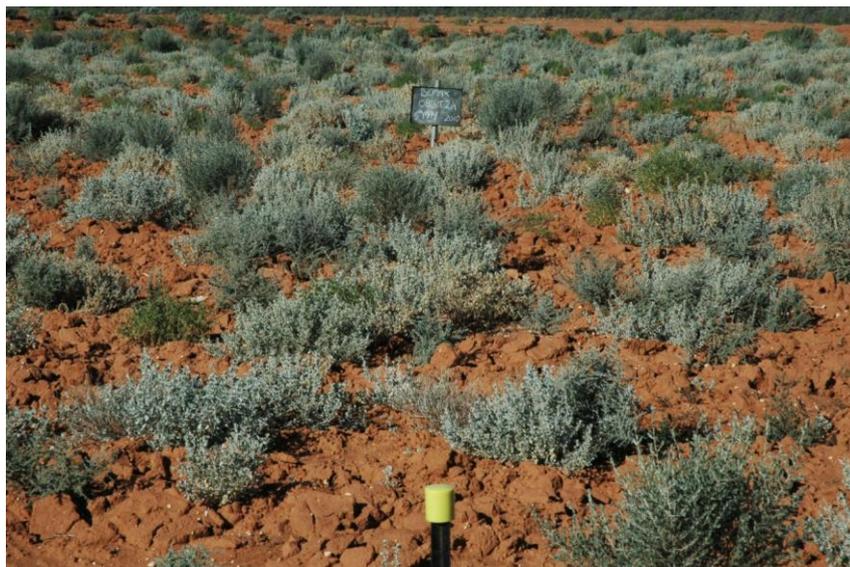
Pad transects are dominated by three plant taxa – *Atriplex vesicaria*, *Maireana pyramidata* and *Zygothymum aurantiacum* (Figure 9).

Figure 9 OB3 pad transect May 2010 showing a dominance of chenopod taxa including *Atriplex vesicaria* and *Maireana pyramidata*

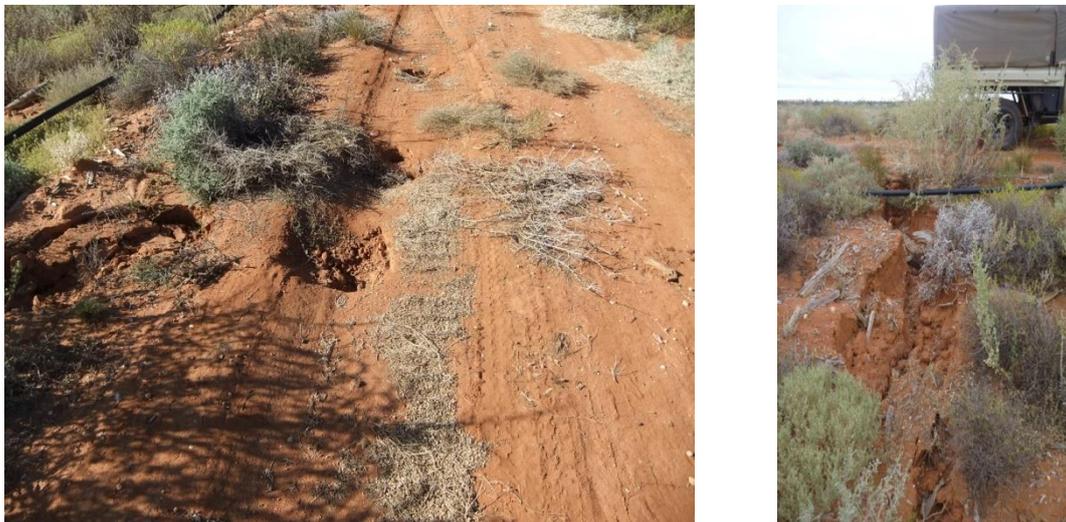
At one location, a track on the perimeter bund of the waste dump concentrated flow and discharged it onto the outer batter rather than back onto the dump top (Figure 11). That location represents the only area of incision on the waste dump batter, and highlights the importance of maintaining perimeter and cross-bunding.

Figure 11 Runoff discharging from perimeter track onto outer batter and causing scour

- Grading the top of bunds inwards to the paddies to prevent any recurrence of flow discharge as shown in Figure 11.
