Shotcrete ribs and cemented rock fill ground control methods for stoping in weak squeezing rock at Wattle Dam Gold Mine

P. Marlow *Ramelius Resources Pty Ltd, Australia*

P.A. Mikula *Mikula Geotechnics Pty Ltd, Australia*

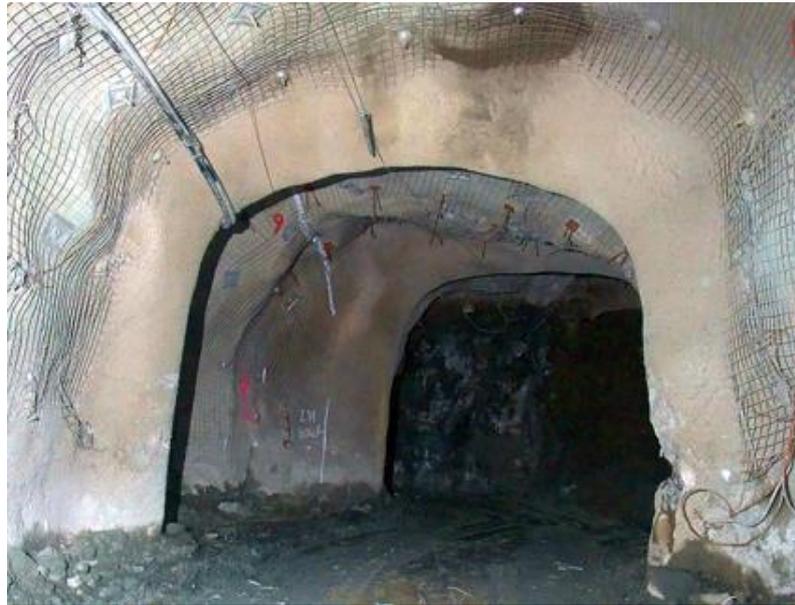
Figure 1 A pair of shotcrete ribs installed for control of wide span backs at Wattle Dam

This paper focuses on the characteristics of the squeezing ground, and the shotcrete ribs (Figure 1) and CRF practices that were used to adequately manage that ground. The mine experienced a wide range of other conditions common to many mines, but these are outside the scope of this paper.

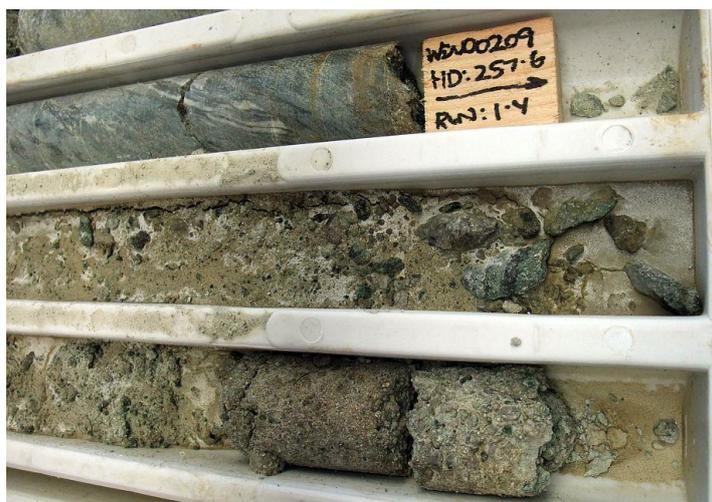
Figure 2 Fragments recovered from borehole WDUD209

Some exploration holes encountered very weak or rubble zones within the ultramafic, i.e. gravel, sand and silty fragments, with no or very few pieces of broken core. In one case (Figure 2) a large amount of fragments was recovered from just a short core interval. This indicated that the material was washed out, or caved into the borehole, leaving a large cavity behind.

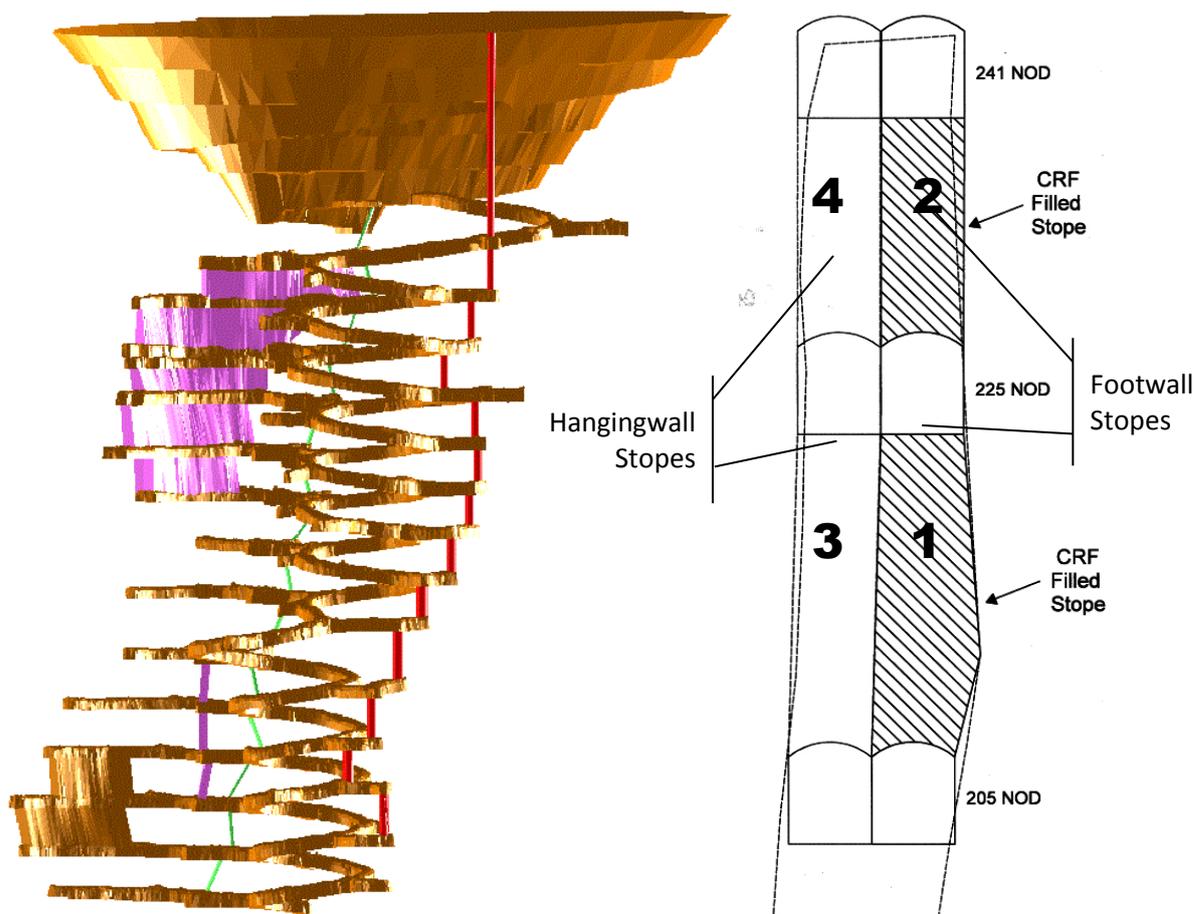
Figure 3 Mine layout showing (left) longitudinal view of an upper block extracted and a lower block in progress, (right) a typical cross-section of stope layout with bold numbers indicating extraction sequence

prior to taking the next stope. Then the second pass hangingwall stopes were recovered from beside, and in some cases beneath, CRF-filled primary stopes (Figure 3). CRF strategy is described in Section 6.

- Stope access was by a footwall drive in the ore, then stoping and CRF backfilling of 6 m strike length primary stopes on retreat (Figure 3). On completion of the footwall slice, a hangingwall slice was taken in a similar manner.

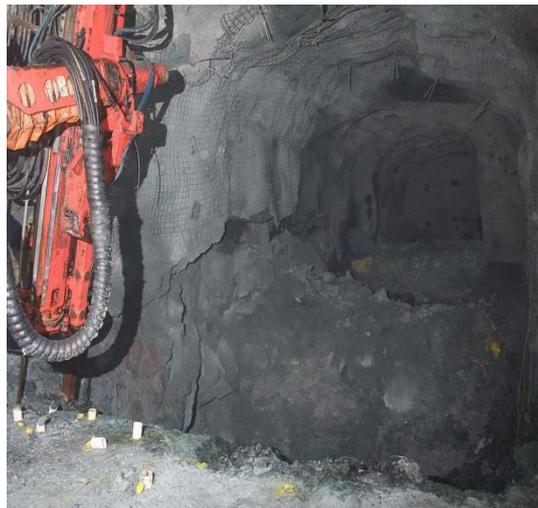
Figure 4 The Panel three stope void on 185 Level seen from above. Drillhole collars seen in the foreground are for the crush firing. The mound in the middle distance is the CRF of the previous stope after being punched up by the previous crush firing

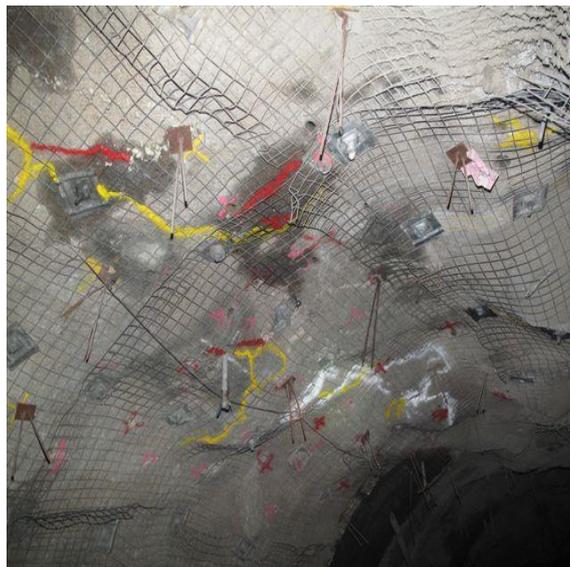
Figure 5 Cracking of fibrecrete in the backs of the Panel nine stope, 185 Level

Backs: Cracking and squeezing occurred in the backs of various ore drives (Figure 5). Essentially a skin of ore, usually 1 m and up to 2 m thick, squeezed and fractured, bulked in volume, and pushed down onto the fibrecrete skin, causing cracks. At the same time, horizontal stresses caused closure, sometimes causing shearing damage in the fibrecrete.

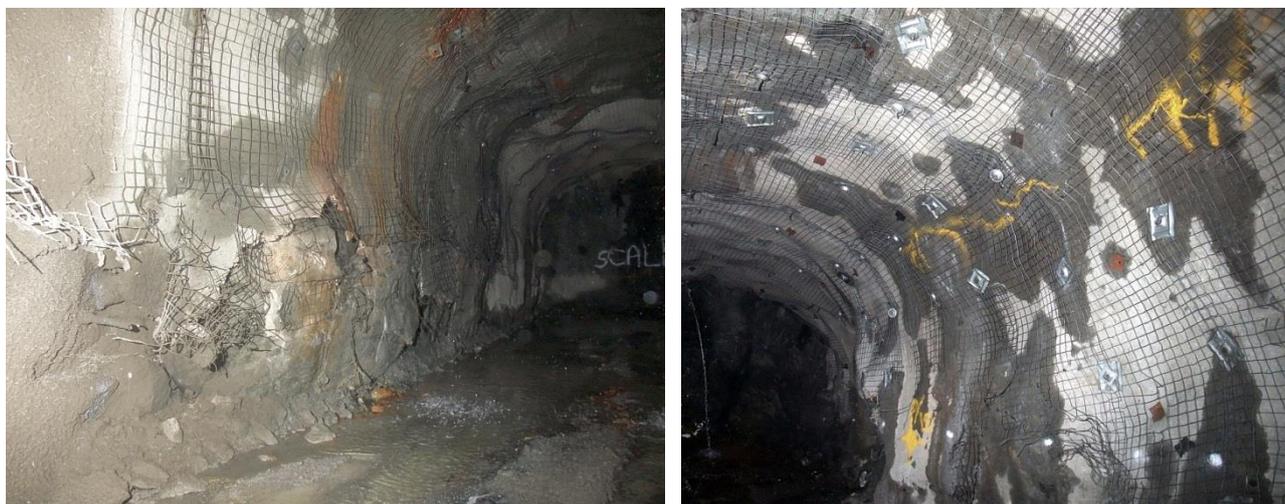
Figure 6 Squeezing in ore in walls at depth: (left) damage on 40 Level west wall, (right) damage exacerbated by water inflow (20 Level)

Walls: Vertical squeezing occurred in walls and pillar noses, fracturing the weak ore lode rock and causing bulking (Figure 6). Fibrecrete initially cracked, then buckled into the drive, and winging (lifting of edges of fibrecrete away from the wall) was common. Damage developed gradually over time. Squeezing was worse where subvertical wall structure focussed stress between the excavation and the structure.

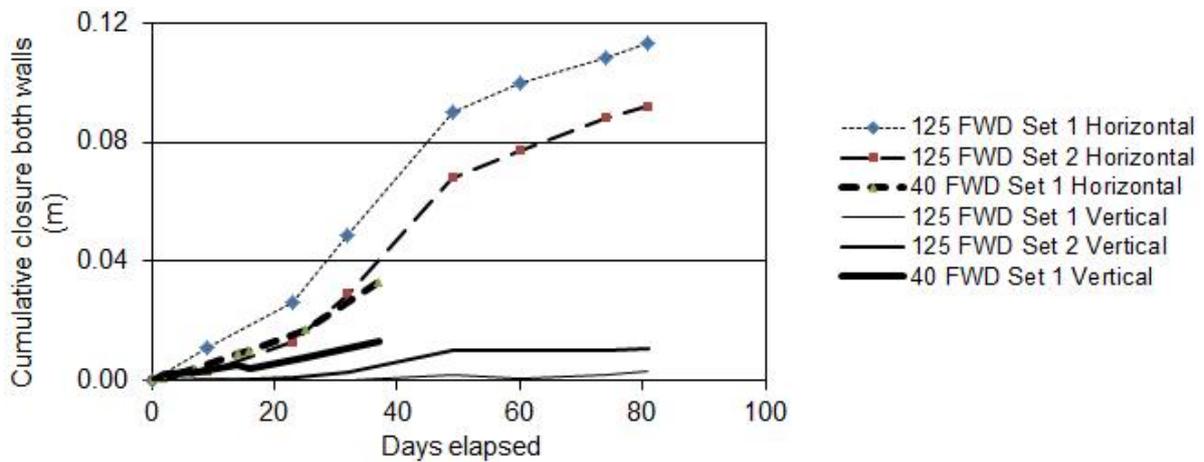
Figure 7 Survey prism data for closures in the 125 and 40 Level footwall ore development drives

On the 125 footwall ore drive, survey prisms (Figure 7) and borehole camera observations were used to enable tracking of wall and back movements during development. The camera results indicated the rock mass was significantly fractured for a distance variably 0.2 to 0.8 m into the wall as soon as it was developed. Further localised damage was seen up to 1.5 m into the wall, and one camera hole was making water from a joint about 5 m into the wall.

In the 40 Level study, the survey prism data indicated horizontal closure of 33 mm (total both walls) and vertical of 13 mm, from the installation of the prisms to the completion of the development stage. The horizontal closure by this time equated to 0.6% of the opening width in each wall. Unfortunately, damage to the prisms prevented this monitoring continuing into the production stage. On 125 Level, wall closures were about the same as on 40 Level during development, but backs closures were less. Maximum measured 125 Level wall closure was 113 mm (total) or nearly 2% of the opening width.

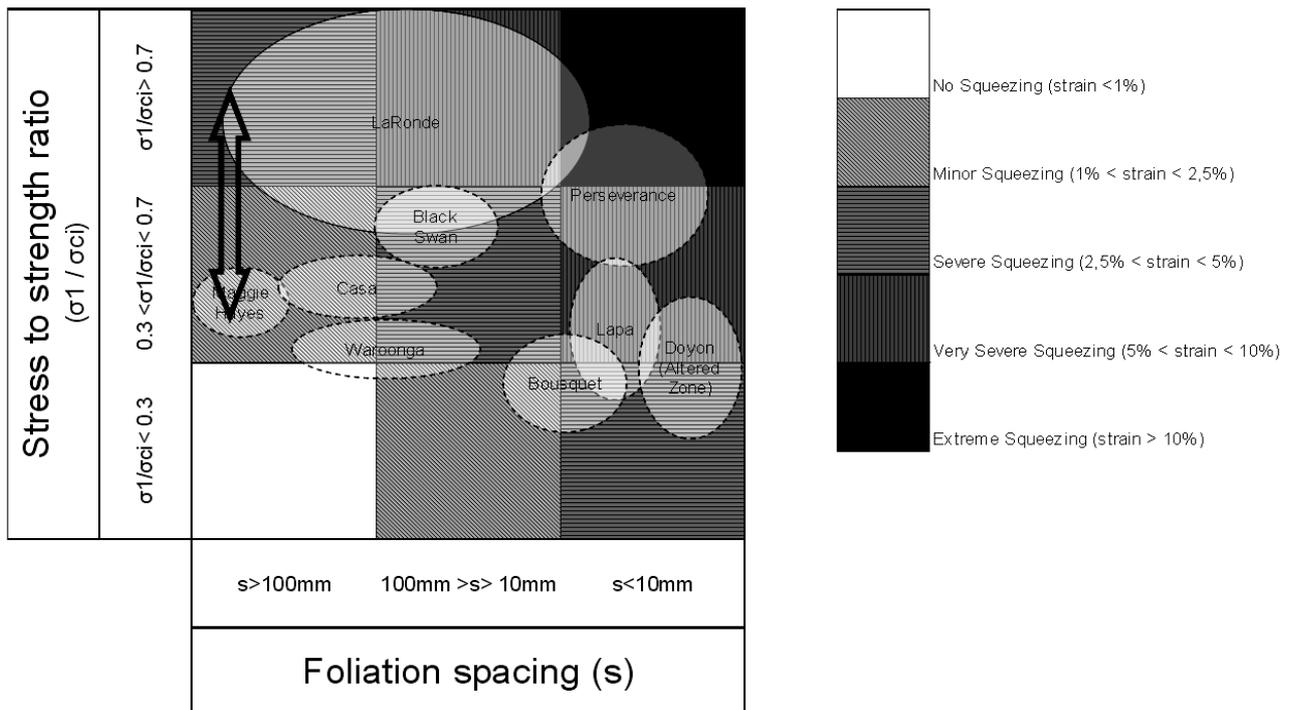
Figure 8 Wattle Dam hangingwall squeezing performance on the Hard Rock Squeezing Index (Mercier-Langevin and Hadjigeorgiou, 2011). The arrow indicates the range of performance at 300 m depth due to the range in strength

Mercier-Langevin and Hadjigeorgiou (2011) presented a 'Hard Rock Squeezing Index' based on stress and foliation data from several mines. The Wattle Dam performance for the walls is indicated (Figure 8) and matches the Index expectations (1 to 5% strain). The ore performance is not shown because ore strength was too low and outside of the Index limits.

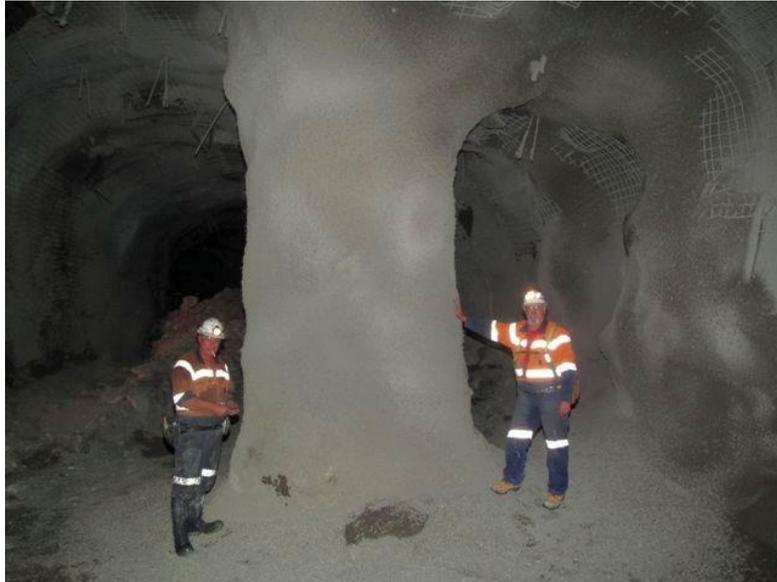
Figure 9 Shotcrete island pillars on the 185 Level

The mine also trialled the use of shotcrete island pillars (Figure 9) for support of squeezing ground in the 185 FWD backs under a particularly wide span (9 m). The pillars were successful, but were not as easy to fabricate as a rib, so were not used going forwards.

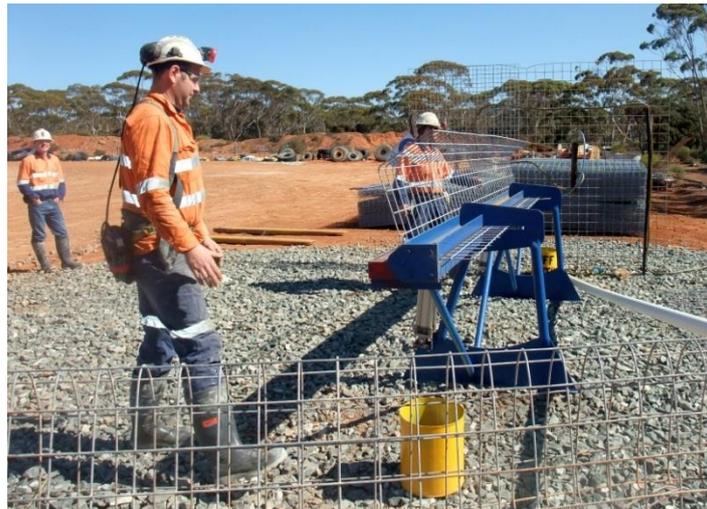
Figure 10 Mesh bending machine

The site enjoyed the use of a mesh bending machine, designed and built in-house by a contractor employee, for the preparation of mesh for the shotcrete ribs (Figure 10). Various profiles could be formed by this machine. The one most used for shotcrete rib mesh was formed from a mesh sheet 4.5 m long by 1.0 m wide. A piece of 300 mm width was bent up along each long edge of the mesh sheet.

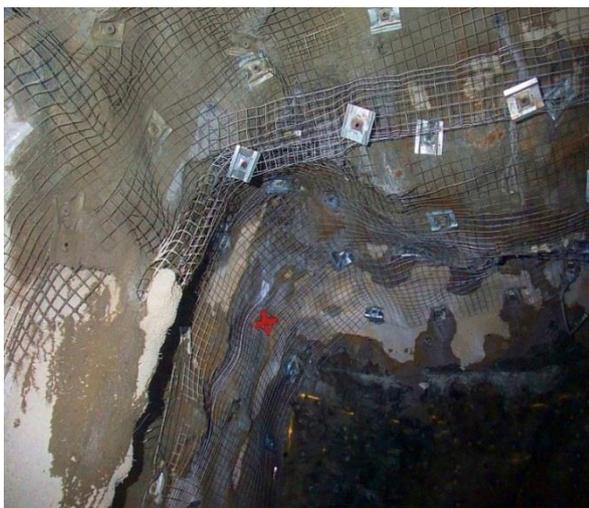
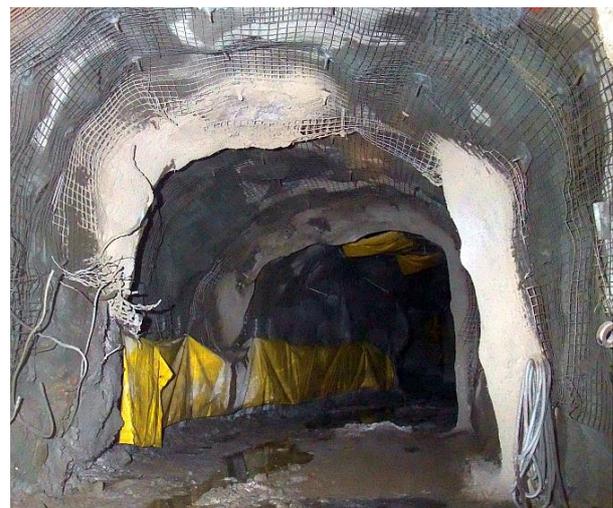
Figure 11 Examples of mesh cage attached to rock, with portions being filled with fibrecrete

The arch or rib was shaped and constructed to withstand compression and reduce the risk of the snap-through failure mechanism operating. The mesh cage was first bolted to the rock, then the cage was filled with shotcrete (Figure 11). For best rib performance, significant steel content was positioned at the free outer edge of the rib, furthest from the rock.

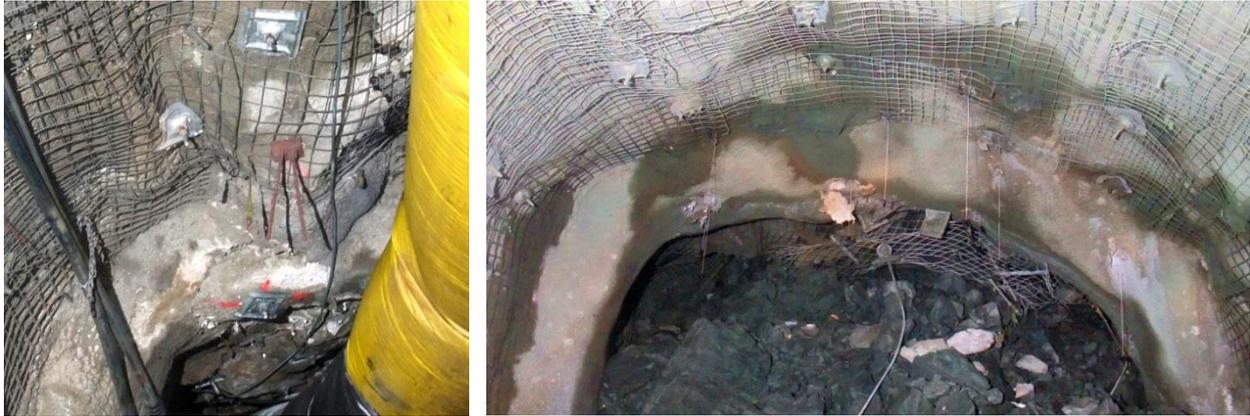
Figure 12 Shotcrete ribs (left) for control in squeezing ground, with significant deformation prior to the rib being installed, and (right) installed for support of a stope brow

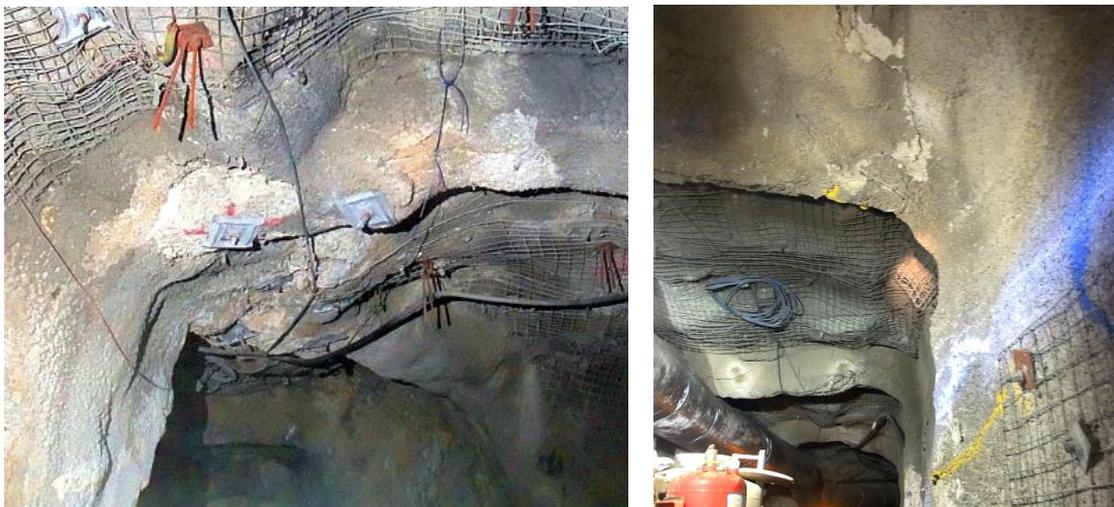
Figure 13 (left) surface spalling, and (right) hinge failure developing in a rib

- Spalling, or cracking parallel to the surface of the rib (Figure 13). Thin plates of fibrecrete outside the mesh cage separated off. Spalling damage was managed by periodic check-scaling of the ribs.
- Cracking across the thickness of the rib to form a hinge (Figure 13). This occurred due to lateral loading (perpendicular to the rib axis).
- Shearing damage (Figure 14) due to high axial compressive loading in the rib due to closure of the ground. Rarely, a rib had to be re-secured with bolting. Ribs nearly always survived for the life of stoping on a level. In general the ribs brought equilibrium to the bulking in the backs.
- Blast damage (blastholes too close to the ribs) causing enough lateral loading to buckle the ribs.

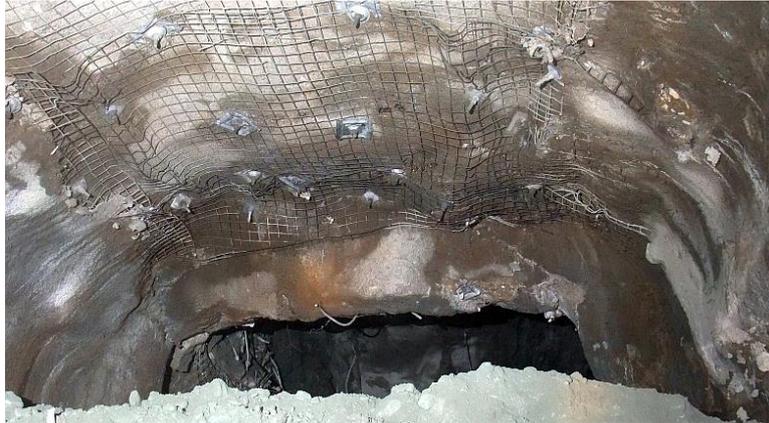
Figure 14 Shearing failure in a rib

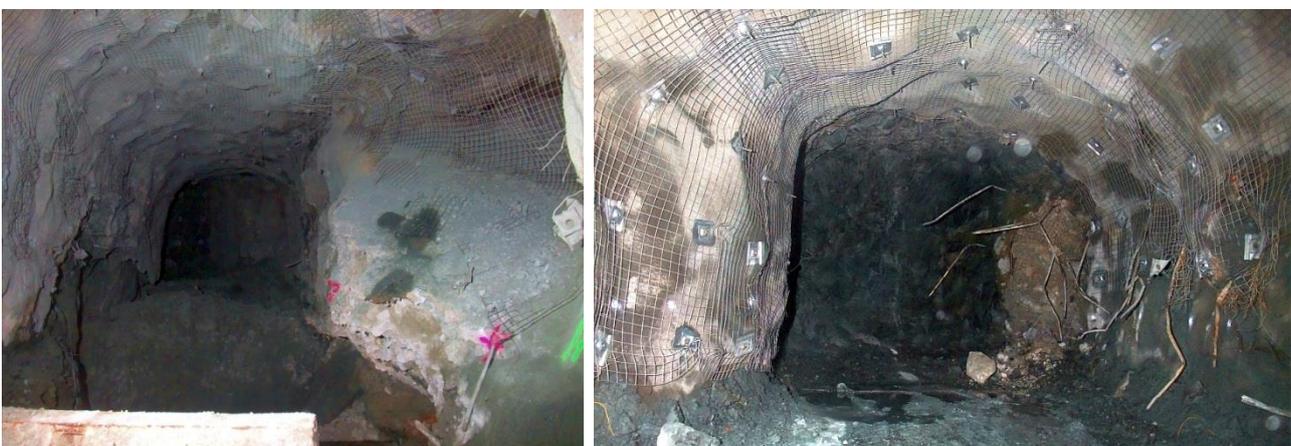
Figure 15 CRF examples: (left) CRF forming a stope wall, (right) development of a HW drive (centre) alongside a CRF-filled FW drive (right)

CRF suited Wattle Dam with its small stopes and placements where quality control was more easily managed, and segregation could be avoided (Figure 15).

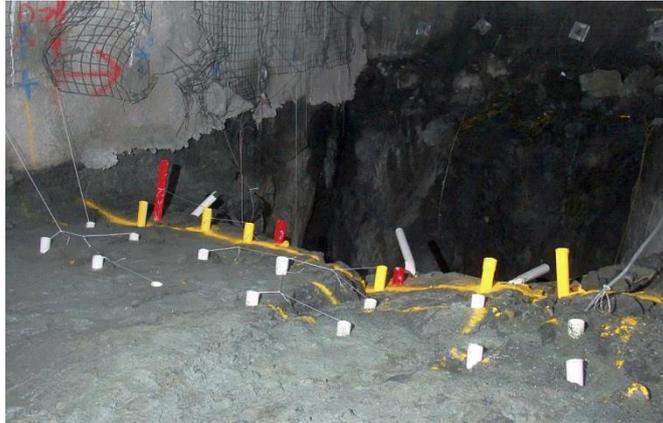
Figure 16 Crush firing blasthole pattern indicated by collars. Weights on cords are suspended in the holes for visual check of hole toes on the level below

Crush firings had a comparatively higher powder factor, and this energy could damage the adjacent brow. Sometimes this meant propagation of overbreak into the brow. In comparison, production firings had less energy and tended not to cause brow damage. The positions of ends of blastholes were checked (weights on strings were observed) and excessively deviated holes were redrilled.
