# Guidelines for the design and construction of underground portals in open pits – a case study of the Gateway Mine

J.H. Graaf *Golder Associates Pty Ltd, Australia*

T. Parrott *Consolidated Minerals, Australia*

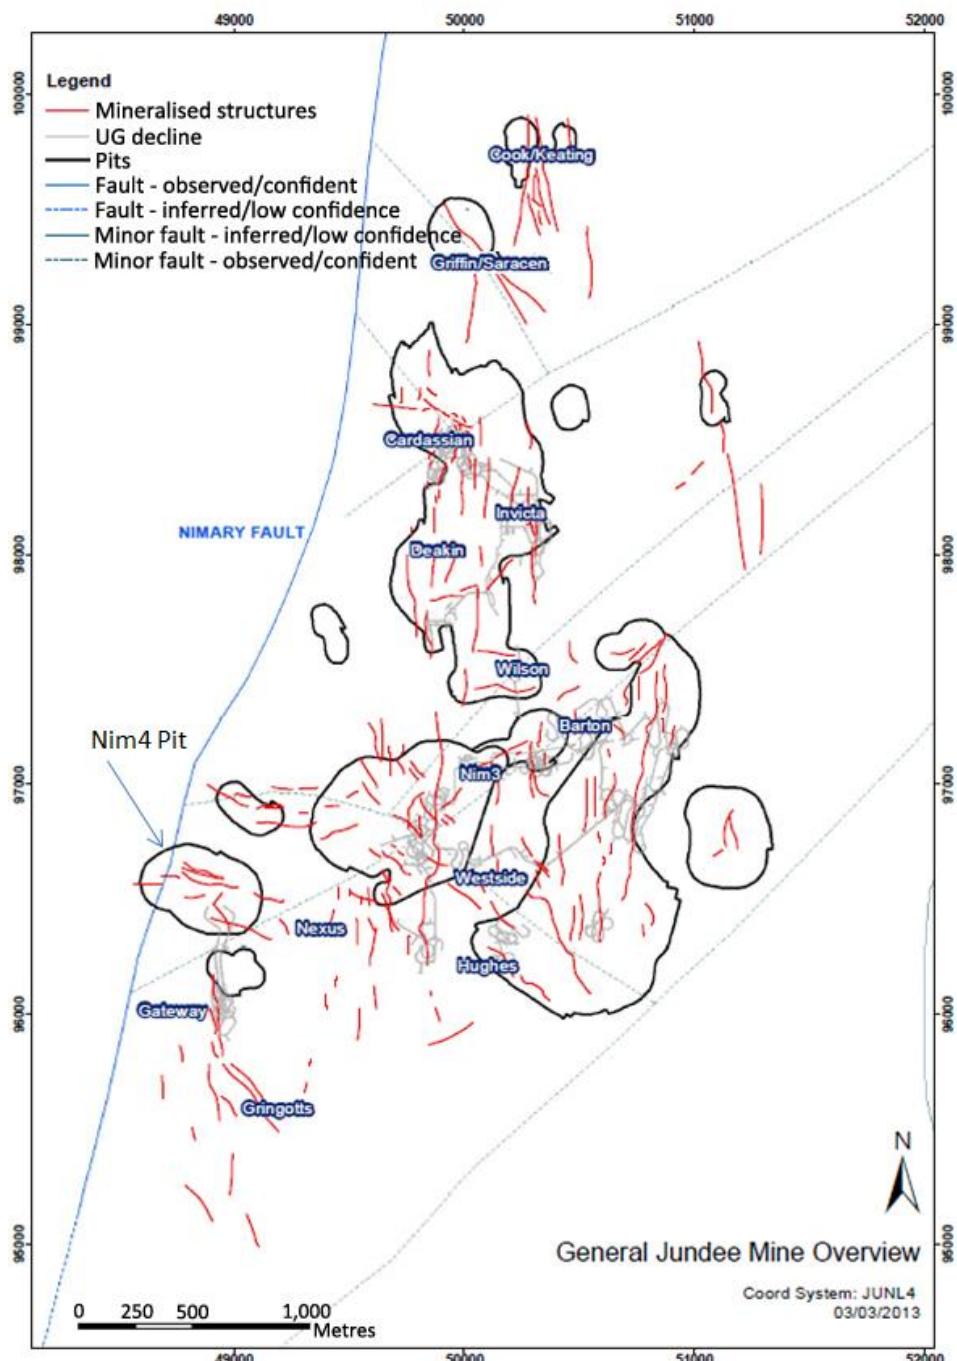
**Figure 1 General overview of Jundee showing some of the open pits and the underground mine locations**

Open pit mining started in mid 1995 and over 20 pits were mined until open pit mining ceased in 2008. There are three separate operational underground mines: Barton, Invicta and Gateway (Figure 1). Underground development of the Barton mine commenced in August 1997, Invicta in 2004 and most recently the Gateway underground mine development started in early 2011.

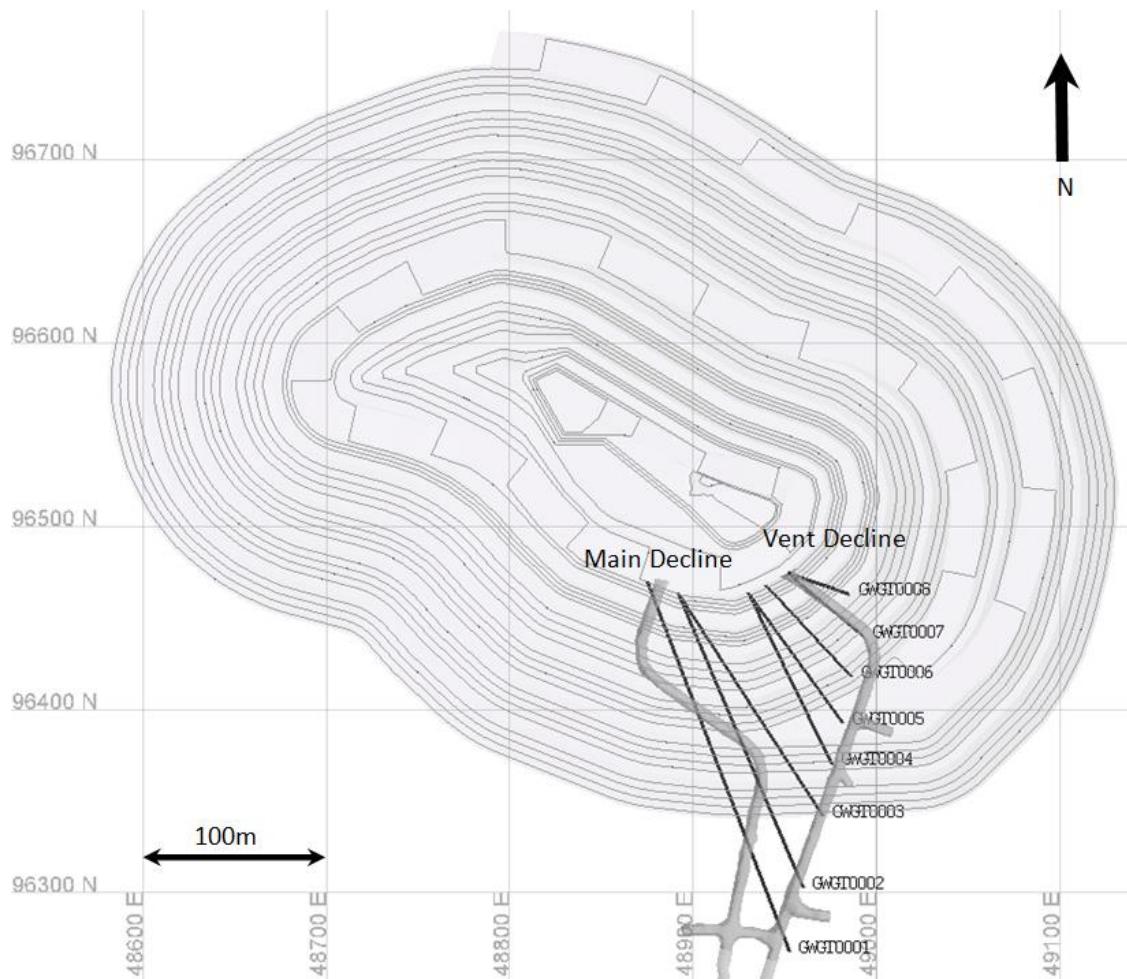
**Figure 2 Plan view of the Nim 4 Pit and the Gateway Declines**

Limited space was available in Nim4 to maintain adequate separation between the two portals to avoid air recirculating. Additional limitations included the pit geometry, ability for both heavy and light vehicles to enter and exit the portal safely, and the need to keep the openings above the 1:100 year flood line due to the presence of a pit lake. Both declines were 6 m high by 5.8 m wide with the main decline in the eastern wall of the pit, and the ventilation portal into the southern wall of the pit (see Figure 2 for portal locations).

Whilst there was substantial geotechnical information collected during resource definition and exploration drilling, this information was located nearly 300 m from the portal entrances. To define the ground conditions in the vicinity of the two portals, an underground diamond drilling rig already active on site was used to drill eight diamond drill holes along the first 200 m of decline development. The locations of these drill holes are shown previously in Figure 2.

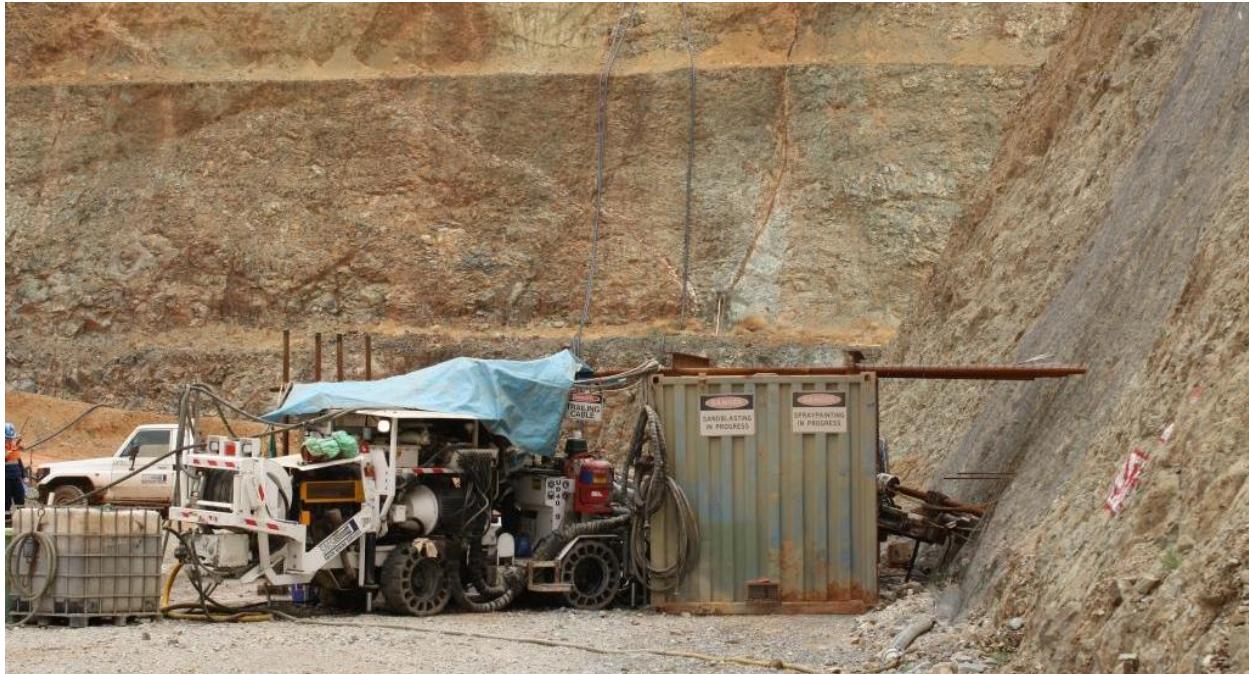
**Figure 3 Set-up of an underground diamond drill rig within an old open pit**

The open pit had already been assessed for stability, however, drilling into the face of an existing batter was a new experience for the underground diamond drillers. To provide a safe working environment for the drillers, the drill rig was set up within a modified sea-container. Old drill rods were placed on top of the sea container and underground weld mesh was placed over the top for rockfall protection. Drilling was restricted to dayshift only due to lighting issues. An example of the drilling set-up in the pit is shown in Figure 3.

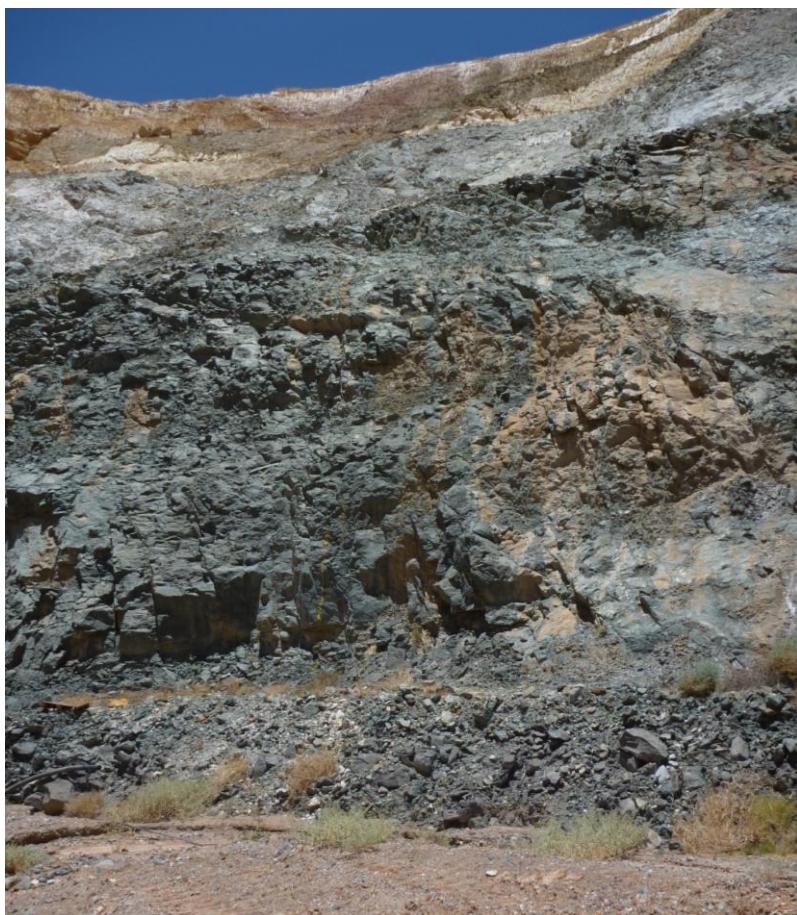
**Figure 4 View of the ventilation portal site on the east wall of Nim4 Pit**

The ventilation portal was located in the deepest part of the pit and would be cut into slightly weathered to fresh basalt of moderate to high strength (Figure 4). There were few structures and no significant faults or large-scale structures in the vicinity and the bench height was at least 20 m allowing for sufficient crown pillar above the portal. Any instability in this portal was expected to result from blocky wedge or planar type failure.

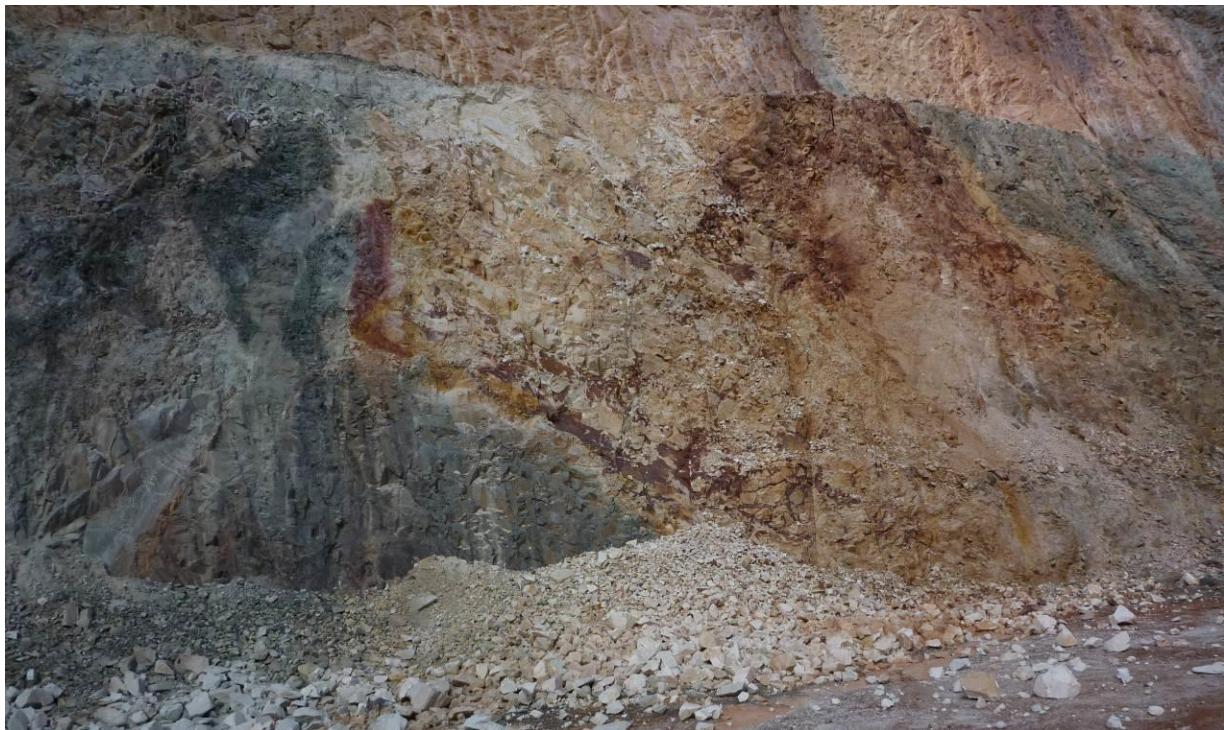
Figure 5 View of the southern wall of the pit looking at the location for the main decline portal

Analysis from drill core and mapping observations showed this portal will be constructed in highly weathered felsic porphyry and basalt clays for approximately the first 30 m of development after which it would be fresh, hard basalt (Figure 5). Significant core loss was observed in the initial 25 m of coring due to poor ground conditions and 9.3 m of core loss in the first 16 m of one hole was observed (Figure 6). Given the weak nature of this material, any failure of the bench in which this portal was expected to be developed was likely to be circular in nature. Slide™ was used to evaluate the safety factor and probability of failure for circular failure surfaces in the pit wall.

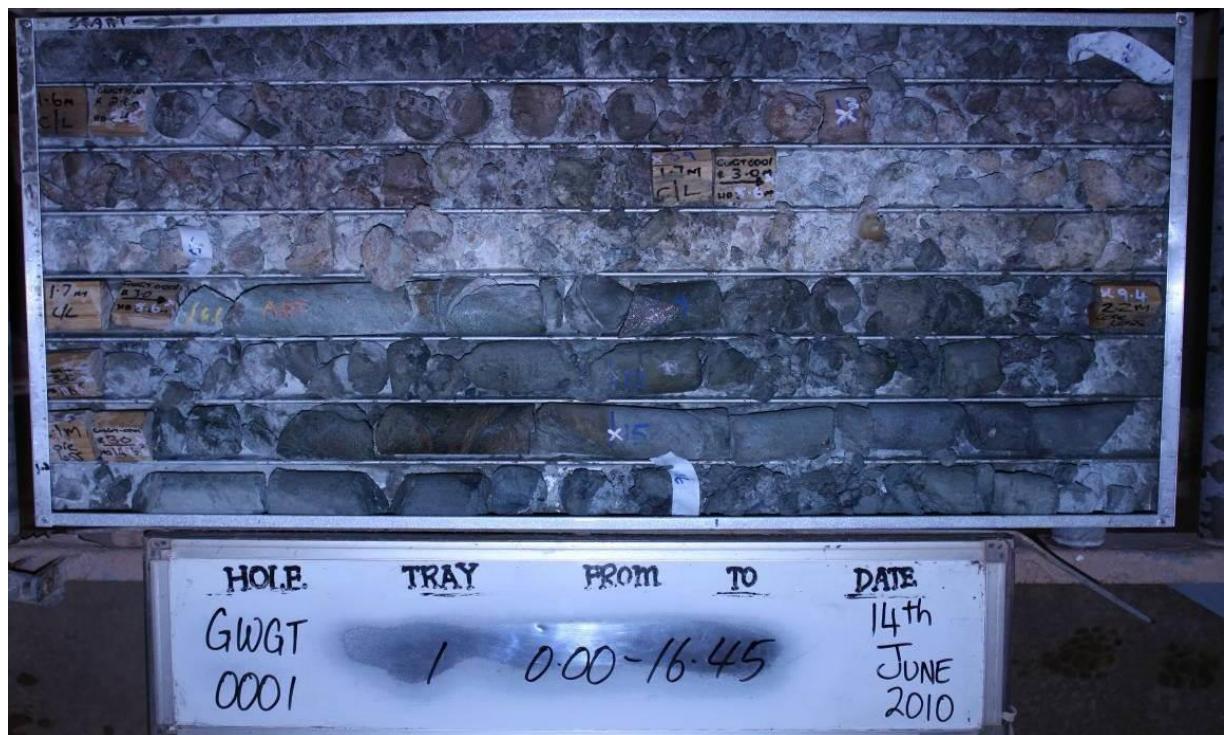
Figure 6 Tray 1 from GWGToo1 showing extremely poor ground conditions encountered in the drill hole and significant core loss

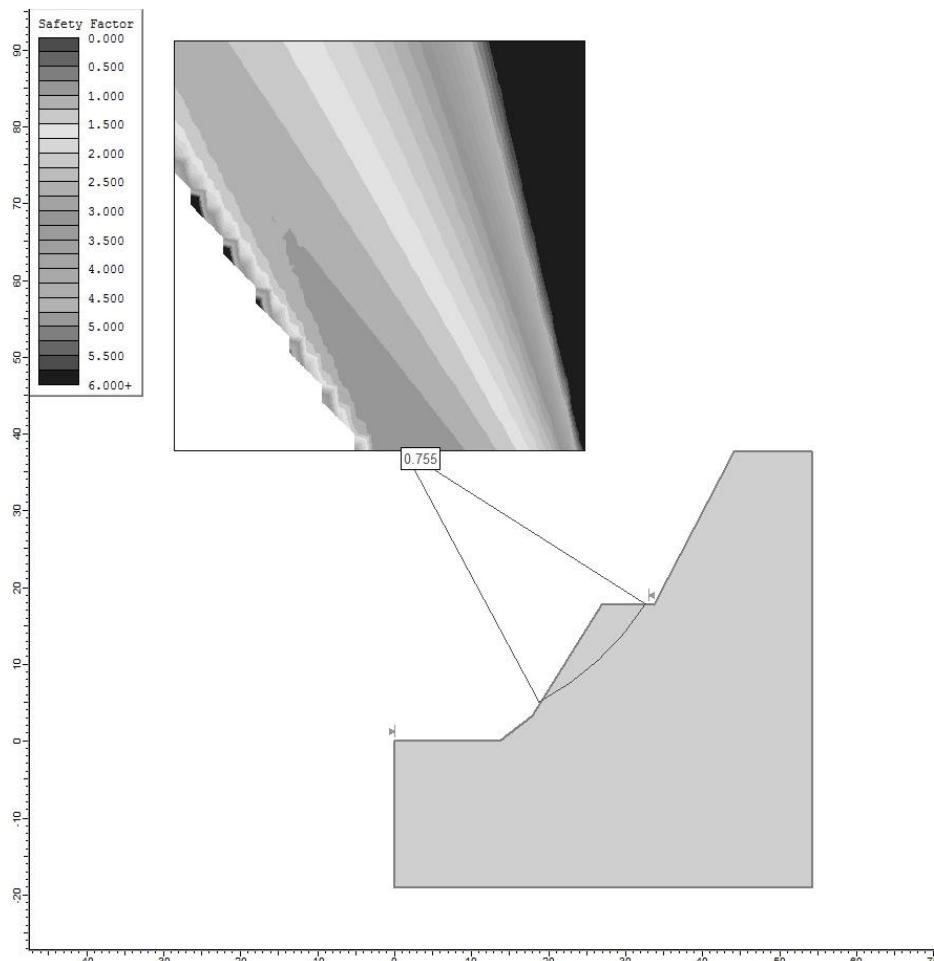
**Figure 7** Slide analysis showing the FoS for the worst possible failure condition in the batter of the main decline portal

Slide analyses estimated that the FoS of the worst possible bench-scale instability that could occur in the pit wall had a depth of failure of 6.4 m and a FoS of 0.75. Prudent mine design for permanent infrastructure require a minimum FoS of 2.0, therefore significant ground support and reinforcement requirements were required for this portal to prevent a potential instability from occurring. As with the ventilation portal, one of the geotechnical cover drill holes had water flowing from it.

Limit equilibrium analysis using Slide indicated that the total driving force of a potential circular failure was 520 kN per metre slice. To achieve a FoS of 2 for the slope, then a driving force of 1,040 kN was required to be supported to make the portal location stable for the long term.

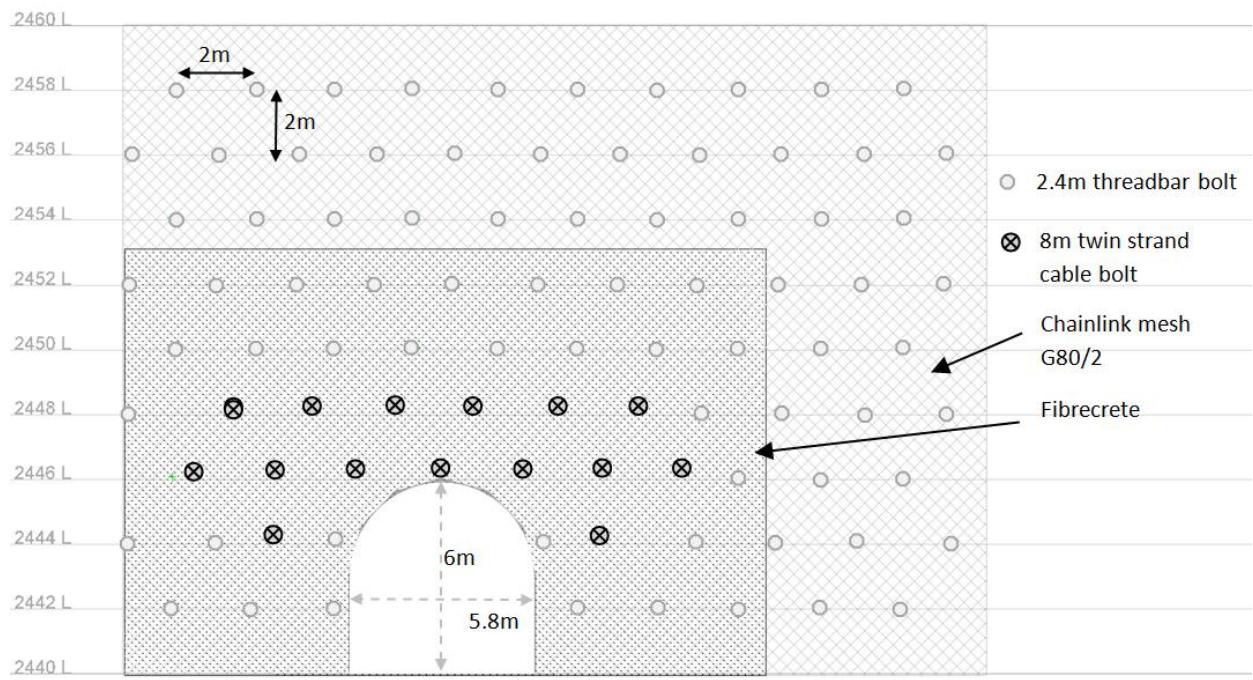
**Figure 8** Perspective view of the ventilation portal showing the ground support design

The results from the kinematic analysis showed that all potential wedge failures could be adequately supported with a  $2.0 \times 2.0$  m staggered pattern of 2.4 m (20 mm) grouted threadbar. In addition to this, a number of pre-tensioned, twin strand 500 kN bulbed and inclined cable bolts were planned immediately above the portal excavation in order to provide deeper stabilisation and active surface pressure to the face (Figure 8).

- 8.0 m long bulbed twin strand cable bolts installed sub-horizontally (5° incline) on a staggered 2.0 × 2.0 m pattern immediately around the portal perimeter, pretensioned to 5 t per strand.
- 2.4 m long 20 mm grouted and plated threadbar installed on a staggered 2.0 × 2.0 m pattern.
- Chainlink mesh G80/2 draped over the face, spaced off the rock face to insure embedment in the middle of fibrecrete.
- 50 mm of 32 MPa fibrecrete (40 kg/m<sup>3</sup> steel fibres) sprayed to approximately one diameter of the excavation around the perimeter of the portal.
- All ground support and reinforcement elements are galvanised.

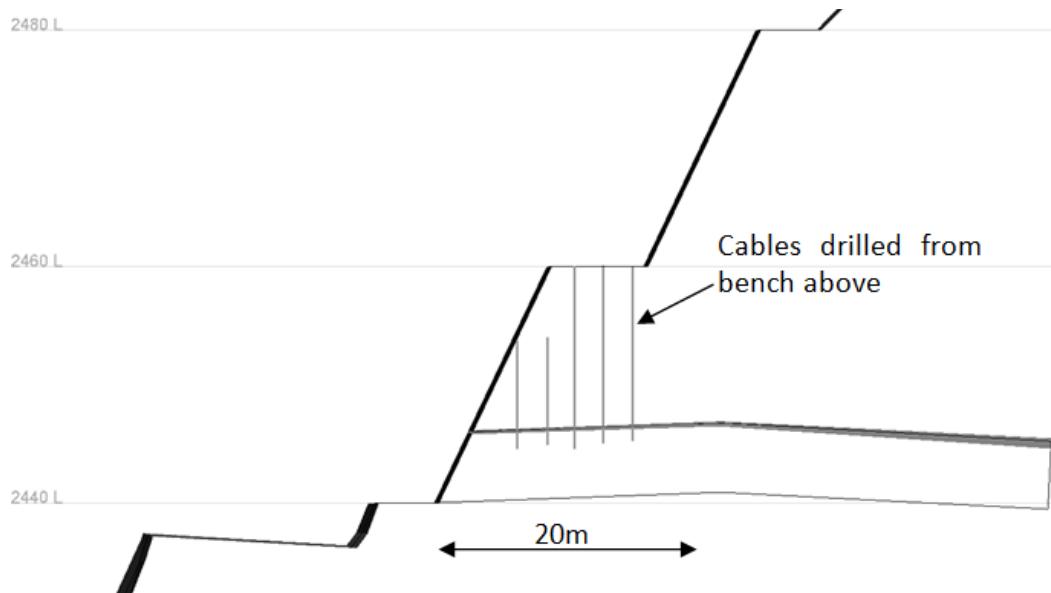
**Figure 9** Section view of the decline showing the cables drilled from the bench above

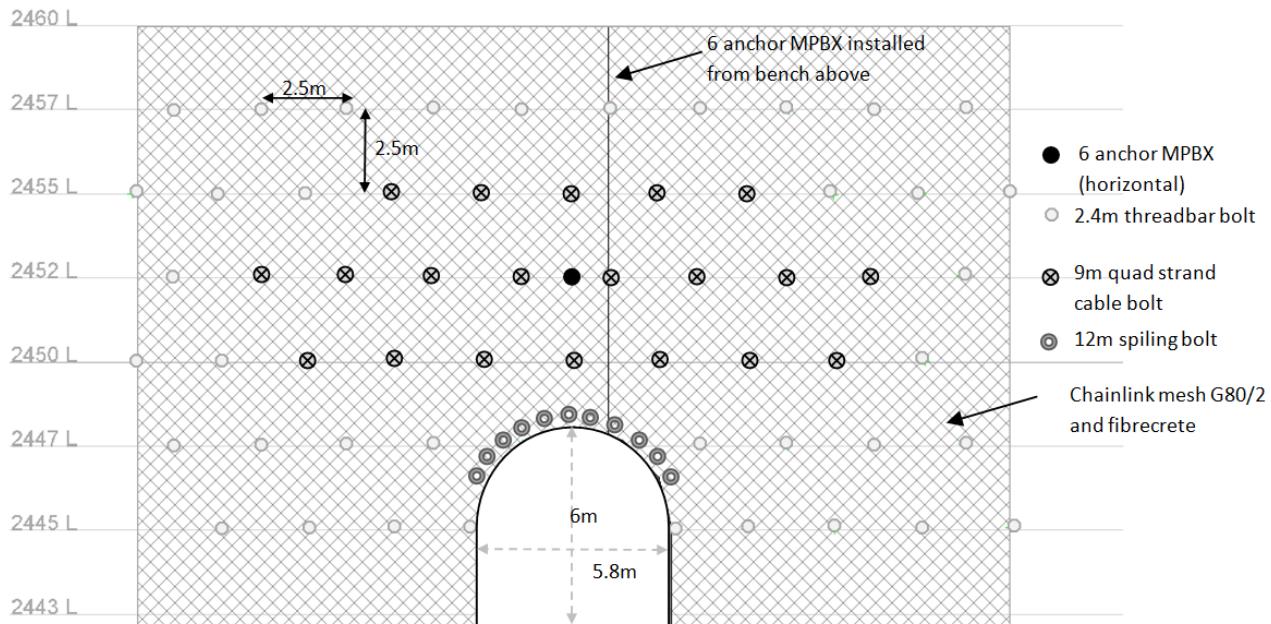
**Figure 10 Ground support for main decline**

Spiling (forepoling) bars (32 mm threadbar) were designed and installed around the perimeter of the arch of the decline profile to provide secondary support. These were on a 0.5 m spacing covering the full arch section of the excavation design and were 12 m long. The spiling bars were installed to pre-reinforce the ground prior to development by providing an umbrella of reinforcement. This resulted in improved productivity in the expected difficult development conditions and reduced the risk of backs unravelling (see Figure 10 for general ground support configuration).

- 9 m quad-strand bulbed cable bolts installed into a 102 mm diameter hole, plated and pre-tensioned to 10 t with 4 m of embedment, installed sub-horizontally on a  $2.5 \times 2.5$  m staggered pattern.

- 2.4 m long (20 mm) grouted threadbar installed on a  $2.5 \times 2.5$  m staggered pattern.
- 11.8 m long (32 mm) grouted horizontal spiling bars installed 0.5 m from the perimeter of the portal at a spacing of 0.5 m.

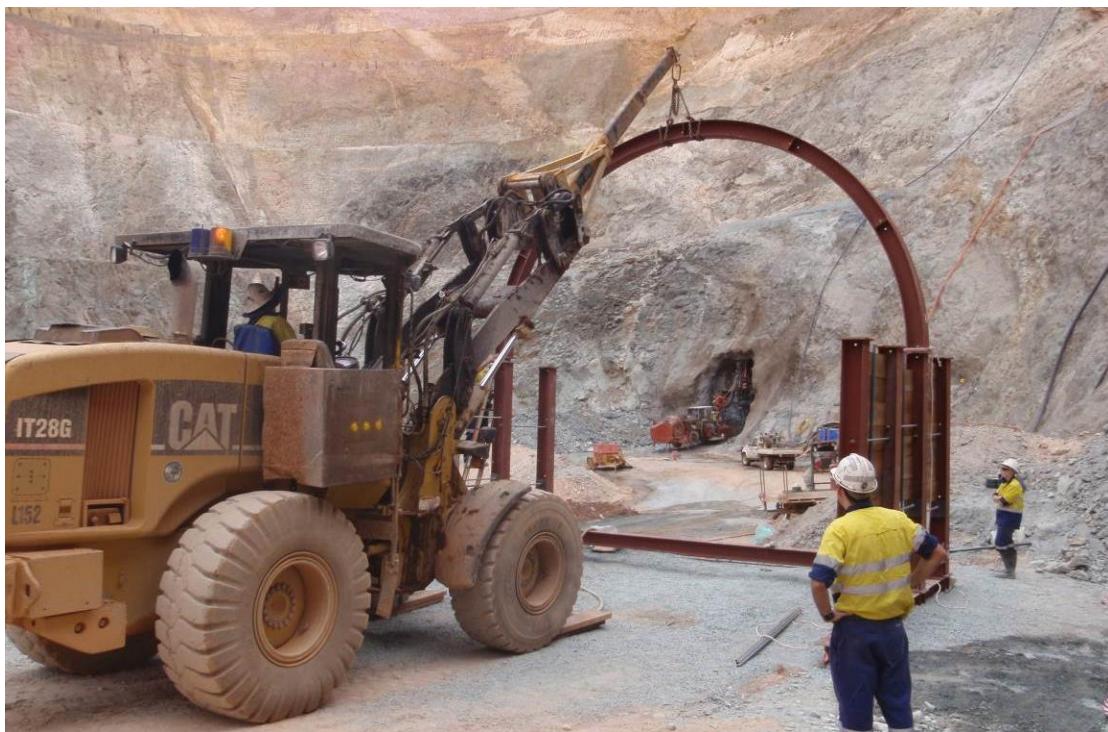
Figure 11 Pre-assembly of the steel arch sets outside the portal

Development was initially restricted to dayshift only, to allow for greater supervision and limit the activities to one crew only. Steel arches were manufactured in such a way to allow for pre-assembly outside the portal on steel skids, five arches at a time. The arches were then advanced (pushed in) with each development round and acted as a canopy in addition to the temporary support regime (Figure 11). The arch design allowed flexibility so that if ground conditions deteriorated at the face, the arches could be set in place and switched over to standing arches in cycle. This, however, never eventuated. Once the portal reached better ground and arches were no longer required, the steel arches were lagged with inflatable grout packs or timber (timber was used when the distance between the arch and the excavation surface
