Pit slopes in weathered and weak rocks

C.D. Martin *University of Alberta, Canada*

P.F. Stacey *Stacey Mining Geotechnical Ltd., Canada*

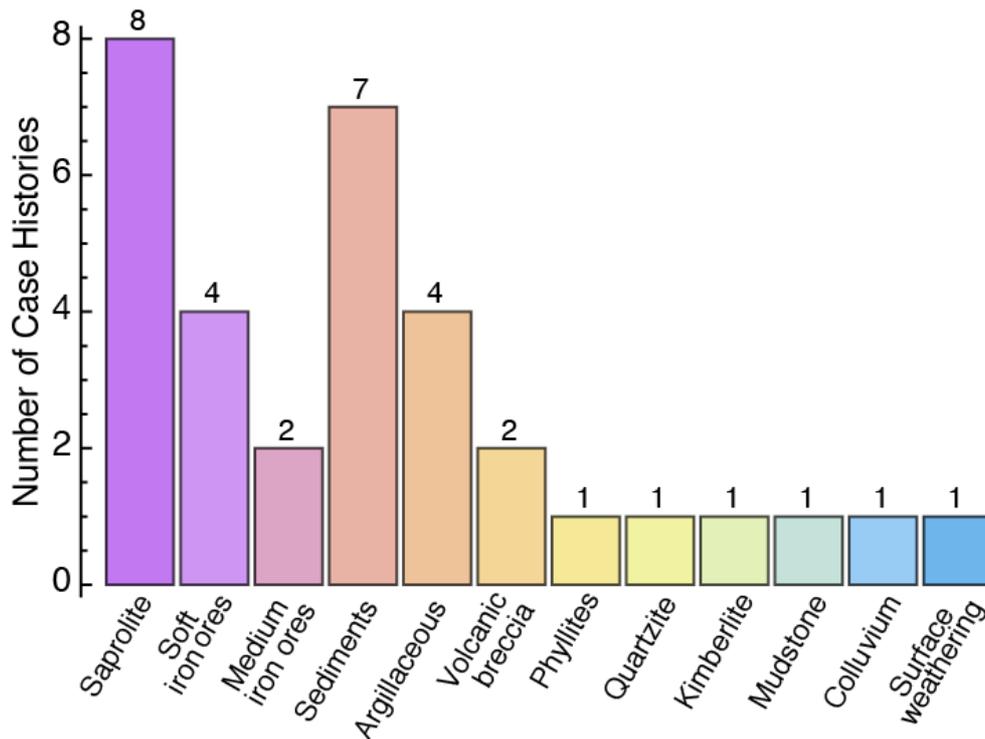
Figure 1 Pit wall instabilities reported by the mining industry and categorised by geology

‘Guidelines for Open Pit Slope Design’ was produced in 2009 (Read and Stacey, 2009). These guidelines were focused primarily on open pit slopes in hard rocks and did not address the challenges that are often associated with open pits in weak rocks. While open pits in weak rocks tend to be shallower than those in hard rocks, pit slopes several hundred metres deep have been developed in weak rock and hence failures can still be significant. Weak rocks typically require flatter slope angles than are used in hard rocks and these flatter slopes can also have significant economic impacts. It is therefore critical that the presence of weak rocks is recognised early in the design process, since they often cannot be mitigated in the same way as hard rocks. Because weak rocks were not addressed in the original guidelines, the LOP is in the process of compiling guidelines for open pit slope design in these weak rocks. The first step in this process was to canvass the mine operators to identify the material that they classed potentially as weak rock, and particularly the materials that presented operational challenges. All the results from that survey are summarised in Figure 1.

Each of the material types reported in Figure 1 has a unique geological origin and can behave in distinctly different ways in an excavated slope. While the initial survey results reported a broad range of rock types the focus for this study was restricted to weak rocks and hence the case histories for volcanic breccias, quartzites and kimberlites were excluded. The purpose of this paper is to provide an overview of the behaviour of slopes in weak rocks that has been observed in large open pits and provide a framework for characterising, analysing and designing in these materials.

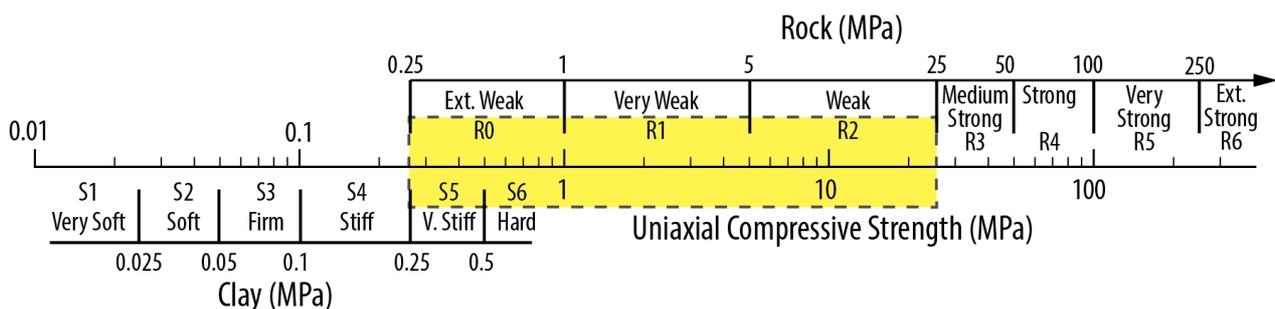
Figure 2 Range of uniaxial compressive strength typically associated with 'weak rock' geology described in this report (ISRM Suggested Methods, Brown, 1981)

The term weak rocks in the International Society for Rock Mechanics (ISRM) Classification ranges from extremely weak (R0) to weak (R2), with associated uniaxial compressive strengths ranging from 250 kPa to 25 MPa, respectively (Figure 2). The R0 class overlaps with soils that display very stiff (S5) to hard (S6) characteristics. Consequently, slope failures in pit walls excavated in weak rocks can display behaviours ranging from those associated with stiff soils to slope failures partially controlled by discrete geological structures. For this LOP project the term weak rocks is used to recognise both the weak rock strength and soil like behaviour observed in the pit slope failures given in Figure 1.

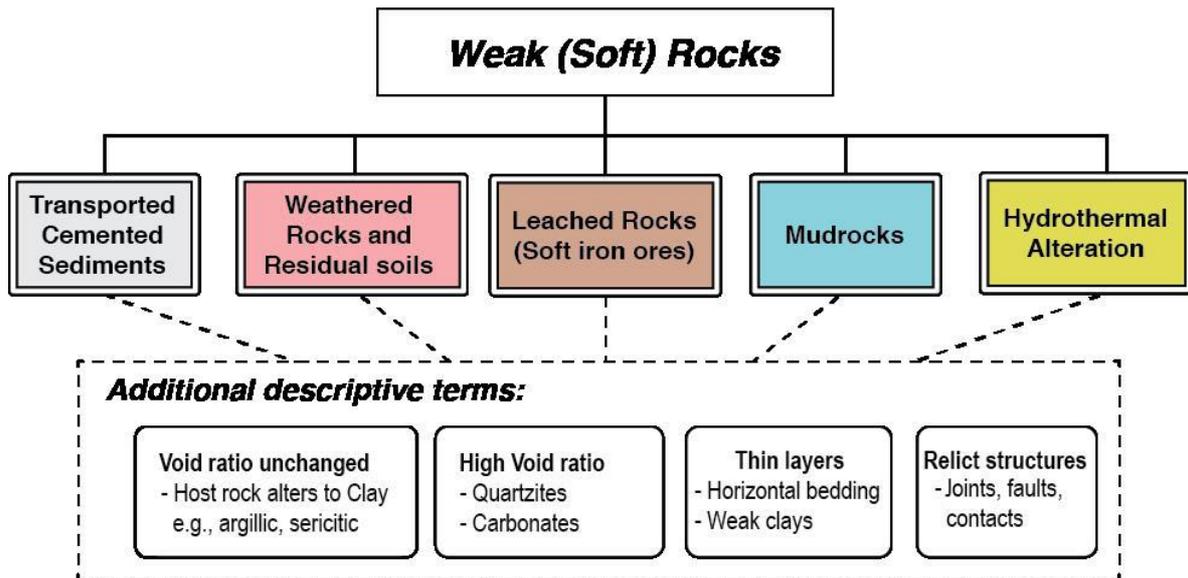
Figure 3 The five geology categories classed as weak rocks

Grouping of the results in Figure 1 resulted in five general weak rock categories that will be addressed by the *Guidelines for Open Pit Slope Design in Weak Rocks*, namely: (1) cemented transported sediments, (2) saprolites (residual soils and weathered rocks); (3) leached rocks/soft iron ores (leached, creating a rock with a high void ratio); (4) mudrocks; and (5) hydrothermally altered rocks. These categories are illustrated in Figure 3 and described in the following sections.

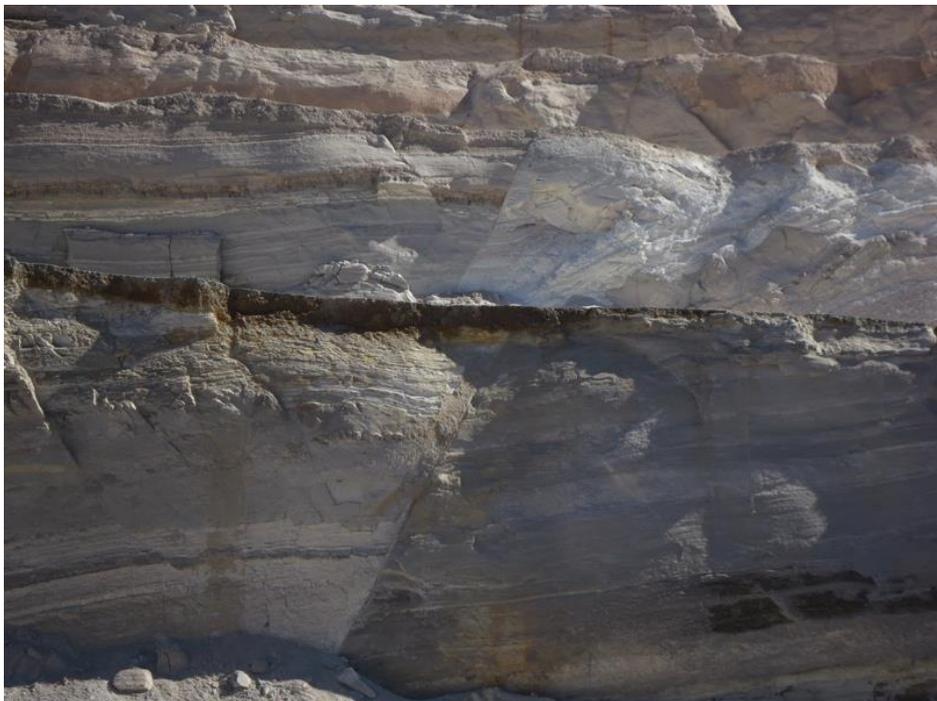
Figure 4 Photo of cemented transported sediments exposed in an open pit slope of Pliocene-Miocene age Carlin Formation, northern Nevada (photo by R. Sharon)

slope angles of up to 60° over heights of up to at least 200 m, as shown (Figure 5). Inspection of Figures 4 and 5 suggests these materials must have significant cohesion, but because of their transported soil origin also have a relatively high porosity compared to most rocks. Consequently, these materials will remain stable as long as the cohesion remains undisturbed. On the other hand, fine-grained lakebed sediments that are weakly indurated to the extent that they can be considered to have ‘rock like’ properties can be susceptible to either block sliding on weak planes or mass failures. The lakebed depositional history implies that the layering may have extensive aerial extent. Hence, slope failures controlled by these weak layers can be extensive. These materials can also fail as flow slides if saturated, with the potential for collapse mechanisms and static liquefaction (Figure 6).

In these materials there is a need for a complete understanding of the geologic setting of the cemented sediments as the primary ‘bad actor’ for pit walls may be faults (Figure 4) and weak bedding planes with adverse orientation. There may also be the potential for collapse of cemented soils if the cementing agent is water soluble and an external water source is applied to the pit wall (leaky tails dam, reservoirs, pipelines). Understanding of the cementing agent (calcium carbonate, gypsum, or iron oxide) could be very important to pit slope design in these materials

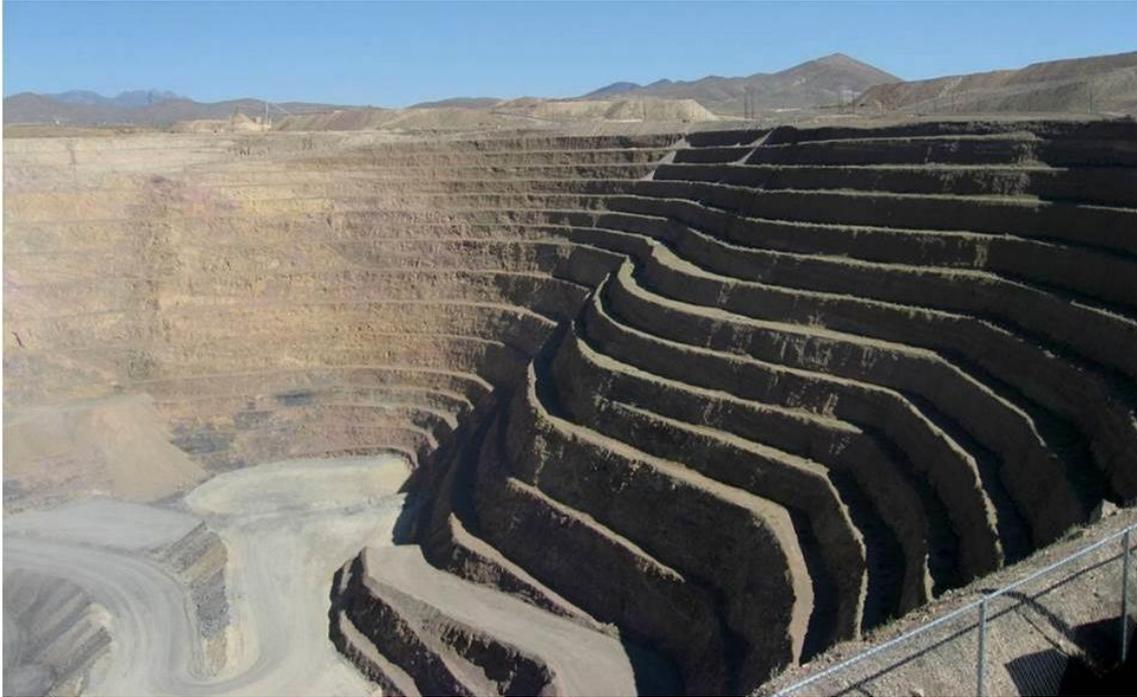
Figure 5 Photo of pit slopes in cemented colluvium Cortez, Nevada

In a mining context, transported sediments typically form the initial materials that may be encountered when developing an open pit. They can range in thickness up to several hundred metres and can hence form a significant proportion of the pit slope, as shown (Figure 5).

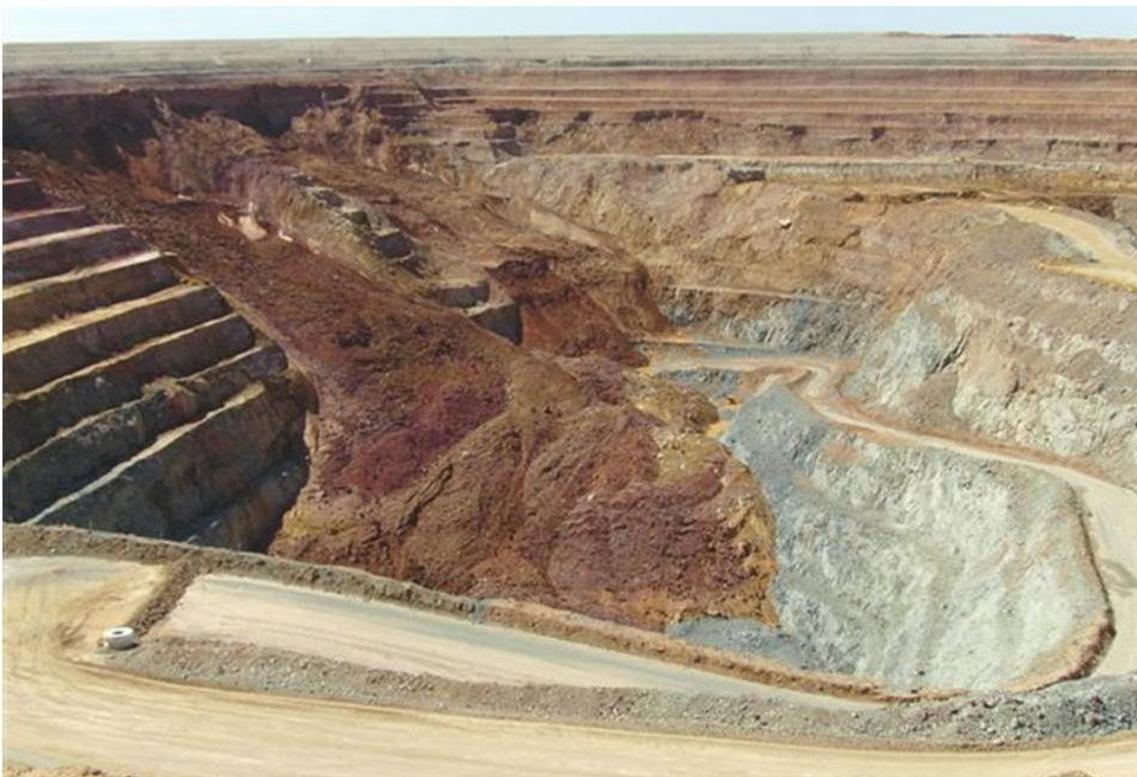
Figure 6 Flow slide of lakebed sediments and saprolite (photo by R. Sharon)

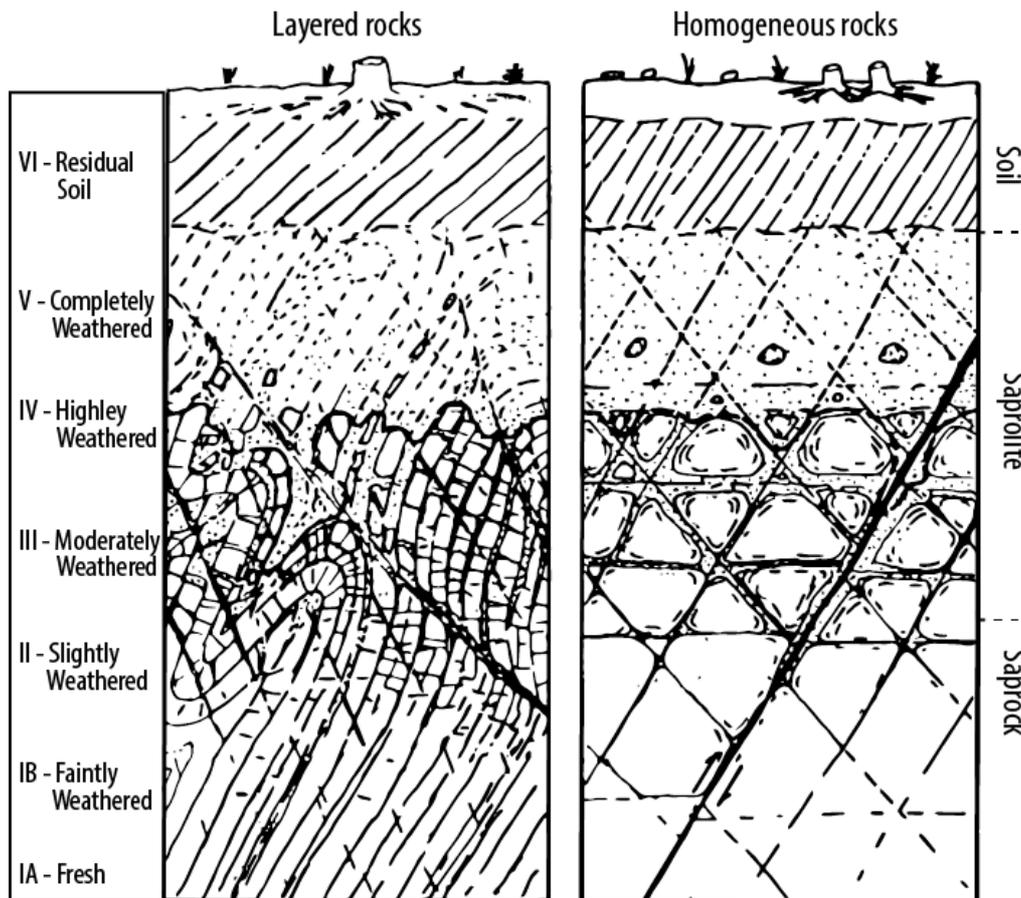
Figure 7 Generalised illustration of residual soils and weathered rocks (modified from Deere and Patton, 1971)

As illustrated in Figure 7, the structure of the parent rock, which is generally referred to as ‘relict structures’, becomes more important with depth as the behaviour becomes more rock like. Hence the challenge with residual soils and weathered rock is developing methodology for describing this heterogeneous soil and rock behaviour. The seminal work by the Geological Society Engineering Group Working Party Report on Tropical Residual Soils provides a comprehensive summary of the engineering behaviour of residual soils (Fookes, 1990). This work was supplemented by a description and classification of weathered rocks for engineering purposes in 1995, (Norbury et al., 1995). The bases for the findings given in these papers were strongly influenced by civil engineering work in Hong Kong, first summarised by Lumb (1975). This work highlighted the importance of soil suction (negative pore pressures) in the stability of partially saturated soils. While this is relevant in the stability of shallow slopes where the behaviour is dominated by the residual soil portion, its importance is reduced as the proportion of weathered rock increases. The recent work by Hencher and Lee (2010) compiled the experience with the slopes in Hong Kong and presents a comprehensive approach to characterising weathered igneous rocks.

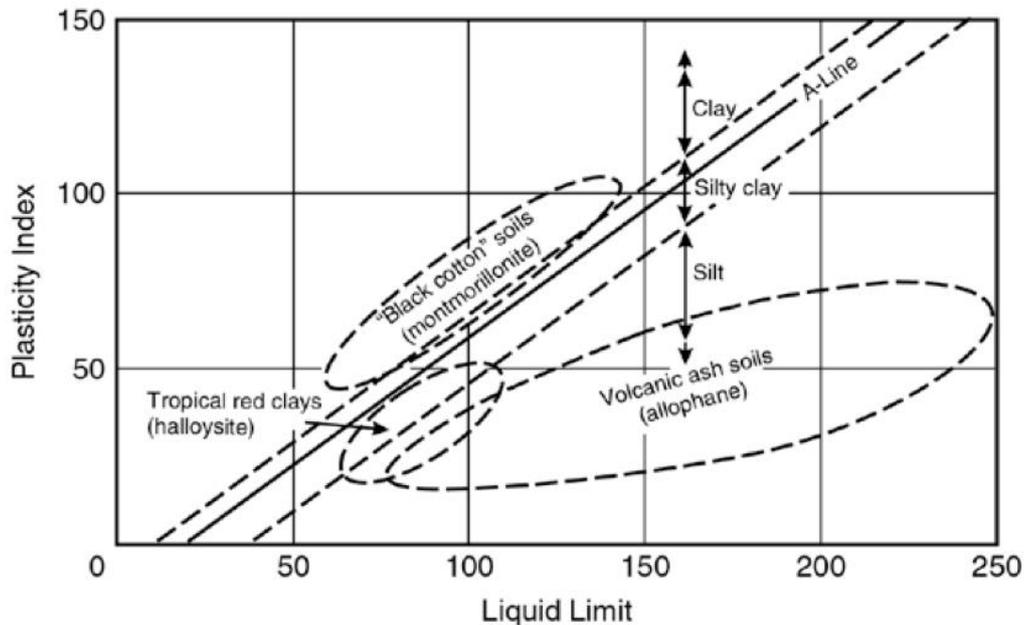
Figure 8 Conventional Casagrande Plasticity Chart showing several tropical residual soils (after Wesley, 2010)

In the completely weathered form structure and fabric are destroyed, and the mineralogy can be significantly changed, typically to clays. For these materials understanding the degree of plasticity and the clay mineralogy is particularly important. In this regard, the use of Casagrande’s Plasticity Chart shown in Figure 8, as well as x-ray diffraction (XRD) can be particularly useful. The minerals often encountered in residual soils are summarised in Table 1, and the location of these soils on Casagrande’s Plasticity Chart is also illustrated in Figure 8. The primary function of this chart is to enable comparison of similar soils so that behaviour can be quantified based on previous experience. Wesley (2010) provides an overview of the challenges that can be encountered when using the Plasticity Chart to classify residual soils.

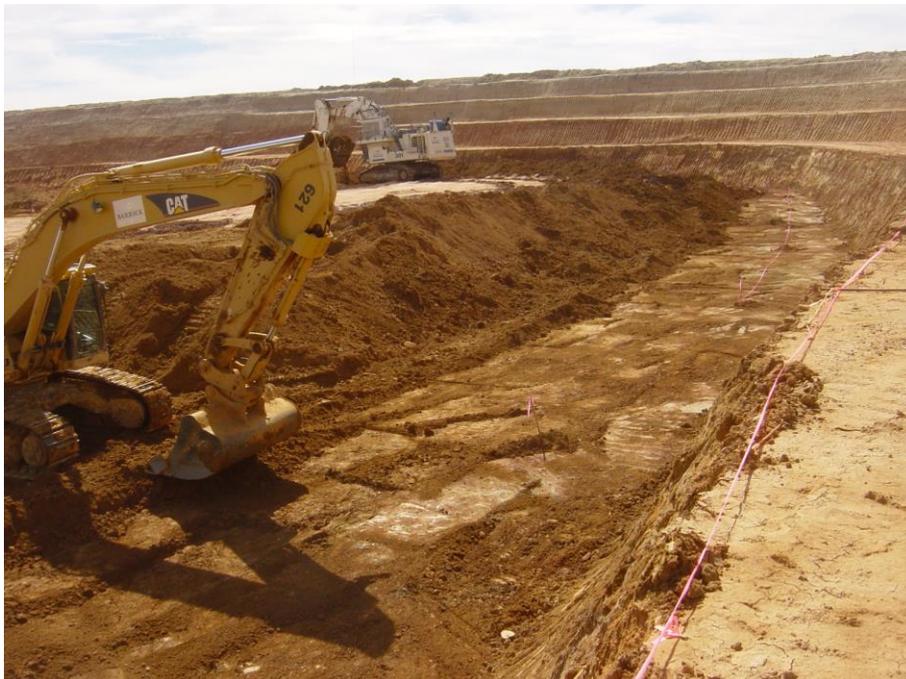
Figure 9 Example of open pit mining in weathered rock and residual soil. At this depth the material is excavated and treated as a soil (photo by R. Sharon)

In open pit operations the 'soil-like' behaviour that can be encountered when mining the more highly weathered rock is illustrated in Figure 9. Although mechanical excavation of the slopes may be straightforward in these materials, characterising them, and establishing their short and long-term behaviour as a basis for slope designs, remains challenging.

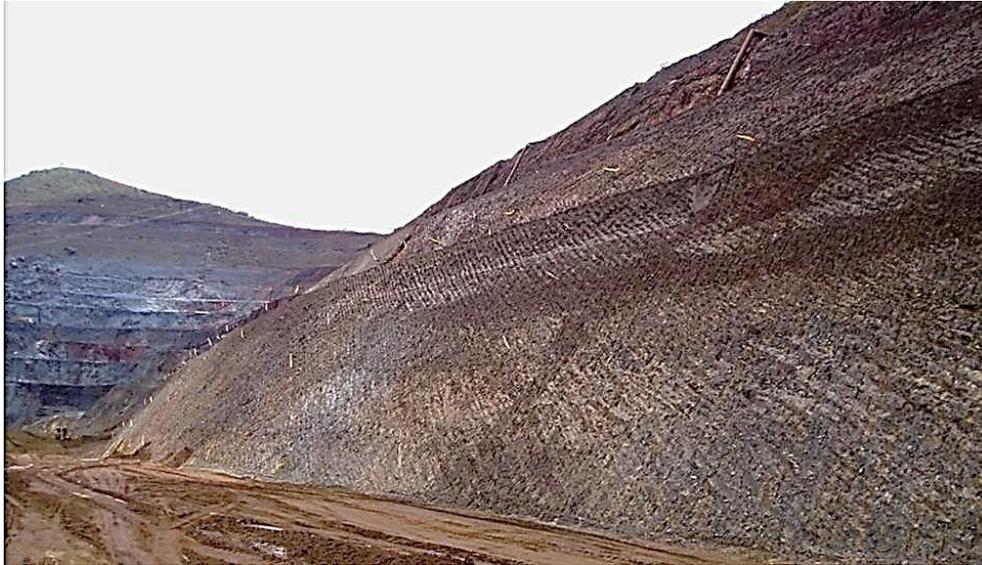
Figure 10 Dozer cut slope in saprolites in a Brazilian iron mine

Saprolitic materials can frequently be excavated without blasting and steep bench faces can be achieved using either excavators or through dozing, as shown (Figure 10). The steep faces can have a significant advantage in tropical climates, since they promote rainfall runoff and minimises surface area exposed to

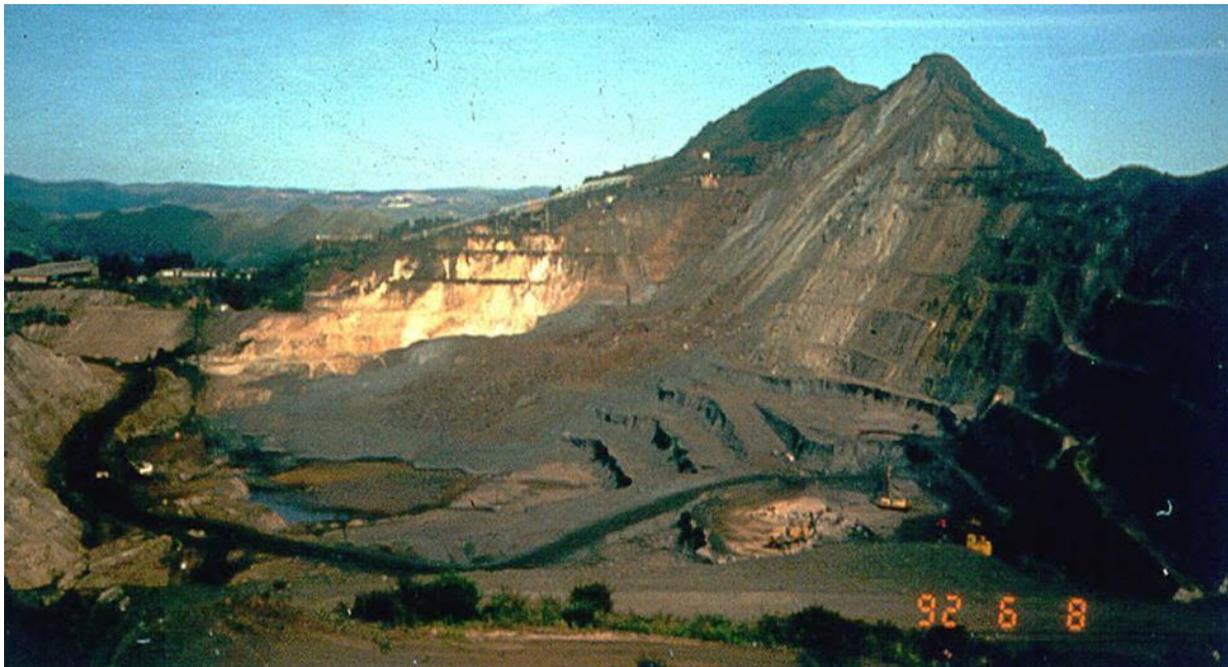
Figure 11 Photograph of a runout from the Patrimônio failure

The first evidence of instability was detected on April 8 in the form of a crack at the crest of the slope, with further cracks appearing a few days later in drainage ditches on the sides of the wall. On April 23 cracks were noted in the operating face and mining was suspended. The failure, which occurred on April 29, involved some 2 million tonnes of soft iron ore, which ran out approximately 500 m across the pit floor and buried the in-pit crusher at the toe of the opposite wall (Figure 11).

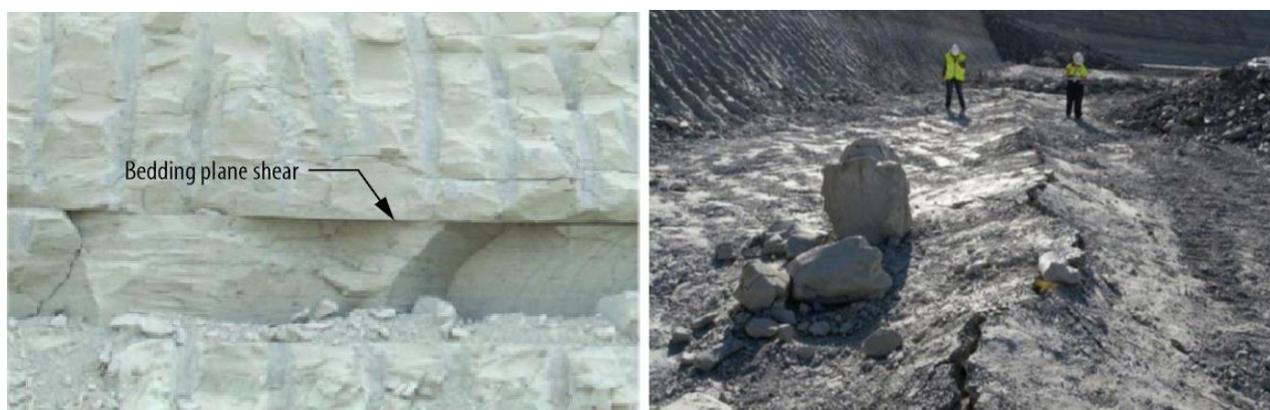
Figure 14 Example of the instabilities observed in the progressive failure along bedding planes in the Cobre Las Cruces open pit (photos from Cooper et al., 2011); (left) shearing of a bedding plane exposed in the pit wall; (right) shearing and buckling on bedding plane below the pit floor

The Cobre Las Cruces open pit in Spain was excavated in mudrocks locally referred to as Guadalquivir Blue Marls. The pit is approximately 1,600 m long × 900 m wide × 250 m deep. Mineralisation is contained in the Paleozoic ore composed of volcanic and other metamorphic rocks underlying 120 to 150 m of Tertiary Guadalquivir Blue Marls. Cooper et al. (2011) describe the behaviour of these marls as that of overconsolidated clay. As is typical of mudrocks, bedding plane shears that developed as the pit was excavated control the stability of the excavated pit slopes. Figure 14 shows the discrete thin nature of the bedding plane shears exposed in the pit wall and the behaviour of the pit floor when the shears were located immediately below the operating bench.

Using an extensive monitoring program consisting of slope inclinometers and survey prisms, Cooper et al. (2011) concluded that the bedding planes were spaced every 3 to 7 m with an average spacing of 5 m. They also show that the inclinometer data indicated the material above the bedding plane moved as a block. Back-analyses of the shear displacement showed that the operational bedding plane shear strength was $c' = 0.02$ MPa with $\phi' = 15^\circ$. These values are in contrast to the intact rock strength reported as c' ranging from 0.11 to 0.28 MPa with the friction angle ranging from 18 to 22°.

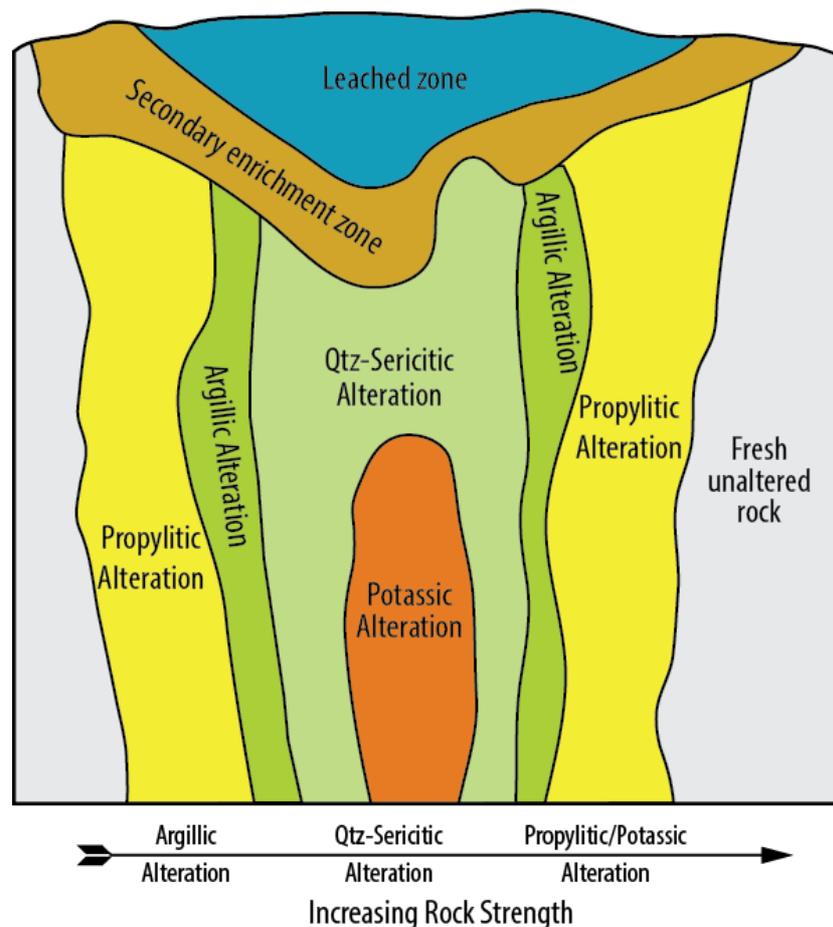
Figure 15 Common hydrothermal alteration halos and surface weathering associated with porphyry copper deposits, modified from Karzulovic (unknown source)

Alteration associated with hydrothermal deposits can be highly variable and can either decrease or increase the strength of the host rocks (Figure 15). Argillic alteration almost invariably significantly reduces the strength of the original rock, destroying any structural fabric in the rock. This strength reduction is associated with the clay minerals, which can range from kaolinite and illite to montmorillonite. As a result, shear strengths can be rather variable with friction angles ranging from as low as 8 to 14°, and variable cohesion. Hence there is a need to classify the argillic alteration both in terms of mineralogy and degree so that those areas with the clay minerals can be identified and treated appropriately. Even with intense alteration, relict structures can also play a significant role in pit slope stability.

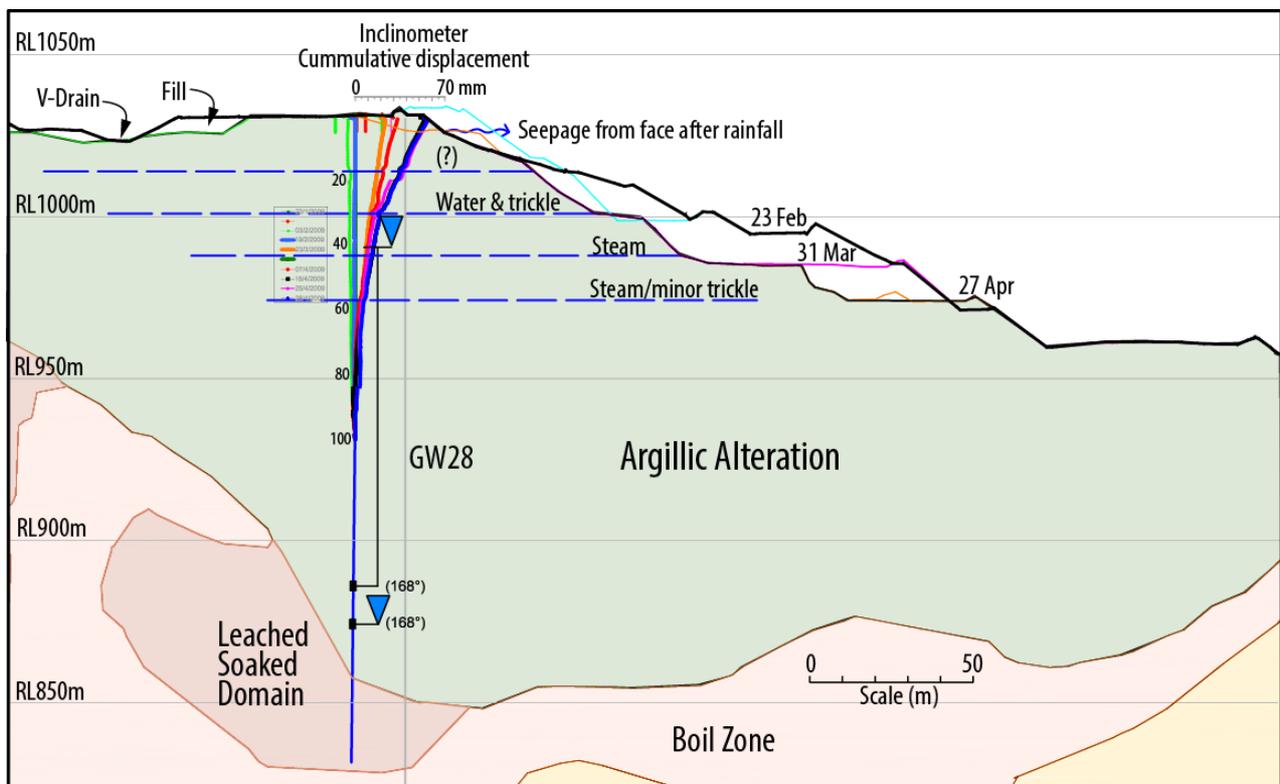
Figure 16 Instability in the Argillic alteration, locally referred to as GW28 slope

Tension cracking around the GW28 steam production well was first noted in October 2007, and associated with mining of a pushback immediately below (Figure 16). A rock mass failure progressively developed. The geotechnical investigation and back-analysis of the failure resulted in modification of the wall design. The design change comprised a small cutback at the crest, mining out GW28; and leaving a 30 m wide buttress at the 956 mRL level. Despite the successful implementation of this first remediation step, further instability developed in early 2009 as the rock mass continued to deteriorate. A second small cutback was undertaken at the crest but was limited by the presence of the steam line at the crest that carried a significant percentage of total steam production at the time.

One of the challenges at Lihir is the pore pressures in the Argillic unit. Figure 16 shows the hydraulic head measured by two vibrating wire piezometers. The lower piezometer reflects the heads associated with the Boil Zone, and illustrates the effectiveness of the Boil Zone as a drain. However the upper piezometer shows the increase in head associated with the argillic alteration. This is routinely observed at Lihir. Despite the efforts to drain the slope and the effective underdrain provided by the relatively high permeability Boil Zone, pore pressures in the Argillic unit remain high.

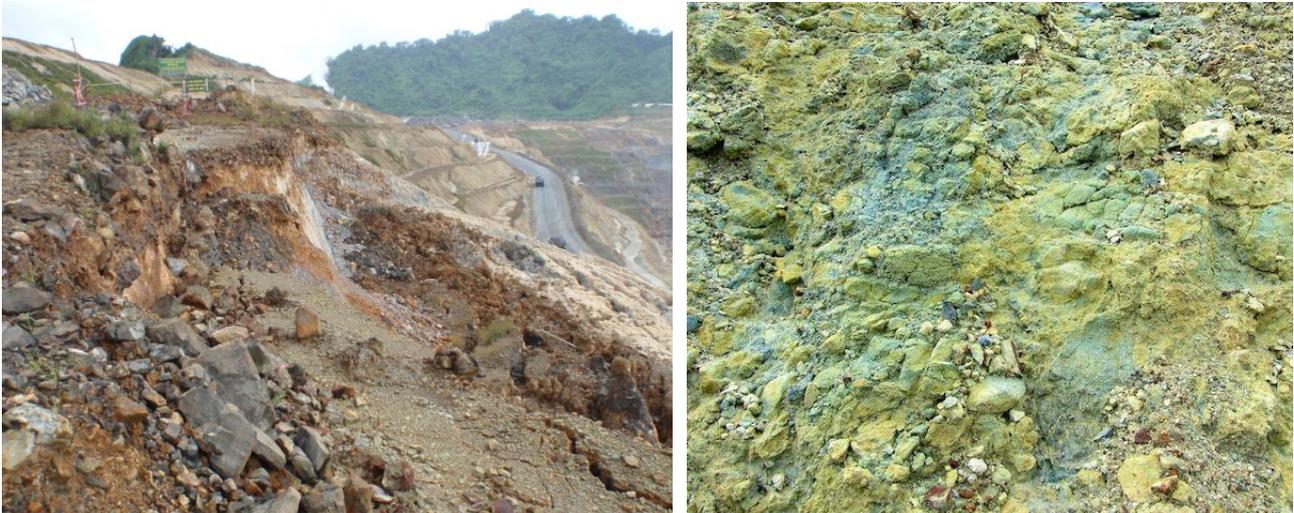
Figure 17 Photo (left) of the GW28 area taken in September 2010, showing the ongoing instability in the Argillic Unit, and photo (right) of upper argillic alteration

Figure 17 shows the ongoing condition of the GW28 slope in September 2010. Local movement picked up by the surface prisms indicate deformation rates of >5 mm/day.

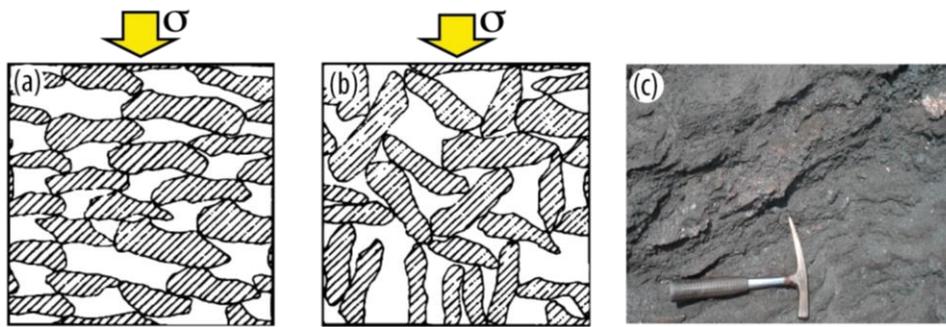
Figure 18 Role of loading direction and fabric of identical material (same porosity) on material behaviour; (a) and (b); the packing arrangement in (b) is more susceptible to collapse compared to the packing arrangement in (a), modified from Holtz et al. (2011); (c) friable iron ore with high porosity (photo by T. Costa)

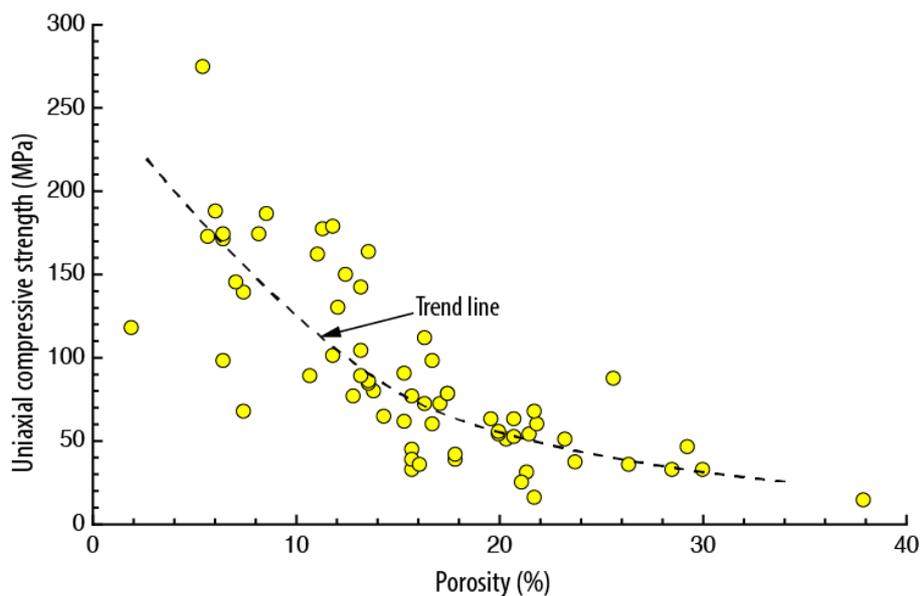
Figure 19 Relationship between porosity and the uniaxial compressive strength in carbonate rocks, data from Palchik (2011)

In addition to the potential for collapse, increasing porosity degrades the strength of a rock. Palchik (2011) compiled the laboratory uniaxial compressive strength for heterogeneous carbonate rocks. Those results are summarised in Figure 19 and clearly show a significant decrease in laboratory uniaxial compressive strength from 175 to 50 MPa, as porosity increases from 7 to 30%. The sensitivity of the strength to porosity implies that site characterisation techniques must be adjusted so that the procedures do not destroy the very structure of the material that is being sampled.

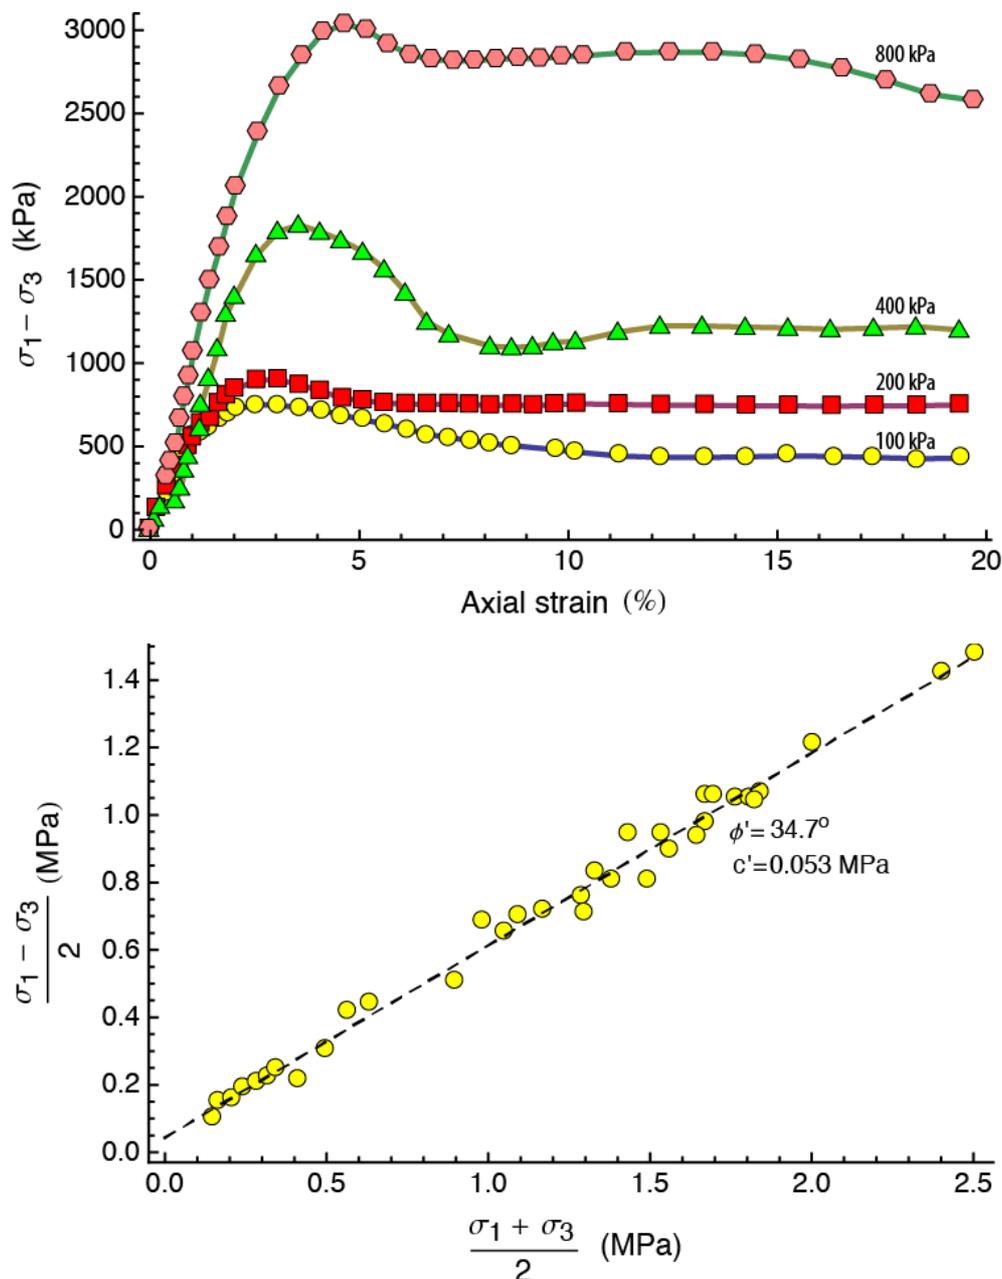
Figure 20 The stress–strain response for friable soft iron ores and the associated peak strength failure envelope, data (from Costa, 2009)

The behaviour and strength of the soft iron ores from Brazil were described by Costa (2009) and Sá (2010). Figure 20 shows the stress–strain response of the friable soft iron ores and the associated shear strength expressed using the traditional ‘soil mechanics’ mean effective principal stress and deviatoric stress. The testing by Costa (2009) was carried out at very low confining stresses (100 kPa) corresponding to approximately 5 m of overburden and these samples were tested perpendicular to the fabric. Even at this low confining stress, there was no evidence of a significant brittle response in the majority of the tests. It is clear from Figure 20 there is no evidence of the type of nonlinear failure envelope that is normally associated with Hoek–Brown behaviour.

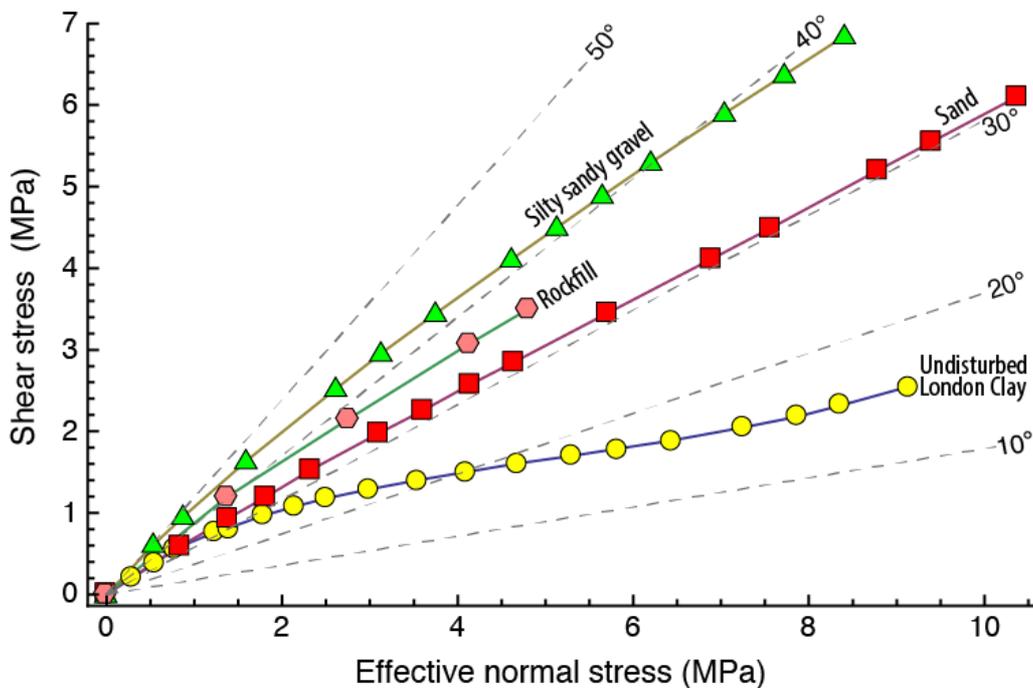
Figure 21 Mohr envelopes for soils under high confining stress (from Bishop, 1966)

Linear failure envelopes usually indicate that the failure process is dominated by a single mechanism, typically frictional sliding. Nonlinear envelopes indicate competing mechanisms, typically tensile fracturing at low confining stress and frictional sliding at high confining stress. Bishop (1966) compiled the strength of

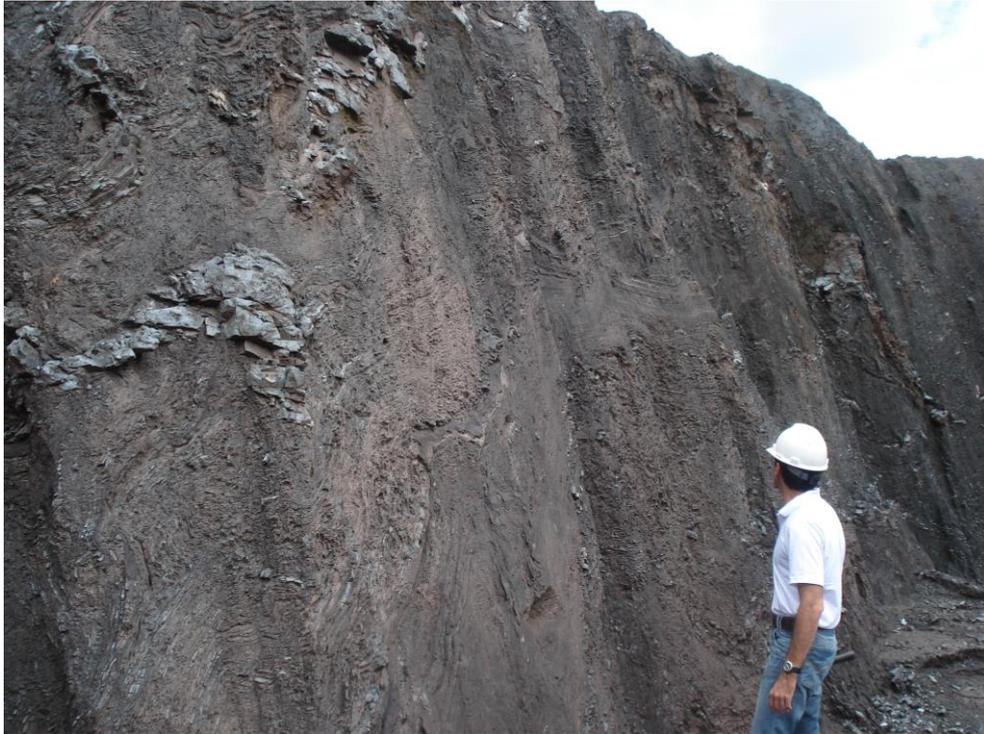
Figure 22 Example of steep slope in soft iron ores (photo by T. Costa)

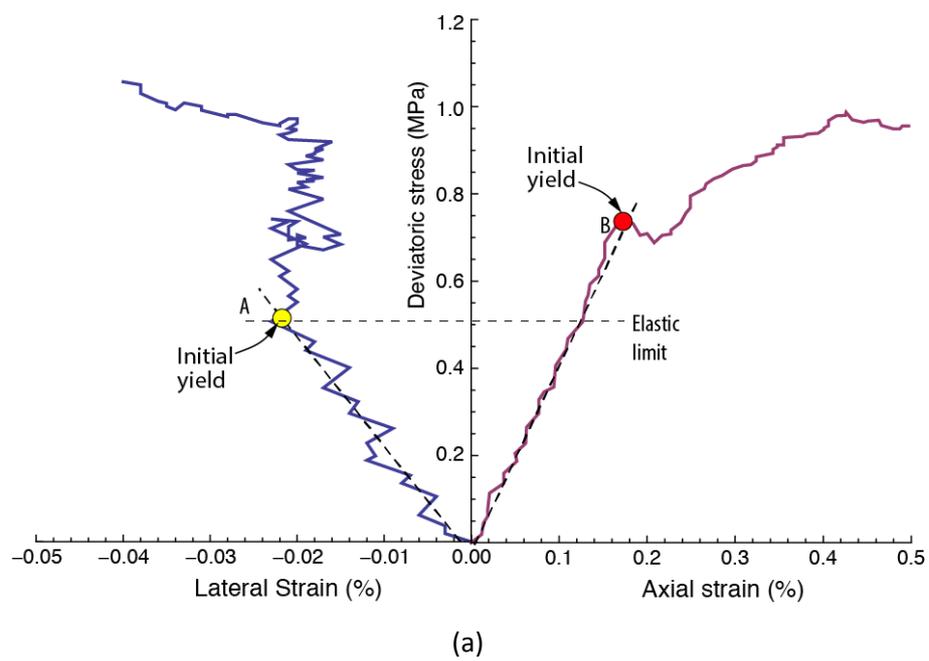
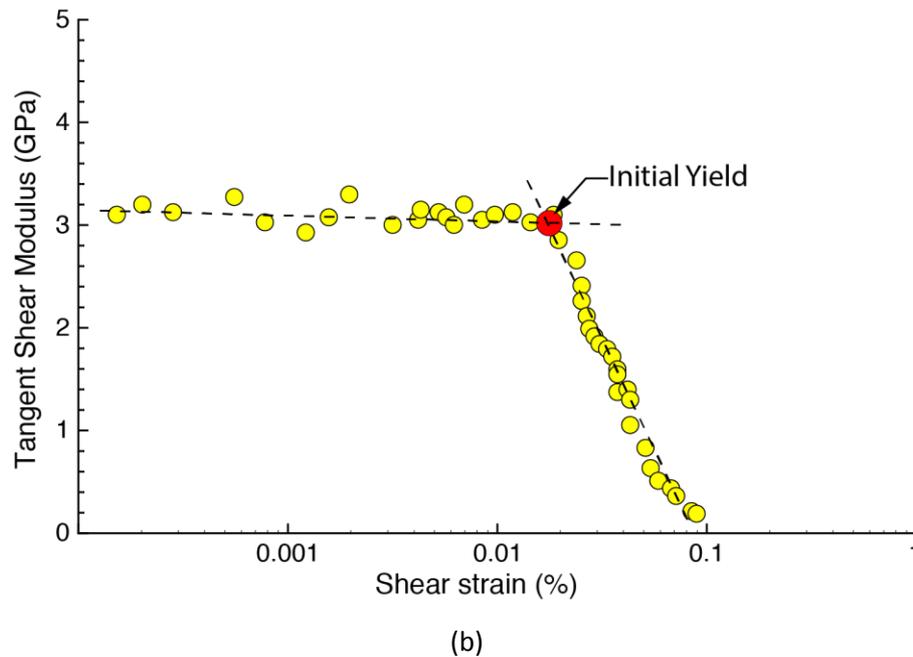
Figure 23 (a) Stress–strain response for calcarenite recorded by local strain measurement system showing the onset of yield before the peak strength is reached (modified from Airey 1993); (b) example of sudden change in shear stiffness in a cemented sandstone at small strains (modified from Cuccovillo and Coop, 1997)

One of the subtle issues highlighted by the data in Figure 23 is the importance of sampling and sample handling during site investigations. As previously discussed the porosity of some weak rocks, particularly weathered rocks, residual soils and these soft iron ores is very high and approaches that of soils. Hence, extracting high quality samples without disturbing the weak rock structure and in particular its cohesion is extremely important. In such conditions special samplers, such as plastic inner tubes to core barrels and the Mazier corebarrel, should be used to minimise the effects of sample disturbance.

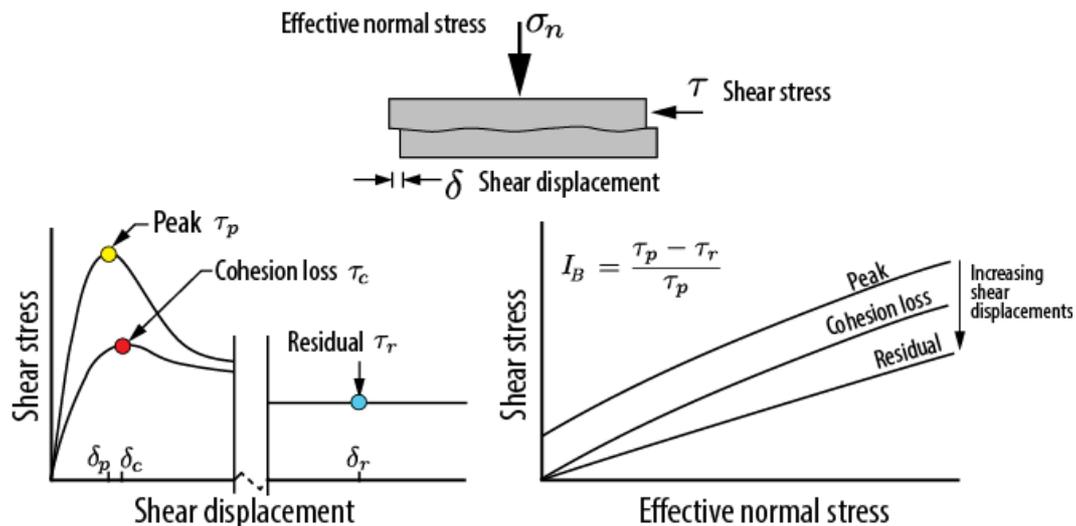
Figure 24 The failure envelope represented by cohesion loss

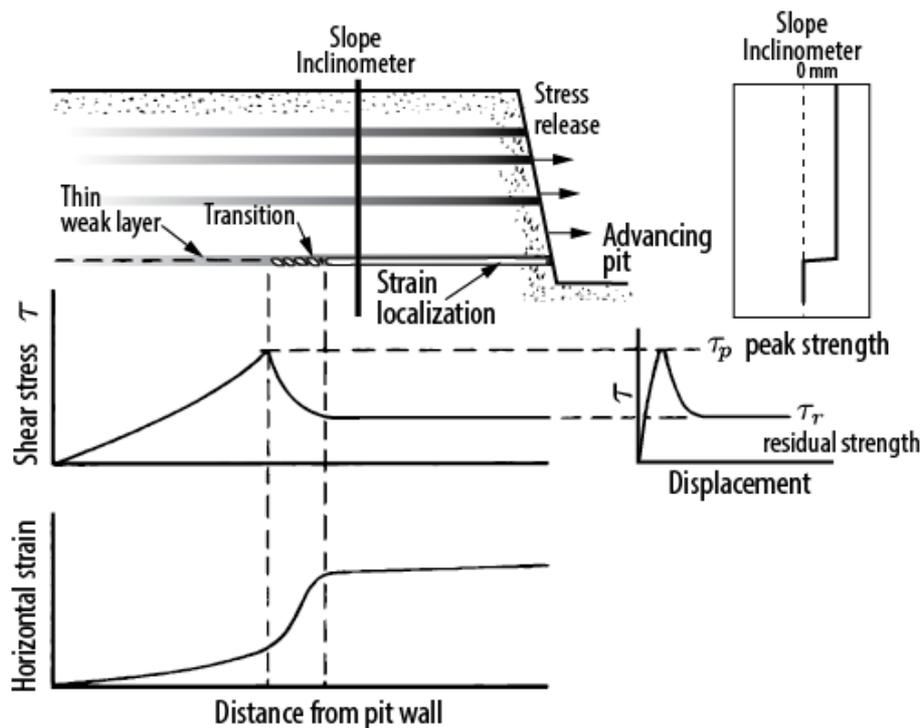
Figure 25 Illustration of progressive failure on a localised shear band in an open pit, modified from Burland et al. (1977)

Burland et al. (1977) documented failure in an open pit mined for brick clay. Using extensive instrumentation they demonstrated that the pit excavation resulted in strain localisation sufficient to develop a shear zone near the base of the excavation. The failure process, illustrated in Figure 25 concentrated along a thin weak layer, with the mass above this layer moving as a block. The process described by Burland et al. (1977) is generally referred to as progressive failure. While Cooper et al. (2011) do not suggest progressive failure processes as the mechanism leading to the formation of the bedding plane shears in the Cobre Las Cruces open pit, their careful documentation supports the progressive failure processes illustrated in Figure 25.

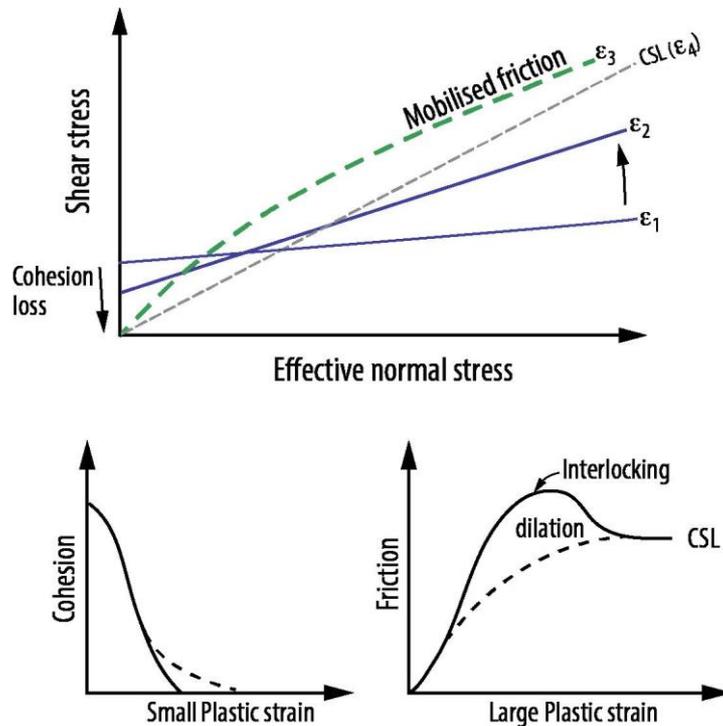
Figure 26 Illustration of the failure envelopes as a function of plastic strain, involving friction mobilisation and cohesion loss

The discussions above demonstrate that establishing design strengths for pit slopes in weak rocks is challenging and that failure criteria are process driven. A fundamental assumption with the traditional Mohr–Coulomb failure envelope is that the two strength components cohesion and friction are mobilised instantly and simultaneously. The wisdom in that assumption was first questioned by Schmertmann and Osterberg (1960) who demonstrated using laboratory tests that the cohesive and frictional strength components were mobilised as a function of plastic strain. Hence there is no unique failure envelope; it simply depends on the plastic strain and the associated cohesion and friction developed in the material. The concept introduced by Schmertmann and Osterberg (1960) is illustrated in Figure 26.
