An extensional mechanism of instability and failure in the walls of open pit mines

M.C. Bridges *AMC Consultants Pty Ltd, Australia*

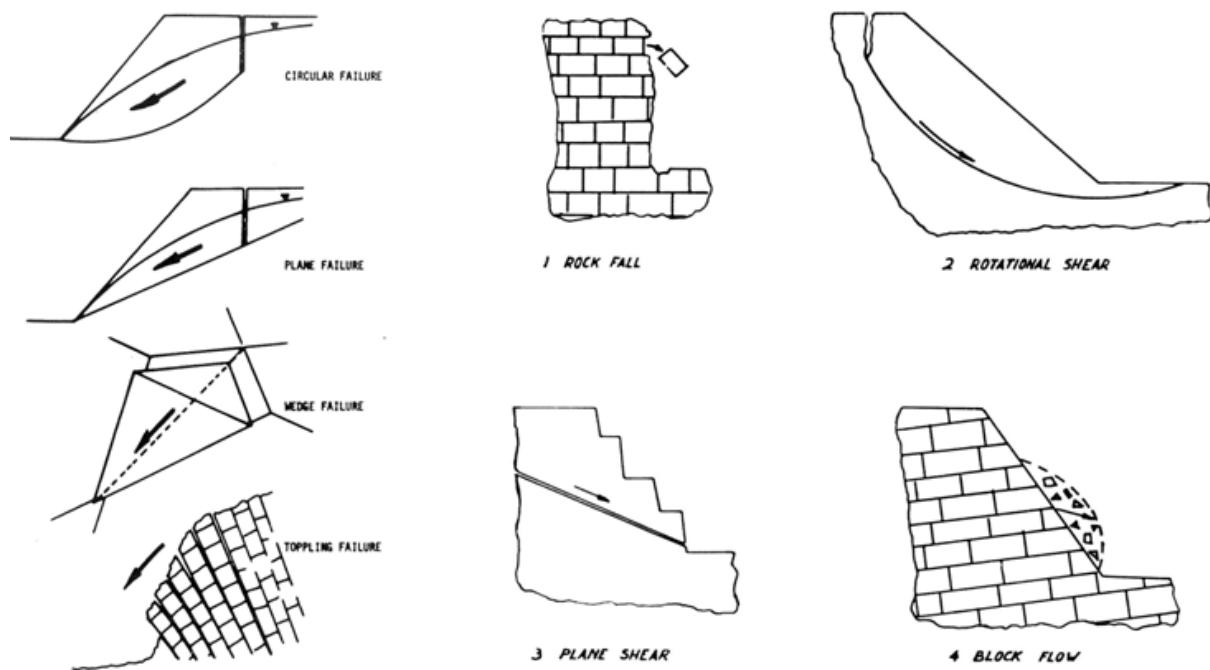
Figure 1 Mechanisms of failure of slopes that were proposed during the 1960s; (left) Hoek's four types of mechanisms (Hoek, 1972); (right) Coates' four types of mechanisms, which included 'block flow' (Coates, 1967)

Coates (1967) and Coates and Yu (1978), from studies in Canada during the 1960s and 1970s, proposed an additional ‘block flow’ mechanism of failure (Figure 1) for rock conditions where the structural conditions do not favour plane shear sliding or are not sufficiently ductile to permit rotational sliding. In these circumstances, crushing of the rock occurs, which propagates through a rock mass, leading to a general breakdown and failure as a flow of broken rock (Figure 2).

In other instances, an unstable pit wall may slump, breaking-down along cracks and geologic structures, but remaining recognisably intact and (meta) stable for a time (Figure 1). This process may extend to a complete progressive breakdown of the failing mass, resulting in a scree pile against the pit wall (Figure 4).

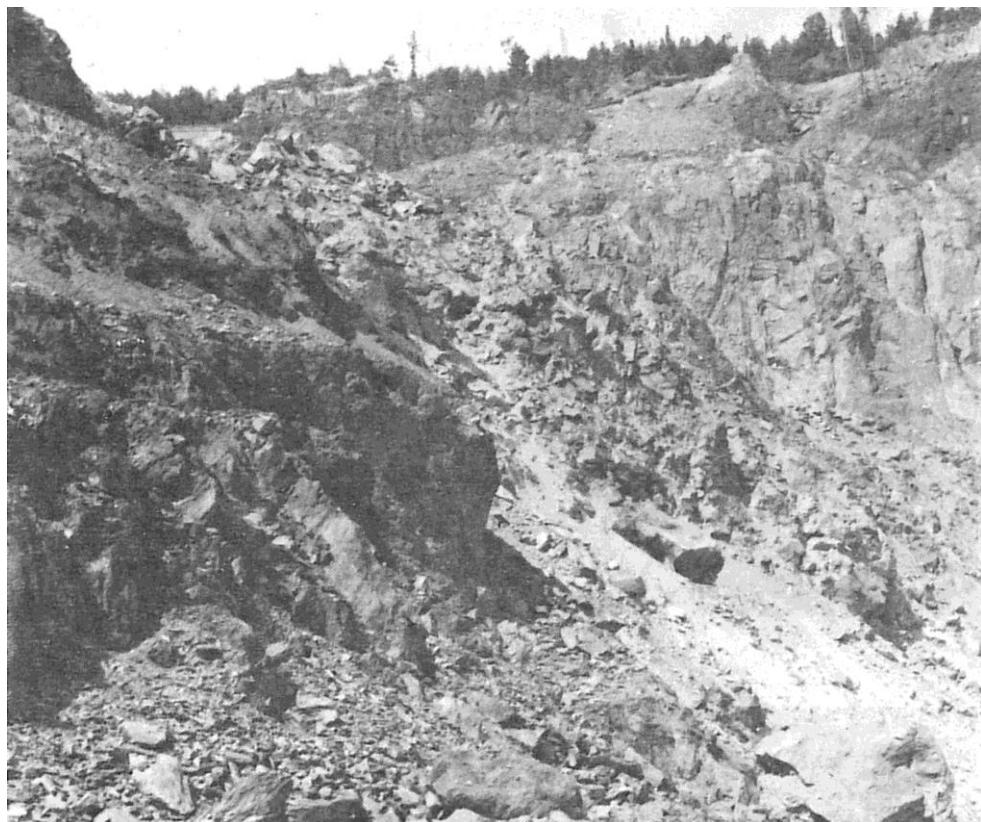
Figure 2 Instability and failure of a pit wall that was claimed to have failed by initiation by shearing at the toe followed by a breakdown of the rock mass (Coates and Yu, 1978)

Typically though, increasing rates of cracking and displacement lead to a final massive collapse of a pit wall (Figures 2, 5 and 6).

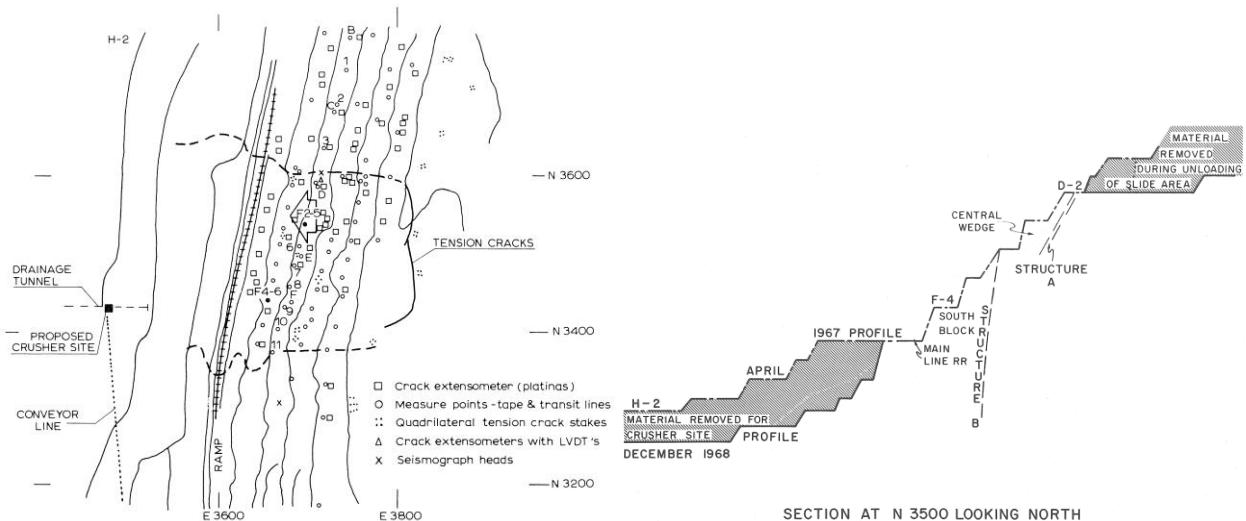
Figure 3 Plan (early 1968) and cross section (looking north) of the site of the failure and collapse in the southeastern sector of the Chuquicamata open pit in February 1969. Plan adapted from Voight and Kennedy (1979), section adapted from Kennedy and Niemeyer (1970)

In December 1967, extension cracks were observed to have opened at the crest of the pit wall. Instruments to measure displacements and seismic events were installed (Figure 3). Geologic structures were mapped. From January 1968, displacements across extension cracks were some millimetres per day. From April 1968, the top of the pit wall was 'unloaded', excavating about 4 million tonnes of rock, cutting down the crest of the pit wall by approximately 28 m (Figure 3).

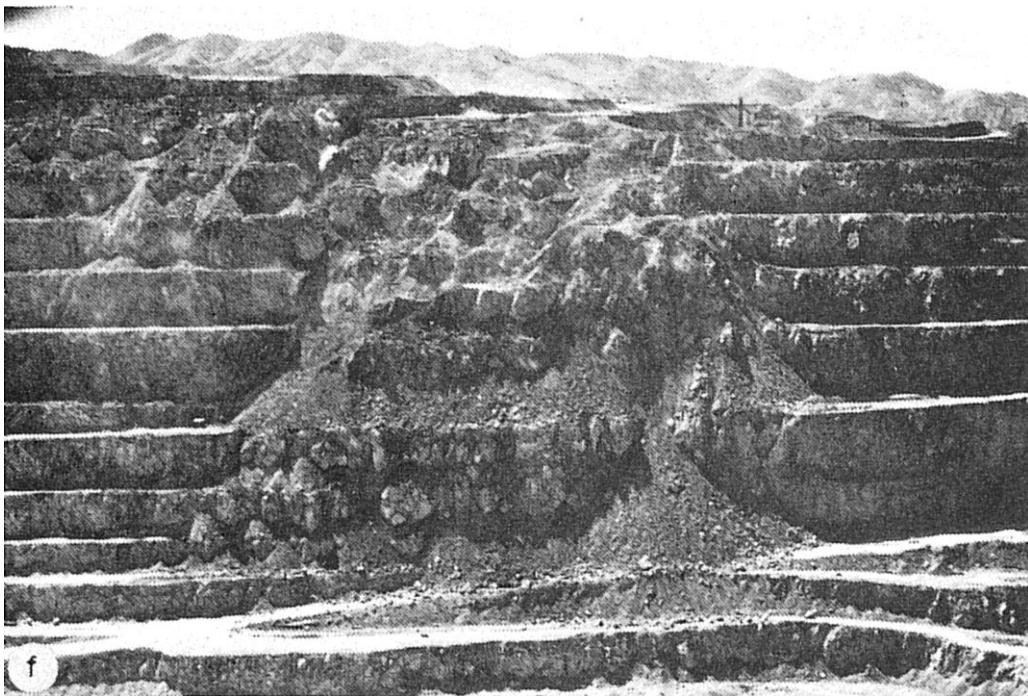
Figure 4 View of the Chuquicamata pit wall after the initial clean-up of the collapsed rock (from Voight and Kennedy, 1979)

By 11 February 1969, velocities on the pit wall ranged up to 460 mm per day. Benches became hazardous and inaccessible. There were many small rockfalls. The frequency of seismic events increased. On 18 February 1969 at 6.58 pm, a part of the pit wall failed and collapsed. The collapse occurred over four minutes. Failure occurred over a height of 123 m, involving an estimated 1.4 million tonnes of material. Most of the collapsed rock was from the zone where the highest velocities of displacement were previously identified. Another estimated 4.1 million tonnes of rock remained permanently 'deformed', with displacements up to 8 m (Figure 4).

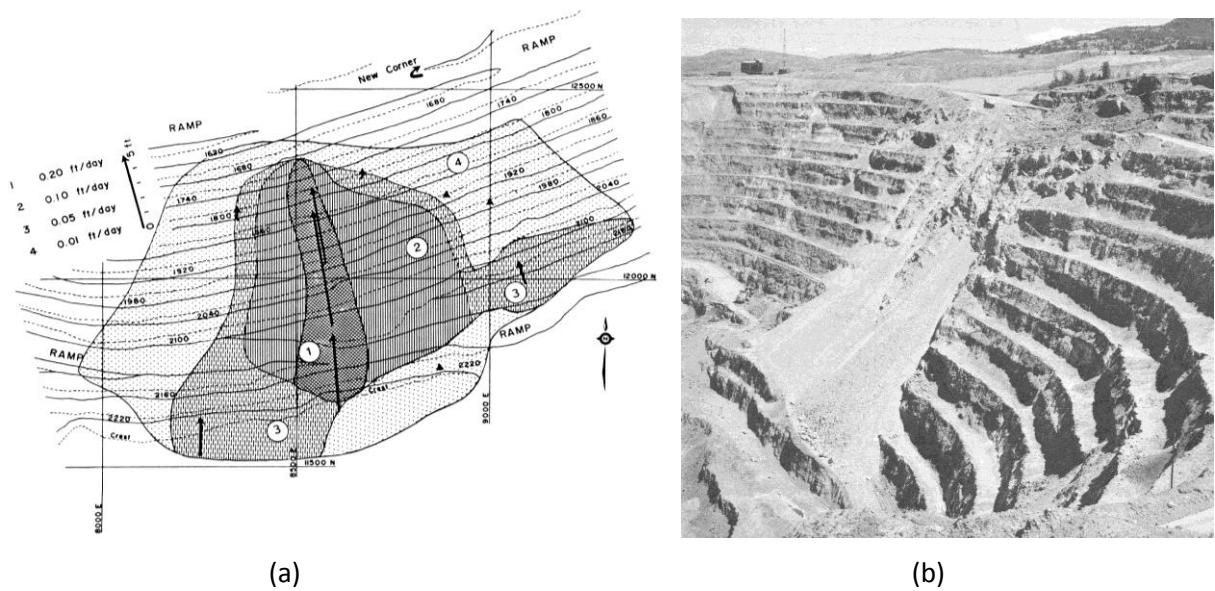
Figure 5 (a) Plan of the Afton pit wall where instability developed, showing zones of velocity of displacement that had developed prior to the failure of the pit wall (Reid and Stewart, 1986); and (b) view of the failure and collapse of the wall of the Afton open pit (Reid and Stewart, 1986)

Data from monitoring stations showed that the central section of the cracked rock in the pit wall up to the failure was moving at a higher rate than the adjacent rock (Figure 5(a)). The previous cluster of bench-scale failures lay at the toe of this zone.

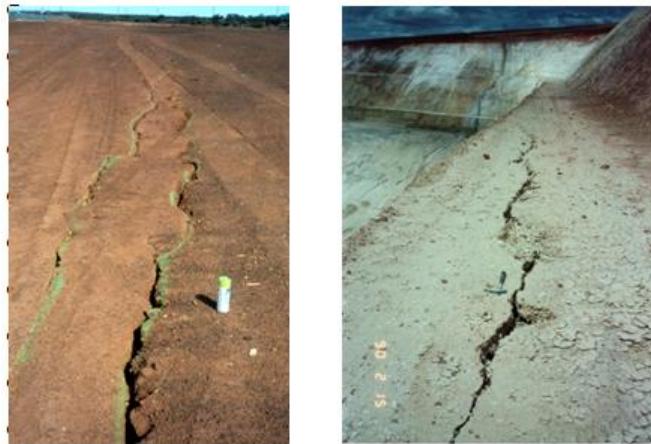
Figure 6 Extension cracks; (left) in the ground surface behind the crest of an open pit wall; (right) in a bench within a pit wall (photographs M.C. Bridges)

Typically, the first visible sign of a potential failure is the development of extension cracks (Figure 6). (These are frequently termed tension cracks, but ‘tension’ implies a known stress condition, whereas ‘extension’ is simply an observation).

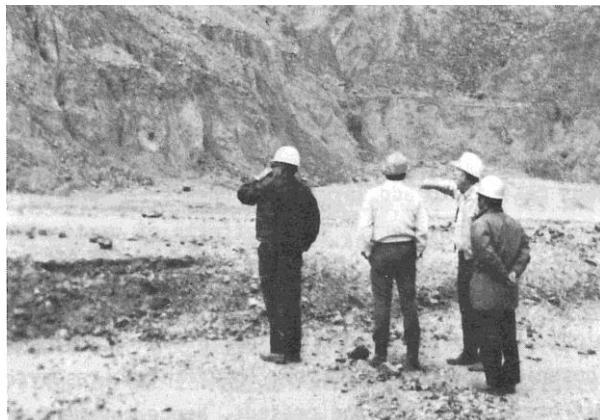
Figure 7 Heave of the floor of about 1 m near the toe of a 90 m high pit wall (from Coates and Yu, 1978)

100 m and more behind a pit's crest at the ground surface. As well, there are reports of cracking, bulging, or distress being observed or measured in the vicinity of the toe of an eventual failure. An example of heave at the toe of a pit wall is shown in Figure 7.

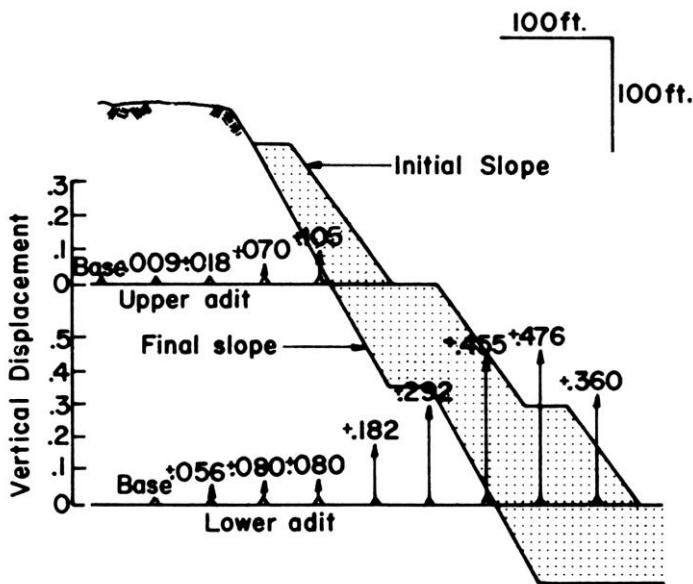
Figure 8 Representation of the vertical component of displacement measured in two adits in the wall of the Kimbley experimental open pit, in response to the shaded cutback of the pit wall. Values are in inches. Adapted from Broadbent (1972)

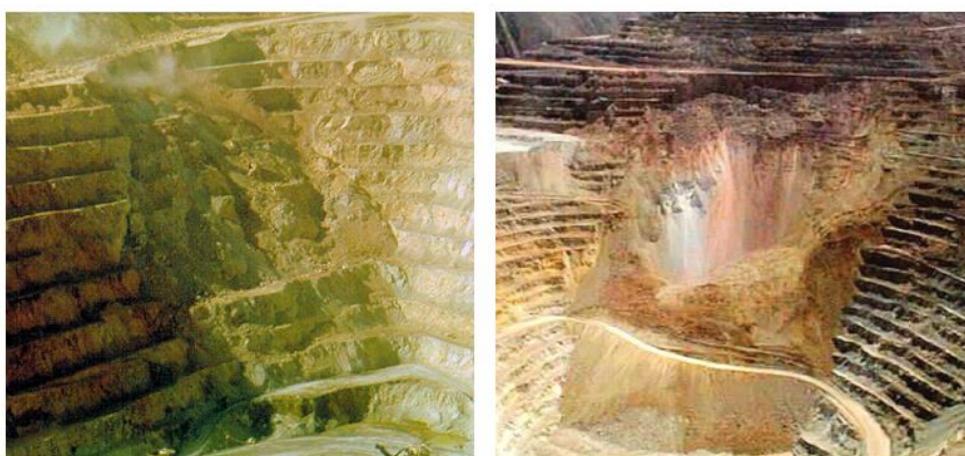
Figure 9 Large-scale failures in walls of open pits; (left) structural control by faults is evident at the top, but the mechanism in the lower part is unclear; (right) evidence of faults at the back of the failure, but the trigger of the failure was unclear (Hoek et al., 2000)

Hoek et al. (2000), presenting an invited paper at GeoEng 2000, noted that current analytical practices recognised two distinct categories: Structurally-controlled, kinematically possible failures, and non-structurally controlled, where some or all of the failure surface passes through a rock mass. They commented that these two categories were inadequate. Two examples, presented in the paper, illustrated the difficulties of the current models (Figure 9).
