Slope stability analysis at Siilinjärvi Mine

Abstract

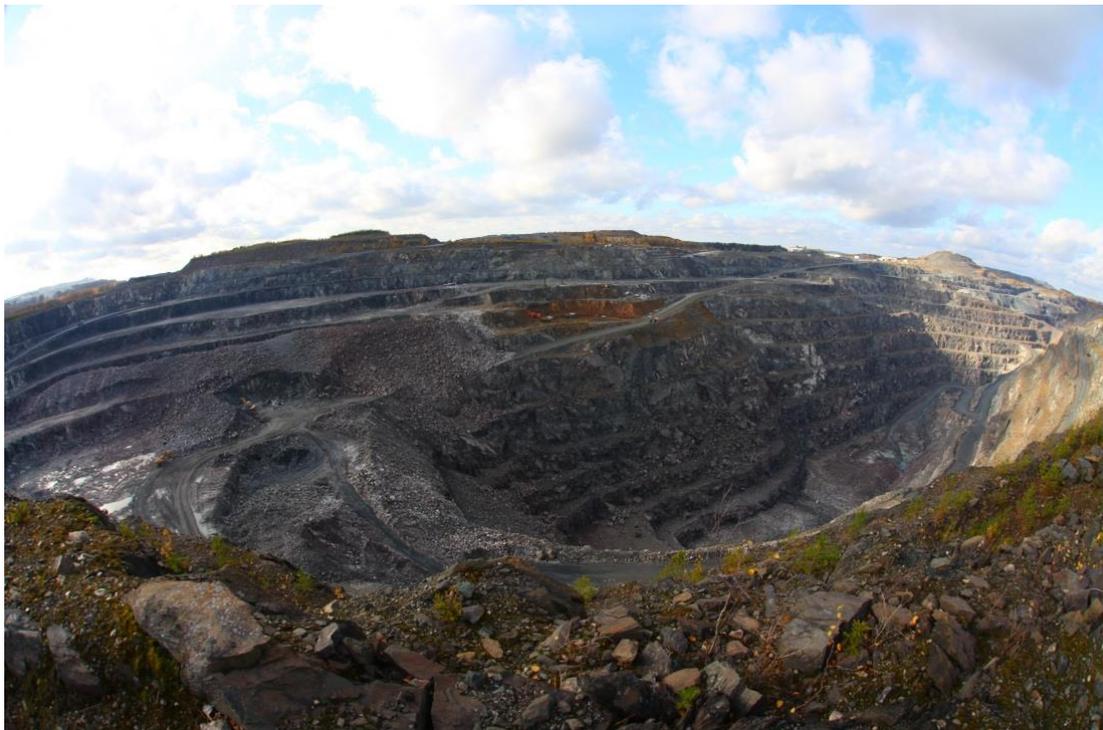
Figure 1 The main pit of Siilinjärvi mine in April 2013. F = 8, 15 mm fish eye objective

Siilinjärvi phosphate mine in eastern Finland has been in operation as an open pit since late December 1979. The current main pit (Figure 1), the Särkijärvi open pit, is 2,900 m in length, 235 m in depth and at its widest part 750 m wide. The ore feed to the mill is close to 11 Mt/a. The stripping ratio in current LOM is on average 0.6 but a major extension program is ongoing in the main pit and for the next nine years the stripping ratio will be around 1.2.

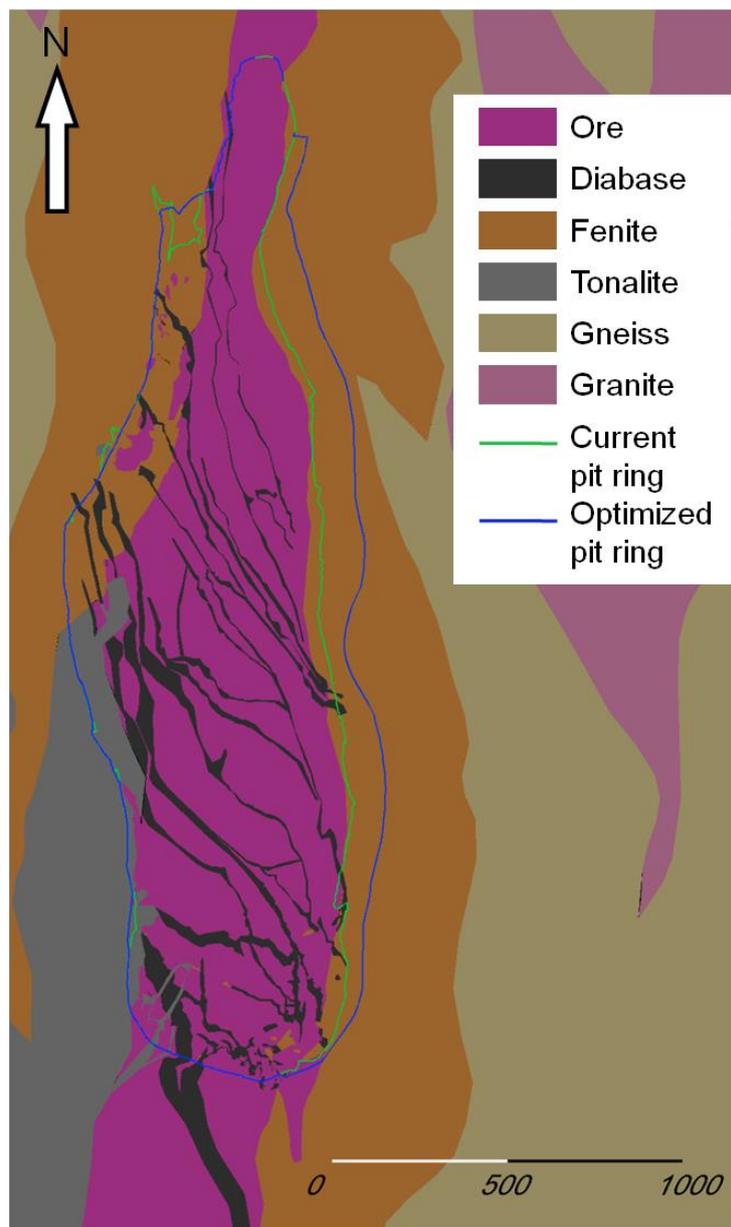
Figure 2 The Siilinjärvi carbonatite complex. Current main pit is located in the middle of the complex at the widest part of the carbonatite (Heino, 2012)

The complex is surrounded by granite gneiss and diorite and comprises mostly carbonate rocks with a fenite halo surrounding it. The fenite halo indicates that contact metamorphism has occurred in the older granite rocks during and post intrusion stages (Figure 2).

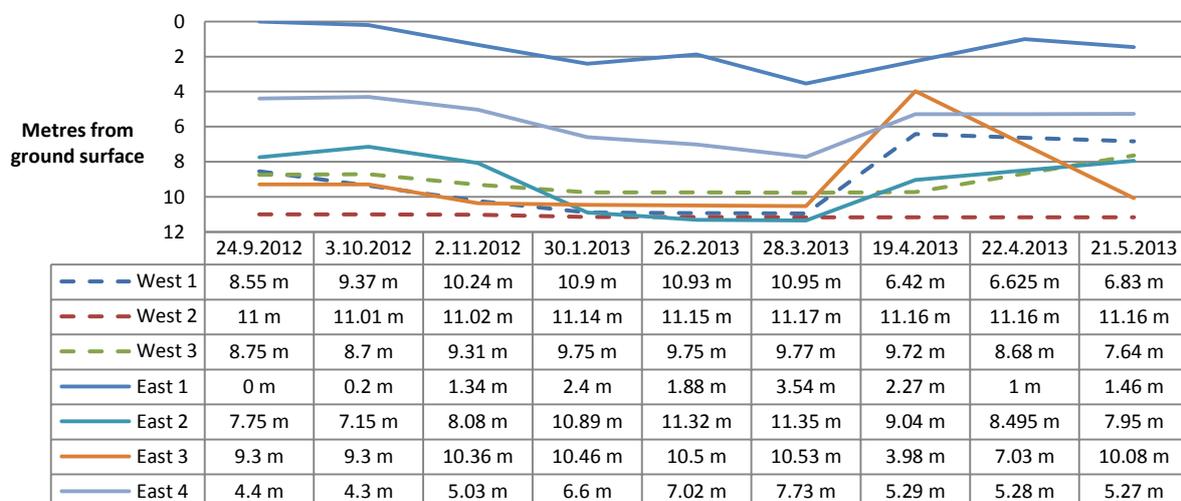
Figure 3 The seasonal variation in the groundwater levels at the open pit rim

The groundwater level is continuously monitored to record the seasonal highs in the water table. In Figure 3 is shown a part of the collected groundwater data from just outside the open pit rim. Monitoring points locate both in west and east side of the open pit. The seasonal variation is seen from the measurements. Similar measurement results are gained in the open pit (access ramps and production levels).

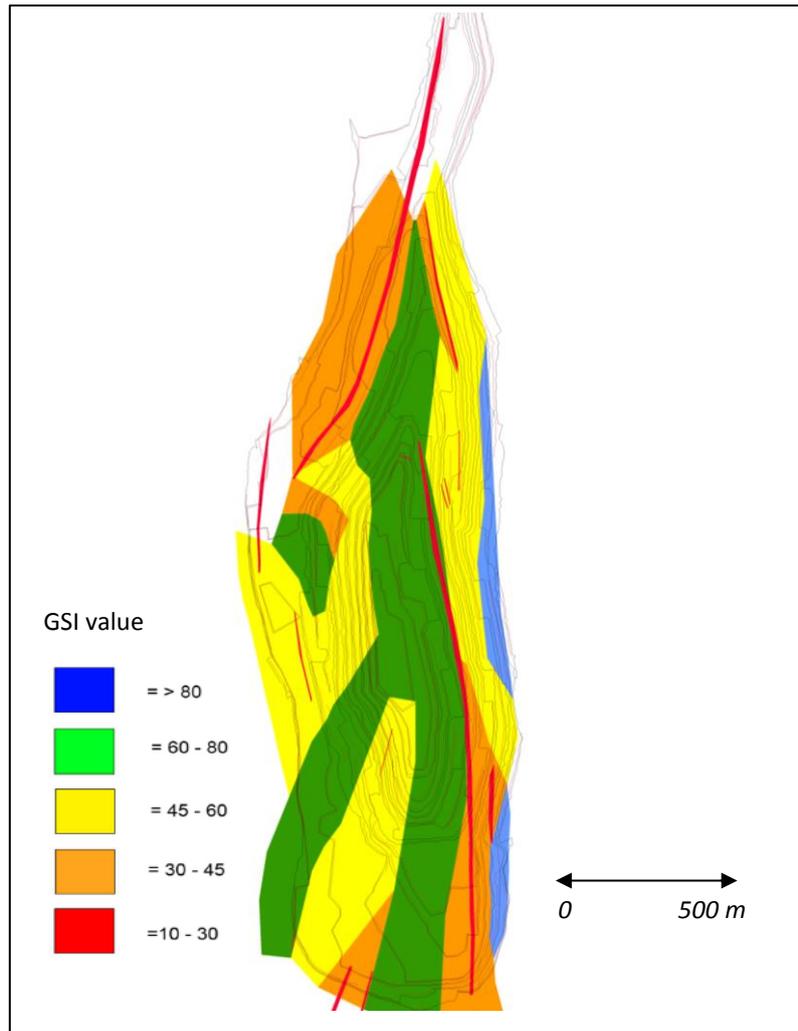
Figure 4 Simplified rock quality map of the Särkijärvi open pit

The goal of the open pit mapping was to create a simplified rock quality map for the open pit that would be useful in future numerical simulations (Figure 4). The idea was to map major faults and shear zones that could cause stability issues in the pit walls. It was previously known that the deposit had experienced post intrusion tectonics and there were many observations of major shear zones in the open pit area. Large shear zones were located in multiple separate zones both in the east and west pit walls. Shear zone thicknesses were ranging from 1 m up to 20 m.

The overall rock quality in the open pit varies from extremely poor to very good (Figure 4). The carbonate-glimmerite has rock quality of good or very good. As carbonate-glimmerites exist in the middle of the carbonatite complex/open pit, it has minor effect on the open pit wall stability. Most of the open pit walls consist of glimmerite rocks that have rock quality varying from poor to good excluding shear zones (glimmerite) that have rock quality of extremely poor to poor. The fenite has rock quality from good to very good. The fenite has only a minor effect on the pit wall stability as it occurs mainly outside of the open pit. In some parts of the pit there are fenite xenoliths seen in the glimmerite matrix. A mixture of xenoliths and glimmerite has caused some smaller bench scale stability problems. The glimmerite schist consists mostly of mica (phlogopite) that occurs in euhedric shape of sheets. The glimmerite has planes of weakness due to its slaty or sheet type texture that is the dominant structural direction, (north–south strike) observed within the whole deposit.

The cross section of the simulation was from the deepest point of the open pit. The uniaxial compressive strength of intact rock was 55 MPa and m_i value was 22. The Uniaxial compressive strength test samples were collected from few drill holes around the open pit. In the disturbed area the disturbance factor (D) was 1. The safety factor versus GSI value and ground water level is shown in Figure 11. The effect of GSI value was studied in the Phase 2 analysis. In the 3DEC analysis the different GSI values were based on distinct rock quality regions see Figure 4. The base case parameters for Phase 2 analysis are shown in Table 3.

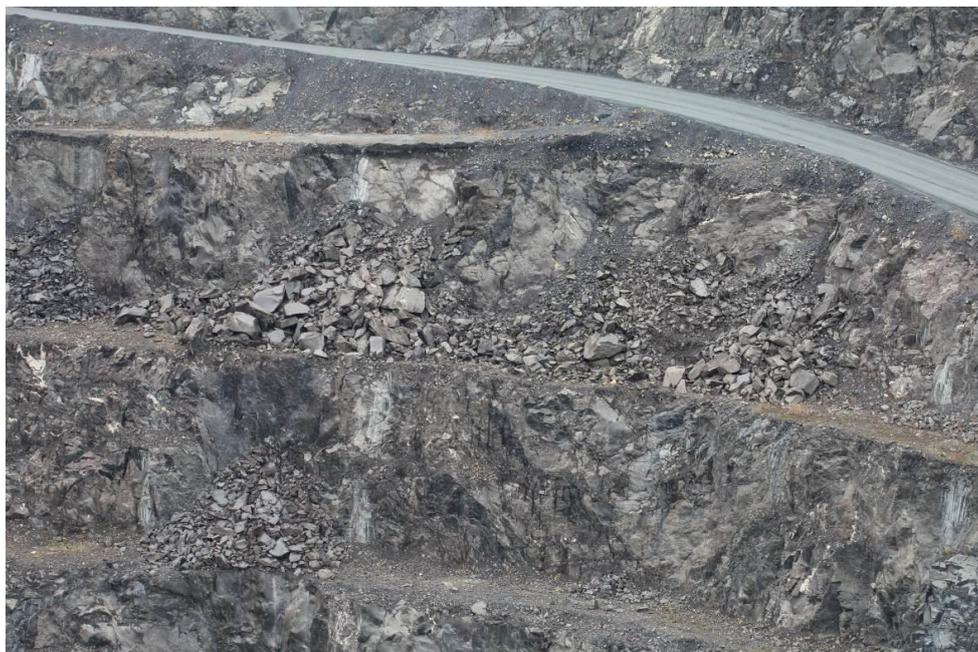
Figure 5 Wedge type failures in northwest – part of the main pit

In the 34 year history of the mine there have been several bench scale failures but also some multi-bench scale failures. The former have been typically wedge type failures on the west side of the main pit (Figure 5) and the latter planar failures in the eastern pit wall due to a major shear zone (Figure 7). During 2013, for safety reasons, the mine will acquire real-time slope monitoring radar.

The shear zones containing low friction joint surfaces have caused stability issues in the east open pit wall mostly in size of one or two bench scale. Similar issues have been noted in the west open pit wall but in less extend. In the northeast part of the open pit the major shear zone has caused multiple bench scale pit failures (Figures 5–7).

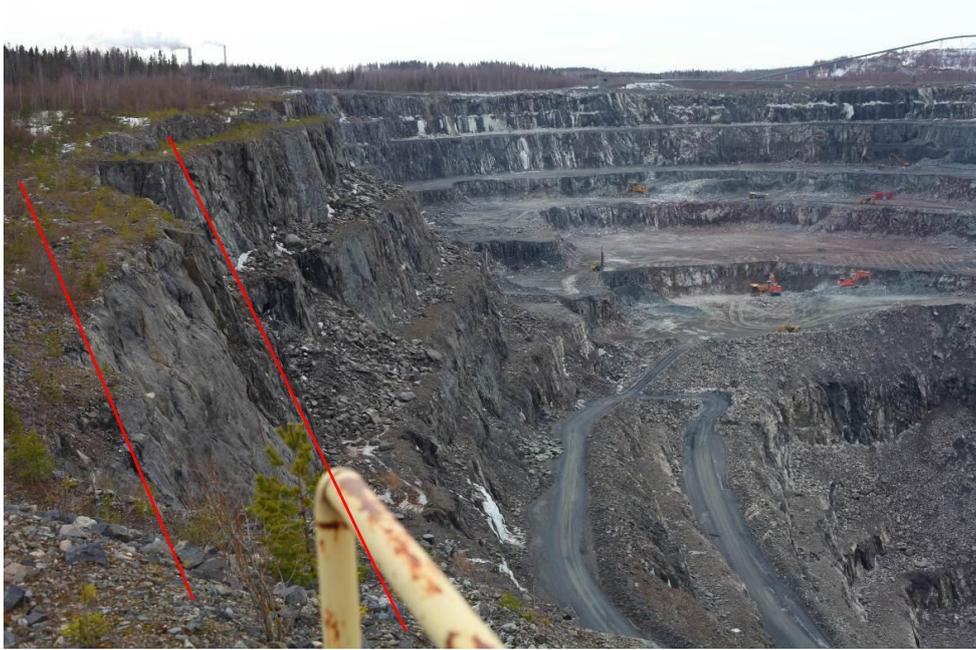
Figure 6 Planar type failure in east pit wall. Most of the shear zone has collapsed

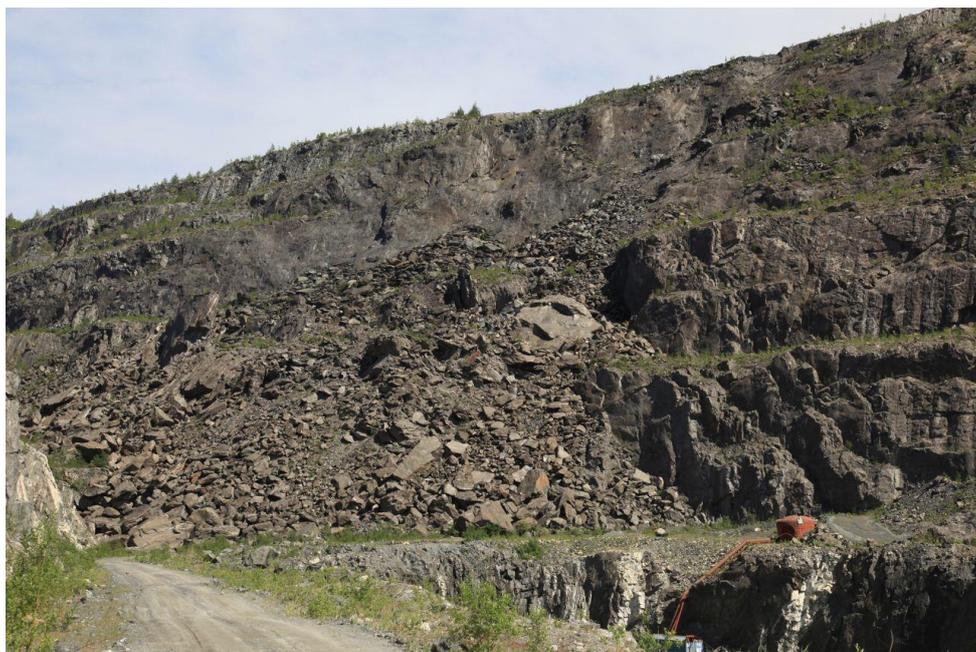
Figure 7 Pit wall failure (April 2002) in northeast – part of the main open pit caused by the major shear zone in the east wall

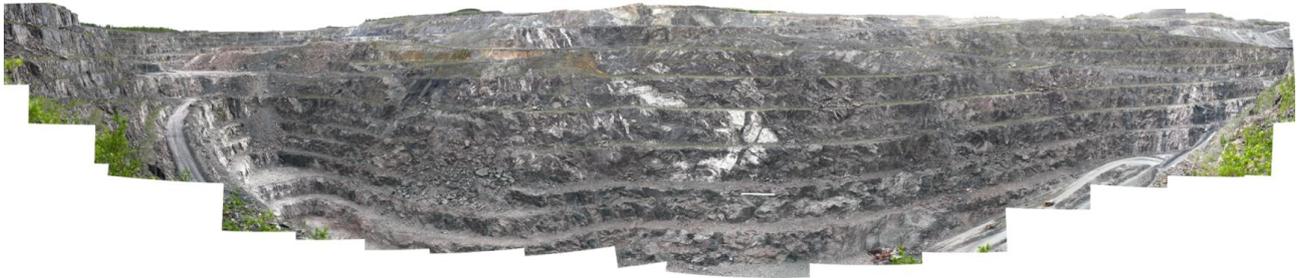
Figure 8 The Särkijärvi open pit west wall. A panorama of multiple photos, f = 8, 100 mm objective. Length of the area in picture approximately 2.5 km (left to right end)

To aid geotechnical mapping the whole open pit was photographed using 3D-photogrammetry method by Adam Technology. A relatively quick method for mapping gave a good understanding of the pit wall geology and the rock quality. The pit was photographed before the geotechnical mapping in the pit was commenced providing geologists a good overall picture of the pit before mapping (Figures 8–9).

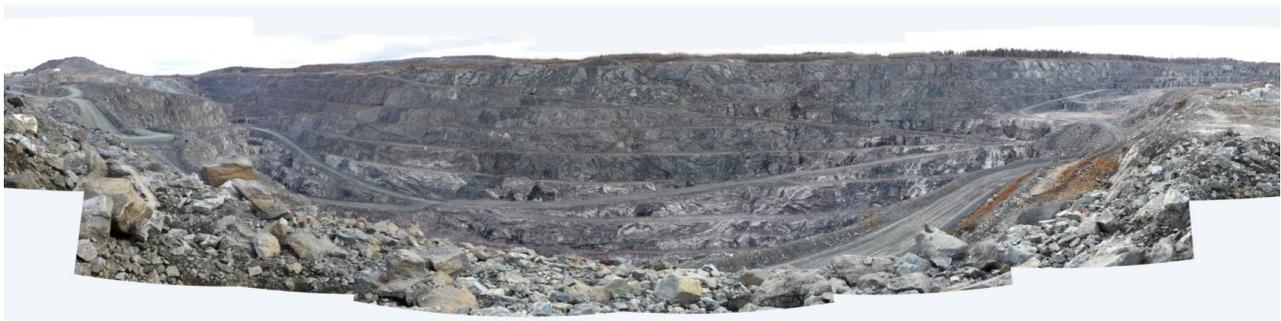
Figure 9 The Särkijärvi open pit east wall. A panorama of multiple photos, f = 8, 70 mm objective. Length of the area in picture approximately 3 km (left to right end)

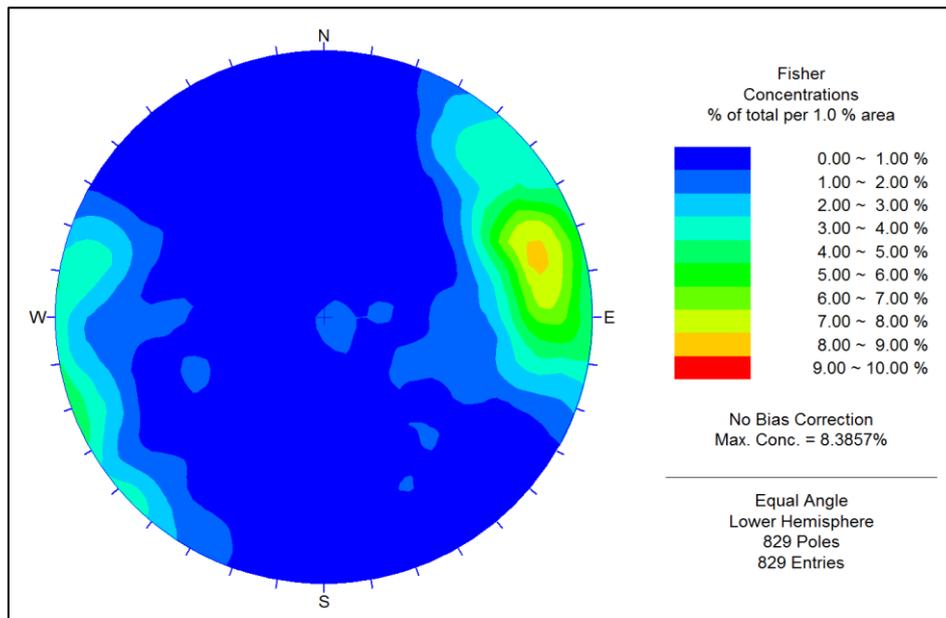
Figure 10 A lower hemisphere projection showing average dip and dip direction in the open pit

Using the 3D-models it was clearly noted that carbonate rich rocks had better rock quality, lower water seepage amounts and lower number of previous bench failures than the carbonate poor glimmerite rocks. It was also noted that most of the shear zones occurred in the glimmerite rocks. A general dip and dip direction for joints was also mapped from the 3D-models. The general joint dip was varying between 70–90° dipping to the west or to the east and having the same strike direction as the foliation direction of the deposit (Figure 10). The major joints including continuum information were imported to the 3DEC analysis models.

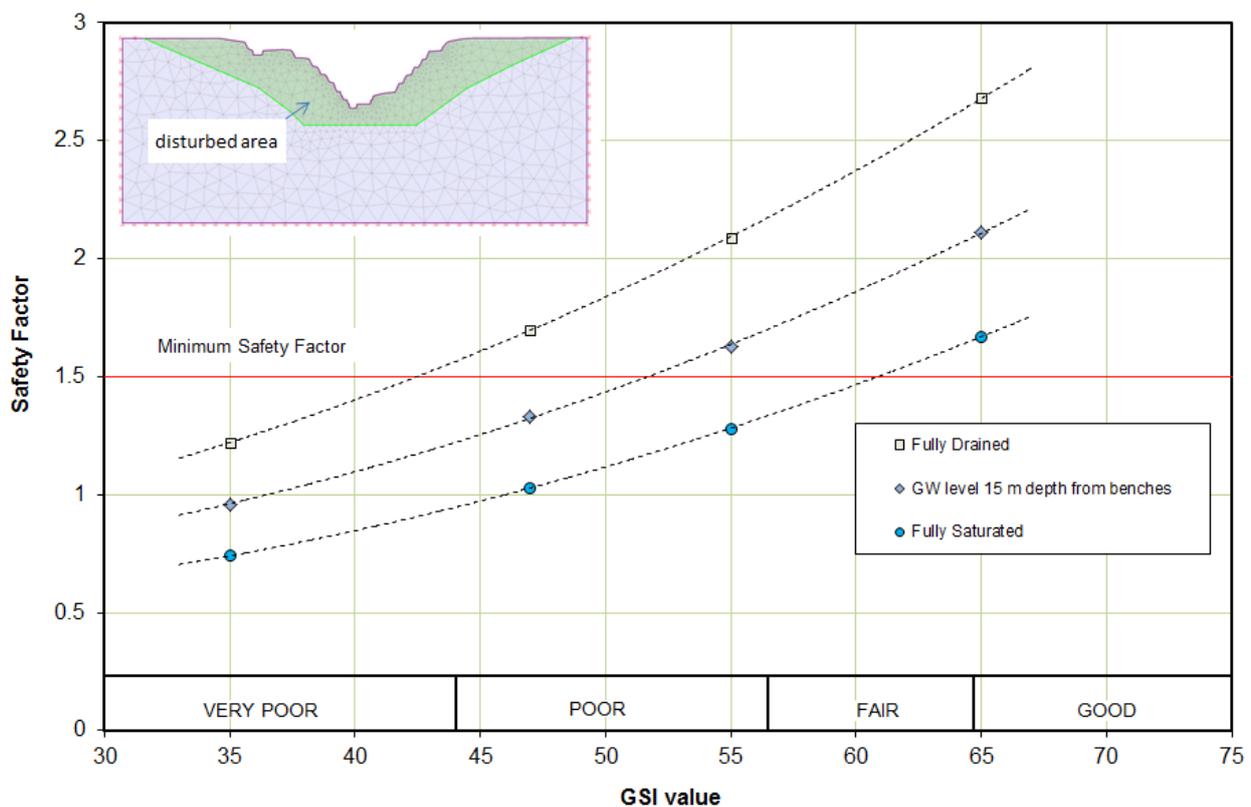
Figure 11 Safety factor versus GSI value with different ground water conditions

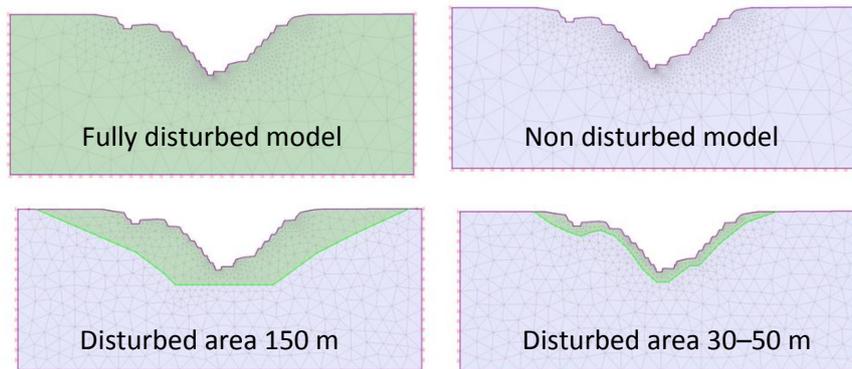
Figure 12 The disturbed areas in the Phase 2 models. Dark area is the disturbed area $D=1$. Light area is the non-disturbed area $D=0$

The Phase 2 analysis were performed as a non disturbed rock mass model and fully disturbed rock mass model and their varieties (Figure 12). The base case analysis were performed using disturbed area that extends up to 150 m to the rock mass from the pit walls.

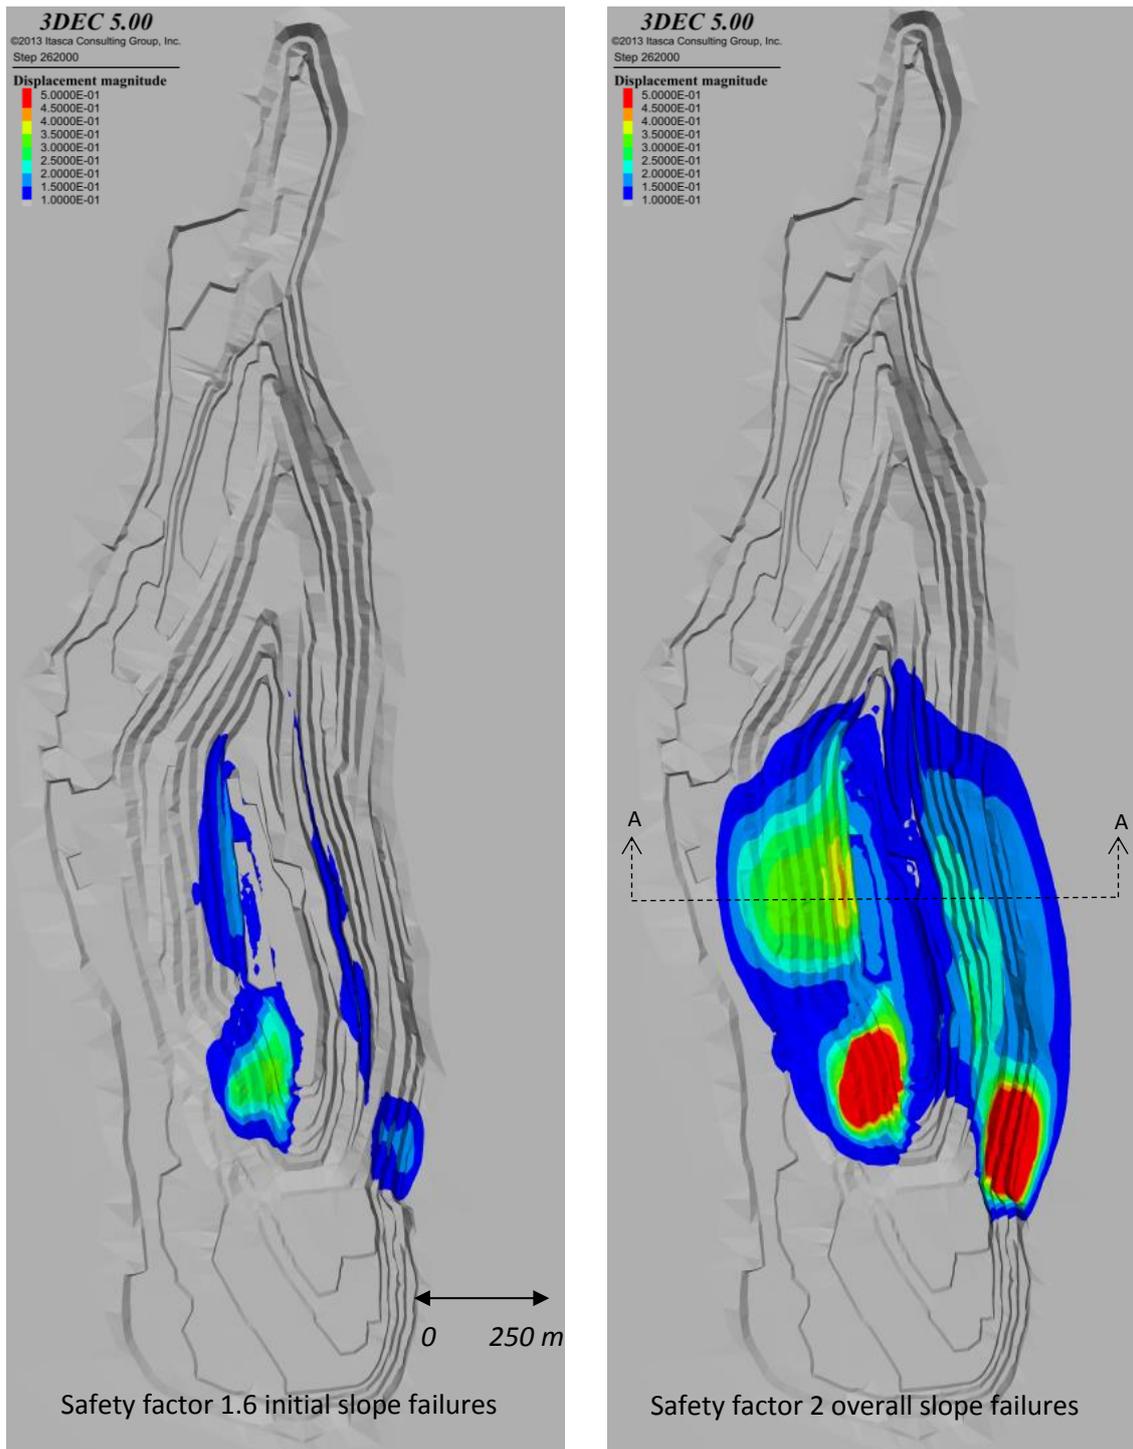
Figure 13 Simulated failed areas in 3DEC in drained conditions. The initial failed areas after strength reduction are seen in the left image. Further developed failures are seen on the right image. The velocities are no longer balanced therefore the amount of displacements is crowing in non-balanced areas

The lowest safety factor was found to be in the weak rock mass area where safety factor for overall stability was 1.6 for the saturated slope and approximately 1.9 for the drained slope. The lowest Factor of Safety area was in the southwest open pit area that has previously had minor bench failures. For individual benches the lowest safety factors varied from <1 to 1.2. In Figure 13 is shown the initial failures in drained conditions after strength reduction (safety factor of 1.6) and further developed overall slope failures after additional strength reduction (safety factor of 2). Cross section (A) of the overall slope failures is shown in Figure 14.

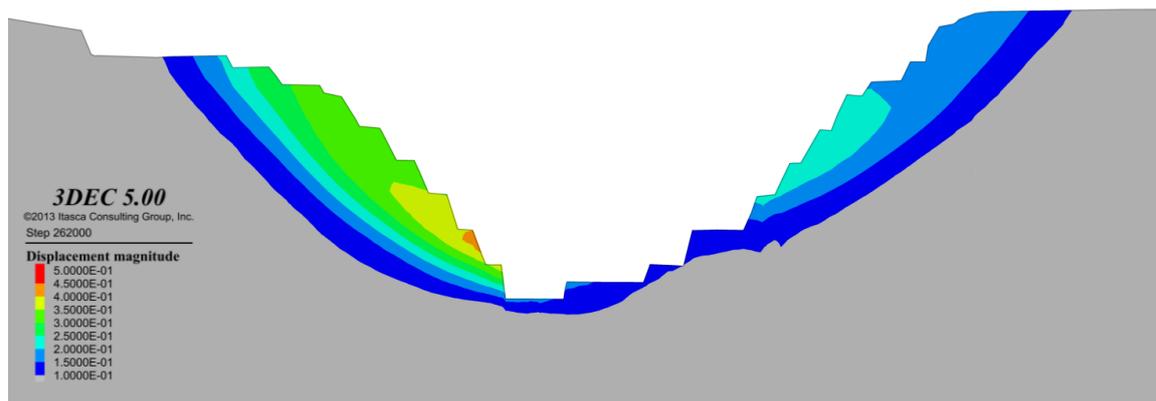
Figure 14 Cross section A-A of the open pit after overall slope failure. The velocities are no longer balanced in areas where displacements are greater than 15–20 cm
