Stability analysis and remedial design of two road cuttings in North Queensland based on remote geotechnical mapping using digital photogrammetry

Abstract

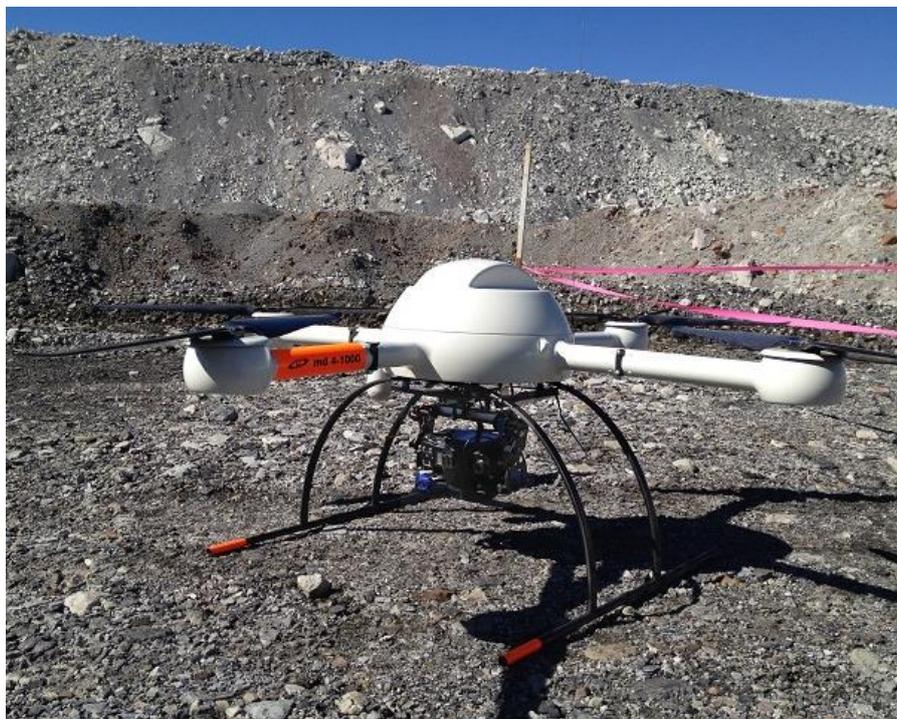
Figure 1 Unmanned Aerial Vehicle (UAV) used in both investigations (courtesy of Helimetrex Pty Ltd)

In the case of the Rex Lookout and Yule Point, photography for both sites was captured using an Unmanned Aerial Vehicle Survey, owned and operated by a specialised aerial photography contractor. Use of the UAV provided benefits in cost, safety and logistics as compared with using a conventional helicopter. Figure 1 shows the UAV which was used in both sites.

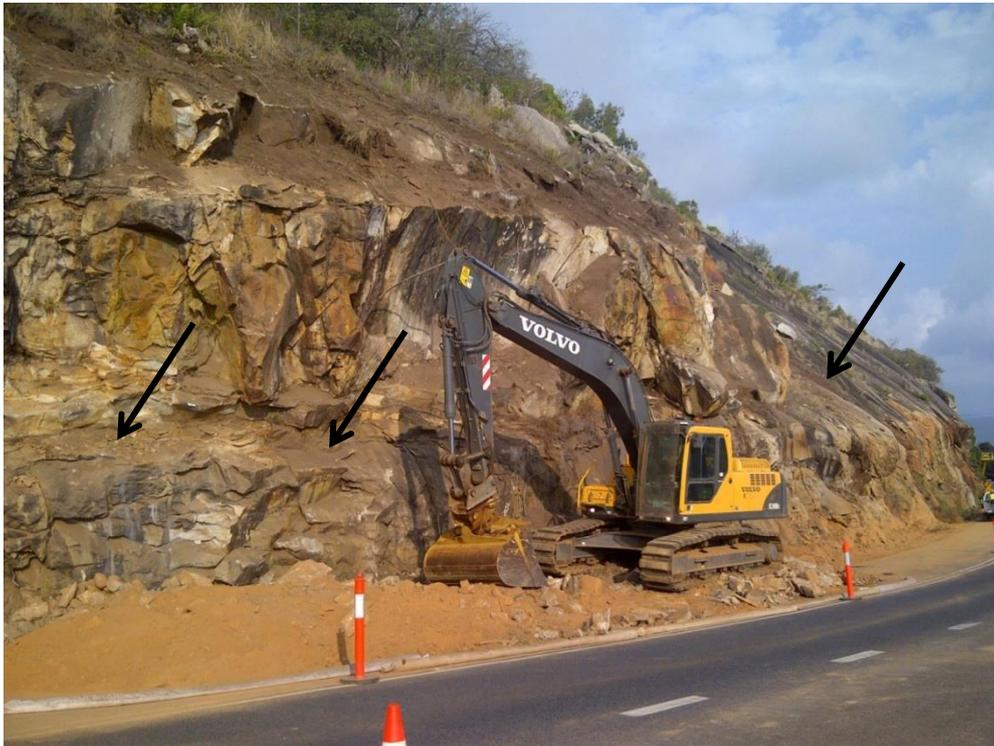
Figure 2 View of the northern section of the Rex Lookout site. The exfoliation joint exposed in the cutting extends to form the natural ground surface to the rear of the excavator

Rock exposed in the near-vertical road cutting contains joints that intersect to form high strength rock blocks up to 5 m across. A prominent exfoliation (stress relief) joint oriented sub-parallel to the natural surface dips out of the cutting, and extends to form the natural ground surface to the north of the site. The rock in the cutting was apparently damaged by overcharging blast holes during the original construction. The ground surface north of the cutting is interpreted to have formed as a result of a landslide controlled by the extension of the exfoliation joint in the cutting. The photo in Figure 2, taken immediately following heavy scaling of loose rock blocks, illustrates these geometric conditions.

The potential for a planar failure mechanism is evident by simple inspection of Figure 2. Figure 3 provides the stereographic representation of the main joint defects. The kinematic admissibility of the planar failure is quickly revealed by the undertaking of a classical static analysis. The planar failure was assessed by means of a static equilibrium calculation. An initial geometry of the failure was disclosed by comparing cross sections from different chainages of the site. To illustrate this, Figure 4 shows a superposition of two cross-sections, along with a basic sketch of the failure mechanism with indication of some of the parameters with an influence on the resulting Factor of Safety.

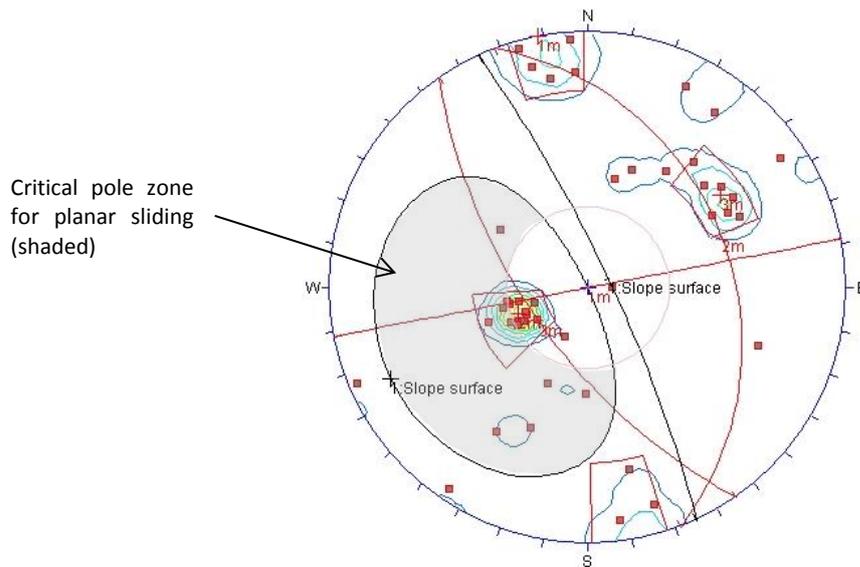
Figure 3 Stereographic projection view of the rock discontinuities in one section of the Rex Lookout site. The potential a planar failure is highlighted

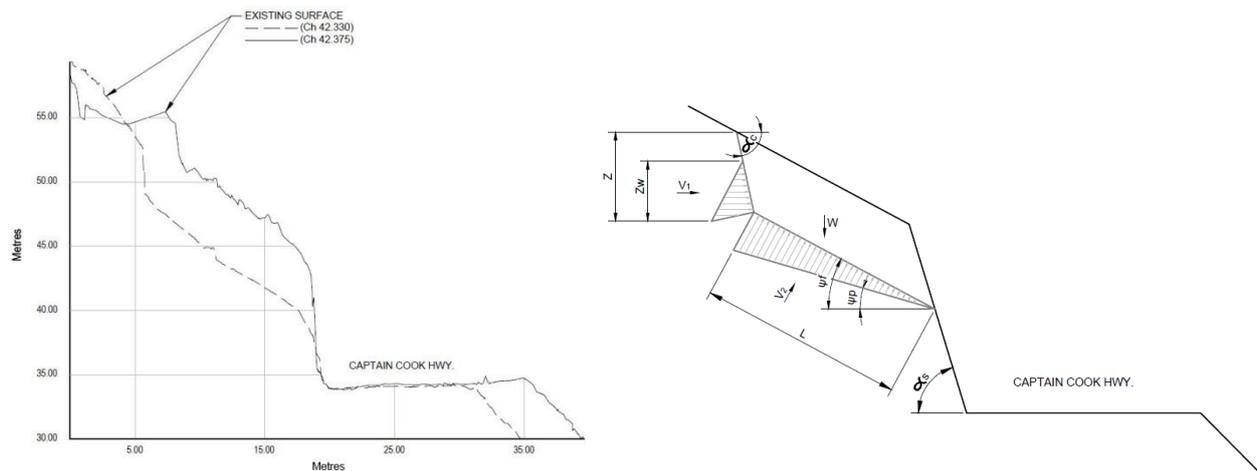
Figure 4 Approximate determination of the planar failure mechanism in the Rex Lookout site by comparison of two cross sections, and sketch of the simplified geometry with some of the parameters with influence in the resulting Factor of Safety

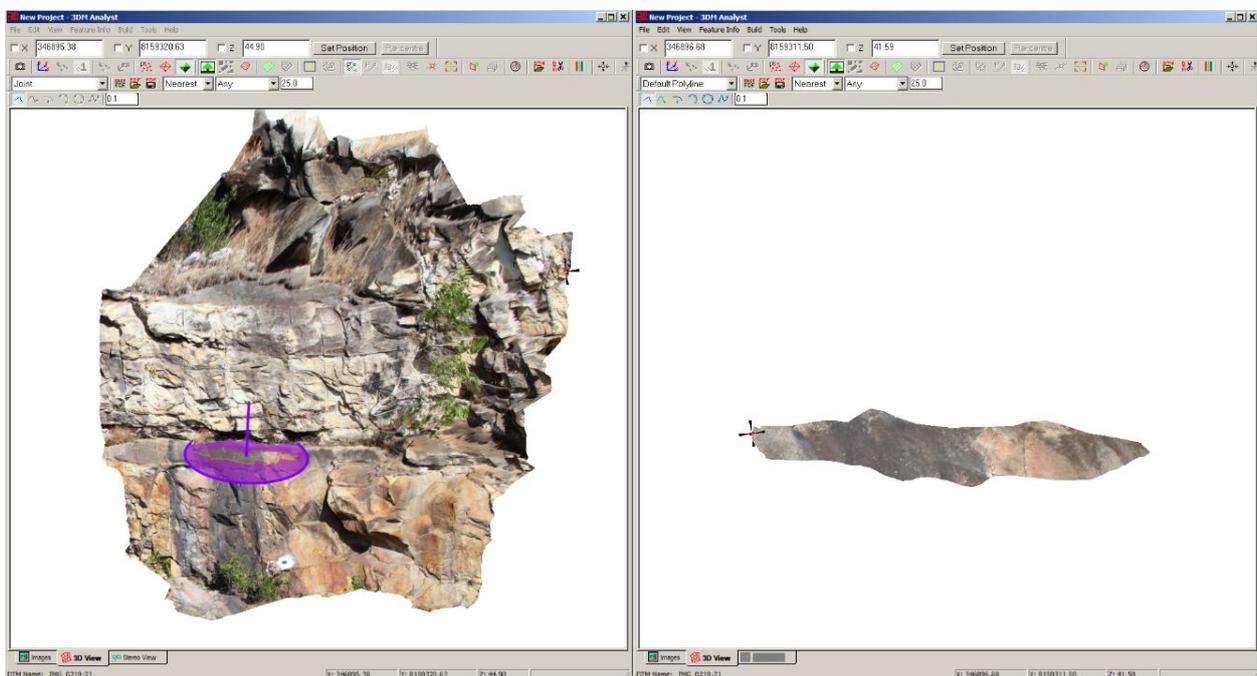
Figure 5 Location of one of the spots where the basal joint is exposed

Figure 5 shows the location of one of the spots where the joint roughness was assessed, which corresponds to the basal joint surface. The digital disk is oriented parallel to (local orientation) and on the joint in question. A detailed view of the joint surface is also presented in the same figure. Figure 6 shows a 3D view of the surface topology of the exposed joint surface, and a profile of the basal joint selected in Figure 5.

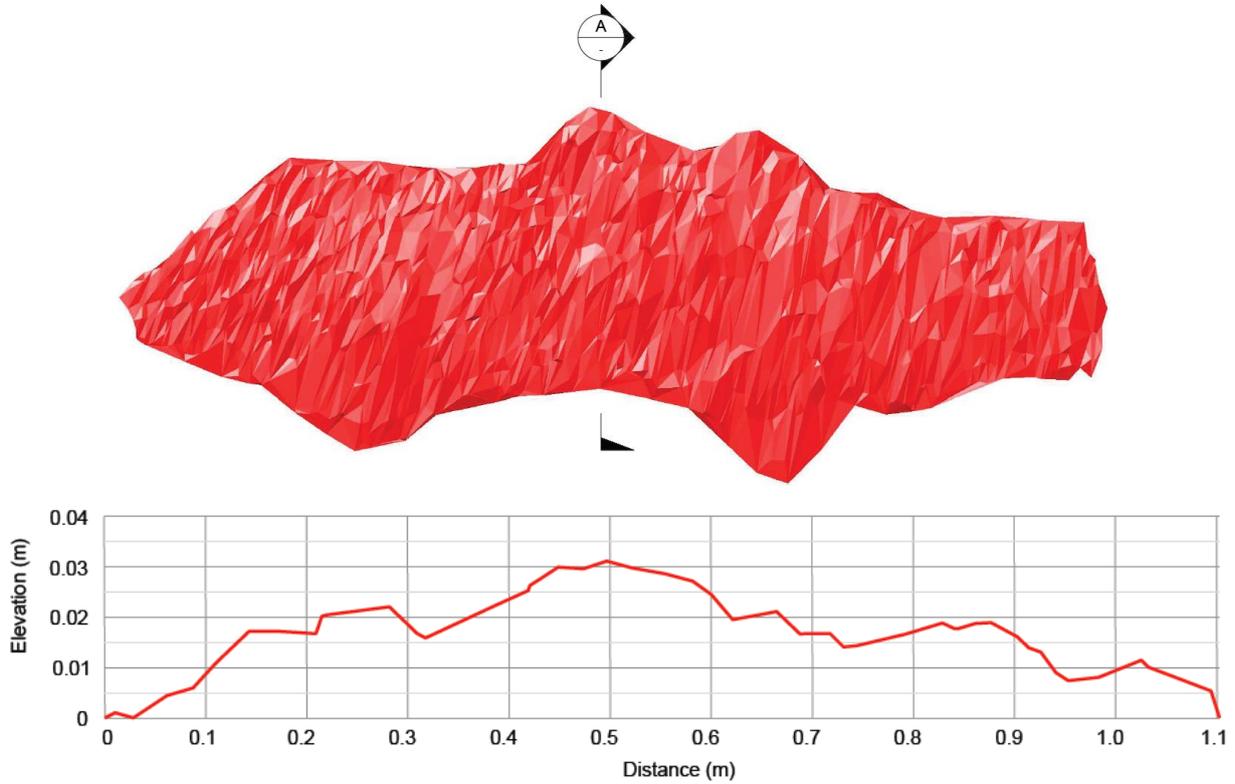
Figure 6 3D view of the joint highlighted in Figure 4 and cross profile in the direction of the probable failure movement (section A)

From this result, JRC can be estimated using the measurements of surface roughness amplitude from a straight edge (Hoek, 2007). As an example, the central section (0.2 to 0.9 m) of the profile in Figure 6 would provide a roughness amplitude close to 15 mm, which would lead to JRC in the order of 10.

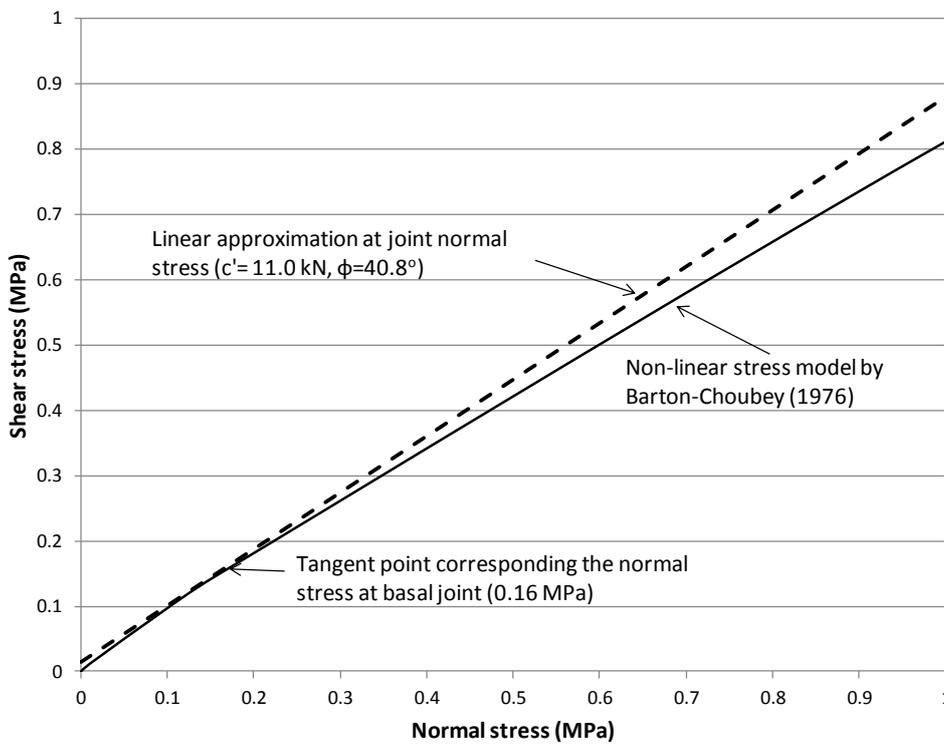
Figure 7 Linear approximation of the non-linear stress relation (Barton and Choubey, 1977) at the mean normal stress acting on the basal joint

Summarising the previous results, Figure 7 presents the graphic representation of Equation 1 for one set of parameters included in the sensitivity analysis approach. A linear stress relation is derived by drawing a tangent to the Barton–Choubey non-linear curve at the estimated normal stress acting on the basal joint.

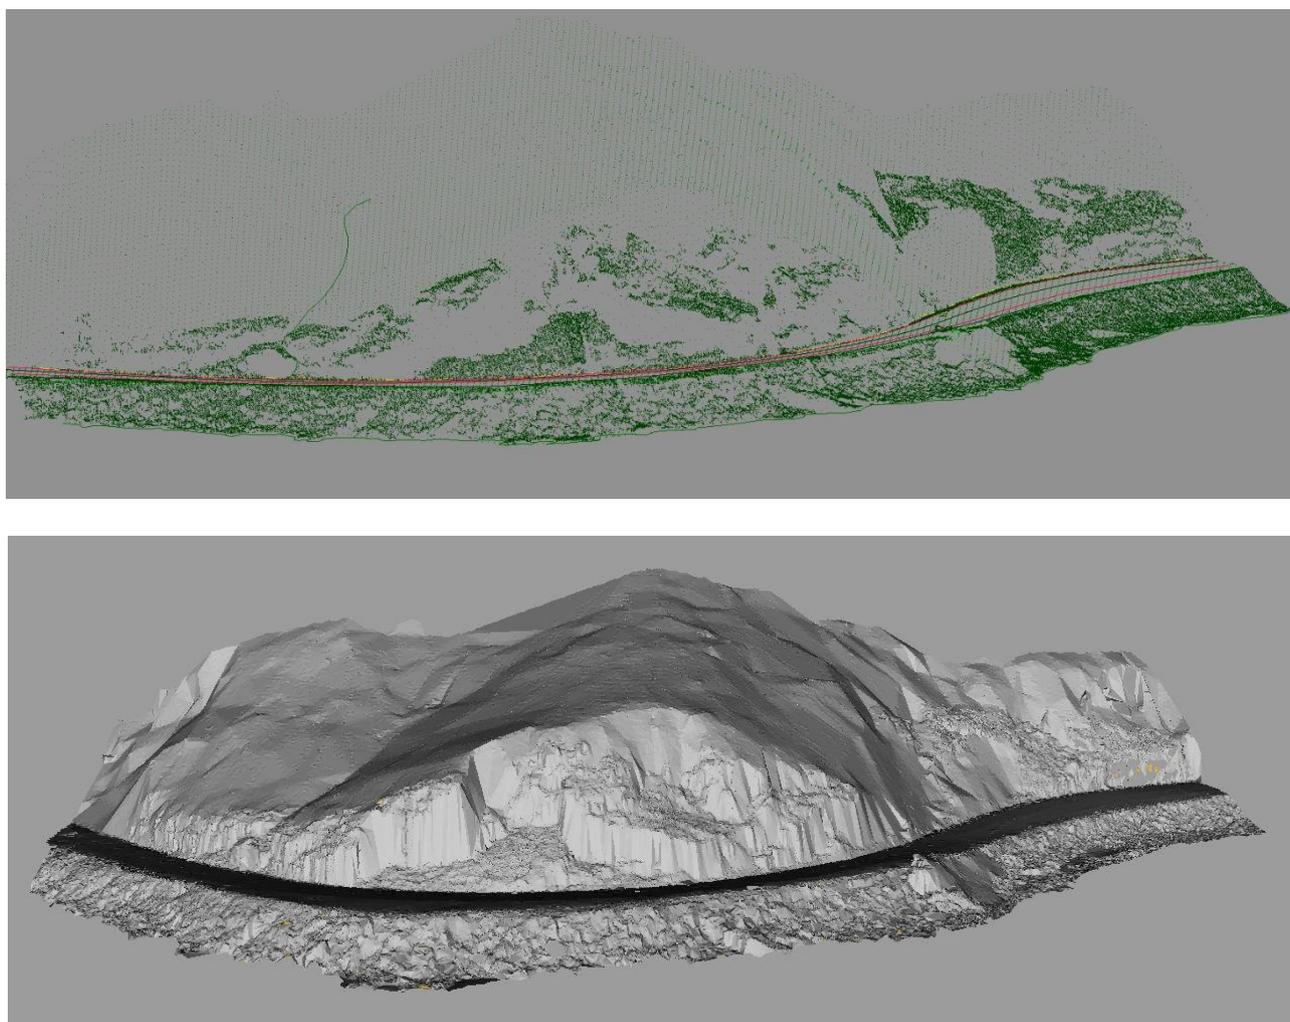
Figure 8 View of the Yule Point site as deduced from the DTM information (point cloud and surface model)

The Yule Point site is located just north of Pebble Beach and about 12 km south of Port Douglas. Regional mapping indicates that the site is underlain by Devonian age Hodgkinson Formation. Hodgkinson Formation rocks are described as variably metamorphosed sedimentary rocks consisting of argillite, quartzite, mica schist, phyllite, greywacke, arenite with occasional bands of marble. Rocks exposed on site are predominantly consistent with the regional mapping, although it appears that the lower part of the cutting is more intensely metamorphosed and less weathered. The foliation partings in the metasedimentary rocks, the predominant structural feature on site, dip steeply (50 to 60°) toward the southwest, consistent with regional mapping. Joints dipping out of the slope intersect with the foliation to form medium to high strength blocks up to about 6 m in maximum dimension and ledges with overhanging faces. Figure 8 presents a view of the site generated by the photogrammetry data.

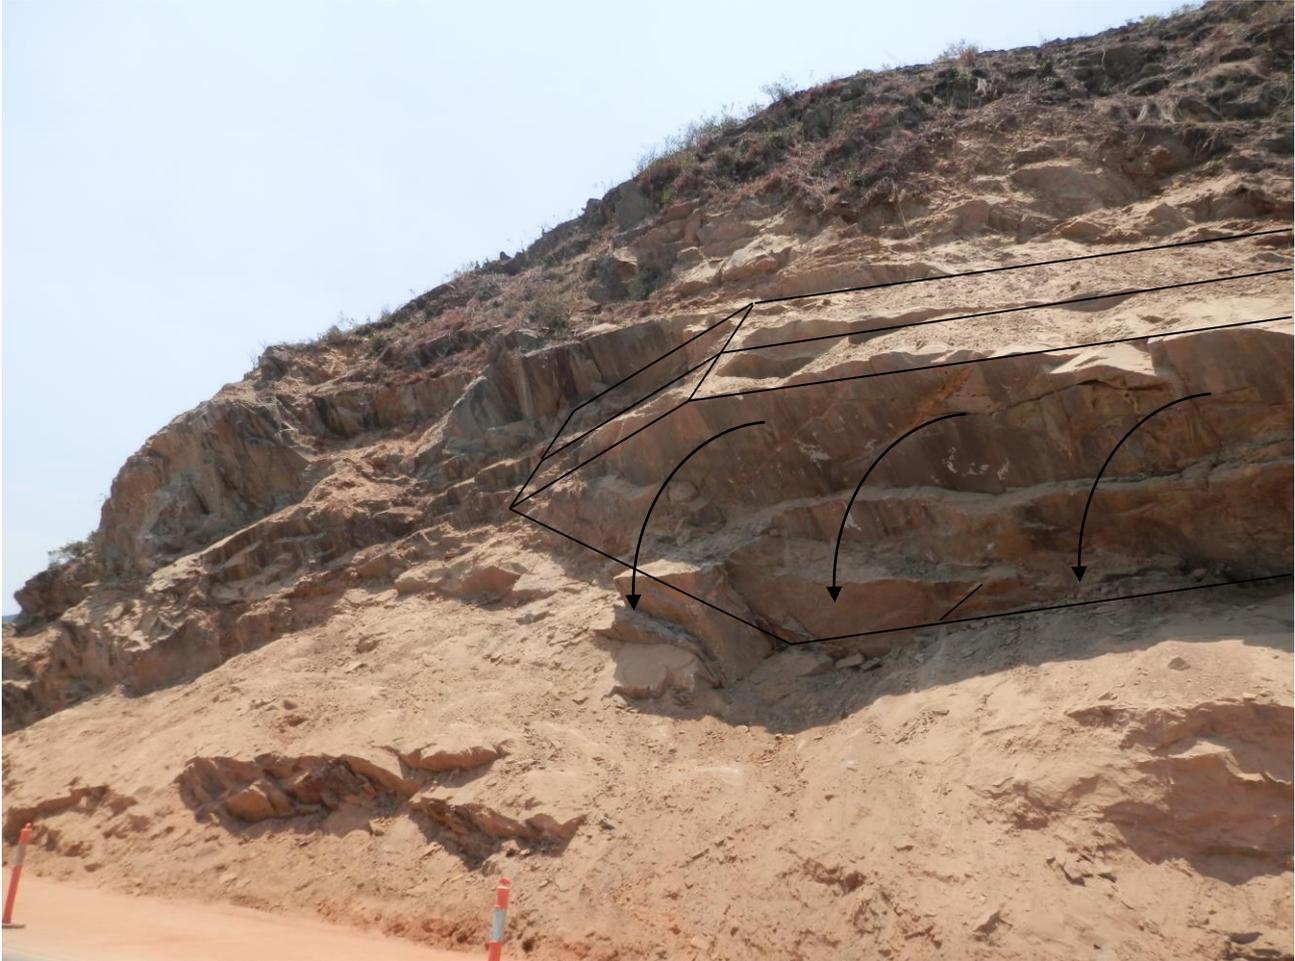
Figure 9 Example of the geometry of Yule Point cuttings. The boundaries of the first slices involved in a probable toppling mechanism are indicated in black lines

The configuration of the rock joints in this area provides the geometric conditions for a toppling failure mechanism to occur. Figure 9 presents a view of the cuttings in the middle section of the site. The potential for toppling failures is evident by simply noting the height and the dip angle of the unsupported rock slabs that configure the lower levels of the slope surface.

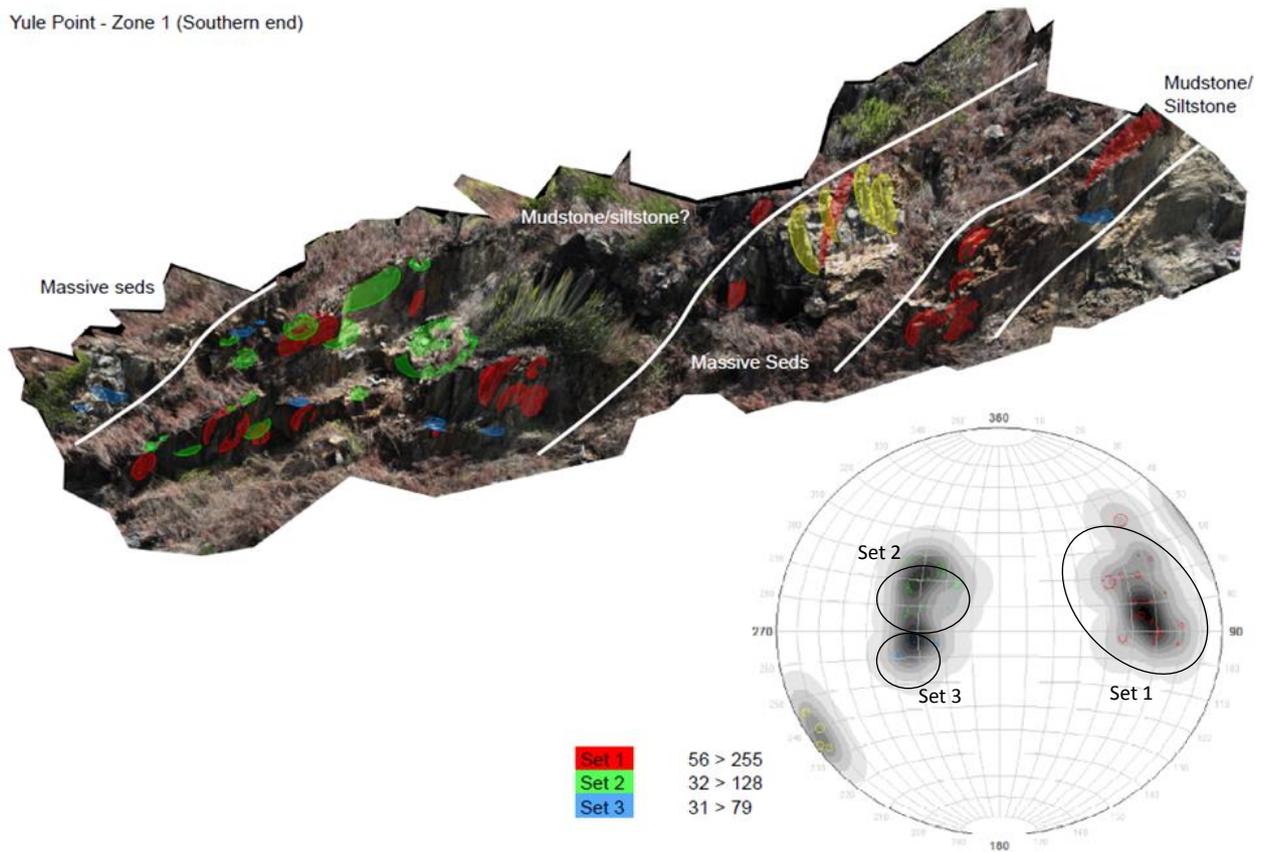
Yule Point - Zone 1 (Southern end)

Figure 10 General view of one of the sections on Yule Point site. Stereographic projection of the main joints in the area is also indicated

The potential for the toppling mechanism is confirmed by the stereographic projection of the rock joints in Figure 10. The possibility of a toppling failure is evident from a static analysis of the joint spatial distribution.

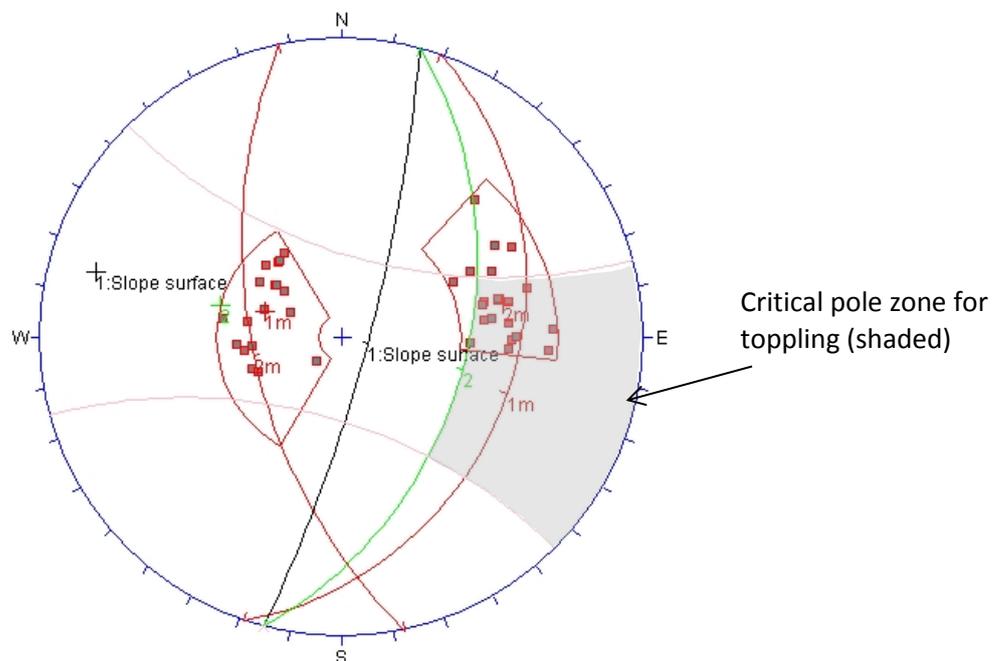
Figure 11 Detailed stereographic projection of the rock discontinuities in the same area as Figure 10. The risk of a toppling failure is highlighted

The toppling mechanism has been assessed by means of the classical approach by Hoek and Bray (1981). The basic parameters of this analysis are the shear capacity of the joints (cohesion and friction angle) and the geometry of the discontinuities (dip direction, dip angle and joint spacing). Figure 11 presents a basic definition of the toppling mechanism corresponding one of the assessed cross-sections.

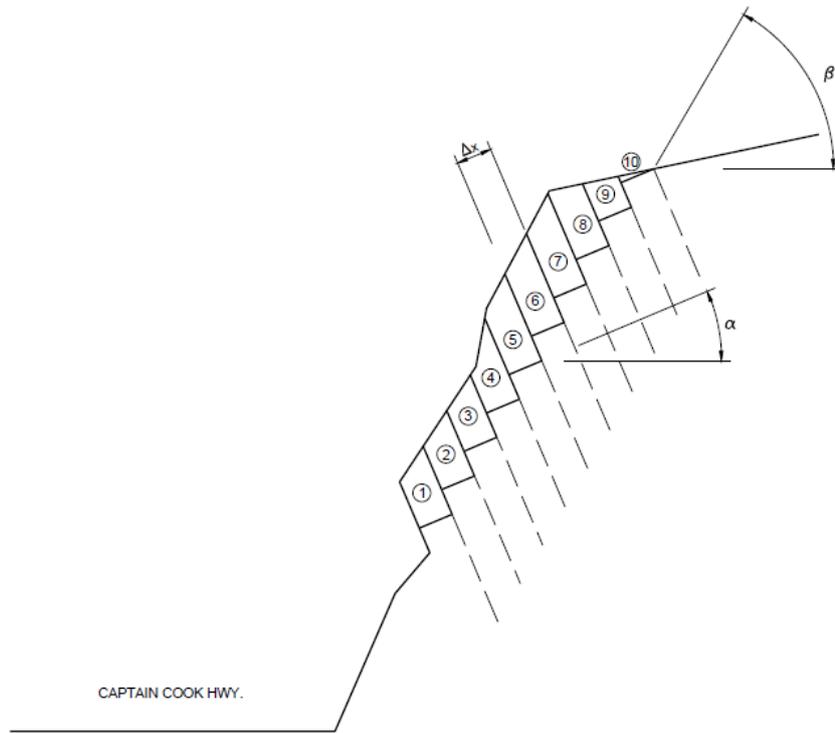
Figure 12 Example of a simplified geometry of a toppling mechanism used to model one of the Yule Point analysis cross sections. Key geometric parameters are indicated (Δx , spacing of discontinuities; α , dip of basal joint; β mean failure dip angle)

To illustrate this, Figure 12 shows the simplified geometric model of one cross section that was considered in the analysis. The main parameters with an influence in the evaluation of the Factor of Safety are indicated in the figure. Most of them can be checked or derived from the information provided by the DTM.

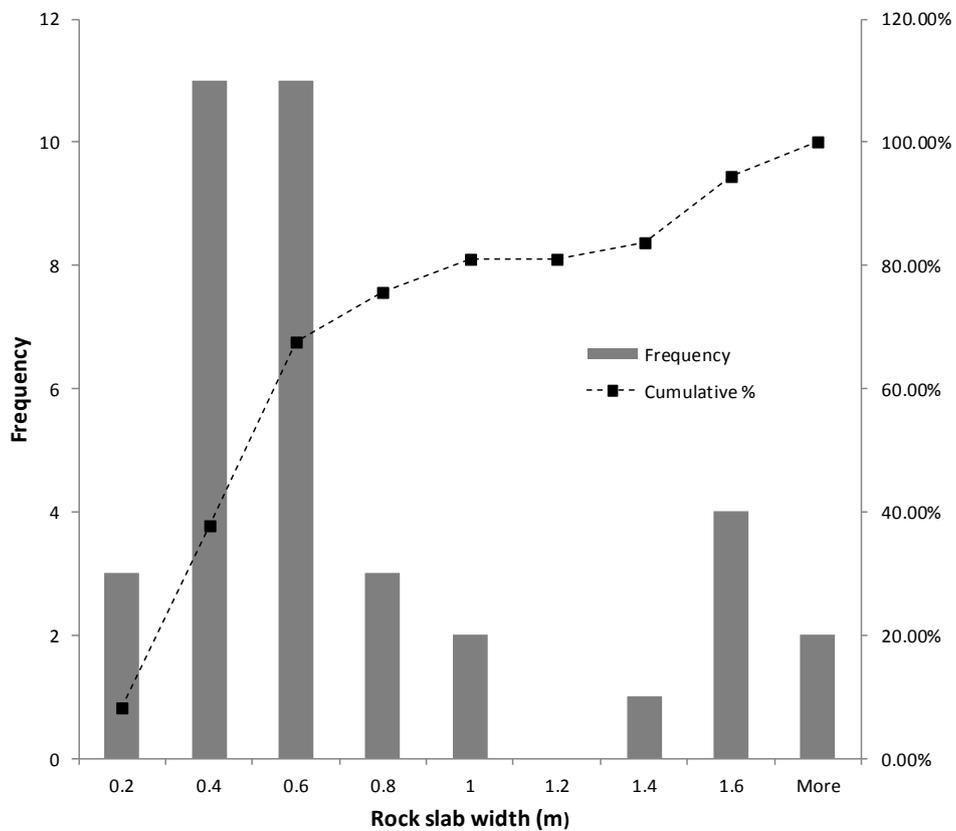
Figure 13 Histogram of the rock joint spacing at the section on Figure 10 (Set 1). Data provided from the DTM

As expected, the stability analysis of this mechanism revealed that one of the key parameters influencing the resulting Factor of Safety is the width of the rock slabs involved in the toppling. Figure 13 presents the histogram of the measured joint spacing data obtained from the photogrammetric mapping. This histogram can be used to assign a design value based on a risk assessment of the slope.
