West Gully Upper – innovative rockfall and debris flow protection systems

H.P. Anderson Geovert Ltd, New Zealand

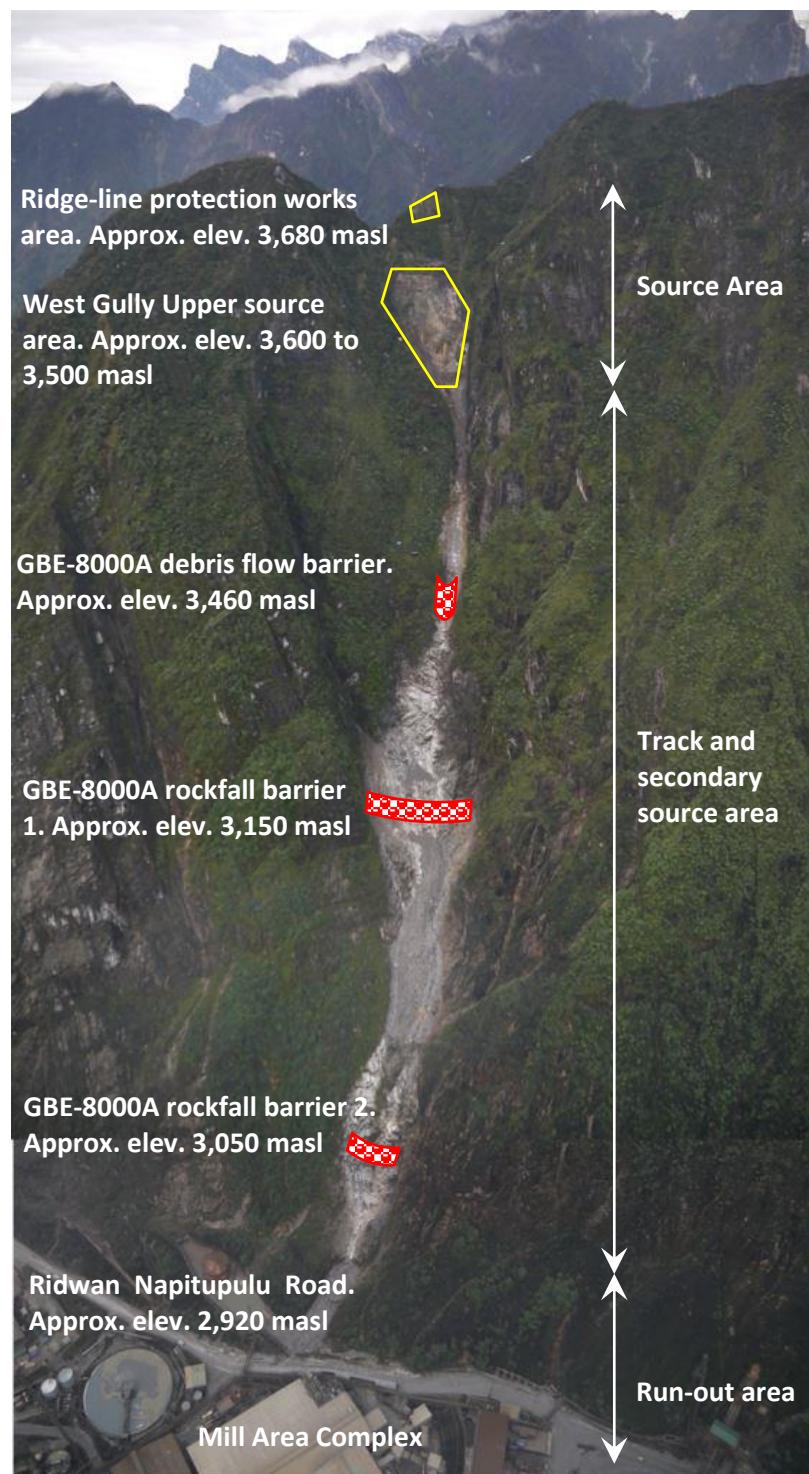
Figure 1 An oblique aerial photo of the eastern aspect of this range showing the West Gully project site: Ridge-line protection works, West Gully Upper source area, west gully track and run-out into the Mill Area production plant complex. Existing SPIDER® NET S4-230 (Geobrugg, 2013) installation of ridge-line and West Gully source area are annotated by the yellow outlined areas. Proposed locations are annotated for the GBE-8000 (8,000 kJ) debris flow and rockfall barriers. The West Gully upper camp is on the western aspect of this range (other side over the ridgeline)

The West Gully project site is essentially divided into the three main work packages representing solutions for particular areas as annotated in Figure 1 and outlined below:

Rockfall modelling identified three ideal locations to construct 8,000 kJ barriers, as shown in Figure 1, in order to enhance Mill Area protection and overall system contingency. Software used was ROCKFALL 7.1 beta software by Dr. Spang GmbH. This 2D software was utilised due to the narrow characteristic of the West Gully; 3D modelling was not considered beneficial for this particular assessment. This modelling focused on the location of the three barriers (2 × rockfall and 1 × debris flow) to maximise catch effectiveness through assessing bounce height and impact energies for various size rockfall events. Figure 10 is an example of the ROCKFALL 7.1 beta simulation with the GBE-8000A Rockfall Barrier effectively retaining material.

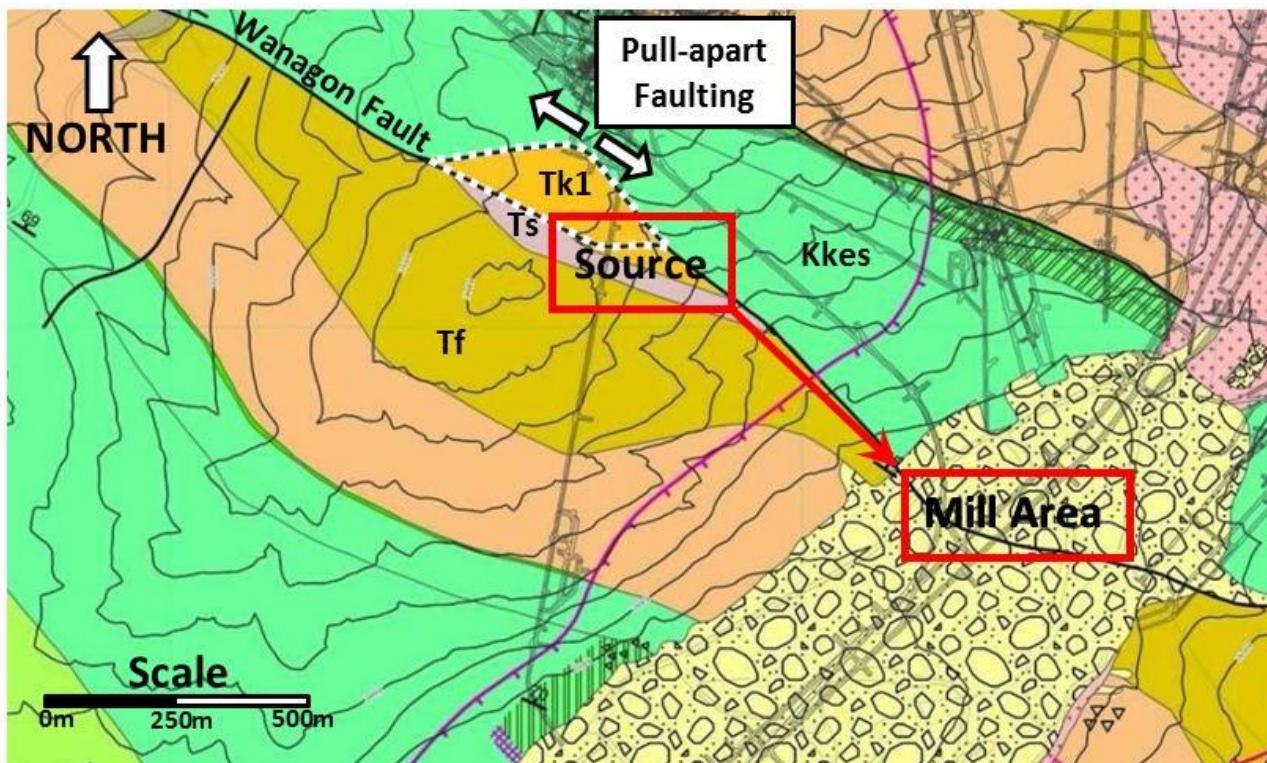
Figure 2 PT Freeport Indonesia contract of work a geologic map supplied by PTFI with underground mine infrastructure superimposed on. Source: Warren (2011) presentation. Annotations: red box 'source' = West Gully Upper source area for rockfall and debris flow, red arrow indicates direction of rockfall and debris flow trajectory down the West Gully itself, red box 'Mill Area' = Mill Area and associated infrastructure threatened by these geohazards at the run-out of the West Gully, Kkes = Ekmai sandstone, Tk1 = kais formation limestone, Ts = sirga formation sandstone and shale, and Tf = faumai formation limestone. Sinistral pull-apart faulting at this bend in the wanagon fault is annotated

PTFI's Grasberg Mine is situated at the convergence of the Indo-Australian and the Pacific tectonic plates. Over time two phases of igneous intrusions have developed both igneous and sedimentary hosted ore bodies. Figure 2 shows the geological setting of the West Gully project site, with the West Gully Upper 'source' area and 'Mill Area' annotated for reference.

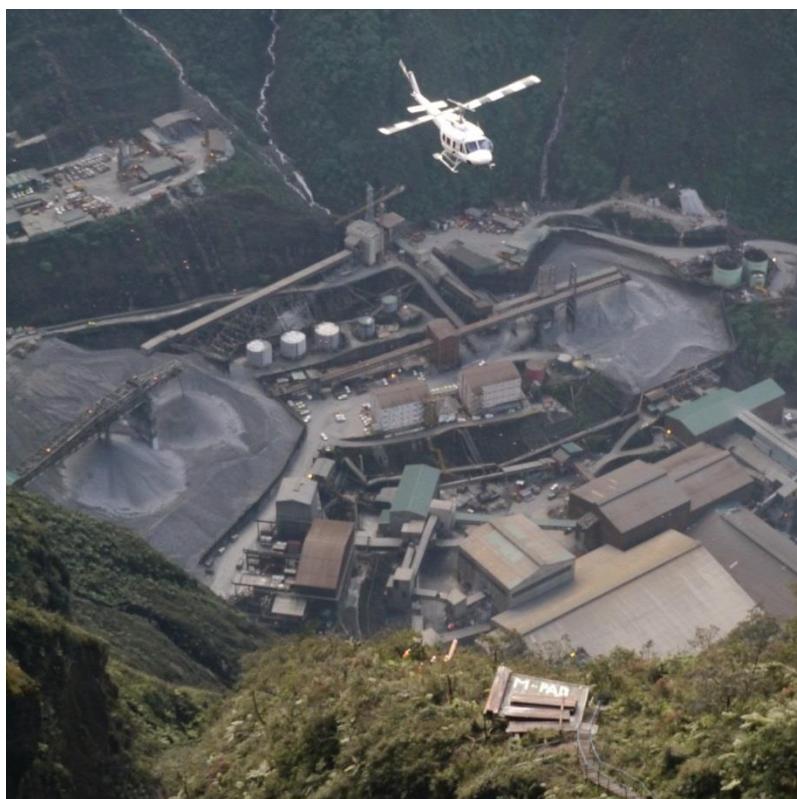
Figure 3 Bell 212 Eagle Huey delivering wood to allow construction of material pad D2 above the Mill Area complex. This helicopter is a critical tool used for the West Gully project with no road and very limited foot access to the project site and support camp

Both the West Gully Upper source area project site and West Gully Upper camp are located at approximately 3,600 masl. The source area work site is on the eastern aspect and the camp (established by PTFI) is on the western aspect of the ridge separating them. Road access is not feasible to either the camp or project site. Therefore project execution was completely reliant on Helicopter assisted deliveries of all materials, equipment, personnel and camp amenities. Figure 3 below captures the Bell 212 Eagle operating above the Mill Area complex for the West Gully project.

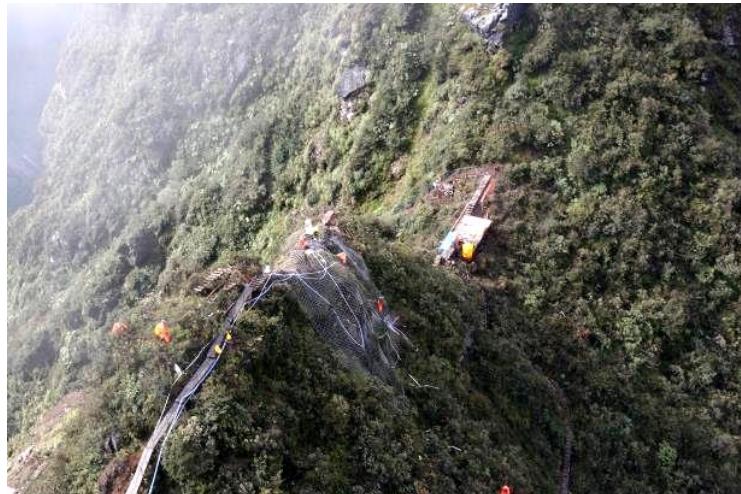
Figure 4 Work in progress on ridgeline protection with installation of SPIDER® NET S4-230 mesh above the West Gully camp. Mesh anchored with RB20 mm

Immediate mitigation works were carried out to reduce this risk to a tolerable level. Active and Passive SPIDER® NET S4-230 installation was anchored with RB20 rock dowel's combined with individual unstable block support by wire rope cable retention. Examples of such installations can be seen in Figures 4 and 5. These additional installations were generally variation works due to the extensive unstable rock mass revealed during vegetation removal on inspection of the ridge following near miss rockfall events.

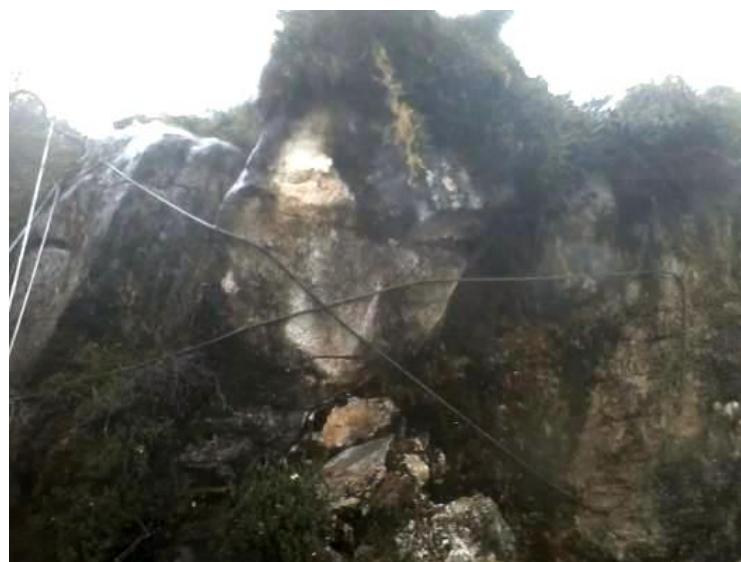
Figure 5 Very temporary wire rope cable installation in-place until SPIDER® NET S4-230 mesh and RB20 anchorage installation

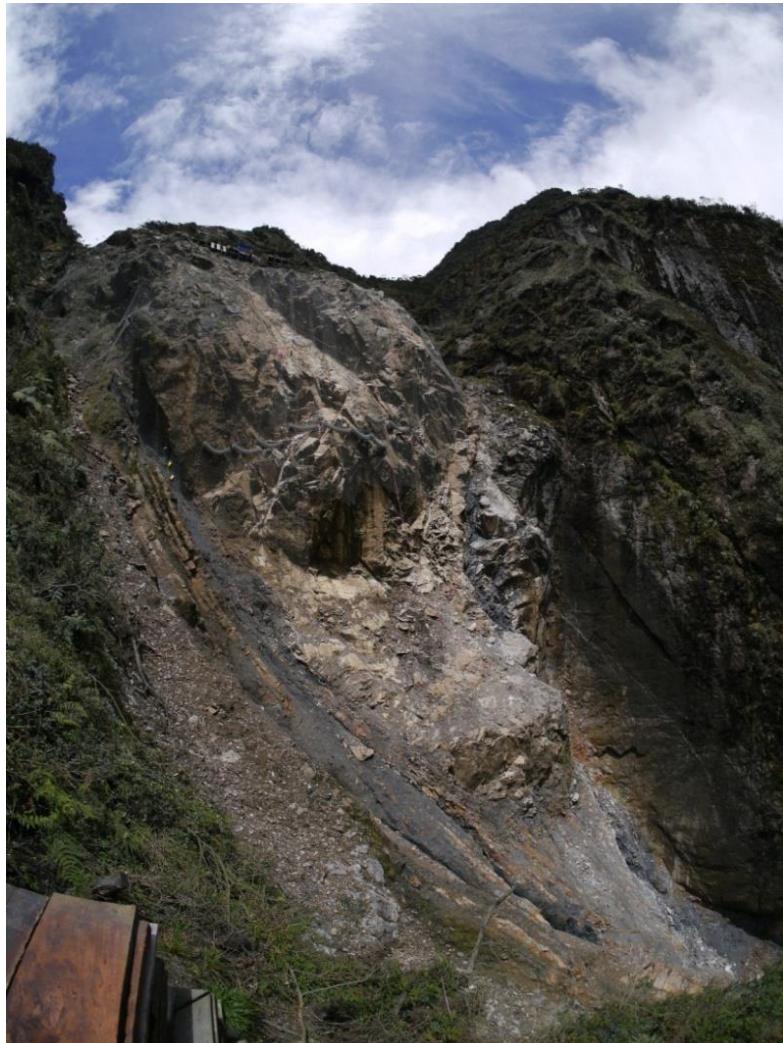
Figure 6 Photo taken using Samyang MFT Fish-eye 7.5 mm lens to capture the entire West Gully Upper source area from material pad D. Progress of SPIDER® NET S4-230 installation as of 20 February 2013. Note attached rolls of SPIDER® NET S4-230 at 3.5 m width indicating extent of area protected approximately 6,800 m²

3. Within the Kais Fm Limestone persistent defects are adversely dipping out of the slope face 'day lighting'. This defect set has an approximate dip of 48° and dip direction of 105° to the southeast. This day lighting is evident in Figures 6 and 7.

A combination of active and passive mesh systems was assessed as providing the best value while maintaining a tolerable level of temporary protection to allow permanent barrier construction works below. This is in combination with management of other site constraints, i.e. reducing site risk by restricting works in rockfall and debris flow run-out areas during high precipitation or during PTFI red alert radar warnings potentially indicating larger site movement. Detailed design analysis was carried out utilising standard anchor load assessment (BS8081) to determine the number of anchors required to support load from the mesh drape system and a 10 m³ design rockfall event. 180 rock dowels with an assumed worst case scenario of 1 m fixed bond length was calculated to resist these loads. A grid matrix of 25 rows and six to eight columns (dependant on site specific topography) provided the required 180 rock dowels. Figure 6 highlights progress of the mesh installation as of 20 February 2013.

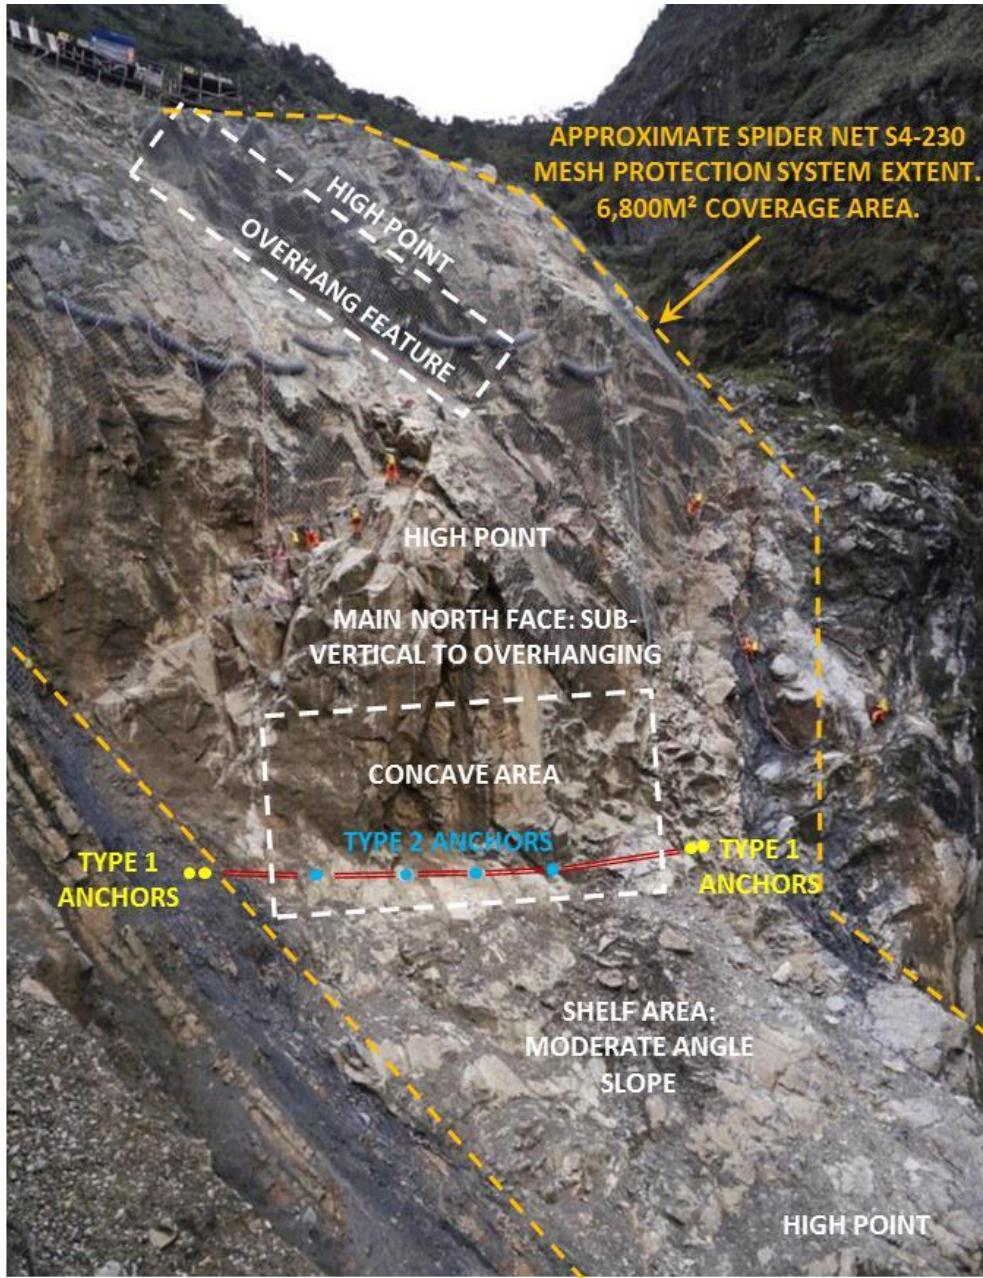
Figure 7 Photo annotating the two areas where suspended SPIDER® NET S4-230 was assessed as being too extensive for adequate containment of rockfall from unstable areas. Site specific and innovative engineering solutions were executed to minimise risk of such implications

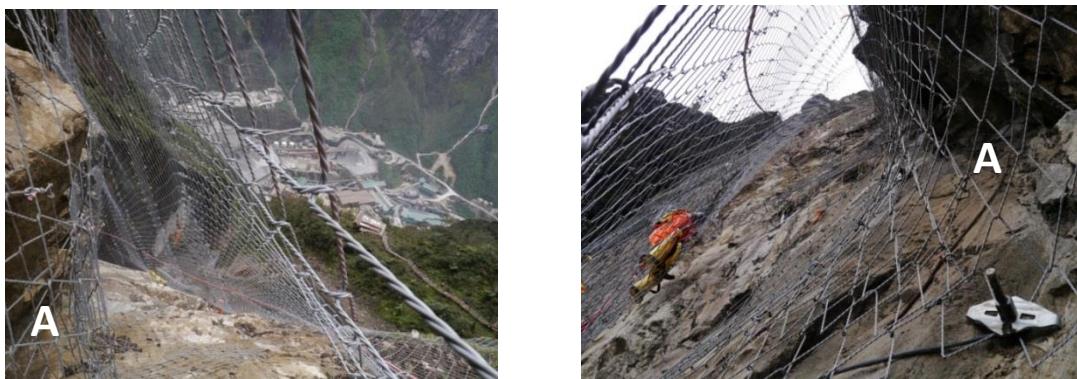
Figure 8 Two opposite perspectives highlighting the significant void space under the passive mesh drape system suspended due to the systems weight below. At annotated white point A the secondary active mesh system can be seen profiled in against the unstable jointed kais Fm limestone 201 m² overhang area

1. For the 210 m² overhang feature treatment involved installing a second active SPIDER® NET S4-230 mesh system profiled against the 210 m² overhanging area to restrict rockfall initiation from it. This second active mesh system being entirely independent from the ‘main scope of works’ overlying passive mesh drape system (Figure 8).

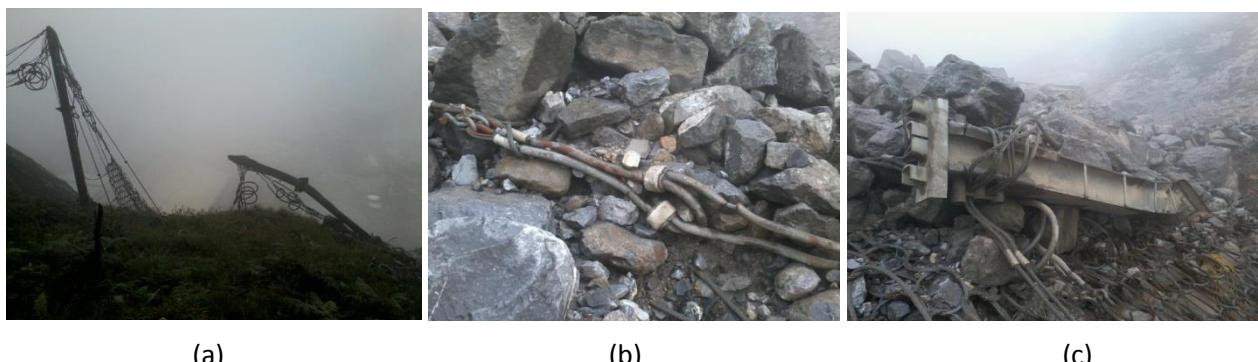
Figure 9 (a) Destroyed RXI-500; (b) activated breakings; and (c) bent RXI post

Specific design was required for both the debris flow and rockfall barriers for this site. Prior to the West Gully Upper project, the greatest capacity barriers available on the market were Geobrugg's RXI series that could withstand up to 5,000 kJ of impact energy. The two RXI-500 (5,000 kJ) rockfall barriers constructed in 2007, situated in themed and lower West Gully, were insufficient in retaining the 45,000 m³ rockfall/debris flow event that occurred during August 2011. Figures 9 to 11 highlight the extent of destruction from high impact forces that were experienced during the August 2011 event, easily exceeding the barrier's 5,000 kJ capacity.

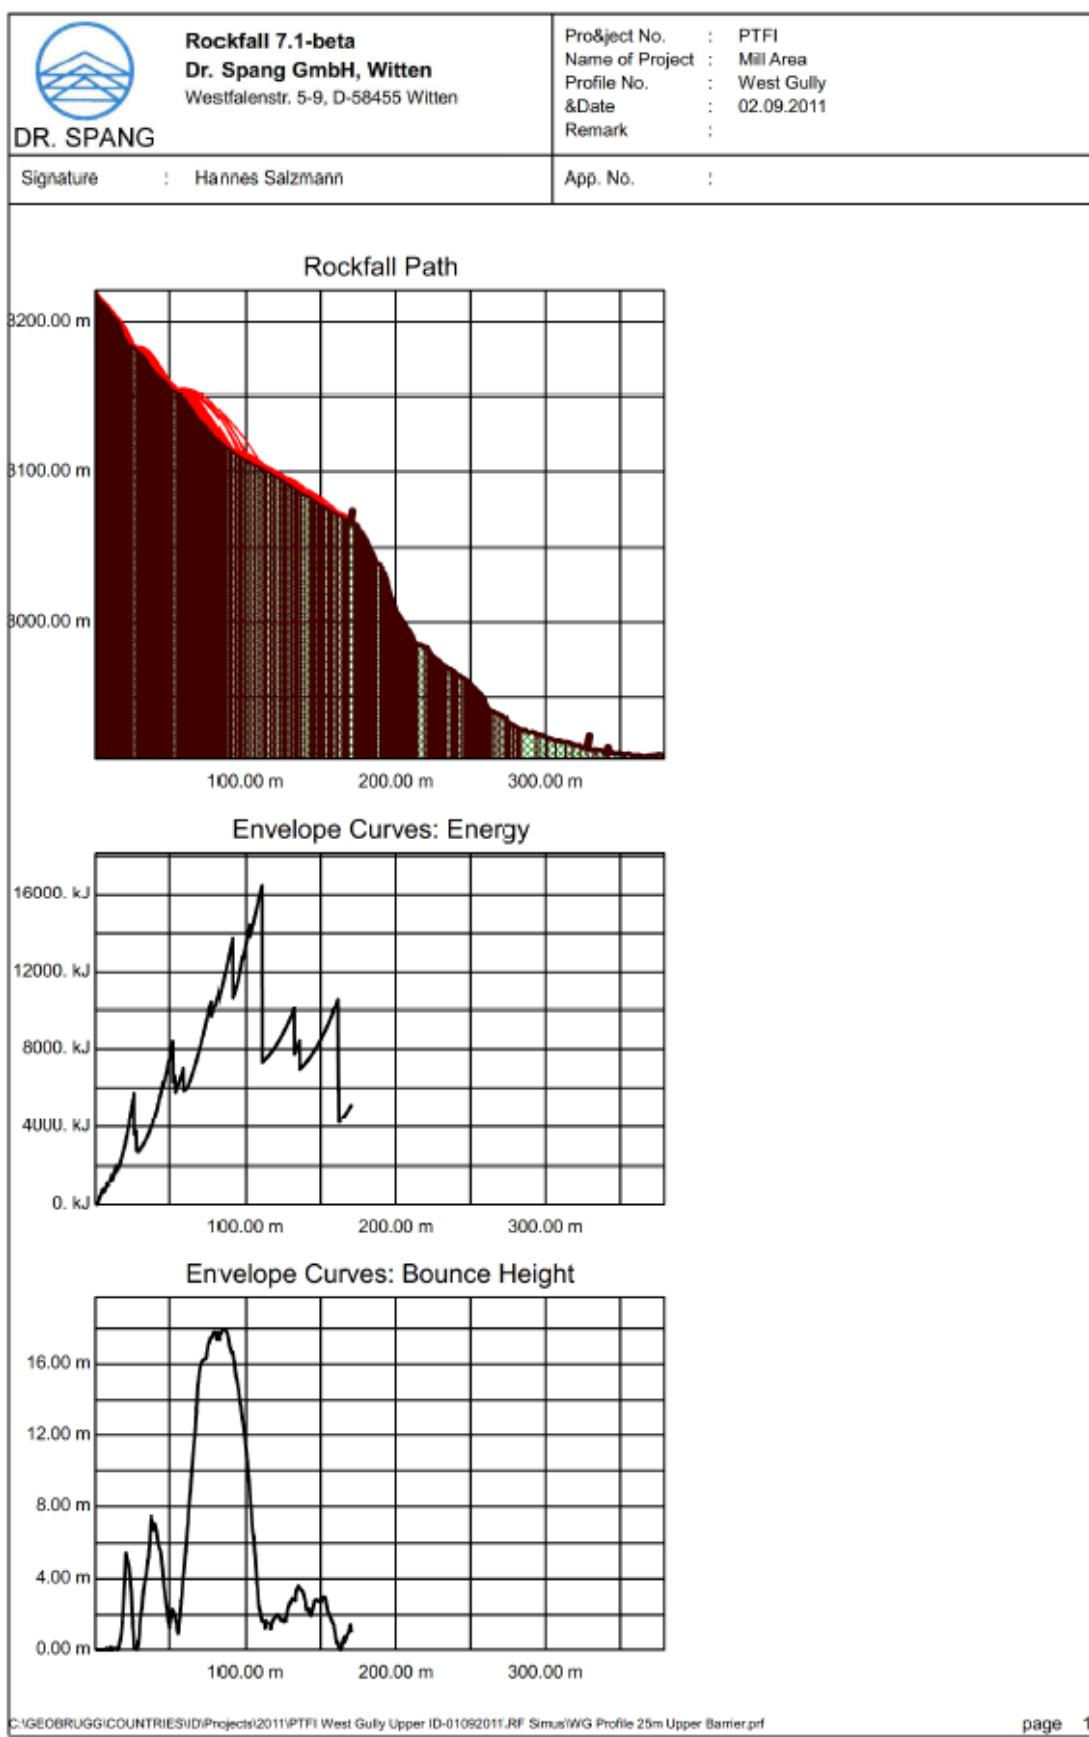
Figure 10 ROCKFALL 7.1 beta simulation run for the GBE-8000A rockfall barrier, retaining rockfall material successfully in the model with careful site selection. Note significant energy output after large bounces
