Rockfall stabilisation of a steep and high slope at West Angelas Mine using pre-tensioned anchored mesh

P.J.G. Lopes *Geovert Pty Ltd, Australia*

Abstract

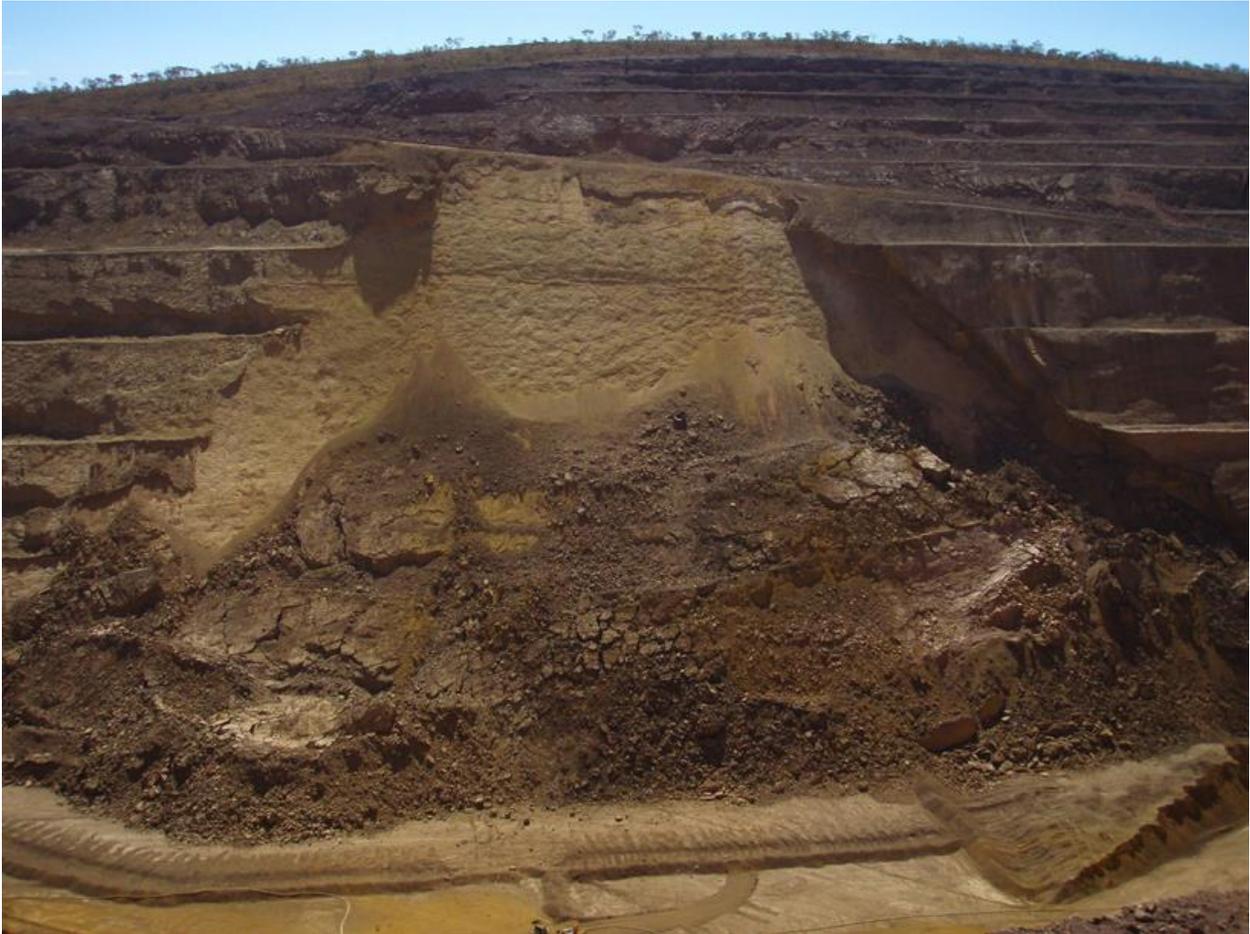
Figure 1 Major slip failure at north wall, West Angelas

After a major slip failure along the north wall of the centre pit north in Figure 1, a significant amount of material was left overhanging at the top of the slope producing significant risk of rockfall. Mining of the area directly below the area of overhang was the critical long term operations target for the client. Drill and blast was conducted to reduce the size of the overhang, however it could not be completely removed as some areas suffered damage during the blasting operations. As a consequence, further treatment was required to secure the crest area where residual rockfall hazard were still prevalent. The hazard was identified as a potential surficial instability of the 0.75 m thick layer of overhanging rock on the slope, a solution was developed and executed with nails and high tensile mesh installed using light weight drilling rigs, cranes and rope access personnel to solve the surficial stability problem.

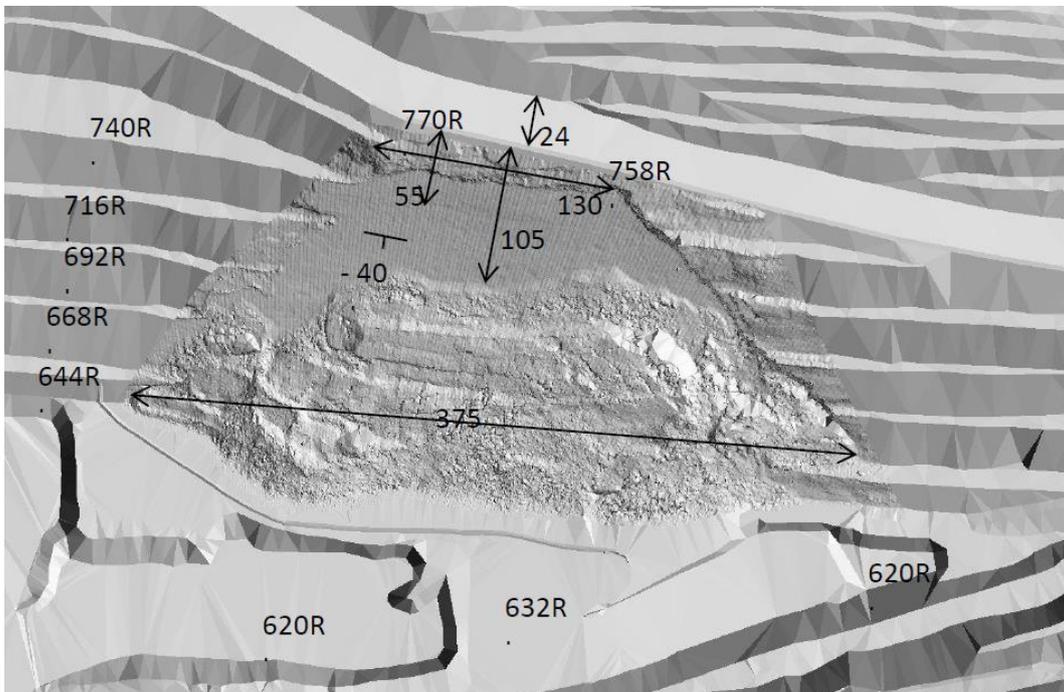
Figure 2 Dimensions of slope area (m and degrees), West Angelas

The ore exploration takes place in the Hamersley Iron Province. The province is characterised by a 2500 million years old late Archaean and early Proterozoic rock formation known as Hamersley Group, predominantly composed of Banded Iron Formation (BIF) which is formed by alternate layers of iron-rich and silica-rich layers. The Marra Mamba Iron Formation hosts the principal orebody. The slip occurred by planar sliding on a shale bed dipping into the pit at an angle of approximately 40 degrees. The dimensions of the slip failure at the slip are shown in Figure 2.

The rockfall risk at the top of the plane failure, at 740 to 770 RL, approximately 4,000 m² as shown in Figure 2, presented significant safety challenge for ongoing mining activities and a construction methodology for rockfall protection. With these difficulties, mitigation options were limited to those which should be completed using top-down installation techniques. This therefore eliminated the option of barrier construction directly at the middle batter of the high wall without prior stabilisation to provide safe access for construction crews. The stabilisation design was therefore based on pinning and supporting the crest overhang. In this case the Geobrugg TECCO mesh (Geobrugg, 2010) was selected due to its strength properties, flexibility, and considering also the execution time and costs related to other solutions.

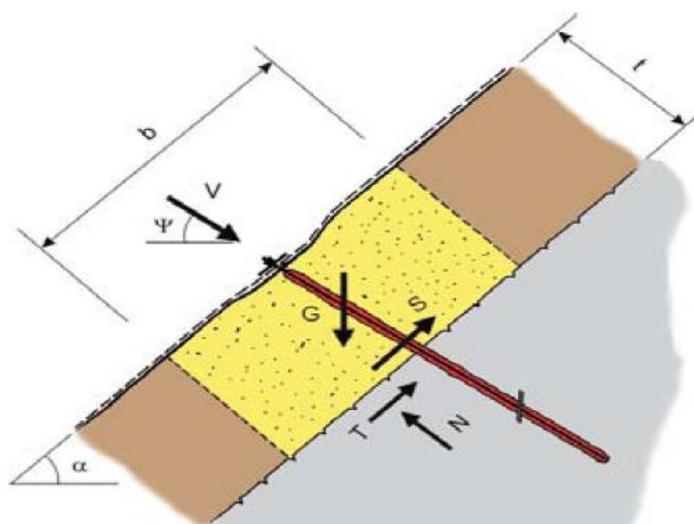
Figure 3 Forces acting on the supported block (Geobrugg, 2010)

- G: dead load of the cubic body (highlighted in yellow)
- T and N: the reaction in vertical and tangential direction of the sliding surface
- S: shear stress acting on the nail
- t: thickness of the layer
- b: nail distance in line of the slope
- V: Pre-tensioning force of the system
- α : slope inclination
- ψ : nail inclination to the horizontal

The investigation of surficial slope-parallel instabilities concerns with possibility of the cover layers sliding off the stable subsoil. In this case, the nailing system is the stabilising agent against the slide hence the bearing capacity of the nails against the sliding effect is required to be investigated. Figure 3 demonstrates the relevant forces acting on the nailing system.

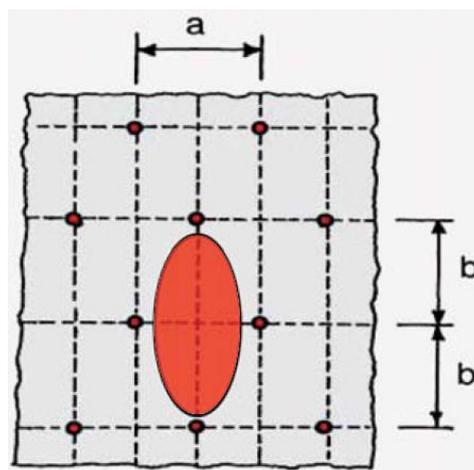
Figure 4 General nail arrangement (Geobruigg, 2010)

The second investigation focuses at the local bodies liable to break out between the individual nails. This investigation is in order to ensure that all local bodies liable to break out will be retained within the mesh and maximum occurring forces are absorbed and transferred to the stable substrate. In a triangular nail pattern, above each nail is a field of width and length $2 \times b$ which must be secured against local stabilities (Figure 4).

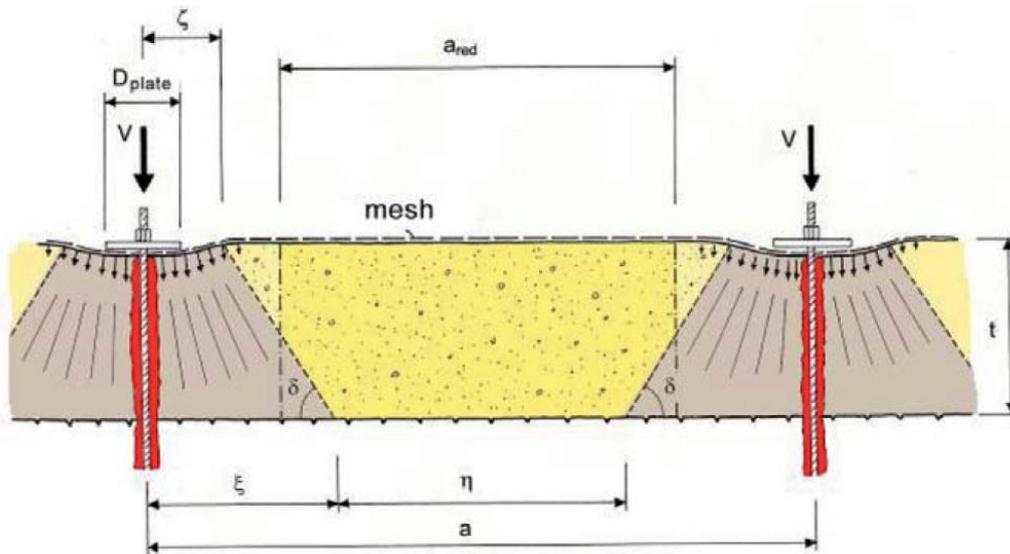
Figure 5 Cross section of the local body liable to slide off with the nail's pressure cone (Gebrug, 2010)

- D_{plate}: diameter of the base plate
- η: is the distance between the base of the pressure cone of two adjacent nails
- V: pre-tensioning force of the system
- ζ: radius of the top of the pressure cone
- ξ: radius of the base of the pressure cone
- δ: inclined angle of the pressure cone = 45°

As every single nail is pre-tensioned to a certain load (30 kN in this case) by tightening its nut, this will cause the spike plate (Figure 5) to press firmly into the ground. As part of the analysis, the pressure cone region is

not considered as part of the local body liable to slide off. The pressure cone is characterised by the radius of the pressure cone (usually $0.5 \times \text{width of spike plate} = 0.5 \times 0.3 = 0.15 \text{ m}$) and the inclination angle δ (45°). Hence, the local body's cross-section area is trapezoidal as seen in Figure 5. The trapezoidal cross-section can be transformed to rectangular with an equivalent area of width.

$$a_{red} = \left(a - \frac{t}{\tan \delta} - 2 * \zeta \right) = 1.95m \quad (7)$$

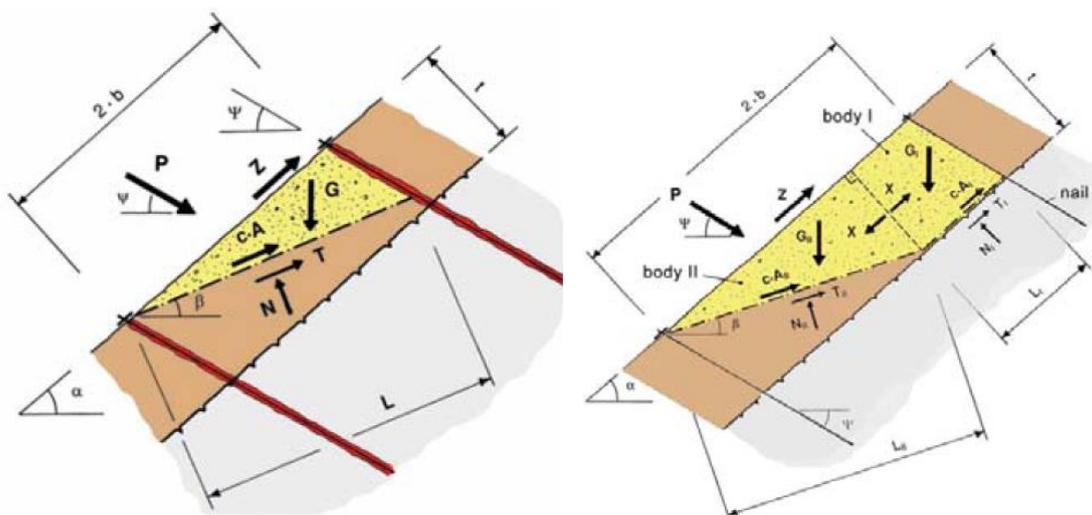
Figure 6 Fault mechanism A and fault mechanism B (Gebrug, 2010)

- P: Max stress on the mesh for shearing-off nail direction

c.A: is the surface area of the sliding body and the cohesion of the ground. This measures the shear resistance
Z: Slope parallel force

Depend on the slip failure angle β , there are 2 fault mechanisms of single-body sliding: mechanism A and double-body sliding mechanism B (Figure 6).

As can be observed, the value for β ranges from -20° to 40° in relation to the horizontal. The range of β in which each mechanism occurs is as:

- Mechanism A: $33.35^\circ \leq \beta \leq 40^\circ$.
- Mechanism B: $-20^\circ \leq \beta \leq 33.35^\circ$.

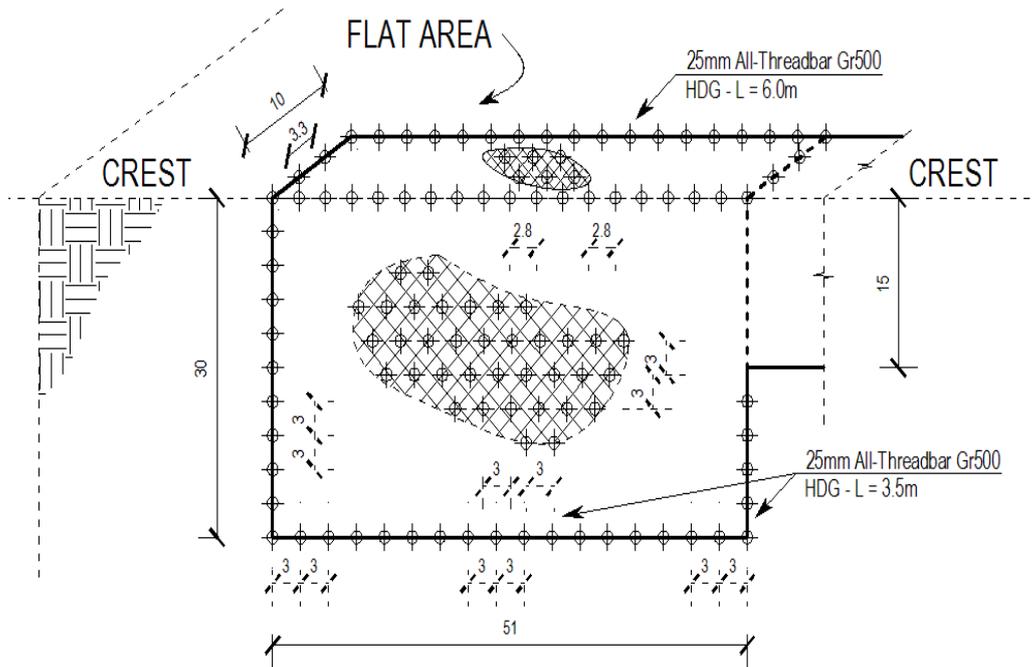
Figure 7 Schematic arrangements of rock anchor and TECCO mesh

At the slope head it was proposed to use additional shorter spaced nails – 25 mm Hot Dipped Galvanised All-Thread Bar Gr500, length 3.5 m, spacing 2.80 m to stabilise the slope crest. The TECCO mesh should additionally be fixed to a wire rope at the crest of the slope. A typical design drawing of this project is illustrated schematically in Figure 7.

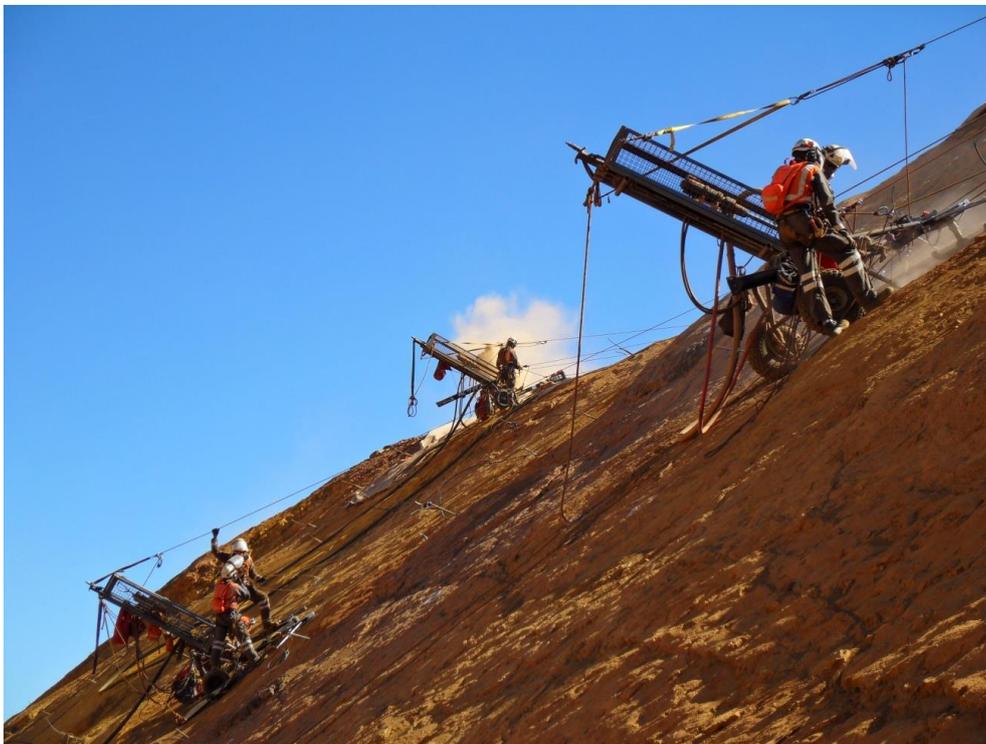
Figure 8 Rope-access drilling with light weight drill rigs at 150 m above the pit base

A total of 498 anchor locations were drilled. In addition, 4 locations were drilled in order to install the wire rope anchors. As part of the design, locations were drilled to a minimum depth of 3.5 m utilising light weight drill rigs specially developed for this type of work (Figure 8). Following drilling, a 4 m × 25 mm Ø galvanised thread bar was installed and prepared for grouting.

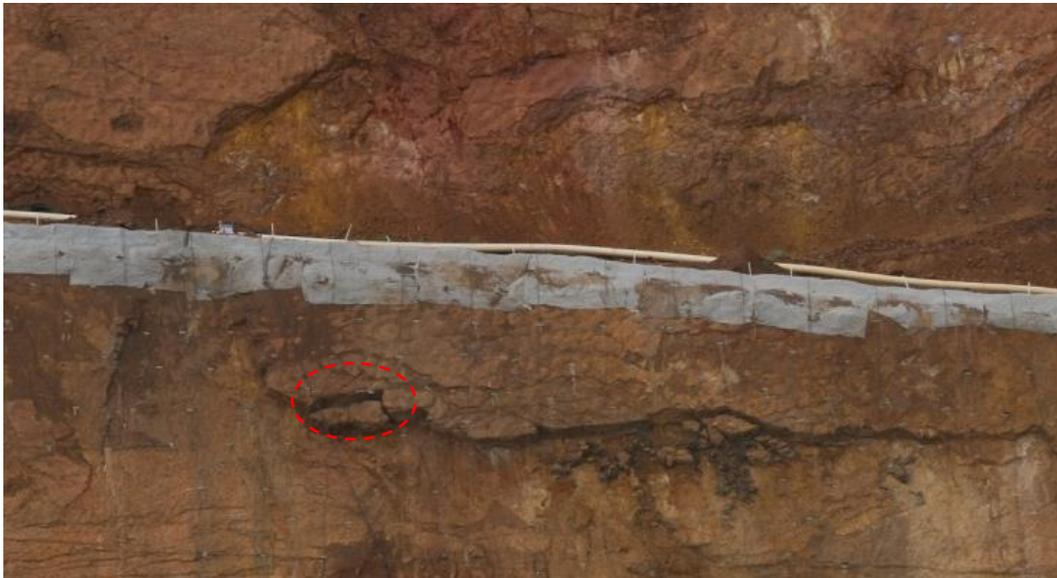
Figure 9 Location of loosened boulders retained by the TECCO mesh system

Since construction, ongoing mining operations occurring in proximity to the slope have caused several boulders to be released and fell from the overhang (Figure 9), which were retained by the installed protection system.

The largest bolder, circled in Figure 9, is approximately 3.5 m long \times 0.75 m thick \times 1.5 m width and weighs approximately 12 tonnes. The TECCO system carried out its function successfully by stopping the boulder and retaining it within the mesh without damaging any part of the system.
