Drape mesh protection at the Savage River Mine, Tasmania

B.J. Hutchison *Grange Resources (Tasmania) Pty Ltd, Australia*

Abstract

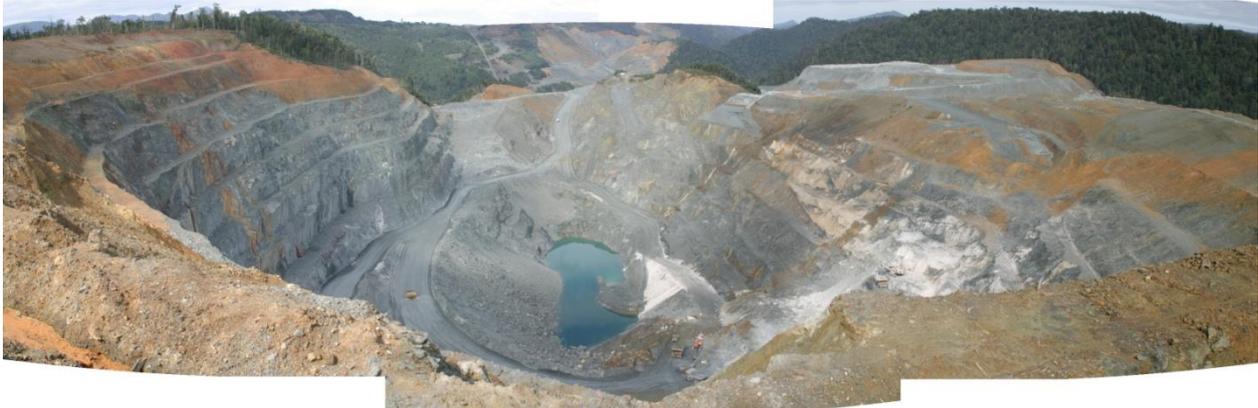
Figure 1 Photograph of North Pit (looking south)

North Pit, (Figure 1), has been mined since the mid 1980s in a series of cutbacks and has experienced many episodes of large scale wall failure comprising several different mechanisms; mainly toppling, circular and slump failures. These have occurred on the northern and western walls, where relatively weak and well sheared schistose rocks prevail. The western wall has typically been cut at inter-ramp angles in the order of 35–37°, with one or two ramps of 25 to 36 m in width.

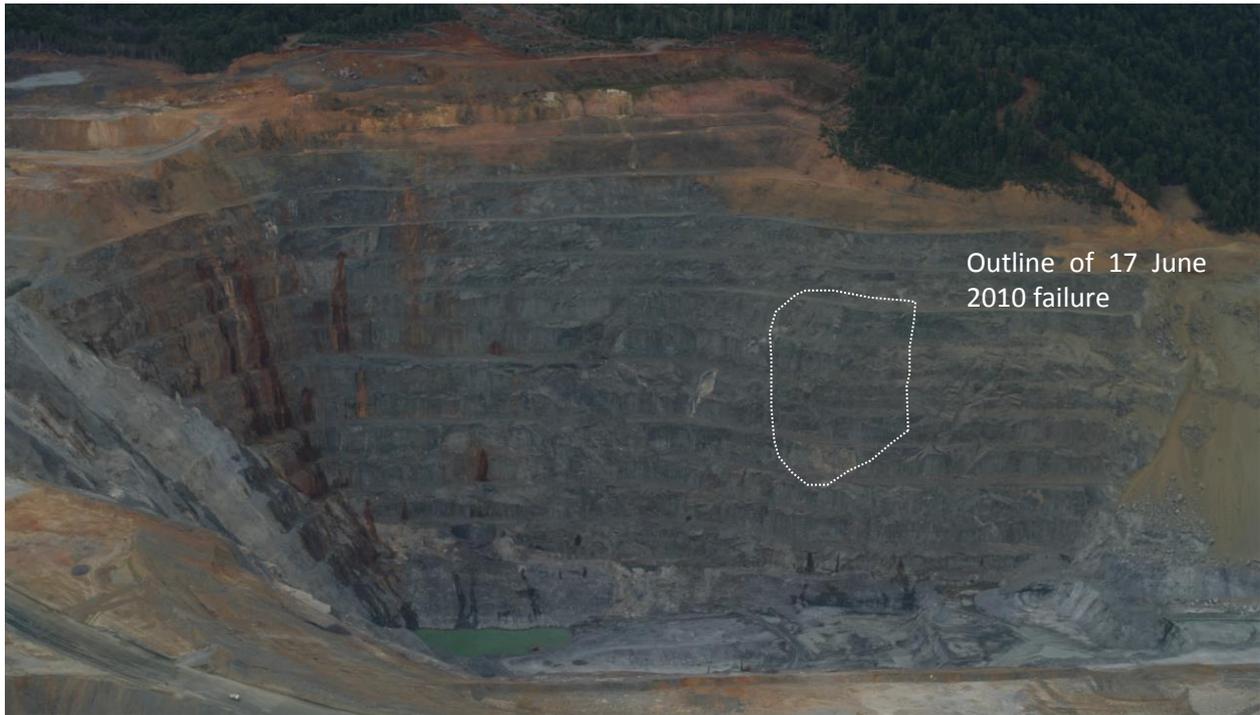
Figure 2 North Pit east wall

Historically the eastern wall has been mined at an intermediate slope angle of 63° , being comprised mainly of 20 m high presplit faces, with 10 m wide berms (Figure 2). By 2010 this eastern wall had reached an overall height of 330 m, due to the competency of the calcite-chlorite schist (amphibolite) in the mid-reaches of the wall.

On 17 June 2010, a 400,000 t section of the eastern wall collapsed in the region of a small bullnose in the wall (Figures 2 and 3). This section of the wall had been exposed and had been stable for four years. The failure was structurally controlled by two joints; a ski-jump joint ($54^\circ/270^\circ$) and a northwesterly dipping joint ($46^\circ/299^\circ$); which formed a basal wedge surface (with a line of intersection dipping $43^\circ/321^\circ$). The main backscarp was a $70\text{--}75^\circ$ westerly dipping haematite shear.

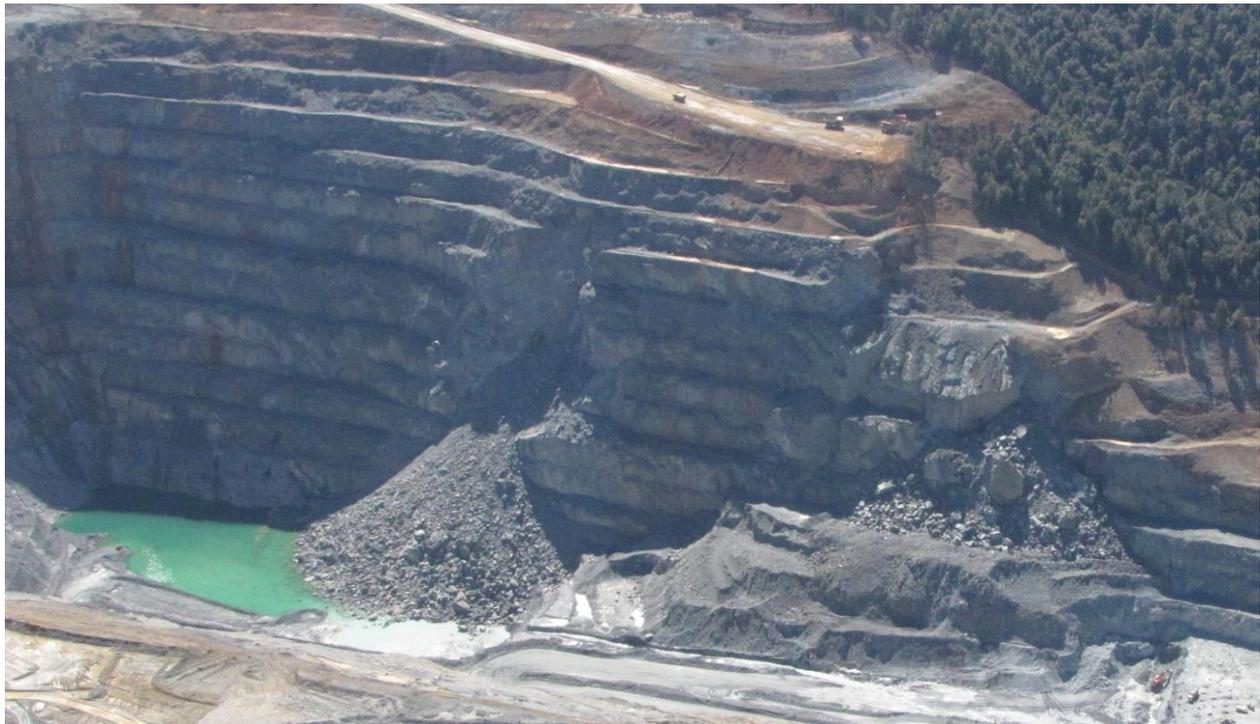
Figure 4 17 June (left) and 30 August 2010 failures

On 30 August 2010 a second failure comprising 200,000 tonne of rock occurred when a trim blast daylighted another ski-jump joint (Figure 4). The base of both slips daylighted in the pit wall well above the contact with the ore.

Progress of the upper access down to the RL 260 staging area (shown in the top of Figure 4) was undertaken whilst the tendering processes were completed. Upon reaching the RL 260 level, anchor and

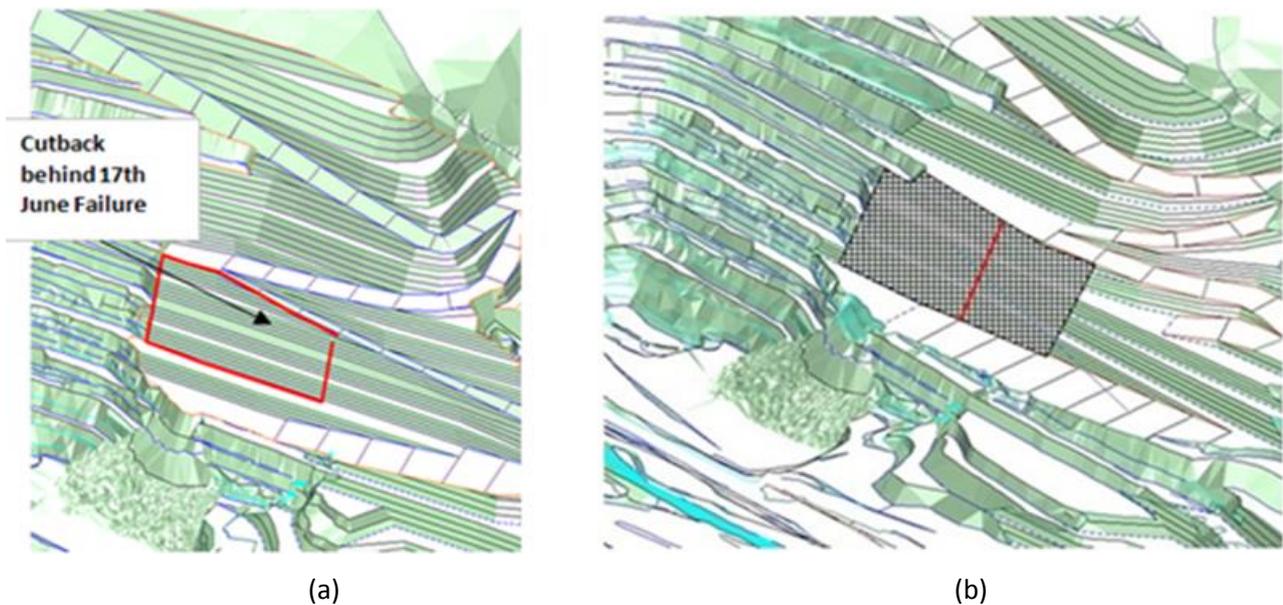
Figure 5 Examples of design options; (a) cutback design; (b) drape mesh design

As designs and schedule options were evaluated it soon became apparent that utilising the smaller fleet in a narrow cutback (such as shown in the left side of Figure 5), although moving less material, would not allow an acceptable vertical rate of advance. The mine planning group then began looking at alternative designs to reduce the pre-split drilling and rock support requirements; which typically take up a significant amount of time in the bench turnover cycle. Needing to move large volumes of material quickly presented options to look at cast blasting, whereby large volumes of rock above the slips and on the steep outer slopes could be thrown off the face and into the base of the pit. From that location a more much efficient loading and trucking operation could then take place.

manually laced together off ropes. With this experience, drape meshing options were also considered for the east wall recovery work (such as shown in the right side of Figure 5).

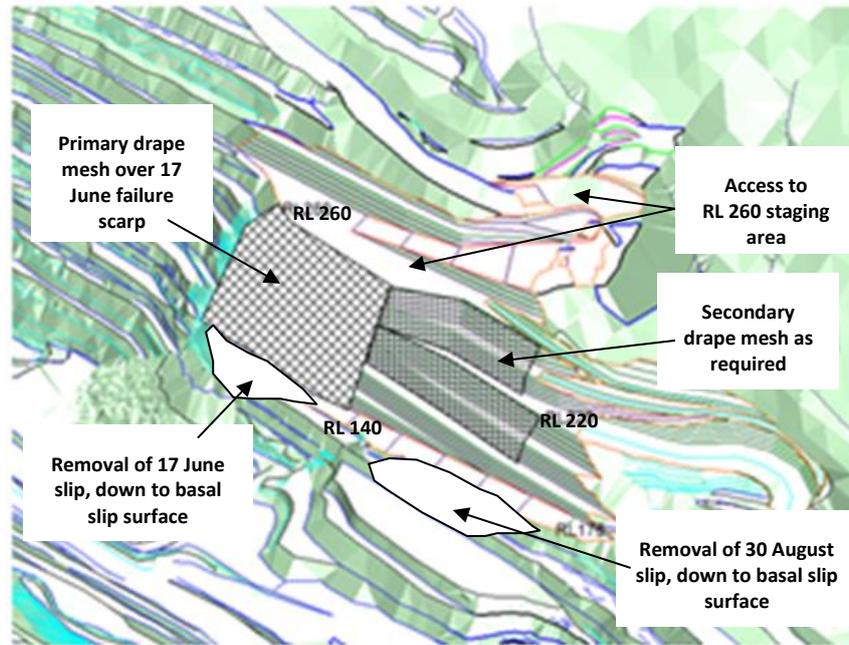
Figure 6 East wall recovery design with drape mesh components

After assessing over forty five design combinations, the following plan was adopted (refer to the schematic in Figure 6 and the cross-section in Figure 7):

- Remove the majority of the waste materials above the top of the backscarp at RL 260 (RL – reduced level in metres) by a conventional Cat 789 truck and Hitachi 3600 shovel operation, hauling out to waste dumps to the north.
- Establish light vehicle and tracked equipment access from the southern end of the pit up to the RL 240 level. This was to be carried out using a small fleet of 30 t excavators and articulated trucks.
- Large haul truck access was in existence below RL 160. Once tracked access was in place to RL 240 the fleet, supplemented by larger equipment when available, was to extend the southern large haul truck access up to RL 220.

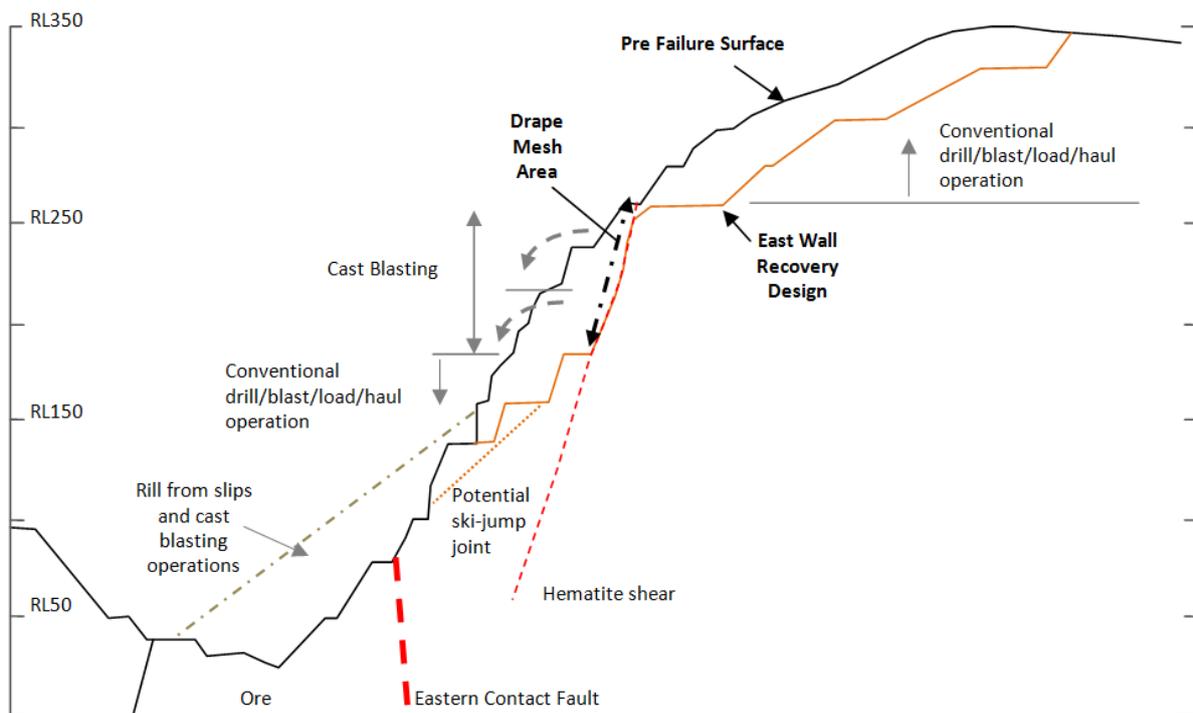
Figure 7 East wall recovery cross section

- Create a working bench at RL 260; from which a 40 m high cast blast would be used to throw as much material as possible, from in front of the haematite shear, down into the pit.

- Install drape mesh, anchored off the RL 260 bench, to cover the exposed haematite shear; the primary purpose of this was to protect personnel and equipment working on the smaller RL 220 bench, during drilling and loading of the second cast blast.

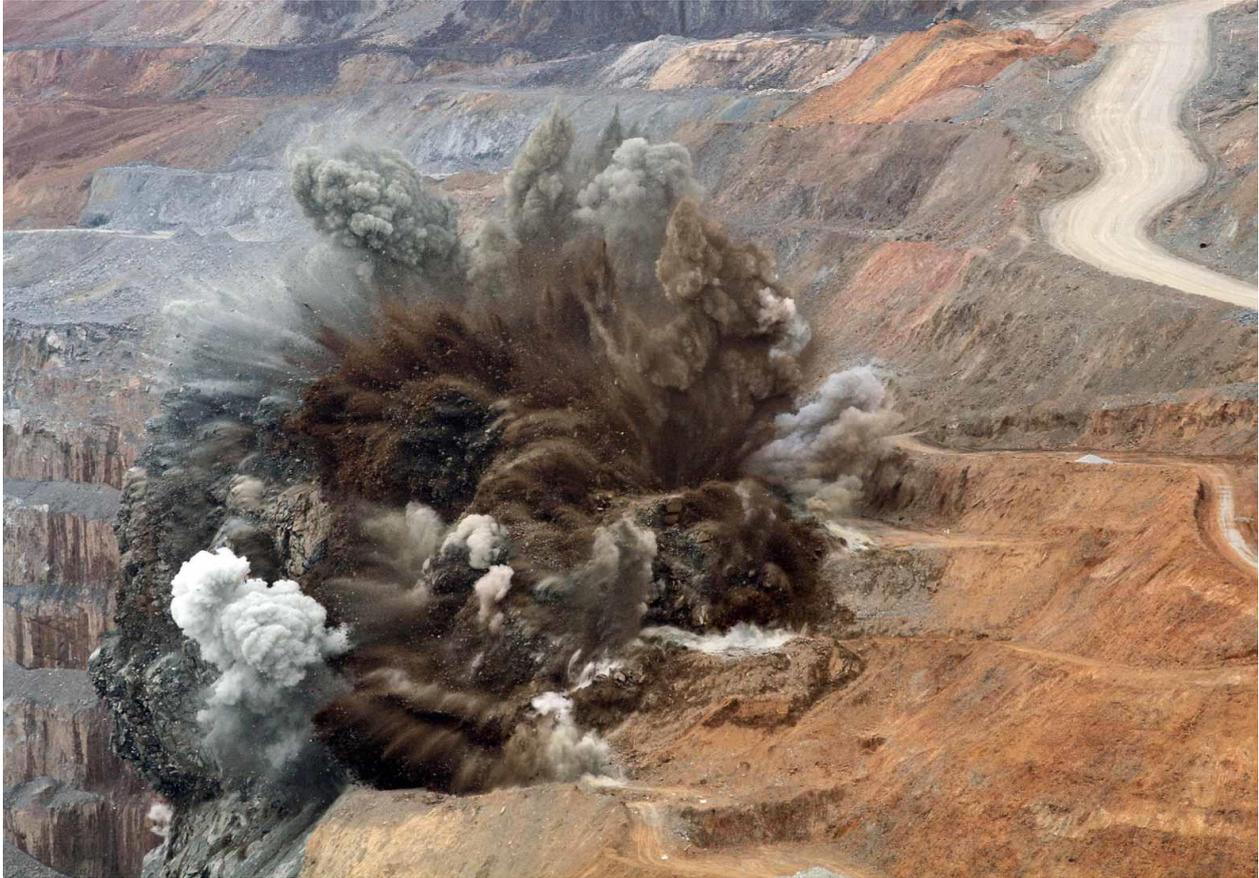
Figure 8 RL 260–220 cast blast

mesh supplies had arrived and installation of the anchor system was undertaken on the northern side, behind the main scarp of the 17 June failure. In the central and southern ends, the first of the two 40 m high cast blasts was drilled and fired (Figure 8).

Both cast blast volumes were approximately 1.2 Mt; of which between 30–35% of the material was displaced over the pit edge and onto the pit floor or onto the slide material rill areas.

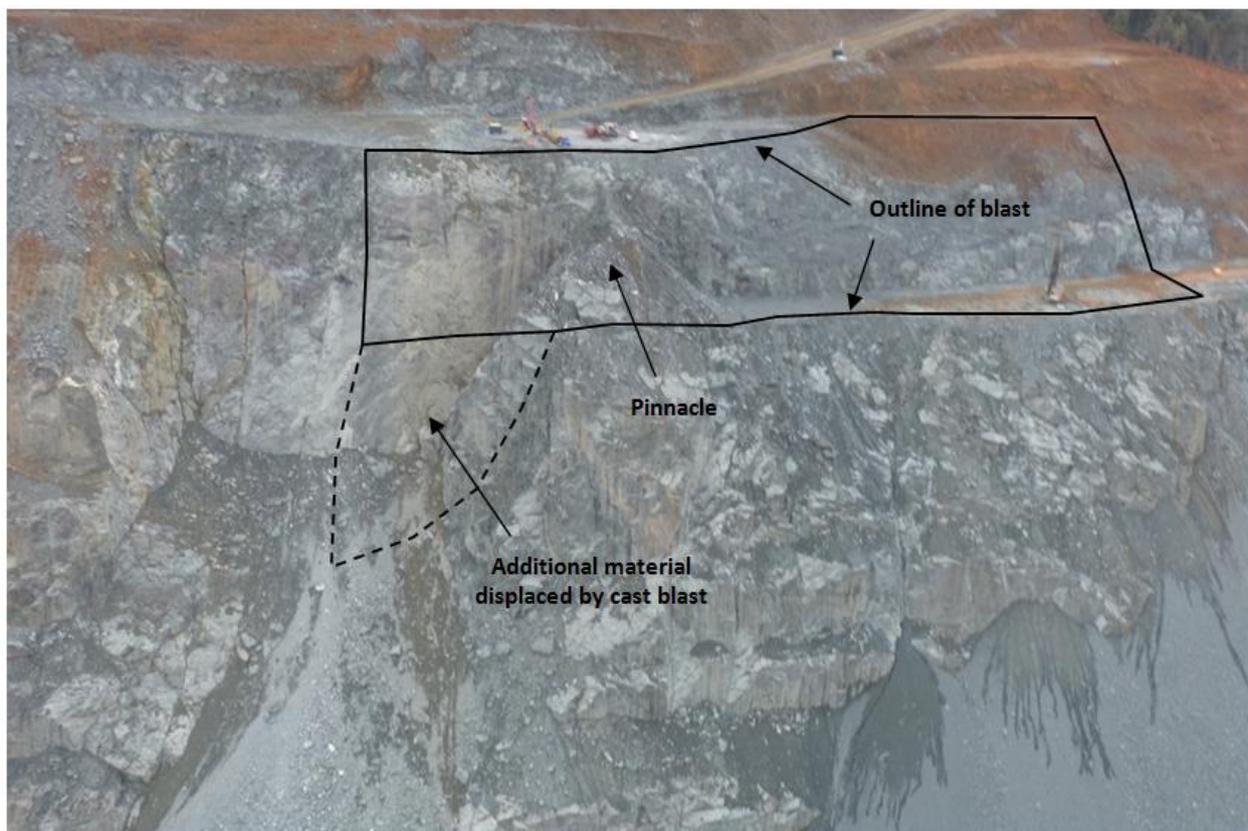
Figure 9 Effect of first cast blast

The first blast was considered to have displaced more volume than the second blast but difficulties had been encountered in drilling through the open cracks extending southwards from the 17 June slip. Following the blasting, a portion of the northern end, which was in front of the open cracks, was not fully blasted; leaving a large pinnacle of rock, refer to Figure 9 (taken after excavation of the majority of the blasted material). This area required considerable additional remote dozer, excavator and secondary blasting work to eventually achieve the RL 220 floor. As shown in the photo a considerable amount of material below the blast floor was also displaced.

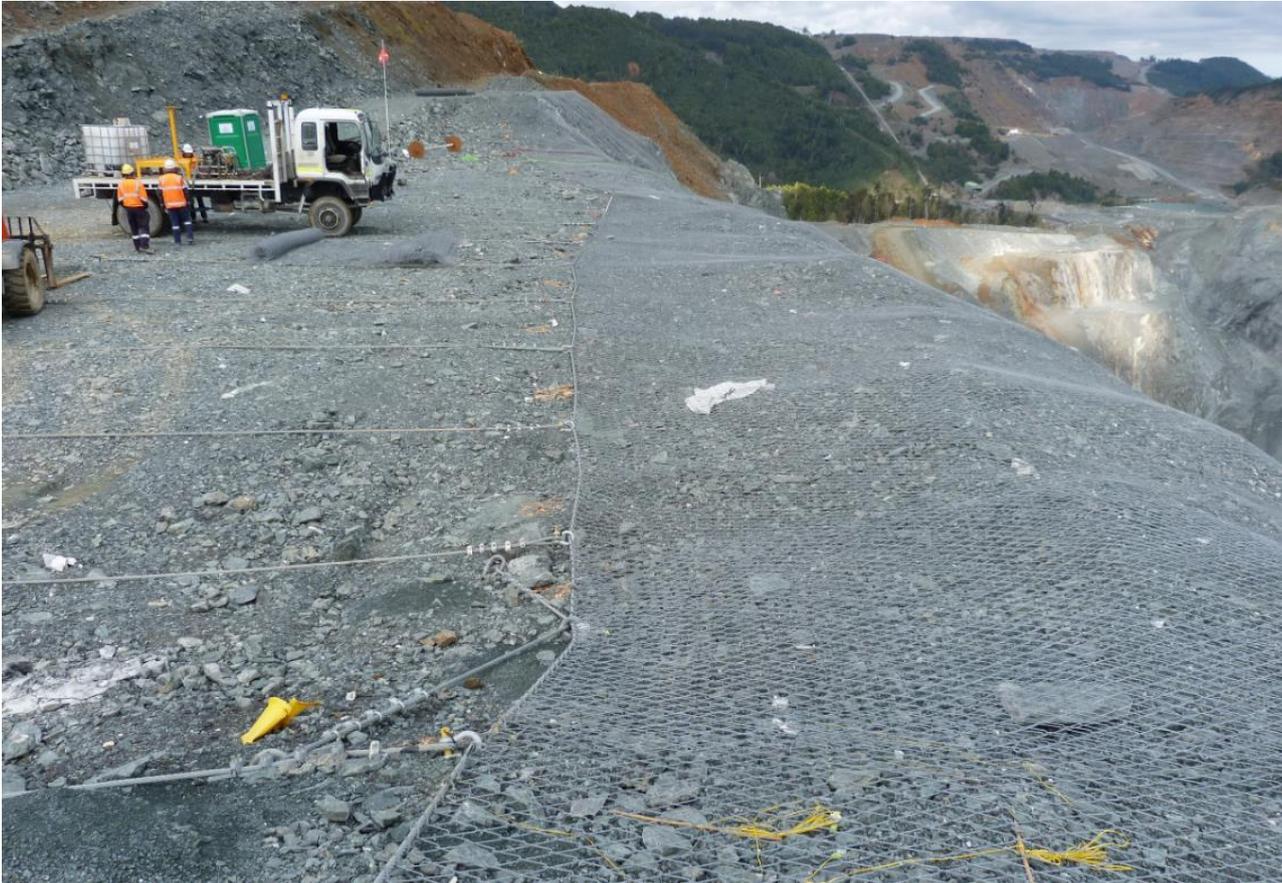
Figure 10 TECCO®G80/4 mesh anchor system layout and crest mesh

The drape mesh installation was preceded by the installation of the anchor system, set approximately 10 m behind the RL 260 crest. The anchors for the SPIDER® and TECCO® mesh systems were 18.5 mm diameter, 4 m long wire rope anchors; attached to 22 mm diameter wire top ropes (Figure 10). The light weight DELTAX® mesh was to be anchored off 10.5 mm diameter, 2 m long anchors; attached to 16 mm diameter wire top ropes.

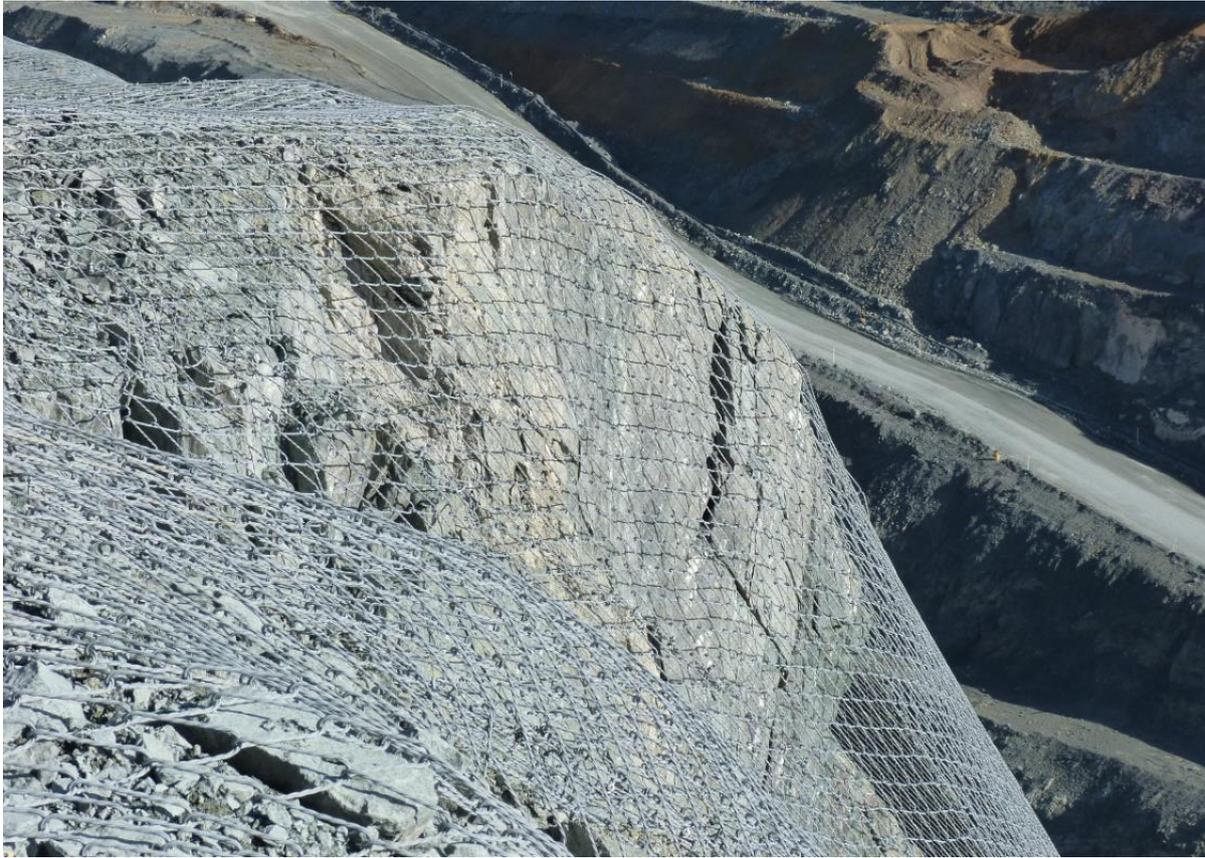
Figure 11 SPIDER®S4-130 mesh

At the northern end of the cutback, behind the 17 June slip, the crest rock loosened significantly after the first cast blast, requiring three additional crest trim shots to remove large blocks. In one case the initial mesh had to be removed and later reinstalled. The trim shots required a new set of anchors to be installed over a short section. Although the majority of the loose rock was blasted or scaled away, the SPIDER® S4 mesh was concentrated in a specific area to retain larger blocks along the crest (Figure 11).

When drape mesh systems are designed, it is mainly the ability to withstand impacts from falling rocks that is considered. In the Savage River case it is apparent that the mesh also provided considerable 'interface friction' or 'confinement', which prevented the large blocks of rock at the crest (Figure 11) or the highly fractured rock mass (Figure 15), from being displaced. It appears the drape mesh suppliers are reluctant to consider this component of additional stability that drape meshes may be able to provide; possibly due to the highly variable situations and the difficulties in providing standard designs to suit those conditions.

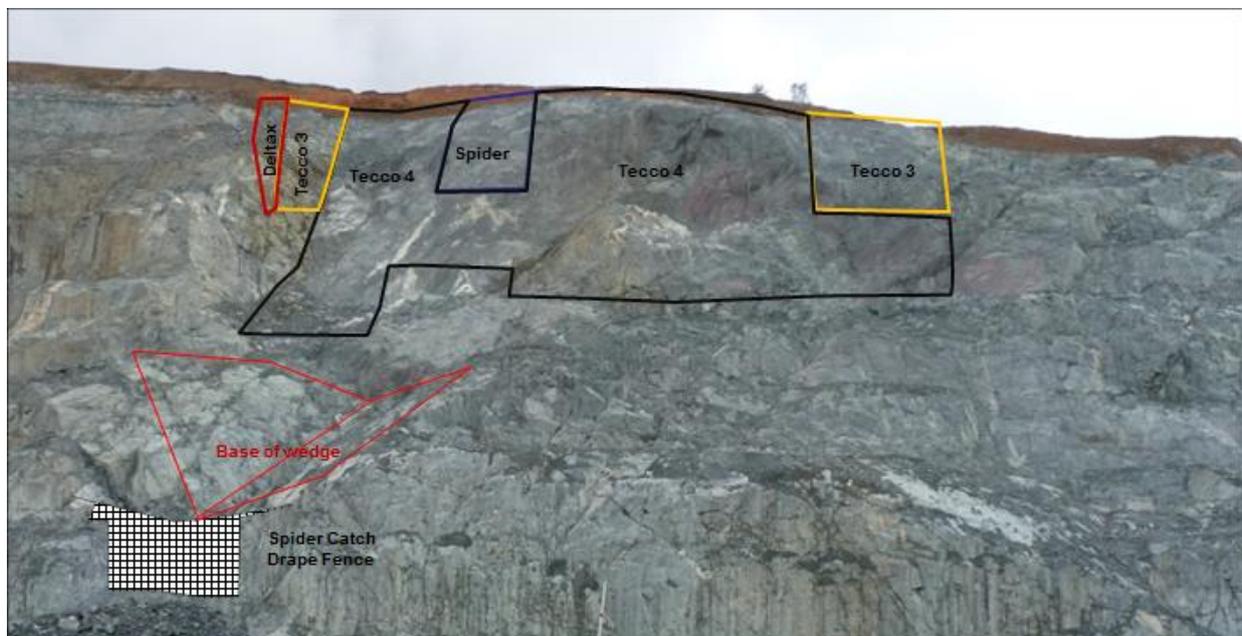
Figure 12 Final excavation and drape mesh coverage areas

The selection and placement of the various mesh types was decided on after the initial cast blasting and scaling results were observed. In general, the cast blasting was very successful in exposing a relatively smooth haematite shear surface that contained a few overhang areas. The final distribution of the various mesh types can be seen in Figure 12.

The highly fractured rock mass, evident in Figure 15, is located to the north of the SPIDER® mesh. There were concerns that blocks of rock dropping down the drape mesh could exit the mesh and shoot out from the base of the wedge of the 17 June failure (Figure 12). To arrest rocks within the drape, extra mesh (the extension to 120 m) was placed on the underlying ski-jump joint. In addition an open based catch fence of SPIDER® mesh was placed at the base of the failure; to slow down any cascading rocks and drop them directly down into the pit bottom.

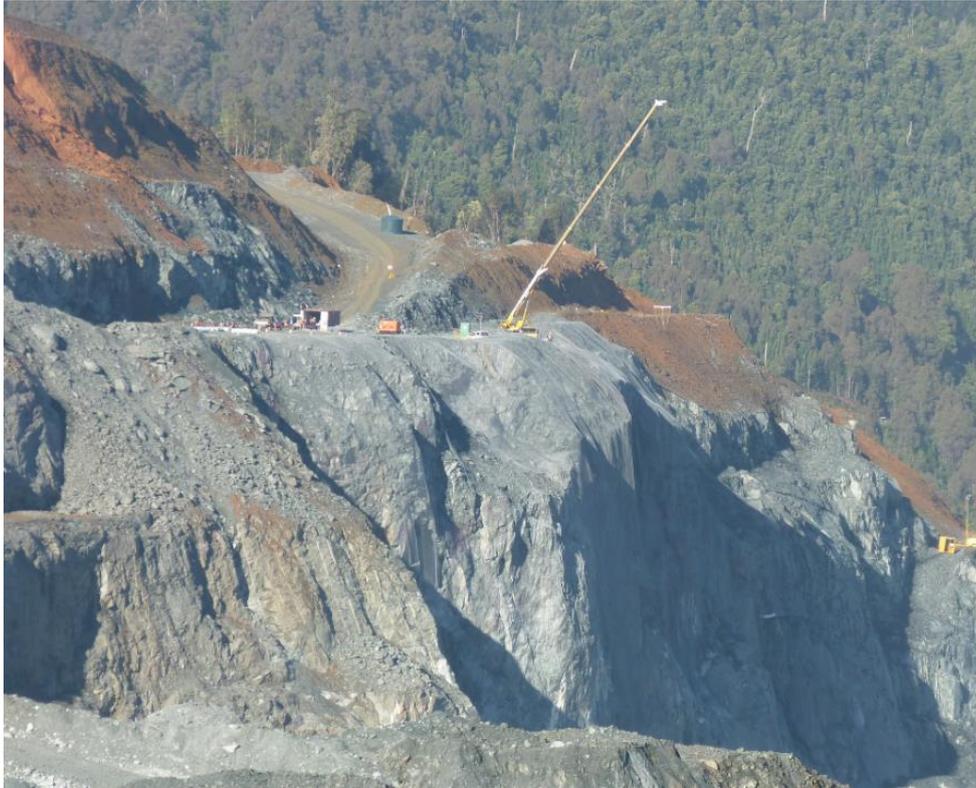
Figure 13 Mesh installation with 150 tonne crane

90 m in height. One area reached 120 m in height but that required the mobilisation of a 150 tonne extendable boom crane to provide sufficient reach (Figure 13). Although the cranes were not in the original plan and budget, they significantly sped up the mesh placement work.

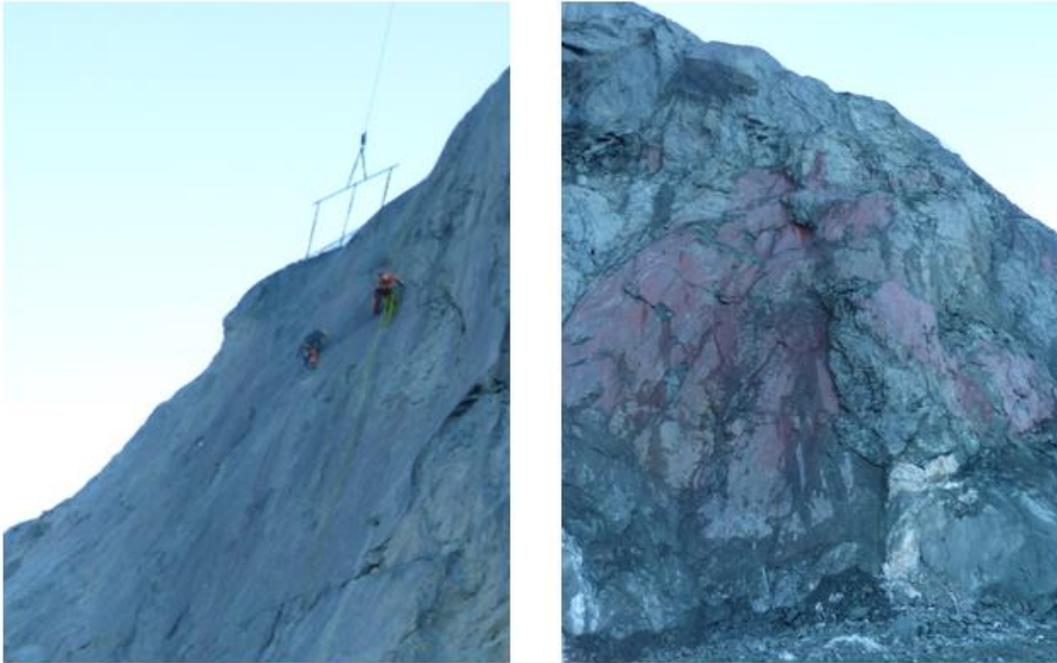
Figure 14 Smooth and blocky/overhanging shear surfaces

The drape mesh performed exceptionally well and allowed the main excavation activities to be carried out under safe conditions right through the high winter rainfall period. The extremes of encountered rock conditions can be seen in Figures 14 and 15.
