# Design, construction and monitoring of the final cover on Wismut's Truenzig tailings facility

**G. Merkel** *Project Tailings Management Facilities, Wismut GmbH, Germany*

**S. Lindner** *C & E Consulting and Engineering GmbH, Germany*

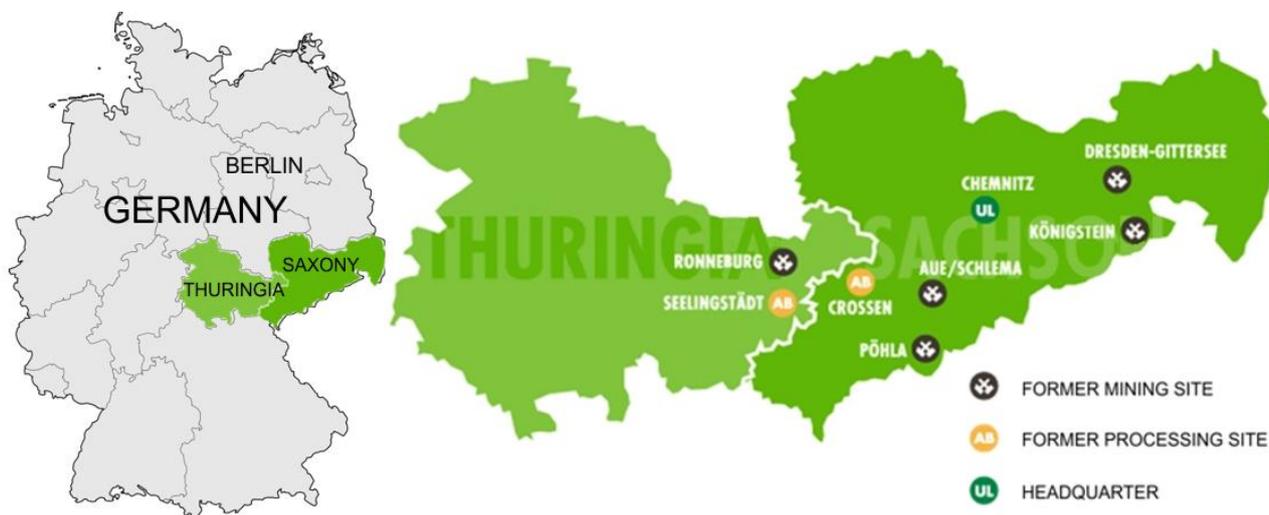
**Figure 1** Wismut remediation sites

Under the control of and in cooperation with the Soviet Union, East Germany was among the world's largest uranium producers from 1945 through 1990. The Soviet-German (SDAG) Wismut company operated numerous uranium mines and two large mills in Saxony and Thuringia. Uranium ore was milled and processed to uranium concentrate (yellow cake) at two hydrometallurgical processing plants located near Seelingstaedt (Thuringia) and Crossen (Saxony) (Figure 1).

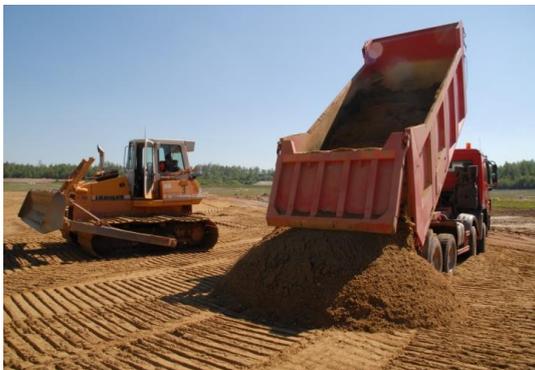
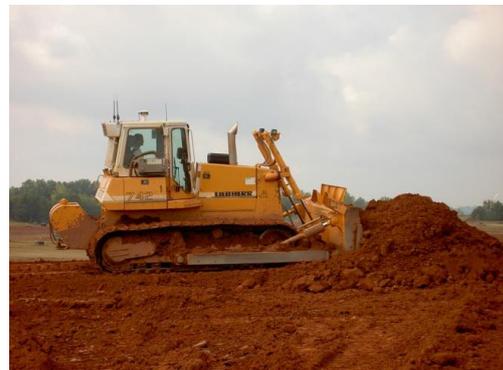
**Figures 6 Final cover during construction**

In 2004, the final covering (Figures 6) began in areas where recontouring had been completed. It started at the flattened North dam and on the tailings beaches (so-called contouring hills no. 1 to 3) in the north of pond A, where the relocated dam material consisting of tailings of the autostable northern tailings dam was placed on top of the tailings beaches, capped with an interim cover. During cover implementation requirements according to the tailings properties (sandy beaches or fine slimes), the underground conditions on the rebuilt tailings, the minimum overlaying of 2.5 m above the tailings surface and the composition of the cover material, especially in the 0.5 m top layer, were constantly verified.

The cross sections for tailings beaches and fine slimes were constructed to meet specific requirements. The cover material was trucked to the site from a nearby mine dump (mixed-grained soil). Degrees of compaction as well as the observation of the layer thickness and the material properties of the cover material were of paramount importance during that stage. The individual layers were constructed with different compaction degrees from  $D_{pr}=88\%$  to  $92\%$  to satisfy the two main criteria of storage capacity and erosion stability. In cases where the relatively low compaction degrees of underlying layers were not successfully demonstrated, these layers were pre-ripped by a bulldozer with ripper teeth. The completion of final covering is scheduled for 2013. Runoff diversion from the last partial area of the tailings facility to the receiving stream is envisaged to be accomplished in 2014.
