Assessing and managing the long-term risks and liabilities at a closed Cornish mine used for waste disposal

S.L. Hobbs *SKM Enviro, UK*

This paper discusses the methodology and findings of the inspection process completed at the former Wheal Sally lead and zinc mine to assess and manage long-term potential risks and liabilities. Particular challenges for the project team, which are detailed in the paper, included:

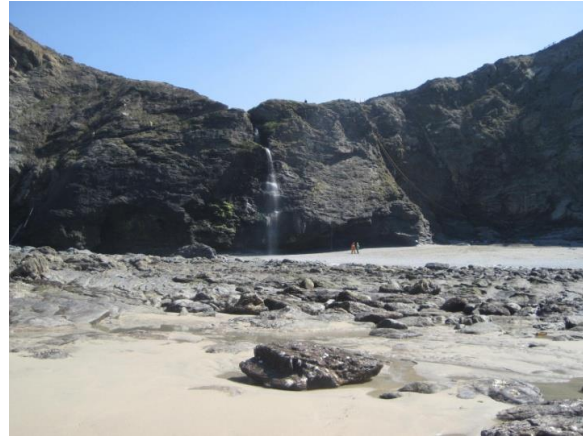
Figure 2 Sally's Bottom Cove with the tide out

The mine is located on the north coast of Cornwall between the villages of Portreath and Porthtowan, some 5 km from the town of Redruth (Figure 1). The only known access to the mine is via the adit portal located on a small beach, Sally's Bottom Cove (Plates 1 and 2), within UK Ministry of Defence (MOD) landholdings at RAF Portreath, a former airfield and current radar station.

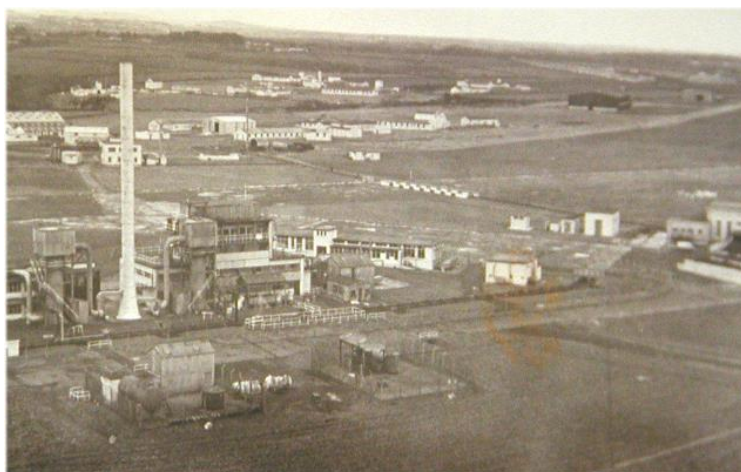
Figure 5 CDE Nancekuke

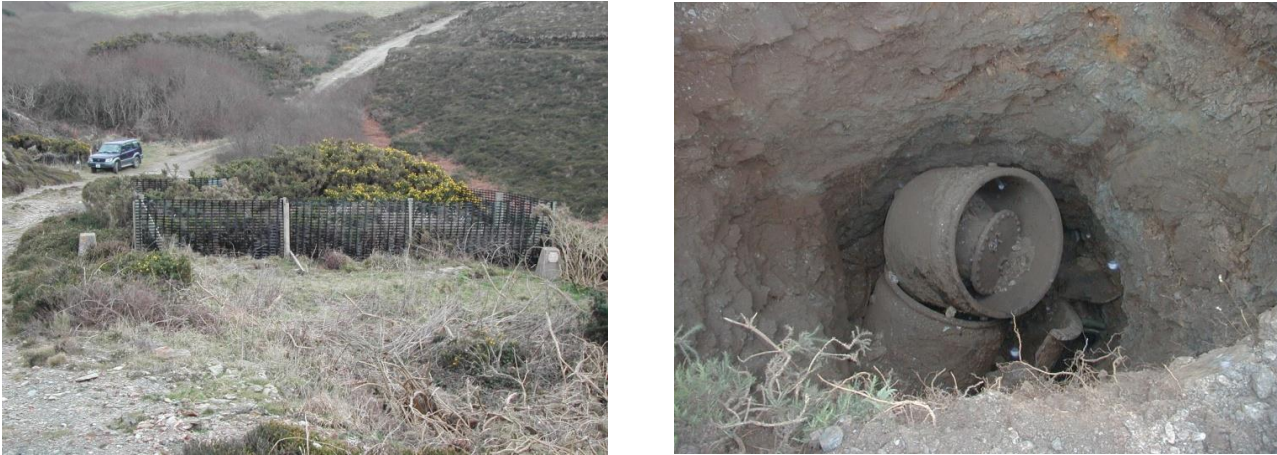
Figure 9 (a) Dump D (fenced area); and (b) excavation of the Ladderway Shaft

The third shaft is Dump D, which is at the location of Sally's Bottom shaft. This shaft is known to have been used for waste disposal by the MOD, with a mixture of wastes reportedly disposed, including general wastes and equipment. The wastes in the shaft were thought to be covered by several metres of earth. Two approaches were adopted to investigate the shaft: angled borehole drilling into the waste deposits and direct inspection of the lower end of the shaft via access along the adit (Enviros, 2007). Based on measurements from historical mine plans, a borehole was drilled into the angled shaft, which was intersected on the second attempt (Figures 7 and 8). A CCTV camera was lowered into the borehole, and several plastic bags and other items of waste could be seen. There were only very small spaces evident, and it was clear that waste infilling had taken place. The borehole entry point into the shaft was approximately half the distance between ground level and the adit. There was no evidence of any waste at the surface with the only demarcation of the dump being a plastic fence and small concrete marker posts (Figure 9).

In order to determine if the Ladderway Shaft was present at the area designated as Dump E or at the location shown on the historical mine plans, the location shown on the mine plan was surveyed and excavated. This revealed a rectangular shaft cut into bedrock approximately 1 × 1.5 m, which was encountered less than 1 m below ground level (Figure 9(b)). The top 3 m of the shaft was backfilled with compacted rock mine waste, below which MOD wastes, including large chemical mixing vessels, were encountered. These were reported to have been decontaminated prior to deposition. A team dressed in full NBC (nuclear, biological, chemical) suits and wearing respirators was used to collect a small number of soil samples from inside near-surface mixing vessels and surrounding rock waste, the laboratory results from which confirmed that they had been decontaminated. Upon completion of the work, the shaft was backfilled with the arisings and the areas marked by a fence. At the end of all the site works at RAF Portreath, the shaft was covered with a robust concrete cap for health and safety reasons.

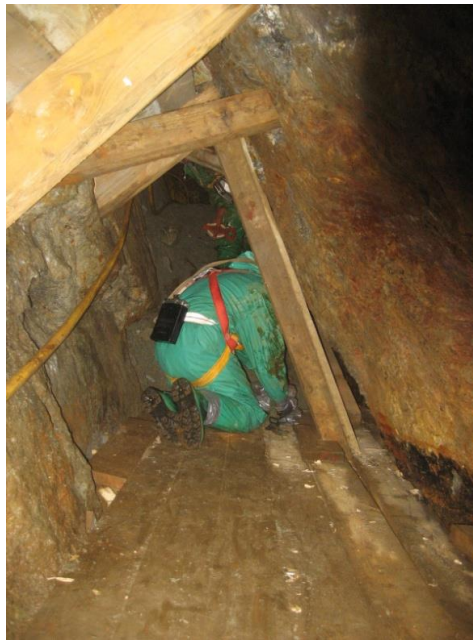
Figure 10 Stabilisation works above a winze

The mine adit was entered by a mixed team of specialists, but progress was limited by areas of collapse and instability. A series of engineering trips were therefore made into the mine to undertake stabilisation works (Figure 10), to place access walkways across winzes and flooded shafts, to place protection in places in the roof of the adit passage that had been worked and to drain areas where water was backed up behind collapses in the adit. As part of this work, a stream at the surface was diverted into a series of pipes, as it was thought that some of this water was entering the workings and had the potential to cause instability. As this work was in the SSSI, it required assent from Natural England and a Land Drainage Consent from the Environment Agency.

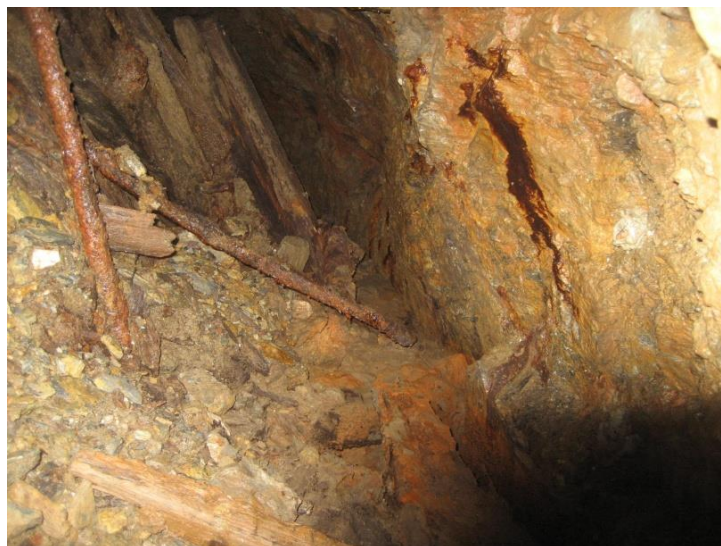
Figure 11 Mine waste at adit level at the base of Dump D

The inspection confirmed that there was a reasonably consistent water flow along the adit, with substantial sediment in places, including iron ochre deposits (Enviros, 2007). The water flow reduced markedly and disappeared towards the base of the two waste-filled shafts. The base of Dump D was clear of MOD waste deposits, and although the shaft used to continue beneath the adit, it was filled with mine wastes (Figure 11), although the stability was questionable and a temporary access was installed over the lower shaft. The shaft looking upwards to Dump D was open for at least 6 m, with partial blockage by rock and soil mine wastes. Samples of this material were taken, but no contaminants that might be expected in MOD wastes were identified. No significant amount of water was identified as flowing down the shaft at adit level. The adit inspection also confirmed the findings of the CCTV survey that the base of the Ladderway Shaft was clear of MOD wastes.

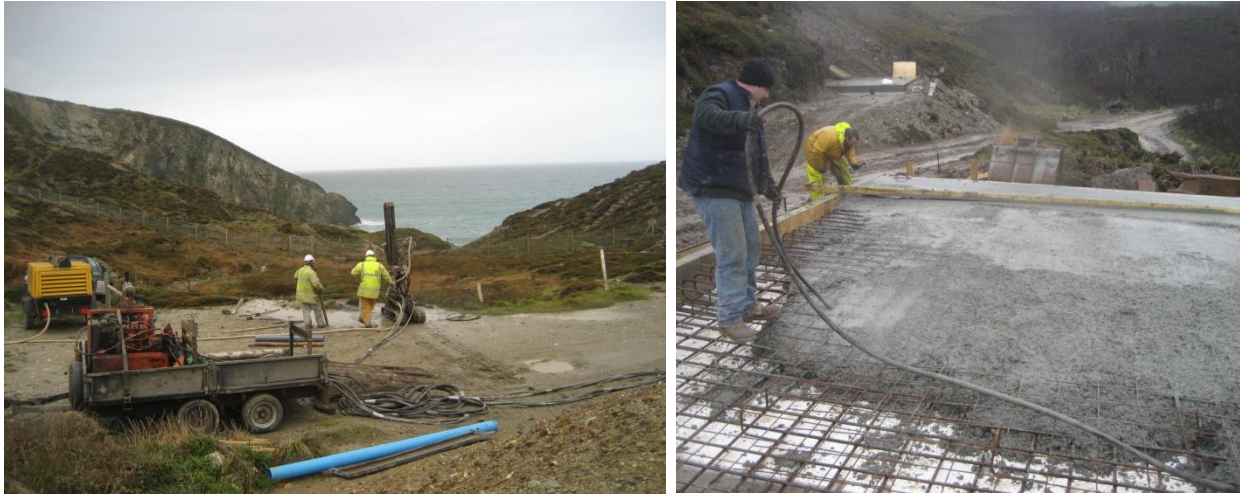
Figure 12 (a) Drilling into the adit to allow water sampling; and (b) shaft capping at Dump D – the cap at Ladderway Shaft is in the background

systems were removed following completion of the inspection to deter future access to the adit and to remove liability for long-term maintenance. Sampling was initially quite constrained and limited to quarterly samples. Once the inspection was completed, a borehole was drilled into the adit (Figure 12(a)) and a small sump was constructed in the floor of the adit – this allowed sampling to be safely completed from the ground surface without rope access. The results of all of the sampling are provided in the monitoring reports (SKM Enviro, 2011: CD1, Report Library, Enviro Reports, Monitoring), with the data from the recent sampling summarised in Table 1. The results confirm that some metals, particularly zinc, are elevated and associated with the mineralisation, but no traces of chemical warfare agents, related contaminants or organic compounds (with the one very minor exception listed in Table 1) have been detected in the water.

In addition to the contaminated land elements of the waste disposal operations completed at the mine, the implications of the health and safety of having three shafts on-site that had not had engineered caps installed remained an issue. Bespoke designs were therefore prepared for the three dumps, and the caps were installed. At Dump D, a key consideration was cap emplacement without disturbing the wastes – this involved identification of the shaft boundaries, excavation of trenches into bedrock and casting load-bearing foundations such that the cap could be laid over the dump without bearing on the wastes (Figure 12(b)). The caps were all landscaped to blend into the environment, and the land was returned to its pre-capping condition within the SSSI and World Heritage site.
