Pipeline wear solution at Kidd Mine: energy absorbent ceramic composites

Abstract

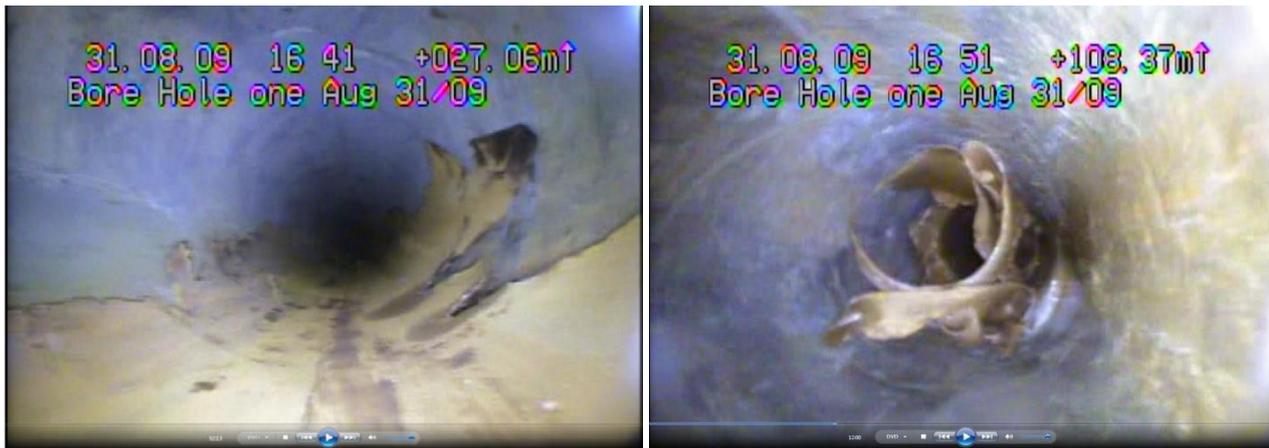
Figure 1 Borehole wear beyond casing into host rock (left) and peeled casing resulting in blockage (right)

- As boreholes wore into host rock, the casing often peeled and resulted in frequent plugging of the distribution system (see Figure 1).
- Increased preventive and corrective maintenance, involving frequent pipeline inspections (non-destructive testing) and replacement of worn pipe, strained the production capability of the system.

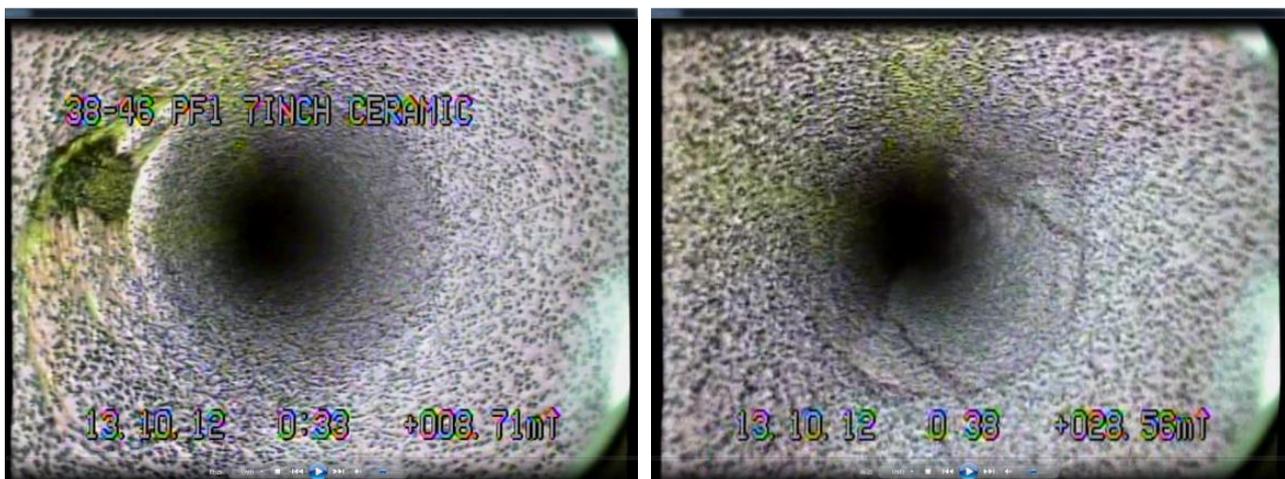
**Figure 2 Minor localised damage of ceramic lining in borehole (left) and small ingress of water at threaded joints in borehole (right)**

Monitoring of the boreholes is also conducted using a winch-mounted camera. These inspections have detected some minor localised defects to be further investigated, as well as a small amount of water ingress at many of the threaded joints (see Figure 2). It is believed that the defects may result from air entrapment in the surface of the lining, but this is currently unconfirmed. They do not appear to have any significant effect on the wear properties or the lining adhesion of the larger system. Camera surveys conducted prior to use and within the first year of service indicate that the above-mentioned defects were noticed and do not appear to have gotten worse. The water ingress at the joints was also noticed in the boreholes post commissioning and does appear to have increased with service. This quantity of water is negligible when compared to that observed during wear of previous boreholes beyond the steel casing and into the host rock, and has not resulted in any noticeable effect on paste flow.

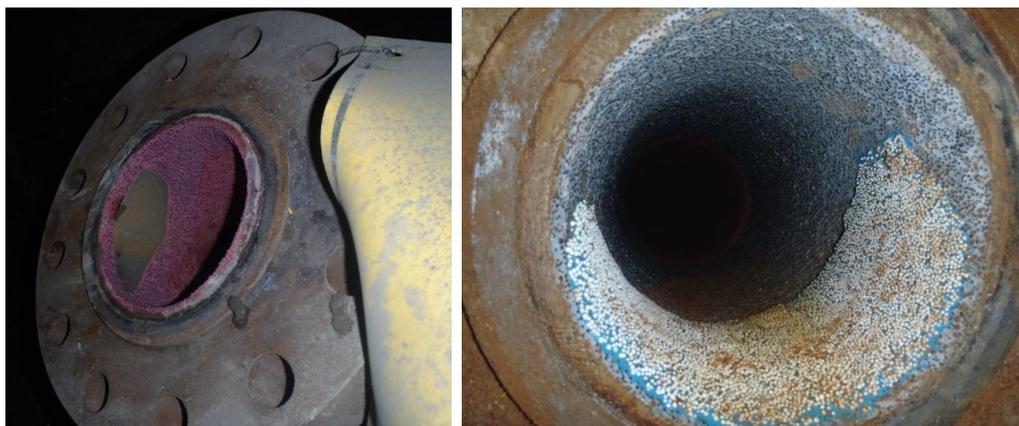
Figure 3 Increased ceramic wear localised at transition from loop to borehole (left) and patch of similar wear after 1.5 Mt of paste fill service (right)

Increased local wear has been detected at some of the transitions from lateral piping to vertical boreholes. This is easily inspected and repaired by removing the elbow and patching with a higher grade composite where required (see Figure 3). If necessary, the flanged section of the casing could be replaced with one lined with a higher grade of composite; however, this has yet to be required as the patch material is performing well. The impact on these sections can also be reduced by creating a more gradual transition to and from the vertical boreholes.

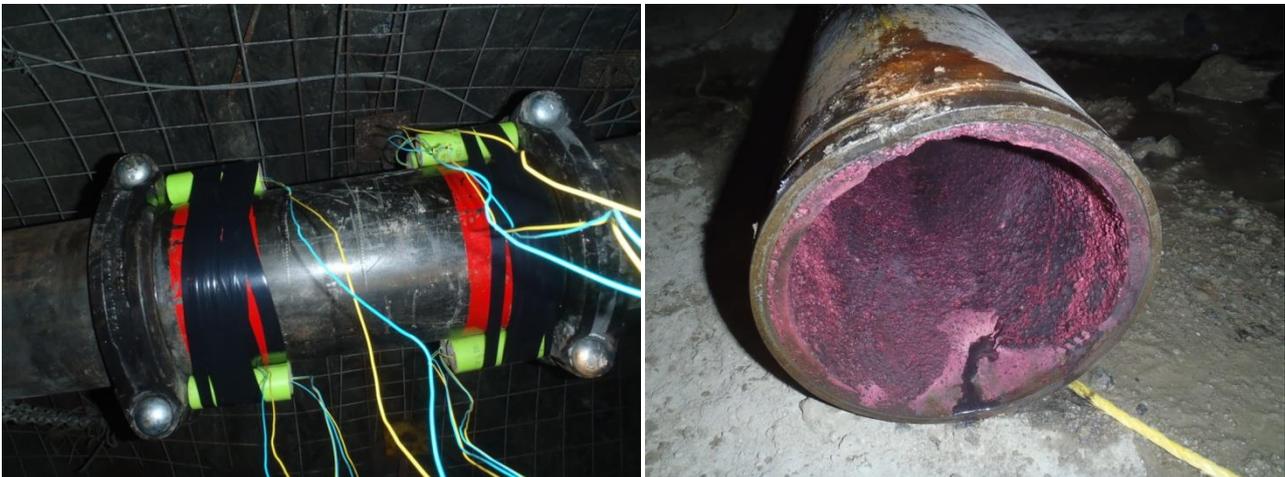
Figure 4 Setup for test blast of clean-out tee clamps (left) and extent of damage to adjacent pipe lined with energy absorbent ceramic composite (right)

Experience with these energy absorbent ceramic composite linings in borehole piping at Kidd Mine has shown no evidence of lining separation through 3.48 million tonnes of paste fill service. Testing of tee-blasting procedures on this lined piping (discussed further in Section 4.2) also evidenced a strong bond of the composite to the steel.

The Kidd Mine procedure for unplugging a blockage of paste in the distribution system involves the use of blasting tees installed throughout the system. These are essentially short lengths of pipe fitted with a 75 mm nipple, from which a cap can be removed through blasting to allow drainage of paste above a blockage. Field testing was conducted to understand the potential lining damage in the surrounding pipes when blasting at the tee and also directly at the clamps. Results showed that even when blasting the clamps, the extent of the damage to the ceramic lining in the surrounding pipes was minimal and evidenced a strong bond to the pipe (see Figure 4). The most significant damage occurred during tests conducted on an empty system, and this was still relatively minor. Damage is expected to be less significant when the system is charged with paste. The decision was taken to make blasting at the clamps the new standard as it provides a greater chance of clearing the blockage and does not require lining of specialty tee pieces. Any damage to the lining of the adjacent pipes will be patched if possible; otherwise, the pipe will be cut down for use in shorter custom lengths. It is important to note that, while system blockages were at one time quite frequent at Kidd, improved controls, particularly around feed material contamination, have almost eliminated these events.
