The operational and laboratory aspects of a thin spray-on liner

PK Boeg-Jensen *Luossavaara-Kiirunavaara AB, Sweden*

G Swan *Rock Mechanics & Mine Design, Canada*

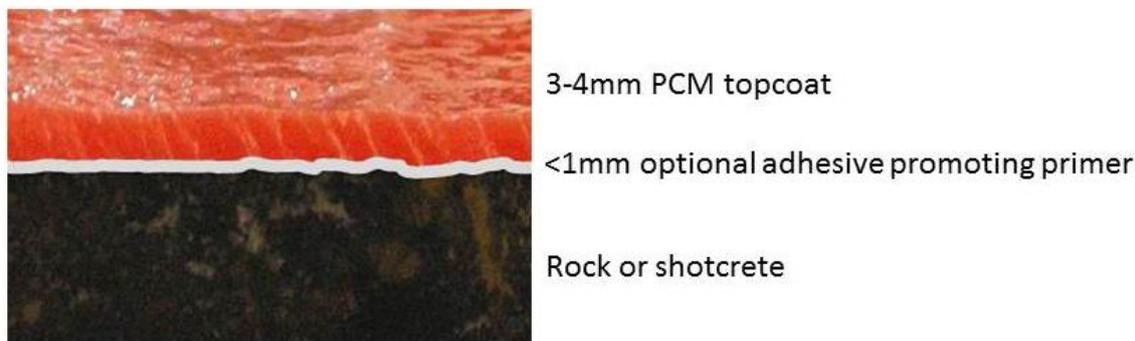
Figure 1 3M's PCM system (Swan 2014)

According to Boeg-Jensen (2013) the original strategy was to apply two layers when spraying the material, since it was a two layer composite system. The application was automated. First a thin primer to promote adhesion was sprayed on a cleaned and prepared rock surface, allowing the main topcoat to mobilise its key physical properties such as tensile strength, elongation and toughness as the load is generated due to eventual loose rock failure. The topcoat is preferably 3-4 mm thick and comprised of a hybrid polyurea chemistry, known for its high tensile strength and toughness. In order to form an adequate ground support, the liner requires support by a standard bolting pattern as with shotcrete and mesh. The basic functions of the 3M PCM and its installation are demonstrated in Figure 1.

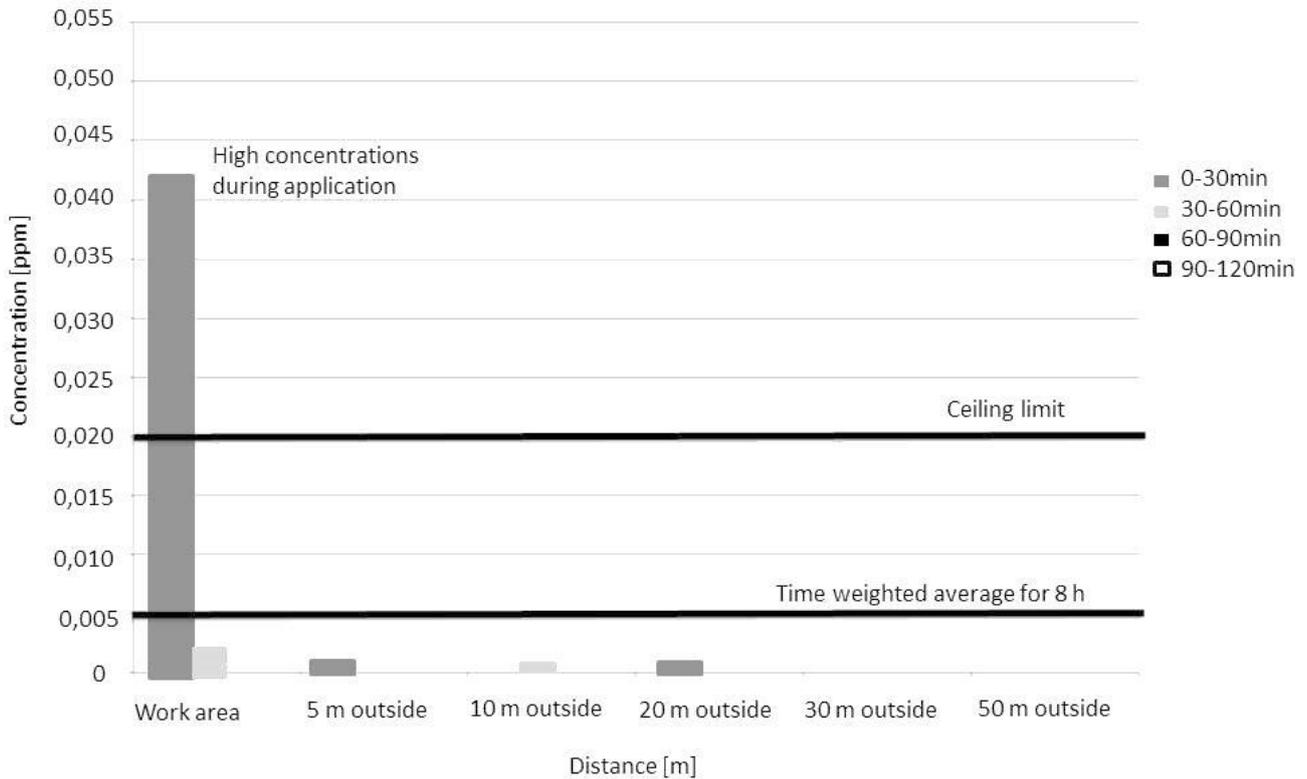
Figure 2 Isocyanate concentrations downstream from the working area and during different time intervals (Boeg-Jensen 2013)

The isocyanate testing was conducted before, during and after the 3M PCM application. The results show that there are high levels of isocyanates during application in the hot zone or work area, but only 5 m outside the hot zone the levels are considerably lower and beneath the time weighted average and ceiling limits, as presented in Figure 2. Between 30-60 minutes after application, the isocyanate levels are beneath the time weighted average and ceiling limits both at the hot zone and downstream from the hot zone. This presumes that the ventilation is turned off during application and for 30 minutes after completed application. A water curtain did not decrease the isocyanate levels and was therefore abandoned. With respect to these results a safety protocol was set up, requiring a barricade 20 m downstream from the hot zone, with no allowance access until 30 minutes after completed application. The safety protocol also requires ventilation to be turned off during application and for 30 minutes after completed application to avoid dispersal of any potential airborne isocyanates (Boeg-Jensen 2013).

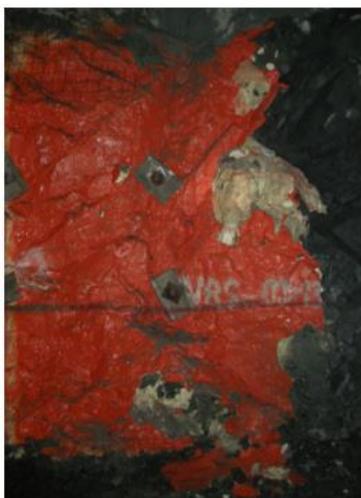
Figure 3 Peel back damage due to blasting of a round for full composite consisting of primer and 4 mm top coat (Boeg-Jensen 2013)

The results from the in cycle blasting trials were immediately apparent after the blasted round. The impact from the blasting caused peel back of the full composite at the leading edges and the blast also caught some of the overlaps and peeled them back. Note that the 3M PCM was not bolted right up to the face as would be done with mesh or shotcrete. Furthermore the perimeter areas generally had a lower total thickness application due to the initial spray pattern setup, and the interface between panel applications comprised of top coat/primer/top coat, rather than top coat to top coat resulting in better adhesion. In several cases the face blast also blasted out the wall behind the applied coating. In addition, post-blast observations confirmed of significant fly-rock damage and cracking. Also the mucking-out operation tended to tear pieces of the 3M PCM. The first sprays in this test were using material that was water contaminated which also contributed to the majority of the small cracks. These observations together determined the results a failure from the performance point of view. The observations are illustrated in Figures 3 through 5, where the fault lines are poorly indicated (Boeg-Jensen 2013).

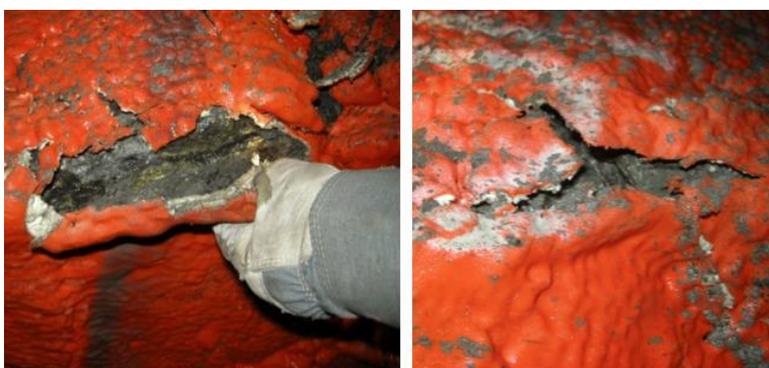
Figure 4 Fly-rock damage in full composite consisting of primer and 4 mm top coat (Boeg-Jensen 2013)

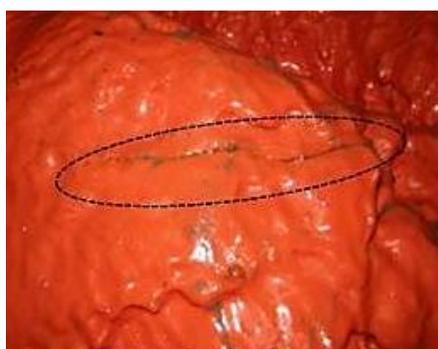
Figure 5 Small crack in full composite consisting of primer and 4 mm top coat (Boeg- Jensen 2013)

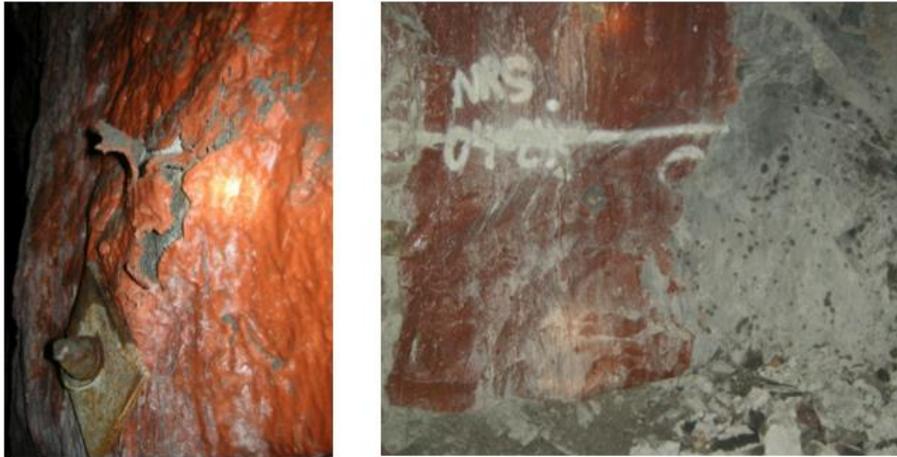
Figure 6 Fly-rock damage to the left, and leading edge to the right, for 4 mm top coat (Boeg-Jensen 2013)

The same test was repeated without the foam for a 4 and 8 mm top coat application respectively, with significant improvement. The peel back was reduced as well as the fly-rock damage for both 4 and 8 mm top coat applications (Figures 6 through 8). Although the 4 mm application managed to decrease the level of peel back and fly-rock damage compared to the full composite, it did not provide sufficient coverage and experienced gaps. The 8 mm top coat thickness gave the best results in terms of minimum peel back,

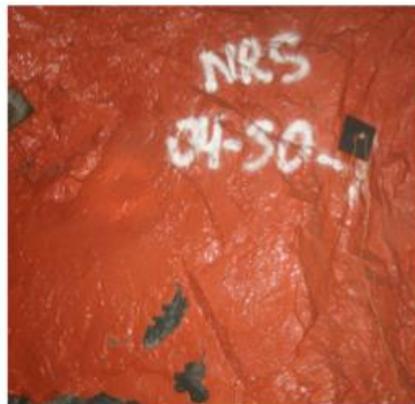
Figure 7 Scoop damage on the lower part of the wall for 8 mm top coat (Boeg-Jensen 2013)

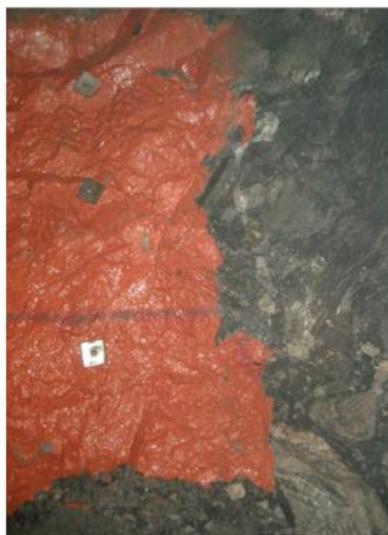
Figure 8 The leading edge after cycle blast for 8 mm top coat (Boeg-Jensen 2013)

sufficient coverage, minimum fly-rock damage, and the immediate area surrounding the fly-rock damage did not loosen up (Boeg-Jensen 2013).

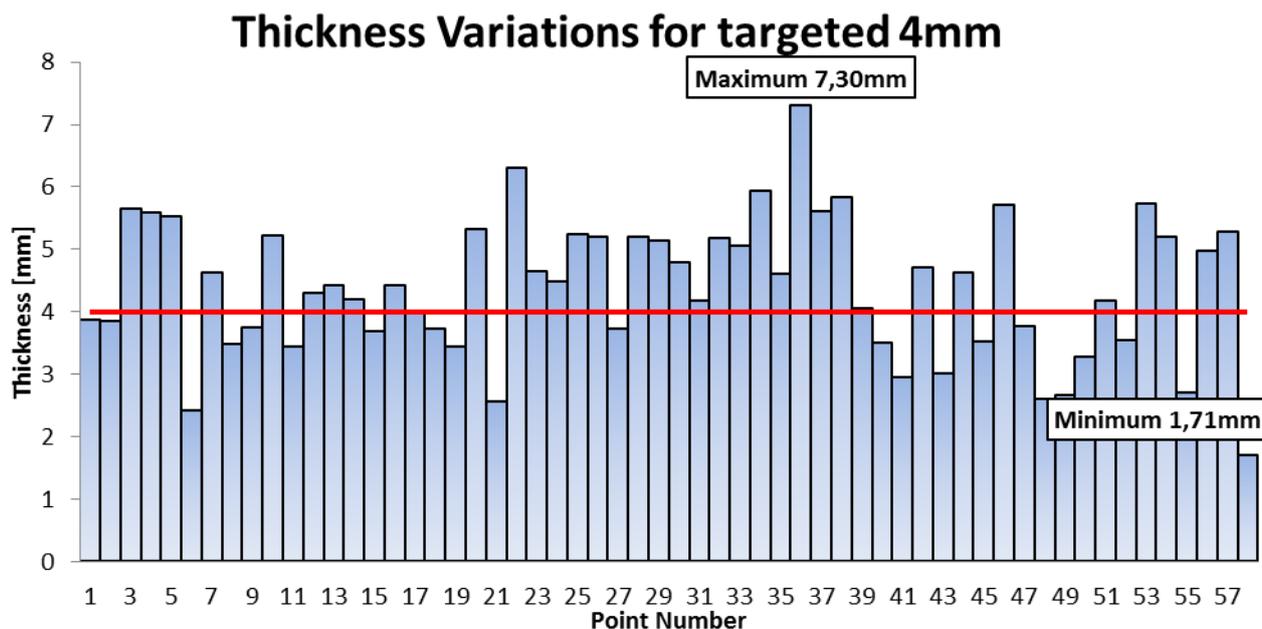
Figure 9 Thickness measurement variations for top coat with desired thickness 4 mm (Boeg-Jensen 2013)

The results from the targetted thickness measurements for the top coat are based on a total of 58 points measured for seven different spray applications for the desired thickness of 4 mm. The maximum thickness reached 7.30 mm and the minimum 1.71 mm with an average 4.38 mm and standard deviation 1.11 mm which shows that there is good consistency for the application thickness. The results are displayed in Figure 9 (Boeg-Jensen 2013).

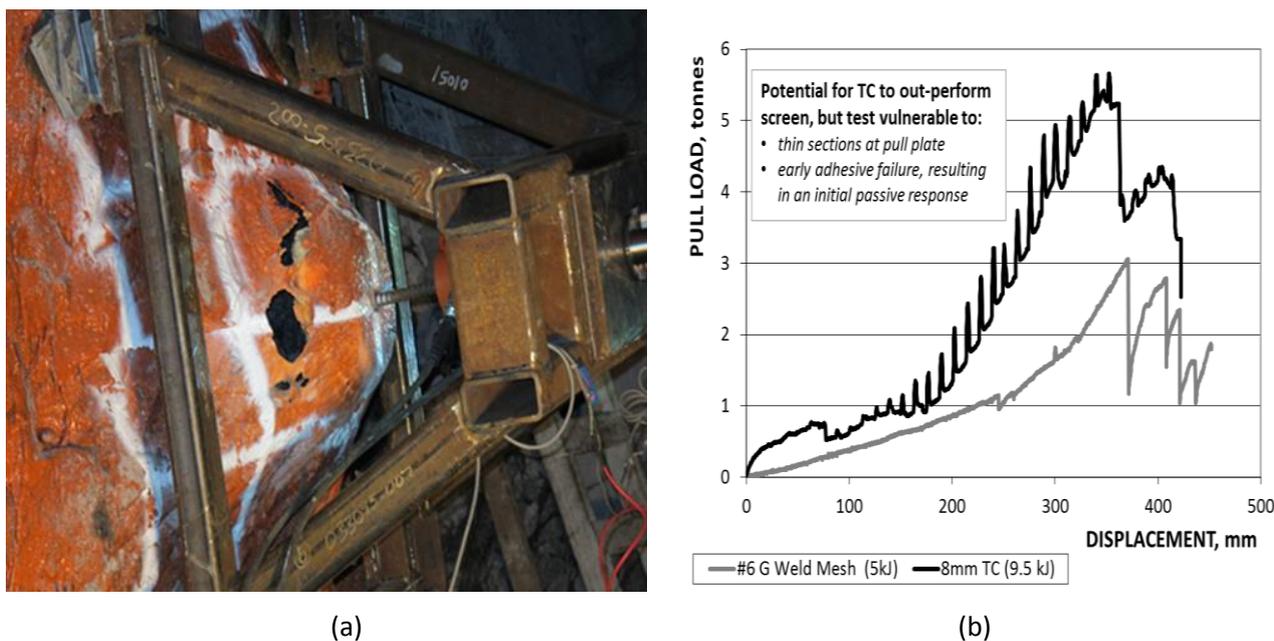
Figure 10 (a) typical top coat failure observed in the large scale pull test; (b) comparison between no. 6 gauge weld mesh and nominally 8 mm thick topcoat (Swan 2012)

In an attempt to better understand the adhesion and toughness of the liner under actual operating mine conditions, a series of large scale pull tests were conducted on underground and blasted wall surfaces at MTI's test ramp site. This version of a test method described by Tannant (1997) and Espley (1999) sacrifices the repeatability of loading the liner indirectly behind a set of plain-surfaced, interlocking paving stones in favour of gaining some operational understanding of the impact of liner thickness variation on the baggage capacity of the liner only for a square bolting pattern of 1 m. This particular series of tests were sprayed with the ABB robotic prototype, which also provided some clarification of the level of confidence with respect to coverage and thickness variation. The general test parameters were to spray a 2 × 2 m patch onto the wall and bolt with a 1 × 1 m grid, (Figure 10).

Due to the highly variable nature of this modified test method, the results show only the general characteristics of the 3M PCM system (with and without primers); the actual numerical results varied greatly if there was a thin spot in the liner, which typically occurred at the pull plate which was the highest stress point in the system. It was found that the 3M PCM system behaved like mesh based on its initial resistance to movement and elongation, but the initial resistance to load could be increased with a thicker application. Typical values for load and deflection based on 4mm of 3M PCM were approximately 3 t and 360 mm respectively; while 4 mm of 3M PCM applied over fibre-reinforced shotcrete withstood 27 t before reaching the load limit of the test ram.

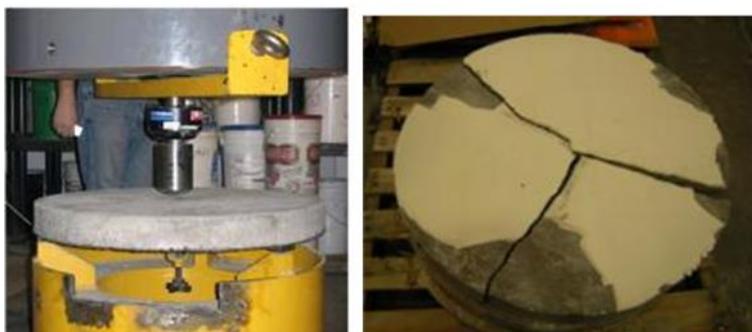
Figure 11 Round determinate panel test configuration and example of a failed sample coated with 3M PCM (Swan 2014)

To complement the in situ testing and to better define the contribution of 3M PCM with a primer on shotcrete samples, several tests were conducted using the ASTM C1550 round determinate panel (RDP) test standard (Figure 12). Figure 11 shows the test set-up. A circular disk of cast fibre reinforced shotcrete was placed onto three rigid points and a ram loads used to the shotcrete at its centre. Several tests were conducted with different thicknesses, primers and cure ages. It was shown that using a primer did not meaningfully improve the results compared to ‘no primer’ tests, and that the 3M PCM top coat provided a reinforcing aspect to the shotcrete. The 3M PCM increased the peak load of the shotcrete before cracking and subsequently carried the load across a displacement of approximately 140 mm, which provided an increase in total toughness by as much as 400% over fibre-reinforced shotcrete only (Swan 2014).

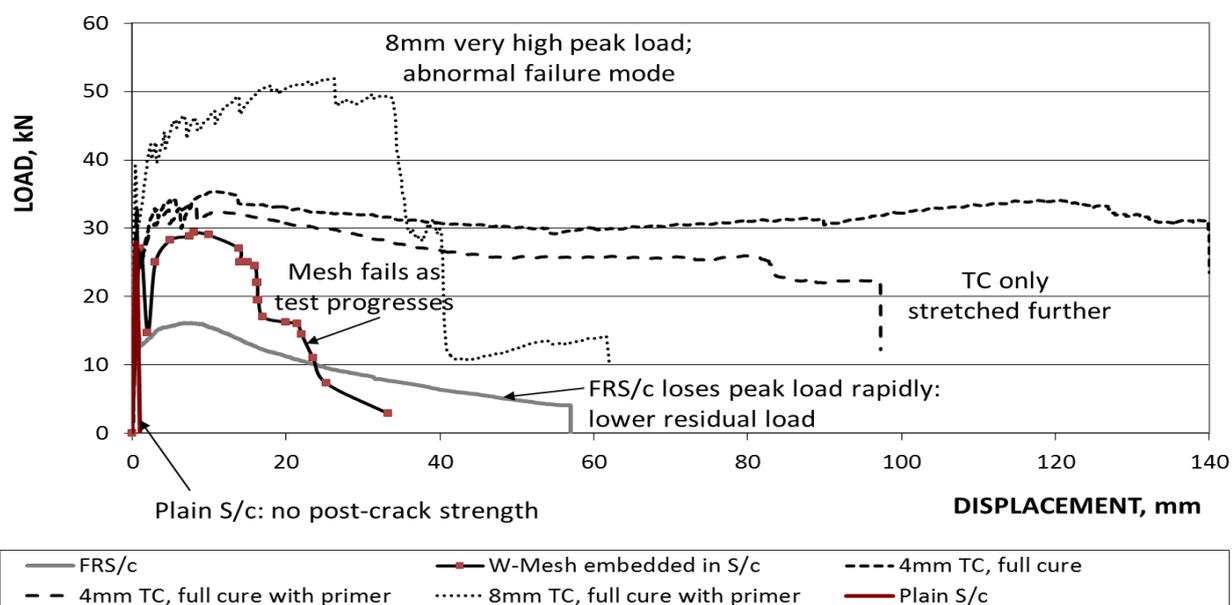
Figure 12 Summary of the round determinate panel test showing the general increase in toughness capacity afforded to shotcrete by the addition of the 3M PCM (Swan 2014)
