# Overcoming high temperature water ingress in deep shaft mining

*Resolution Copper Mining LLC, along with mining contractor Cementation USA, Inc., are in the process of developing what is planned to become the largest copper-producing mine in North America. A project of this magnitude does not come without challenges, and No. 10 Shaft, the first of six record-breaking shafts, has presented many. An impressive feat of engineering, the project will eventually use block caving methods to mine approximately 1.7 b t of porphyry copper ore at rates of up to 120,000 t per day. It will rely on the six 2,130 m deep shafts for ore extraction, ventilation, man access, and utilities.*

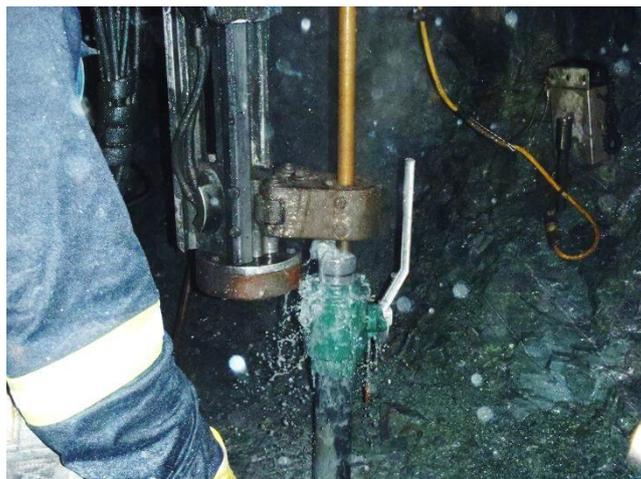
**Figure 2 A cementation miner using a pneumatic jumbo rock drill to drill a 25 m probe hole on the 1,969 m bench**

Based on analysis of core samples from the shaft pilot hole, a geotechnical consulting firm recommended that water probe holes be drilled ahead of all shaft advance. For every 15 m of shaft advance, four 67 mm diameter, 25 m deep water probe holes are drilled from the shaft bottom, ensuring 9 m of overlap. As shown in Figure 2, these holes are drilled through grouted standpipes with high pressure shut-off valves to ensure that if significant water was encountered, it could be contained. Prior to 1,770 m in depth, these holes were typically dry with the exception being a hole producing 1-2 L per minute (L/min). Small pockets of water inflows were experienced between depths of 1,770 and 1,969 m, but cumulative inflows never exceeded 250 L/min at the shaft bottom. Cementitious pressure grouting was used to slow these inflows, and while they were never sealed off completely they were typically reduced to some degree.

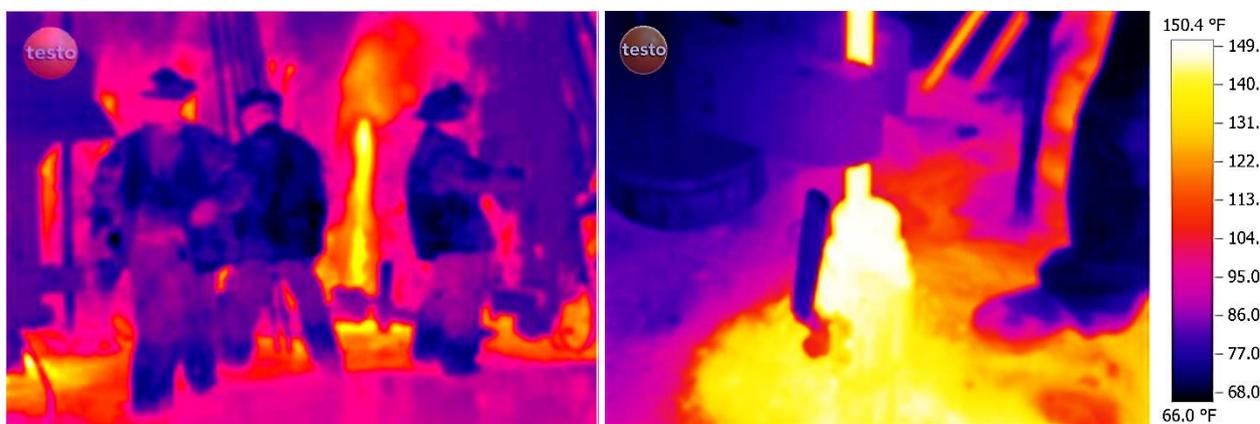
**Figure 3 Thermal imaging of miners drilling grouting holes on the 1,969 m bench**

Multiple rounds of pressure grouting were attempted to seal off the water inflows and establish a grout curtain in the rock outside the shaft diameter. As shown in Figure 3, extremely hot water along with fractured rock made grouting extremely difficult. Grouting continued for three months before the decision was made to resume sinking and attempt to handle the water inflows. Resuming sinking from the 1,969 m bench was a slow and deliberate process. As the shaft advanced, water inflows continued to increase rapidly, exceeding 1,700 L/min by the time the 2,019 m bench was reached. Innovative methods were required to pump these high volumes of hot water from such extreme depths up to surface, especially with an installed shaft dewatering system designed to handle a maximum of 750 L/min.

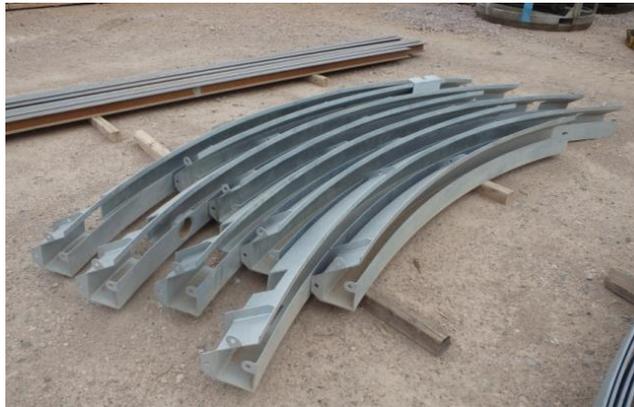
Figure 4 Sections of a water ring on surface before installation

Upon encountering the initial inflows, limited pumping infrastructure existed in the shaft and dewatering of the shaft bottom was reliant upon pumping water into the sinking buckets. The shaft crew would fill these 7,200 L buckets using pumps on the shaft bottom, after which they would be hoisted to an existing level 335 m below surface and siphoned into the level sump. The double-drum hoisting setup in No. 10 Shaft allowed for dewatering rates of up to 1,300 L/min with this method. However, this rate could not be maintained consistently as the hoist was also required for man travel and delivery of supplies throughout the day. This method's reliance on the hoist also slowed all other shaft activities, delaying shaft progress. The areas of water ingress that were intersected between 1,770 and 1,969 m did not generate high enough volumes to completely halt sinking operations, but they did significantly reduce advance rates for this reason. Pressure grouting was somewhat effective in slowing the inflows, but upon advancing the water would begin to report through the matchers in the concrete liner between sets and run down to the shaft bottom below. To counter this, steel water rings were installed in the liner when an inflow of approximately 100 L/min was accumulated. These water rings (Figures 4 and 5), have an inside diameter matching that of the shaft and collect all water flowing down the liner before it can reach shaft bottom.

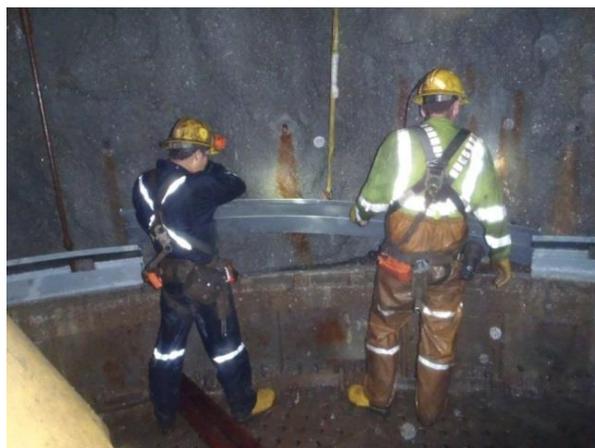
Figure 5 The installation of a water ring during a shaft liner pour

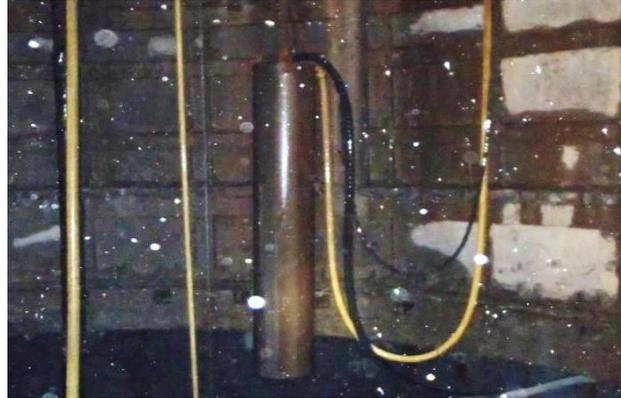
**Figure 6** The hanging sump in operation

Initially, the water ring would drain to a temporary hanging sump that would be suspended from the shaft forms using properly-rated rigging and house a submersible pump as shown in Figure 6. This engineered sump was fabricated onsite using a 3 m long, 300 mm diameter pipe with an integrated pump shroud and centring brackets. Located in the shroud, the pump would be hoses to a pipe embedded in the concrete

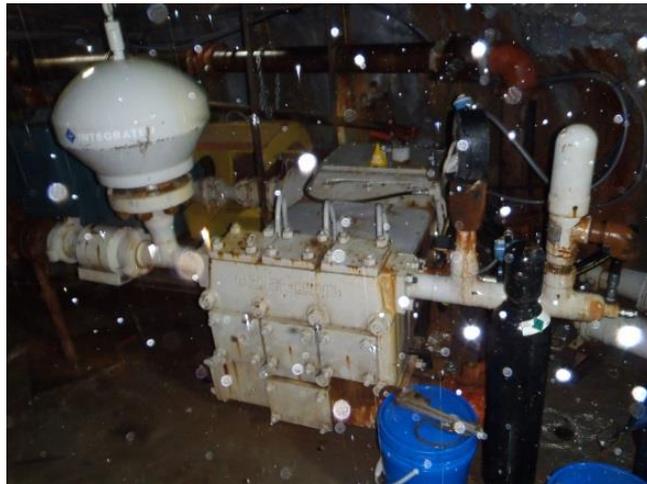
**Figure 9 One of two positive displacement pumps installed at the Set 326 Pump Station**

It was decided to install an unplanned pump station at Set 326 (1,987 m below surface) to allow for more efficient water handling. Due to poor ground conditions, the station was not excavated beyond a 3 m ring around the shaft, making a tight fit for the pumps and equipment. Given the high solids content of the water being pumped from shaft bottom, it was decided to install positive displacement pumps at this station, as shown in Figure 9, rather than centrifugal pumps that were typical throughout the shaft. Two pumps were installed with a capacity of 1,150 L/min each, designed to run in an alternating setup in order to provide sufficient downtime for each. The feed tanks for these pumps were fed by submersible pumps on the shaft bottom through 150 mm steel pipe embedded in the shaft liner. There were some issues with the system and maintenance plan initially, primarily due to inexperience with these types of pumps. The heavy pyrite content of the rock, which is extremely abrasive to pump parts, caused additional problems with premature wear of the pump parts. Over time, an intensive maintenance plan was established, significantly increasing the uptime of the pumps and reducing associated delays to sinking.

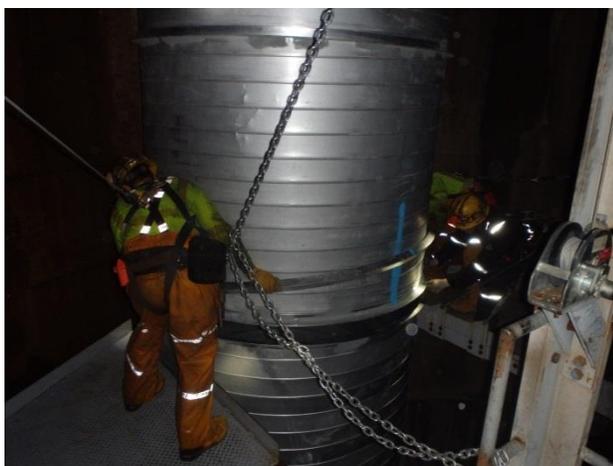
**Figure 11** Installation of the 2 m diameter exhaust fans at the Pump Level

Cementation began the installation of the 2 m diameter exhaust duct from the Set 326 Station. The new exhaust line was built from the bottom up with 3 m sections slung down from Pump Level by a temporary winch installed at a level 335 m below surface. Figure 11 demonstrates the complexity of this work and the ingenuity required to complete it efficiently and safely. The duct was installed using two work decks with retractable wings, one on each side of the double-drum hoist. Tied off with safety lines, the miners would guide the duct on the winch into place from above, couple it to the duct below, and install a bracket every 6 m securing the duct to the shaft wall. The installation was completed without incident and the duct was successfully tied into the upgraded exhaust fans in the existing Pump Level Vent Service Drift between No. 9 and No. 10 Shafts (Figure 12).

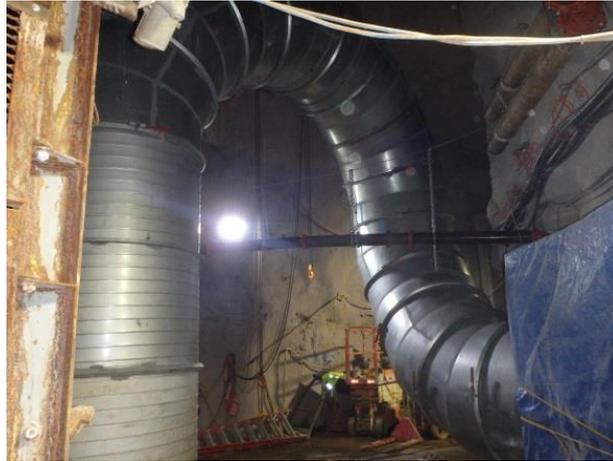
**Figure 12 Exhaust line tie-in to the exhaust duct mid-shaft**

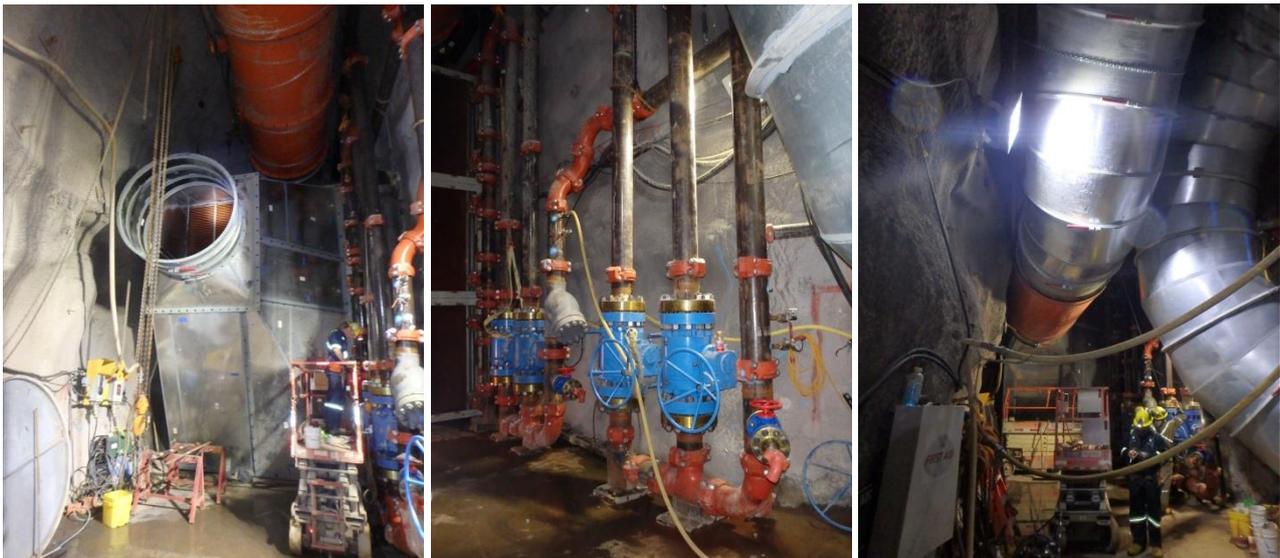
**Figure 13 Upgraded cooling installations at the Pump Level in No. 10 Shaft**

Installation of the cooling coils in the Vent Level Access Drift on surface was completed by the third-party contractor. The six 5,900 kg coils at the Pump Level along with all required infrastructure were installed by Cementation. These coils were placed in structural frames and stacked in two banks of three. High pressure 200 mm piping was run from the shaft to the coils through a large valve bank required to control and isolate the coils. A massive plenum was then attached to the front of the second bank and tied into 1.8 m duct which carried the cold air to the existing shaft duct and down to the shaft bottom (Figure 13).

The coils on surface are fed glycol from the cooling plant via 600 mm lines and handle approximately 6,800 m<sup>3</sup> per minute of air through them via one 186 kW fan. This cooled air is forced down the shaft barrel to the six cooling coils installed at Pump Level. Glycol is circulated through these coils from the cooling plant on surface via high-pressure 200 mm lines that run down the shaft. Two 186 kW fans take in the cool air fed from surface and force it through the coils and into the shaft duct.
