# Dredging of an active thickened tailings storage facility at the Ernest Henry Mine

TG Fitton Fitton Tailings Consultants, Australia
WJ Neumann Neumann Contractors Pty Ltd, Australia

#### **Abstract**

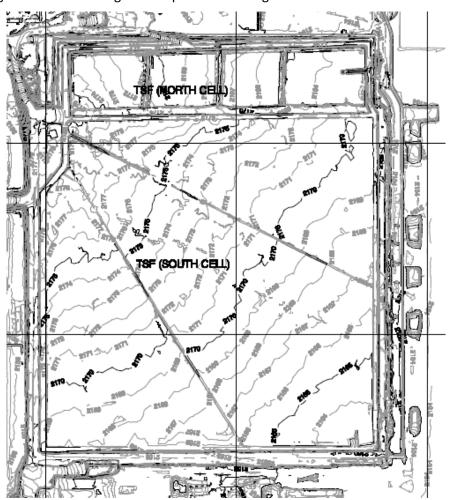
Figure 1 A layout of the two tailings cells at the Ernest Henry Mine, showing the topographic contours of the tailings surface after 14 years of storage

A general arrangement of the tailings cells is presented as Figure 1.

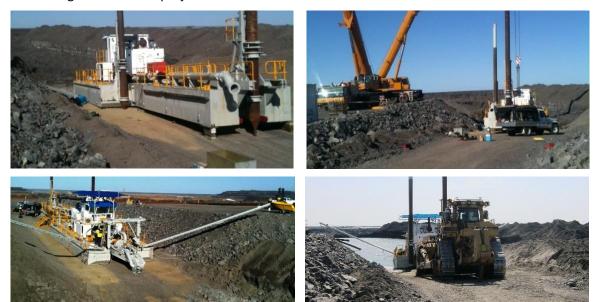
Figure 2 The dredge being assembled on the ramp after mobilisation to site. Once the starter pond had been filled, a dozer was used to push the dredge into it

As neither of the two TSFs had a decant pond on its surface, it was necessary to excavate a starter pond prior to commencement of dredging. A ramp was also excavated at the edge of the starter pond, where the dredge could be assembled and set up for launch. The ramp was about 60 m long and 15 m wide, with a 1 in 15 grade. Following the assembly of the dredge, the starter pond was filled with water, and a dozer was used to push the dredge out onto the pond. A minimum pond depth of around 2 m is required for the particular dredge used on this project.

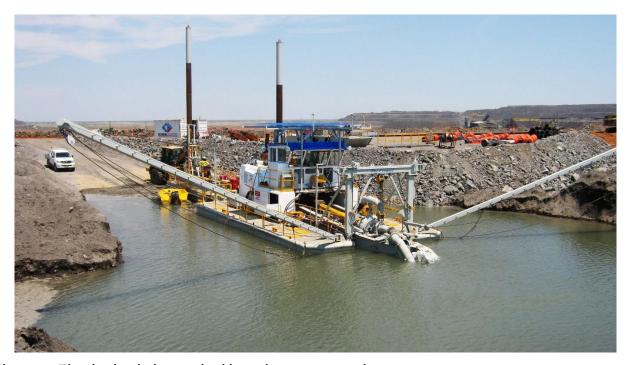
Figure 3 The dredge being pushed into the starter pond

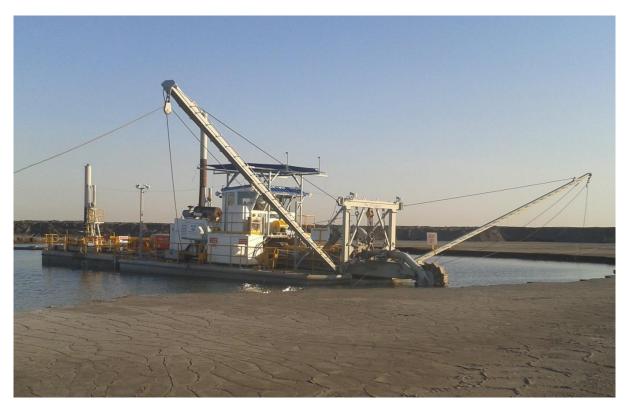
Figure 4 A photograph of the dredge at work. The bucket-wheel cutter has been raised above the pond surface, and can be seen at the front of the dredge

The dredge that was used at the EHM was a diesel-powered, Neumann-built bucket-wheel type cutter suction dredge, which used a bucket-wheel type cutter mechanism. The dredge was fitted with a fixed and travelling spud assembly, which improves dredging accuracy and increases operational efficiency by reducing the time required to change the position of the dredge.

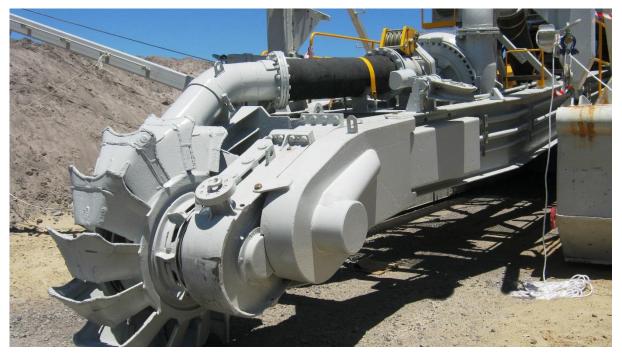
Figure 5 The bucket-wheel cutter head of the dredge, with the on-board centrifugal pump visible at the far end of the black flexible hose

The dredge was equipped with a Warman 10/8 GH slurry pump and had sufficient capacity to transport the tailings/water mixture the horizontal distance of approximately 1,500 m through a 300 mm diameter polythene pipeline. The dredge pond on the tailings dam was approximately 20 m higher than the slurry discharge point into the magnetite circuit.

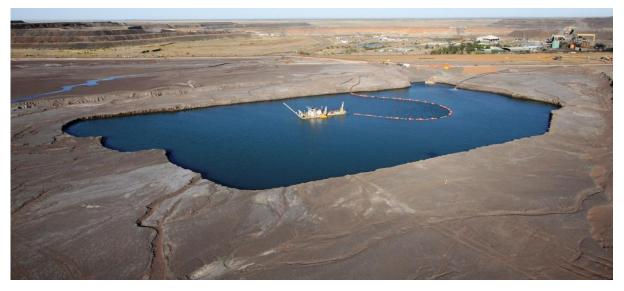
Figure 6 An aerial photograph of the dredge pond. On the far side of the pond the training bund can be seen, with an active tailings channel running beyond it

Active tailings discharge was occurring in the same cell that was being dredged. The training bunds that EHM had already constructed were exploited for keeping the active discharge from entering the dredge pond. A certain amount of sterilisation of magnetite-rich tailings was occurring in the adjacent deposition area, with barren tailings being deposited above it. However, the plan was to minimise this sterilisation by constructing underwater bunds in the dredge pond, and discharging the barren tailings in the mined out portion of the pond at the earliest possible opportunity. Such underwater bunds can be constructed by

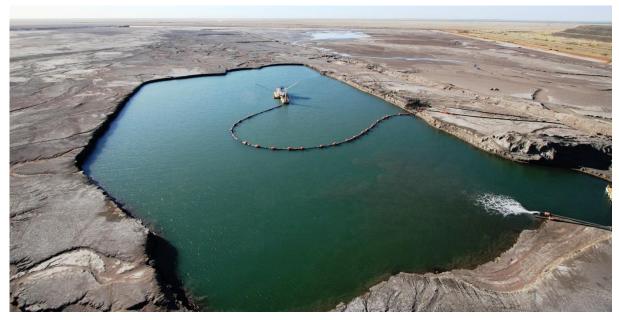
Figure 7 Another aerial photograph of the dredge pond. The freeboard at the far end of the pond is lower than at the near end, as a result of the beach slope. Return water is seen being discharged into the pond

Due to the 0.8% average slope of the tailings beach, it was necessary to start dredging at the high end of the beach and progress the pond towards the low end. This kept the freeboard down to a manageable height, thus reducing the risk of uncontrolled failures of the pond banks which could damage the dredge.

To manage this issue, the downslope length of the pond was kept within manageable limits, so that the differential in freeboard did not become excessive.

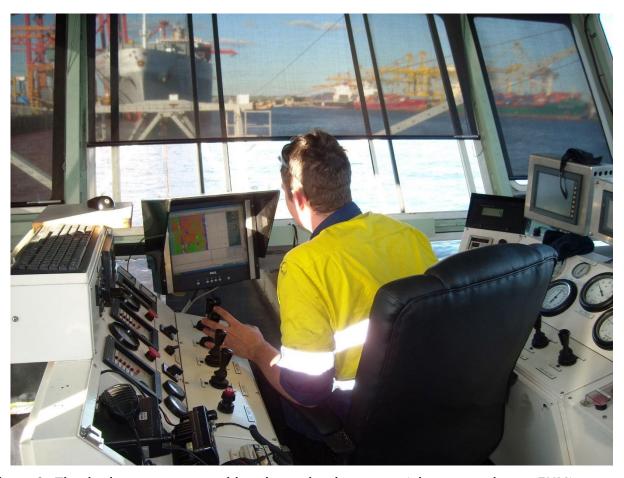
Figure 8 The dredge operator watching the navigation screen (photo not taken at EHM)

Navigation of the dredge was enabled with a Trimble HYDROpro Real Time Kinetics (RTK)/Differential Global Positioning System (DGPS) on board the vessel. Coupled with other equipment such as a clinometer to sense the angle of the suction pipe, the position of the dredge's cutter was able to be continuously determined to a high level of accuracy. A predetermined dredging pattern was loaded into the dredge's navigation system computer, enabling the operator to accurately guide the cutter in accordance with the plan. The actual position of the dredge's cutter was recorded and stored for quality assurance purposes.
