Monitoring — the good, the bad and the ugly

PJN Pells *Pells Consulting, Australia*

Abstract

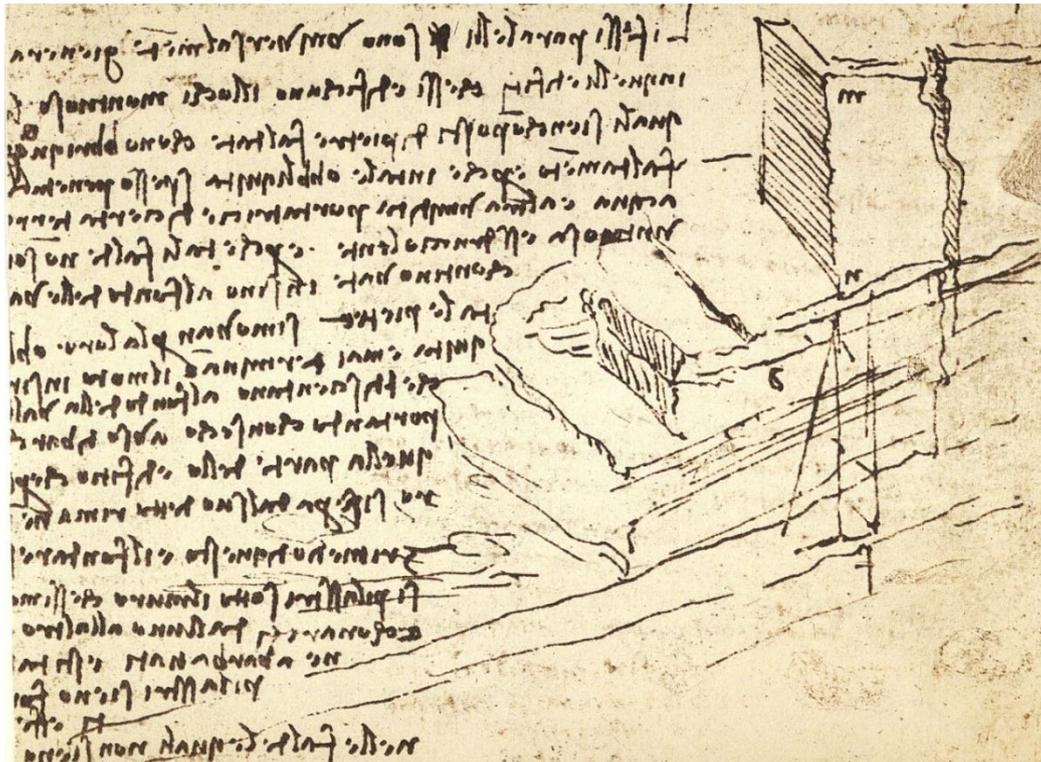
His sketch of a natural landslide (*Codex Arundel IV*) showing shearing along inclined bedding, is given in Figure 1. His advice is as follows:

Figure 1 Leonardo’s investigation of a shear plane in a natural landslide

“In order to find the solid part of these strata, it is necessary to make a shaft at the foot of the wall of great depth through the strata; and in this shaft, on the side from which the hill slopes, smooth and flatten a space one palm wide from the top to the bottom; and after some time this smooth portion made on the side of the shaft, will show plainly which part of the hill is moving.”

We may nowadays choose to use inclinometers rather than hand dug shafts, but the principle remains the same. Understand the geology monitor appropriately, and you will probably understand a landslide.

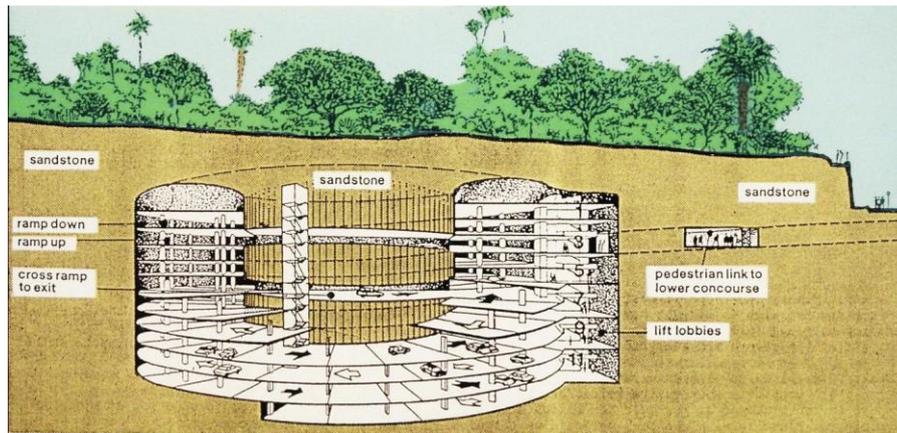
The parking station is a free standing double helix concrete structure in a donut shaped cavern. The helical concrete structure does not touch, or support, the cavern roof or sidewalls.

The cavern has an outer diameter of 71.5 m, with a central rock column 36.4 m in diameter (Figure 5). Parking space requirements dictated a free span of 17.5 m.

Figure 5 3D sketch of the double helix in its cavern

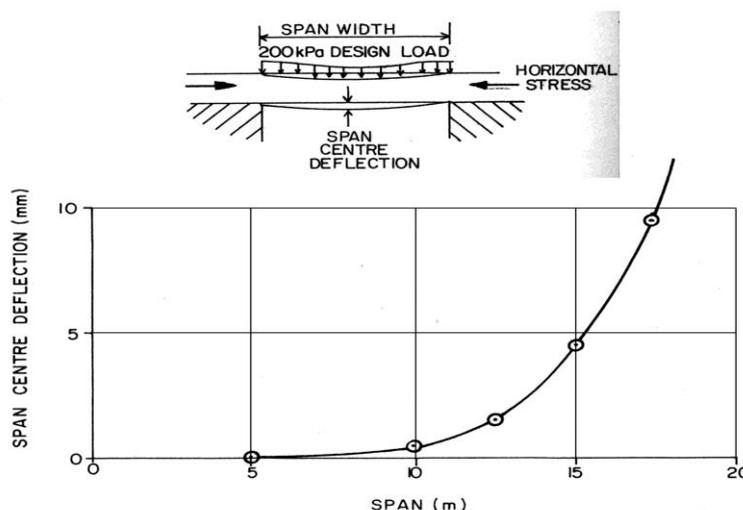
Calculations were made as to how crown sag would increase with sequentially increased span, as the key design idea was to use monitoring of crown sag as the span was progressively increased, to prove, or disprove, the design assumptions. The original diagram showing calculated crown deflection as a function of increasing span is given in Figure 6.

Figure 6 Design predictions of crown deflection versus increasing span (1990)

The analyses showed that 6 m of massive sandstone could span 17.5 m with a predicted deflection of about 10 mm and a safety factor of greater than 10 against compressional failure at the haunches. The problem was that the real 6 to 7 m of sandstone comprised beds 1 to 2 m thick, so it was necessary to design a reinforcing system which would make this laminated system act as a single 6 m thick, no tension, pseudo-elastic medium. There were many parameters that had to be estimated for this design and we were acutely aware of the consequences if we were wrong.

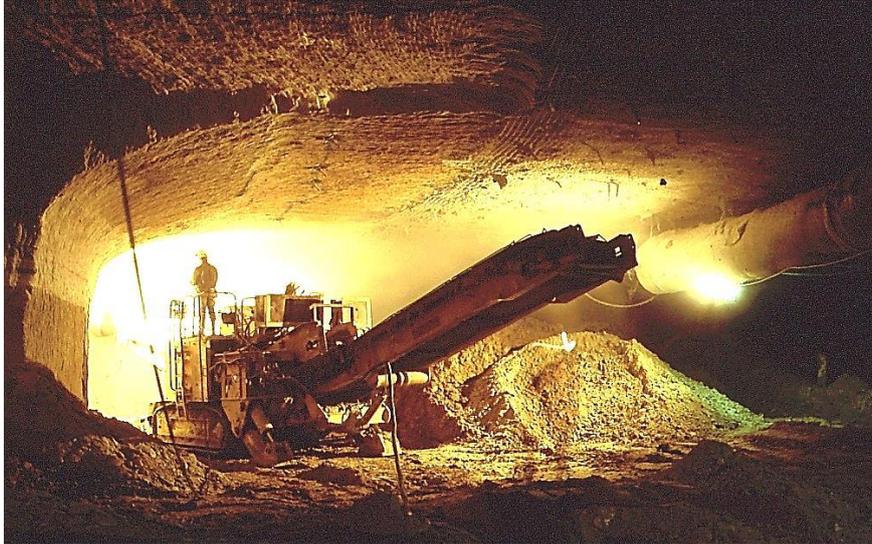
Construction was programmed so as to increase the crown span in steps (Figure 7), with monitoring of crown sag, surface settlement and rock mass dilation, specifically established to allow comparison of field reality with design modelling. This monitoring was explicitly set up to allow verification, or otherwise, of the design expectations and to ensure that unexpected and unacceptable performance was determined before a disastrous situation could develop.

Figure 7 Incremental widening of the crown of the carpark donut-cavern

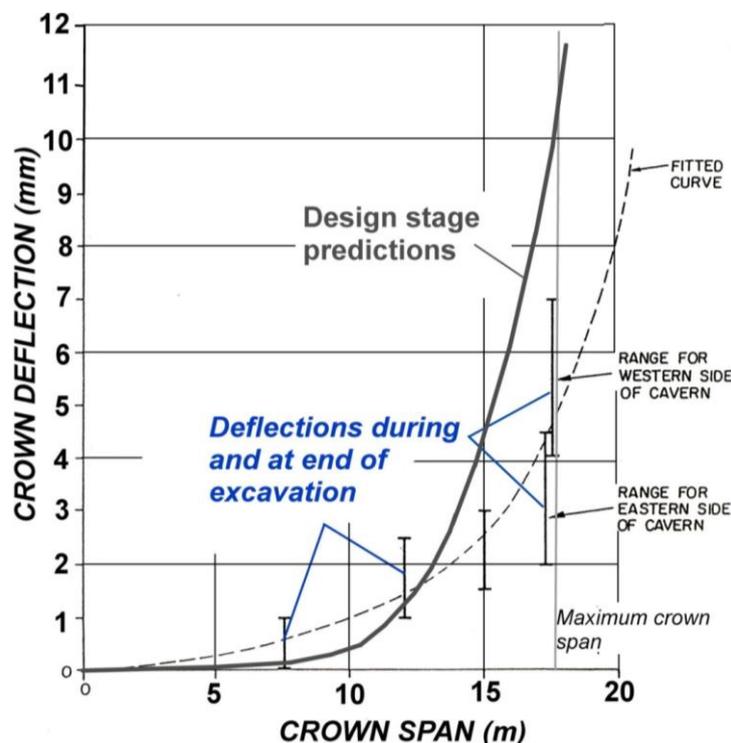
Figure 8 shows the comparison between measured crown sag, as the span increased, with the design stage predictions. Comparison of surface subsidence with internal sag measurements showed that the sag over centre span was directly transferred to the surface. This agreed with extensometer measurements which showed typical bed separation of about 1 mm.

Figure 8 Comparison between design calculations and construction monitoring

These data gave us confidence that the actual rock mass behaviour was consistent with our models, and that the design was appropriate.

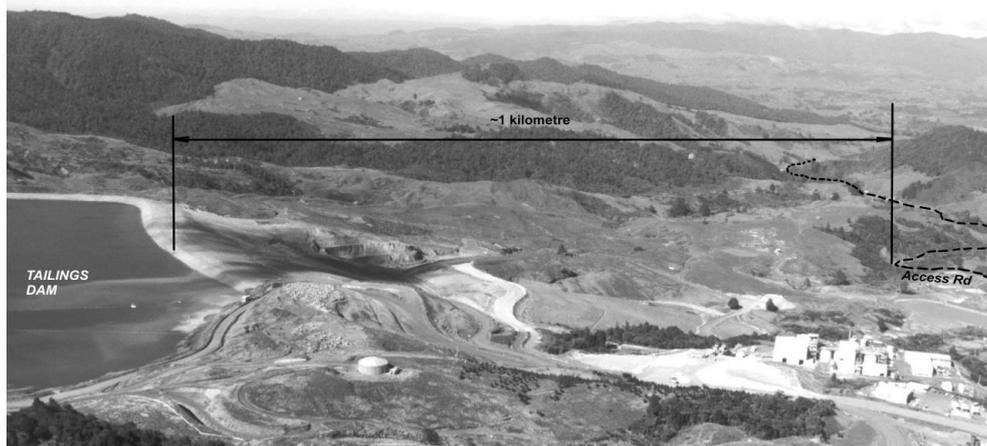
Figure 9 Golden Cross mine site — view to south

In the early 1990s, Coeur d'Alene Mines bought the Golden Cross gold mine in the Coromandel Peninsula of New Zealand. This was an old underground mining area, and was opened up with a new open pit, processing plant and tailings dam. The area is beautiful and environmentally sensitive, and the mine infrastructure was developed with great care. Trout could be caught just downstream of the ore processing plant. As shown in Figures 9, 10 and 11, the tailings dam was on a hillside about 1 km upslope of the access road.

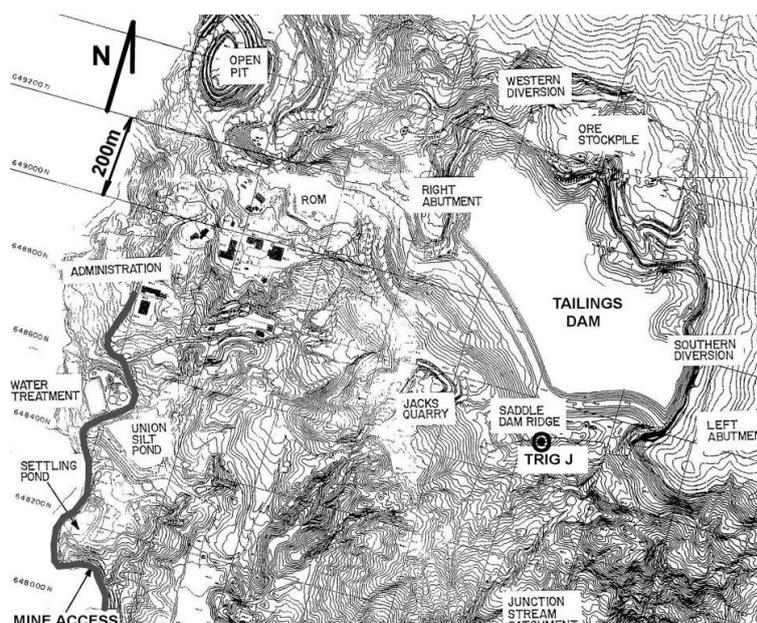
Figure 11 Plan of Golden Cross mine site

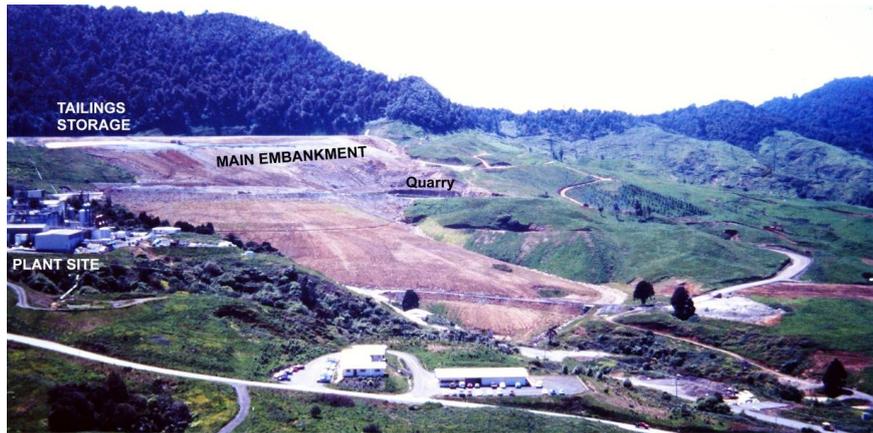
Meanwhile consultants were involved in design and monitoring of the tailings dam. Concerns had arisen regarding cracking in the left abutment area. Investigations had been undertaken. What were considered to be appropriate and comprehensive monitoring measures were established. However, all focus was on the area within about 200 m of the wall. The designers were confident that the issue had to be localised. Further fill was placed against the, already gentle, downstream face of the dam (Figure 12). However, as Nobel Laureate Kahneman (2011) says:

Figure 12 Downstream face of the main embankment on hillside about 1 km above access road

Movements continued, and the whole issue heated up when a crack, with associated shearing, opened about 100 mm at Trig J near the left abutment of the dam.

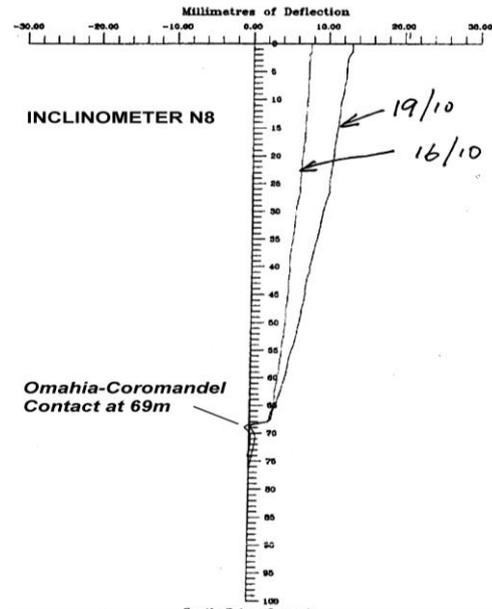
Hoping to clinch the argument, an inclinometer was installed in a 100 m deep hole downslope of the dam. After a few weeks, there appeared the characteristic shear step, at a depth of 69 m (Figure 13).

Figure 13 Initial readings from Inclinator N8

Sullivan noted the ‘noticeable deflection at the unconformity’ in N8: but the designers of the dam, with all the emotional baggage that had to go with that position, recorded that *“the plot of N8 at enlarged scale shows no significant movement has occurred at the kink and the apparent deformation is most likely settling-in.”*

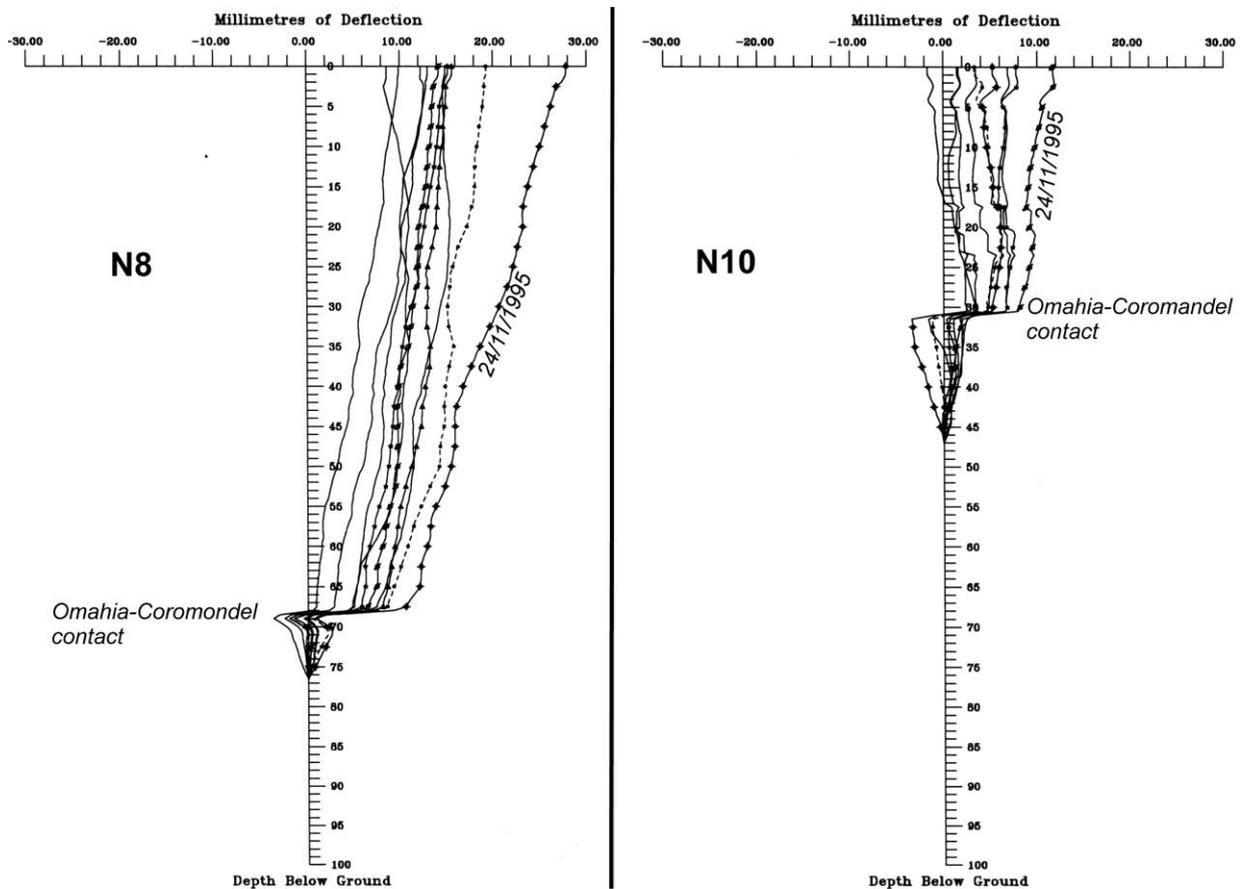
Additional inclinometers replicated what by then very clear in N8 (Figure 14).

Figure 14 Inclinator N8 and N10, 24 November 1995

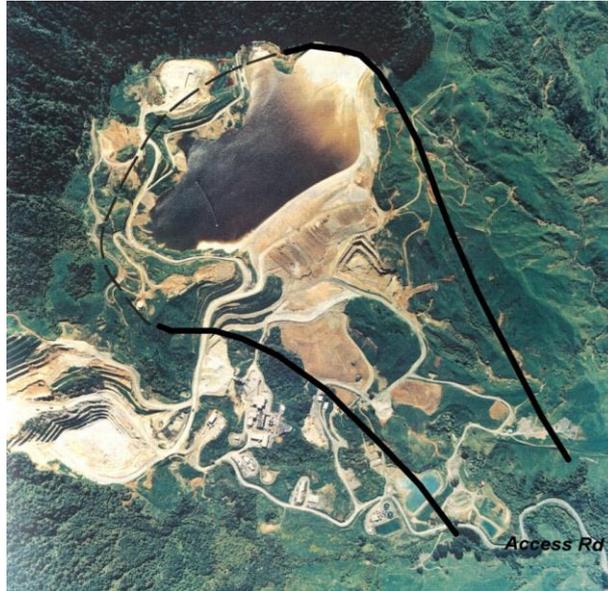
- The area containing, and to the south of the tailings embankment, was a large deep-seated translational landslide.
- The head of the slide was located upslope of the tailings embankment, and there was evidence to indicate a toe region west of the access road, a distance of over 1.5 km.
- The basal shear surface was along the low strength, slickensided, contact zone located around the base of the Omaha Andesite. This shear zone was up to 80 m below the ground surface.

Figure 15 The approximate boundaries of the landslide at Golden Cross

By early 1996, the following conclusions had been reached (Figures 15 and 16).

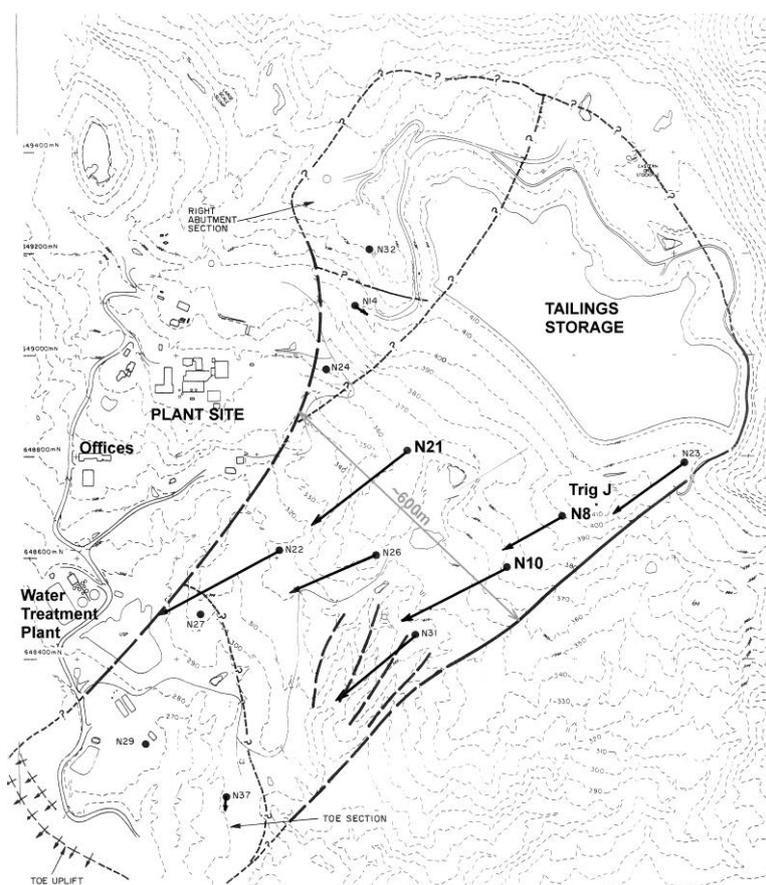
Figure 16 Vectors from inclinometers, showing interpreted landslide by PSM

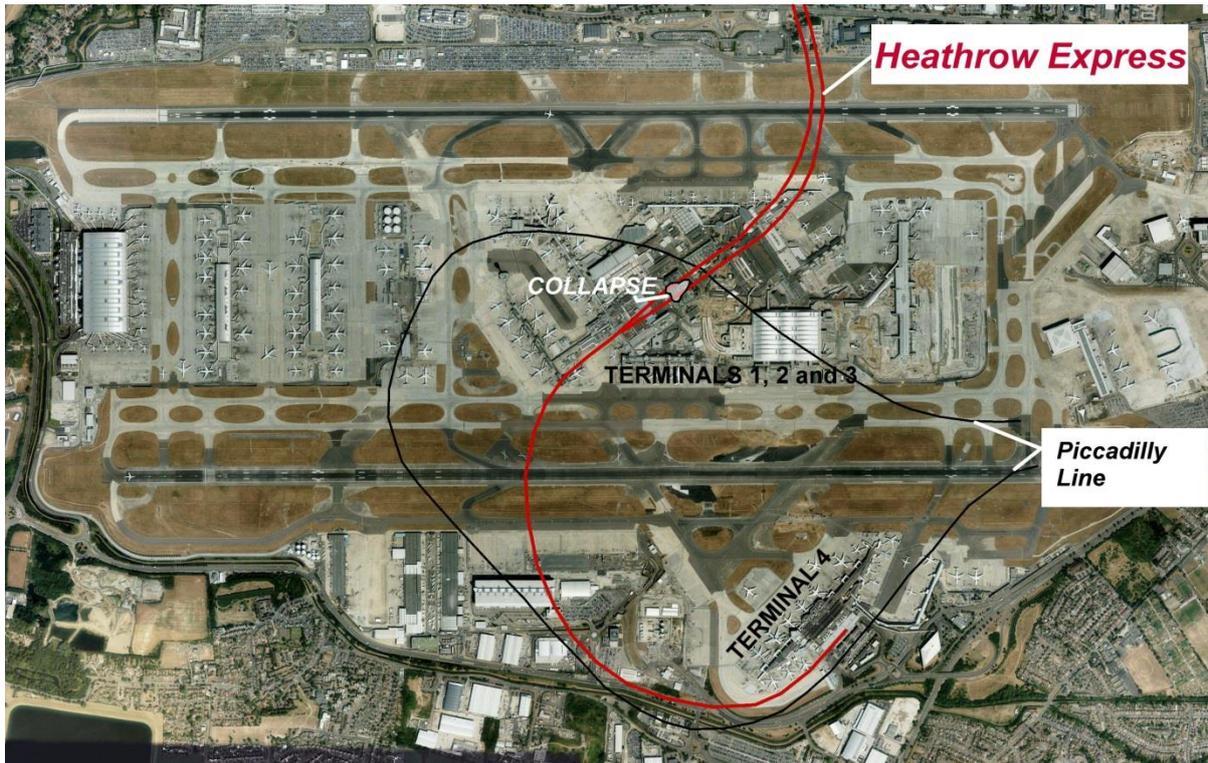
Figure 17 Location of the Heathrow Express collapse

Recovery from the collapse cost GBP 150 million, nearly three times the original contract (New Civil Engineer, 8 November 2012). The location is shown in Figures 17 to 19.

"One of the worst civil engineering disasters in the United Kingdom in the last quarter of a century occurred during the night of 20-21, October 1994 when tunnels in the course of construction beneath Heathrow Airport's Central Terminal Area (CTA) collapsed. They continued to collapse over the following days. The public and those engaged in the construction work were exposed to grave risk of injury. Workers were evacuated from the tunnels minutes before the first collapse. Some had been carrying out repairs to critical parts of a tunnel lining while others had been advancing a parallel tunnel. By remarkable good fortune no one was injured. Major short-term disruption to the airport followed. The Heathrow Express Rail Link project of which the tunnels were a part, suffered a severe set-back."

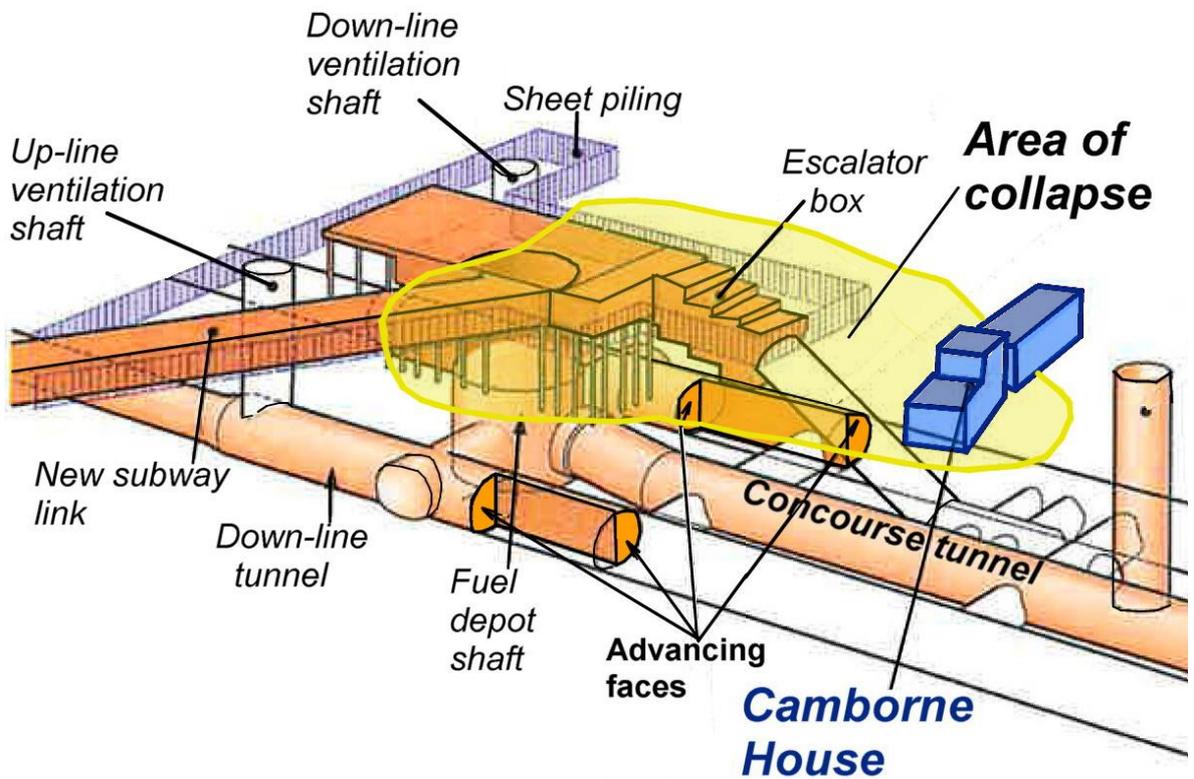
Figure 18 Perspective sketch of tunnels at time of failure

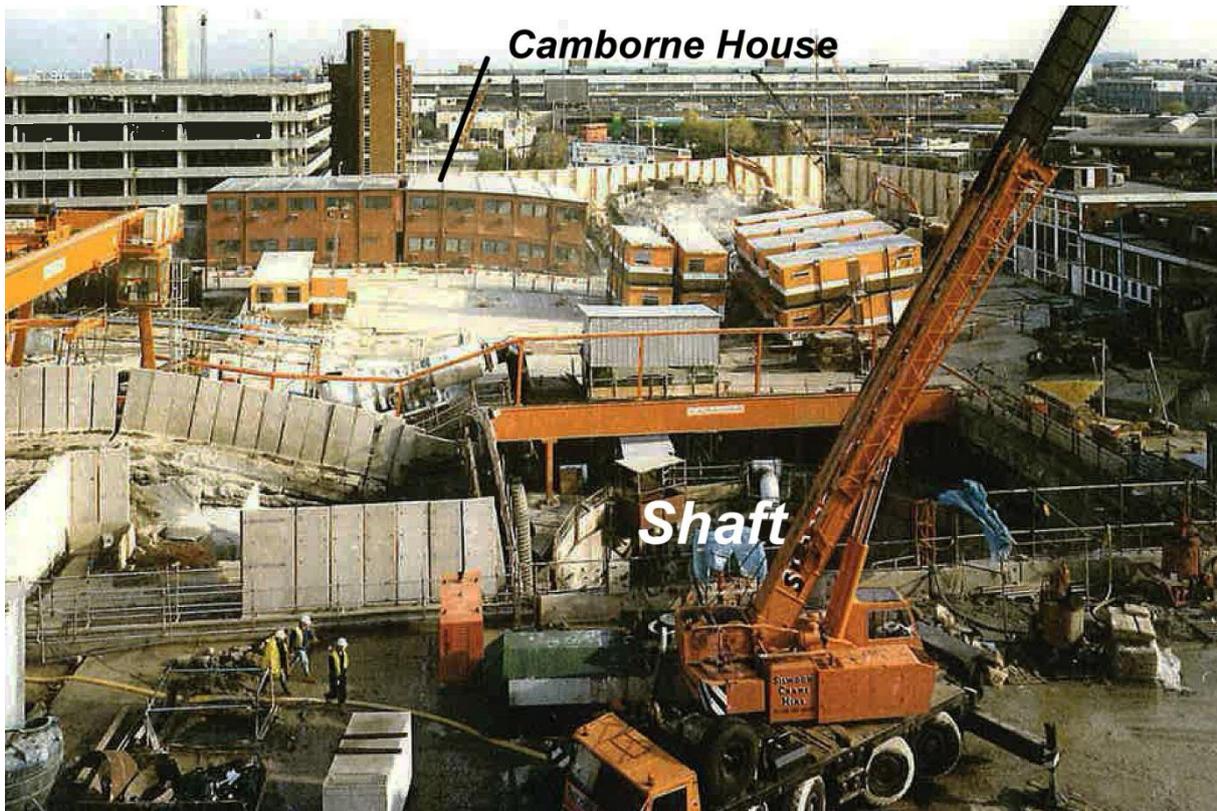
Figure 19 Surface damage view from top left of Figure 19

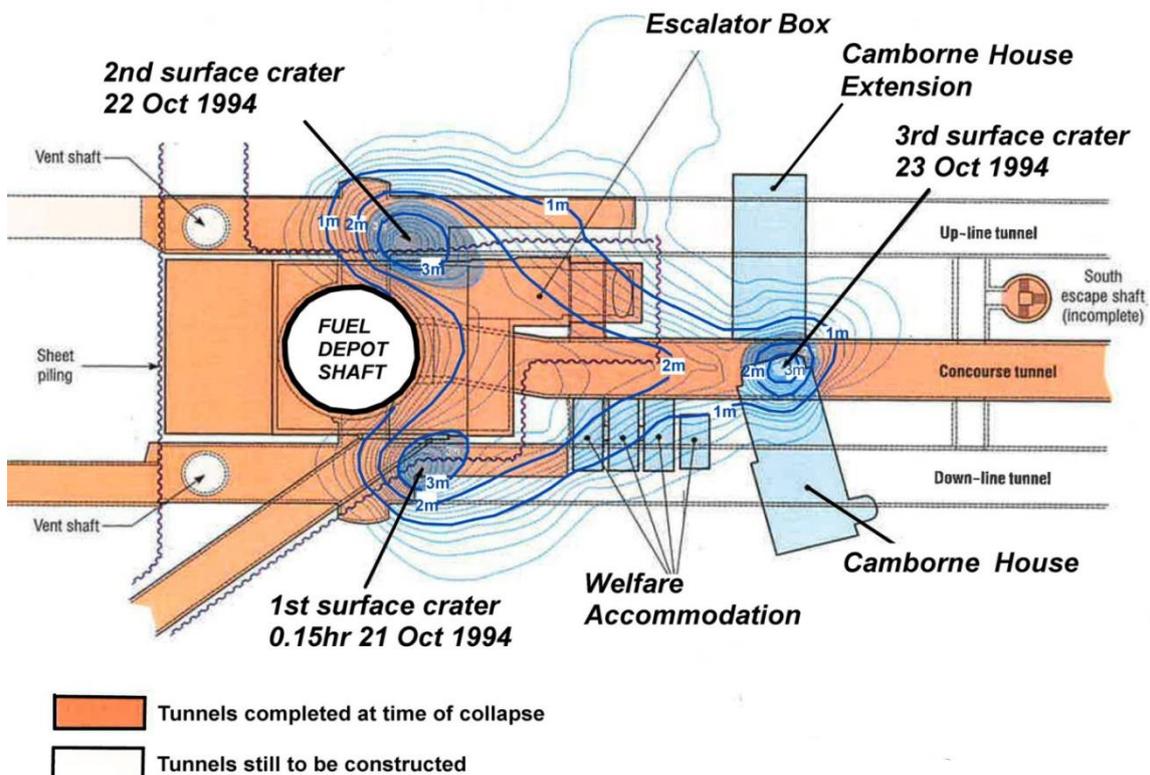
Contours of settlement over the area of about a rugby field are shown in Figure 20.

Figure 20 Surface settlement, in excess of 3 m at three 'bulls-eyes' (Health & Safety Executive 1994)

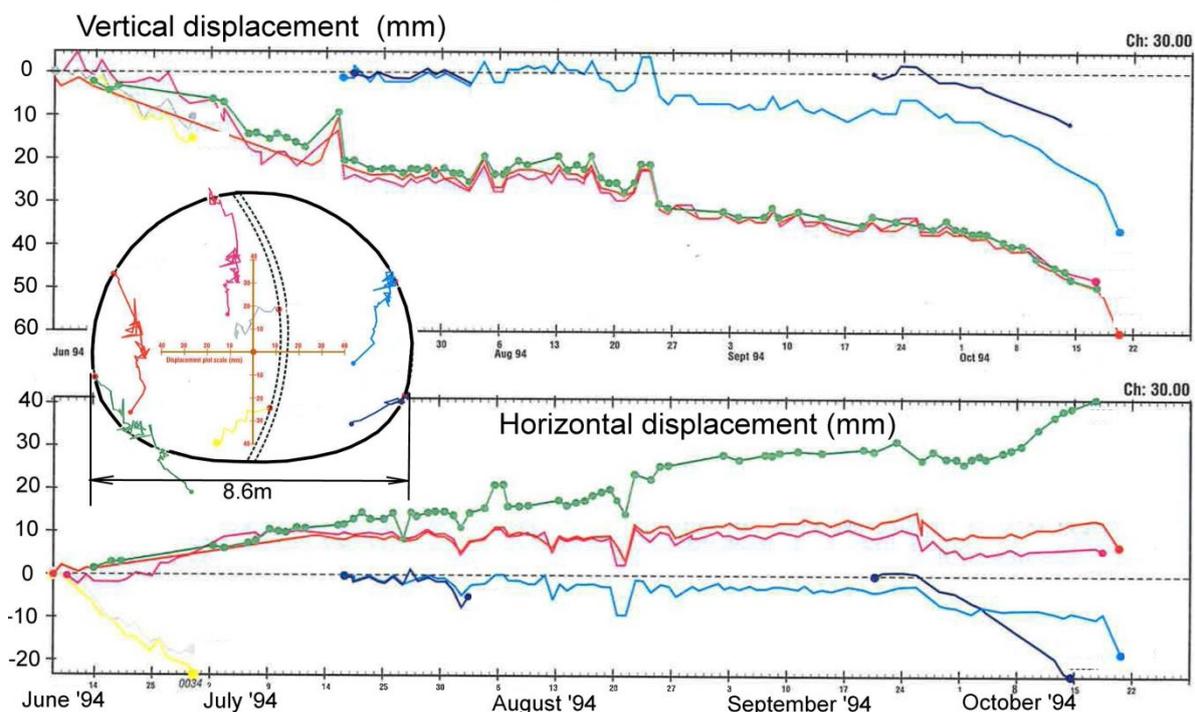
Sir Alan Muir Wood noted that recorded monitoring data and other contemporaneous evidence indicated imminent collapse up to 14 days before the event of 21 October 1994 (Figure 21).

Figure 21 Summary of monitoring data (modified from HSE 1994)

Another European forensic engineer noted that, despite limited instrumentation and inadequate software for processing the data, there was sufficient recorded data to indicate the high probability of failure, and the failure mechanism (Wallis 1999).

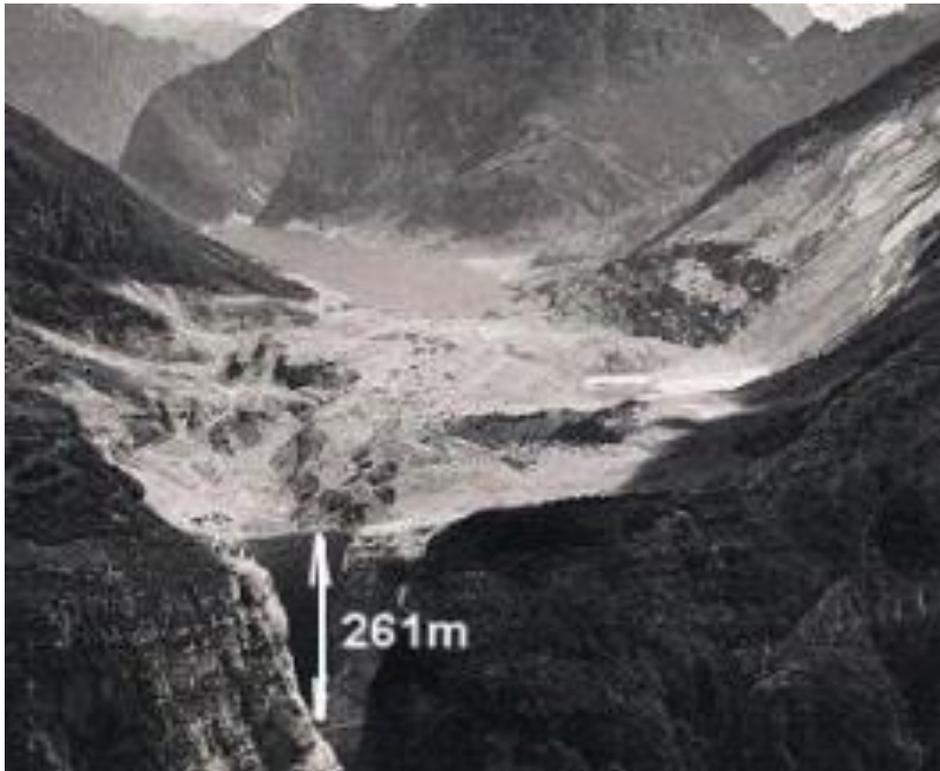
Figure 23 Oblique aerial photo shortly after the failure

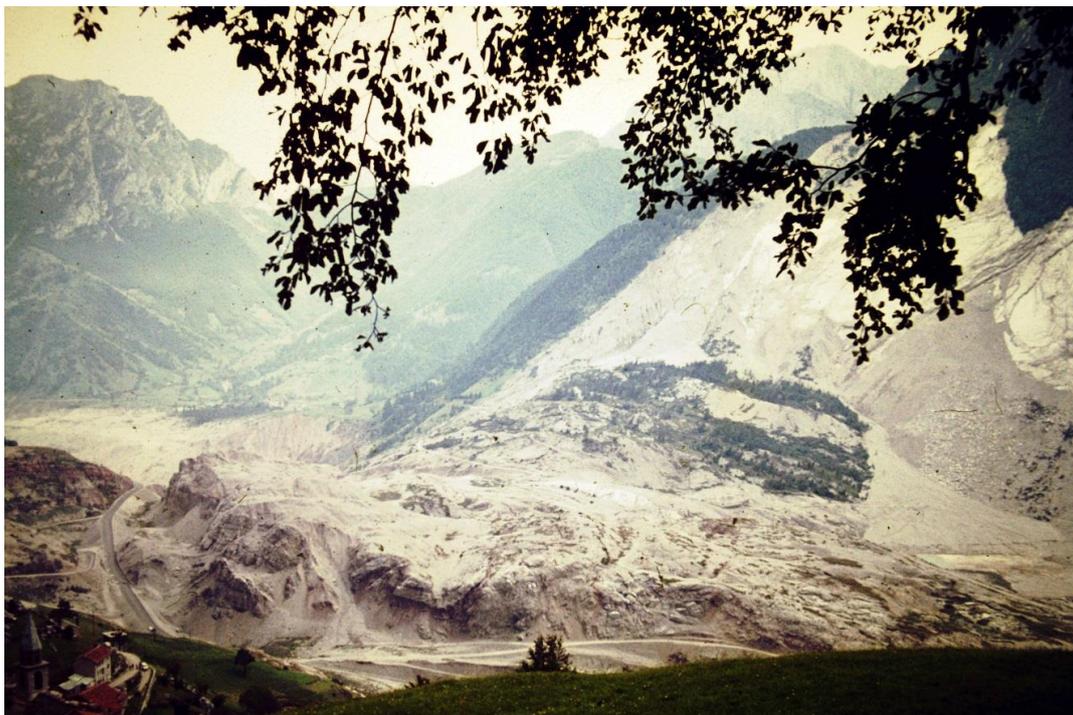
Figure 24 The extent of the slide from above the village of Casso (lower left corner) that was partly swept away (photo Pells, 1968)

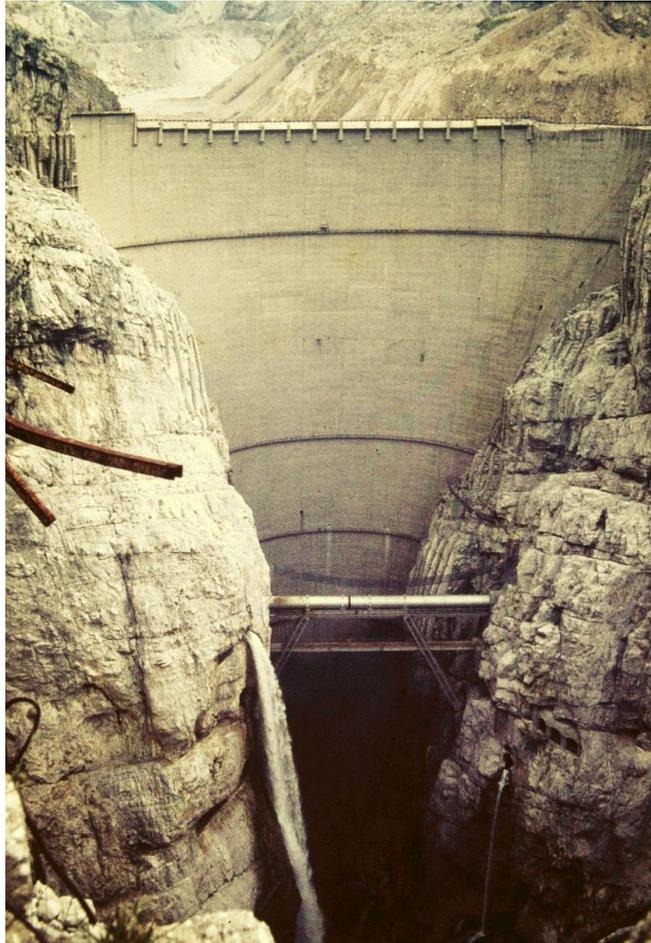
Figure 25 The arch after the wave had passed over the crest — note the abraded concrete reinforcing 0.5 km downstream and 300 m above the valley floor (photo Pells, 1968)

The entire mass slid approximately 500 m northwards, at up to 30 m/s. The slide completely blocked the gorge to a depth of up to 400 m, and it travelled up to 140 m up the opposite bank. Movement of the landslide mass ceased after a maximum of 45 s. The reservoir contained 115 million m³ of water. A wave of water was pushed up the opposite bank and destroyed the lower part of the village of Casso, 260 m above lake level. The displaced water then overtopped at more than 100 m above the crest.

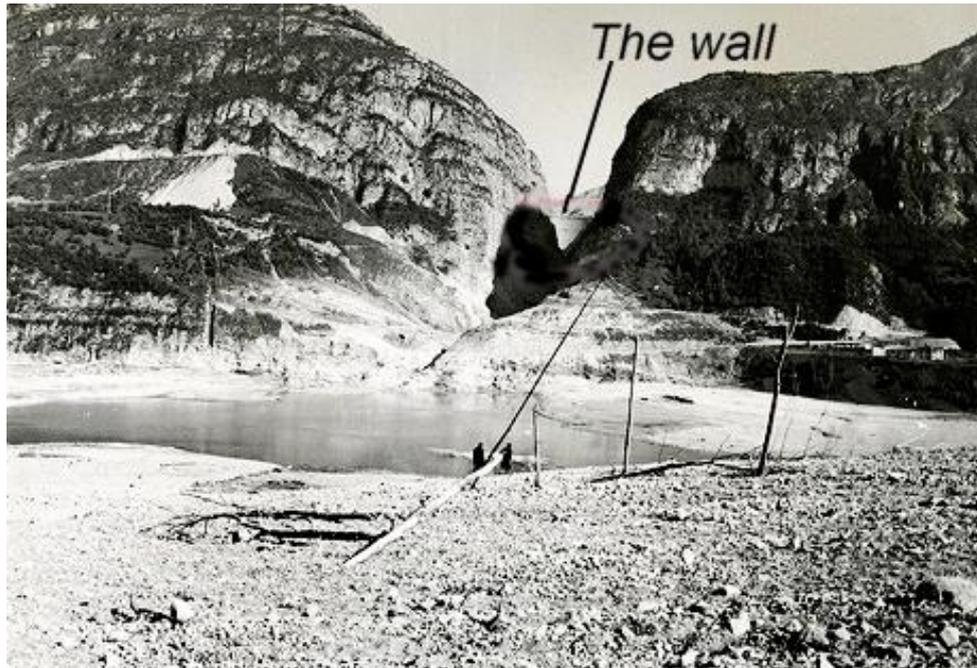
Figure 26 Looking up towards the dam from what was Longerone, shortly after the tragedy

An estimated 30 million m³ fell into the narrow gorge of the Vaiont River, roared out into the Piave valley and destroyed the villages of Longarone (Figures 26 and 27), Pirago, Villanova and Rivalta.

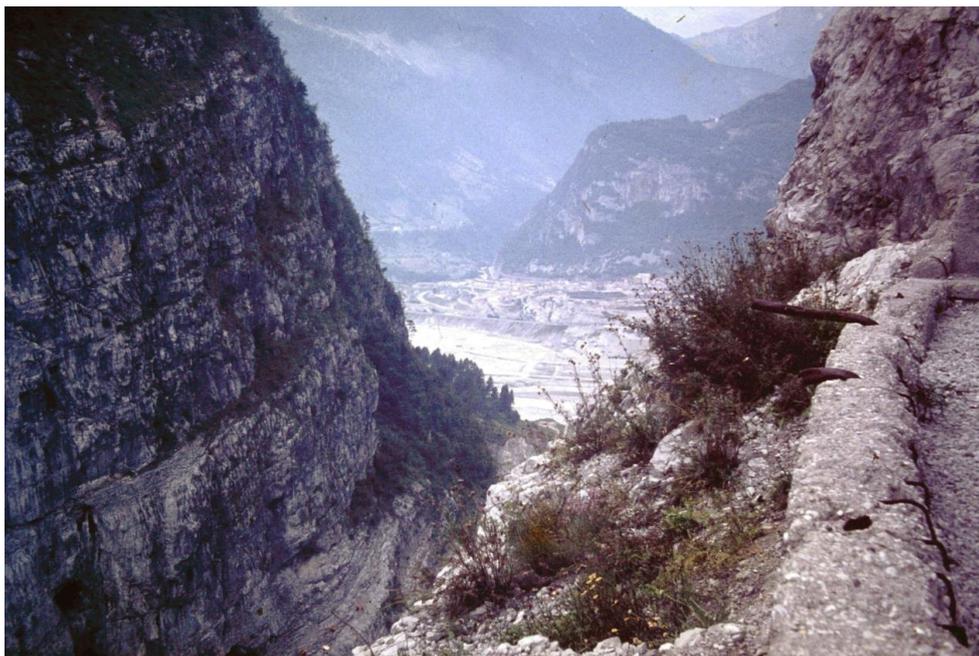
Figure 27 View downstream from same point as Figure 26. The remains of the village of Longerone can be seen at the mouth of the gorge. Note again, as per Figure 26, the abraded reinforced concrete wall

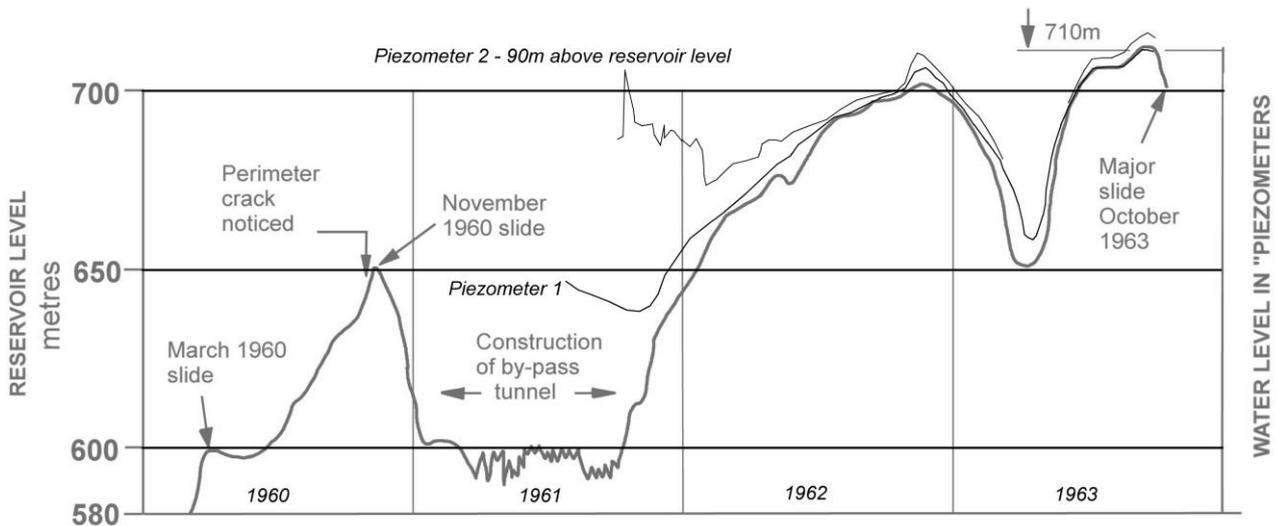
Movement of the mountainside had become apparent in 1960 shortly after the wall was completed. Extensive monitoring was implemented some of which is summarised in Figures 28 and 29.

Figure 28 Plots of reservoir and piezometer levels

As can be seen from Figures 28 and 29, the lake level started to be raised again during April 1963. Movements started again after the reservoir level reached 700 m. Velocity remained low until, in early September, at a lake elevation of 710 m, the rate of slope movement increased from 5 to 10 mm/day. This continued to increase throughout September, reaching 20 to 40 mm/day at the beginning of October (Figures 29 and 30).

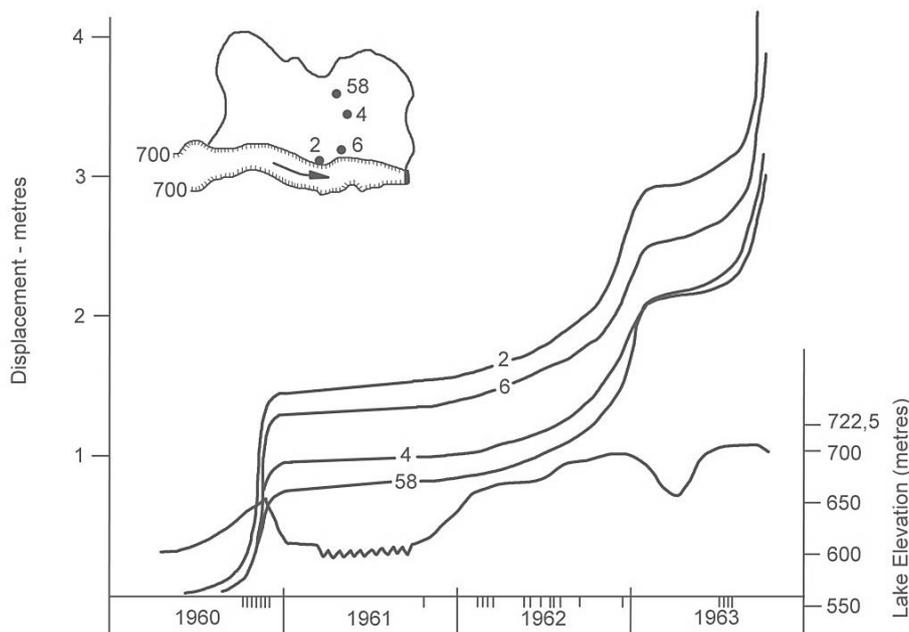
Figure 29 Plots of displacements versus time

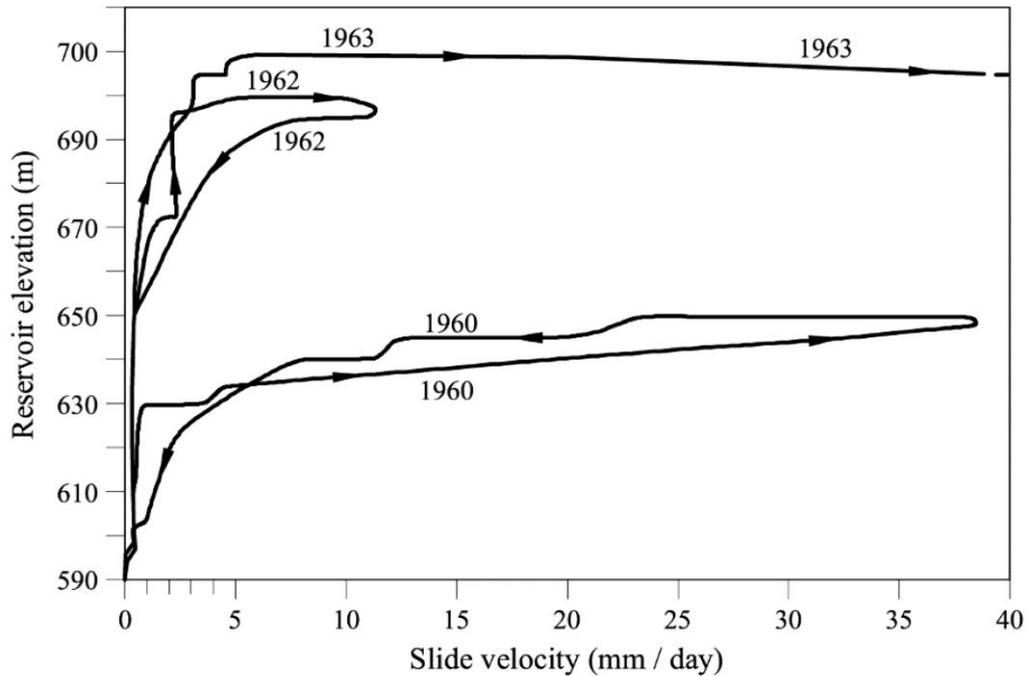
Figure 30 Slide mass velocities pre-failure

The reservoir was lowered to about 700 m but the velocity increased up to 200 mm/day. At 2239 h on 9 October 1963, the southern rock slope of Mount Toc failed (Figure 31).

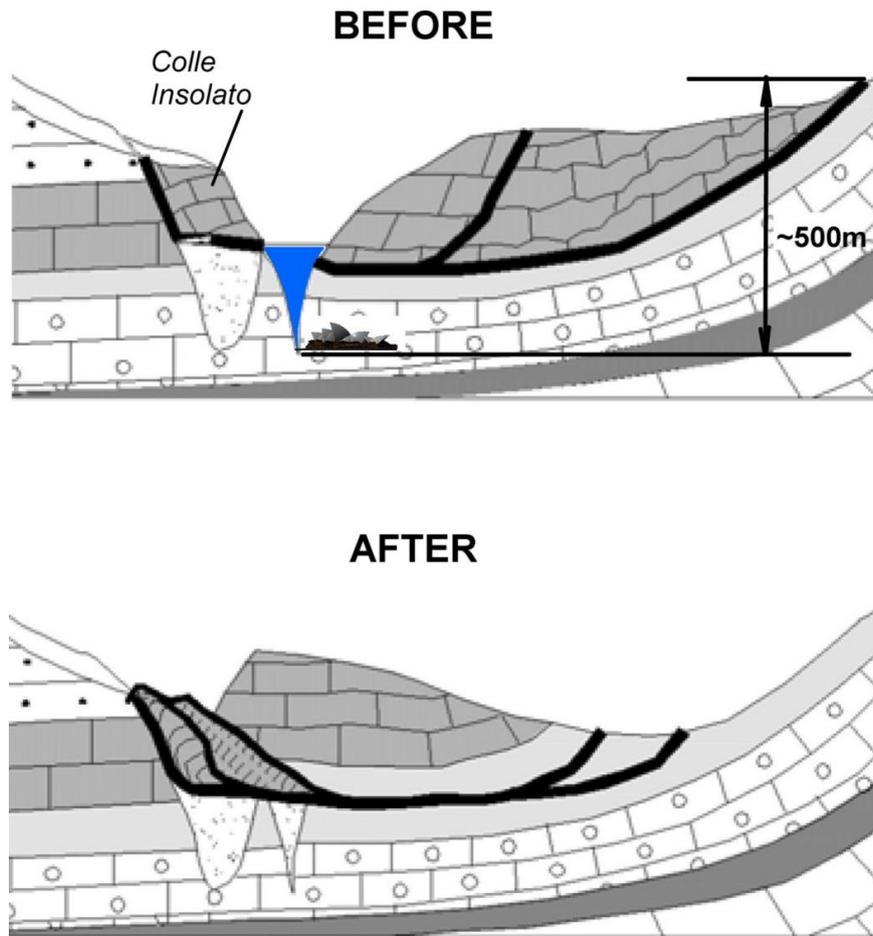
From fieldwork, Eduardo identified geomorphological features that he correctly interpreted as evidence of a very large, ancient landslide deposit, extending some 1.5 km along the left flank of the reservoir area. He postulated that this landslide had filled the valley after the retreat of the Würm glacier. Subsequently a new Vaiont river cut through the deposit leaving most of the original slip mass on the left flank, and a portion on the right side. This portion was subsequently called Colle Insolata. In the failure, Colle Insolata was pushed up the right flank of the valley (Figure 31).

Figure 31 Cross-section before and after. Note the Sydney Opera House to scale in the upper section

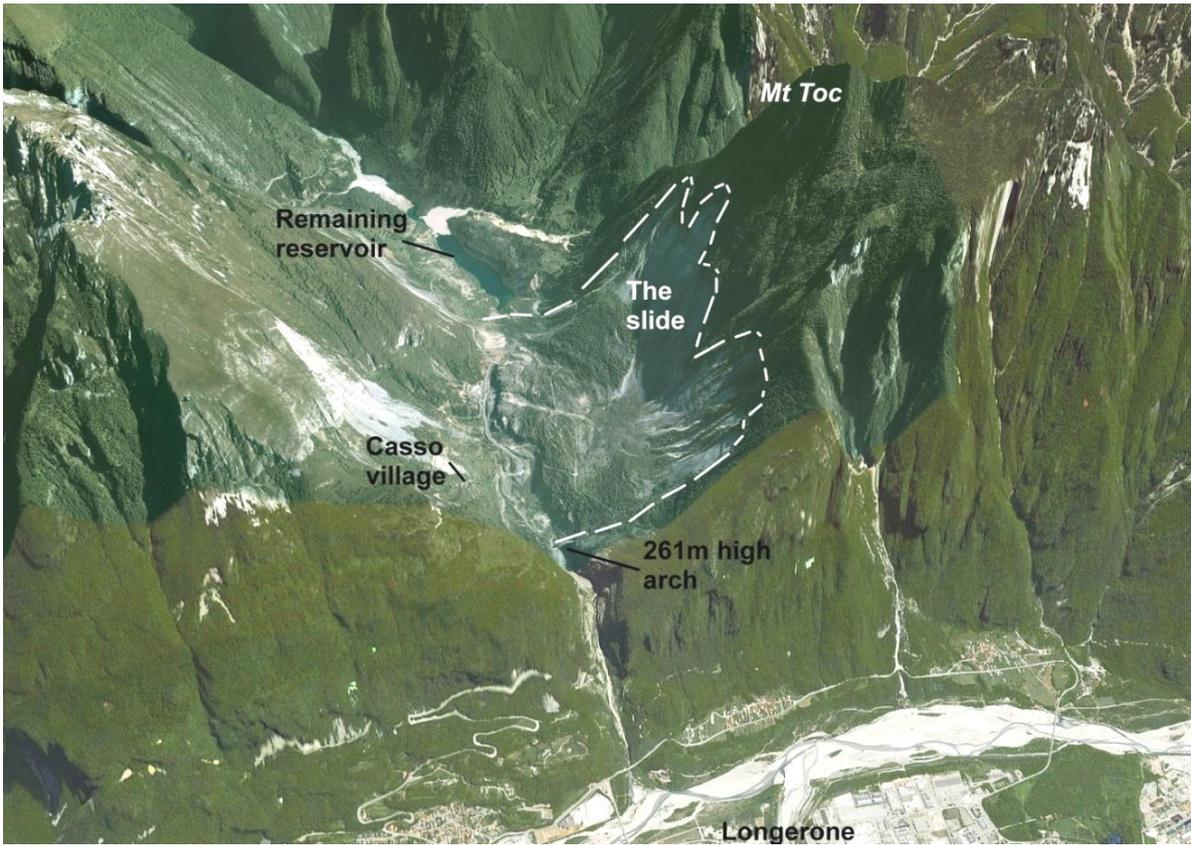
Figure 32 3D view of the landslide area — Google Earth 2012

Nobody predicted what happened and, to this day, there is no consensus as to why it moved so suddenly and so quickly (Figures 32 and 33).

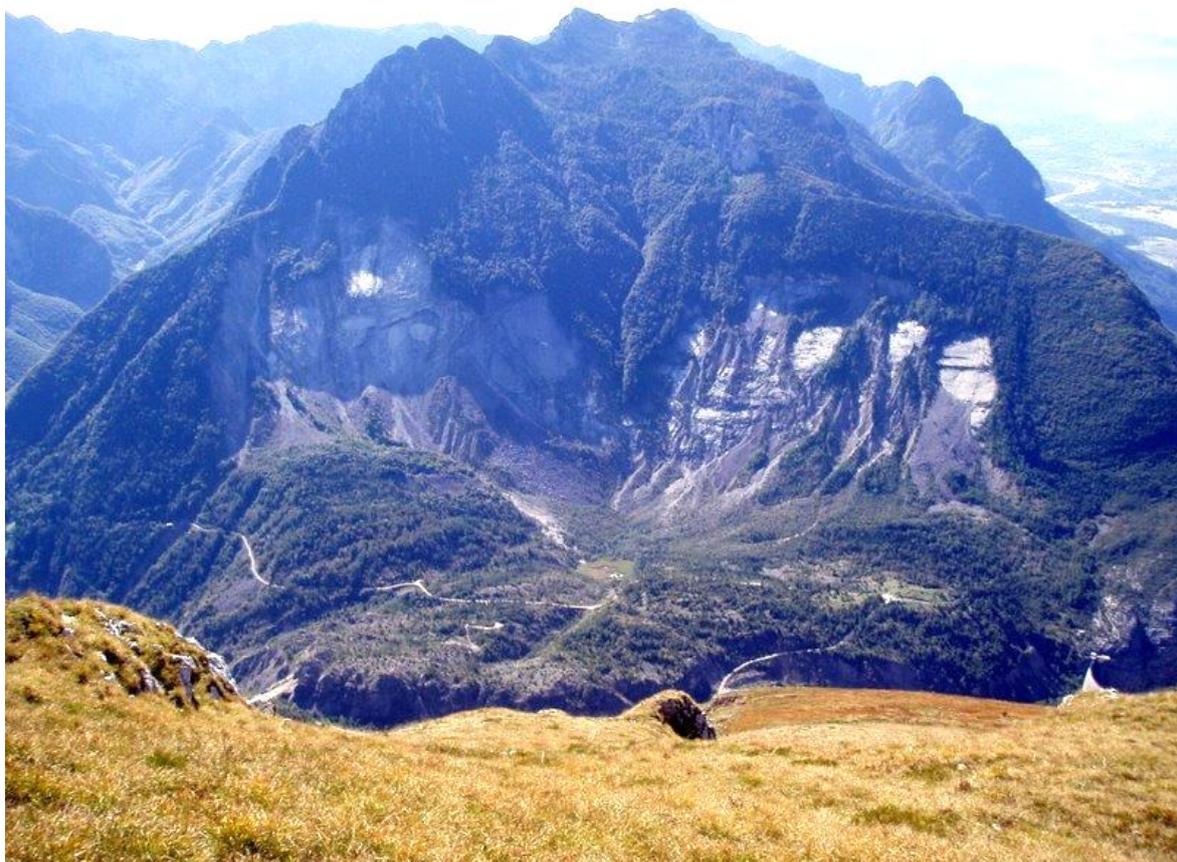
Figure 33 The landslide area 2013
