Improving existing monitoring systems in six dams by automation and central data management

In the period from June 2012 to April 2014, SISGEO S.r.l. completed an important project focused on the rehabilitation of existing monitoring systems in six dams owned by JSC Macedonian Power Plants (ELEM), all located in the Republic of Macedonia. The first four rockfill dams, namely Mavrovo, Spilje, Globocica and Tikves, were constructed between 1952 and 1969. The manual instrumentation in the four dams was, to a large extent, the same as originally installed and, due to careful maintenance, the instruments were still in good condition. The Kozjak rockfill dam was commissioned in 2003, whereas the Sveta Petka concrete arch-dam was commissioned in 2012. Both dams already had a local automatic monitoring system that was in very good condition. Nevertheless, ELEM wished to have a centralised monitoring system for the abovementioned dams. The purpose of the project was therefore to automate, to centralise all the existing monitoring system and to create a central data management unit in the ELEM facilities located in the city of Struga.

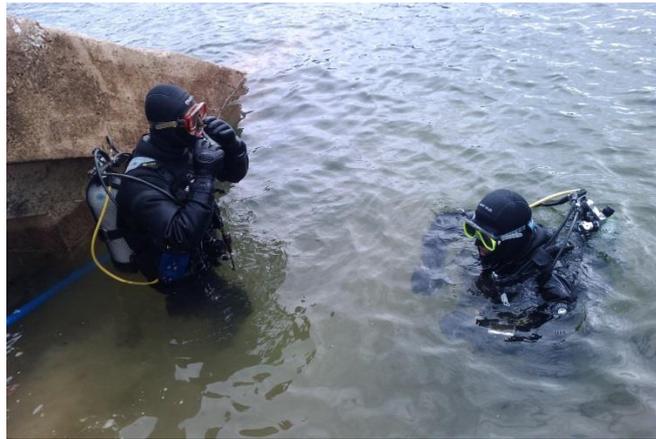
Figure 2 Divers for installation of water level gauge in the reservoir

Vented pressure transducers were also selected for the automation of measurement of the water level in the reservoir. The installation of such instruments was difficult, and in order to install the sensors 5 m below the minimum reservoir level, it was necessary to employ professional divers who carried on the job in the winter period (Figure 2), when the level of the reservoir was at the minimum. There were no alternatives, since the visibility in the lake at depth of over 6-8 m was not suitable for the installation works.

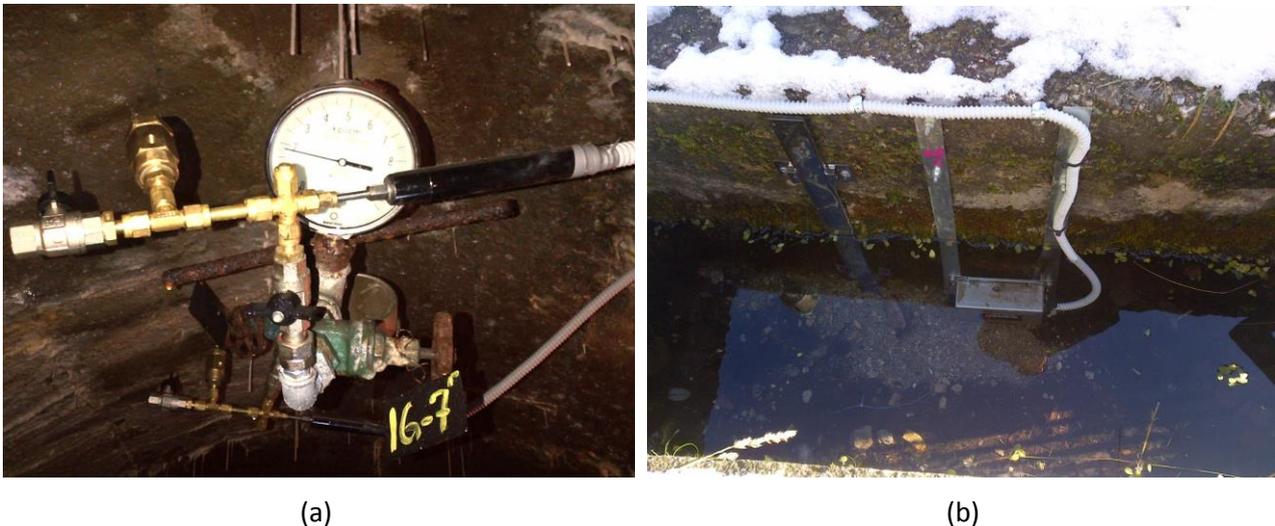
Figure 3 Automation of existing piezometer under pressure (a) and of seepage weirs (b)

The piezometers under pressure, mainly located in the galleries, have been automated by means of vibrating wire pressure transducers. The hydraulic connections have been replaced as well in order to fit the new transducers (Figure 3).

Pressure transducers have also been installed in seepage weirs in order to allow automatic readings of water level (Figure 3) and to obtain the water discharge by specific formula. The pressure transducers were equipped with special rods to allow for positioning under water. In some cases, especially in the galleries, the weir was completely rebuilt, as there was no other choice than to do it manually because of difficult access to the lower part of the galleries.

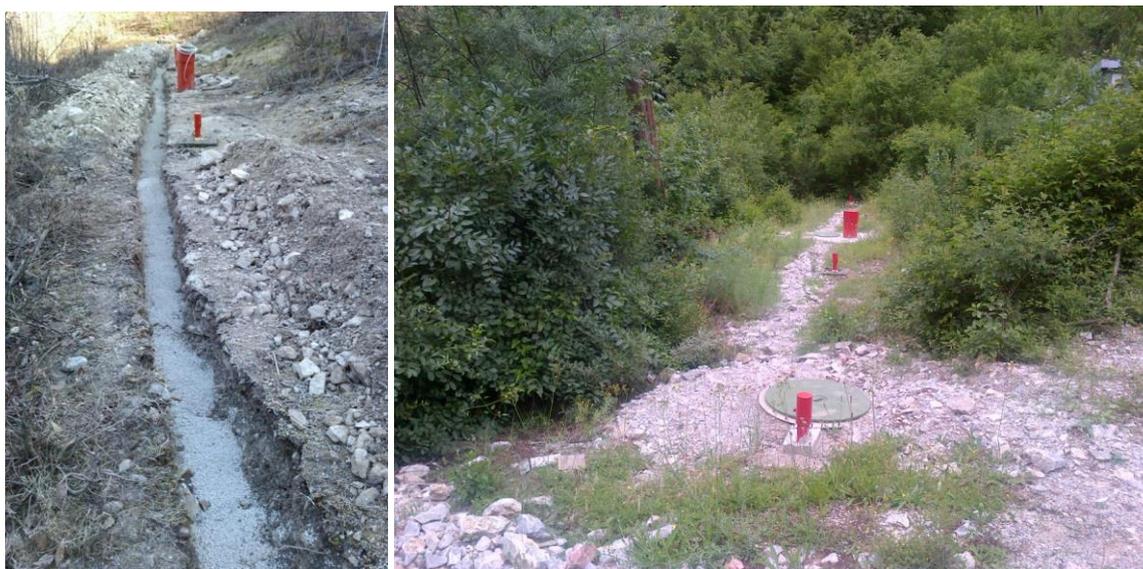
Figure 4 Trenches and manholes for sensor cabling

Once the instruments were installed, the major problem was to lead the cables to the control room of each dam site, where the automatic datalogger has been located. In total, more than 20 km of different types of cable (from two wire signal cables up to 32 wire multicore cables) have been installed for the six dams. The cables have been mostly laid in trenches or, alternatively, in specific conduits, especially in such locations where soil condition (e.g. rock, excessive slopes etc.) prevented open trench excavations (Figure 4).

Manholes have been installed along the way to allow inspection of the cable paths and future maintenance on the cabling system. While building the manholes, particular attention was paid to the drainage of the water, ensuring that the cable and the junction boxes are in dry conditions.

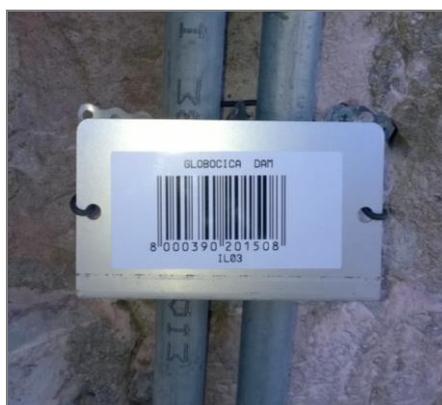
Figure 5 Example of barcode labels

- Identification of the instruments with the barcode reader (Figure 5).
- Receiving the manually read value of the corresponding instrument (input via keyboard).
- Storage of the keyed-in value together with the actual date and time.
- Interface to the local data processing centre to download the collected data and incorporate it into the database for the corresponding dam.

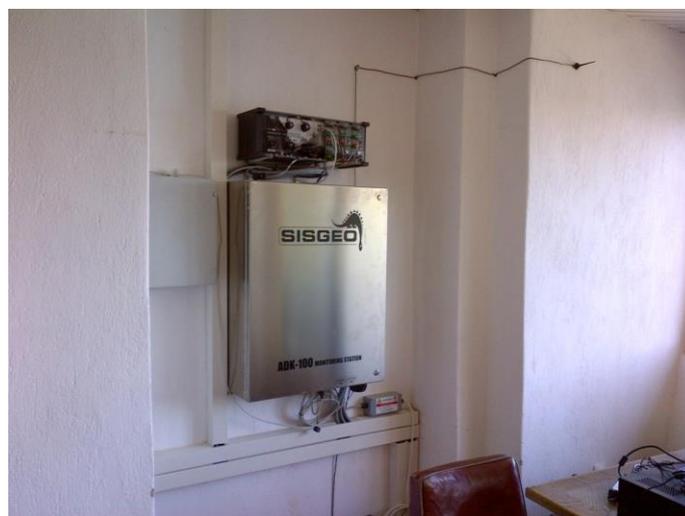
Figure 6 ADAS installation in the auscultation room

The core of the system is represented by an automatic data acquisition system (ADAS) installed at each control room. The ADAS units are designed to power the sensors, receive, store and transmit the data to the central control station (Figure 6).

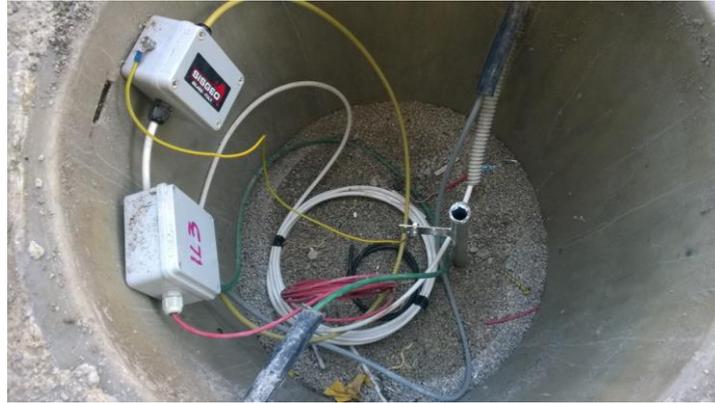
Figure 7 Overvoltage protection for external sensor

- Additional overvoltage protection (OVP) in all junction boxes, which are located close to an instrument.
- Connection of the OVP by copper cable to a metallic part, e.g. existing piezometer casings or V-notch plates.
- Replacement of the conventional cables running close to the powerhouse by fibre-optic (FO) cables, which are not affected by electrical noise, and installation of additional dataloggers to connect to the FO cables.
- Connection of the protection system included in the ADAS unit to a proper grounding system.
- Connection scheme for the shield wire for the signal and multicore cable. The shield wire for the cable coming from the sensors was connected to the OVP, while the shield wires of cables running toward the ADAS were not.

An example of grounding system for an external sensor is shown in Figure 7.

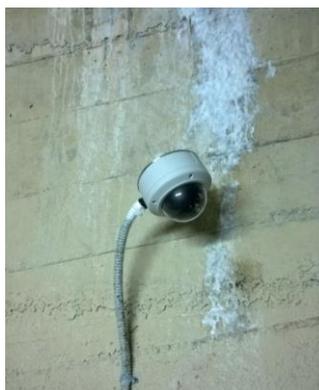
Figure 8 Infrared cameras in dam gallery

A total number of 34 infrared video surveillance cameras have been installed in the dam galleries (Figure 8) plus one outside at Tikves Dam site. They provide monitoring from a computer terminal situated in the local auscultation room. A still picture is taken from each camera every 12 hours and stored on the computer's hard disk. In addition, the still pictures are sent via the data transmission system to the central control Station (in the city of Struga).

The cameras are connected via Ethernet cable to switch boxes, and connection from switch boxes to the auscultation rooms is implemented with fibre-optic cable. The images and the pictures are stored into a dedicated computer located in the local control room.

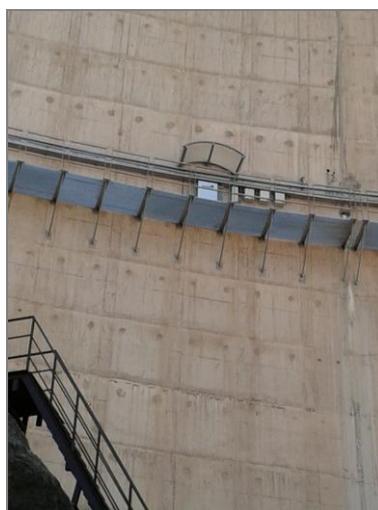
Figure 9 Sveta Petka arch dam with an existing ADAS on the downstream face

The instrumentation and dataloggers for Sveta Petka Dam were initially supplied and installed by the same contractor as the present project. Therefore, they were readily compatible (Figure 9).

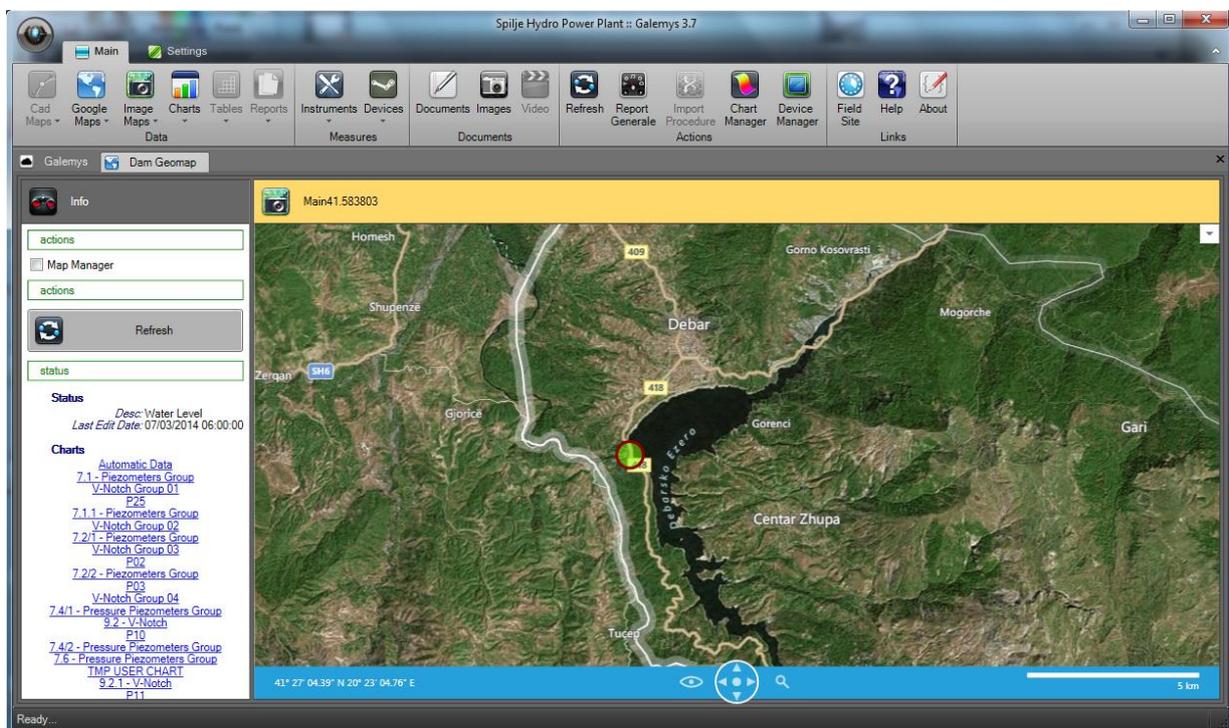
Figure 10 WMS Software homepage for Spilje Dam site

All data coming from the dataloggers at the auscultation buildings are managed by web monitoring system (WMS) software (Figure 10).

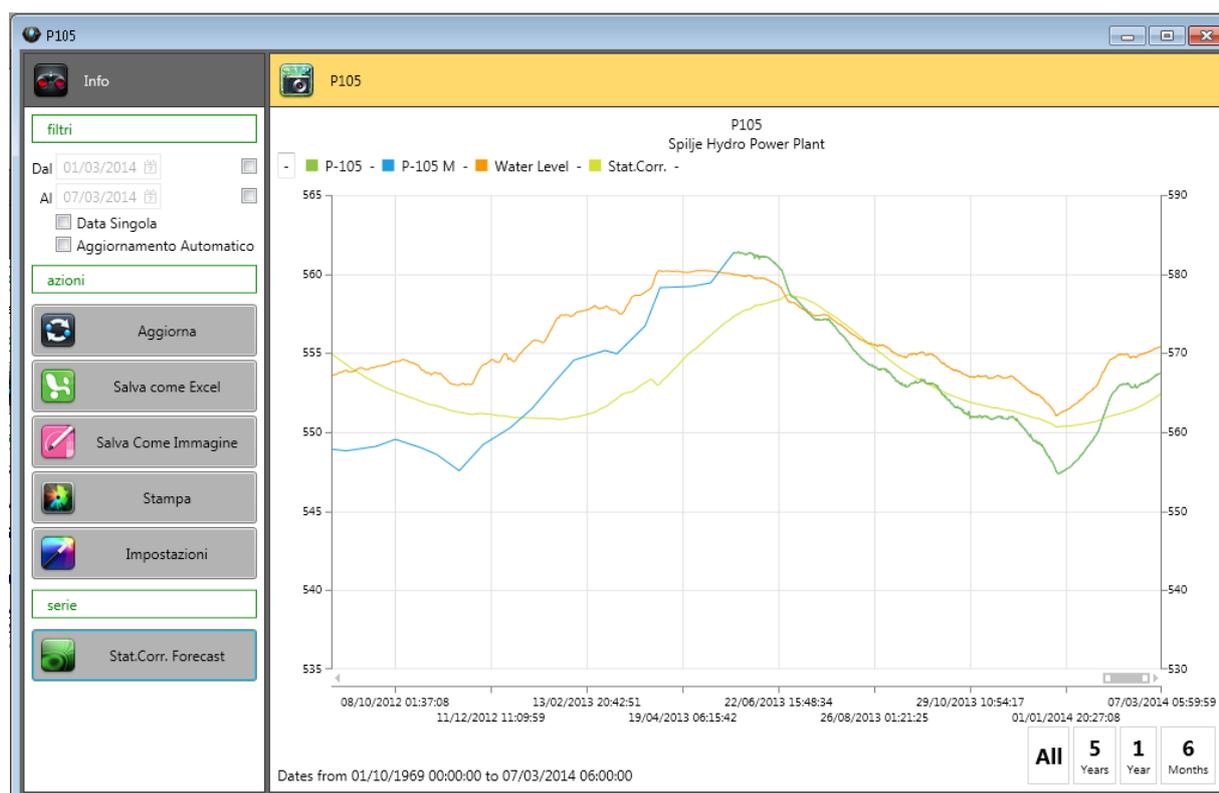
Figure 11 Typical graph for a group of sensors
