An acoustic emission slope displacement rate sensor — case studies

Abstract

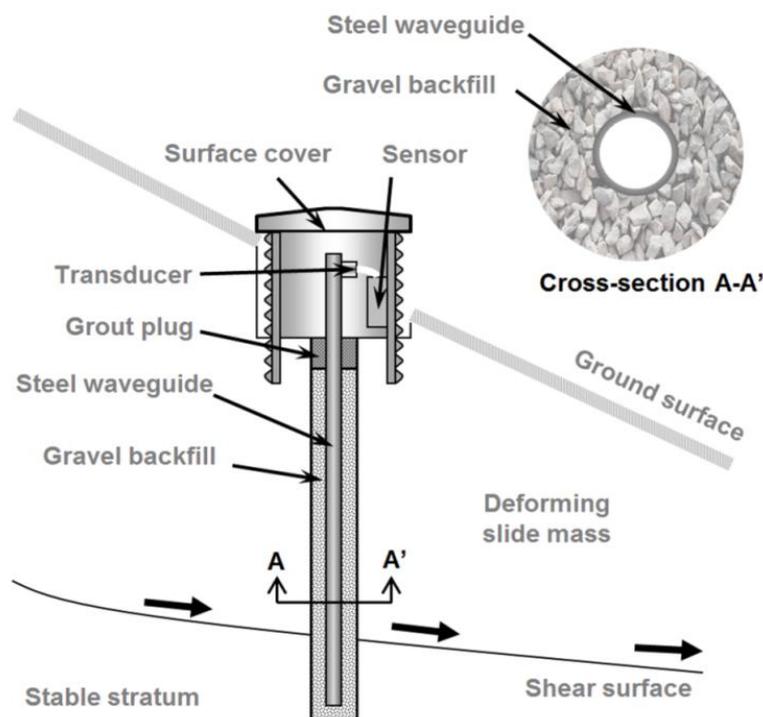
Figure 1 Schematic of an active waveguide installed through a soil slope deforming on a shear plane, with a sensor connected at the ground surface and protected by a cover (after Dixon et al. 2012a; Smith et al. 2014a)

In order to apply the AE monitoring approach to soil slopes, Dixon et al. (2003) conceived the active waveguide (Figure 1). This is installed in a borehole through existing or anticipated shear zones. Deformation of the slope strains the waveguide generating detectable AE. The use of a reproducible 'active' waveguide allows standard interpretations from the system to be developed. Additionally, the granular backfill soil generates measurable AE and overcomes the small magnitude AE generated by slopes formed of 'quiet' fine-grained soils. AE monitoring using active waveguides has become an established approach to monitor the stability of soil slopes; however, the challenge has been to develop strategies to quantify deformation behaviour from the measured AE. Physical modelling (e.g. Dixon & Spriggs 2007; Smith & Dixon 2014) and field trials (e.g. Dixon et al. 2003; Dixon et al. 2014; Smith et al. 2014a; Dixon et al. 2015) have demonstrated that active waveguide-generated AE is proportional to the rate of deformation, and this relationship can be quantified to allow slope displacement rates to be derived from measured AE.

The active waveguide (Figure 1) is installed in a borehole that penetrates stable stratum below any shear surface or potential shear surface that may form beneath a slope. It comprises a metal waveguide with a granular backfill soil surround. When the host slope deforms, the column of granular soil also deforms generating AE that can propagate along the waveguide. A transducer coupled to the waveguide at the ground surface converts the AE to an electrical signal, which is sequentially processed by the AE sensor. The AE sensor amplifies the signal and removes frequencies outside of the 20 to 30 kHz range. This is an important step in removing low frequency (<20 kHz) background noise such as traffic and construction activity. The sensor then logs the number of times the waveform crosses a pre-programmed voltage threshold level within pre-set time intervals; ring-down counts (RDC) per unit time (AE rates). The AE monitoring system that has been developed is called Slope ALARMS (Assessment of Landslides using Acoustic Real-time Monitoring Systems). Figure 2 shows an annotated photograph of the system taken from inside a surface cover.

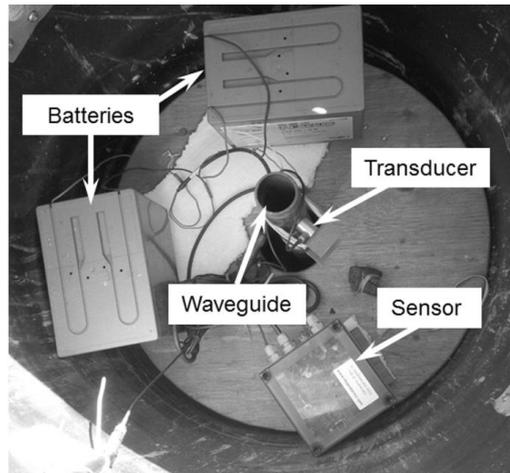
Figure 2 Photograph of the Slope ALARMS AE measurement system from inside the protective surface cover (after Smith et al. 2014b)

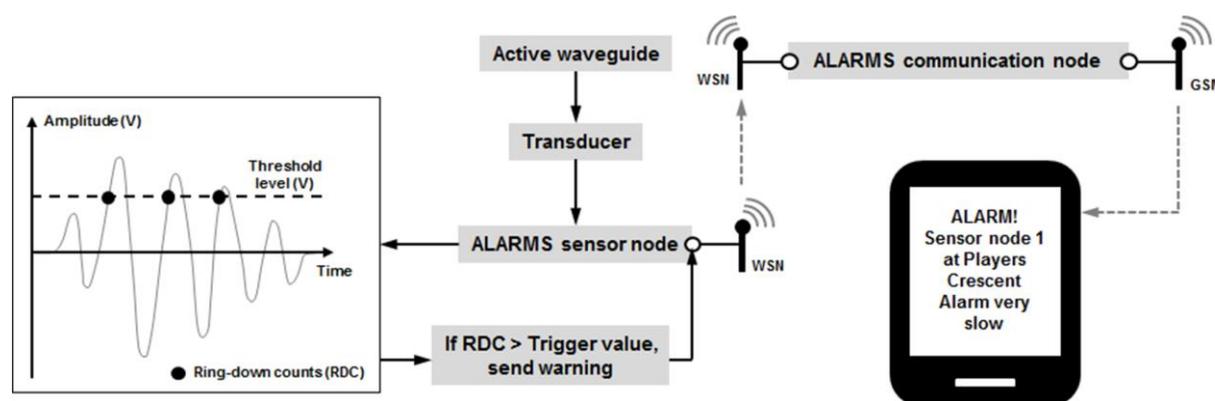
Figure 3 Schematic of operation of the AE monitoring for soil slopes and communication system (after Smith et al. 2014c and Dixon et al. 2015). In rock slopes the active waveguide is replaced by a passive waveguide

AE rates recorded by the measurement system in each monitoring interval are compared to a series of threshold levels, which are derived from the order of magnitude slope displacement rate classifications (e.g. Cruden & Varnes 1996): 'slow' (e.g. 1 mm/hour), 'moderate' (e.g. 100 mm/hour) and 'rapid' (e.g. 10,000 mm/hour). If a Slope ALARMS sensor detects RDC within a set time period that exceeds a trigger warning level then the sensor transfers this to the communication system through a wireless network link. The communication system subsequently sends an SMS message to responsible persons so that relevant action can be taken (e.g. send an engineer to inspect the slope or immediately stop traffic). The absence of generated SMS messages means that slope displacement rates are lower than the minimum threshold set. Automatically generated daily health SMS messages provide information on the status of the system, demonstrating it is operational. The system therefore provides continuous near real-time information on slope displacement rates with high temporal resolution (i.e. monitoring periods are typically 15 or 30 minutes) (Dixon et al. 2015). Figure 3 shows an operation schematic of the AE early warning system.

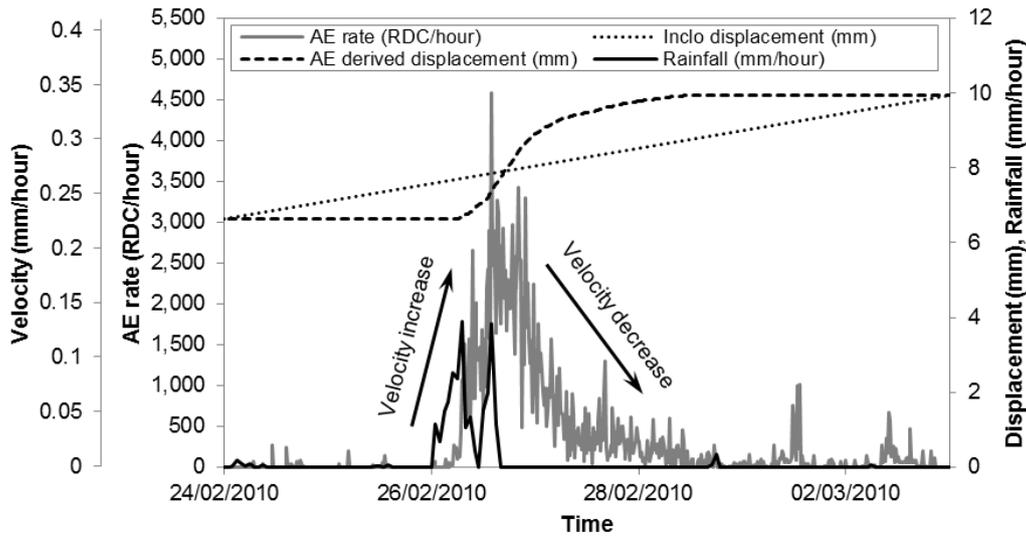
Figure 4 AE rate-, AE derived velocity-, inclinometer measured displacement-, AE derived displacement- and rainfall-time series for a reactivated slope deformation event at Hollin Hill after Dixon et al. (2014)

Figure 4 shows the typical AE response to a reactivated slope movement event at Hollin Hill. Note that the inclinometer measurements (produced from manual surveys of the casing) are separated by an interval of seven days and therefore have low temporal resolution. During the reactivation event both the velocity of the sliding mass and the AE rates generated increase exponentially until they reach a peak, at which point they subsequently decay exponentially as pore-water pressures dissipate, shear resistance is mobilised within the slide mass and through remoulding of the landslide toe. The shape of this curve is analogous to the conceptual velocity–time relationship for reactivation events described by Leroueil (2001). This produces the 'S'-shaped displacement–time curve that was derived from the AE rate data (through determination of the rate of change with respect to time and equating the area under the curve to the magnitude of displacement measured by the inclinometer; a method developed in Dixon et al. 2014) and provides increased temporal resolution for the deformation event.

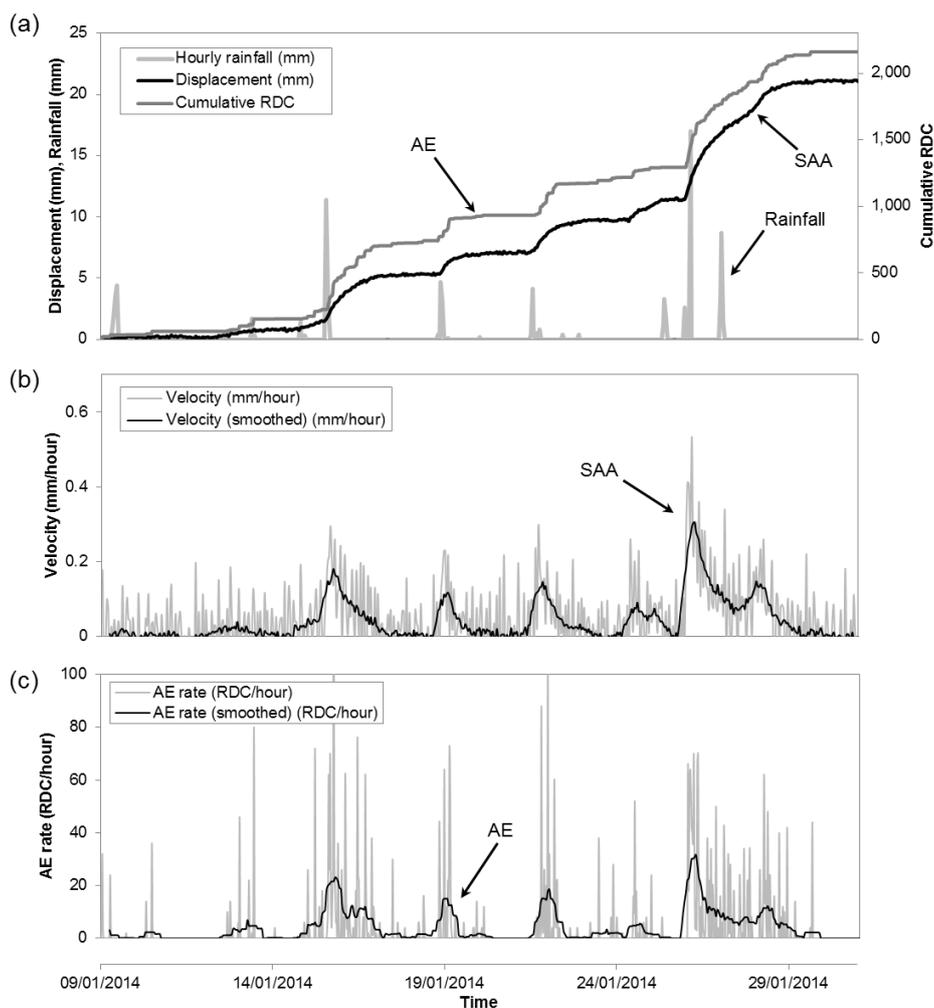
Figure 5 Time series for reactivated movements at Hollin Hill: (a) Rainfall, cumulative AE and cumulative SAA displacement; (b) SAA velocity; and (c) AE rate (after Smith et al. 2014a)

SAA's installed at Hollin Hill have allowed the comparison of continuous AE with continuous subsurface deformation measurements. A series of reactivated slope movements (i.e. small magnitude displacements with low velocities as the shear surface is already at or near residual strength (Hutchinson 1988; Leroueil 2001) occurred in response to periods of rainfall that produced transient elevations in porewater pressure along the shallow shear surface in January 2014 (Figure 5). Note that the smoothed curves were calculated using 10-hour moving average values. These comparisons confirm that: AE rates generated by the system are directly proportional to the rate of deformation; AE monitoring of active waveguides can provide continuous information on slope displacements and displacement rates; and the technique is sensitive to small displacements, displacement rates (i.e. less than 1 mm per hour) and changes in displacement rates (i.e. accelerations and decelerations).

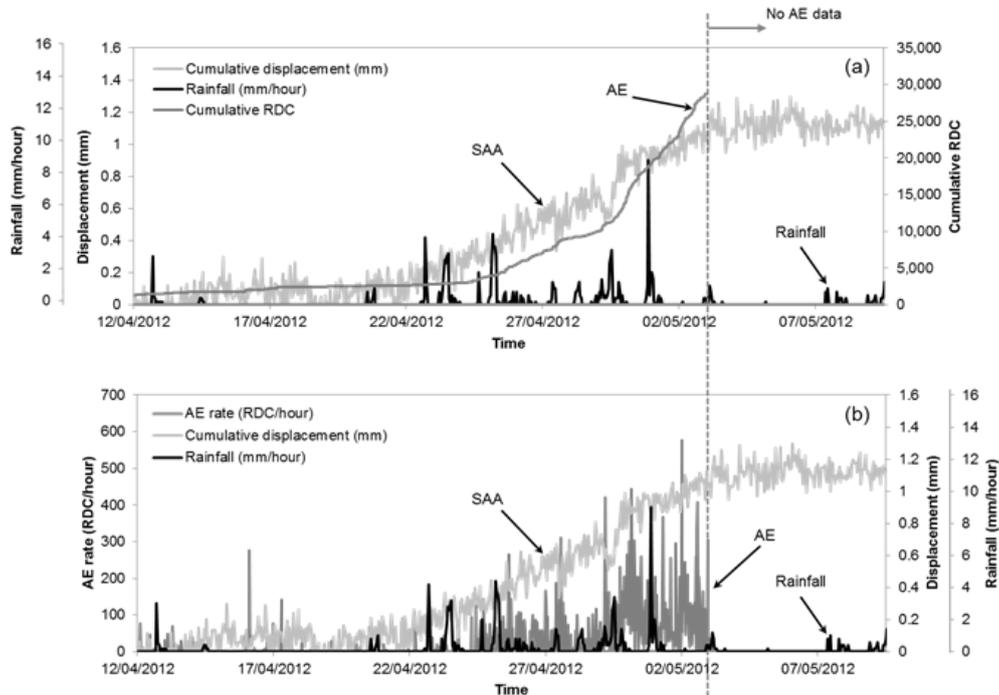
Figure 6 (a) Cumulative RDC, displacement and hourly rainfall versus time for a small magnitude low velocity reactivated deformation event, and (b) AE rate (RDC/hour), displacement and hourly rainfall versus time (data from the SAA and AEWG near the toe of the slope) (after Dixon et al. 2015)

Figure 6(a) shows cumulative RDC, deformation and hourly rainfall with time for a period of slope movement that occurred between 19 April and 5 May 2012 at Players Crescent. The continuous deformation information was recorded by an SAA installed down-slope (i.e. near the toe, adjacent to an AE monitoring system). Figure 6(b) shows the AE rate (RDC/hour) time series superimposed on top of the same deformation event. Approximately 1.2 mm of shear surface deformation occurred during this 16-day period. The gradient of the SAA deformation-time series during the event was relatively constant and therefore the velocity of movement was relatively constant. The velocity can therefore be determined using the displacement/time relation and this generates values of 0.075 mm/day or 0.003 mm/hour; these rates of movement would be classified as 'very slow' according to Cruden and Varnes (1996). The active waveguide and AE sensor node also detected this small, low velocity slope movement event. Of particular interest is the dramatic continual increase in AE rates as slope movement initiates and this continues throughout the 'very slow' deformation event.

The AE system produced continuous information with high temporal resolution, which demonstrates the potential of the system to provide alternative deformation rate information to detect and provide an early warning of slope movements. The ability of the AE system to detect such small low velocity slope movements highlights its potential for use as an early warning system. Unfortunately, the AE data ended on

3 May 2012 due to reaching storage capacity on the datalogger, so the final two days of the deformation event were not monitored. However, based on monitoring trends from similar events at other sites, it is expected that the AE rates generated by the active waveguide would have reduced as the rate of slope movement reduced. Additionally, the gradient of the cumulative RDC curve would gradually decrease and become horizontal as deformation ceased, and the column of gravel backfill would approach equilibrium (as in the slope movement events shown in Figure 5).

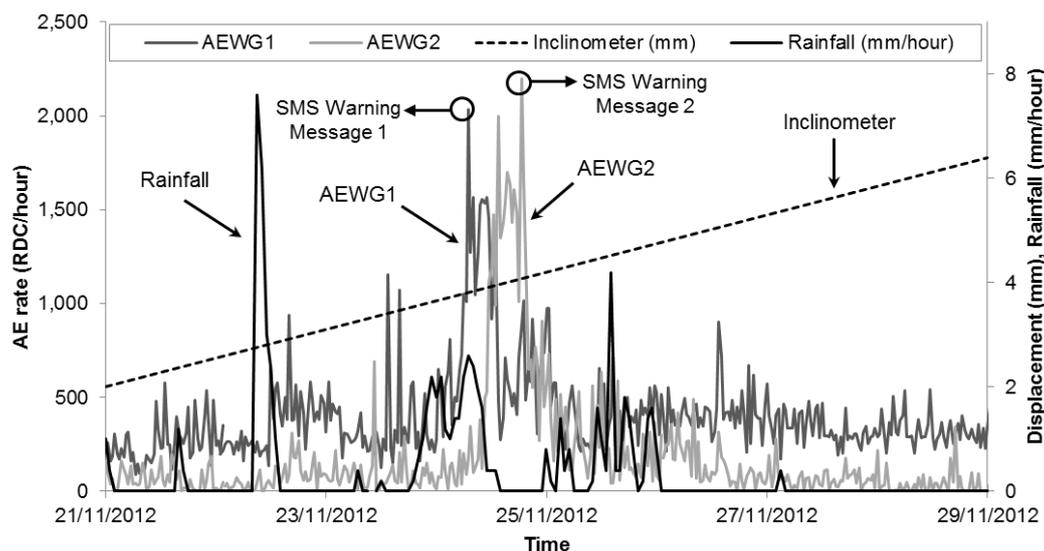
Figure 7 AE rate (RDC/hour), inclinometer measured displacement and hourly rainfall versus time for a period of slope movement in response to intensive rainfall (data from AEWG1 (near the toe), AEWG2 (near the head) and the inclinometer), the timing of the SMS warning messages are also shown (after Dixon et al. 2015)

Pre-defined trigger levels were set on the sensors at Players Crescent related to displacement rates. If the measured RDC in any given monitoring period exceeded one of the trigger levels, a SMS message was generated. The communication system sent a SMS alarm status on 24 November 2012 at 0700 h, which stated that AEWG1 (near the toe) had detected 'very slow' movement as the AE rate exceeded 2,000 RDC/hour (Figure 7).

Another SMS was sent on 25 November 2012 at 0630 h, which stated that AEWG2 (near the head) had also detected 'very slow' movement (both of these were received by the author's mobile phones, one of which was in Peru at the time). Only one text message was generated at each of the two instrument locations during this period of movement because the AE rates subsequently decreased beneath the lowest trigger threshold in the successive measurement intervals. These warnings were generated by the peaks in the bell-shaped AE rate-time curves shown in Figure 7, which are characteristic of deformation events.

Figure 7 shows the AE rate, inclinometer displacement and hourly rainfall versus time series for the period in which the deformation events and alarm SMS messages were triggered. The 11.5 hours which separated the warning messages indicated that movement had been detected in the lower part of the slope prior to being detected in the upper section of the slope. Subsequent interrogation of the data shown in Figure 7 confirmed that the toe of the slope indeed moved before the head (i.e. AEWG1 generated a bell-shaped AE rate curve prior to AEWG2).

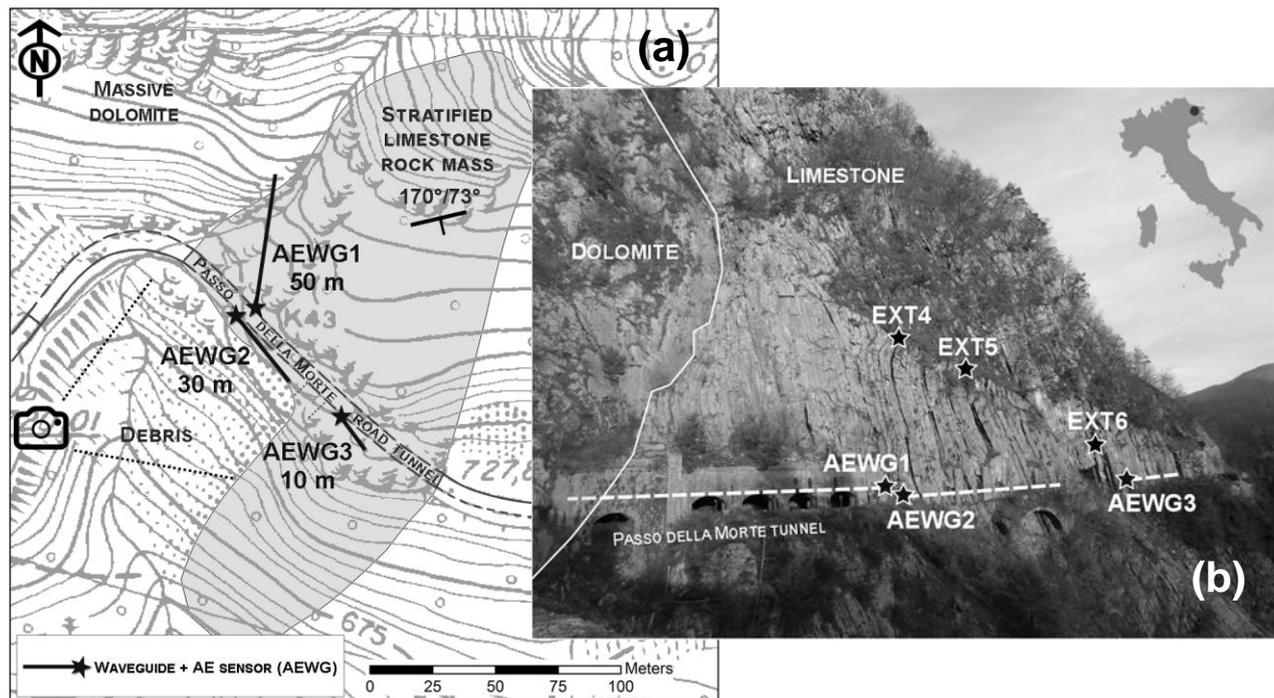
Figure 8 Passo della Morte (Forni di Sotto, Italy) trial site: (a) schematic of the unstable limestone rock mass and position of the three waveguides (AEWG1, AEWG2, AEWG3); and (b) photo of the west rock mass face with projection of the waveguides position and location of crackmeters (EXT4, EXT5, EXT6)

Application of the AE monitoring approach to rock slopes using grouted waveguides is recent (Dixon et al. 2012b). The Passo della Morte trial site in the Italian Alps (Figure 8) was set up four years ago and data have been collected continuously. This long data set has been cleaned to remove environmentally generated AE (e.g. from sensor maintenance and construction activity) and systematically analysis has commenced. A preliminary overview of the most recurring types of AE events is presented in the following sections. It should be noted that there is still not enough experience to determine which processes are generating the measured AE behaviour. A key part of the work to identify the link between rock deformation mechanisms and generated AE is on-going evaluation of data from a wide range of classical geotechnical monitoring instruments, such as extensometers, crackmeters, TDR cables and an inclinometer. Three AE waveguides are located through the steeply dipping limestone layers that form the rock mass being monitored due to concerns over slope stability. They were all installed from a road tunnel located in the limestone with only shallow (tens of metres) of cover. AEWG1 is 50 metres in length and penetrates into the rock mass away from the slope and AEWG2 (30 metres in length) and AEWG3 (10 metres in length) penetrate the limestone layers between the tunnel and the slope surface. The AE sensors are located in the tunnel within 50 metres of each other. As for the soil monitoring system, the sensors record RDC for set monitoring periods, typically set at 15 minutes. The RDC recorded are a function of the sensitivity of the sensor, the magnitude of AE events generated by deformation of the rock mass and the attenuation that occurs as the AE signals propagate through the rock to the waveguide and along the waveguide to the sensor. Therefore, relative

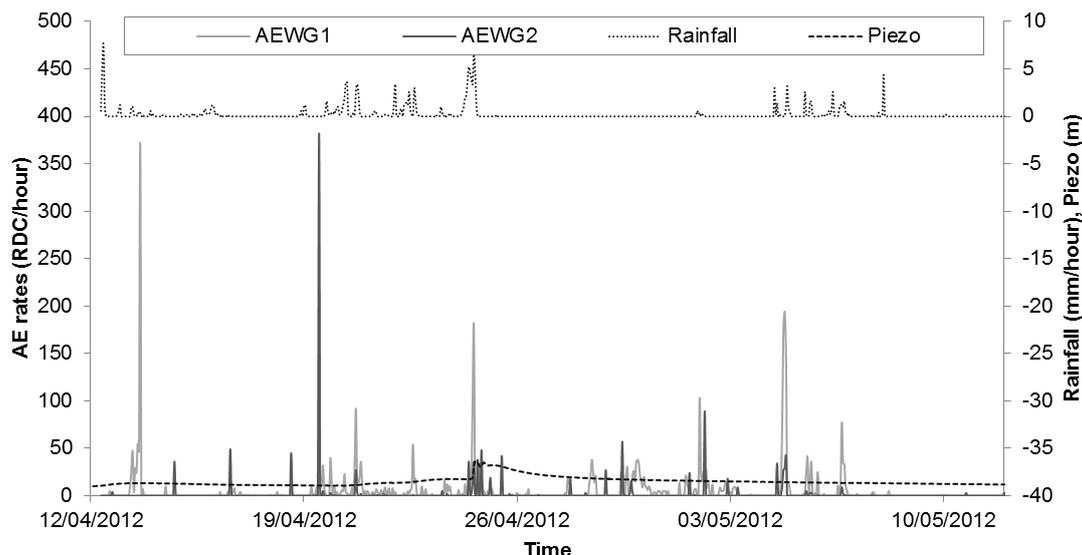
Figure 9 AE rate (RDC/hour), rainfall (mm/hour) and piezometric level (m) versus time for low AE rate events (<1,000 RDC/hour). AEWG3 was not installed in early 2012

Low AE rate events are rather common throughout the data series. As can be seen in Figure 9, they occur both during rainfall events and during dry periods and their duration is from hours to a few days, with occasional spikes of AE that are several times higher than the average. These events are often recorded by all the three sensors (AEWG1, AEWG2 and AEWG3).

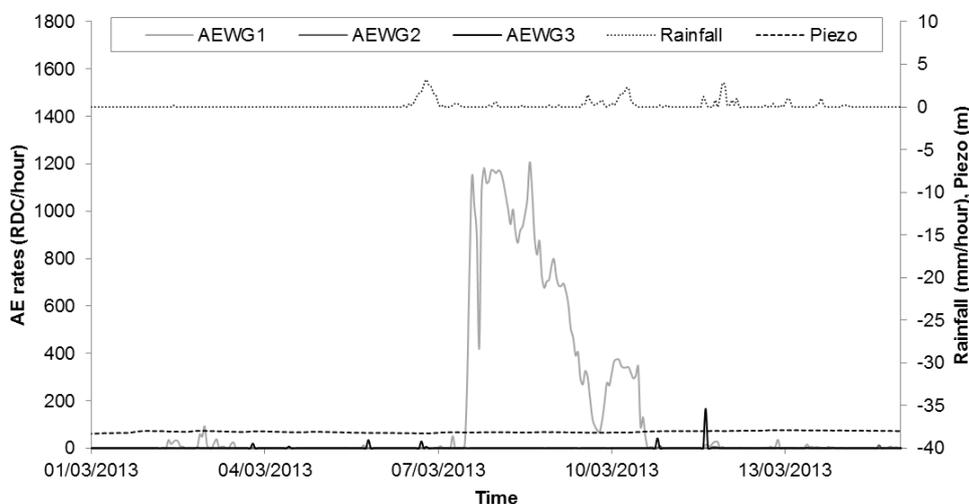
Figure 10 AE rate (RDC/h), rainfall (mm/hour) and piezometric level (m) versus time for medium AE rate events (1,000-10,000 RDC/h)

Medium AE rate events usually last for a few days and are recorded in particular from one sensor while the other two are silent or show lower activity levels. As in the example in Figure 10, they do not seem to be associated with particular rainfall events and the piezometric level does not change. These types of events can show a sharp increase at the beginning, as shown in Figure 10, or they can gently rise to a peak AE rate, but in both cases, the rates usually decrease gradually.

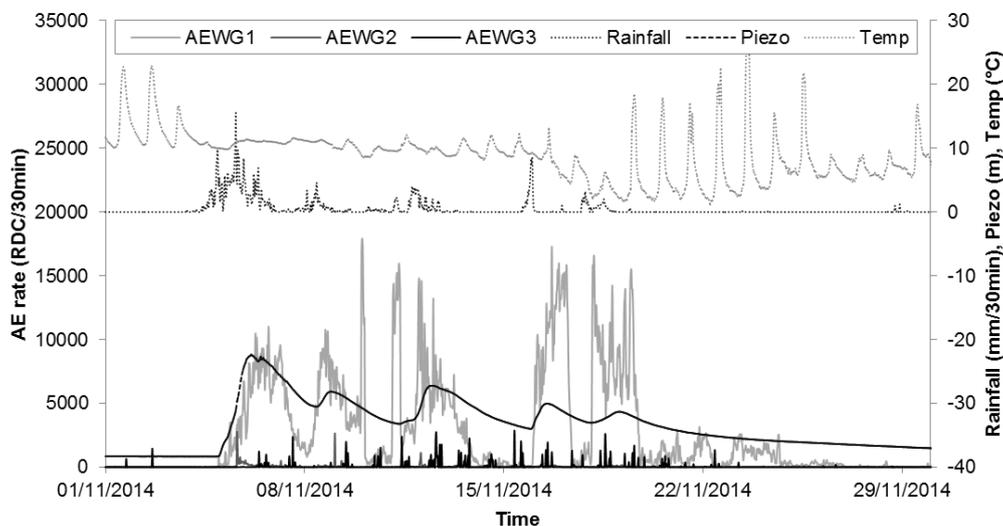
Figure 12 AE rate (RDC/30 min), piezometric level (m), rainfall (mm/30 min) and temperature versus time showing AE rate trends due to changes in piezometric level. Data are plotted for 30-minute periods

Figure 12 shows a series of AE events that occurred in November 2014 and which lasted for several days. These events can be attributed to changes in water pressure within the rock mass due to variations in the piezometric level. It can be observed that there is a delay of some hours between rainfall events and the rise in the water level, but AE are recorded by waveguide AEWG1 simultaneously with changes in the water level. AE rates tend to accelerate when the water table rises and to decrease, more or less sharply, when it drops. Hence, the AE trend follows the stress changes within the rock structure.
