Rock engineering design — the importance of process, prediction of behaviour, choice of design criteria, review and consideration of risk

TR Stacey *University of the Witwatersrand, South Africa*

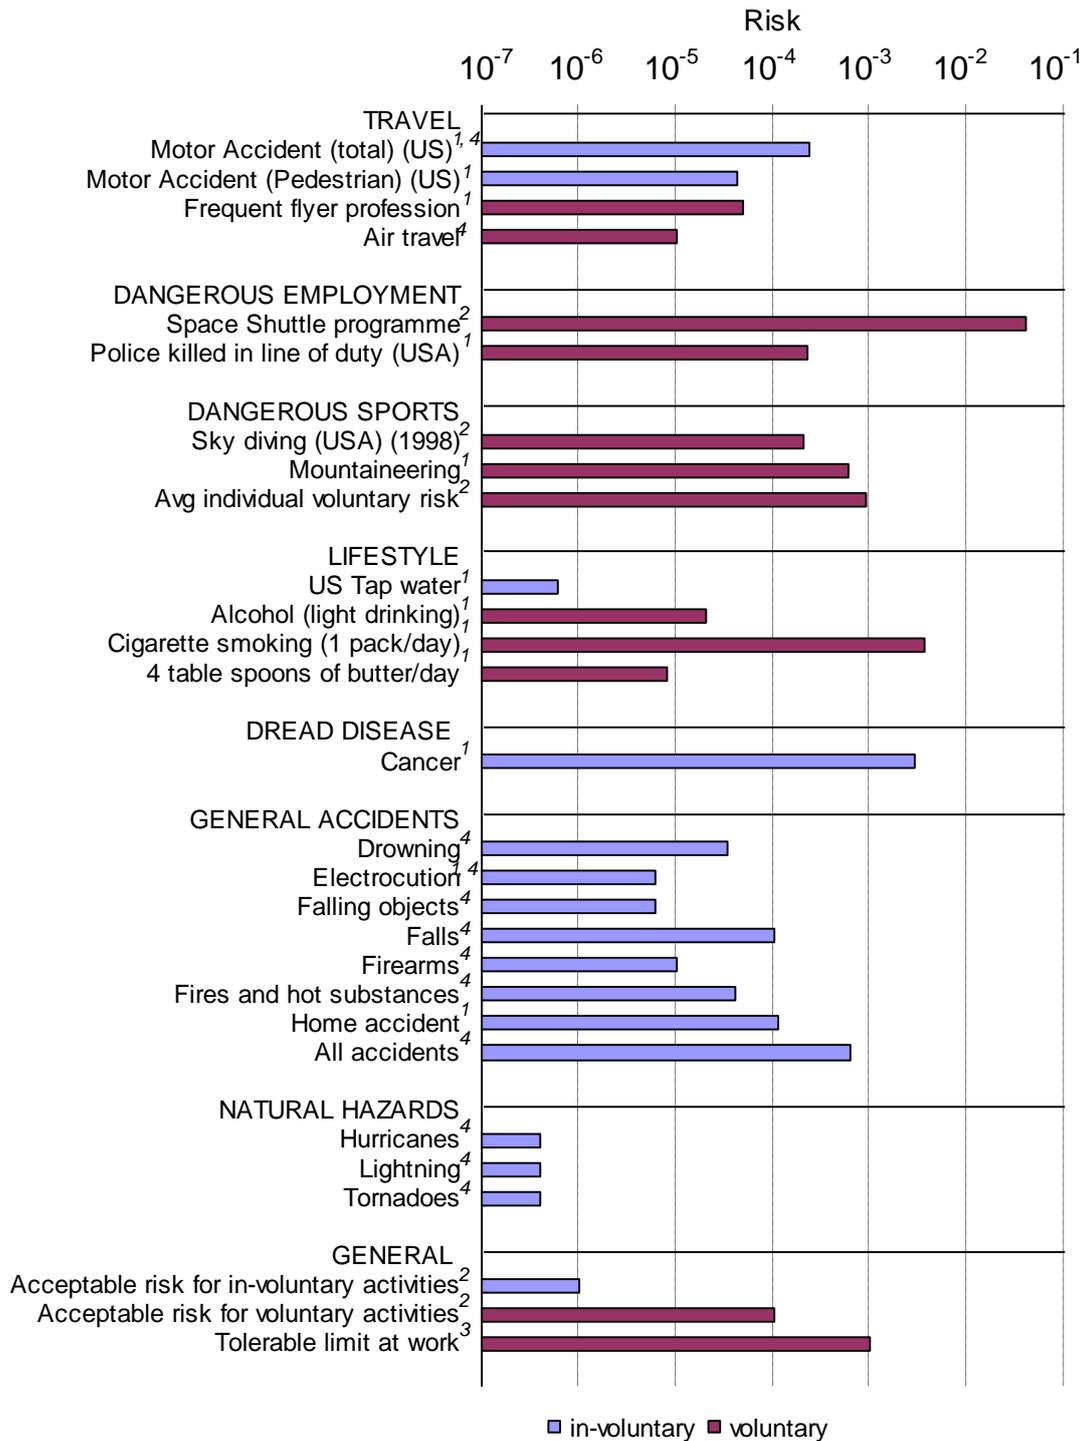
1 Wilson and Crouch (1987); 2 Philley (1992); 3 Hambly and Hambly (1994); 4 Baecher and Christian (2003).

Figure 1 Comparative accident statistics (Terbrugge et al. 2006)

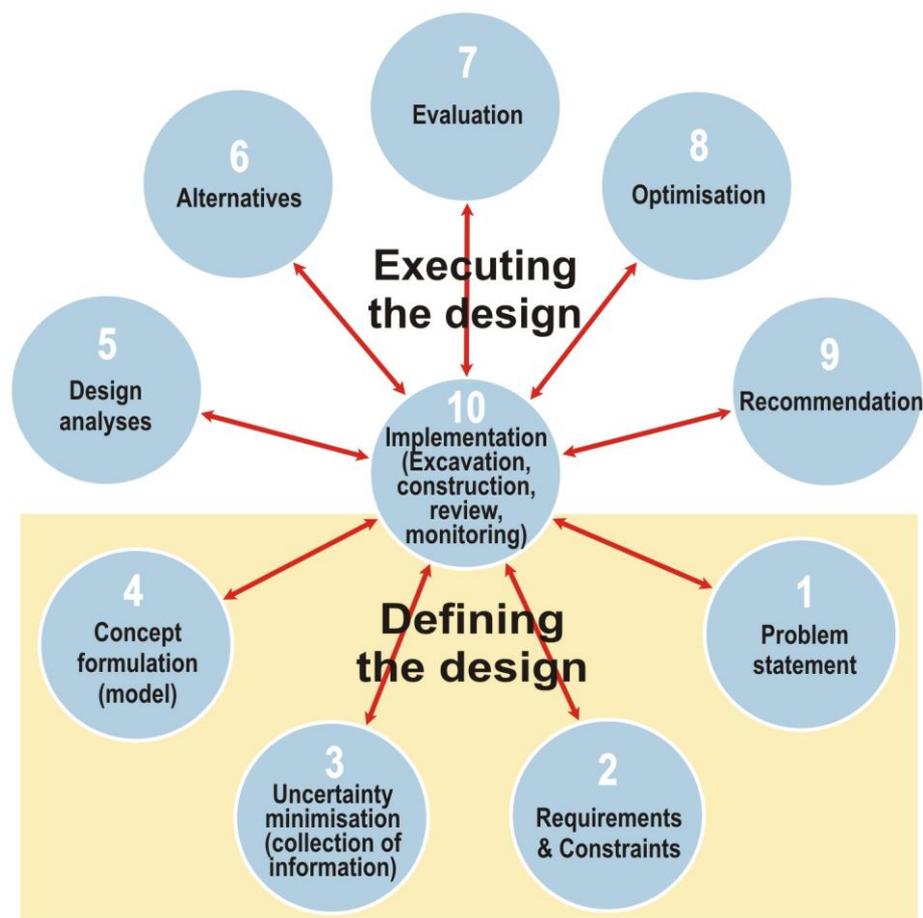
The design methodology corresponding with these design principles is summarised in the ten steps shown in the “circle, or wheel, of design” (Stacey 2006) in Figure 2.

Figure 2 Engineering ‘circle, or wheel, of design’ (Stacey 2006)

The first two steps, statement of the problem and requirements and constraints, are extremely important steps in that they set out the design objectives, which are fundamental to achieving the desired result. These two steps would therefore include relevant corporate policies that could affect the design. As shown in Figure 2, the engineering design process can be divided into two phases: defining the design (the very important front end loading part), and executing the design (the implementation of the design at various levels of detail). It is the first phase, defining the design, that creates most value for the project, and determines whether the project will be successful or not in returning the expected performance on time and on budget. In the ‘defining the design’ part of the process (steps 1 to 4), the formulation of the conceptual model (step 4) is probably the most important step in the process. The development of the conceptual model requires an interpretation of the expected behaviour of the excavation and the definition of design criteria. This requires interpretation of the likely mechanisms of failure development, which may involve unusual mechanisms that could have large impacts on behaviour. Examples are buckling, a violent mode of failure not considered in conventional rock failure criteria (Germanovich & Dyskin 2000); the fan shear failure mechanism in which frictionless shear takes place (Tarasov and Potvin 2013); and cohesion weakening friction strengthening behaviour (Hadjiabdolmajid et al. 2002).

Review and monitoring are extremely important aspects of design since they allow any faults in the design to be identified at the earliest possible stage. They also show whether actual behaviour corresponds with predicted behaviour. The importance of review and monitoring in any engineering design process is emphasised by the location of this step at the centre of the wheel and by the spokes of the wheel, which link it to all other steps. The implication is that the design must meet the stated objectives at all stages. Independent review during the design process provides a very important control on the quality of the design being carried out. Such an activity should be both informal and formal and could take place at various stages, depending on the magnitude of the design project. The aim of review is to ensure, independently, that the design is robust and that the design objectives are being addressed.

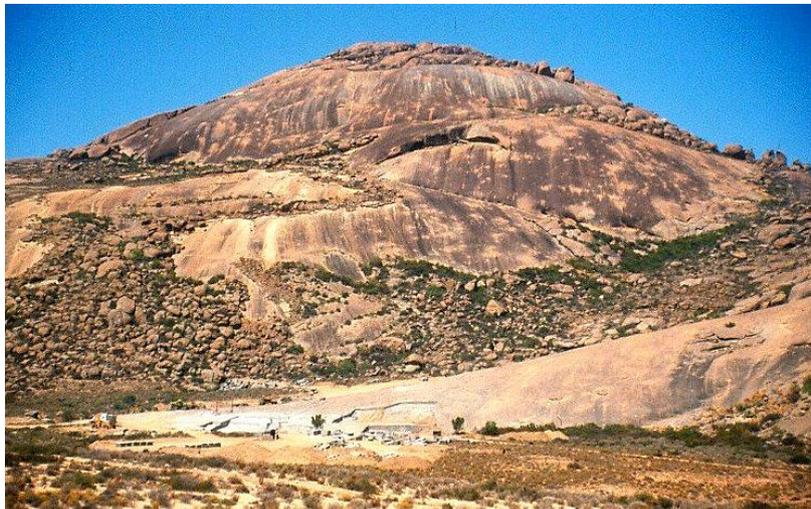
Although this is not an underground example, it does illustrate particularly the issue of design/failure criteria. The environment of this case is shown in Figure 3, illustrating a small dimension-stone quarry in high quality granite. At the very early stage of mining shown, only limited extraction of rock had taken place, with quarry depths being only a few metres (Figure 4). No detailed mapping, no laboratory testing and no in situ stress measurements were carried out; therefore, this case is purely observational.

Figure 3 Setting of the dimension-stone granite quarry

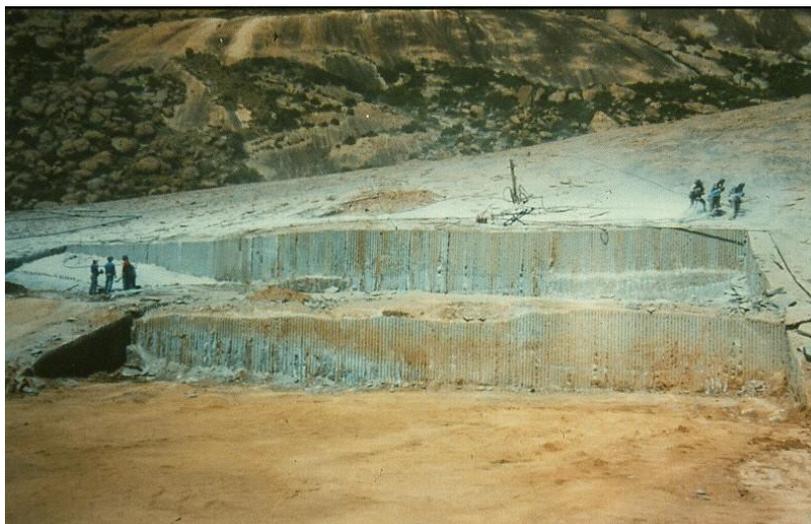
Figure 4 Extent of the quarry

The granite is dimension-stone quality, and rock strength is unlikely to be less than 200 MPa. The stresses in the rock are unknown, but, taking into account the near surface location and the shallowness of the quarry, are unlikely to exceed say 10 to 20 MPa. Realistic values of Hoek–Brown and Mohr–Coulomb strengths for the rock far exceed the likely stresses acting in the rock. Therefore, the conventional methods of prediction of rock failure do not appear to be appropriate in this case. However, after excavation, fractures developed sub-parallel to the surface (Figure 5). These often occurred with considerable violence and, on one occasion, the machine used to drill the closely-spaced vertical holes was reported to have been thrown about 3 m into the air. Sub-vertical fractures developed subsequently, parallel to the cut face of the quarry, as shown in the Figure 5(b), and it can be seen that they have extended beyond the boundary of the excavated quarry face.

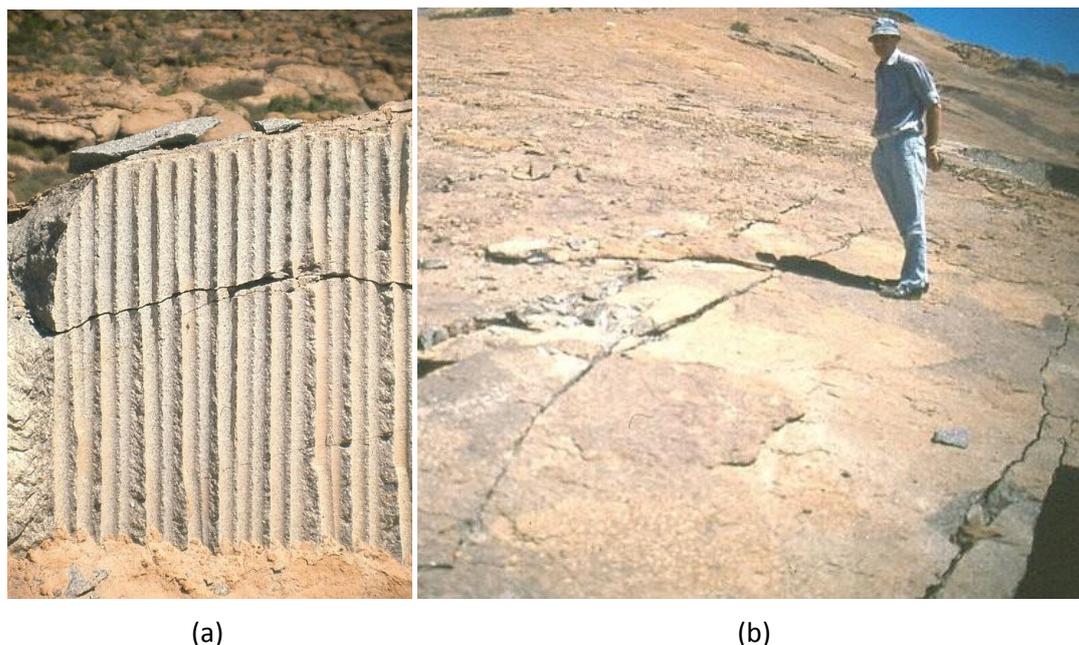
Figure 5 Stress-induced fractures sub-parallel to the surface and to the quarry face

If one considers strain instead of stress, a compressive stress in the near surface rock will induce extension strains in the rock, normal to the minimum principal stress. This stress is approximately sub-vertical prior to excavation and then also sub-horizontal, normal to the quarry face, after excavation. With compressive stress magnitudes in the range of 10 to 20 MPa, the resulting extension strain magnitudes can be expected to be in the range of 100 to 200 μ strain, sufficient to cause the initiation of fractures (Stacey 1981). The determination of strains requires the input of all three principal stresses. From reports of the time of occurrence of fracturing, temperature effects, due to heating during the day and cooling at night, also appear to have had an influence. The measurements of strains that develop in exposed rock surfaces due to temperature variations, carried out by Dünner et al. (2007), indicate that strain magnitudes can be significant. They measured compressive strains of about 200 μ strain sub-parallel to the surface and extension strains of about 100 μ strain perpendicular to the surface. Such temperature-induced strains would add to the strains resulting from the in situ stresses acting in the rock and would clearly contribute to the development of extension fracturing. The development of extension fracturing in the quarry is likely to have led to the formation of incipient slabs, and a buckling mechanism was probably involved in the violent failure that occurred. The consequence of the fracturing was a very large percentage of waste, which was very detrimental to the profitability of the mining operation.

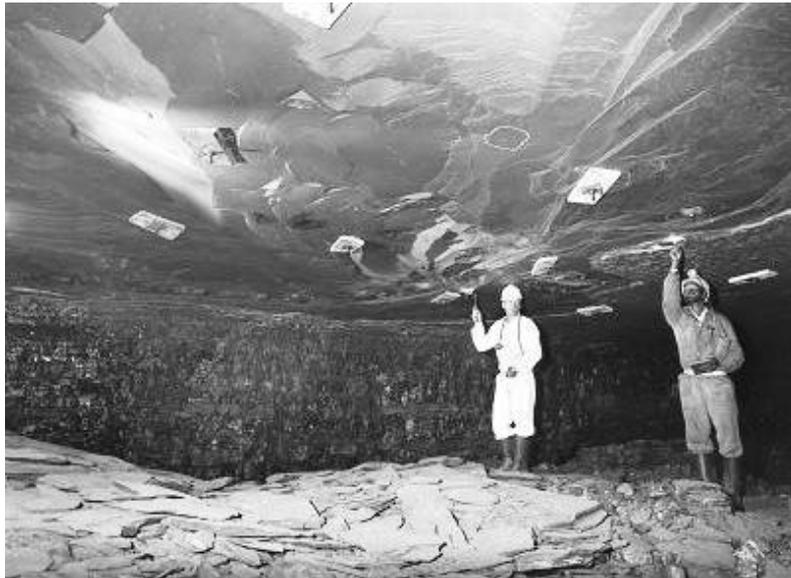
A case of dynamic failure of roof rock in a coal mine (effectively a rockburst) at a depth of only 22 m, was described by Ortlepp and Moore (1987). Figure 6 shows a photograph of the failure area after it had been re-supported with rockbolts. The geometry of the failure is shown in the plan and section in Figure 7. The failure took place during top-coaling removal of the top slice of the seam, as can be seen in Figure 7; the primary bord and pillar extraction having been completed some months before. A roofbolt hole was being drilled at the time of the failure.

Figure 6 General view of the roof failure

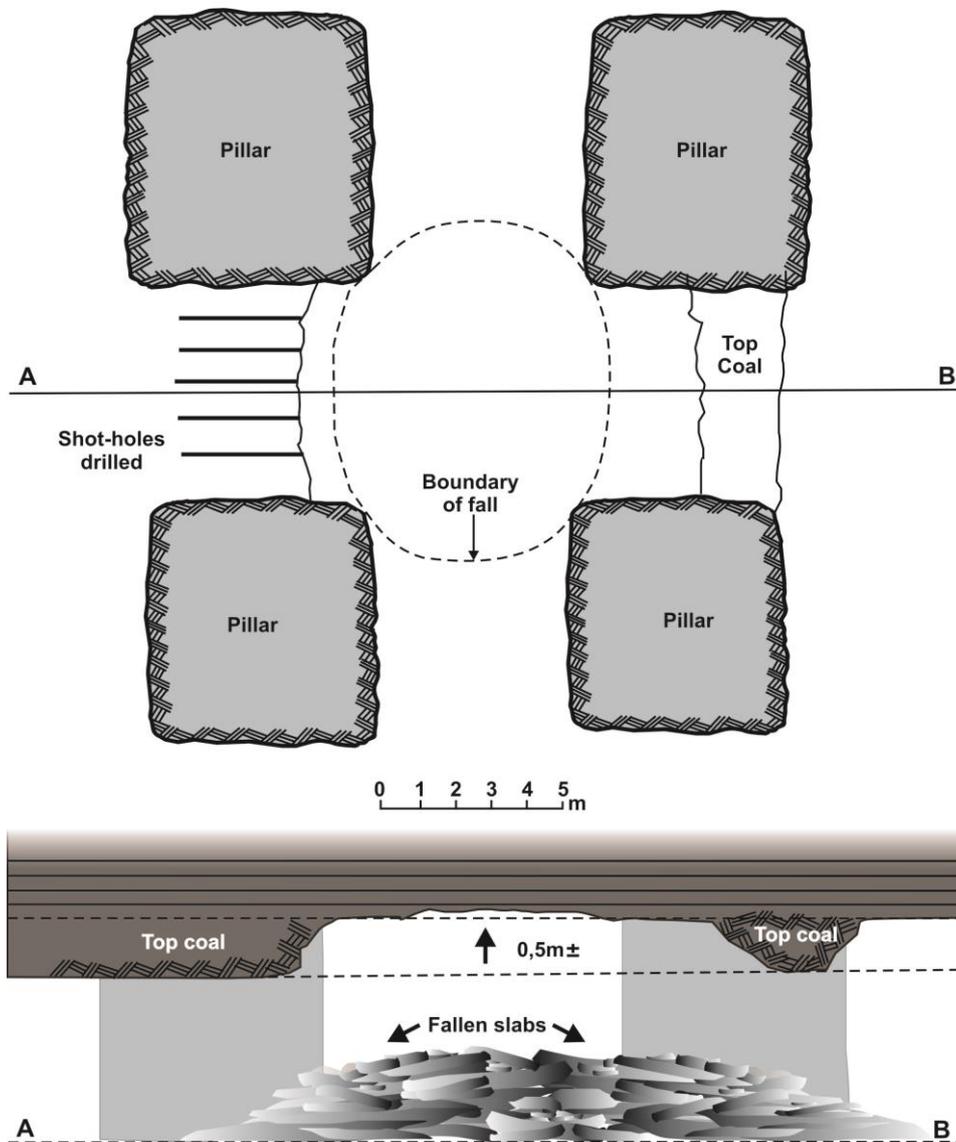
Figure 7 Plan and section of roof failure

The roof rock involved was very fine-grained and anisotropic carbonaceous shale. Its UCS normal to the stratification was about 65 MPa and its tensile strengths normal to the stratification and in the plane of the stratification were, respectively, 2 and 4 MPa. The stress level was not measured or known specifically. However, at this depth, the vertical stress could be estimated as 0.5 MPa. It is known that the horizontal in situ stress in the coalfields can be significantly greater than the vertical stress (Frith et al. 2002), so an estimate could be 3 MPa. This is so significantly less than the UCS of the rock that failure of the intact rock would certainly not be predicted by conventionally used criteria such as Mohr–Coulomb and Hoek–Brown. Normally, in such a bord and pillar environment, one could expect beam bending type behaviour, and the tensile strength in the plane of the stratification could be a criterion. In fact, the failure mechanism appears to have been of a plate buckling mode.

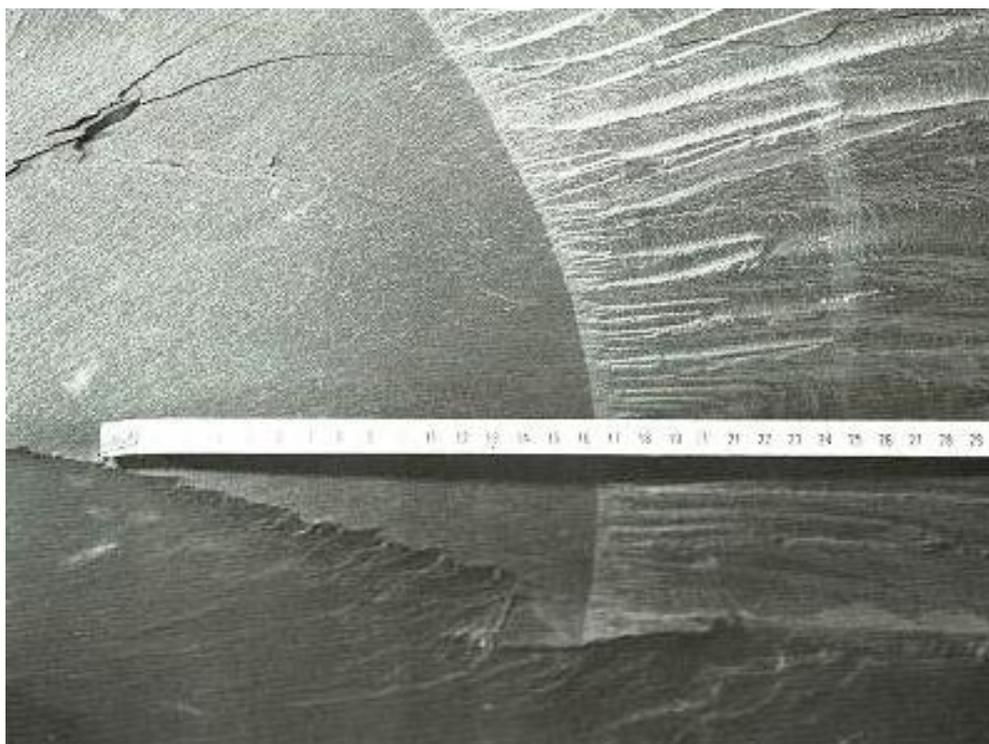
The failure involved the creation of a fracture surface through the intact rock (Figure 8).

Figure 8 Detail of fracture propagation

In Figure 8, the detail of a near-perfect arc can be seen, defining the transition from a stable fracture process spreading smoothly at an increasing propagation velocity, to unstable fracturing of a hackly nature. Ortlepp and Moore (1987) studied the mechanics of the failure process and estimated a value of 1.1 MPa for the tensile stress normal to the crack plane at the time the crack front reached the uniform-hackly boundary, which was reasonably close to the tensile strength normal to the stratification. They stated that the fact that there appeared to be several initiating flaws was difficult to explain. However, an explanation might be that there will be a relatively uniform distribution of extension strain in the roof above an intersection, and that the strain levels are likely to be high enough to initiate fracturing. Fractures may therefore have initiated parallel to the stratification at several localised weaker areas.

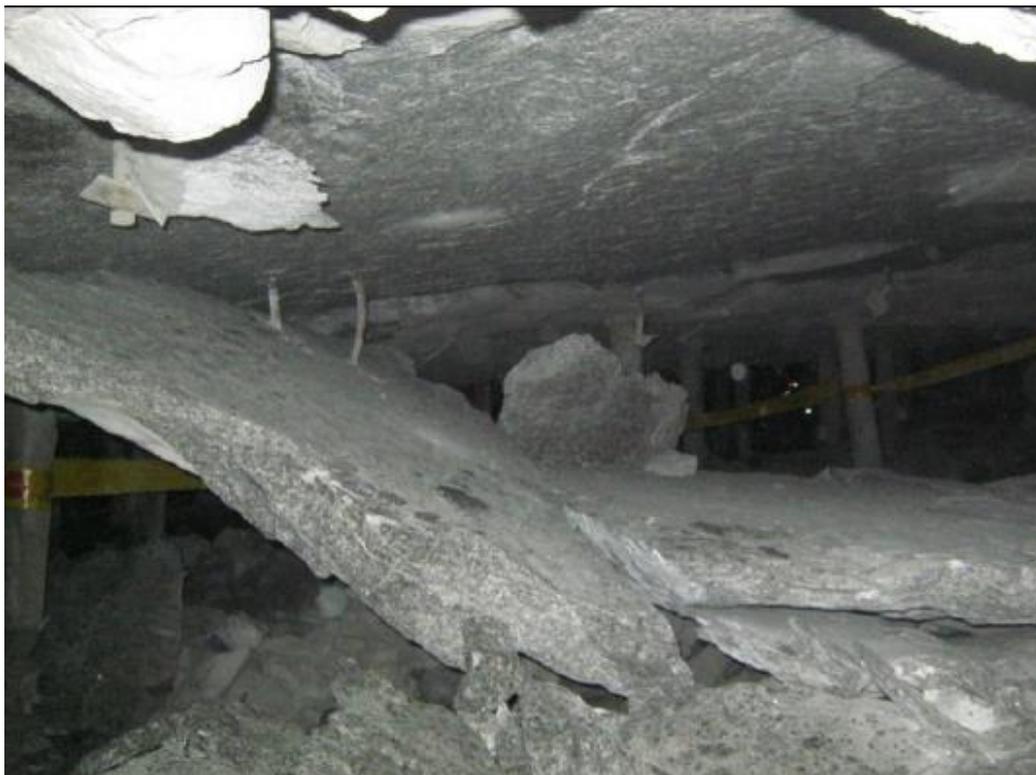
Similar dynamic failure behaviour was observed in a platinum mine (Figure 9). The dynamic failure was preceded by the occurrence of a substantial amount of microseismicity.

Figure 9 Dynamic roof failure in a tabular platinum mine stope (Stacey & van Rooyen 2014)

It is also possible that time could have been a factor in both cases — that it was a case of strength decreasing to meet stress (or strain) levels rather than stress increasing to meet the strength; and that incipient slabs or plates by initiation and propagation of fractures in the biaxial stress environment (Sahouryeh et al. 2002). This possibility is supported by the results of Brazilian tensile testing work carried out by Nyungu (2013) on rocks from the platinum mining environment, which showed that long-term tensile strengths are between 60 and 70% of the tensile strength normally reported from laboratory testing, and could possibly even be less than 60%.

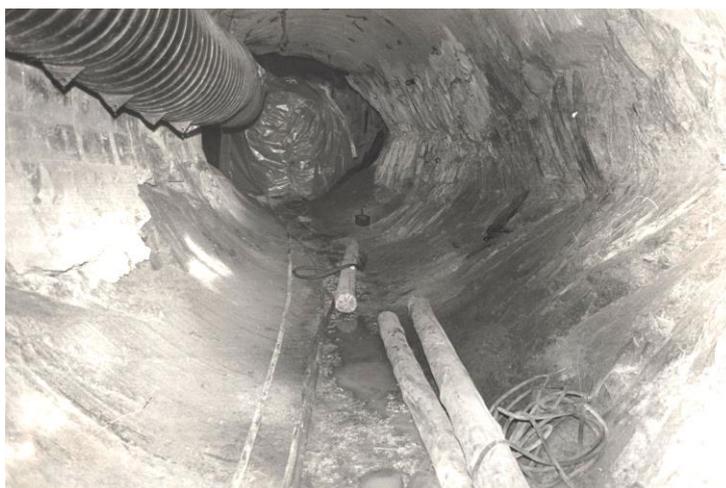
After the short length of boring, these problems became such that the machine could no longer continue, and it was removed from the mine. The tunnel produced is shown in Figure 10. Similar problems were experienced with another tunnel boring experiment in a different gold mine (Taylor et al. 1978).

Figure 10 Bored tunnel in a high stress gold mining environment

An after-the-event investigation and analysis of the problems was carried out (Stacey & de Jongh 1977). This involved three-dimensional stress analyses, and field work to map the extent and orientation of stress-induced fractures around the bore. It was found that the Mohr criterion was inapplicable regarding prediction of both occurrence and orientation of fracturing, and similarly for the Griffith fracture initiation criterion (Stacey 1981). However, an extension strain criterion (then referred to as a limiting tensile strain criterion) very successfully predicted extent and orientation of fracturing at all locations: sidewalls, face, around the corner where face and sidewalls intersect. The following quotes are relevant (Stacey & de Jongh 1977):

The fracturing of the sidewalls could be clearly seen by an observer looking back along the tunnel from the face. The fractures in the east sidewall had strike directions in the range of 10° to 20° to the tunnel axis, whereas those in the west sidewall were inclined at about 20° to 25° to the axis ... The agreement with the theoretically predicted orientations is remarkable. When slabs were prised out of the sidewall it was seen that they were curved with approximately the same radius as the tunnel. This again agrees with ... the criterion of limiting tensile strain.

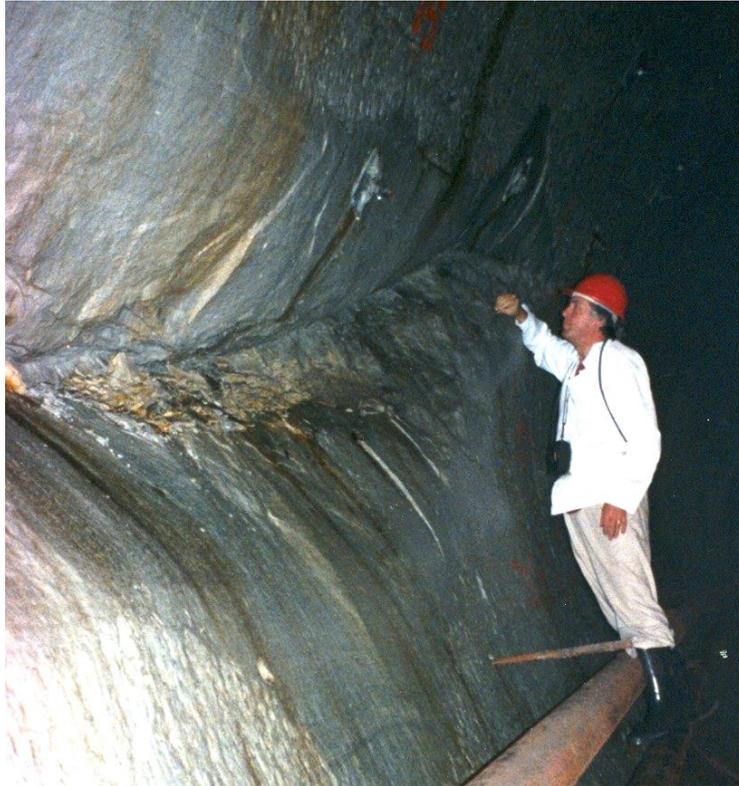
There are two further examples of fracturing around circular tunnels that can be quoted. The first deals with a 5 m diameter tunnel bored in massive sandstone at a depth of 150 m (Stacey & Yathavan 2003). Some months after excavation, sidewall spalling occurred, resulting in a sidewall breakout to a depth of about 400 mm (Figure 11).

Figure 11 Stress-induced breakout in a bored tunnel at a depth of 150 m

The vertical stress is estimated to have been between 3.5 and 4 MPa and the strength of the sandstone was in the range of 20 to 30 MPa. The ratio of the major principal stress to the uniaxial compressive stress is therefore between 0.12 and 0.2 and; under these conditions, failure would not be expected nor predicted using conventional failure criteria.

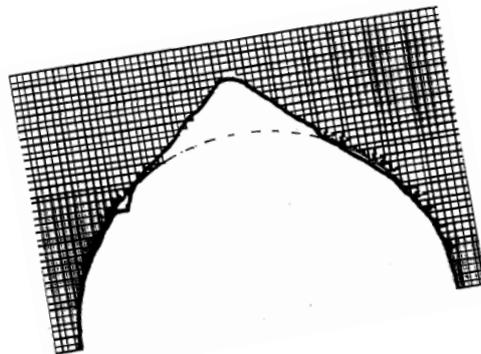
The second case is the well-published Atomic Energy of Canada Limited tunnel in Canada (Martin et al. 1997). This is a high quality case study since parameters are well known: the rock strength parameters and the in situ stresses, as well as the history of fracture and failure development. Breakout development has been modelled using alternative failure criteria. The observed breakout geometry was matched well using the cohesion weakening friction strengthening criterion (HadjiabdoImajid et al. 2002), but this also indicated failure on the sub-horizontal axis, which did not occur. The Mohr–Coulomb prediction was completely incorrect. Wesseloo (2000) modelled the development of the breakout with FLAC, using an extension strain criterion. Failed zones were nulled to simulate fallout of spalling rock. The predicted development of the breakout eventually stabilised, and its final geometry matched the observed geometry perfectly, as shown in Figure 12. Predicted failure using the three criteria are summarised in Figure 13.

Figure 12 Prediction of AECL tunnel breakout using an extension strain criterion (Wesseloo 2000)

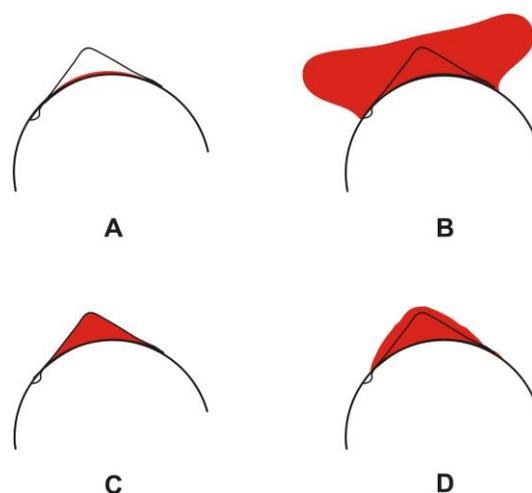
Figure 13 Extent of failure predicted by alternative criteria: (A) observed geometry; (B) Mohr–Coulomb; (C) extension strain; and (D) cohesion weakening friction strengthening

This case shows the importance of using an appropriate failure criterion that corresponds with the expected failure mechanism, and secondly, the importance of the fourth step of the design process. Note that, if the purpose of the analysis was to determine the required length of rockbolts or cables, then approaches B, C or D in Figure 13 would be adequate. However, if the requirement was the prediction of the extent of failure, then C or D is satisfactory. If the prediction of the orientations of the fracturing is required, then only C is satisfactory.

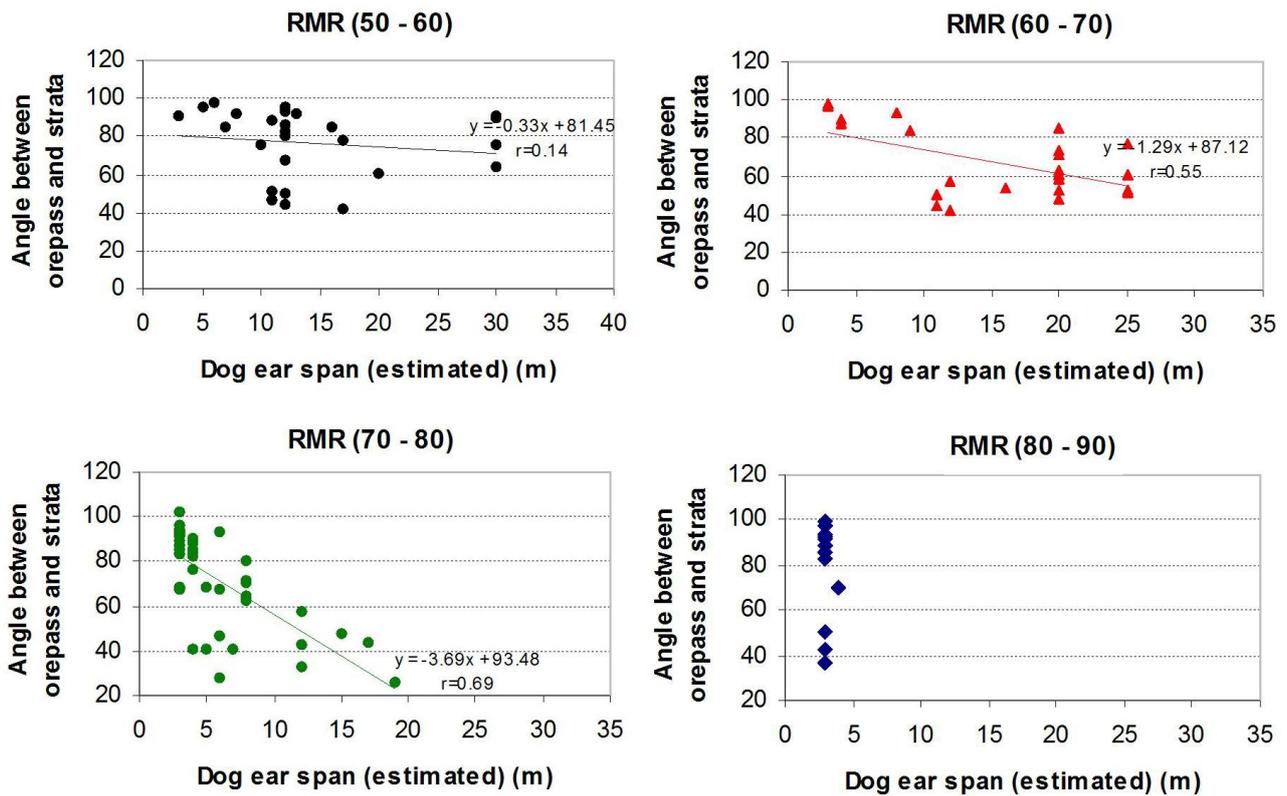
In the above investigation of pass performance, rock mass quality was estimated and correlated with the extent of breakouts (referred to as 'dog ears') (Figure 14).

Figure 14 Relationships between rock mass quality, pass orientations relative to strata dip, and breakout spans (Joughin & Stacey 2005)

Therefore, in spite of the poor quality of the data and in the absence of better information, it does appear that they could be useful for empirical prediction of pass performance in the deep level gold mining environment, albeit with substantial variability.

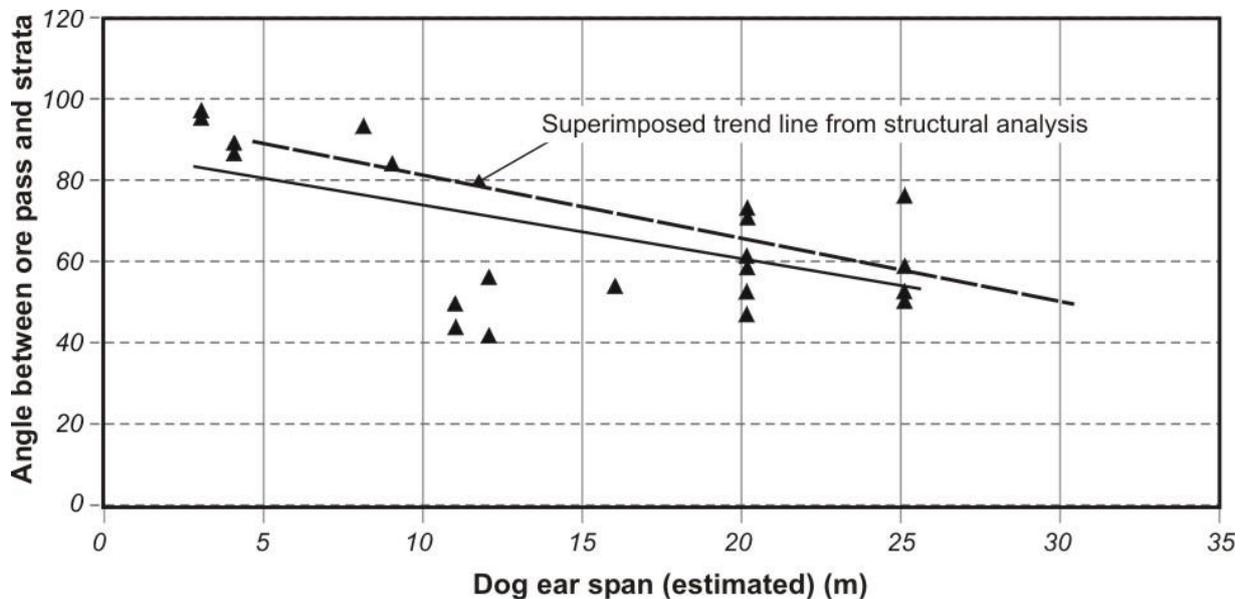
The validity of the data was assessed using a discrete fracture network approach (Stacey et al. 2005) (Figure 15), and gives some confidence in its usefulness.

Figure 15 Estimated breakout spans versus angle between pass and strata for rock mass quality RMR 60-70 (Stacey et al. 2005)

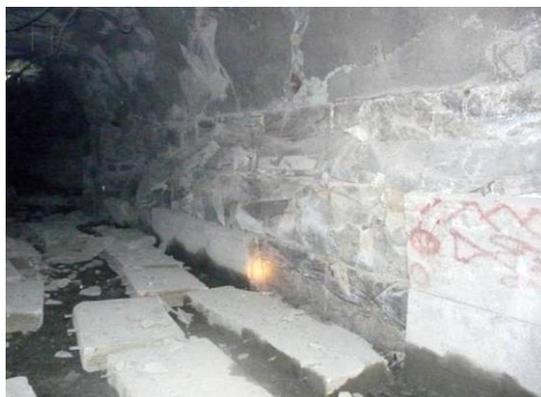
The tunnel support system shown in Figure 16 (Stacey & Rojas 2013) consists of concrete panels, each panel being retained against the rock surface by fully-grouted cables. After a rockburst, it was found that panels had been ejected from the sidewalls, causing significant damage to the support system. This represents a failure of the support design, resulting in an unsupported rock surface, a potentially hazardous situation.

Figure 16 Concrete support panels ejected during a rockburst event (Stacey & Rojas 2013)

The concrete panel support shown in Figure 16, a satisfactory design in static conditions, could be considered to be an inappropriate support system for dynamic, rockburst conditions. Concrete panels retained by fully-grouted cables represent a rigid support system. Such a rigid system is contrary to the commonly understood rockburst design requirement of compliant, yielding support systems that can absorb energy during deformation but at the same time maintain their load carrying capability. Therefore,

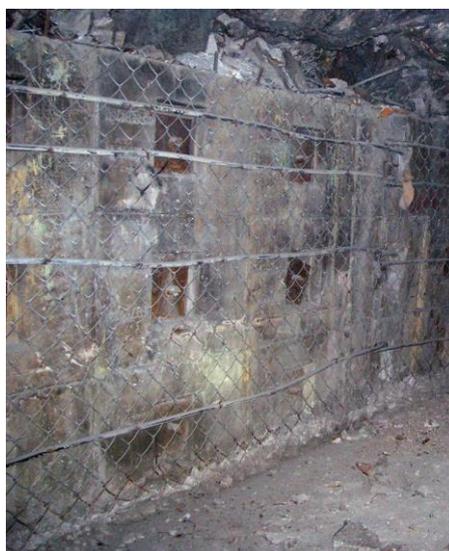
To ensure safe, stable working areas it was necessary to implement remedial measures at short notice. The solution adopted was the installation of steel wire ropes, wrapping over the panels, with the ends of the ropes being grouted into boreholes drilled through the panels. This remedial support design is illustrated in Figure 17, the photograph showing the support prior to its being sprayed with shotcrete protection against mechanical damage. Owing to the geometry of the remedial support ropes, they are colloquially referred to as staples. Such staples provide the containment support to the panels, preventing them from being thrown off in a rockburst event. The wire ropes need to be loose enough to perform in a secondary mode — to catch the ejected panels but not to be part of the primary support system.

Figure 17 Remedial staple support with wire ropes (Stacey & Rojas 2013)

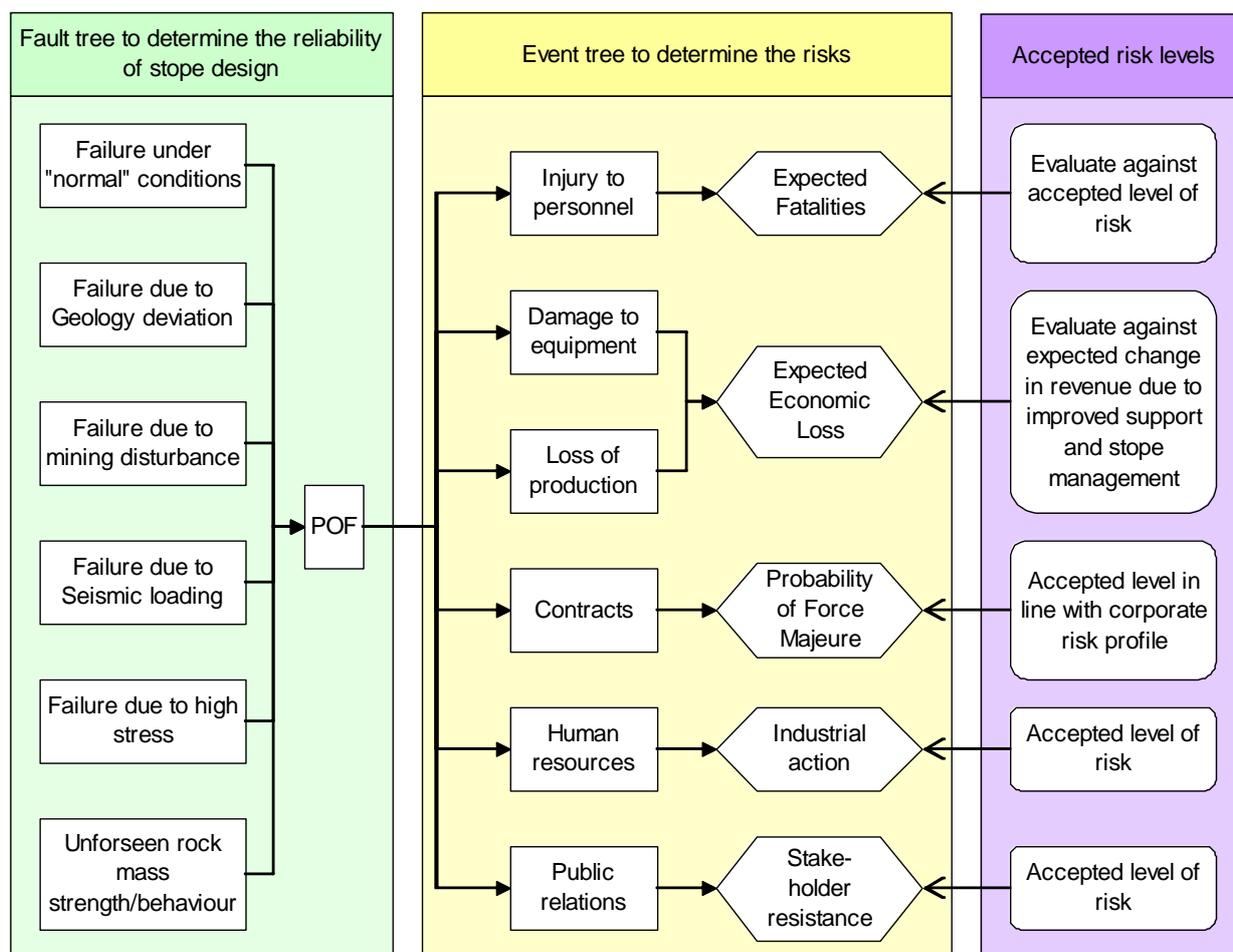
A risk evaluation process for an underground slope is illustrated in Figure 18 showing a fault tree for calculating the POF, the logic diagrams (event trees) for determining the risk exposure that follows from the

selection of a specific stope support design and the evaluation of the risks against the specified risk criteria. The risk/consequence analysis has been described in some detail by Terbrugge et al. (2006).

Figure 18 Risk evaluation process (Terbrugge et al. 2006)

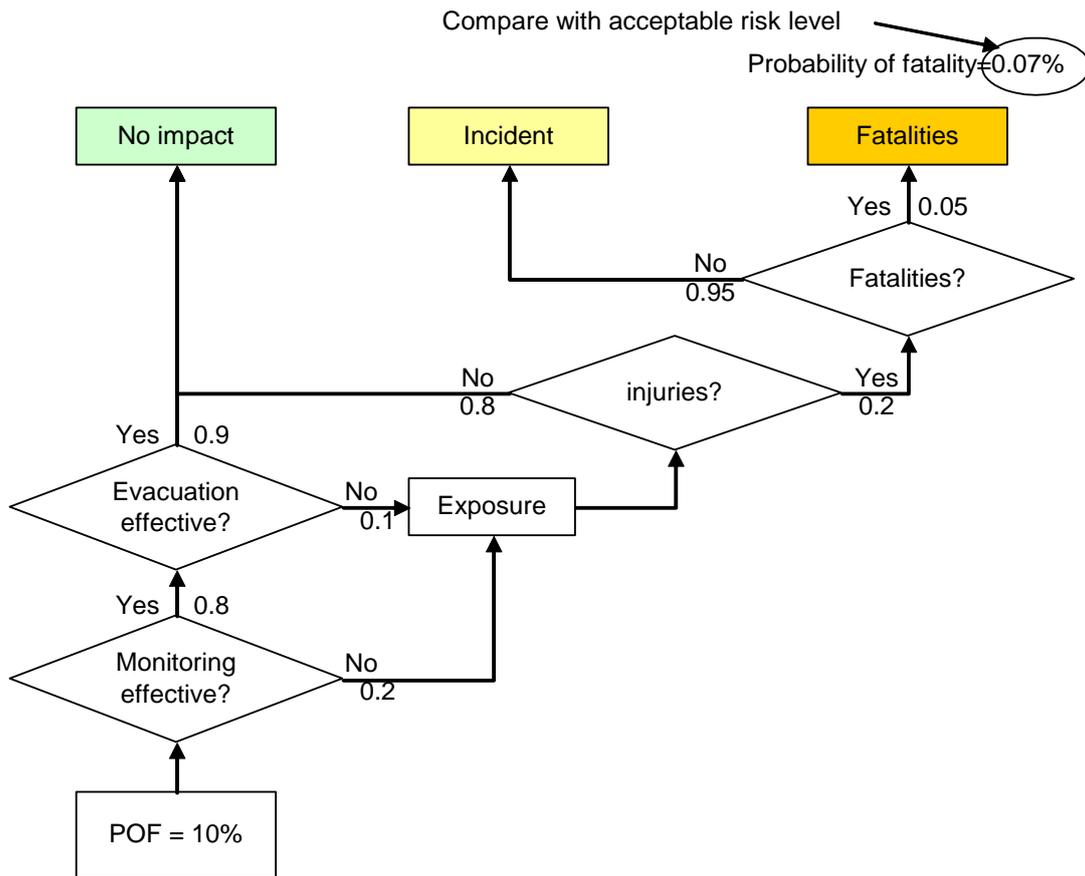
Safety risk can be evaluated using the event tree model shown in Figure 19. The potential for injuries and fatalities can be managed by instituting strict stope management procedures, hence changing the probability of a fatality. Without such procedures, the risk to personnel is dictated by the effectiveness of the stope support. The implementation of the stope management procedures, as indicated in Figure 19, shows how risk could be reduced without increasing the support installed to reduce the POF. For example, improved effectiveness of the monitoring system and an improved evacuation procedure would substantially reduce the probability of annual occurrence of an accident. A similar event tree can be used to assess the risk of damage to, or loss of equipment.

Figure 19 Simplified event/consequence tree for injuries/fatalities (Terbrugge et al. 2006)

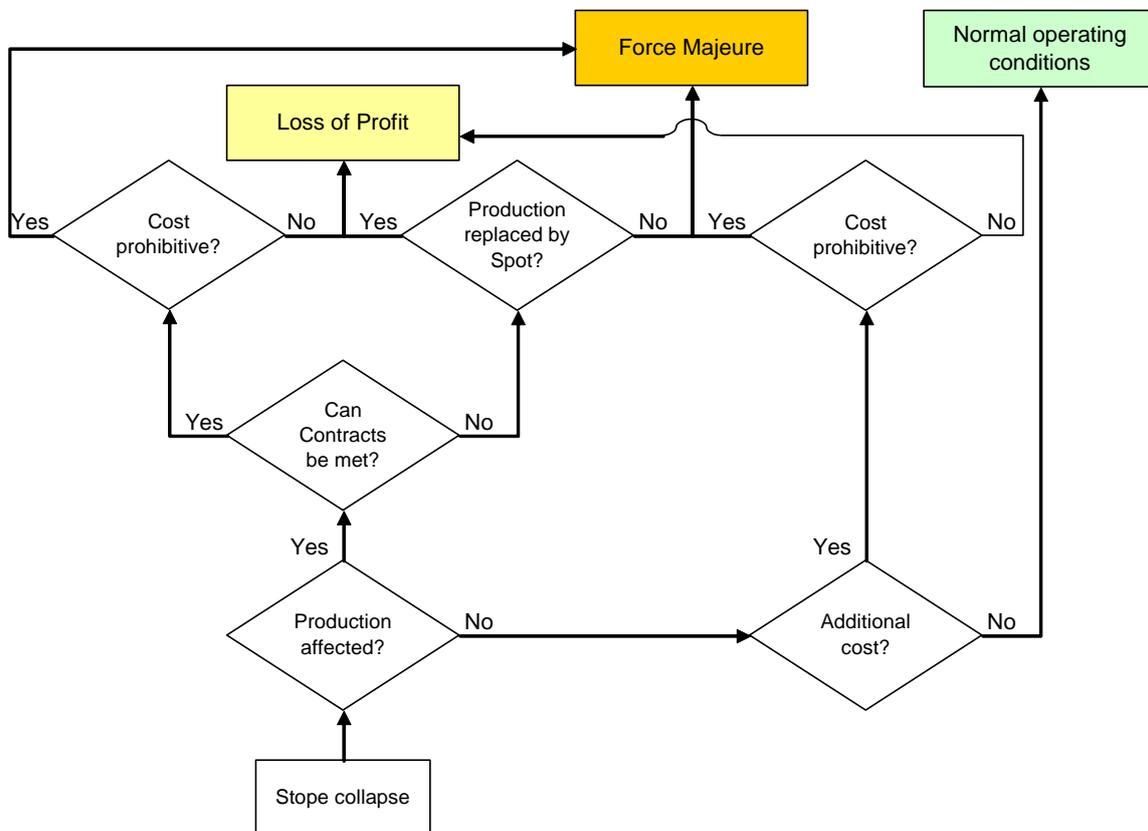
In addition to the safety risks posed by rockfalls, they can result in economic consequences. An example of an event tree for the economic impact of a significant collapse is shown in Figure 20. A major economic impact needs to be defined to quantify the risk. This could be force majeure, as illustrated in Figure 18, or simply the closing down of the mining operation.

Figure 20 Event tree example for evaluation of economic consequences of failure (Terbrugge et al. 2006)

The consequences of a collapse that need to be considered include: clean-up cost, removal of collapse material; stope rehabilitation; stope re-access; equipment redeployment; unrecoverable ore and dilution; damage to equipment and infrastructure; direct and indirect costs associated with fatalities and injuries; and disruption of production. Once these consequences have been quantified, the decision whether to accept the excavation and support designs is a management one, weighing up the economic risk character of the alternatives within the corporate risk profile. The outcome from this risk methodology process ensures that risks in the areas of safety, equipment damage, economic impact, force majeure, and industrial action and negative public relations are within the required criteria set by the mining executives.
