# Evaluation of the adjusted rockburst damage potential method for dynamic ground support selection in extreme rockburst conditions

## Abstract

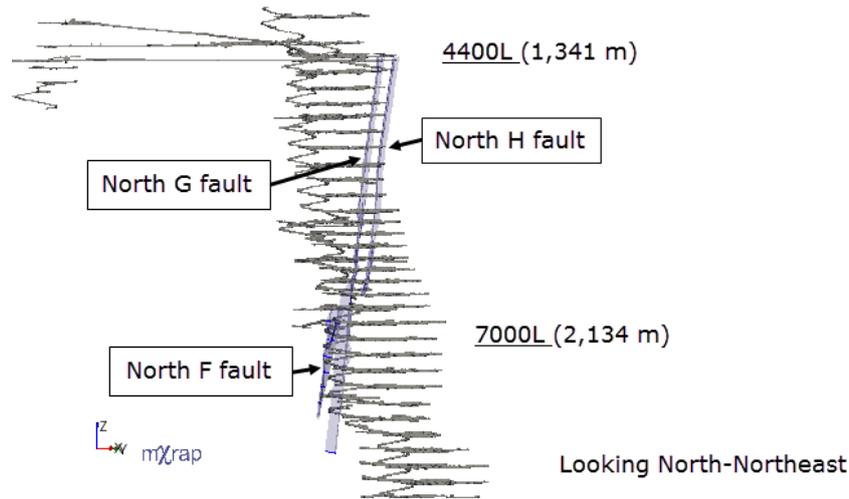
Figure 1 Kidd Creek Mine strong north trending structures

The three strongest of these structures in the rockburst vicinity are the North F, G and H faults. They are illustrated in Figure 1.

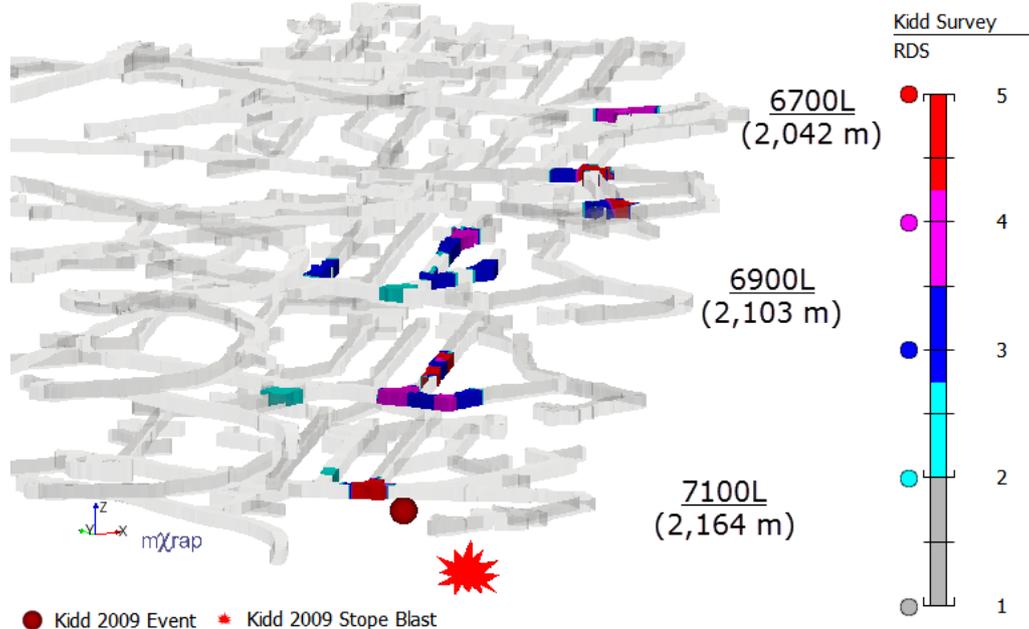
Figure 2 Kidd Creek Mine 2009 survey coloured by RDS

Damage to the excavation observed following the 2009 rockburst spans across seven levels. Damage severity of R1 was not mapped during the follow-up inspection. All damages to excavations coloured by RDS, as well as event and blast locations, are shown in Figure 2.

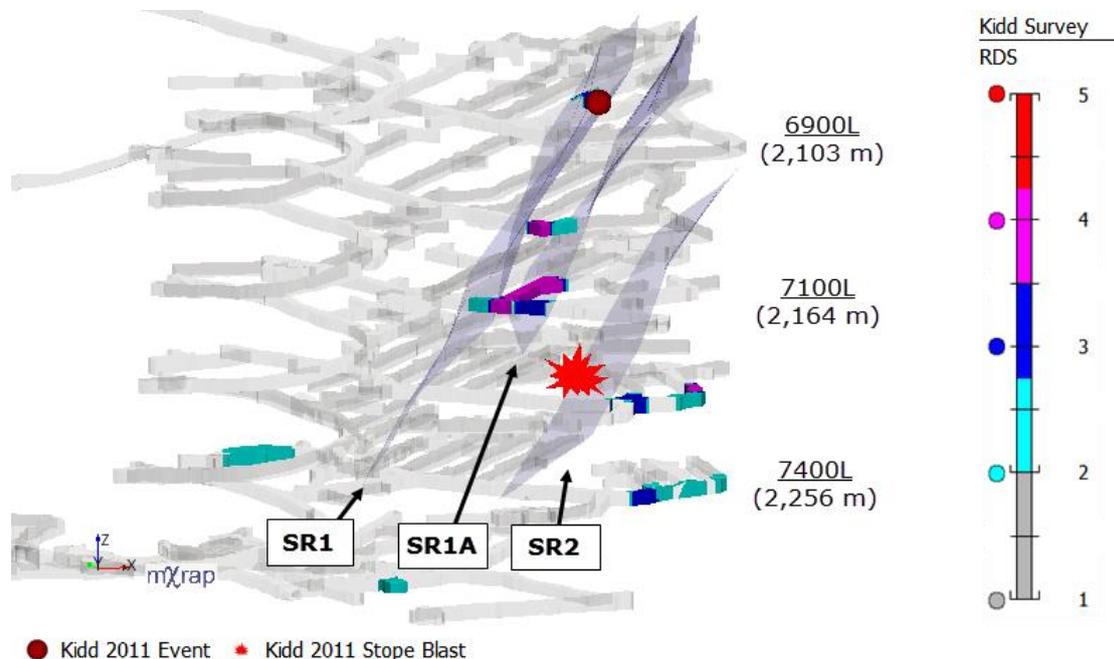
Figure 3 Kidd Creek Mine 2011 survey coloured by RDS

A series of new ‘faults’ was mapped following the January 2009 rockburst. These new faults are referred to in this study as seismic ruptures (SRs). The damage observed following the 2011 rockburst coloured together with three significant SR are shown in Figure 3.

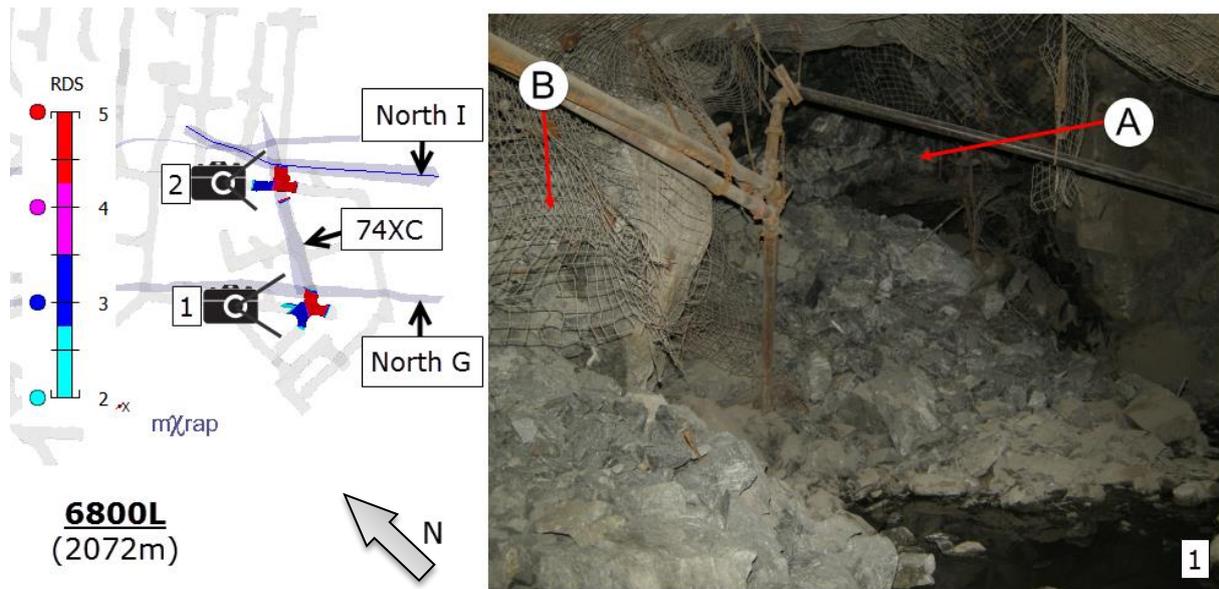
Figure 4 Kidd 2009 rockburst 6800L 74XC and DD intersection fall of ground

The damage observed on 6800L was mostly restricted to along 74XC. The back of the intersection to the west of 74XC (Location A) had failed to depth in excess of 4 m and over 100 t of material was displaced from the back. A RDS rating of R5 was assigned to Location A. This is illustrated in Figure 4.

Adjacent to this at Location B, extensive bulking occurred with approximately 10 t contained by the support system. A RDS rating of between R3 and R4 was assigned.

The adjusted RDP method performed well for A and C. For Location B, with  $P_{R3} \sim 100\%$  one would expect a damage level of R5. The experienced damage level of R3/4 is overestimated. For Location B the result is conservative but fair.

Despite the method performing well for Locations A and C, it was noted that the stress factor used in this case study is much higher than the largest value in the original ACG database ( $E1 = 95$ ). Since the square of the stress factor is used in Equation 2, the use of extreme stress factors quickly exceeded the model's applicability and resulted in a saturated probability forecast.

It was also noted that the failure depth at A and C likely exceeded the maximum support system embedment depth. Such situation would not allow the full dynamic capacity of the support tendons to be mobilised and the assigned E2 rating of 10 is likely overestimated.

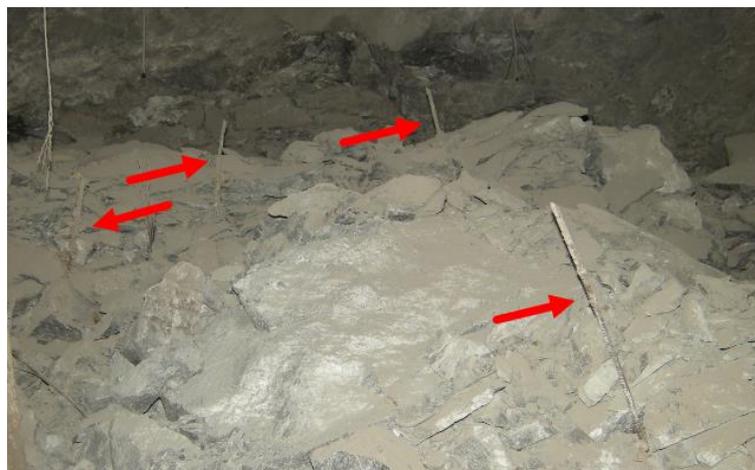
Figure 5 Kidd 2009 rockburst 6800L 74XC intersection with 68-01 Dr. S. Note rebar protruding vertically

Further east from Locations A and B, fall of ground was observed at Location C (68-01 Dr. So. intersection with 68-74 and 76 XC's) with over 100 t of material ejected from the back. A RDS rating of R5 was assigned to Location C. A large number of rebar bolts were seen protruding vertically on top of the failed debris as shown in Figure 5. The height of the pile has exceeded the original height of the excavation and development beyond the failure was not accessible.

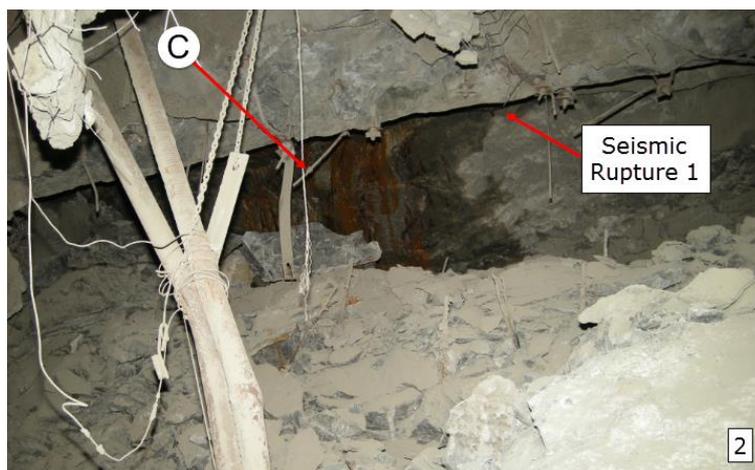
Figure 6 Kidd 2009 rockburst 6800L 01S and 76XC intersection fall of ground

A new and not previously known SR was mapped following the rockburst. This SR dips at 65 degrees to the NNW and can be observed from 6800L down to 7100L. This newly formed rupture is closely spatially associated with most of the severe damage observed for the 2009 case study. The collapse of the 68-01 Dr. So. intersection and the back of the 68-76 XC to the northeast illustrated in Figure 6 is located on the SR.

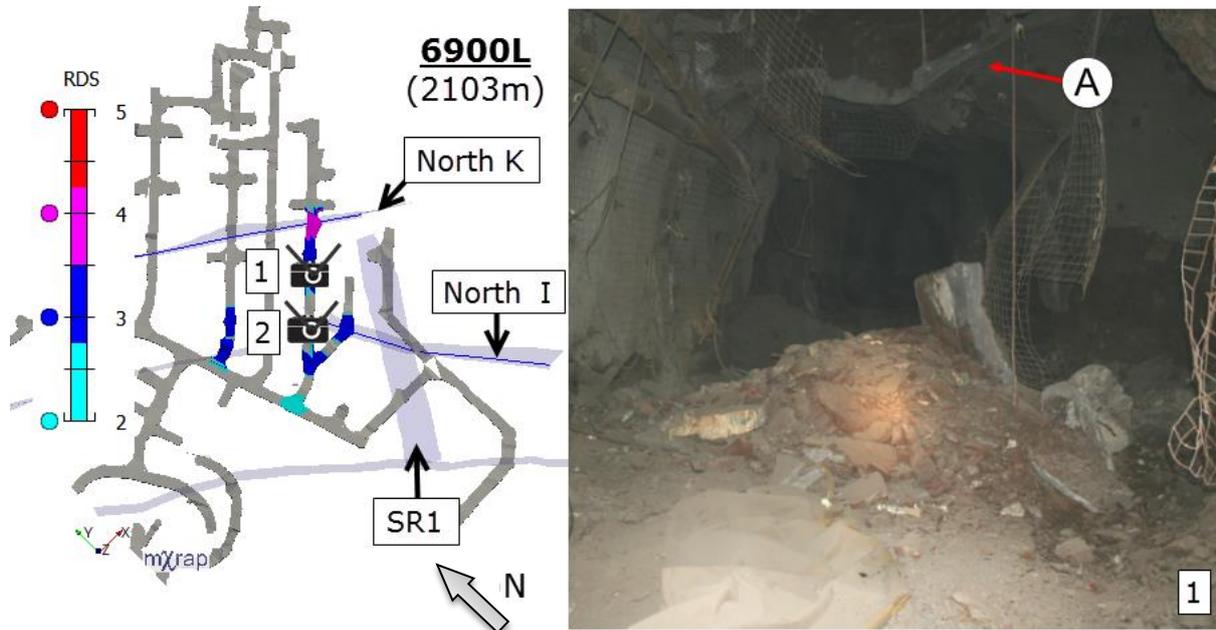
Figure 7 Kidd 2009 rockburst 6900L 82XC fall of ground. SR is denoted as SR 1

There was approximately 15 t of material ejected from the back at Location A in 82XC, as illustrated in Figure 7. The ejected rock fragments were approximately 20 cm in size or less and mainly consisted of slabs. Bulking of more than half a metre was seen in the back over an area of 5 × 5 m and a RDS rating of R4 was assigned to Location A.

The adjusted RDP model performed well for Location A, but apparently less satisfactorily for B. It should, however, be noted that the damage scale is based on the volume and not the severity of the damage. The limited damage volume resulted in a R2 rating even though the damage is quite severe.

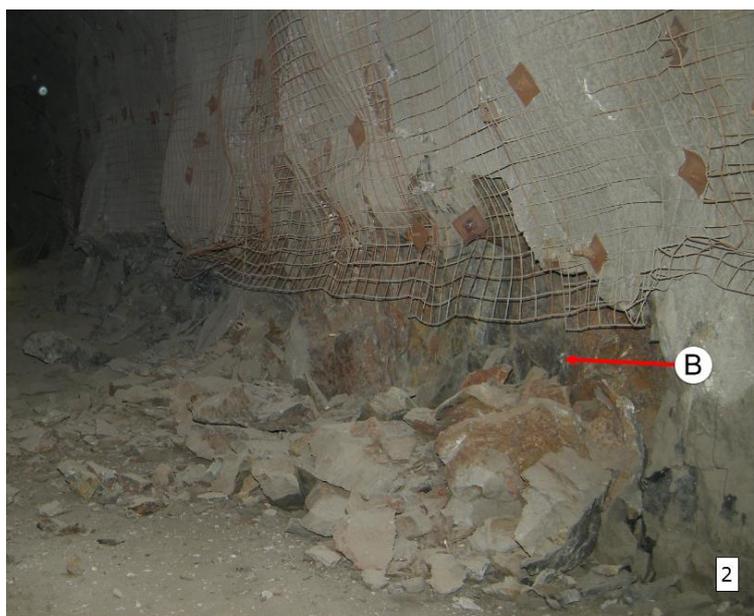
Figure 8 Kidd 2009 rockburst 6900L 82XC lower wall shakedown

Further back the drive along 82XC, expulsion of rock from the lower wall below the mesh line was seen frequently, as illustrated in Figure 8. Approximately 1 t of material was displaced at Location B below the mesh line for over 5 m along the drive. A RDS rating of R2 was assigned.

Given the severity of the damage, it is reasonable to expect that a larger failure volume would result when larger areas with  $E2 = 2$  were exposed. Bearing this in mind, the prediction is regarded as being fair, although it highlights the need to reevaluate the rockburst damage scale. It is noted that whilst only 1 tonne of material at location B was locally ejected from near the floor (where support is minimal), the entire wall to a depth of several meters was damaged, and required extensive scaling or shotcrete application, followed by installation of new tendons, mesh and strap support throughout, so the outcome of the whole wall was more in line with an R4 level of repair. Therefore, the predictor performed well, and the actual damage is in fact understated in this example.

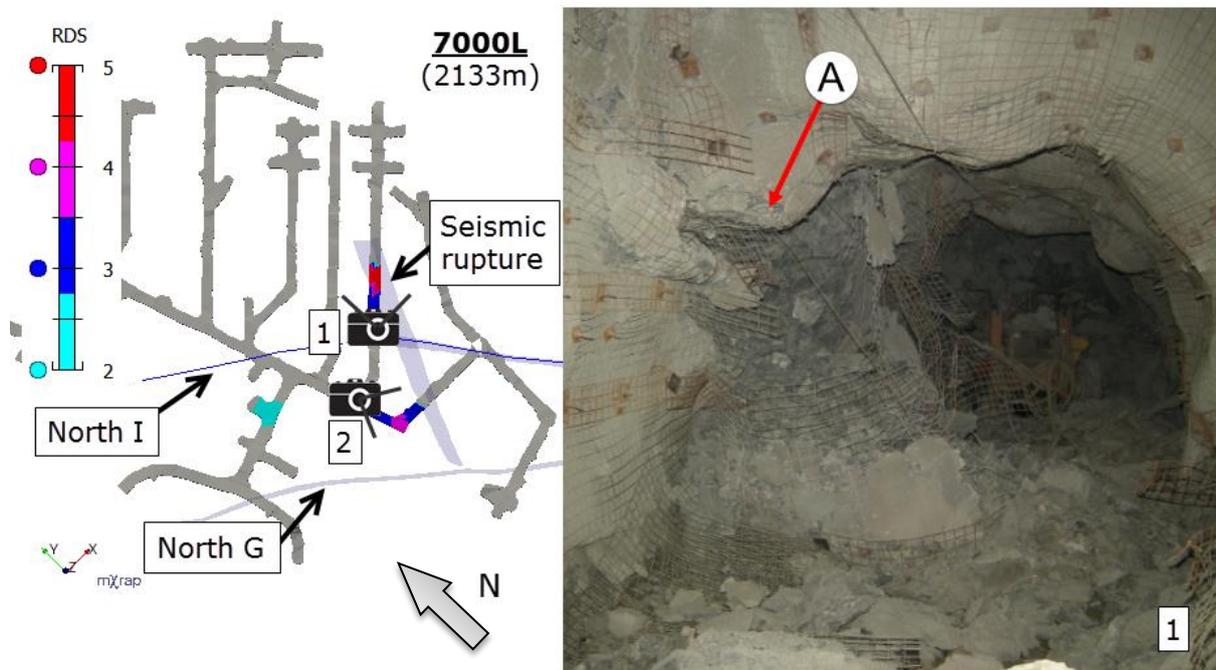
Figure 9 Kidd 2009 rockburst 7000L 82XC wall ejection

Over 100 t of material was ejected into the excavation at Location A in 82XC, approximately 10 m behind the service lift shown in Figure 9. The ejection ruptured the surface support of mesh over fibrecrete and straps. Large numbers of modified cone bolts failed due to necking, as the vibration wave resulted in high levels of shear, which prevented the bolts from slipping in an axial direction. The same applied to the super swellex bolts, installed where the ground was too disrupted to allow the installation of resin based tendons due to previous rockbursting in late 2008. The failed rock was mostly in the form of pulverised rock with an average size of 5 cm. A RDS rating of R5 was assigned to Location A.

Where the tendons did not fail, the support system retained the failed rock mass; however, deformation of up to 1 m was observed in the back and walls. Bolts located in the wall following SB 1A were seen to be failing in shear 1 m from the rock surface, with displacement across the bolt elements of up to 5 cm laterally.

The new RDP model performed well for Location B and C, but less satisfactorily for A, failing to predict the extent of the observed damage. The failure depth at A is estimated to have exceeded the bolt length of 2.2 m. Assigning an E2 value of 25 implicitly assumes that the support system dynamic capacity will be fully mobilised, which is not the bolt length. This particular case can thus be regarded as a failure of the support system rather than a failure of the RDP method. It does, however, highlight a shortcoming in the method which does not in any way take the bolt length into account when evaluating the support capacity.

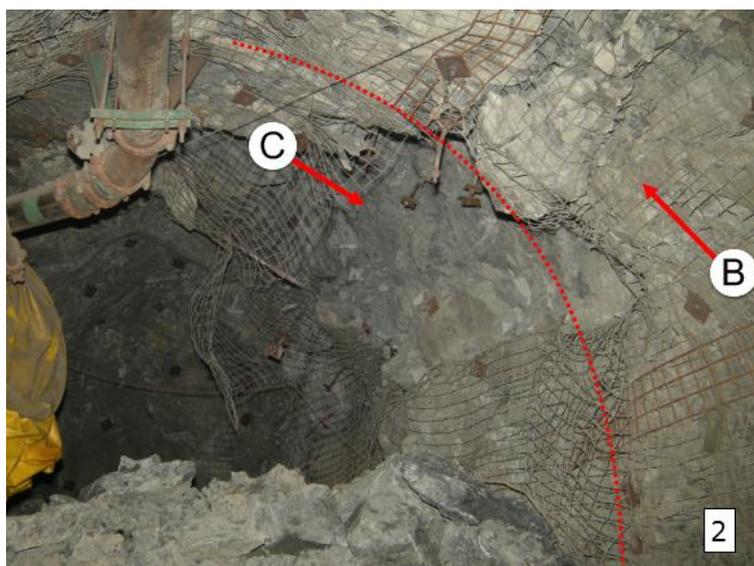
Figure 10 Kidd 2009 rockburst 01S shoulder ejection

Significant damage was also observed at the intersection with S46 shown in Figure 10. The dynamic support system which included additional straps and modified cone bolts was installed up to Location B illustrated using red dotted line. The support system at C failed completely and at B only suffered minor bulking. Over 10 t of material was displaced at C and the support system suffered complete failure. Location C was assigned with a RDS rating of R4 due to the severe damage to the support system. Less than 1 t of material was displaced at B and all was well contained resulting in a RDS rating of R2.

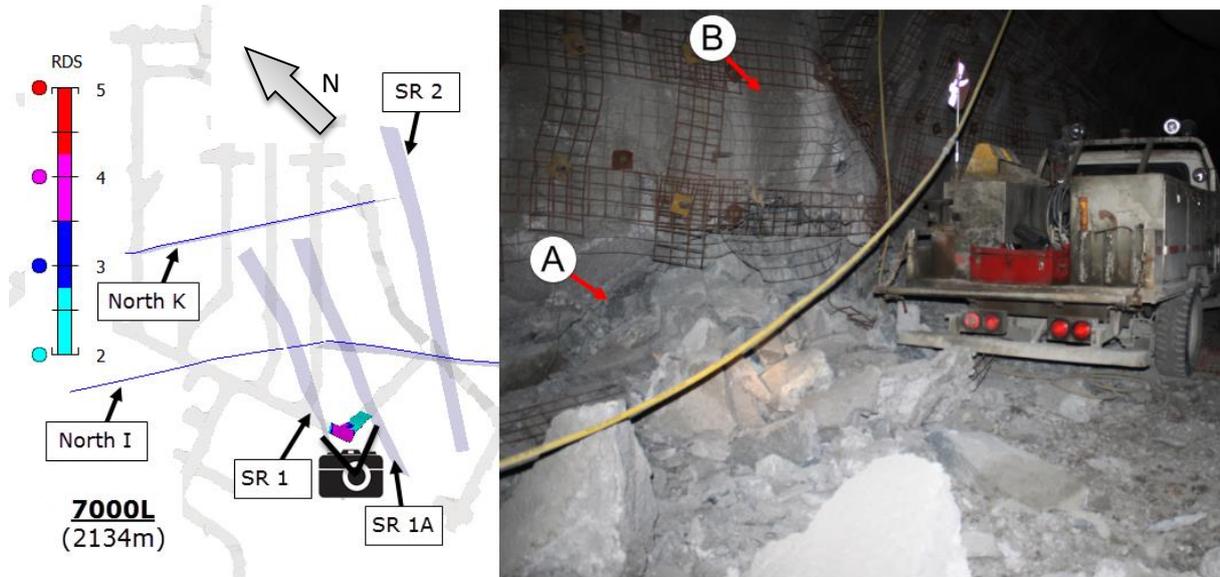
Figure 11 Kidd 2011 rockburst 7000L 01S and S46 intersection

The damages observed on 7000L following the 2011 rockburst were mostly restricted to the south end of the level similar to the 2009 rockburst. The north wall of the intersection (Location B) between S46XC and 01S drive was damaged as shown in Figure 11. The displaced material measured by drilling to repair the damage was approximately 2 m deep, over an extensive area (~60 m<sup>2</sup>). As a result it is estimated that approximately 600 tons were displaced and therefore an RDS rating of R5 was assigned.

Over 10 t of rock was ejected into the excavation from lower wall (Location A) accompanied by some floor heave. The largest rock debris ejected measures 0.5 × 0.5 × 0.5 m. The support system at Location A suffered extensive damage and a RDS rating of R4 was assigned.

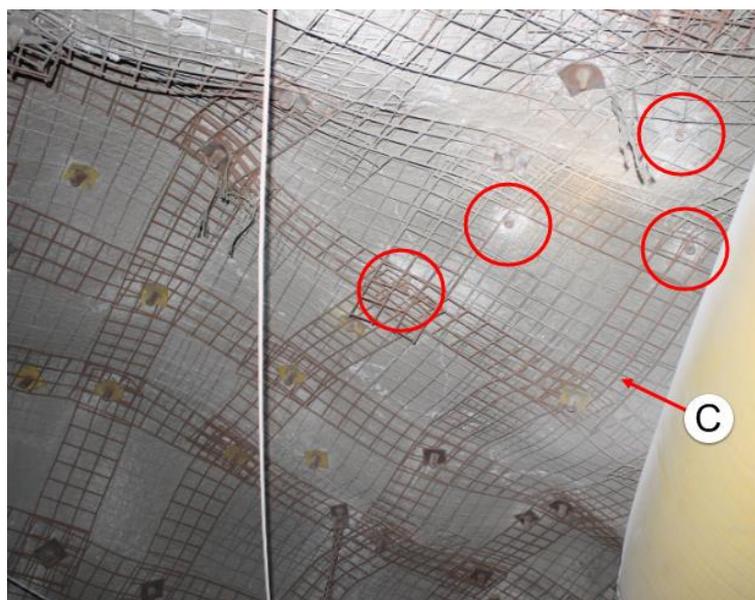
Figure 12 Kidd 2011 rockburst 7000L 01S and S46 intersection roof bulking

Large bulking up to 30 cm over an area of 3 × 3 m was observed in the back of the intersection at location C. Multiple bolt plates were stripped off the Super Swellex bolts (highlighted in red circles in Figure 12). Up to 5 t of material was displaced and contained in the roof and a RDS rating of R3 was assigned.

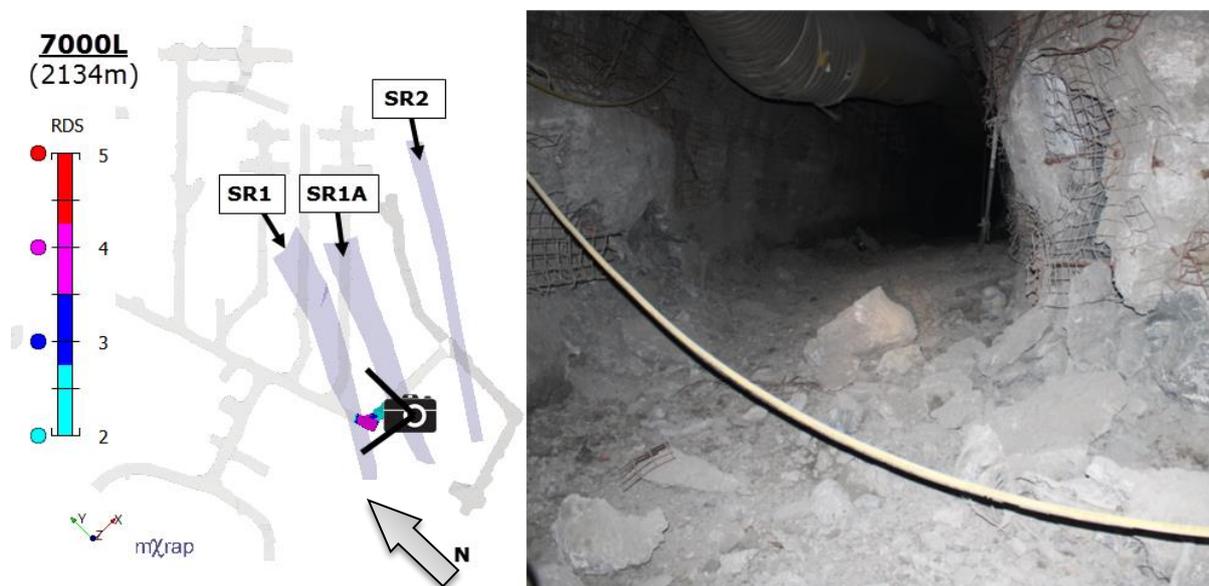
Figure 13 2011 Kidd Mine rockburst 7000L broken straps and ejected debris

This damage location was supported with patterned self-drilling rebar and Swellex bolt, straps and mesh over fibrecrete at all three cases. Higher capacity dynamic rock bolts such as the cone bolt was not used due to the poor ground condition. The damage at this location was generally well contained in the wall and roof by the support system. Pieces of a strap originated from lower wall can be seen lying on the floor together with rock debris up to half a tonne in weight shown in Figure 13.

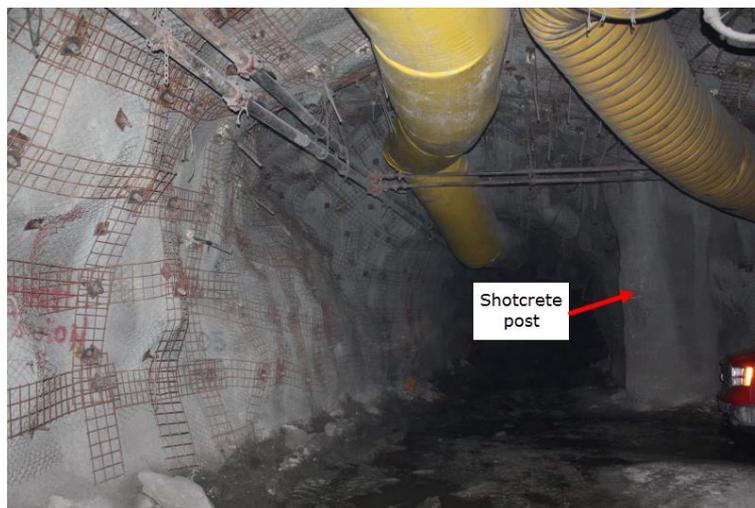
Figure 14 2011 Kidd Mine rockburst 7100L 84XC intersection prior to damage. Photo is looking northwest and 84XC is situated behind the red truck

A shotcrete post was also constructed to support a wedge formed along the SR 1 on the northeast corner of the intersection as shown in Figure 14. For comparison purpose, a photo of 84XC prior to the rockburst is shown in Figure 15.

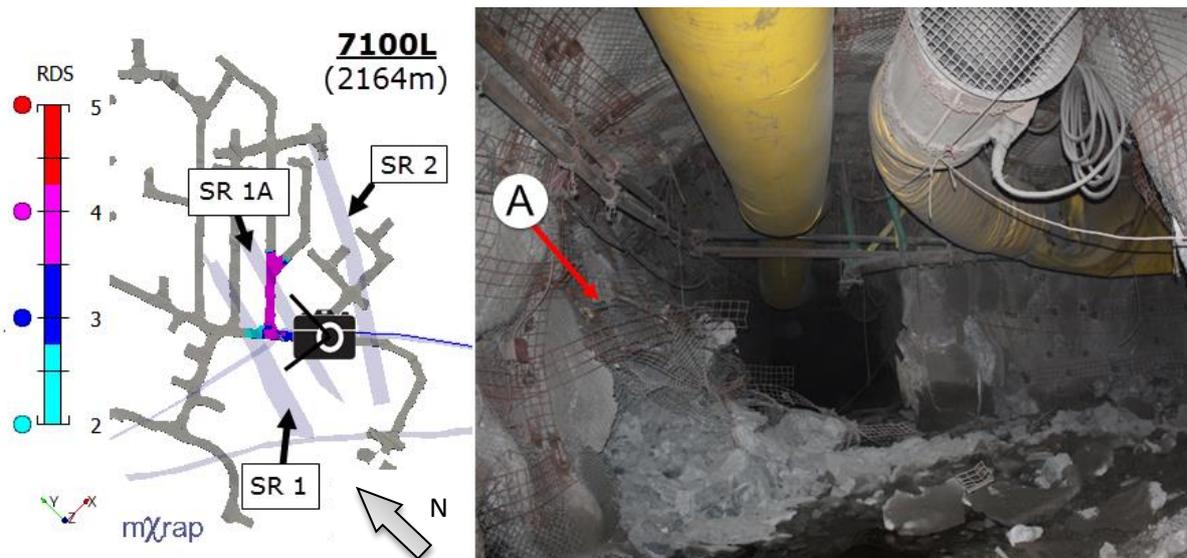
Figure 16 2011 Kidd Mine rockburst 7100L 84XC intersection damage. Looking northwest

Following the rockburst, the roof of the intersection was seen displaced north-easterly relatively close to the base of the post, which resulted in large shearing movement in the shotcrete post (Figure 16). The west wall of the intersection or Location A suffered severe ejection in the lower half of the wall with failure depth up to 2 m. Swellex bolts were broken and ejected into the excavation together with straps. There was no support in the floor, resulting in the highest loads being transferred to the bolts closest to the floor low on the walls where the highest degree of failure occurred. The furthest ejection was approximately 6 m

away from its point of origin. Approximately 50 t of material was displaced at this location and a RDS rating of R4 was assigned to A.

The method performed adequately only for Location C, but poorly for A and B. The extreme deformation observed at these locations suggests that the dynamic loading at this location is extreme.

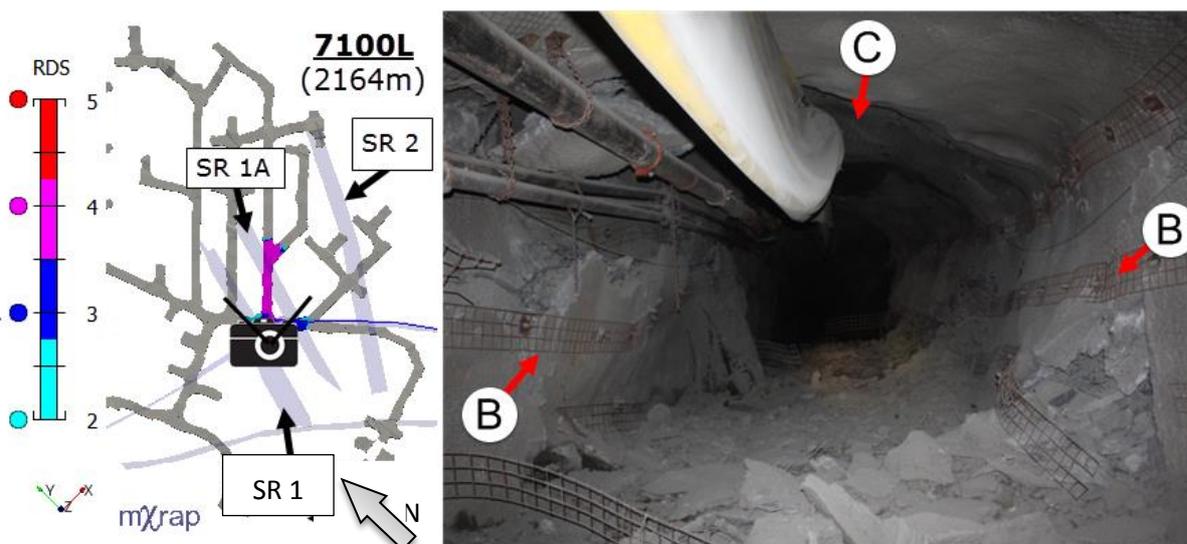
Figure 17 2011 Kidd Mine rockburst 7100L 84XC damage. Looking northeast

Along 84XC, there was more severe damage. The damage was caused by the footwall moving east-northeast, resulting in strike slip along the SR 1A trace. Since the southwestern mine footwall portion of the XC translates northeast along the strike of the rupture surface relative to the remainder of the XC further to the northeast, as well as the crosscut being foreshortened, the back of the XC appears to translate south. Plunge movement, down the plane of the seismic rupture surface, which dips 65 degrees to the west northwest, also tends to “drive” slabs within the translating block down and outwards along the walls. The reinforced dynamic support system in the wall suffered severe damage, however, remained mostly in place with no catastrophic failure.

Approximately 50 t of material was displaced on each side of the wall (Location B) for approximately 30 m, most of which was contained. This is shown in Figure 17. A RDS rating of R4 was assigned to B. The roof (Location C) only suffered minor bulking with cracks occasionally seen resulting in a RDS rating of R2.
