# Cowal gold mine — documentation of slope deformations due to mining to final pit walls — a case history

RL Crouse *Evolution Mining, Australia*

DR Wines *Itasca Australia Pty Ltd, Australia*

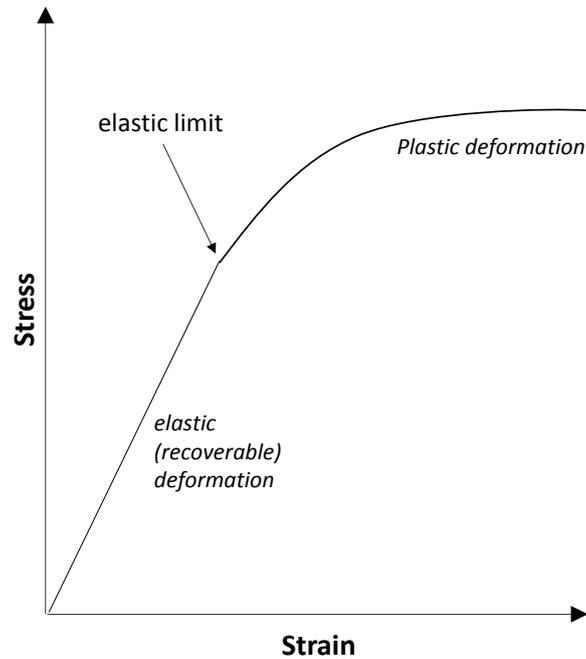
When deformation occurs in a soil or rock mass, the deformations can be classified as elastic or plastic. In theory, elastic movements occur if the strains are fully-recoverable when the loads causing the deformation are removed. Plasticity occurs when there are non-reversible changes in response to applied loads. In this case, some damage has occurred, which in a rock mass may be in the form of new fractures, movement along existing discontinuities etc. A conceptual stress–strain plot showing elastic and plastic deformations is provided in Figure 1.

Figure 1 Stress–strain plot showing elastic and plastic deformations

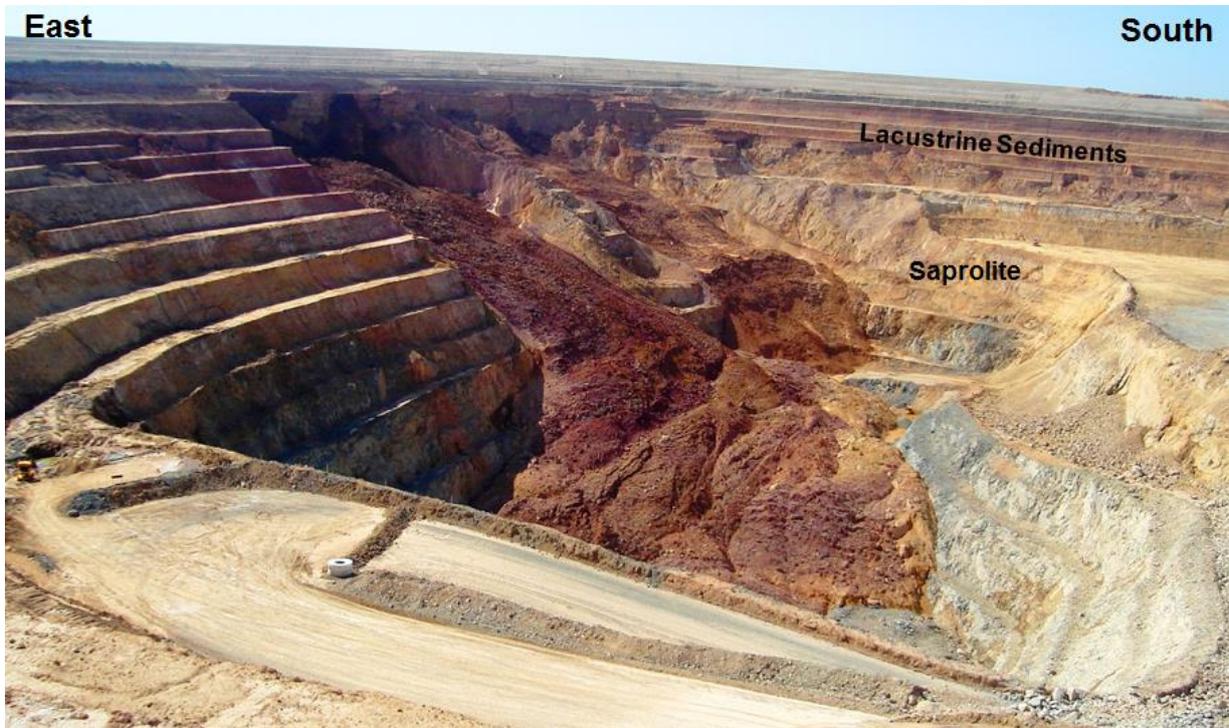
In 2007, two failures occurred in the surficial materials in the east side of the pit. The second failure, which was the larger of the two, started at the toe and unravelled upward towards the pit crest (Figure 2).

Figure 2 East wall failures — December 2007

The 2007 failures served as the ‘wake-up call’ for the mine. The east wall of the pit had been mined at 31 degrees instead of the design angle of 25 degrees, the lacustrine clays and saprolites were fully-saturated and the regional stress direction was essentially east–west. All three of these factors contributed to the failures. In the next two years, the mine initiated an extensive horizontal drain drilling program and installed several automated prism monitoring stations. For the first time, prisms were set out on a relatively tight spacing around the entire pit area. With adequate monitoring in place, the next question was how much slope movement was considered to be normal, i.e. elastic and plastic deformations due to mining, and how much slope movement would indicate possible early signs of eventual failure. These are the questions that will be addressed in this paper.

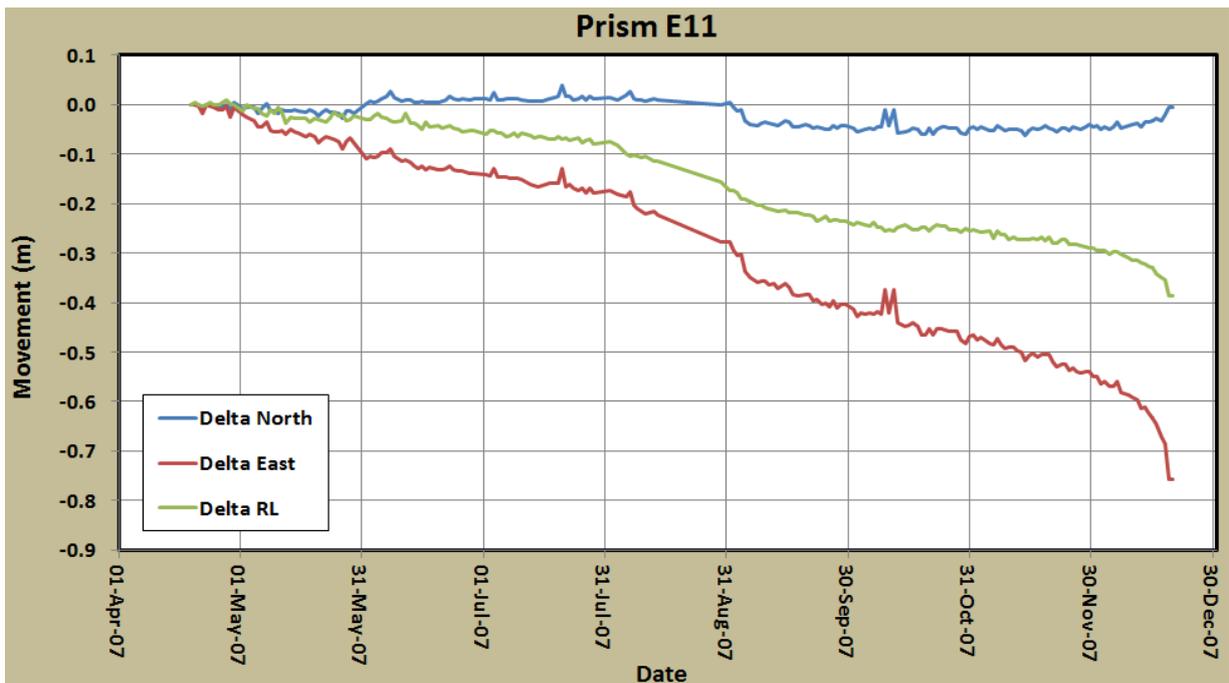
Unfortunately, prism monitoring and movement analysis prior to the failures were not adequate to properly document the slope movement before the instability occurred. The prism coverage was very sparse, so the initial wall movement in the affected area was not recorded. The graphs in Figure 3 show the wall had experienced movement prior to the placement of the prisms.

Figure 3 East wall prism movement graphs

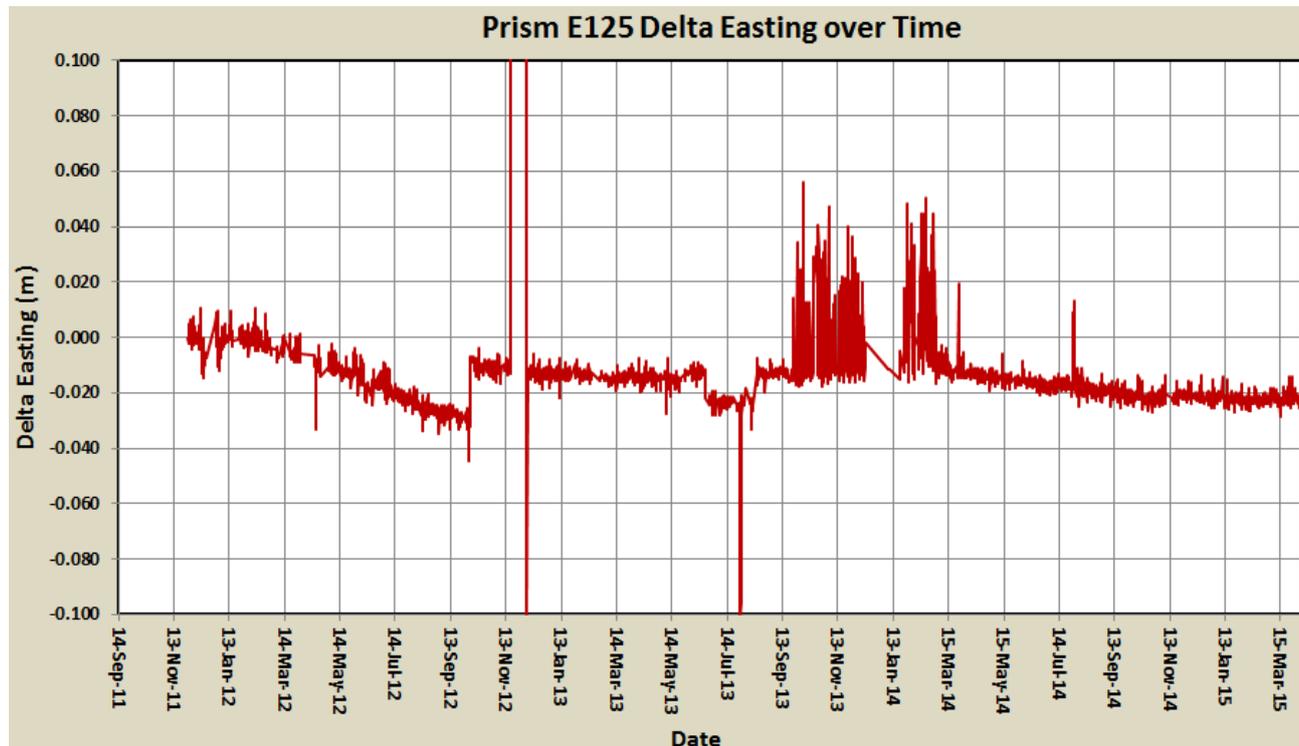
The automated prism survey stations were located on the pit crest, so any calculated prism movement had to take into account movement of the survey station as well as movement of the prisms being surveyed. For this reason, a satellite GPS receiver was installed at each survey station, so the movement of the survey station could be removed from the calculated prism coordinates. The survey instrument uses a laser beam to determine the slope distance from the instrument to the prisms. The changes in the individual x-, y- and z-prism coordinates from the initial surveyed coordinates are the measurements that are utilised in this study. An automated prism monitoring database is seldom ‘clean’, meaning there are random outliers, non-random outliers, and ‘jumps’ in the data, all of which make it difficult to make meaningful movement graphs, especially when the prism movement is of a small magnitude. As a result, the individual prism data had to be converted to Excel data files in order to remove the outliers and ‘jumps’ of the data prior to graphing and analysis. An example of the raw data and corrected data for eastings are presented in Figures 4 and 5 respectively.

Figure 4 Example of raw prism data graph

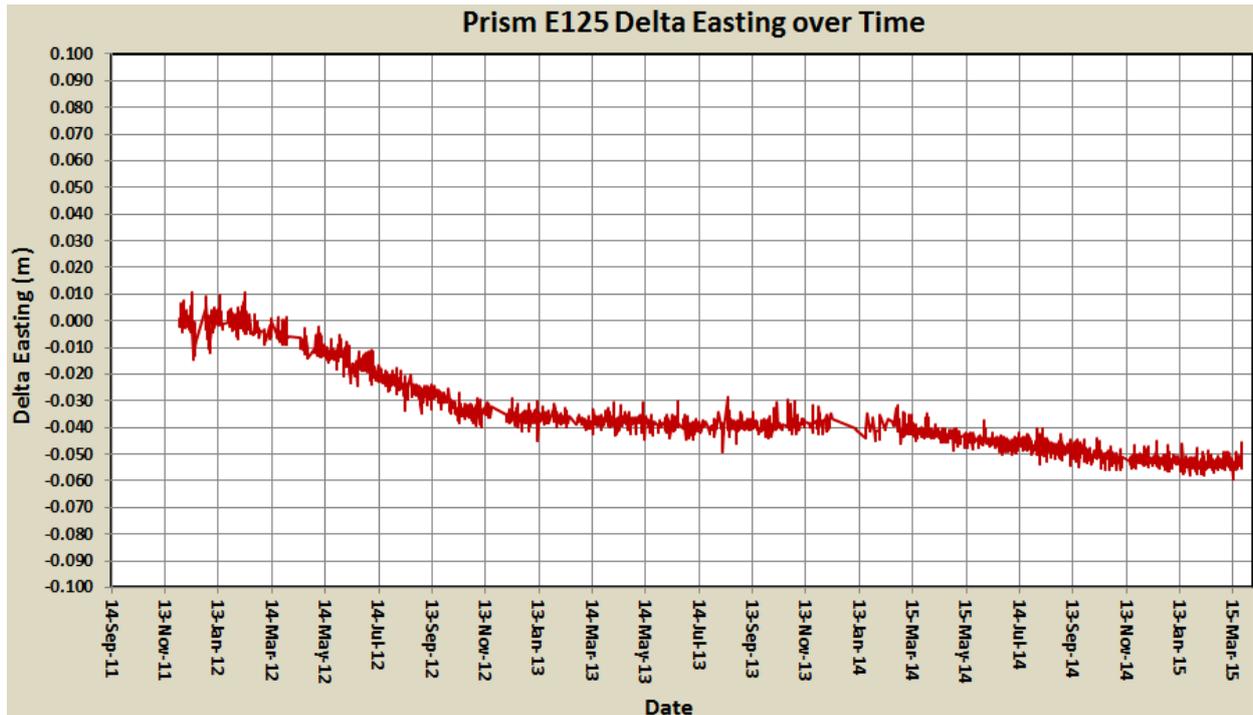
Figure 5 Example of adjusted prism data graph

The non-random outliers on the right side of the above graph were the result of the installation of a prism almost directly in the line of sight of the back sight prism, so the system chose the incorrect backsight on numerous occasions.

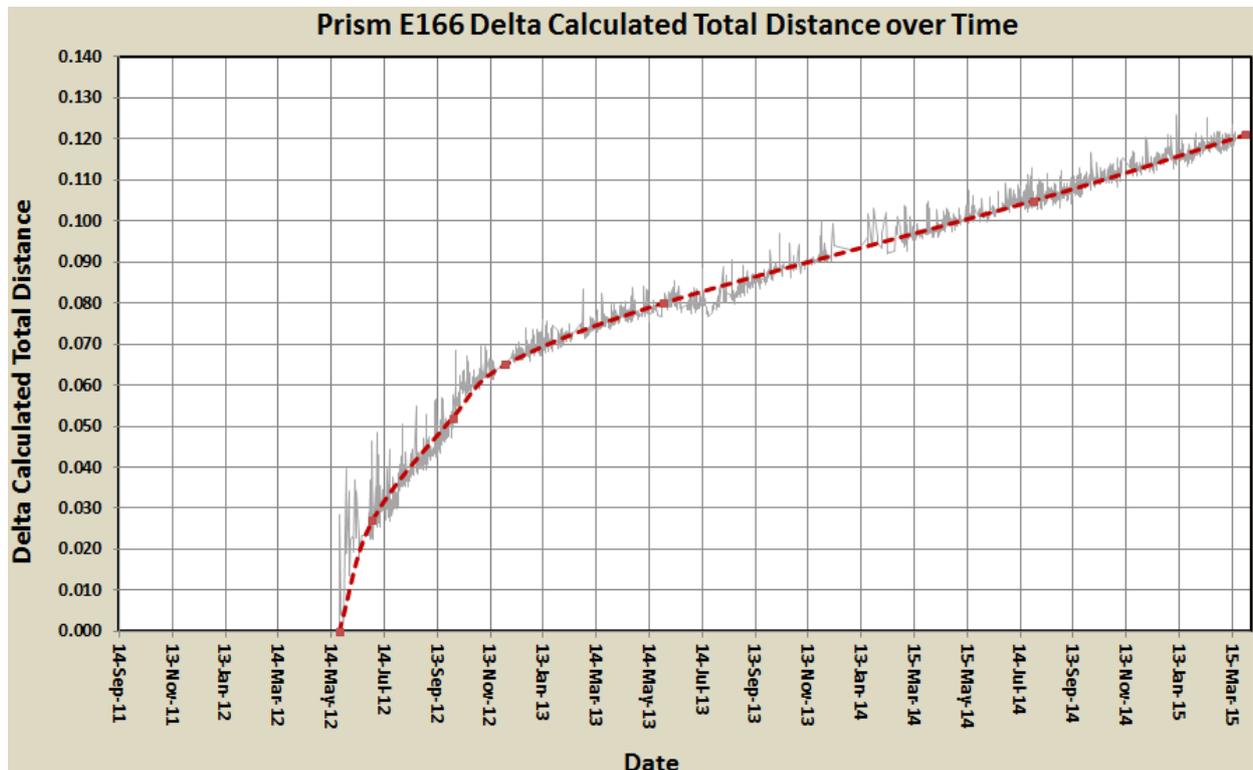
The adjusted prism data for delta easting, delta northing and delta elevation were used to calculate the total movement in three dimensions for each prism. This total movement data was then graphed, after which a visual 'best fit' line was created through the graphed data, as shown in Figure 6.

Figure 6 Example of a visual 'best fit' line

This line, which presented the prism movement without the 'noise' is what was used in the presentations that follow. The process is time consuming and tedious, but it is a necessary process if a potential failure area is to be identified early in the movement cycle.

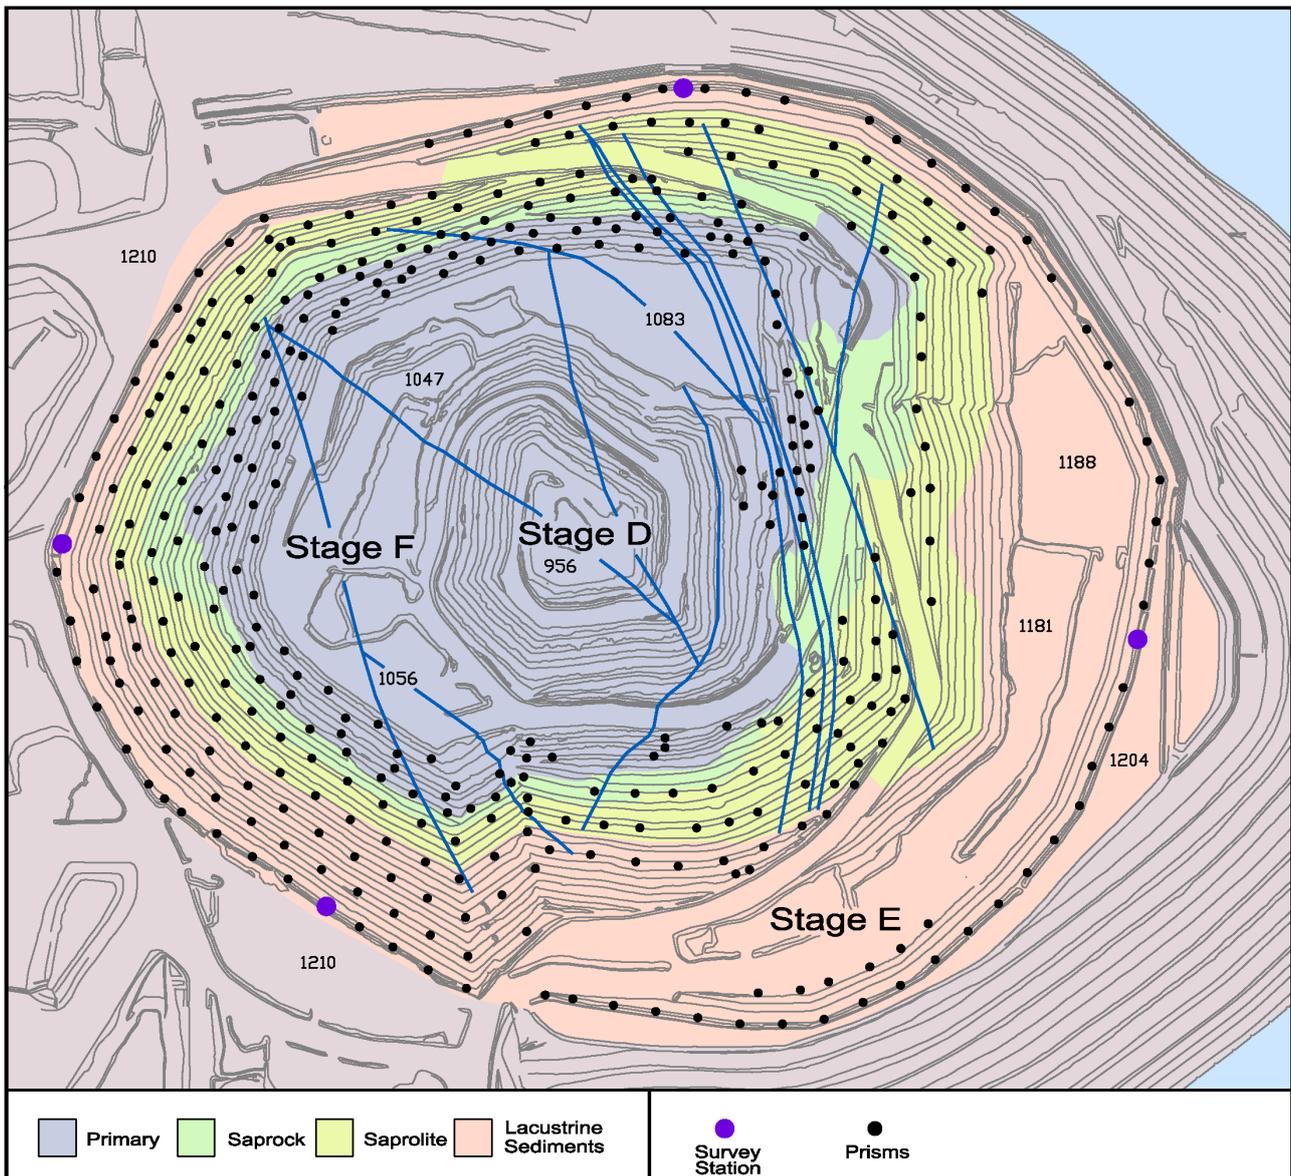
From 2008 through 2011, several phased cuts were successfully excavated without further large-scale instabilities. By December 2011, Stage F had been excavated to the final design limit in the western half of the pit, to the 1047 RL (Figure 7). Note that the original ground surface level varied from 1205 to 1210 RL. The Stage E excavation had just been initiated to the final design limit in the eastern half of the pit.

Figure 7 December 2011 pit with prism coverage

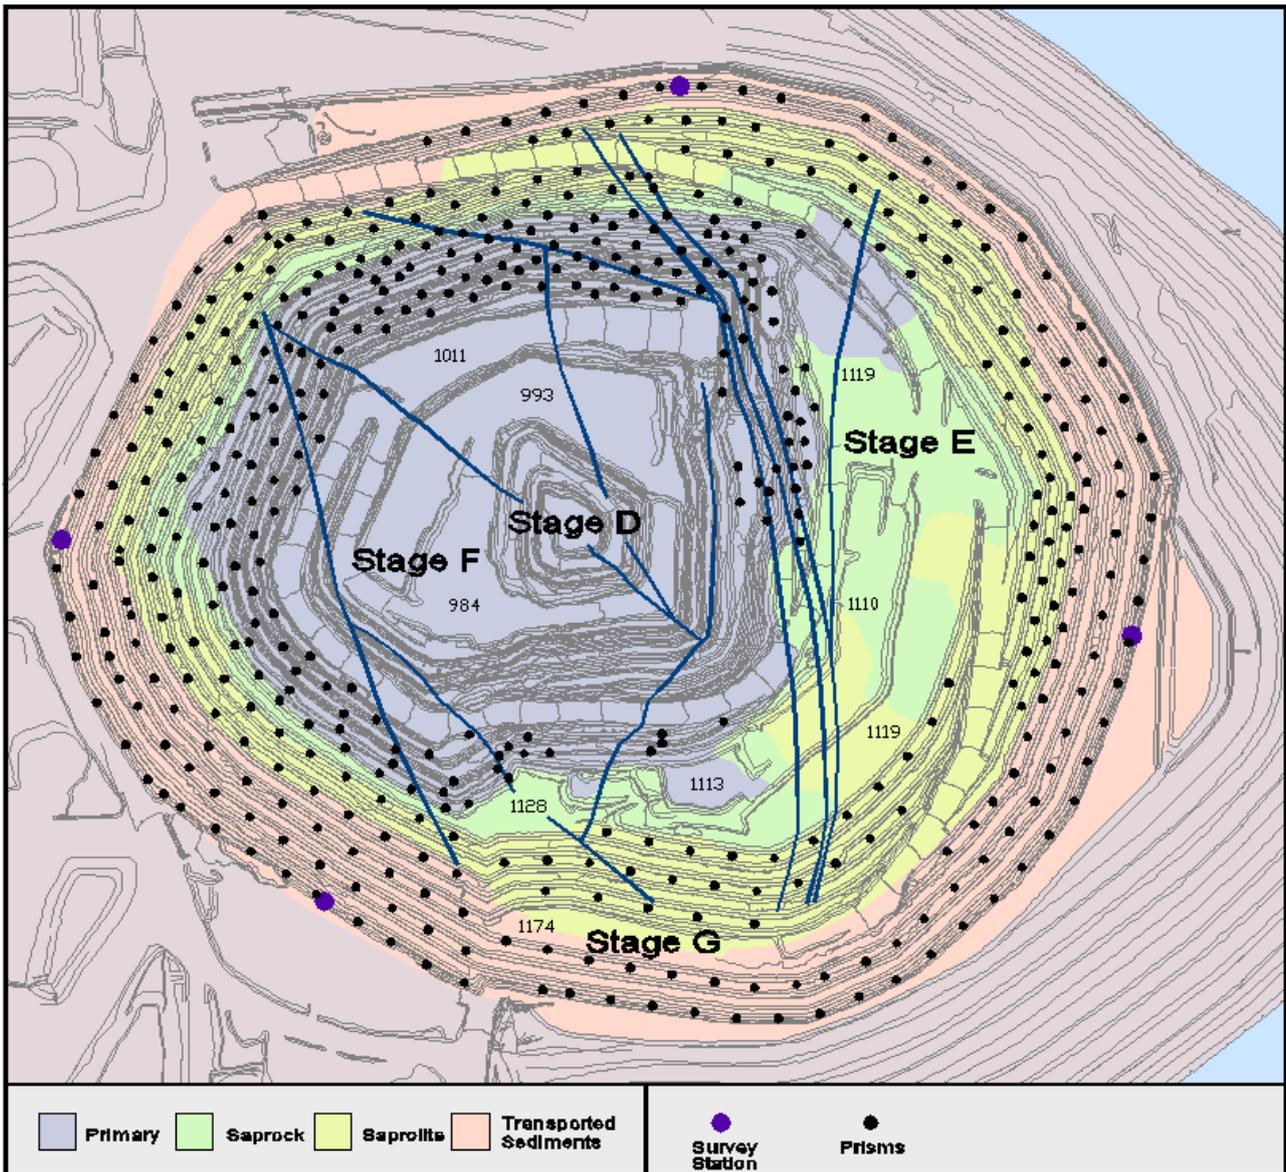
By December 2012, the excavation through the lacustrine sediments and saprolites in the eastern half of the pit was almost complete (Figure 8). Stage F had been excavated to the 984 RL, and the Stage E had been excavated to the 1110 RL. Stage G excavation had begun, with the removal of the upper benches of the temporary Stage E haul ramp on the south pit slope.

Figure 8 December 2012 pit with prism coverage

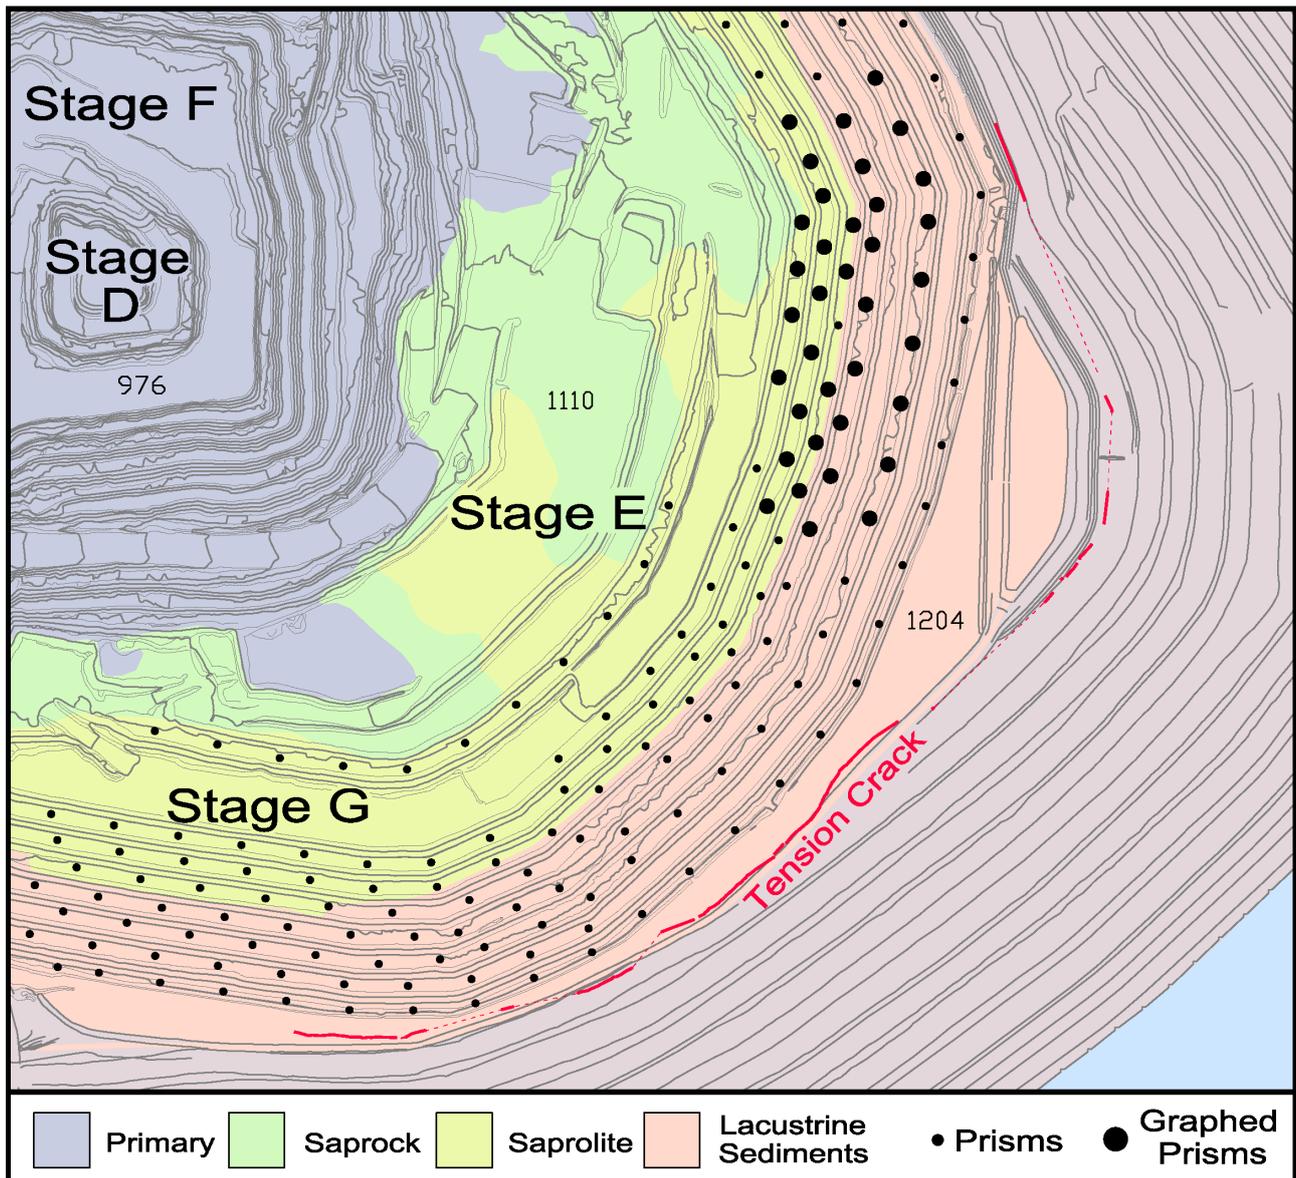
In February 2013, a tension crack was observed sub-parallel to the southeast pit crest (Figure 9). It was 20 mm wide at its widest, but nothing more than a hair line in most areas. Twelve pin sets were placed across it, which were measured weekly to determine if the crack was still active. The pin sets did not show any sign of additional movement after the initial discovery of the crack.

Figure 9 Southeast pit monitoring — February 2013

Movement graphs for prisms represented by the larger black dots in Figure 9 are presented together in Figure 10. The orange lines indicate prisms located above the base of the lacustrine sediments, the red lines indicate prisms located in the base of the sediments and the green lines indicate prisms located in saprolite. The stepped dashed black line represents the elevation of the benches on the east side of the pit as Stage E excavation progressed.

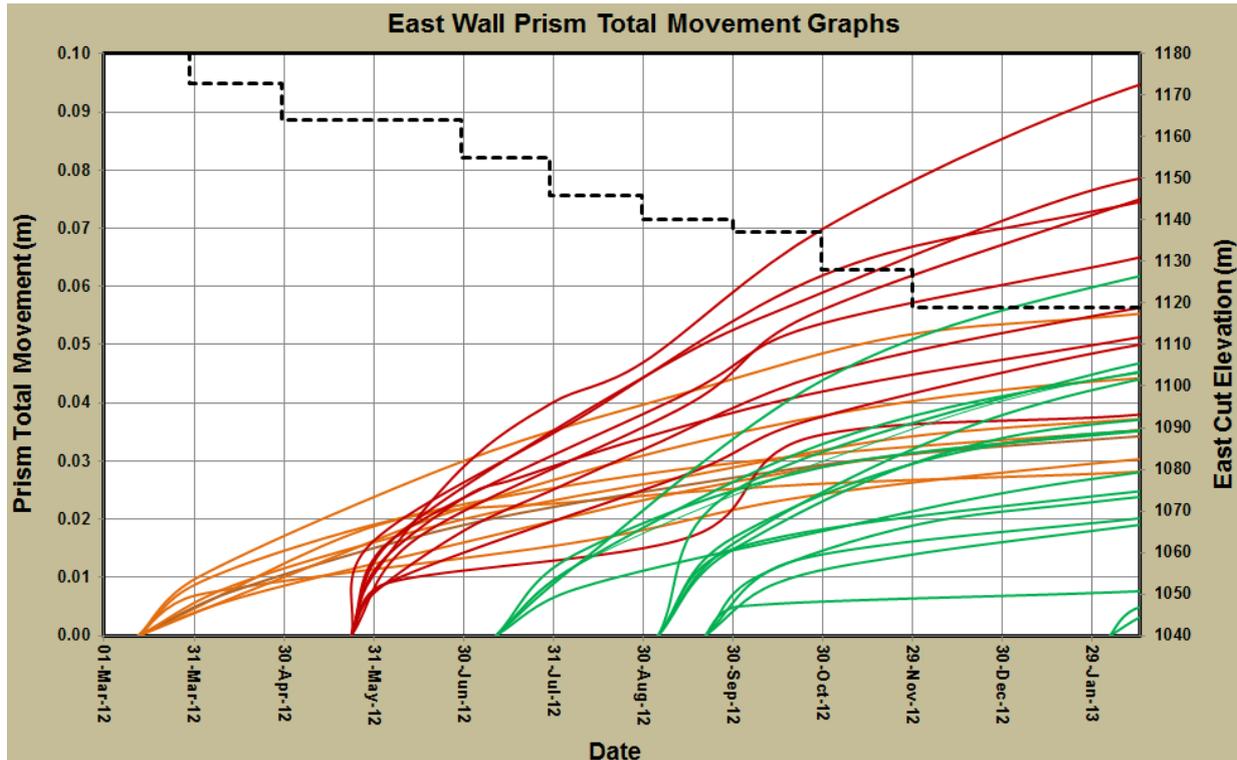
Figure 10 Graph of east wall prism movement as of 15 February 2013

The graphs indicated that the prisms located above the base of the lacustrine sediments had approximately the same rate of creep as the prisms in the saprolite. They also indicated that the creep was gradually slowing down over time. The prisms located in the base of the sediments showed a similar trend, but with more total movement due to the presence of excess water in the sediments there. A maximum movement of 85 mm was recorded. By September 2013 the excavation through the lacustrine sediments and saprolites on the eastern half of the pit was complete, as shown in Figure 11.

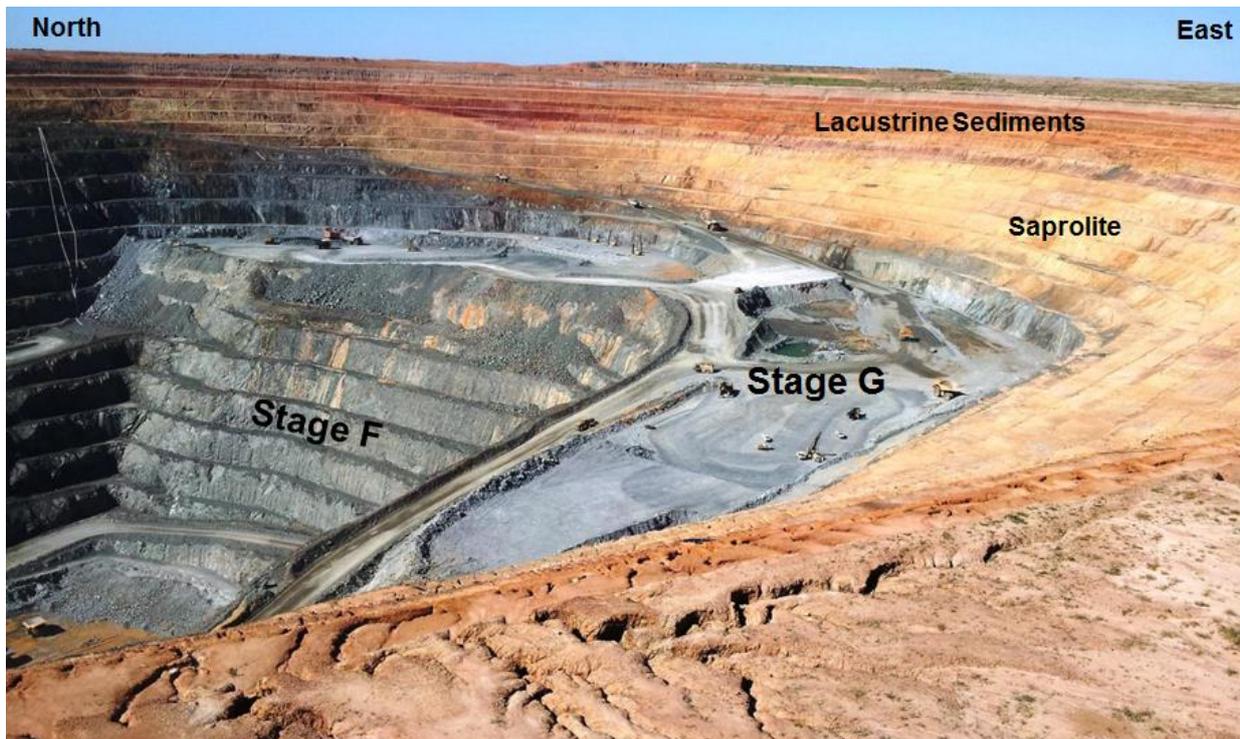
Figure 11 Stage G after successful excavation through the saprolites — September 2013

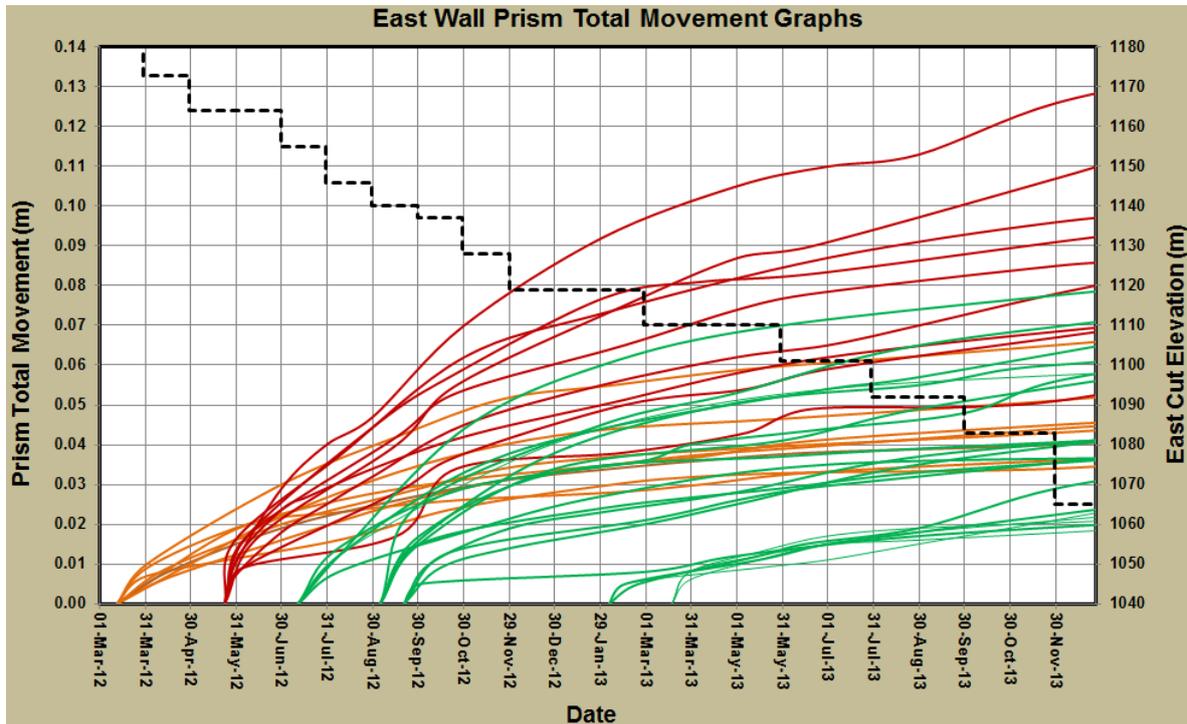
The pit walls in the surficial materials continued to remain stable; however, the prism creep continued. Movement graphs (Figure 12) for the same prisms shown in Figure 10, but a year later, indicated a steady rate of creep for many of the graphed prisms. The maximum movement had increased to 135 mm.

Figure 12 Graph of east wall prism movement as of 15 February 2014

At the time, it was hoped that the observed prism creep was the result of elastic deformation of the pit slopes due to mining and not indicative of the onset of failure. Due to the elevated water content at the base of the lacustrine sediments, the prisms located there were expected to continue to creep until multi-bench failures occurred (Figure 13), as had been observed in several areas in the southeast pit slope. These multi-bench failures were a nuisance, but were unimportant in terms of the stability of the overall pit slope.

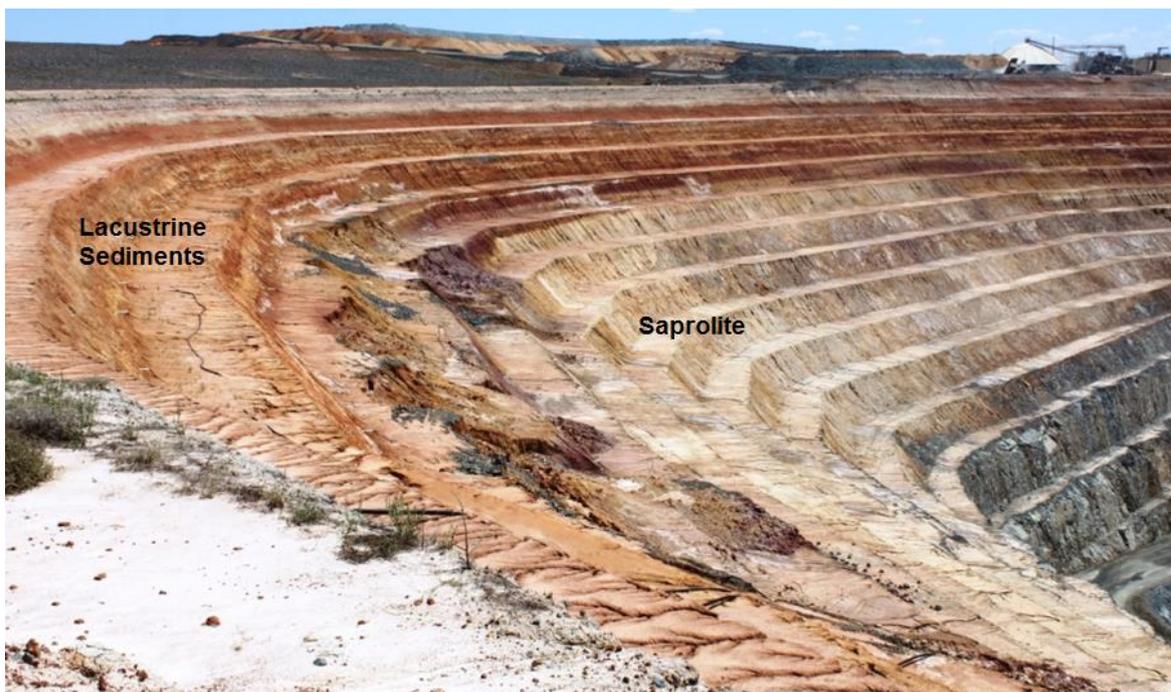
Figure 13 Multi-bench failure at the base of the lacustrine sediments

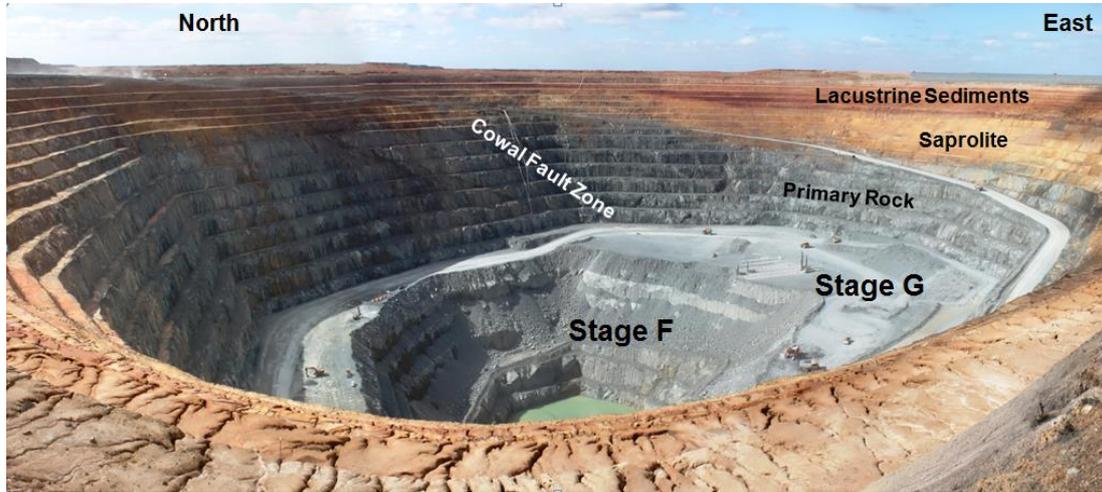
Documentation of the prism movement in the primary rock has also been performed, allowing a comparison of monitored displacements in the primary and surficial materials. By March 2015, the Stage G east wall had been excavated into the Cowal Fault Zone in the primary rock (Figure 14).

Figure 14 Pit as of 15 March 2015

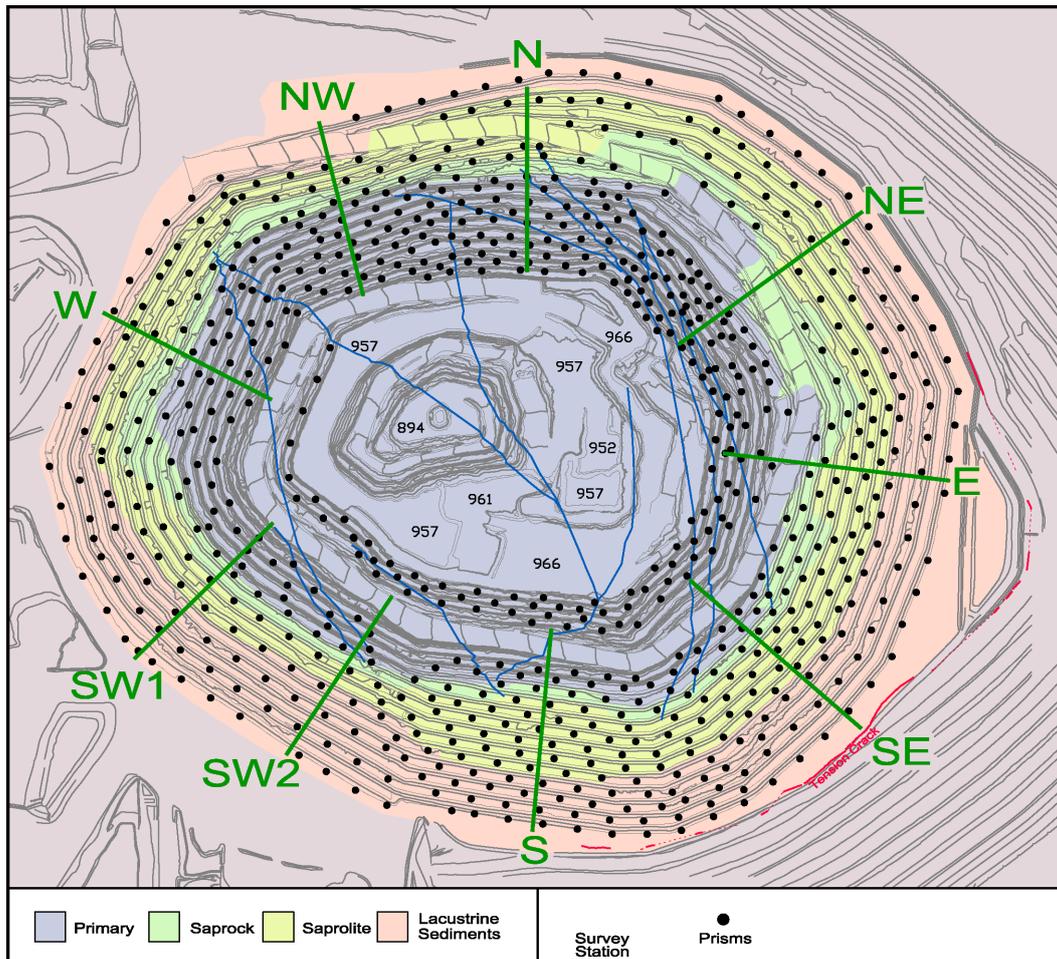
Prism data was processed for a series of cross-sections around the entire pit perimeter, as shown in Figure 15.

Figure 15 September 2015 pit with prism section lines

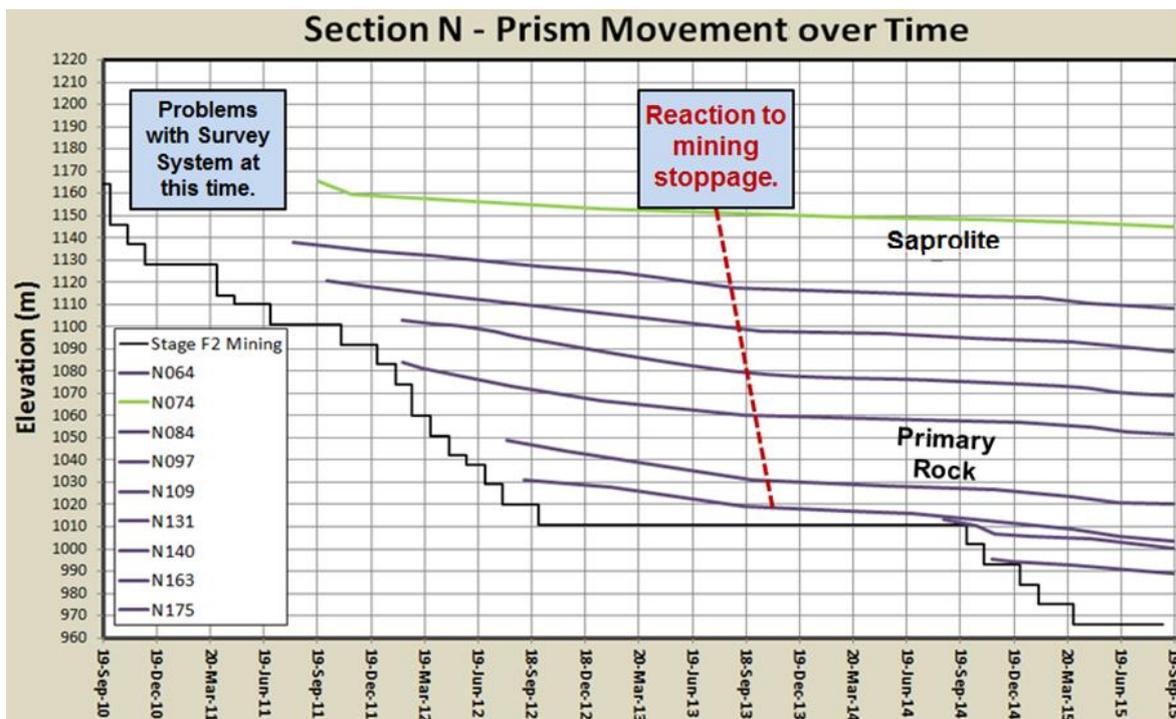
The prisms on Section N have remarkably similar movement lines (Figure 16). They all have the same delayed reaction to the mining stoppage in September 2012, indicated by the dashed red line on the graph. No material was excavated from the final wall for about two years, so the movement graphs are relatively flat. The graphs show a similar delayed reaction to the resumption of mining in September 2014.

Figure 16 Prism movement on pseudo section N

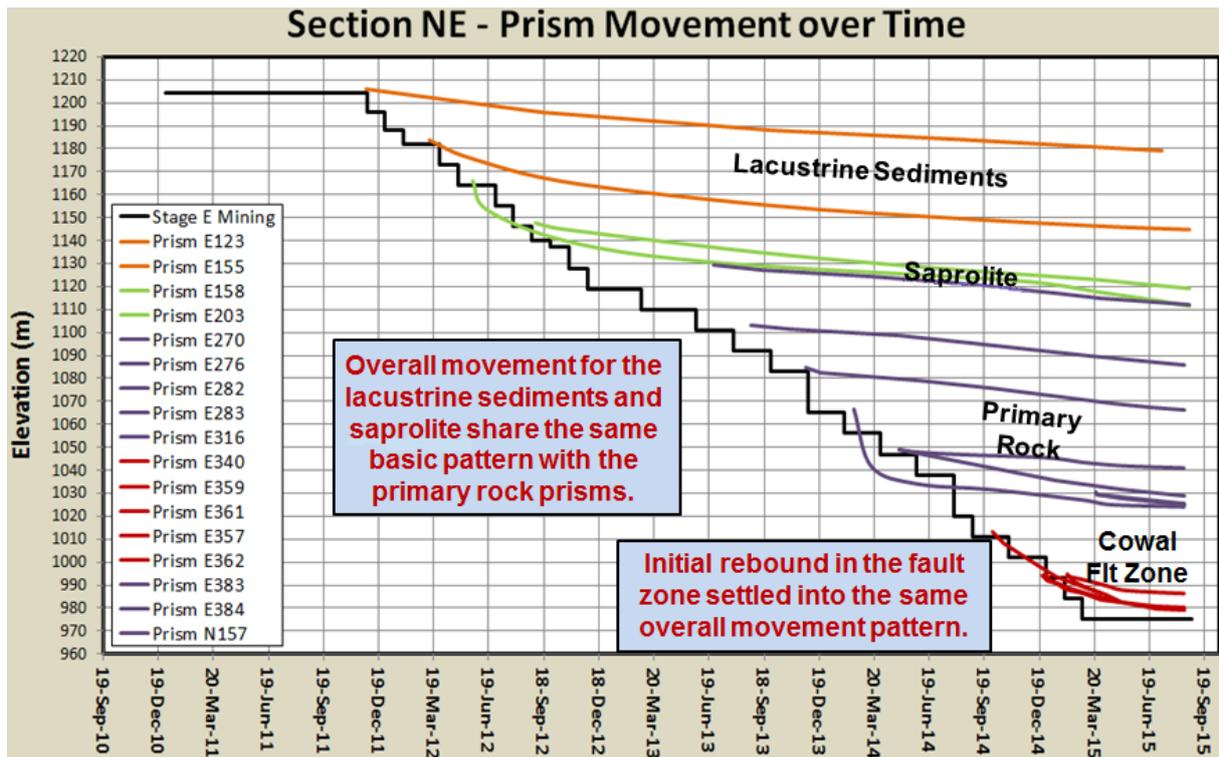
The prisms on Section NE also have remarkably similar movement lines (Figure 17). There is a remarkable similarity of the prism movement in the lacustrine sediments and saprolite with the prism movement in the primary rock below. Note that two prisms had high initial movements, but each settled into the same overall pattern after a few months. The prisms in the Cowal Fault Zone showed a higher initial movement rate than the prisms in the primary rock above, which was a source of concern. However, after about nine months, these prisms also settled into the same overall movement pattern.

Figure 17 Prism movement on pseudo section NE

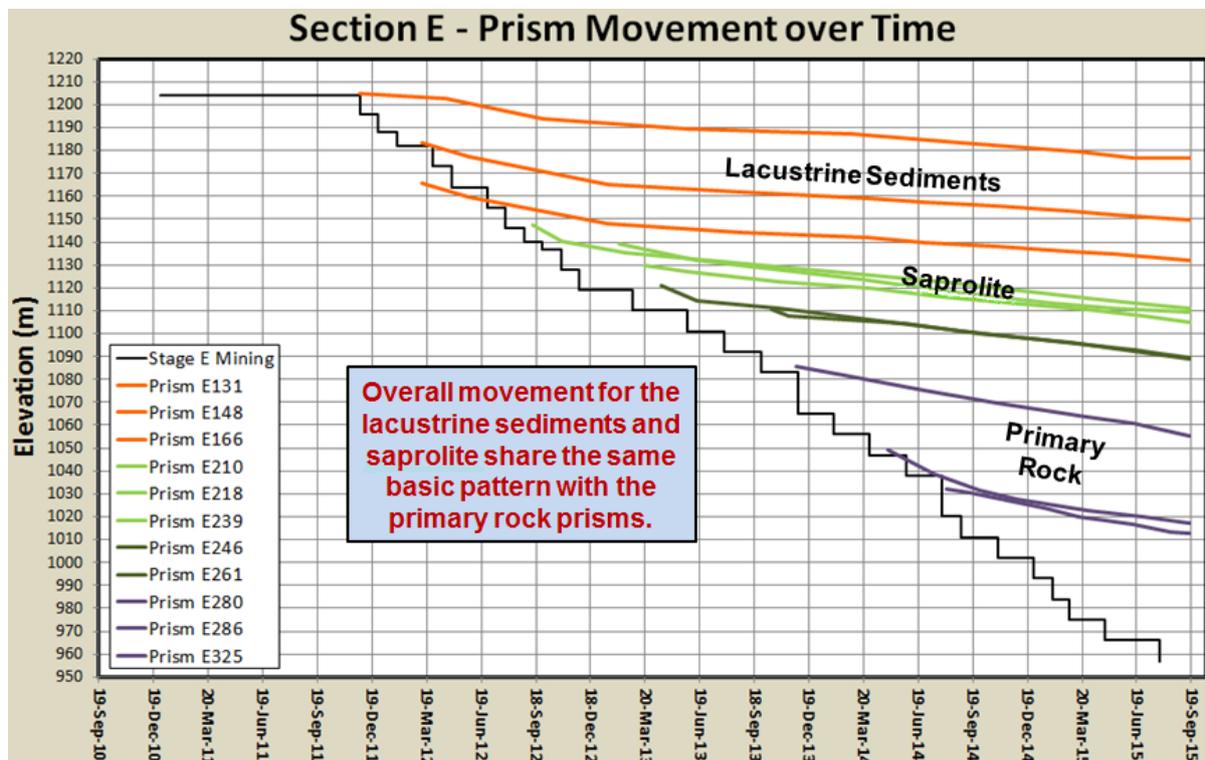
The prisms on Section E (Figure 18) showed a similar trend, gradually becoming sub-parallel regardless of the rock type, although the movement rates for this cross-section are higher than those on the other cross-sections. The sub-parallel movement pattern for the entire cross-section was not expected when the study was begun, due to the large differences in material properties between the lacustrine sediments and saprolite versus the primary rock.

Figure 18 Prism movement on pseudo section E

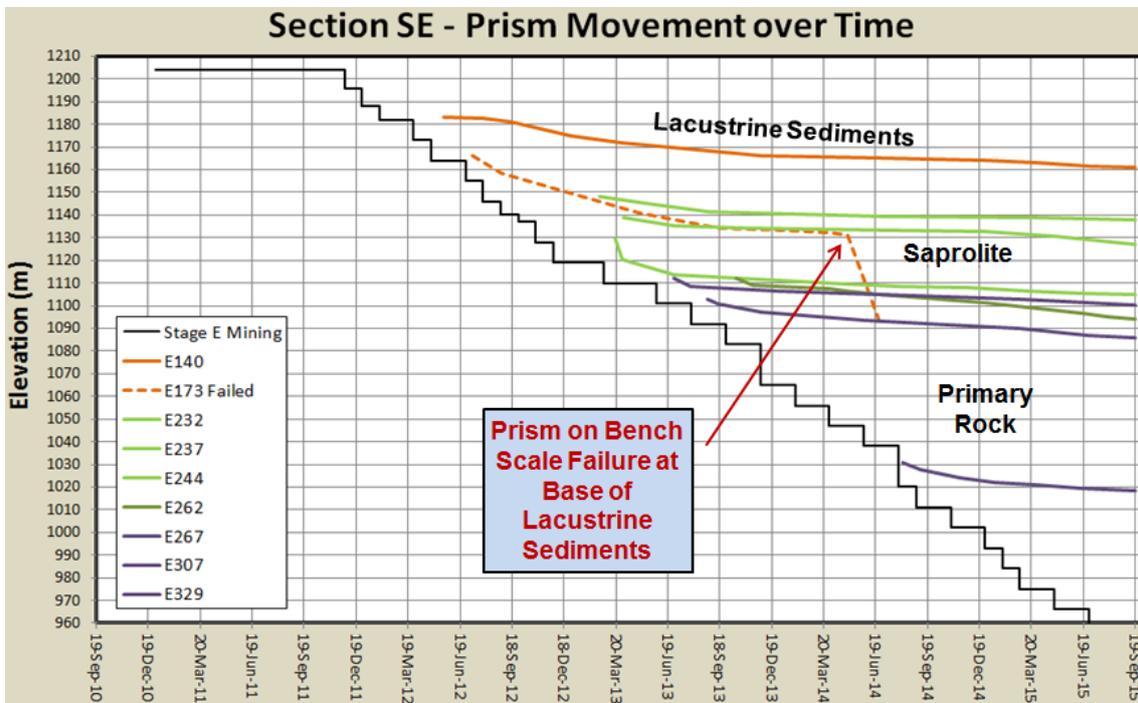
The prisms on Section SE (Figure 19) show the same trend as in the other cross-sections, except that there is one prism, indicated by the dashed line, which was lost in a bench-scale failure at the base of the lacustrine sediments. Note that the prism was moving at the same rate as the nearby prisms at the time it was lost.

Figure 19 Prism movement on pseudo section SE

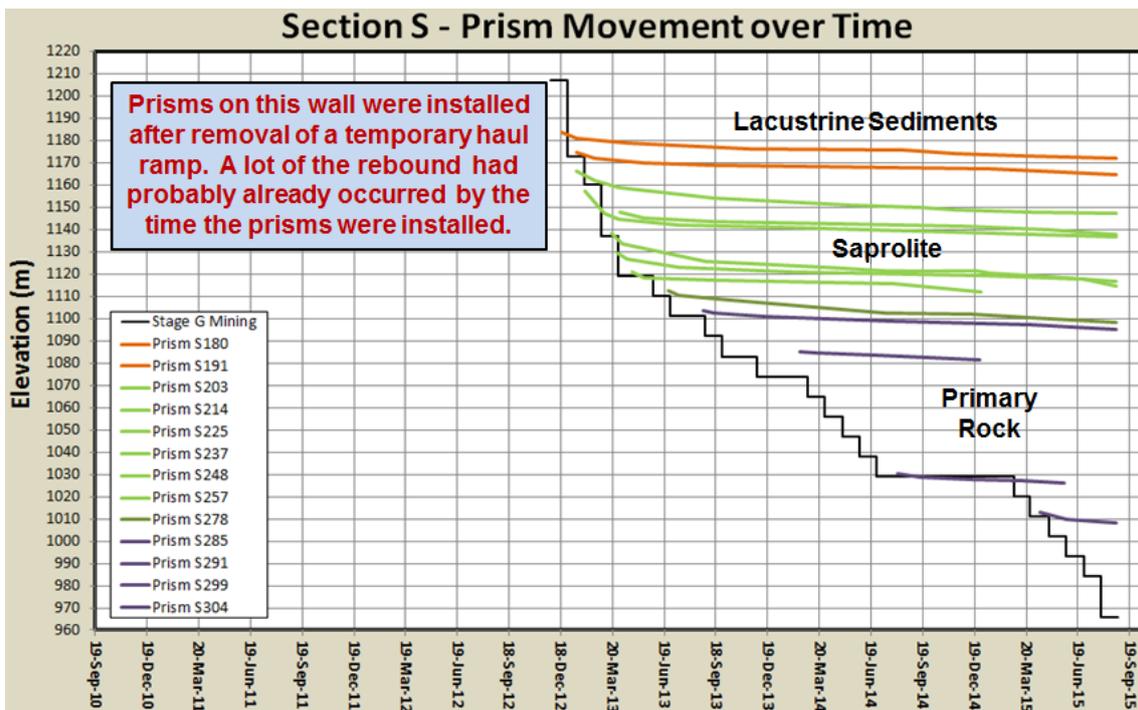
The prisms on Section S (Figure 20) show the least movement of all. The section was located where a temporary ramp was mined out in the last phase of the Stage G cut. A lot of the pitward movement had probably occurred before the temporary ramp was mined out, which would explain the low apparent movement of pit slope in that area.

Figure 20 Prism movement on pseudo section S

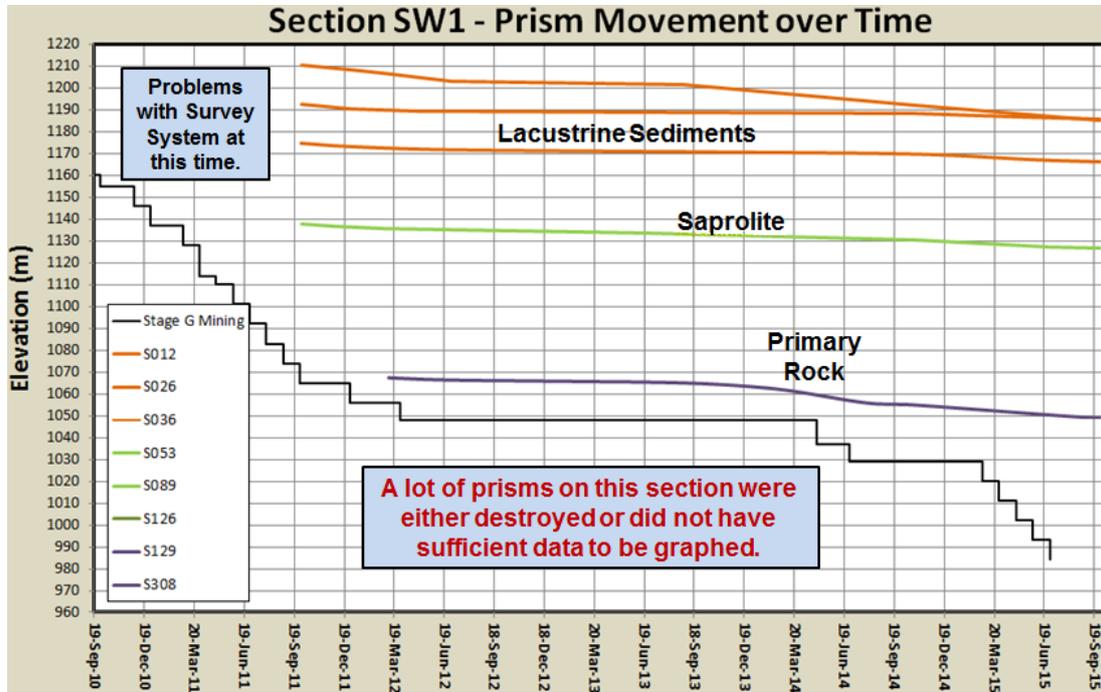
There were problems with the automated monitoring system prior to 1 October 2011, so it was not possible to plot prism movement data before that date. The apparent flatness in the following cross-sections, which were mined to primary rock prior to that date, can be explained by the lack of early monitoring data on these sections. The prisms on Section SW1 (Figure 21) show an absence of apparent movement, due in part to stoppage of mining of the west pit walls from late 2011 to early 2014, and in part to the lack of monitoring data for the initial mining sequence.

Figure 21 Prism movement on pseudo section SW1
