# Cowal gold mine — documentation of slope deformations due to mining to final pit walls — a case history

RL Crouse *Evolution Mining, Australia*

DR Wines *Itasca Australia Pty Ltd, Australia*

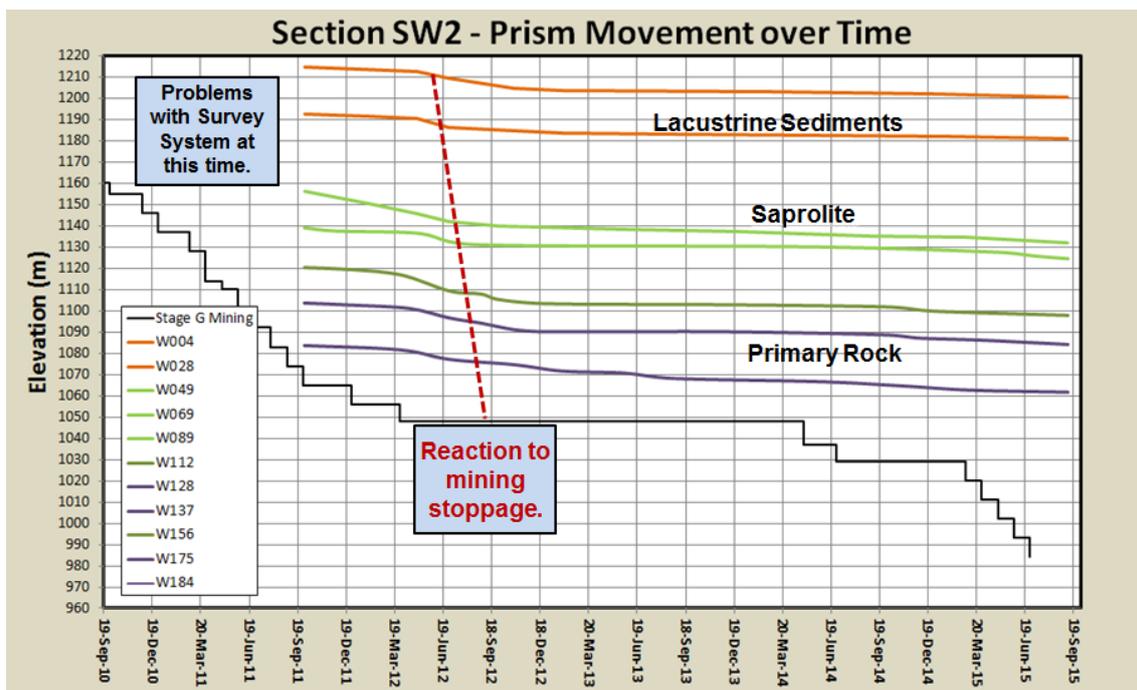
The prisms on Section SW2 (Figure 22) show a delayed response due to mining stoppage, as was observed on Section N.

Figure 22 Prism movement on pseudo section SW2

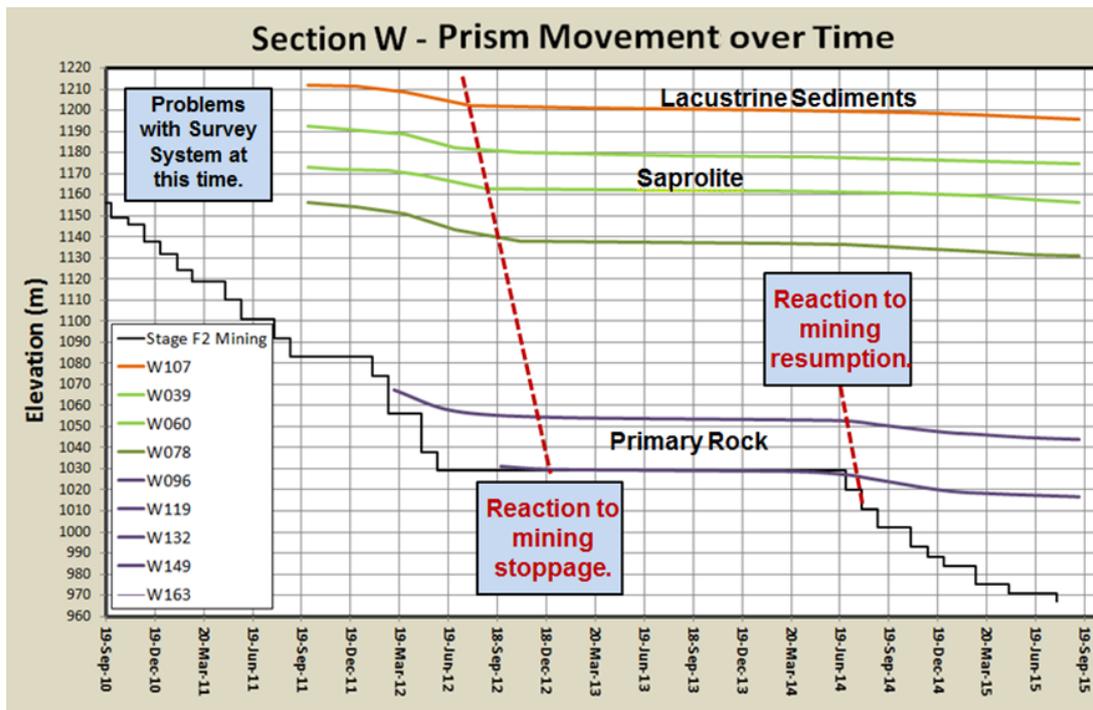
The prisms on Section W (Figure 23) show a similar delayed response due to mining stoppage, as well as a delayed response to resumption of mining in June 2014.

Figure 23 Prism movement on pseudo section W

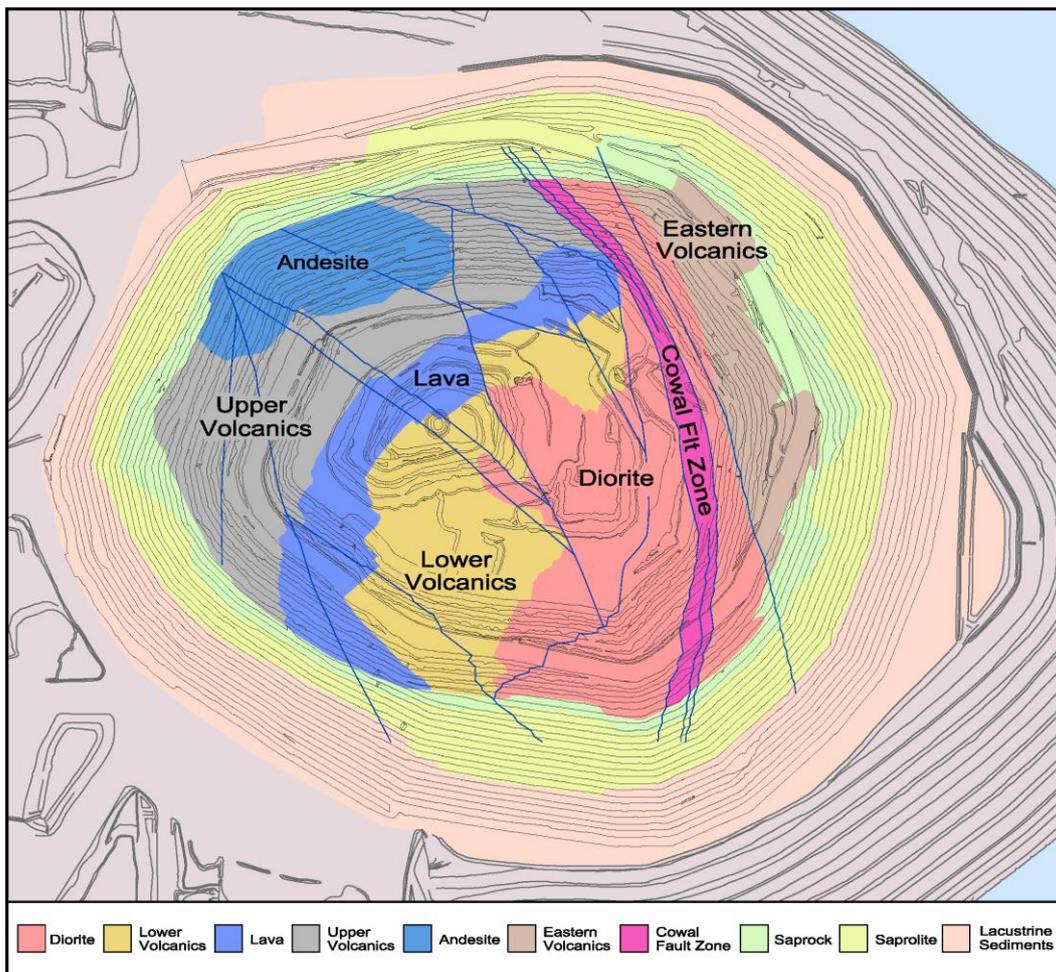
In May 2015, a numerical analysis was performed using 3DEC (Itasca 2013) to assess the current and future stability of the Cowal slopes. A plan view showing the primary rock domains and faults in the model as of May 2015 is shown in Figure 25.

Figure 25 Primary rock numerical model zones

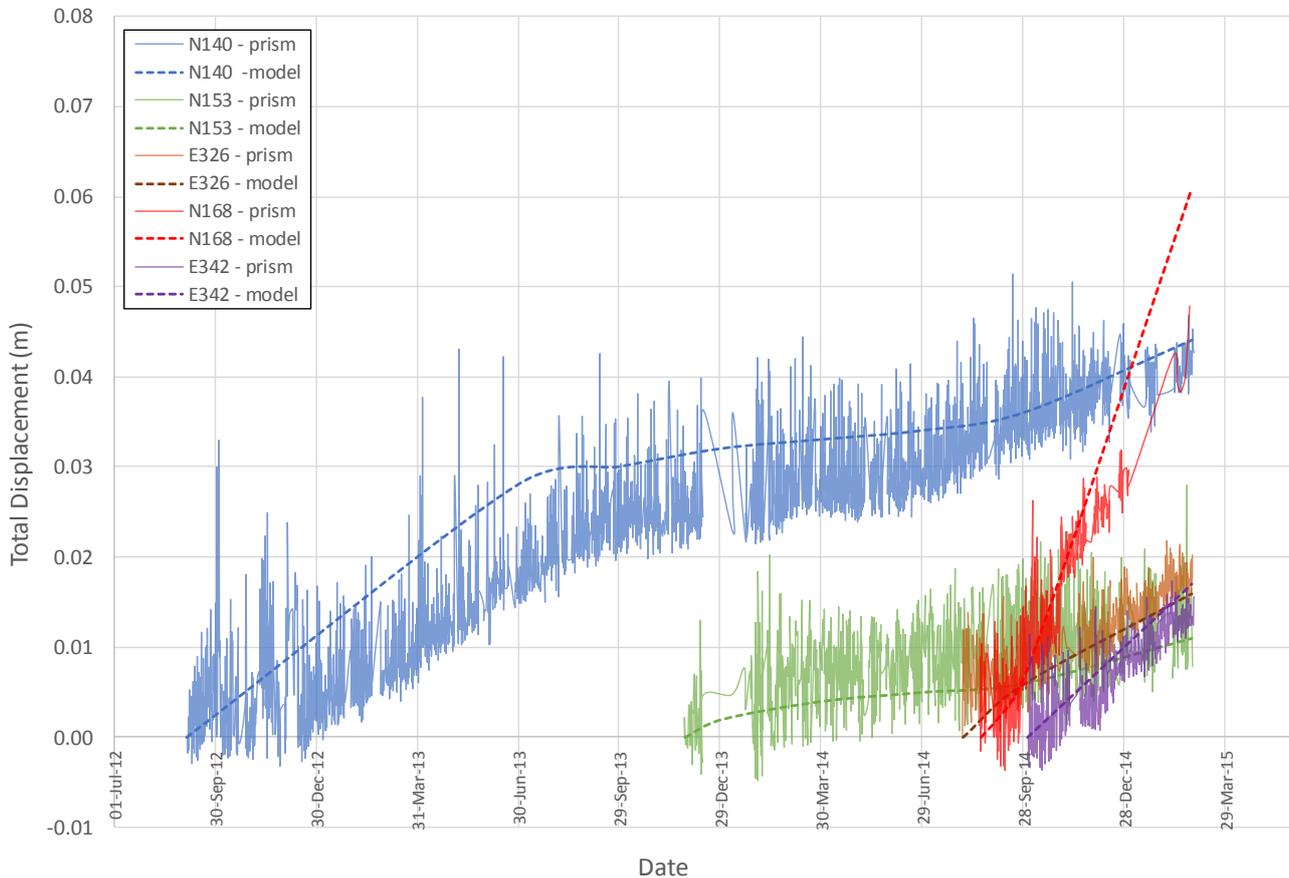
At the current excavation stage, a reasonable correlation was achieved between the modelled and monitored displacement magnitudes and rates. A chart is provided in Figure 26 showing prism and model displacements since installation for five selected prisms around the existing walls. It is seen that the displacement magnitudes and rates produced by the model correlate well with the actual prism displacement rates. It is noted that the rate produced by the model at the location of prism N168 is significantly higher than the other prisms, which is consistent with the actual prism data. This prism is situated within the relatively low strength and low modulus Cowal Fault Zone.

**Figure 26 Model versus actual prism displacements**

The favourable correlation between modelled and monitored displacements provides confidence that the adopted elastic properties (Young's modulus and Poisson's ratio) are reasonable, but does not necessarily indicate that the adopted strength properties (cohesion, friction angle and tensile strength) are reasonable. Separate back-analyses were also performed for one of the 2007 failures, which, along with the results of laboratory testing, were used to estimate and refine the adopted strength properties for the surficial materials. Therefore, calibration to the existing slope performance and back-analysis of the previous failure provided confidence that both the elastic and strength properties adopted for forward analyses were reasonable.
