Mine site rehabilitation — are we reinventing the wrong wheel?

DJ Williams *The University of Queensland, Australia*

Abstract

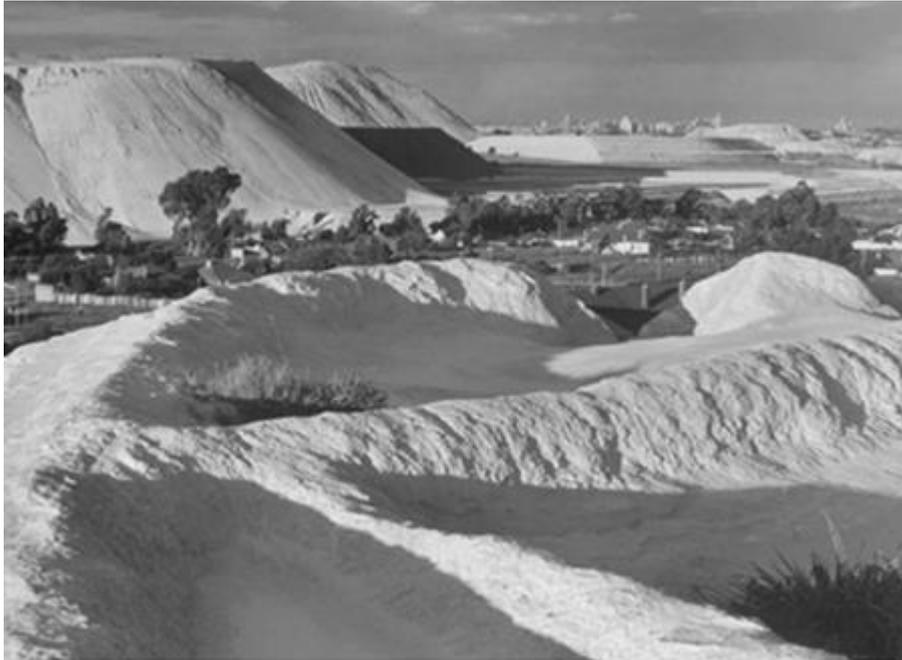
Figure 1 Early view of the gold tailings dumps up to 100 m high bordering Johannesburg

In the early years of gold mining in the Witwatersrand from 1910, the prevailing near legal vacuum presented little obstacle to the disposal of waste rock; cyanide-rich, acid-generating sand and slimes; mine-affected waters; and spent process chemicals (based on the excellent expose by Reichardt and Witkowski (2014)). Reichardt and Witkowski (2014) argued that the advance of applied science and engineering is rarely linear or logical. It is far more often subject to economic, political and personality issues. The history of South Africa's mine site rehabilitation from 1910 to 1991 is a good exemplar of the theme of this paper, in that there has been an ongoing focus on a topsoil and grass cover over gold tailings dumps despite this solution continually failing, as described in the following summary of the findings of Reichardt and Witkowski (2014). An early view of the gold tailings dumps up to 100 m high bordering Johannesburg is shown in Figure 1 (after Mason 2012).

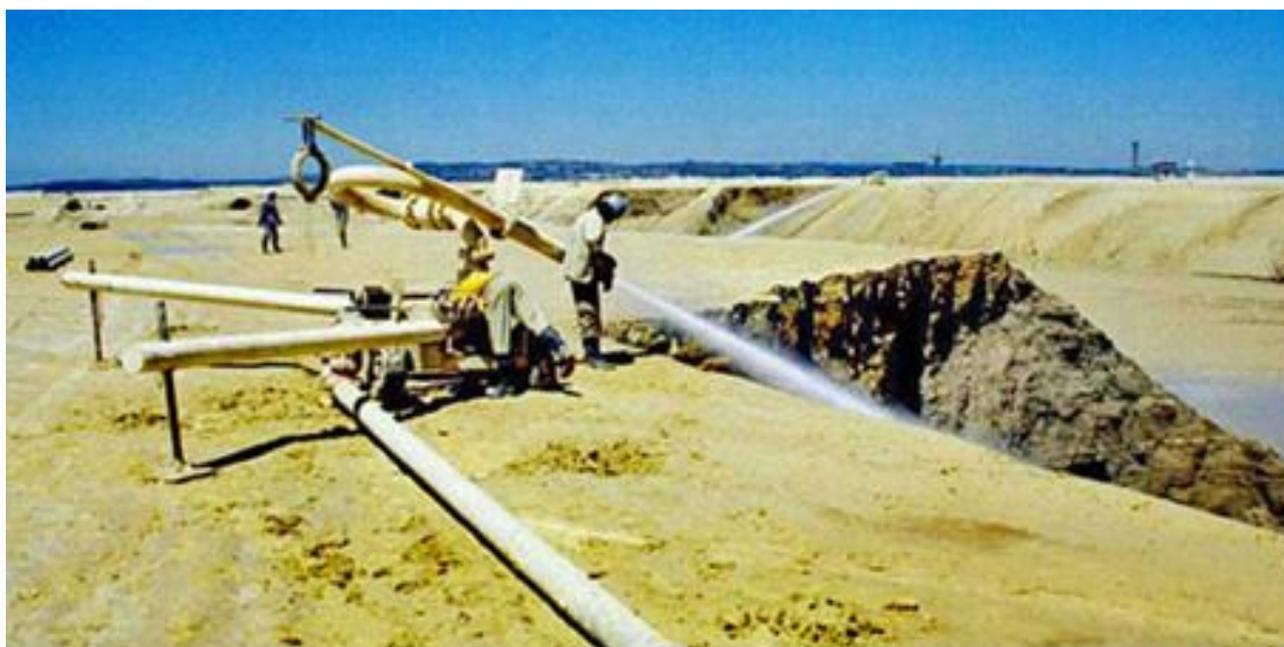
Figure 2 Hydraulic mining of gold tailings in Johannesburg prior to re-processing (source: Tailings.info 2015)

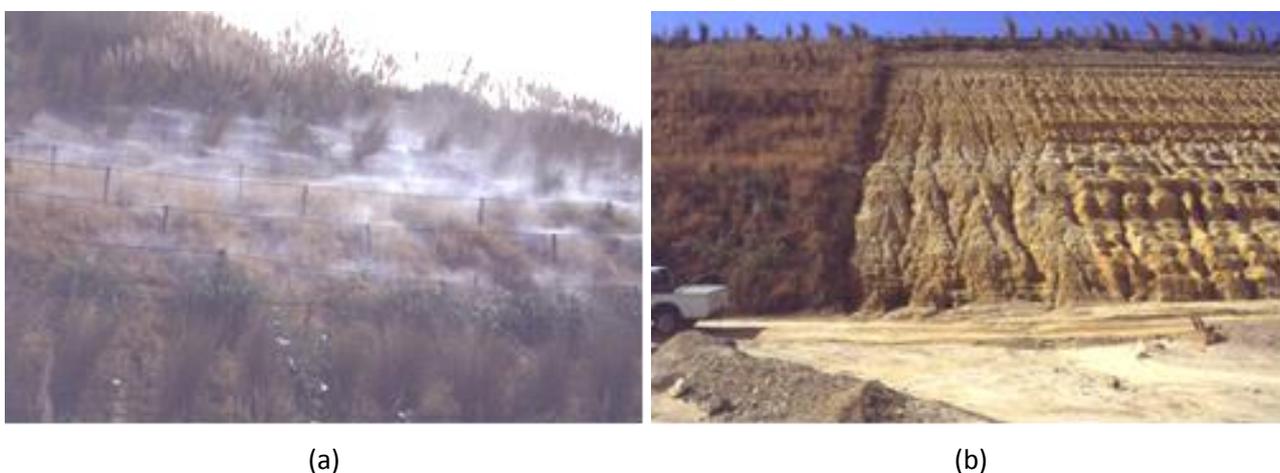
Figure 3 1996 grass covers on Johannesburg gold tailings dumps, showing: (a) watering to leach acidity, and (b) grassed, and eroding smoothed and unsmoothed slopes

Since 1991, attempts at grass covers have persisted, with continuing varied success, (Figure 3). Gold tailings dumps in Johannesburg continue to showing deteriorating grass covers on slopes and to be reclaimed for re-processing (Figures 4(a) and (b)). New topsoil and grass covers continue to be constructed on gold tailings dump slopes, while at the same time severe dust storms continue to plague Johannesburg (Figures 5(a) and (b)).

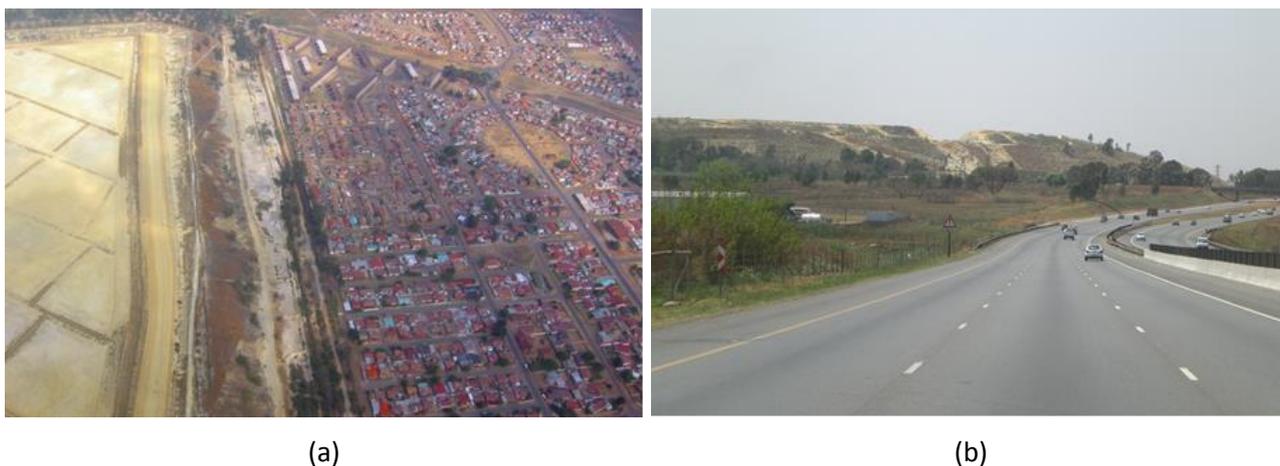
Figure 4 Gold tailings dumps in Johannesburg, showing: (a) deteriorating grass cover of slope adjacent to suburbs (source: Future Terrains 2014), and (b) partially re-claimed gold tailings in for re-processing (source: Sprott Gobal 2013)

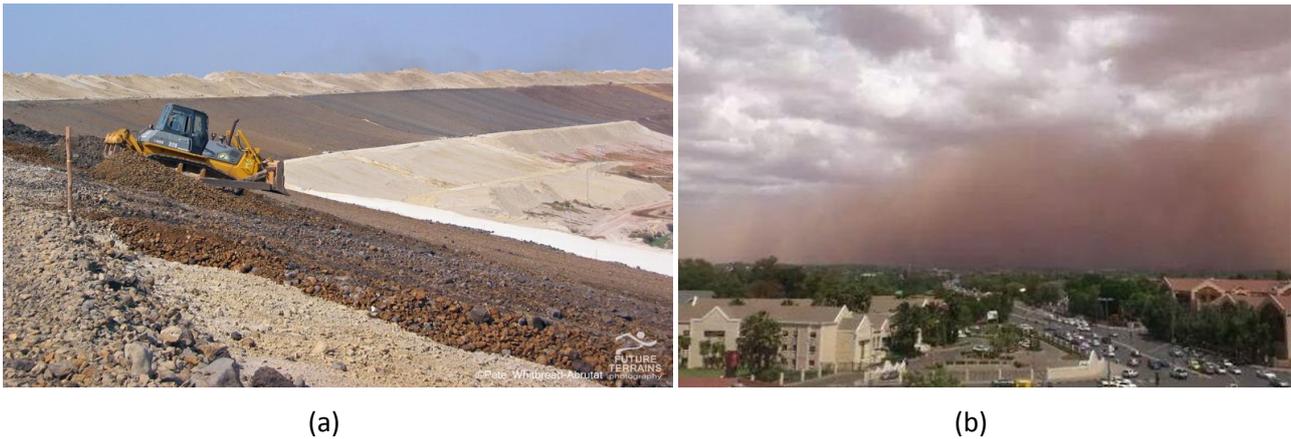
Figure 5 Continuing: (a) practice of topsoil and grass covers on gold tailings dump slopes (source: Future Terrains 2014), and (b) dust storms (source: Enca 2014)

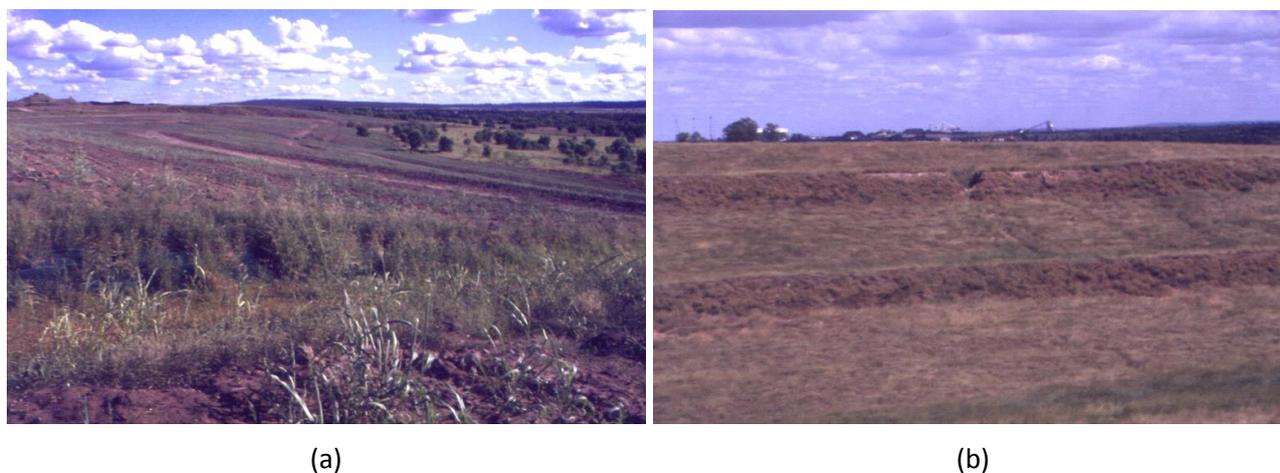
Figure 7 Bowen Basin spoil piles rehabilitated for grazing: (a) recently flattened, contour-banked, topsoiled and grassed, and (b) established grass cover showing overtopping of a contour bank

To facilitate a post-mining grazing land use, the spoil piles were flattened from the angle of repose (nominally 35° or 1 in 1.4 or 70%) to typically 8.5° (1 in 6 or 17%). Contour banks were used to reduce slope lengths in an effort to reduce erosion, and the flattened slopes were topsoiled and grassed. Rock-lined downslope drains were constructed to manage rainfall runoff. Introduced grasses were planted, since there was a shortage of native grass seed and native grasses were found to be more difficult to establish. However, there was little utilisation of rehabilitated spoil slopes for grazing. This was partly because the grass cover was too poor to support grazing, but also because local graziers (and their cattle) considered the slopes still too steep, the grass was of poor quality, and there was no water available on the slopes (Figure 7).

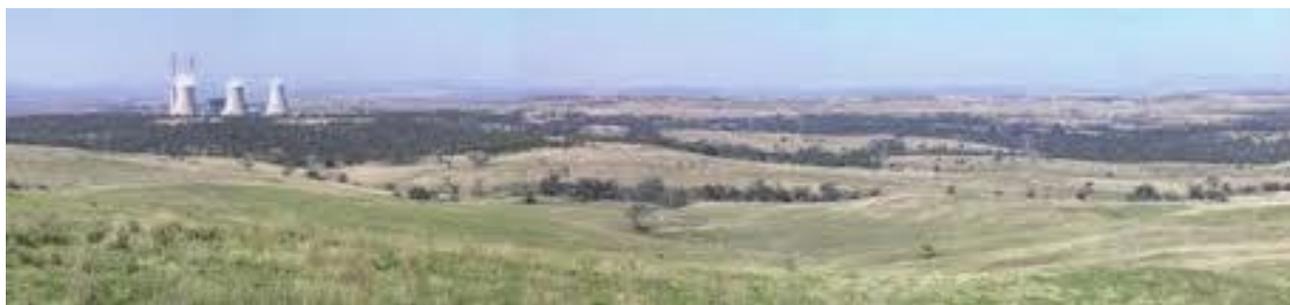
Figure 8 Typical Hunter Valley spoil pile rehabilitation for grazing (source: NSW DPI 2007)

Prior to topsoiling, all rocks in excess of 0.5 m in size, which might seriously interfere with later cultivation operations, are required to be removed from the surface. This is unfortunate since rocks would also be effective in limiting surface erosion, particularly while a vegetation cover is establishing. Topsoil, previously stripped from the mined area, is required to be spread over the flattened spoil, to a thickness increasing for steeper slopes. This presumably is in recognition that a greater depth of topsoil will be lost to erosion on steeper slopes. After the pasture is well-established and the risk of further serious erosion seems minimal, surface rocks exceeding 0.2 m in size are required to be removed or buried, again reducing the resistance to surface erosion. This requirement is aimed at making the area safe for vehicle traffic and stock after it has been returned to grazing. Typical Hunter Valley spoil pile rehabilitation for grazing is shown in Figure 8.

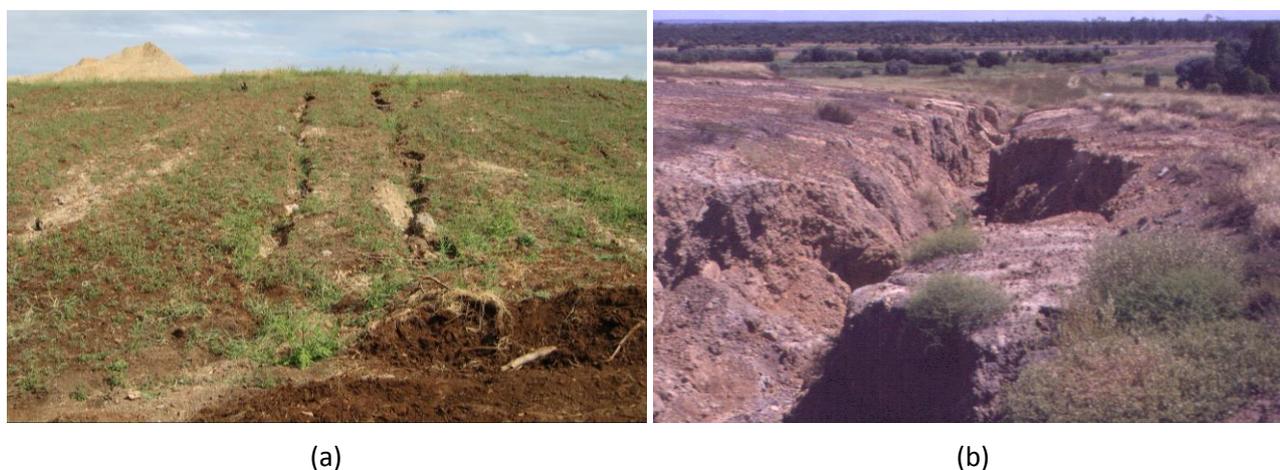
Figure 9 Flattened Bowen Basin spoil piles, showing: (a) rill erosion of grassed topsoil, and (b) failing downslope drain

The over 4-fold flattening of spoil pile slopes for rehabilitation purposes increased their catchment 4-fold, and crushed or buried coarse-grained rock, making the surface smoother and increasing the runoff (Williams 2001a). The topsoil placed for revegetation purposes was finer-grained than the spoil and often more erodible (Figure 9(a)). Further, while coalfields rainfall typically averages about 600 mm/yr, it can be highly variable and dominated by intense rainfall events that exacerbate erosion. Contour banks and downslope drains concentrate rainfall runoff 10 to 100-fold and inevitably fail (Figure 9(b)). Recognising this, contour banks became seen to be temporary, to be removed once revegetation was established.

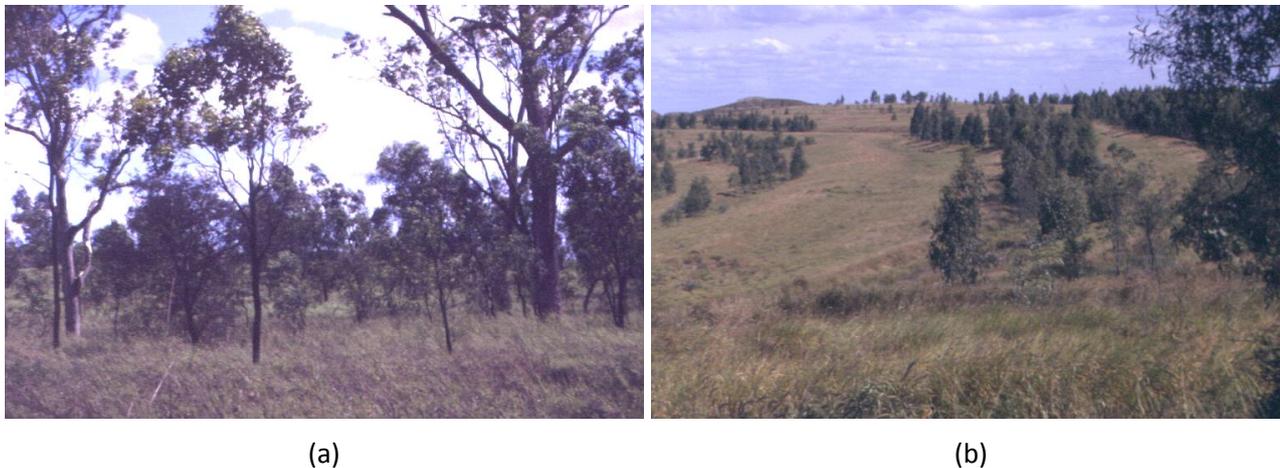
Figure 10 Flattened Bowen Basin spoil piles, rehabilitated for: (a) native habitat, and (b) alternating grasses and trees

From the late 1990s, a number of mines in the Bowen Basin Coalfields gradually changed their post-mining land use from grazing to native habitat (Williams 2001b, 2001c). However, this typically did not involve a change in the flattening of the spoil piles from the angle of repose to 8.5°. It merely meant a change in the vegetation from pasture grasses to native shrubs, trees and grasses (Figure 10(a)). At Curragh Mine, alternating strips of grasses on topsoil and trees on coarse reject or directly on spoil were adopted (Figure 10(b)).

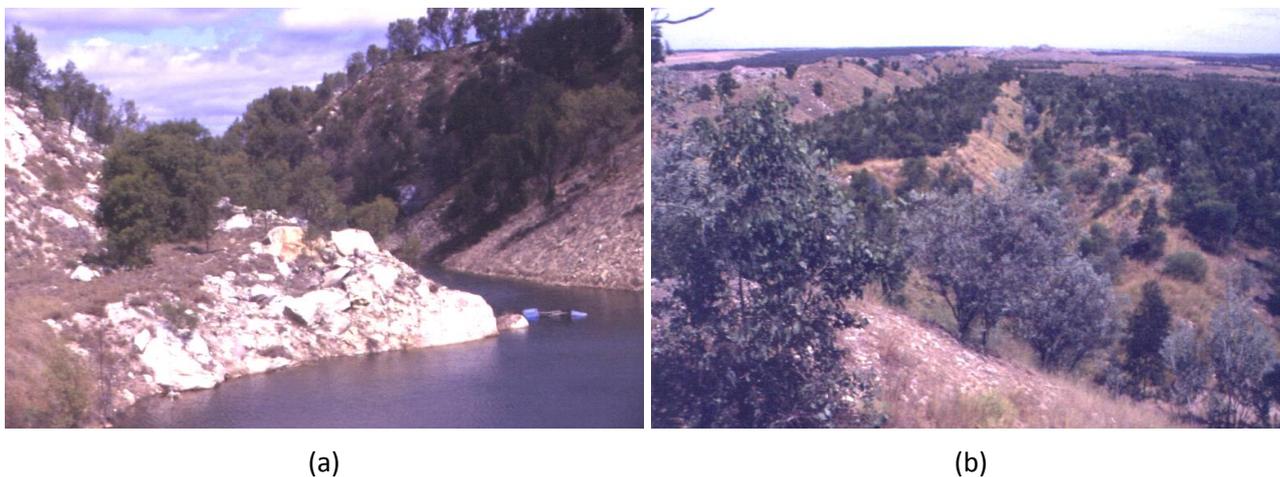
Figure 11 Alternative rehabilitation of Bowen Basin spoil piles: (a) volunteer native shrubs, trees and grasses on angle of repose sandstone slopes, and (b) native trees planted on flattened spoil pile tops, and native grasses and shrubs on angle of repose spoil slopes

There is no need to flatten spoil pile slopes to this extent for native habitat establishment. Spoil pile slopes could have been left at the angle of repose if the spoil was capable of revegetating directly (Figure 11(a)). At a number of mines in the Bowen Basin, internally-drained or water-harvesting spoil landforms were trialled successfully. They involved flattening the tops of the dragline saw-tooth spoil piles to form small ponds with a perimeter bund to retain water, and retaining the outer slopes at the angle of repose (Figures 11(b) and 12).

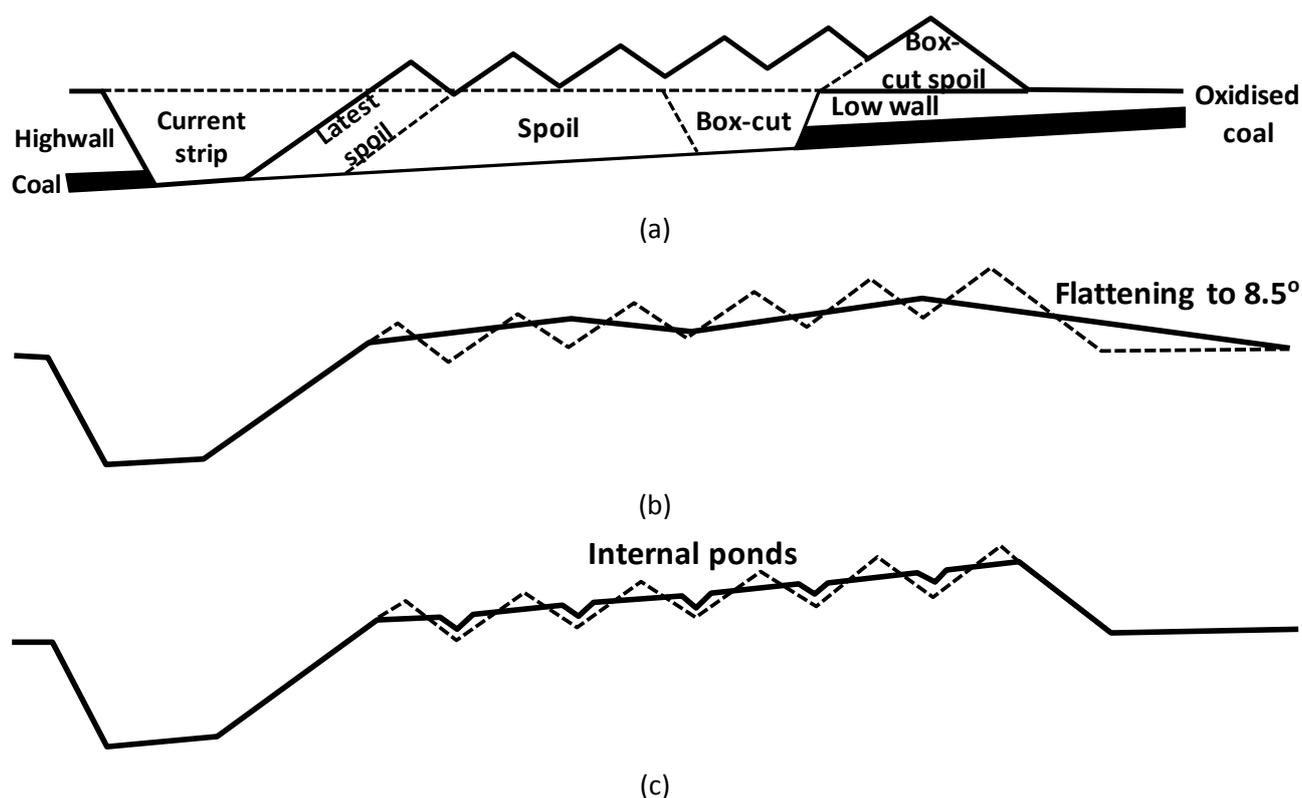
Figure 12 Alternative rehabilitation of Bowen Basin dragline saw-tooth spoil piles: (a) as-constructed, (b) flattened to 8.5°, and (c) internal ponds

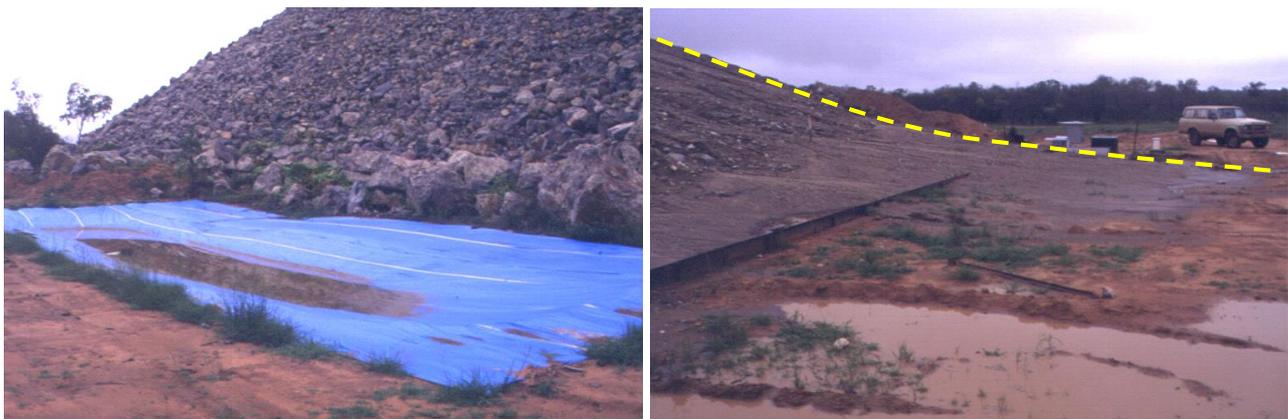
Figure 13 Waste rock dump erosion due to a 25 mm rainfall event, showing: (a) negligible erosion off an angle of repose slope, and (b) substantial erosion of a slope flattened to 1 in 3 and covered with a 500 mm thickness of growth medium

The conventional rehabilitation of an angle of repose waste rock dump slope, which involves the flattening of the slope angle to less than half the angle of repose, the construction of contour and downslope drains to manage rainfall runoff, and topsoiling, can result in a final slope with adequate geotechnical stability but inadequate erosional stability (Figures 13 and 14). While pushing down the slope angle improves geotechnical stability, dozing crushes and buries the coarser-grained boulders and smooths the surface, thus increasing rainfall runoff and reducing erosion resistance. The fine-grained growth medium cover is particularly prone to erosion, especially until revegetation becomes established, if it does.

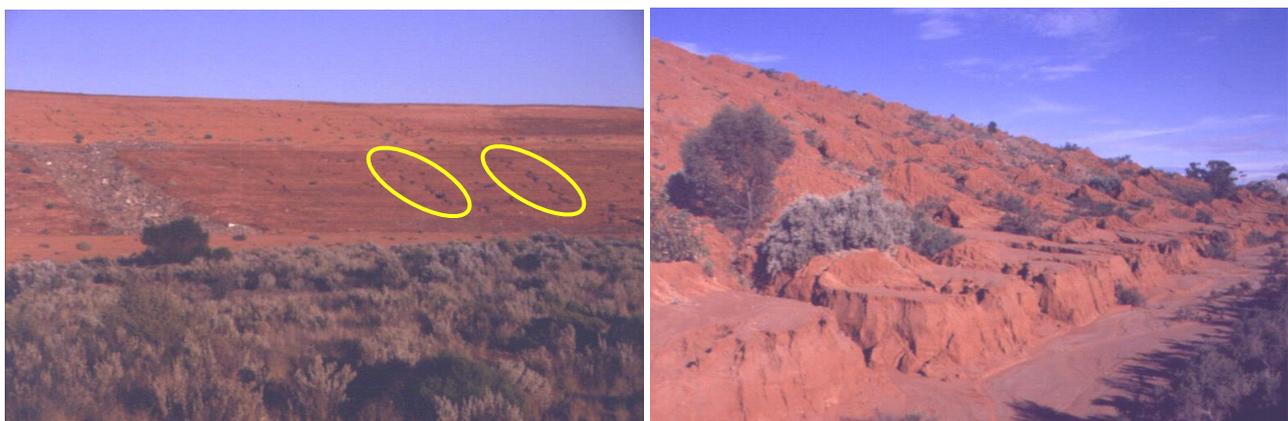
Figure 14 Waste rock dump flattened to 1 in 3, with contour and downslope drains constructed, and topsoiled, showing: (a) rilling away from downslope drain on first rainfall event, and (b) deep erosion gullies through thick topsoil over time

over 1,000 mm of runoff. If the contour drains have low points and/or are not adequately sloped towards the down slope drain, there is a distinct possibility that the rainfall runoff will not reach them and they will be even more ineffective (Figure 14(a)).

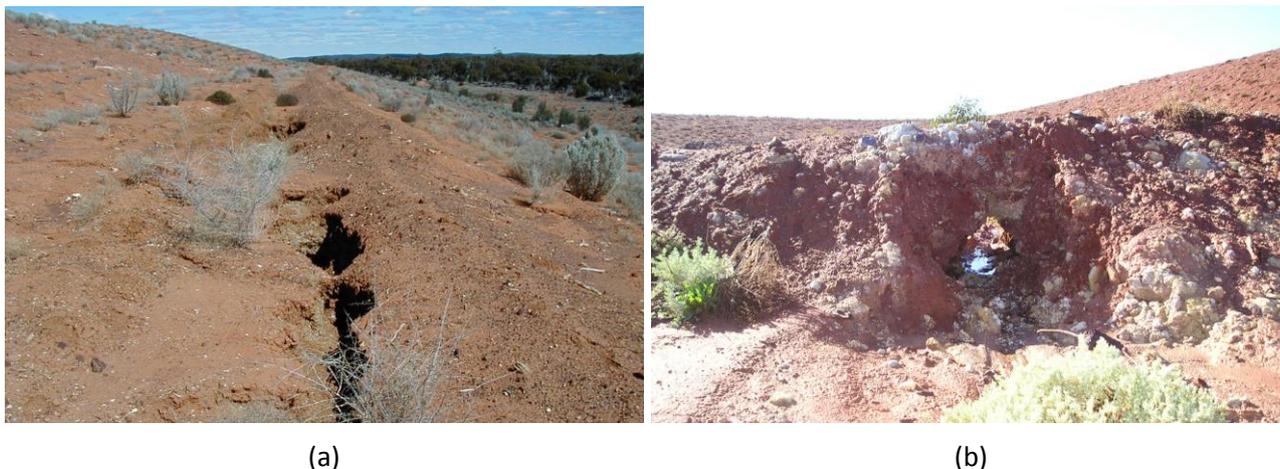
Figure 15 Contour drain in dispersive waste rock, showing: (a) tunnelling inlets along contour drain, and (b) major tunnel outlet, prior to collapse to form a gully

The concentration of rainfall runoff in contour and downslope drains makes the slope more prone to tunnel erosion and gullying, if the materials are dispersive (Figure 15). If the rainfall incident on the top of the dump is shed over the dump sides, it is concentrated about 10-fold. Rainfall runoff will be concentrated a further 10-fold or more in downslope drains. Hence, a modest 10 mm rainfall event can be magnified to

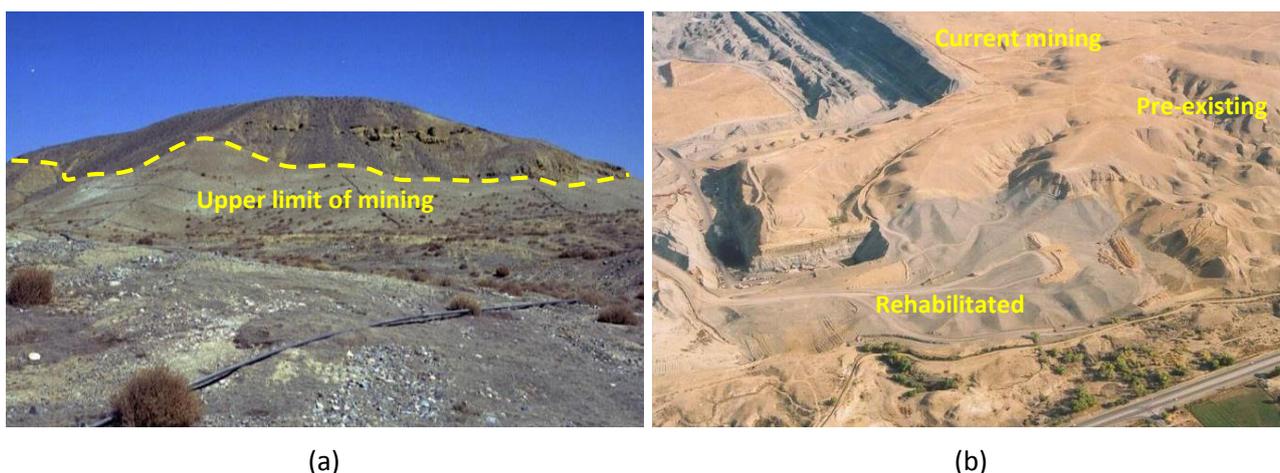
Figure 16 Fluvial geomorphic mine waste rehabilitation design principles employed at BHP Billiton’s La Plata and San Juan coal mines in the Badlands of New Mexico: (a) rehabilitated hill scape, and (b) pre-existing, current mining and rehabilitated landforms

Alternative approaches to creating stable final slopes, drawing upon surrounding natural analogues, offer the potential to produce sustainable slopes of high geotechnical and erosional stability, and improved aesthetics (Williams 2006). Natural hillslopes differ from constructed mine waste rock slopes in a number of crucial ways. While mine waste rock slopes are generally constructed and reshaped to a linear profile, natural hillslopes are generally concave-shaped, which tend to capture erosion sediment on the slope, and are of diverse angle, length, and surface texture. Natural hillslopes are protected from erosion by rock armouring, cemented cap rock, and vegetation. Mine waste rehabilitation earthworks should aim to reconstruct similar distributions of slope angles, slope lengths, vegetation patterns etc. to those pre-mining, for minimum earthworks and hence minimum cost. Fluvial geomorphic mine waste rehabilitation design principles, such as those used at BHP Billiton’s La Plata and San Juan coal mines in the Badlands of New Mexico, should be employed in preference to linear engineering design principles (Figure 16).
