The Challenger gold story — do it once, do it well

P Waters MWH Australia Pty Ltd, Australia

Abstract

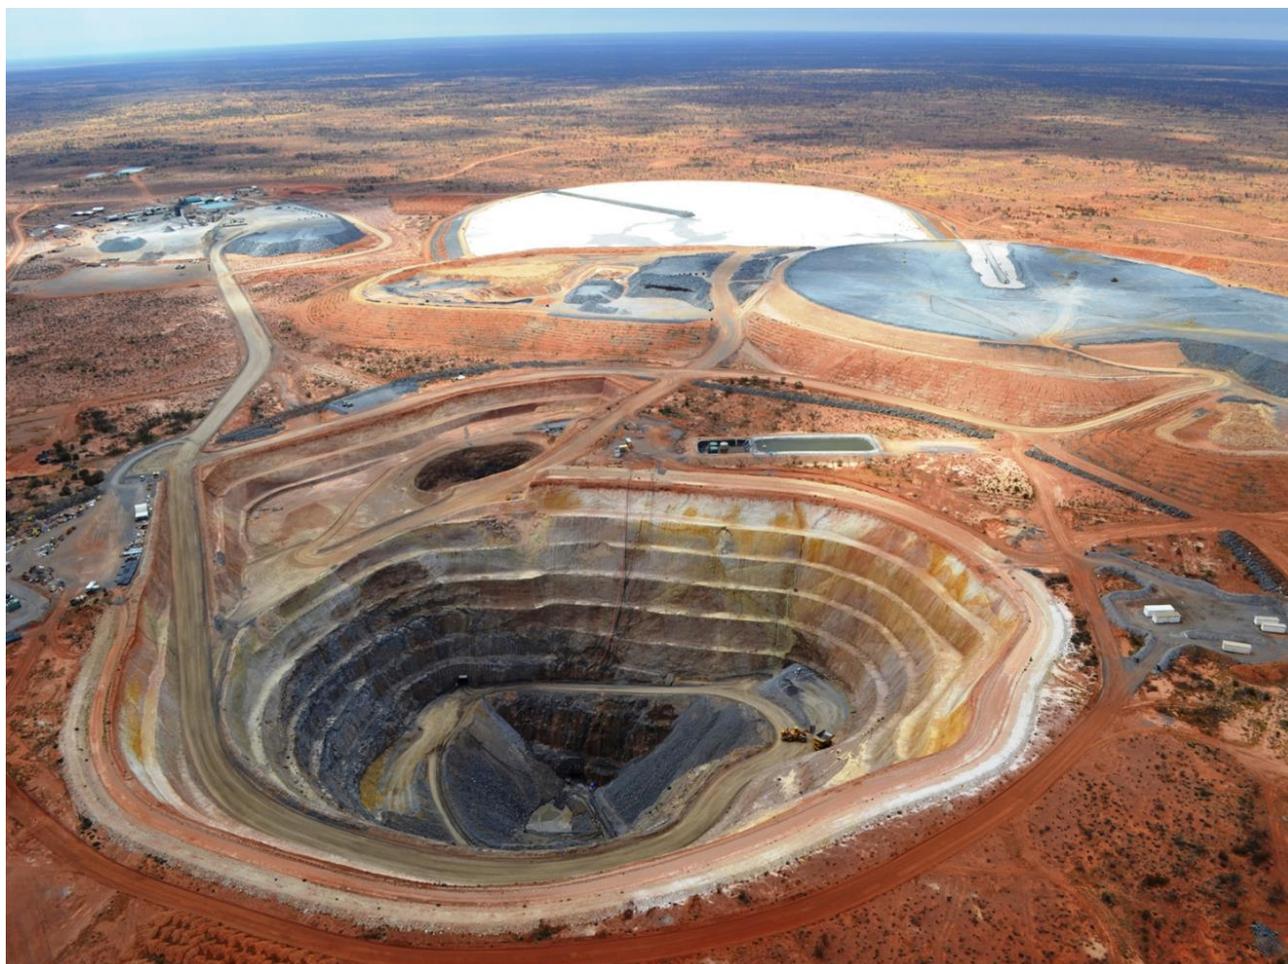
Figure 2 Aerial view of the Challenger gold operation

The operation comprises an open cut and underground gold mine and processing facility (Figure 2). The infrastructure covers an area of approximately 300 ha and includes the processing plant, a mine village housing up to 240 personnel working a fly-in/fly-out roster, aerodrome, reagent and fuel storage facilities, offices, workshops, a laboratory, ancillary buildings and haul roads.

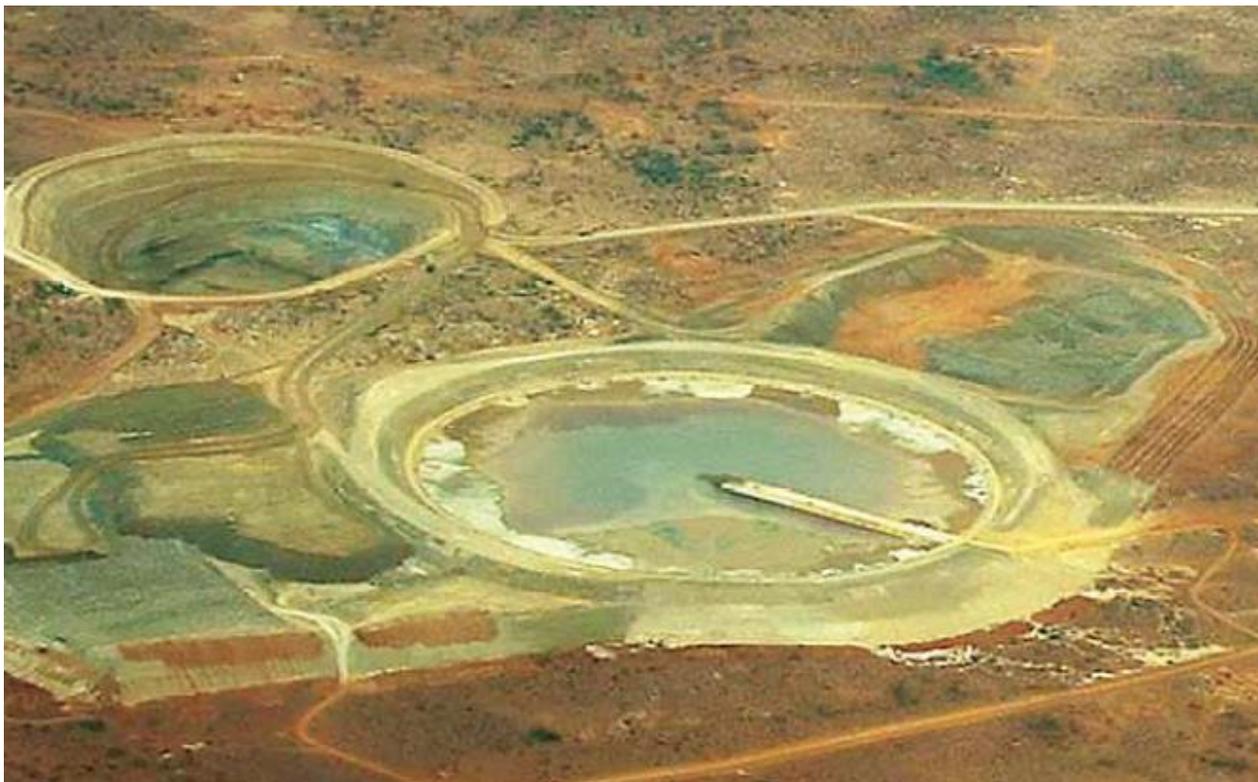
Figure 4 Aerial view of the IWL during construction

- Starter embankments are free standing and comprised of inert oxide waste.
- Mine waste rock is then progressively placed to allow for downstream construction.
- Oxide waste is stored (specifically placed) to allow subsequent raising of the internal compacted zone downstream (Figure 4).
- External batters progressively rehabilitated (Figures 5(a) and (b)).
- Internal embankment raised progressively using stored oxide waste.
- Dumping exclusion zone to allow staged construction.
- Compacted clay blanket over the tailings storage floor area.
- Underdrainage water recovery system.
- Central decant for recovery of supernatant water.
- Perimeter spigotting to maintain a centrally located water pond.

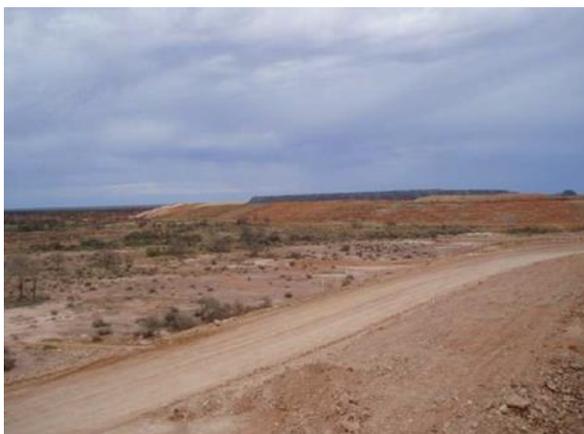
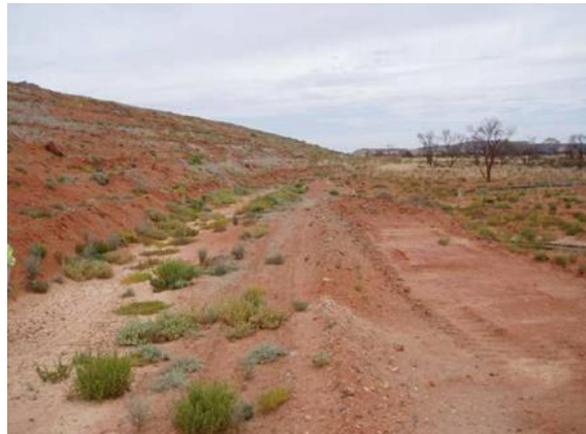
Figure 5 Images of the rehabilitated outer IWL slopes

- Continued operation during construction with limited disruption and improved water recovery.
- Increased reagent recovery.
- Ability to progressively rehabilitate the mine waste and integrated tailings facility (refer Figures 5(a) and (b)). Refer to Sections 5 and 6 for further discussion on progressive rehabilitation and monitoring success.
- Reduced materials rehandling as placement of materials is pre-planned.
