Photogrammetry in underground mining ground control — Lucky Friday mine case study

DJ Benton *National Institute for Occupational Safety and Health, USA*

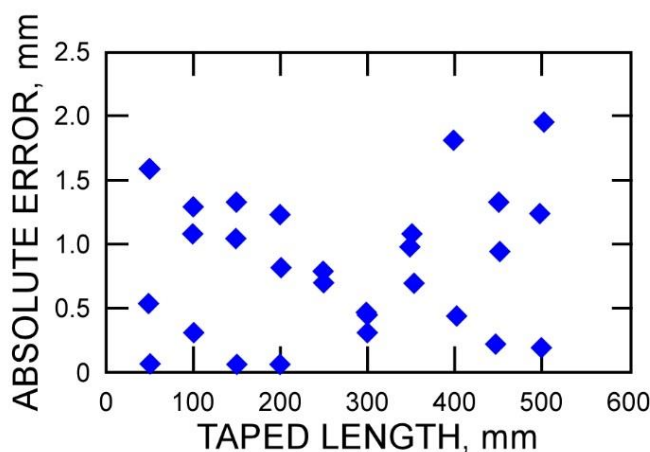
Figure 1 Comparison of the absolute error of photogrammetric linear measurements to known linear distances in laboratory conditions, revealing an average accuracy of ± 1.0 mm

Tests were conducted to determine the accuracy of the linear measurements obtained from the photogrammetry system (Benton et al. 2014). Twelve sequentially stacked wooden boxes, of known dimensions, were used as verification control. The boxes were constructed of 6.4 mm plywood and 5.0 × 5.0 cm boards and assembled to the desired dimensions of 5.0 × 5.0 × 30.5 cm. Measurement points were placed centrally on three of the four edges of each box. The height of each point, above the base level, was measured using a metal tape, with measurement divisions of 1.0 mm. The tape measurements were interpreted to 0.5 mm, resulting in an expected error +/- 0.5 mm for each measurement.

As each box was placed, a pair of photographs was taken. The stereoscopic photo pairs were then imported into the software, and 3D images were reconstructed. From these images, the linear distance between measurement points on two different boxes was determined. This linear distance is equivalent to the change in vertical-axis position of the measurement points. The relationship between tape measurements and photogrammetric error is shown in Figure 1. The average photogrammetric error was approximately 1.0 mm, whereas the maximum recorded error was 2.0 mm, and the minimum was 0.0 mm. Considering the accuracy of the tape measurements (+/- 0.5 mm), the photogrammetric system is slightly less accurate when measuring flat, planar surfaces, but it still provides measurements within an accuracy of 1.0 mm.

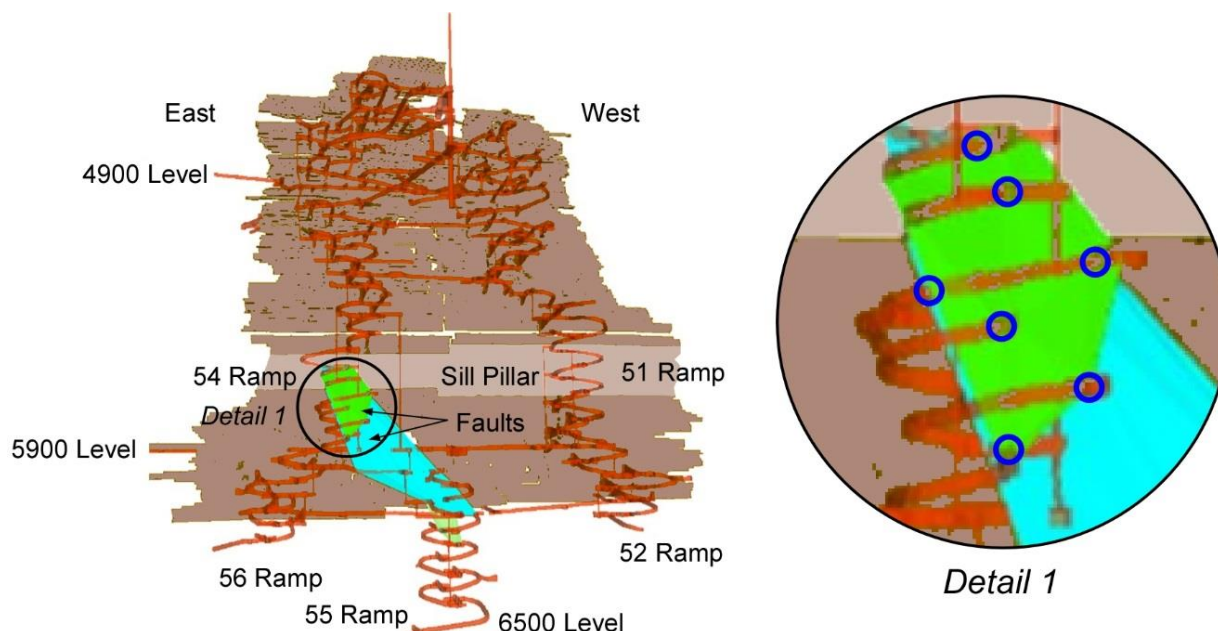
Figure 2 (Left) schematic of development workings (brown), backfilled stopes (dark purple), sill pillar (light purple), and faults (light blue and green) in the Gold Hunter deposit; (right) photogrammetric survey locations (dark blue circles) along fault intersections with the 54 ramp

At the Lucky Friday mine, Hecla is currently using underhand cut-and-fill mining methods to mine Ag-Pb-Zn ore from narrow, steeply dipping veins in the Gold Hunter deposit at a depth of about 2,100 metres. Mining-induced stress changes near a large sill pillar in the mine's main production vein have created challenges to mining in these rockburst-prone ground conditions. As the sill pillar is being mined, its vertical extent decreases, which concentrates and progressively increases the stresses acting in the remaining portion of the pillar, thus, increasing the potential for strainbursts. As mining progresses, local stresses are also being reoriented along the direction of problematic faults that intersect the sill pillar and dip 50 to 60° to the north. Fault-slip seismic events, some with moment magnitudes exceeding 2.5, have occurred along these faults, particularly at locations where they intersect the underground workings (Figure 2).

As noted by the insert in Figure 2, photogrammetric surveys were conducted at several locations in the 54 ramp, where fault intercepts were exposed on the surfaces of the underground entries. As the photogrammetric surveys were conducted in one of the main access entries for this section of the mine, better results were typically obtained during times when mine traffic was at a minimum. This was not a necessary precondition for the photogrammetric surveys, but the intensive regimen employed for research purposes required minimal interference. Data from these surveys were used to measure and monitor bulk movement in the ramp system's entries and also to help interpret and verify crackmeter measurements, which indicated the likelihood of displacements along the exposed fault planes. Photogrammetric surveys were conducted at eight pre-selected sites where the faults intersected the ramp system. The typical order of operations for each site survey was as follows (Figures 3 and 4):

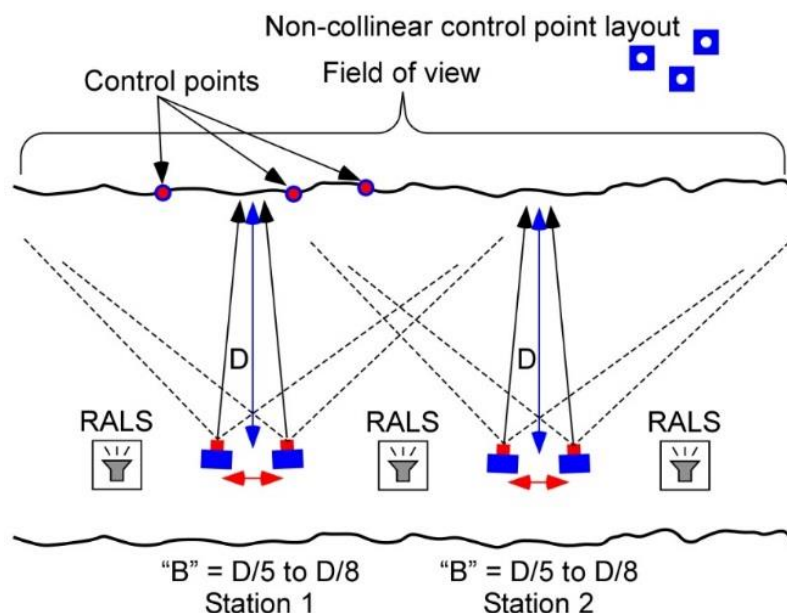
Figure 3 Plan view of the typical configuration for a stereoscopic photogrammetry survey set-up at the Lucky Friday mine

- Select the desired field of view.
- Determine suitable control point locations.
- Measure the normal distance to the opposite rib (D) from the first camera station.
- Determine the required lateral movement of the camera between photographs (B) based on D.
- Position the lighting units with a spacing roughly equal to D.

At each site, the desired field of view was selected for the target scene, and camera stations were established as close to the opposite rib as possible. Once the field of view had been determined, tools, hoses, bags, and other materials obscuring the scene were, if possible, removed from the target rib. Suitable locations for control points were then identified to simplify scaling during reconstruction of the photo pairs. Bolt plates were found to be the best surfaces for control points because their flatness reduced survey error and their position remained fairly constant over time, compared to the rock surface between the bolts. A minimum of three non-collinear points were needed for site orientation and scaling during processing. The normal distance from the first camera station to the target rib (D) was measured and then used to determine the required camera spacing (B). One-fifth to one-eighth of D was the best range for B . Lastly, the RALS units were placed along the opposite rib, facing the target rib, and spaced generally equal to D , with each camera station centred between the two lights.

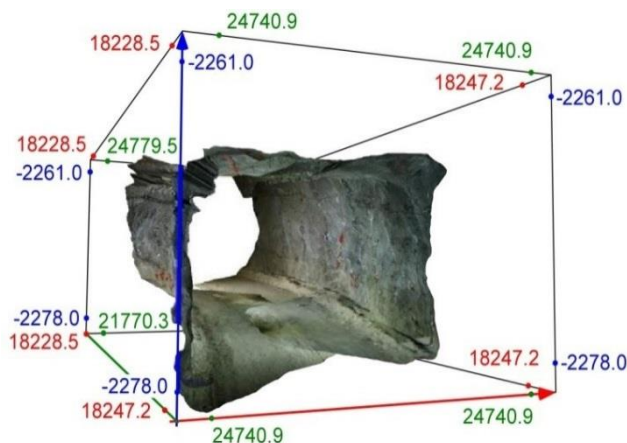
Figure 5 Scaled photogrammetric reconstruction of an underground entry at the Lucky Friday mine, with a bounding box georeferenced by global northing, easting, and elevation coordinates

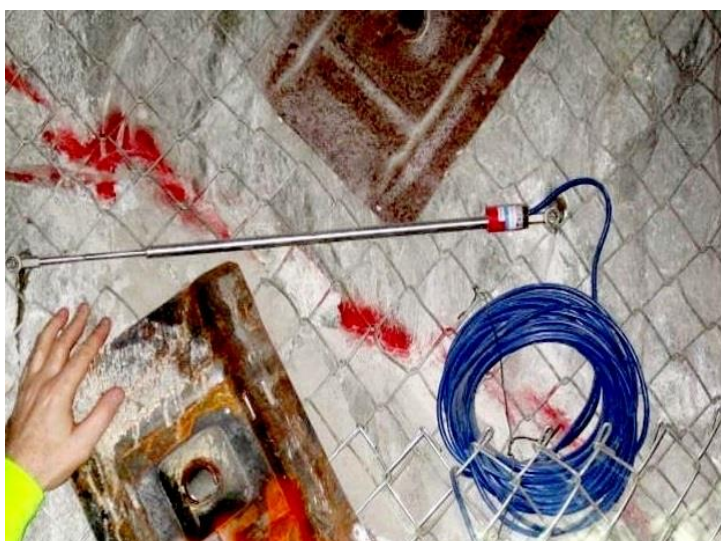
Figure 6 Crackmeter installed across a fault exposed on the surface of a ramp entry at the Lucky Friday mine

Photogrammetric measurement techniques were used to aid in the interpretation of displacement measurements obtained from Geokon Model 4420 vibrating-wire crackmeters that were installed by Hecla engineers to monitor fault movement. As shown in Figure 6, crackmeters were installed at selected locations where fault intercepts were exposed along the ribs of the 54 ramp. The crackmeter was positioned across the fault and attached to the rock using shallow grouted anchors at either end of the instrument. The crackmeters used in this study have measurement lengths of either 100 or 150 cm and are accurate to within $\pm 0.1\%$ full scale. As a result, the crackmeters have an overall accuracy of about 1.0 to 1.5 mm, essentially the same accuracy as SMRD's photogrammetry system.

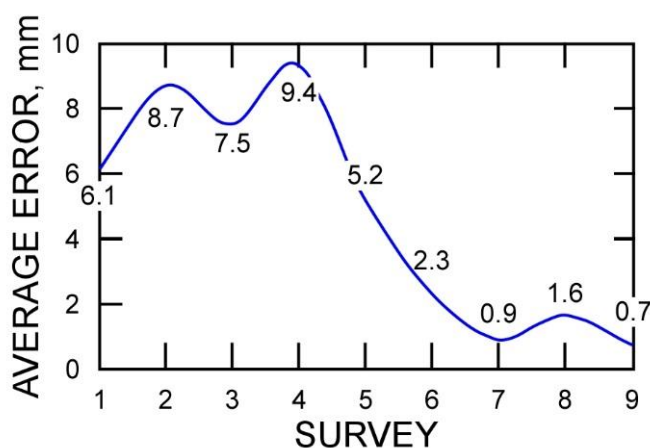
Figure 7 Evolution of photogrammetric measurement accuracy using vibrating-wire crackmeters as a control, beginning October 2013 and ending May 2016

Over 100 measurement comparisons were completed for the photogrammetric and crackmeter measurements collected from May 2013 through May 2016. Initial comparisons showed large discrepancies between the two measurement methods, with photogrammetric measurements routinely exceeding an absolute difference of 1.0 cm in comparison with the crackmeter readings. However, as methodology and technology were refined, the average difference between the photogrammetric and crackmeter measurements was reduced to 1.0 mm, as shown in Figure 7. Refinements that led to improved photogrammetric accuracy included the use of a higher megapixel camera (22.1 versus 10.2 megapixels), and the adoption of Agisoft PhotoScan Pro software, which allowed for more precise target selection, as well as denser coverage of photographed scenes. Field verification of the SMRD photogrammetry system, thus, indicates that photogrammetric methods can be used to reproduce distance measurements along the surfaces of underground entries that are equivalent in accuracy to displacement measurements from conventional instruments, such as crackmeters.

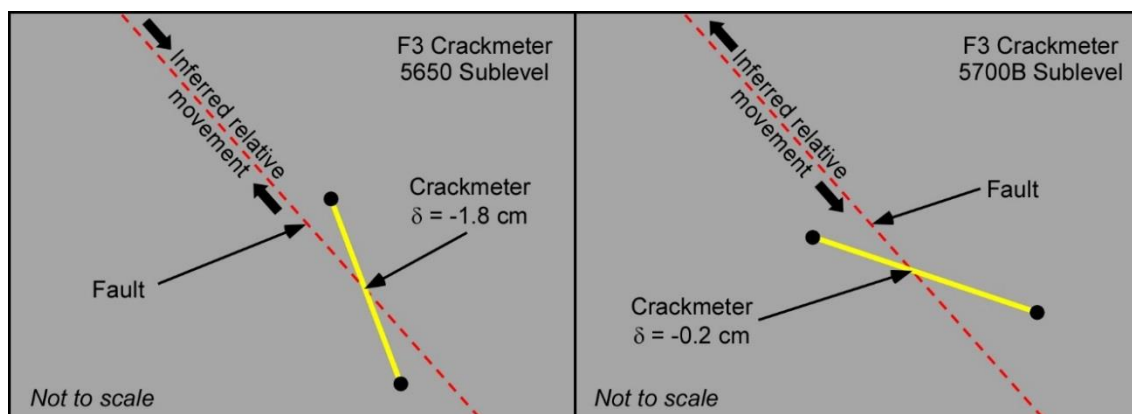
Figure 8 Contradictory indications of relative movement along the F3 fault at the Lucky Friday mine, inferred from crackmeter measurements

In theory, crackmeters installed at various orientations and locations across the same fault can provide reliable descriptions of the fault's movement. However, an analysis of the data collected from the crackmeters, which were installed in the 54 ramp to monitor movement along the F3 and F4 faults, yielded conflicting results. Although both of the crackmeters installed across the F3 fault measured compression (shortening) of the instrument, the relative movements of the hanging wall and footwall sides of the fault inferred from this compression were in opposite directions, as shown in Figure 8. Two of the three crackmeters installed across the F4 fault measured compression and were consistent in the directions of the inferred relative movements of the hanging wall and footwall. In contrast, however, the third crackmeter measured a significant amount of tension (lengthening) of the instrument, and the relative movements of the hanging wall and footwall inferred from this tension were in opposite directions to those of the other two crackmeters (Figure 9).

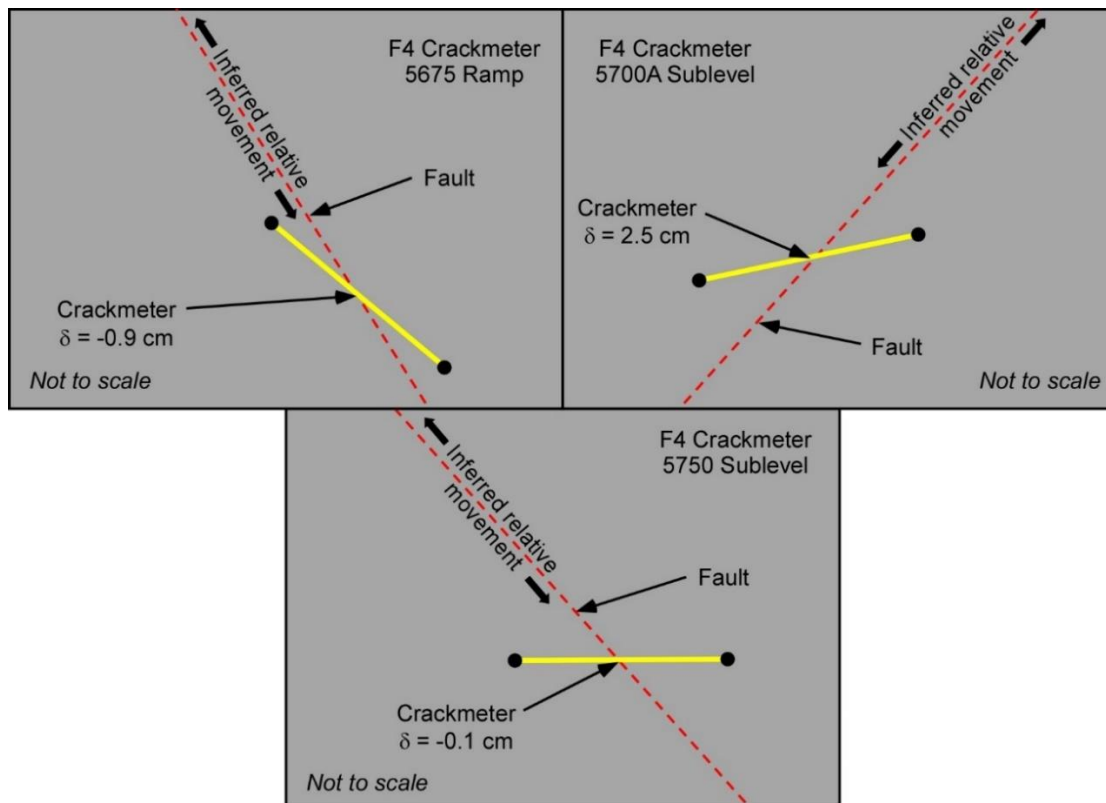
Figure 9 Contradictory indications of relative movement along the F4 fault at the Lucky Friday mine, inferred from crackmeter measurements

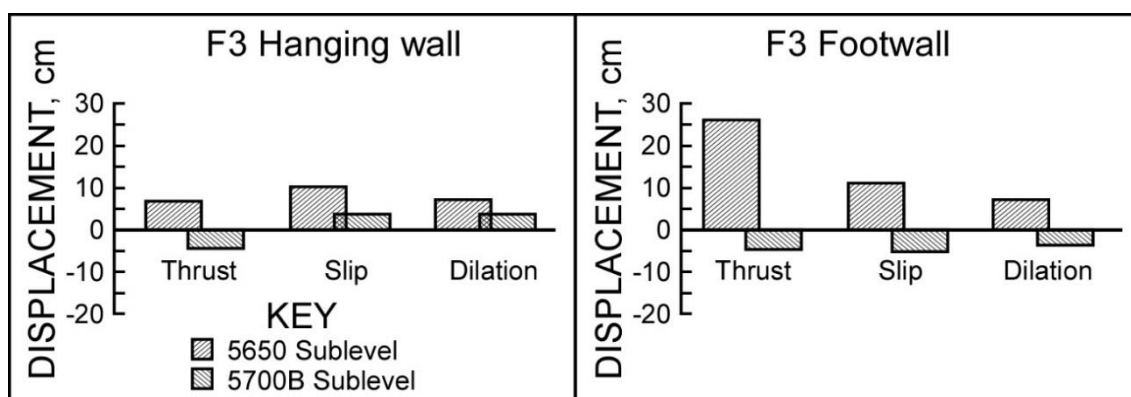
Figure 10 Descriptions of hanging wall and footwall movements for the F3 fault between May 2013 and May 2016 at the Lucky Friday mine, provided by photogrammetric data

A photogrammetric analysis of the ground movement at the five crackmeter locations in the 54 ramp did not indicate a general trend in movement for either the F3 or F4 fault, but instead revealed a general lack of uniformity in fault behaviour. This random movement at the crackmeter sites is illustrated in Figures 10 and 11, which have been scaled equally to provide a relative comparison of movements in the thrust, strike, and dilation orientations for the F3 and F4 faults, respectively. Overall, the primary rock mass movement appears to be rib convergence, with the apparent fault movement more than likely being a result of local deformation within the skin of the entry, rather than a clearly defined global displacement of the fault. Local deformation in the skin of the entries also explains the varying degrees of displacement recorded by the crackmeters, which are secured in the rock mass with shallow grouted anchors.

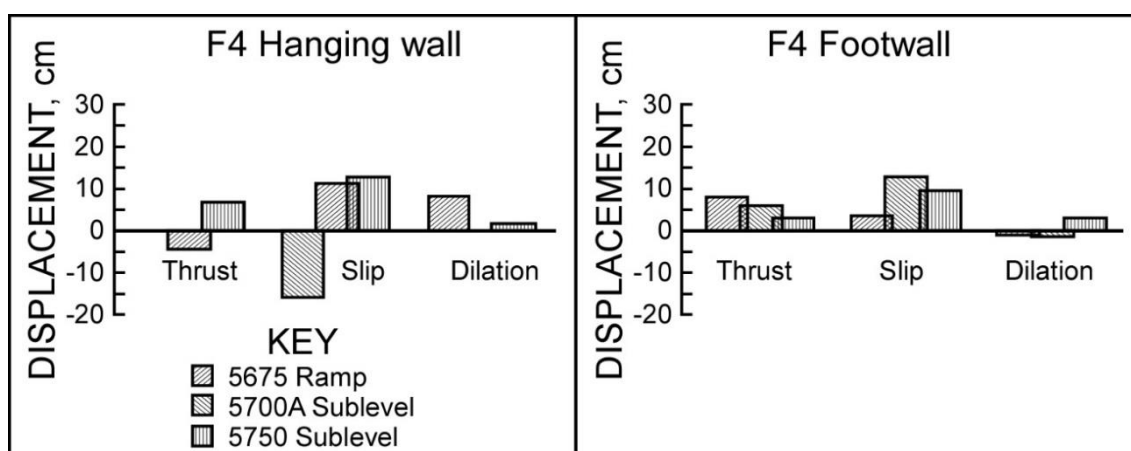
Figure 11 Descriptions of hanging wall and footwall movements for the F4 fault between May 2013 and May 2016 at the Lucky Friday mine, provided by photogrammetric data
