Elliptical shaft excavation and furnishing in response to depth induced ground pressure

Hecla Limited is nearing completion of the Lucky Friday mine No.4 shaft located in Mullan, Idaho. The shaft is collared at the 4940 Level of the mine and will have a final mine level depth of 8620, or 2,923 m (9,590 ft) below the surface. After reaching the 7400 Mine Level the shaft encountered ground deformation higher than allowed for in the design for a circular shaft excavation and concrete lining. This additional ground deformation required portions of the shaft concrete liner to be reinforced with frameless, steel liner plate. To eliminate the installation of the liner plate from the remaining shaft development, the design of the shaft excavation starting at the 7650 Mine Level was changed to an elliptical cross-section based on the overall stress field orientation as well as the orientation of the structure of the host rock surrounding the shaft. The elliptical cross-section was instrumented to confirm the shaft excavation and lining was performing as designed. This design change has allowed the shaft to continue to the planned 8620 Mine Level without the need to install liner plate in t

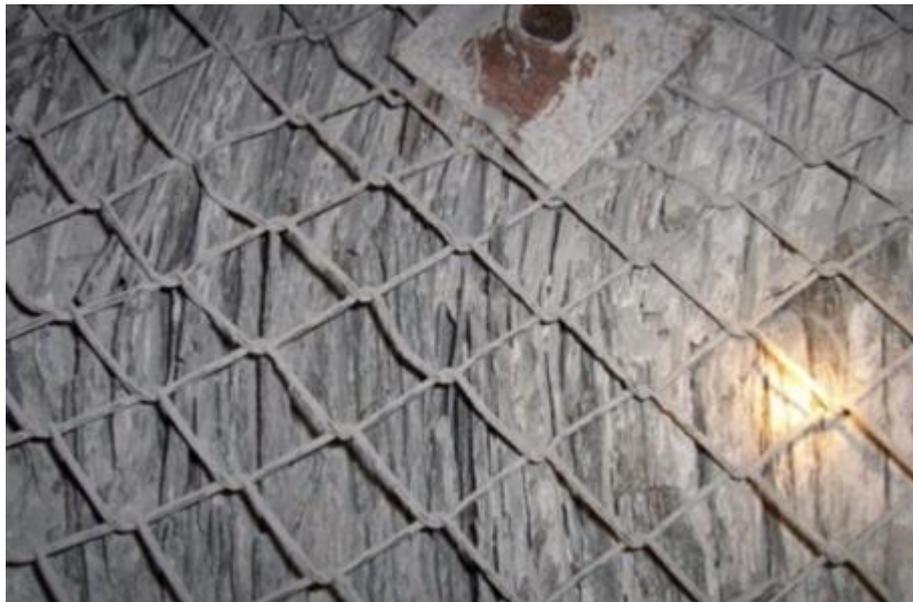
Figure 2 Typical vertical bedding (foliation) of less than 15 mm in the argillites of the Wallace formation

The Gold Hunter orebody is hosted in the pre-Cambrian Wallace formation of the Belt Supergroup. The Wallace formation consists of thinly bedded argillites with a roughly east–west strike and a near vertical dip (Figure 2). These bedding/foliation planes are typically coated with talcy minerals. The rock mass has an estimated rock mass uniaxial compressive strength of 48 MPa (7,000 psi), (Pakalnis 2008), which is highly anisotropic, being distinctly weaker perpendicular to the foliation. The maximum in situ stress strikes roughly northwest–southeast with a ratio of maximum horizontal to vertical stress of about 1.5 to 1.

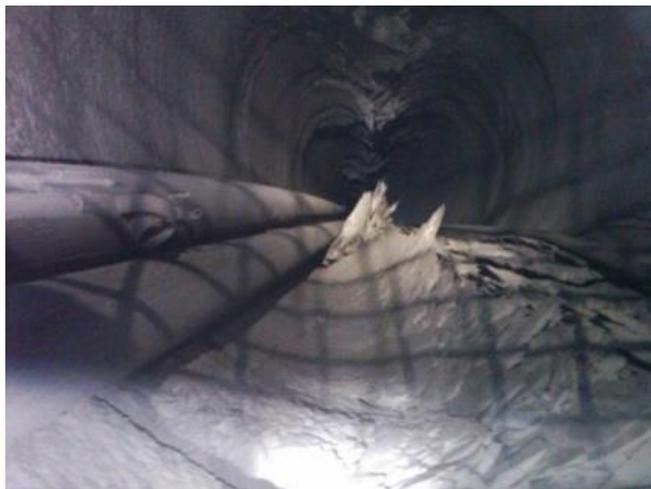
Figure 3 Buckling of argillite beds in north and south walls of a 1.8 m (6 ft) diameter bored raise

Prior to excavation of #4-Shaft, it was recognised that the primary failure mode of the ground would be buckling and opening of the beds when excavating parallel to bedding. Bored raises had shown buckling of the north and south walls in the past (Figure 3).

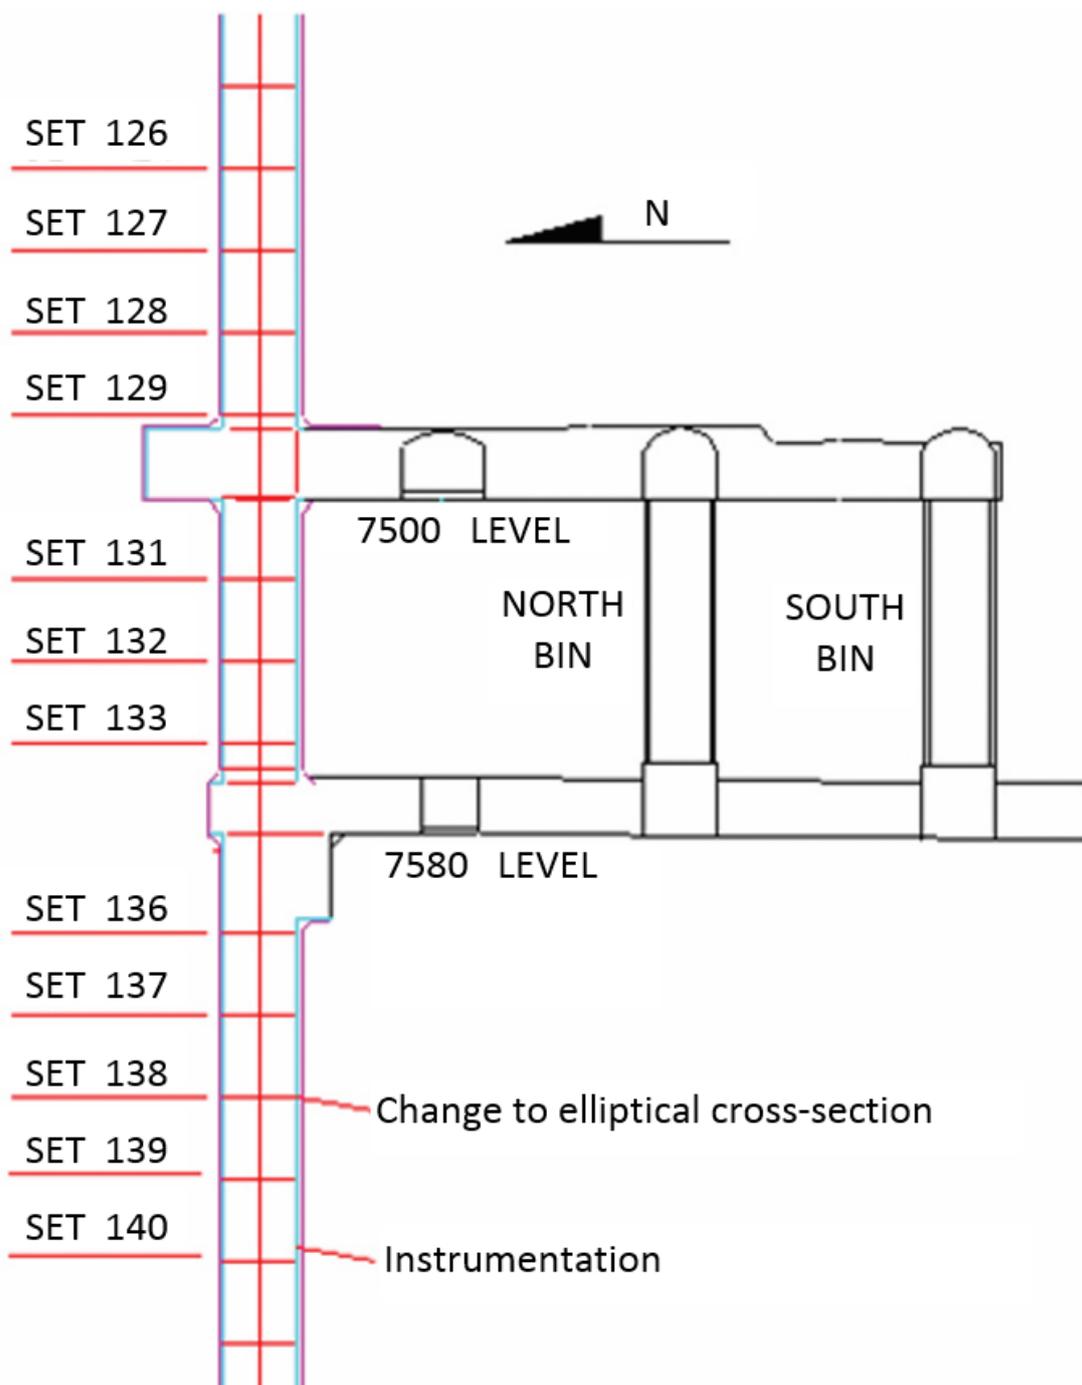
Figure 4 Vertical section of the shaft at the 7500 and 7580 Mine Levels

Cable bolting resumed as the shaft bottom came within 12 m (40 ft) of the 7500 production level (Figure 4) approximately 2,580 m (8,460 ft) below the ground surface, on 22 July 2014. The concrete liner was completed to the brow of the 7500 shaft station in early August of that year, and excavation of the level began. By 28 October, the shaft had reached the brow of the 7580 Level, and severe, vertical fracturing of the north wall of the concrete liner above the 7500 brow developed. Shaft ground support was increased to five 6 m (20 ft), resin grouted, 18 mm (0.7 in), bulbed, tensioned cable bolts per row on the north and south walls spaced on a 1.2 x 1.2 m (4 x 4 ft) pattern, with 3.6 m (12 ft) Dywidags placed midway, or 'five spotted', between them (Figure 5).

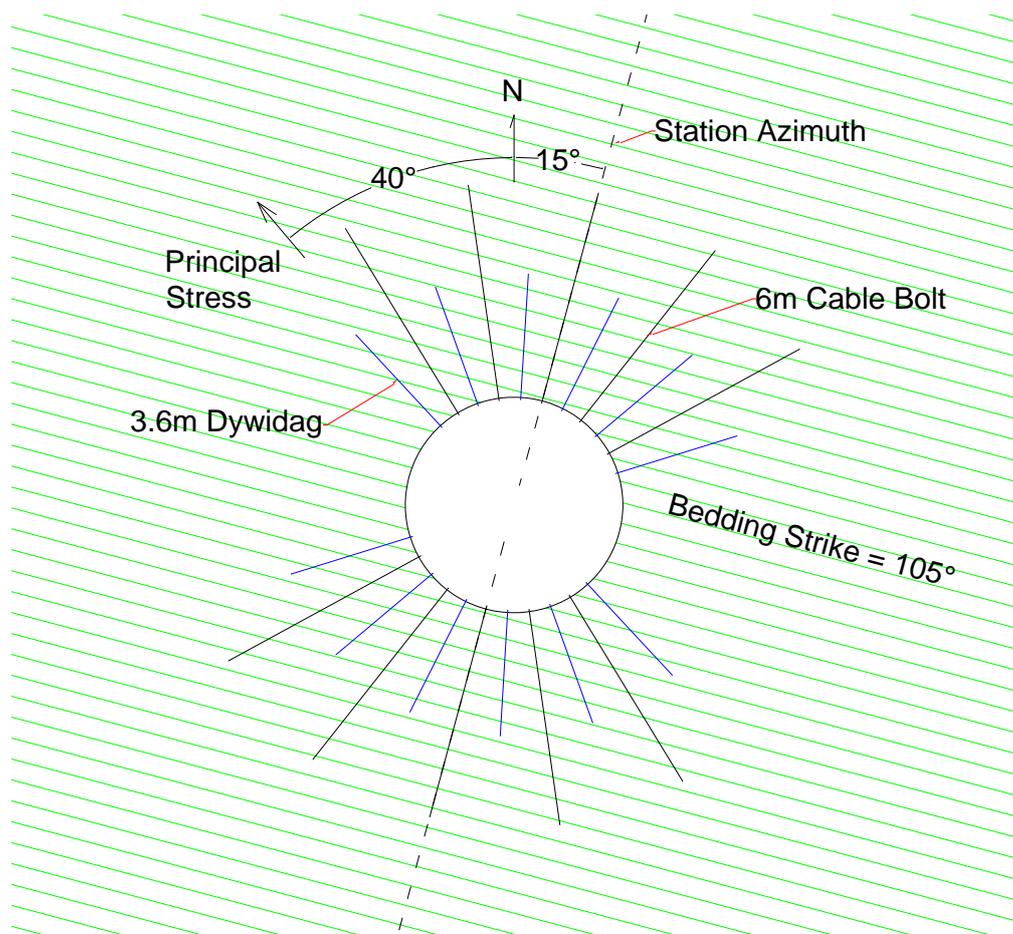
Figure 5 Ground support installation beginning at the 7580 Level

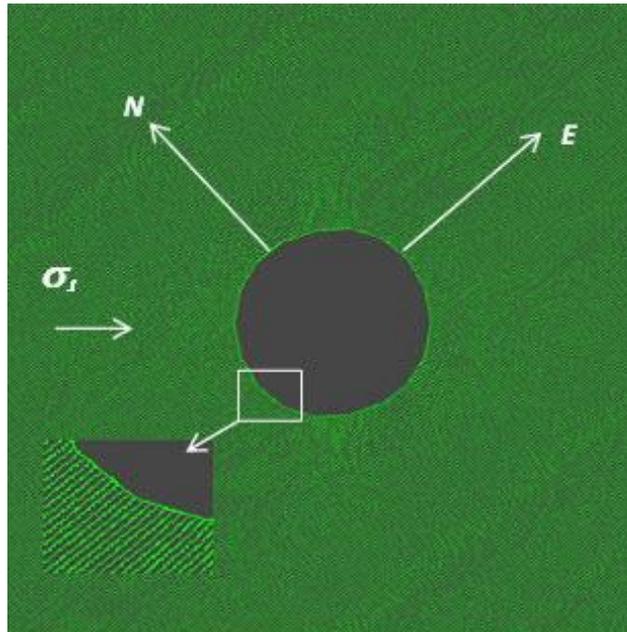
Figure 6 Circular shaft shape used in the model. The inset shows the model has a series of thinly spaced beds with an east–west strike

Traditionally, timbered shafts in the district were mined with “the long horizontal axis oriented normal to the bedding of the country rock. Experience has shown that such a position is best able to resist rock pressure at depth” (McWilliams 1960). After consideration, it was decided to change the excavation to a more elliptical shape with the long axis perpendicular to bedding, similar to the orientation of a timbered shaft, believing this would provide a more stable opening and reduce point loads on the concrete shaft lining. To examine the impact of such a non-circular shape, some simple numerical simulations of both circular and notched shaft cross-sections were run in UDEC Version 5, a ‘discontinuum’ type program developed by Itasca Consulting Group. The models simulated a series of thinly-spaced beds oriented east–west, with the major principal stress oriented N40W and assumed to be 1.5 times the vertical (gravity) stress, or about 100 MPa (14,500 psi) (Figures 6 and 7).

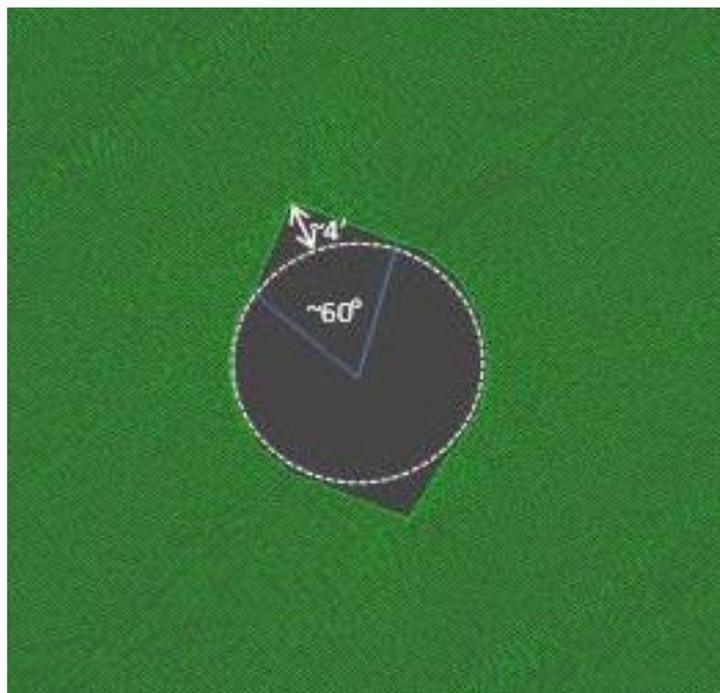
Figure 7 Notched (1.2 m) shaft cross-section used in the model

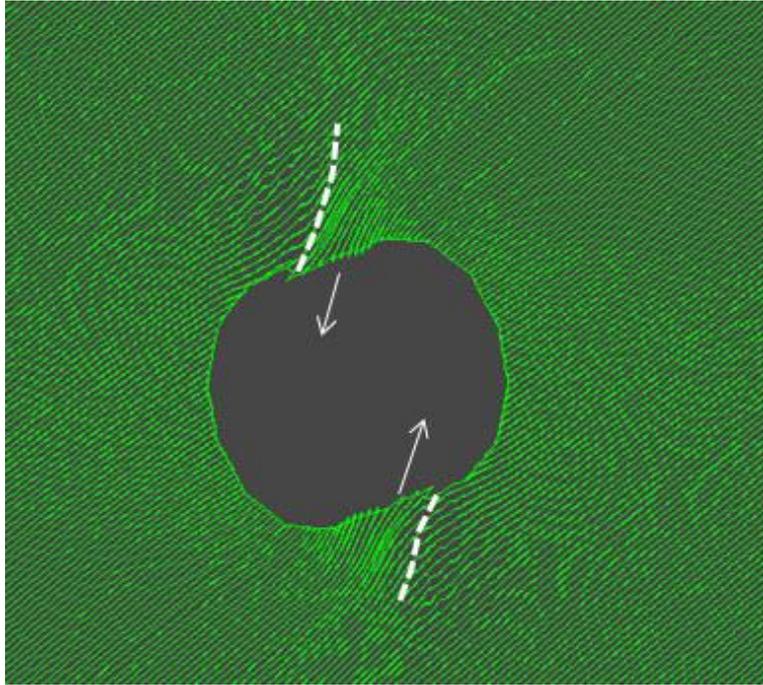
Figure 8 Magnified view of deformation showing mechanism of failure of the shaft walls with the circular shaft cross-section. The white dashed line shows where a kink forms at the north and south sides of the shaft, causing a wedge to push into the shaft

The simulation, as expected, showed the bedding tends to slip and buckle at the north and south sides of the shaft where the beds are more-or-less tangent to the wall in the circular case (Figure 8) as observed in other areas of the mine. As the thin beds, defined by foliation, buckle, they fracture in tension with resultant dilation into the opening. This mechanism was simulated with UDEC Version 5 by simulating discrete, narrowly-spaced joints characterised by zero cohesion and tensile strength and 20° friction angle. The intact rock comprising the beds was given a Mohr-Coulomb material model with zero tensile strength cut-off. The results showed an elliptical-shaped movement zone that is about 1.8 m (6 ft) deep on the north and south sides of the shaft (Figure 9). The maximum movement was shown to be directly perpendicular to bedding at opposite sides of the shaft.

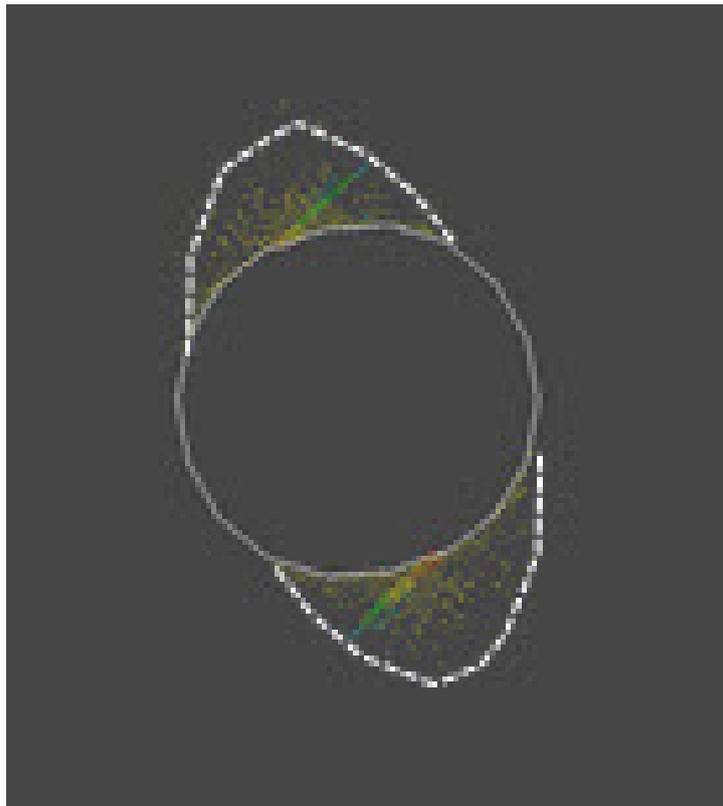
Figure 9 Region of shear displacement on bedding, approximately 1.8 m (6 ft) deep, for the circular shaft cross-section. Dashed, white line shows the elliptic-shaped failure zone

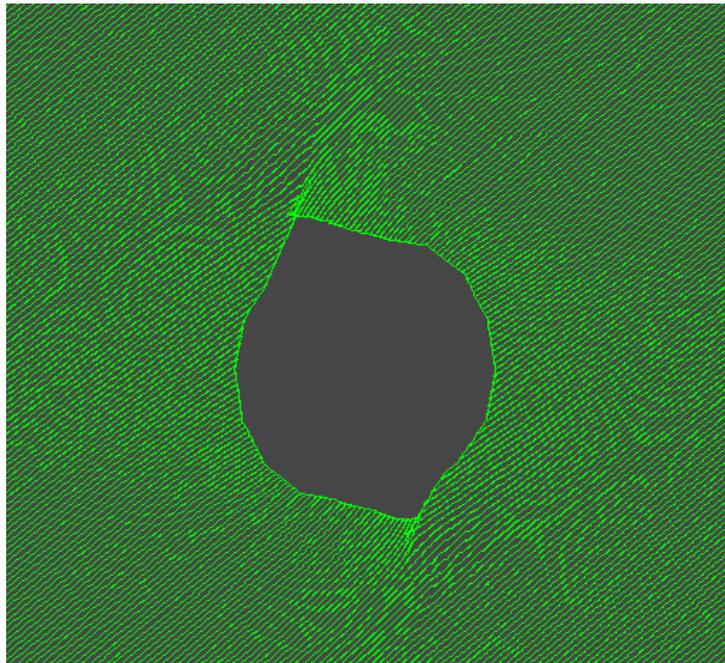
Figure 10 The notched cross-section prevents the formation of the wedge. Even though there is some shear at the tips of the notch, the cross-section maintains its original shape

Figures 10 and 11 show the notch shape largely eliminates the buckling and shaft deformation. The only significant movement remaining was shear on bedding directly at the notch tip.

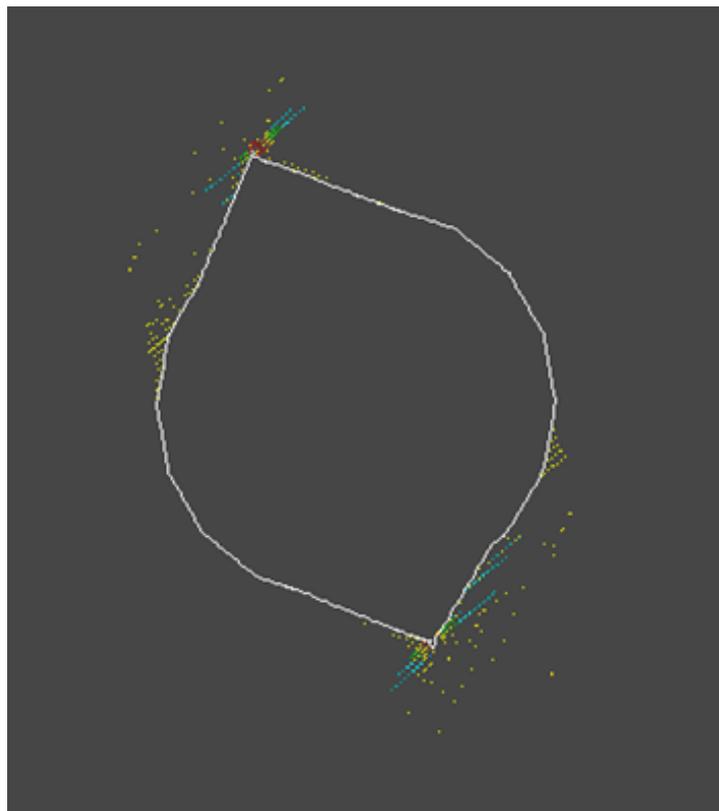
Figure 11 Failure region as shown by shearing bedding planes is largely eliminated by simply mining out the potential failed region before it is formed

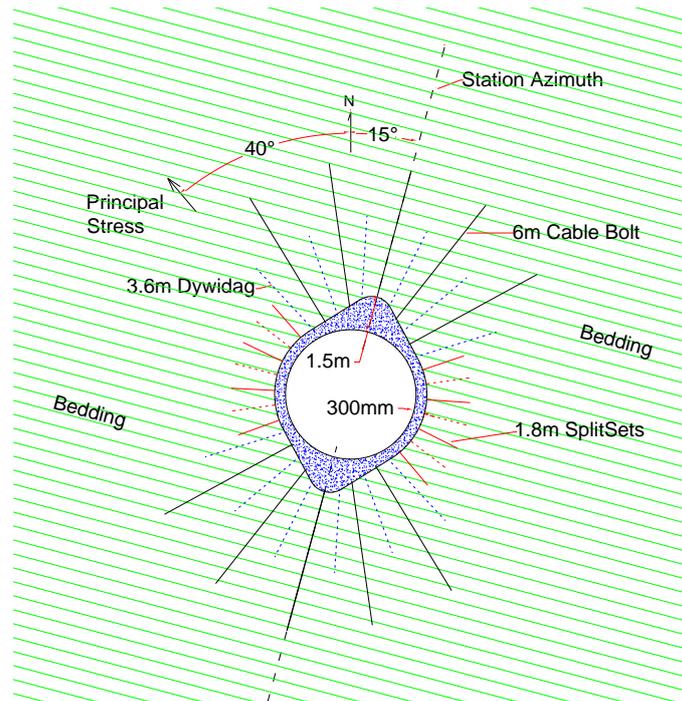
Figure 12 Shaft cross-section as redesigned. Cable bolts are only installed within 25 m (80 feet) above or below of shaft stations

Based on this modelling, the decision was made to change the excavated cross-section of the shaft to an elliptical shape, long axis perpendicular to bedding, with the final dimensions determined by the capabilities of the equipment being used to mine the shaft (Figures 12 and 13).

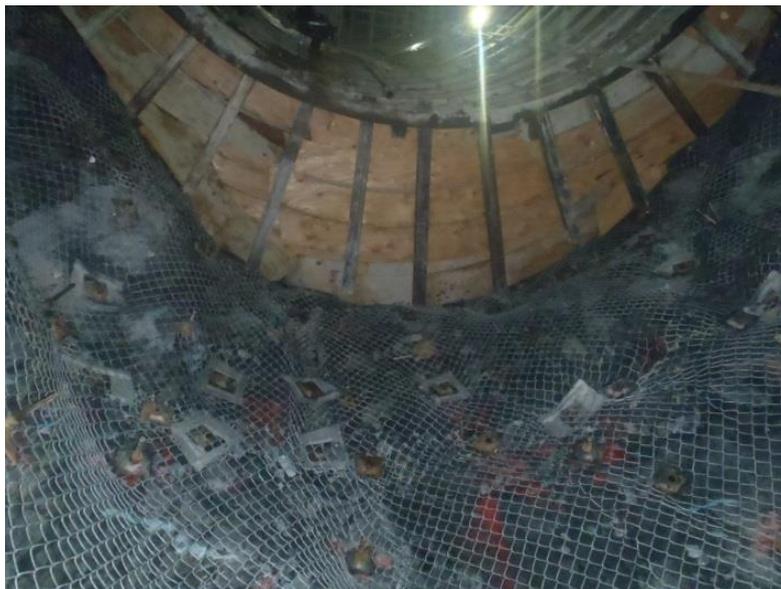
Figure 13 Looking up from the shaft bottom at the scribing on the bottom of the concrete forms. The elliptical excavation to the north of the shaft is clearly visible

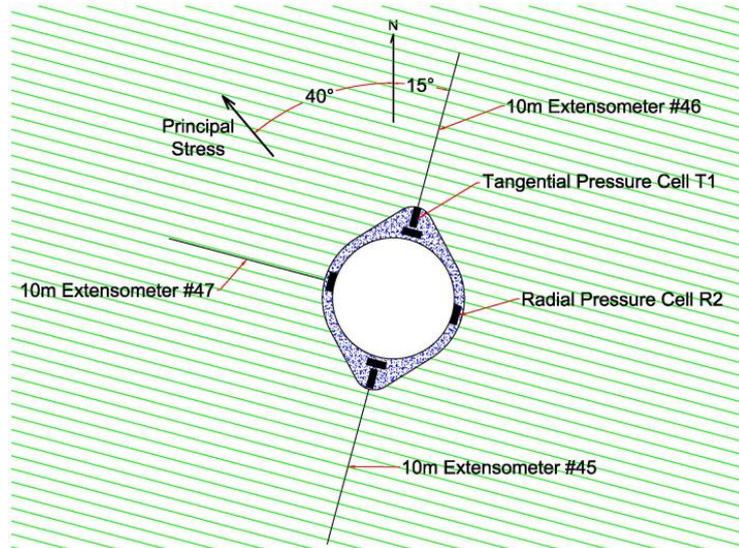
Figure 14 Plan view of instrumentation installation at set 140

Three 10 m (33 ft) multipoint borehole extensometers (Smart MPBX's), produced by Mine Design Technologies of Kingston, Ontario, were installed in 50 mm (2 in) boreholes, one each in the north, west, and south shaft walls. Four concrete pressure cells for monitoring of radially-oriented liner stress, model 4850-2, and two

stress cells oriented to monitor tangentially-oriented liner stress, model 4850-1, by Geokon of Lebanon, New Hampshire, were installed at the same elevation. The tangential cells were installed in the north and south shaft wall positions where they were expected to see the highest stresses (Figures 14 and 15).

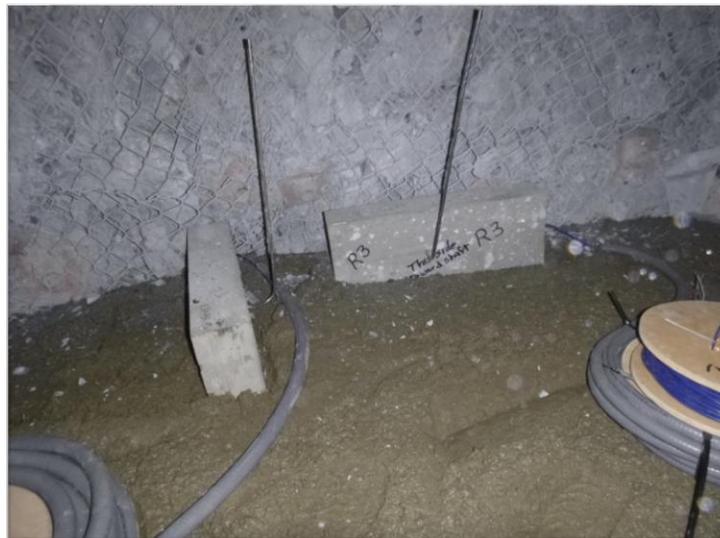
Figure 15 Instrumentation installation in south wall position of set 140

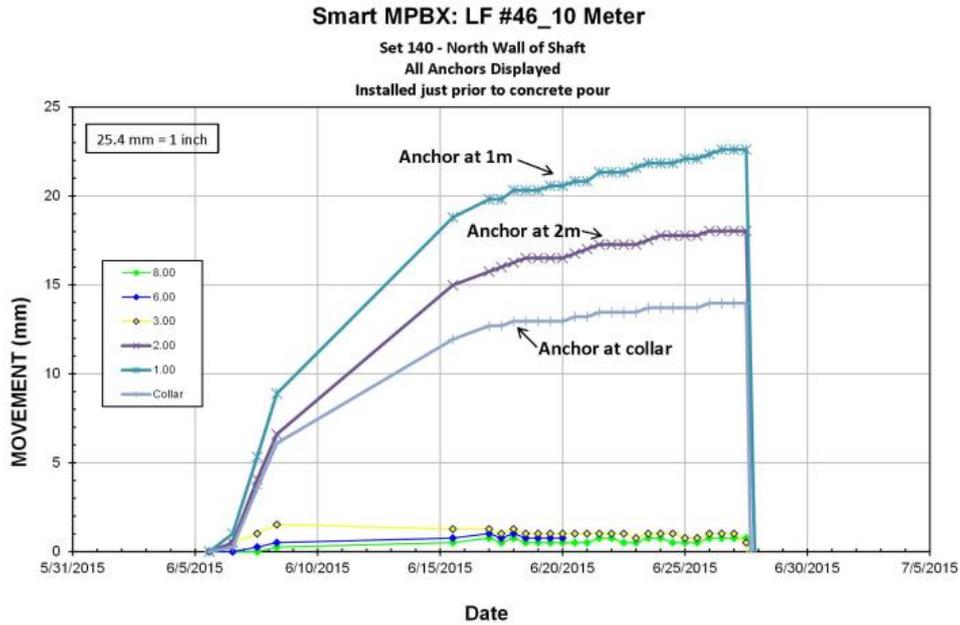
Figure 16 Extensometer #46, installed in the north wall of the shaft

The pressure cells and extensometers were installed during the shaft liner concrete pour on 4 June 2015, while the area had been excavated on 30 May. Therefore, the shaft bottom had advanced 6.6 m (21.5 ft) and the shaft walls had five days to equilibrate prior to installation of the instruments and pouring of the concrete liner. Prior to being destroyed on 27 June, extensometer #46 in the north wall of the shaft showed movement on the bedding at least 3 m (10 ft) from the shaft wall, deeper than what was estimated by the model (Figure 16). The anchor at the collar showed a maximum displacement of 14 mm (0.55 in), while the anchor one metre in from the collar showed a displacement of 22.6 mm (0.9 inch). This differential can most likely be attributed to the dilation of the bedding near the shaft wall immediately after excavation. As soon as the concrete was placed and began to strengthen, the movement of the collar was arrested, while the surrounding rock mass deformed toward the shaft, compressing any dilated bedding near the liner contact. This north wall extensometer showed the greatest displacement of the three installed. Extensometer #47 in the west wall of the excavation showed maximum displacement of only 1.3 mm (1/16 in), while extensometer #45 in the south wall showed 18.3 mm (3/4 in).

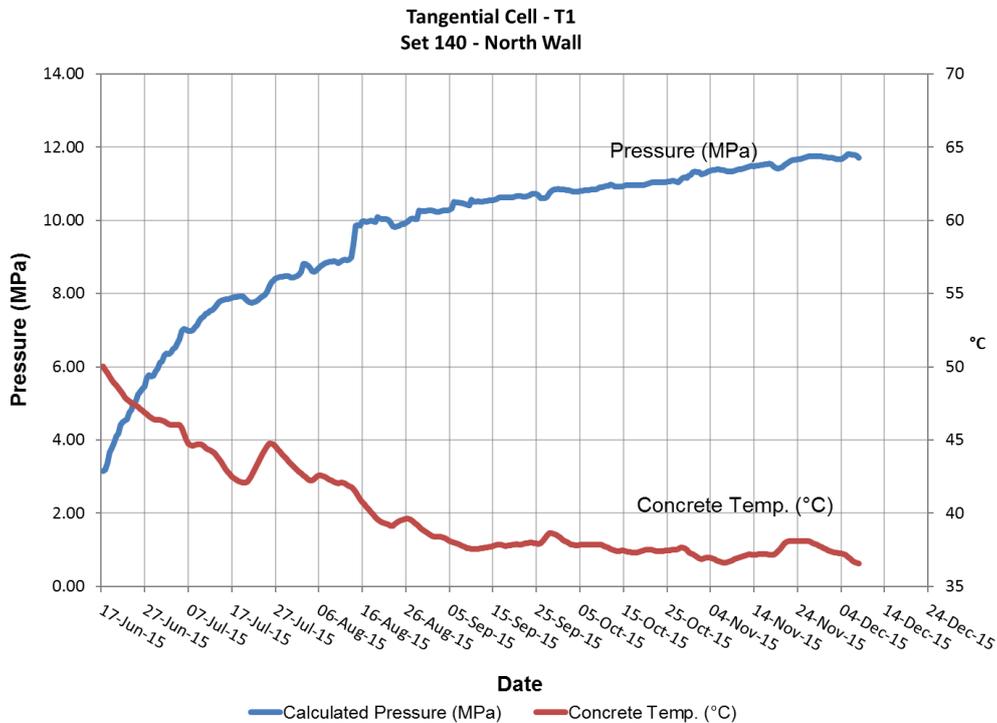
Figure 17 Tangential stress cell T1 (blue), north shaft wall, and concrete curing temperature (red)

The maximum pressure (compression) in the liner was 10.9 MPa (1,580 psi) recorded on 11 October 2015, at the north end of the elliptical excavation, in tangential pressure cell T1 (Figure 17). The rate of increase diminished as the concrete liner cured and shaft excavation moved away from the area. The highest compressive pressure seen by a cell oriented to monitor radial liner stress was in the east wall where, other than a few spikes caused by instrument sensitivity to temperature fluctuations, the pressure reached 6.5 MPa (940 psi), (Figure 18). No liner cracking was observed after implementing the elliptical shape from set 138 to the eventual shaft bottom at 8620 Level. Temperature effects on pressure readings in stress cells in Figures 17 and 18 have been removed from values shown.

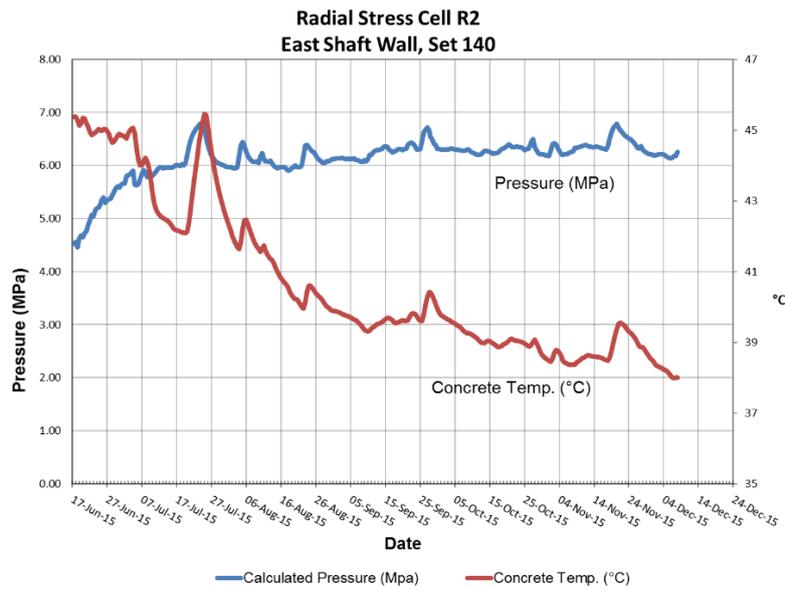
Figure 18 Radial stress cell R2 (blue), east shaft wall, and concrete curing temperature (red)

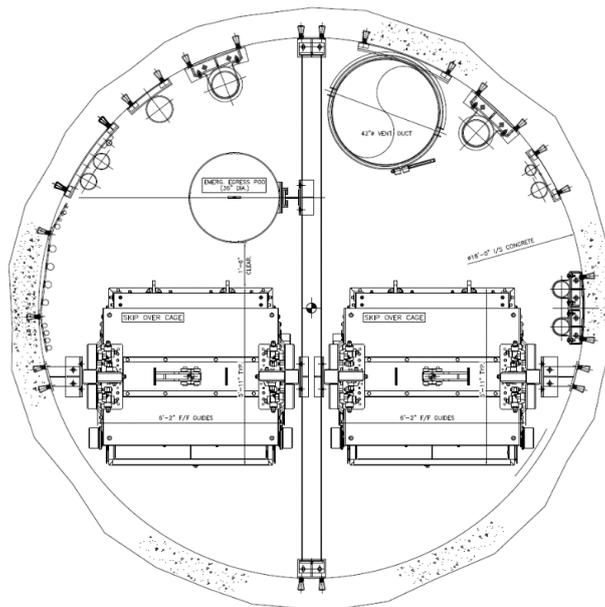
Figure 19 Typical shaft furnishing plan view

The shaft will be furnished with steel buntons and guides on 6.1 m (20 ft) spacing as shown in Figure 19. When the deformation was first observed, planning was initiated how best to furnish the shaft given the permanent deformation of the shaft liner. While it was known that deformation existed, the extent of the deformation was not well defined. Prior to the completion of sinking, an opportunity to better define the deformation was proposed by Cementation USA Inc. This plan involved high definition surveying of the shaft liner to a level never utilised in conjunction with furnishing before. Because the shaft was not sunk to full depth at this time, the scan was to be completed in two phases. The first phase would provide baseline data while there remained time to modify the permanent shaft steel if required. The second phase would take place after the completion of sinking and would scan the remainder of the shaft and re-scan key areas of the shaft as determined by phase one, including areas where additional deformation may have occurred.

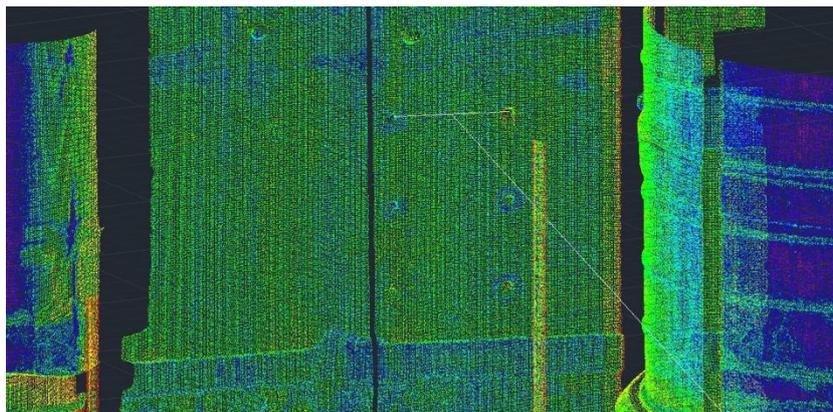
Figure 20 Dimensions were typically pulled from the midpoint of the top two inserts

The chosen equipment for the first phase was the Leica ScanStation P20, a portable unit capable of scanning one million survey points per second. This unit generated a model of the shaft with a minimum point density of 108,000 points per m², sufficient accuracy and resolution for this analysis and to record defects on the face of the shaft liner. The methodology for scanning the shaft involved placing the scanner unit on an aluminium arm that was mounted to the shaft wall using two bolts into existing shaft steel inserts. A separate scan was taken in each 6.1 m (20 ft) shaft set to ensure consistent accuracy of data within each set. Control targets were placed in each scan and left in place for the adjacent scans, allowing all of the individual scans to be tied together with a high level of precision. The product of each scan was a point cloud, all of which were integrated and registered into AutoCAD files in which dimensional analysis could be completed. Dimensions were verified between the north and south steel inserts as well as the east and west inserts to model how the steel would fit at each set (see Figures 20 and 21).

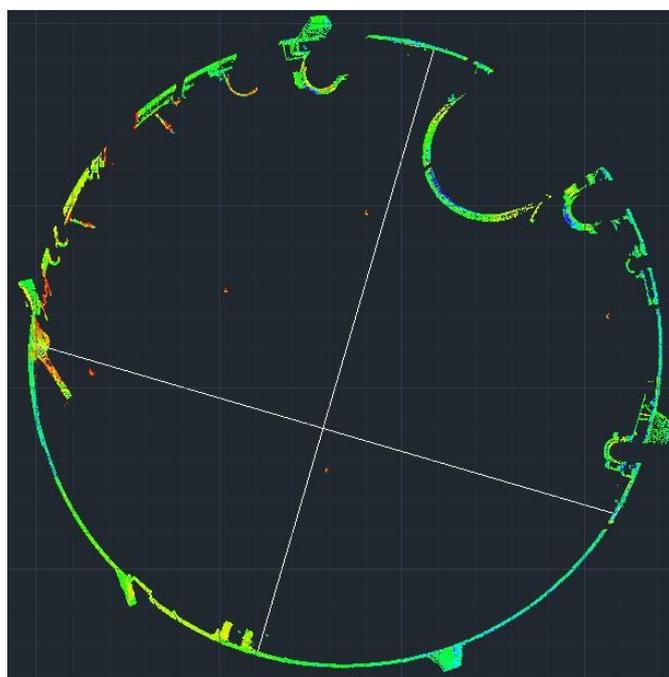
Figure 21 Typical shaft set scan data with dimension pulled between inserts

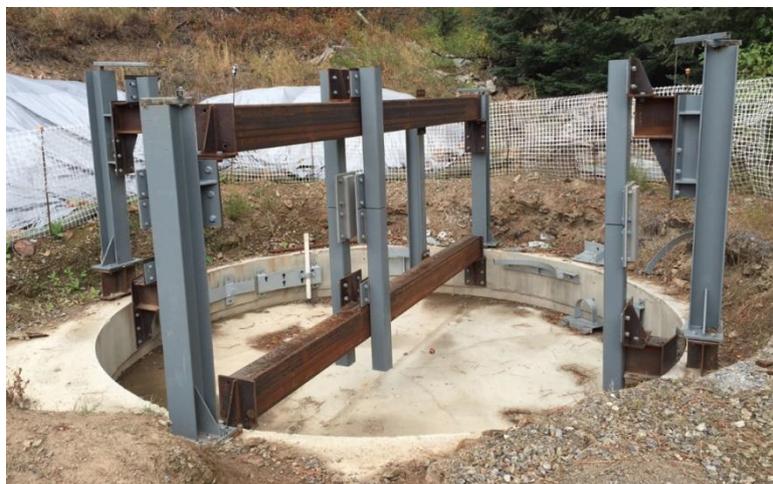
Figure 22 Surface training facility

As an additional training and testing supplement, a shaft furnishing training centre was established on surface, as shown in Figure 22.

This mock-up of a typical shaft steel set was constructed by pouring an exact replica of the shaft liner A-ring in a small excavation, complete with bolt inserts for the shaft steel. Wall brackets were installed in the ring and the steel was constructed within it as a training exercise. All steel was full-scale, with the exception of the guides, which were shorter than a typical set for logistical reasons. The original intention of the centre was to train crews on the proper and safe installation of steel, a purpose that was fulfilled. However, the training centre also came to serve as a test centre for modifications and improvements, such as determining the best design for steel installation jigs, concrete and liner plate notching, and installation of modified wall brackets.
