TamCrete structural support liner – a rapid polymeric structural support lining

T Kothe *Normet International Ltd, Switzerland*

Abstract

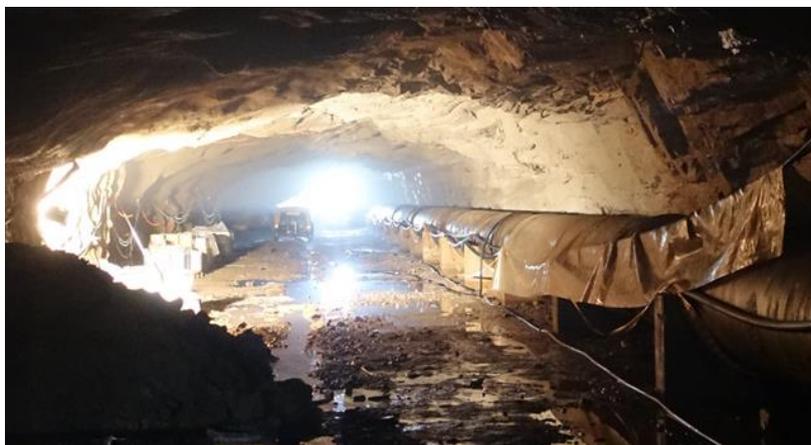
Figure 1 Granite tunnel with water supply pipe and TamCrete SSL as support liner in the crown

In most Scandinavian cities, water supply tunnels are in solid rock which can have unlined sections without a concrete lining. Some of these tunnels are now being upgraded, but logistically, the use of concrete is complicated or impossible where the supply pipes are installed and must not be removed. Tests were requested for a water supply tunnel (Figure 1) regarding the mechanical performance and future application quality of the TamCrete liner. The testing and onsite results are shown and discussed in the following sections.

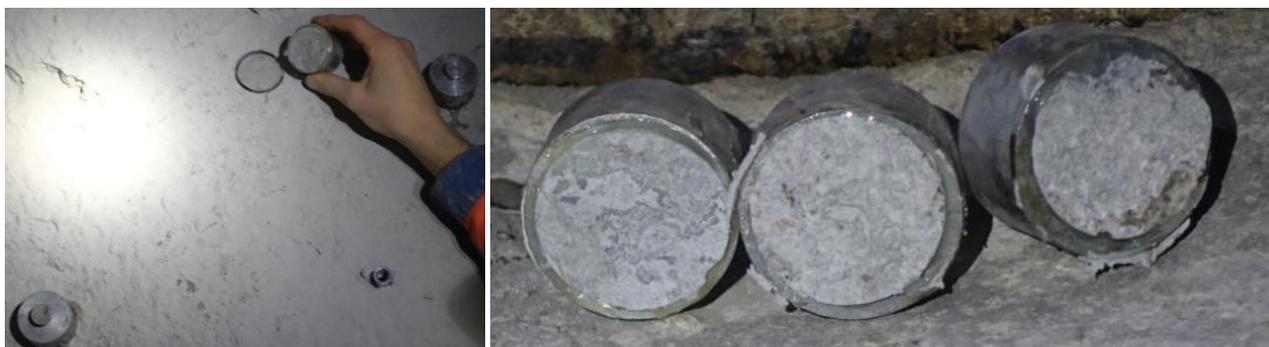
Figure 2 Onsite samples 6, 7 and 8 after adherence test

Table 1 gives an overview on the single adherence test results with Figure 2 showing typical samples at site.

Nr	Adherence in MPa	Failure mode
1	0.59	Failure in glue on SSL surface
2	No result	Failure already in rock
3	0.59	Failure in glue on SSL surface
4	> 0.59	Failure in SSL, thin application (1 mm)
5	No result	Glue failed when tester was installed
6	0.88	Failure in glue on SSL surface
7	> 0.59	Failure in SSL
8	0.88	Failure in SSL
9	3.42	Failure in SSL
10	0.59	Failure in rock

All samples reached the expected tensile adherence of > 0.5 MPa, however, they do not show the > 1 MPa bond suggested by EFNARC (2008). The true adherence is clearly higher than the test results. The first five tests were mainly limited by the glue. However, even with the better glue used in tests 6 to 10, the failure is always on the SSL surface area. During application, a certain amount of reactive TamCrete SSL slurry is as mist in the air and will settle down in small spheres onto the thickly applied TamCrete liner with less bond to the cured TSL. It seems that this layer of settled mist is measured and needs to be removed in future tests. As a consequence, the results seem to reflect more the adherence between the cured TamCrete lining and settled and reacted material aerosols on top, rather than the bond to substrate. Only sample 9 showed an exceptionally high value and a failure within the structure. None of the samples failed at the rock interface.

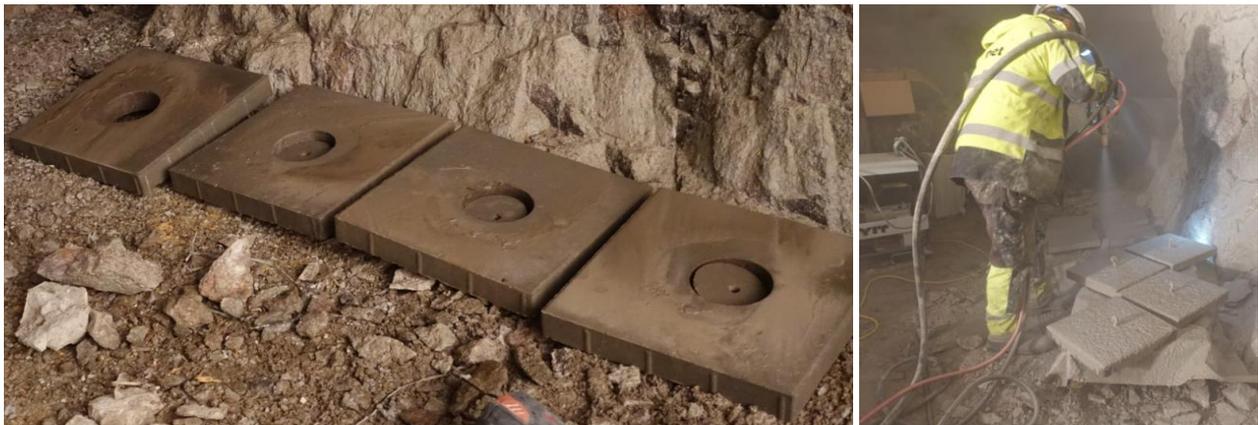
Figure 3 Sample preparation

Initially a drill core of rock from the crown was meant to be glued and covered with TamCrete SSL to test the block bearing capacity. As it turned out, the rock was too brittle and the initial test could not be executed. To measure the bearing capacity, four concrete panels were prepared and sprayed for pull-out tests as shown in Figure 3 instead. The diameter of the drill core was 114 mm and the resulting gap was 2–3 mm in width. The concrete core was put back so that the panel and core were ready to be coated with TamCrete SSL. Two panels were sprayed with two layers and the other two panels were sprayed with three layers of TamCrete SSL. As seen in Figure 4 showing the back side of the panel, TamCrete SSL penetrated and filled the whole gap made by the drill bit in the concrete panels. The panels are 50 mm thick.

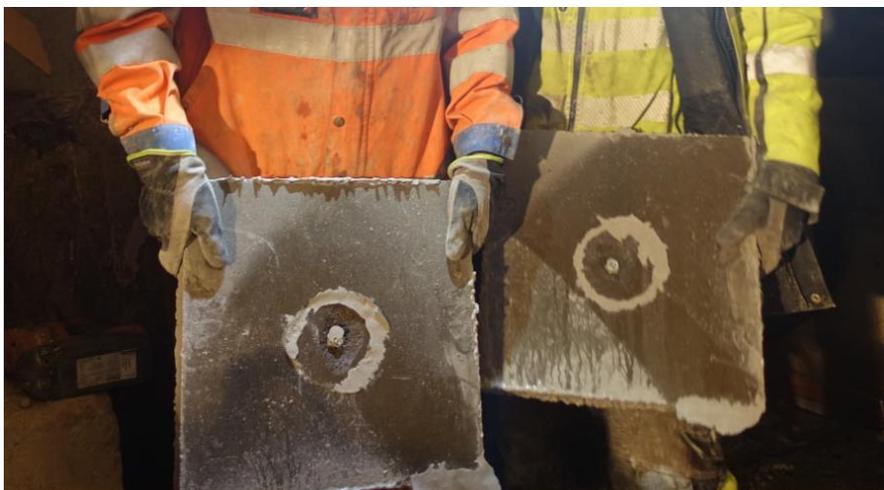
Figure 4 View on the back side. Penetration of SSL all through the gap

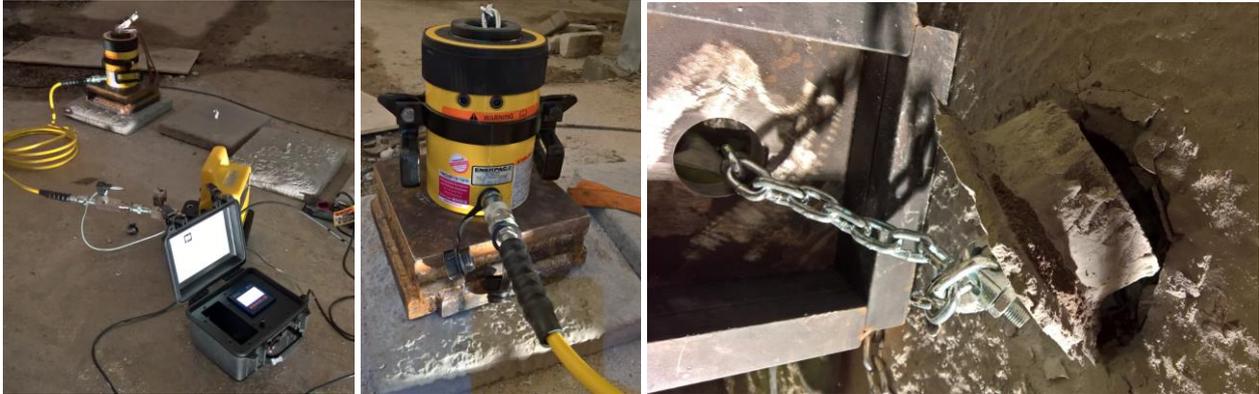
Figure 5 Test set-up

For testing the bearing load of such simulated loose rock situations, an Enerpac 603 Hollow Plunger Cylinder was placed onto an extra steel frame and a maximum weight was measured at failure of the system, as indicated in Figure 5.

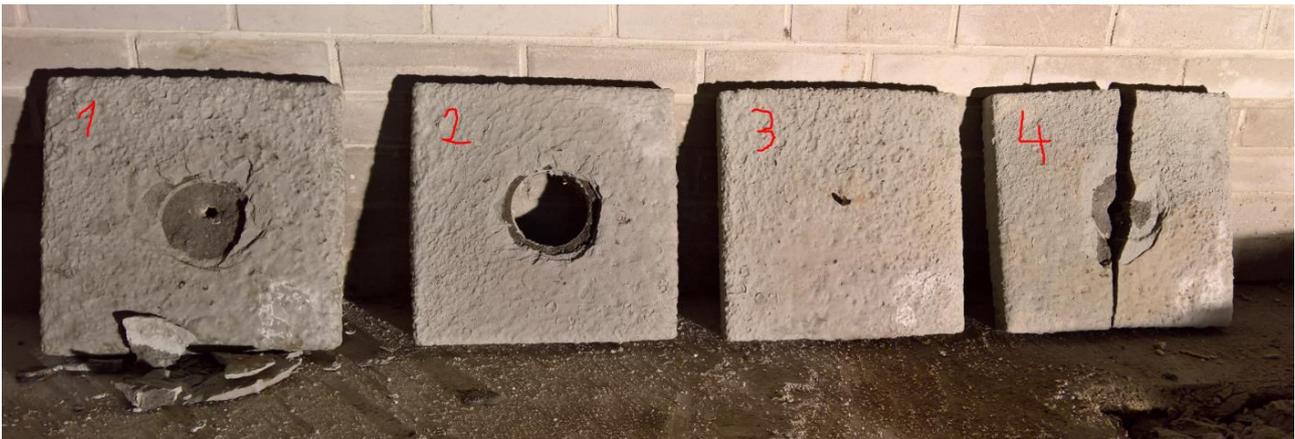
Figure 6 Samples 1–4 after pull-out test

The failure load was evaluated approximately five weeks after application. Figure 6 shows all samples after the pull-out test. The failure mode varies strongly. While sample 1, with 10 mm thickness, failed within the concrete cylinder, sample 2 failed somehow in shear, sample 3 failed at the drilled pull-out anchor, and sample 4 ruptured in two parts. All samples resisted a strong load.

The basic purpose was to simulate a situation in which a loose rock is glued with coverage and penetration to the surface. As a result, as shown in Table 2, we can see that a block of 11 cm diameter is kept in place up to a weight of 2 t. Since the geometrical set-up was complicated, with the steel frame and the anchor attached, this test applied already different stresses and forces onto the material. These results rely strongly on penetration of the SSL in cracks and the resulting shear force that may not exist when the material is applied onto rock.

Applied layers	Total layer thickness (mm)	Tonne	kN
Sample 1	3	10	2.1	20.6
Sample 2	2	8	1.8	17.6
Sample 3	3	10	2.6	25.5
Sample 4	2	8	2.5	24.5

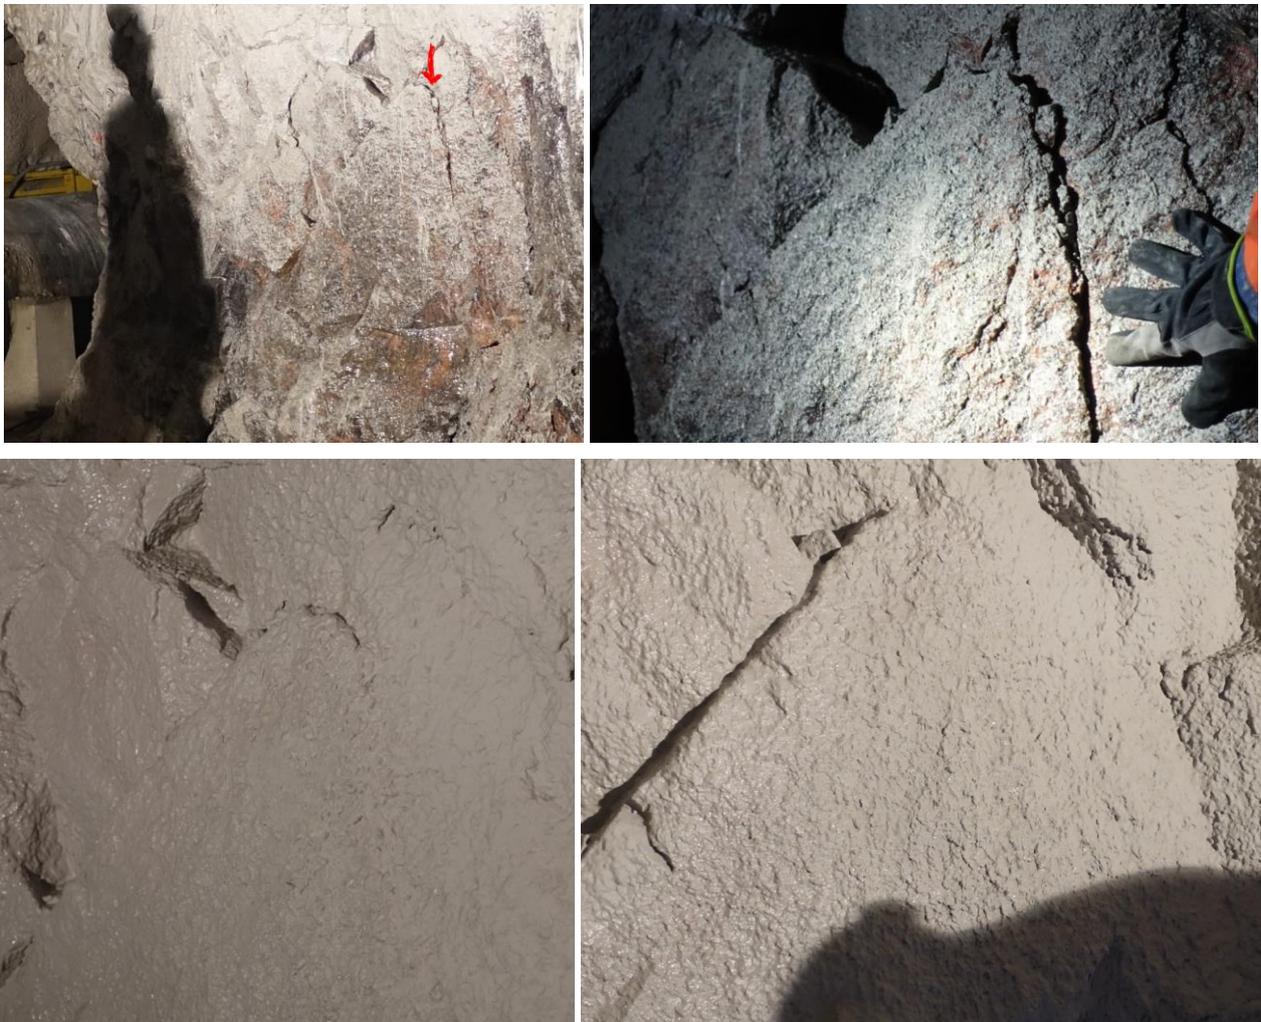
Figure 7 Pictures of zone A before and after spraying

Finding cracks to drill in the already sprayed areas at site turned out to be very difficult. Two crack zones were found. Zone A had a crack 1.5–2 cm thick (Figure 7), while zone B had a 1–2 mm wide crack (Figure 8). Both zones were sprayed with TamCrete SSL and drill cores were taken to monitor the penetration of the product into the crack.

After spraying in zone A, drill cores were randomly taken and the crack zone visually inspected. The big gaps and voids were filled completely even though the spray angle could not be varied and was straight onto the surface. The drill cores often fell apart due to the fractured nature of the rock and the drilling process. Figure 9 shows good penetration of the SSL.

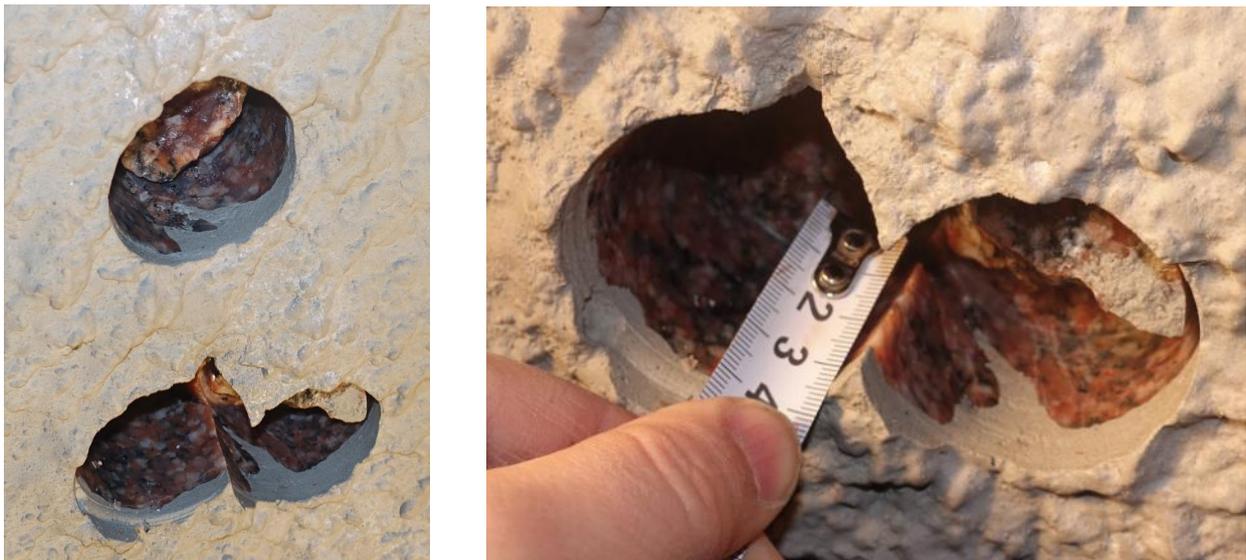
Figure 9 Penetration depth zone A

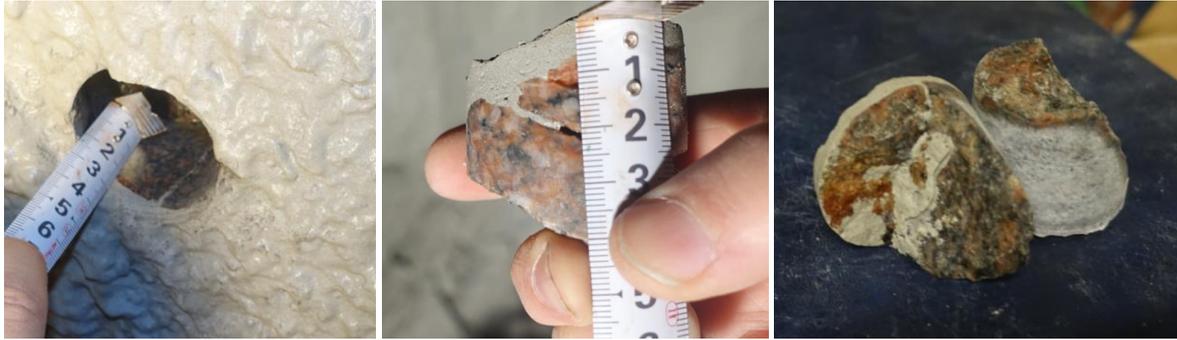
Figure 10 Penetration depth zone B

Two cores were taken in zone B which intersected the cracked zone (Figure 10). One core fell apart and showed an area with 11 mm penetration into a 1 mm wide crack, while the other core showed 15 mm of penetration. In addition, the spray angle was not straight into the crack zone, but angled to the surface.

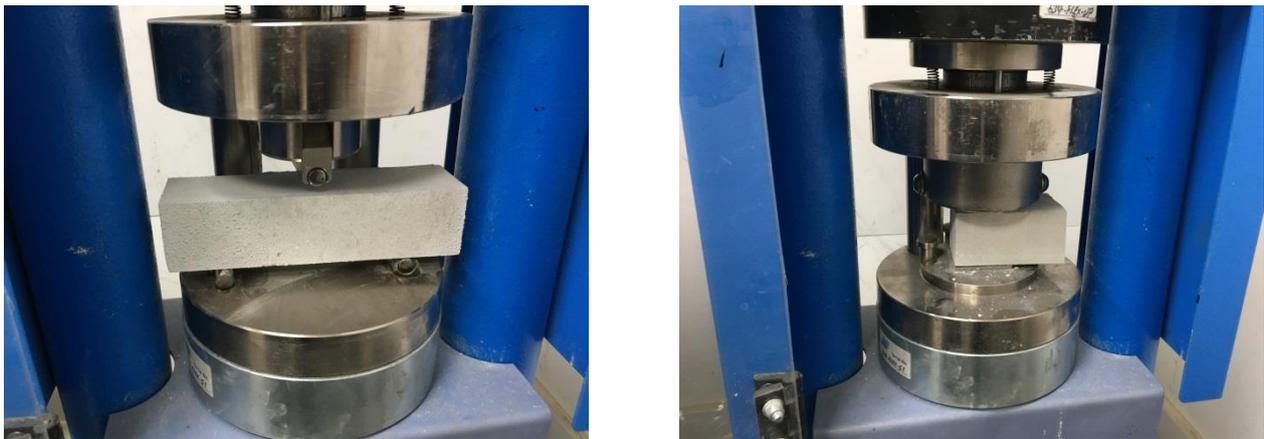
Figure 11 Flexural and compressive strength test device with SSL sample

Flexural and compressive strengths have been tested in accordance with BS EN 1015-11 (British Standards Institution 1999) after 28 days. As shown in Figure 11, the three-point bending test is applied for a flexural strength test. The broken pieces have been used for compressive strength tests.
